Condition Report

Roof Condition
Various Blocks
for NOCS

Kendall Kingscott

Job No. 170071

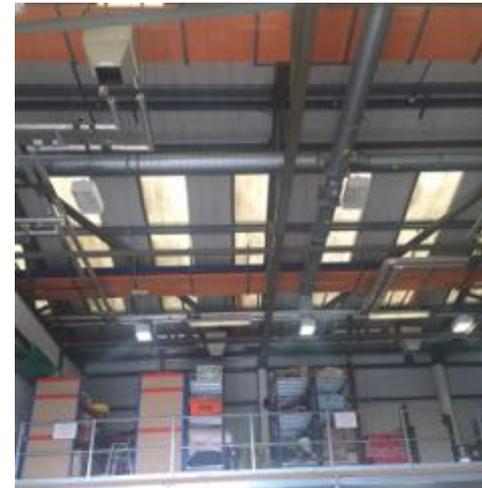
Photo 1: Internal view of the stores and workshops.

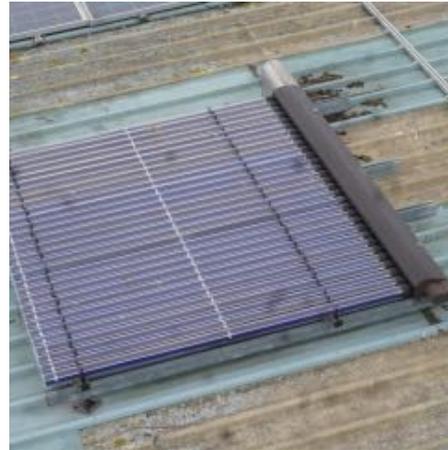
Photo 3: Solar water heating system.

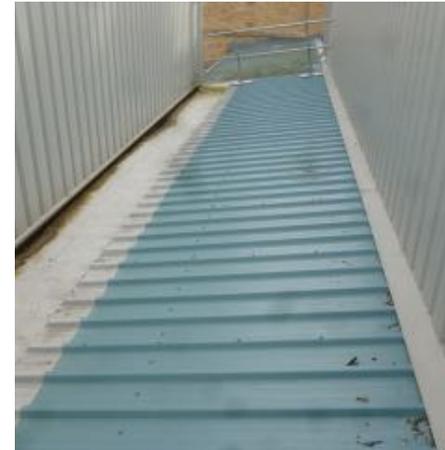
Photo 17: General view of the lower sections of roof.

The profiled metal sheeting to the roofs have surface soiling and are showing signs of cut edge corrosion. A further section of exposed sheeting at eaves level has significant surface corrosion. The roof sheets immediately adjacent to the access door are protected from the prevailing weather, with no immediate signs of cut edge corrosion. However, the surfaces do have minor soiling and we noted surface staining caused by corrosion. We suspect this has been caused by swarf from the installation of new coverings to the roof above.

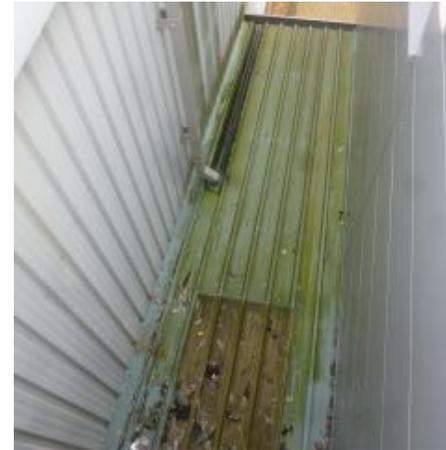
Photo 21: View of infill section of roof between MARS and stores.

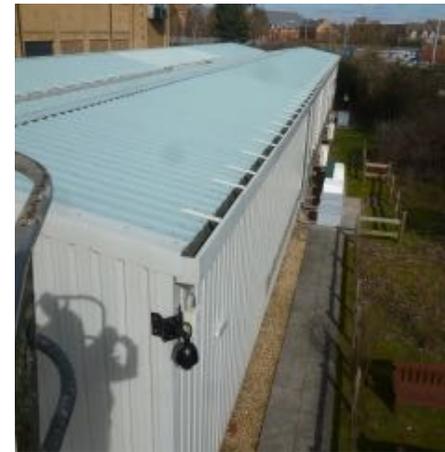
Photo 25: View of building A1.

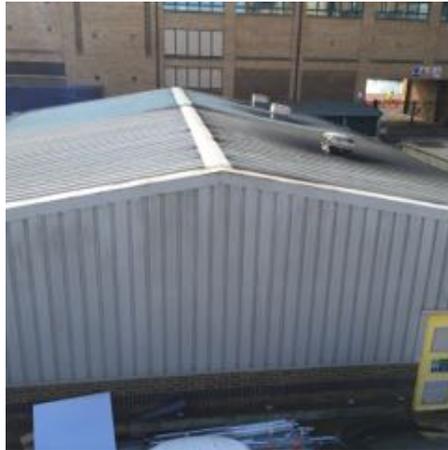
Photo 30: View of building A3

The coatings to the roof sheets have degraded with cut edge corrosion and areas of spot corrosion in various locations. The roof sheets are heavily soiled, contaminated and stained. The profiled metal ridge and trims to the property are in a similar condition to the roof sheets, with cut edge and spot corrosion alongside heavy soiling and contamination.

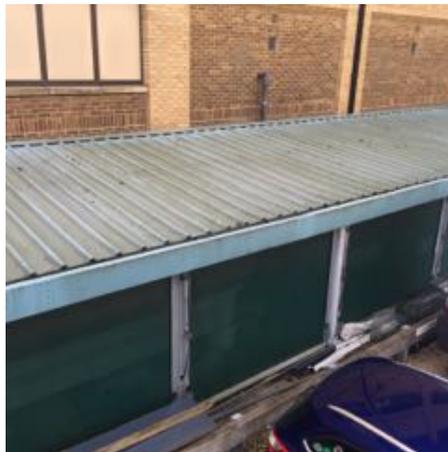
Photo 35: View of building A4

The coatings to the roof sheets have degraded and cut edge corrosion was evident alongside areas of spot corrosion in various locations. The roof sheets are also soiled and stained. We did note some minor deflection to the roof sheets and minor impact damage but these do not appear to be affecting the performance of the coverings. The profiled metal ridge and trims to the property were generally in a similar condition to the roof sheets, with cut edge corrosion, spot corrosion and soiling. Some minor distortion is present to the trims but hasn't caused any significant issue.

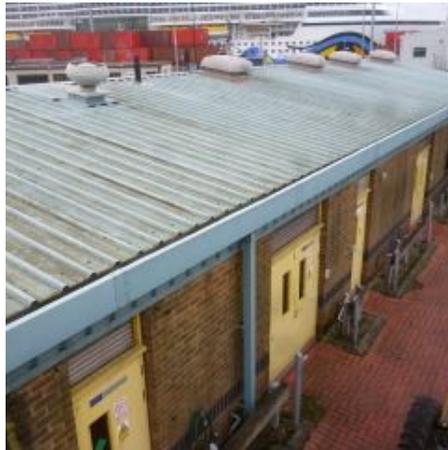
Photo 38: View of building A5

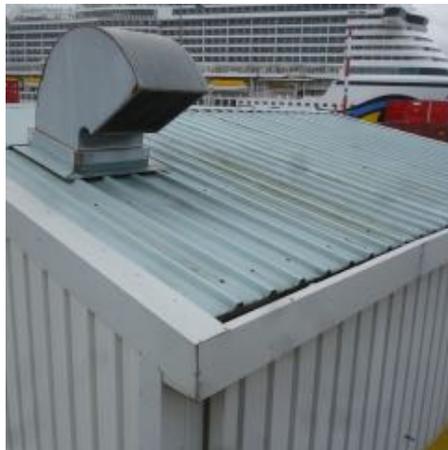
Photo 42: View of roof to building A6

The coatings to the roof sheets have started to degrade with cut edge corrosion to the coverings, the worst of which is concentrated to the Southern roof pitch. The roof sheets are also lightly soiled and stained and, to the Southern pitch, one has been replaced with a new darker coloured sheet. The profiled metal ridge and trims to the property have some minor distortion but

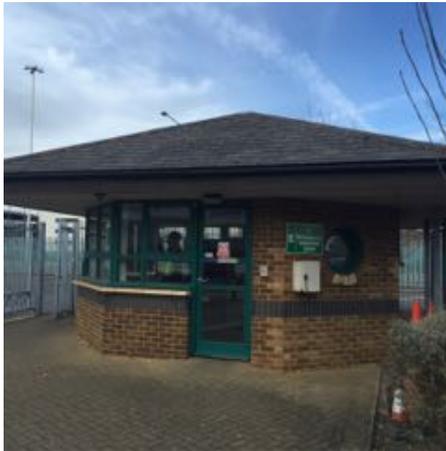
Photo 44: View of building A7

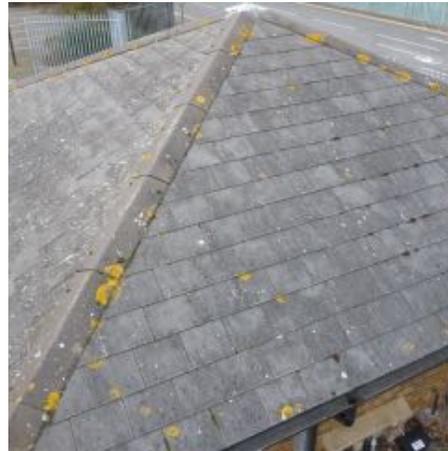
Photo 45: View of slate roof coverings.

The synthetic slate roof coverings are generally soiled with considerable moss growth to the surfaces. The slates are in a fair condition with no cracks evident at the time of our inspection. We did note that one of the hip tiles near to the apex of the roof is cracked and requires replacement.

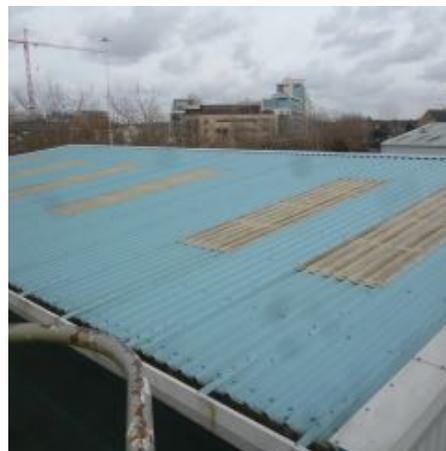
Photo 50: View of roof to Building A8

This roof appears to be more modern than the majority of the buildings at the site and is generally in a better condition. There was no evidence of cut edge corrosion at the time of our inspection although there was some light soiling at the edge of the sheets which indicates water is collecting and drying in these locations. The fixings to the roof sheets also appear to be in a fair condition at this time.

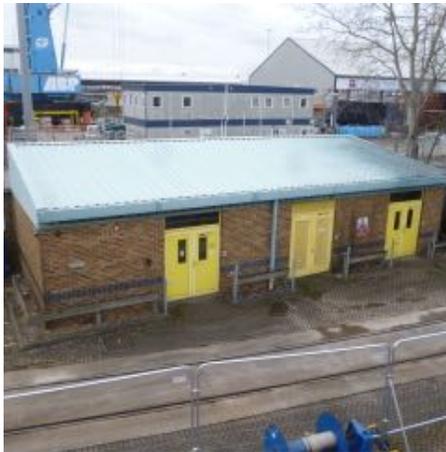
Photo 52: View of building A9

The coatings to the roof sheets have cut edge corrosion at eaves level and are soiled and stained. The profiled metal ridge and trims to the property have corrosion, particularly to the apex of the roof.

This building is located adjacent to trees and we noted vegetation growth within the guttering. This will need to be cleared to prevent damage to the guttering, roof and property, and to keep the rainwater goods free flowing. We note the gutter is only served by one downpipe which may be inadequate for the size of roof.

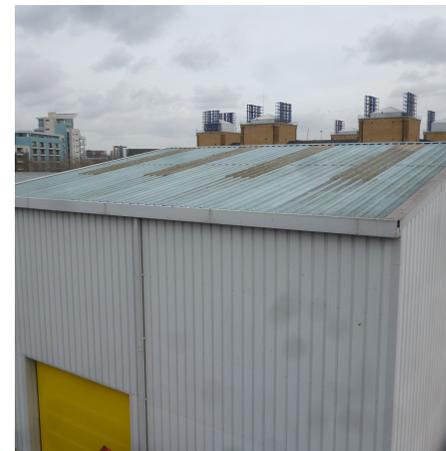
Photo 53: View of Building A10

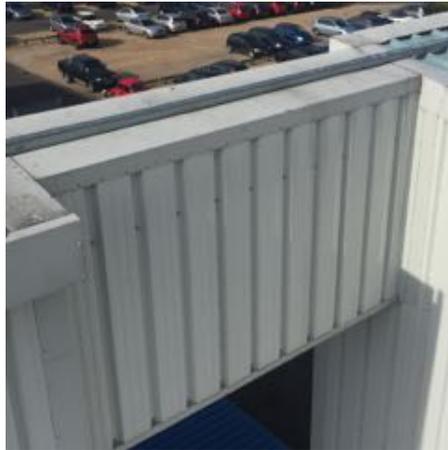
Photo 54: High level link to the Stores and Workshop Roof

The coatings to the roof sheets are degraded and have cut edge corrosion. The roof sheets are also soiled and stained. The profiled metal ridge and trims to the property are in a similar condition with cut edge corrosion and soiling. Some minor distortion was noted to the trims but this is unlikely to cause any significant issues. The fixings to the roof are generally intact, with no missing caps visible.

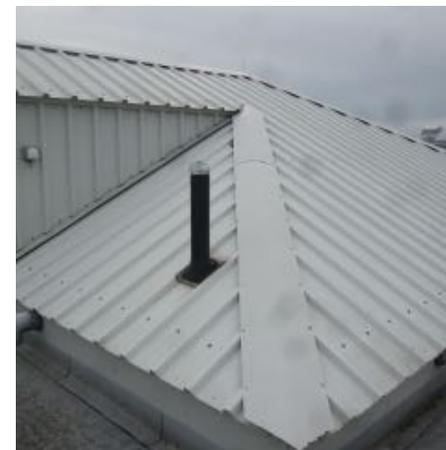
Photo 56: View of metal roof coverings to Node 3.

stanchions with tensioned plastic coated steel cables and a steel handrail. The coatings to the roof sheets have degraded with cut edge corrosion and a few minor areas of spot corrosion. The coatings are also chalking from UV degradation. The ridge and hip cappings are in a similar condition to the roof sheets, with cut edge corrosion and chalking finishes. A number of SVP's penetrate the roof but are generally in fair condition.

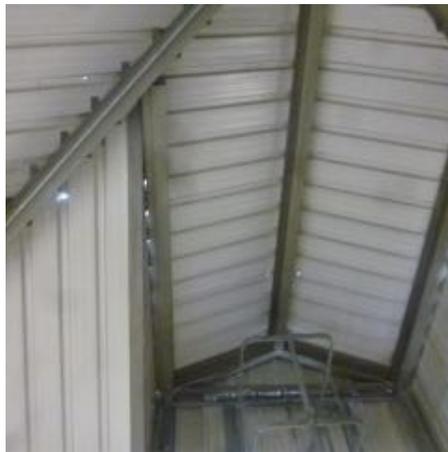
Photo 57: Internal view of Node 3.

Internally, we noted a number of holes within the roof coverings and ridge / hip flashings. This was evident by clear daylight being visible within the roof void. On closer inspection, we found a number of missing fixings that require replacement. We are of the opinion these were installed under high tension and seasonal thermal movement within the metal coverings has caused their eventual failure.

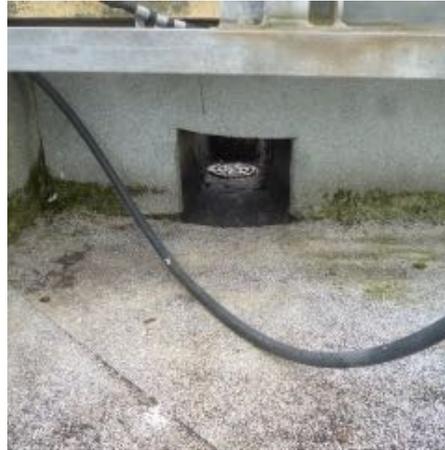
Photo 61: Rainwater outlet.

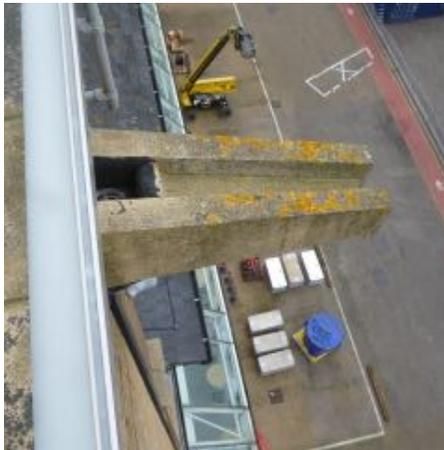
Photo 62: Overflow chute.

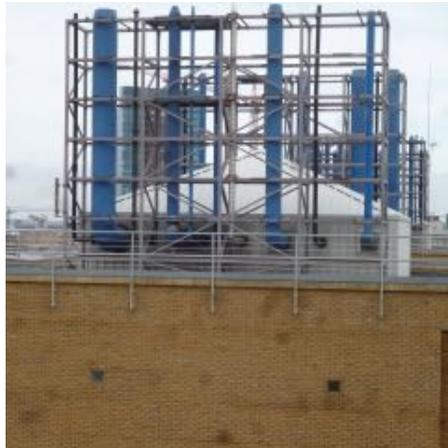
Photo 65: View of Node 2 from Node 3

It is our opinion that the pre-finished profiled metal cladding, roofing sheets and trims are likely to be in a similar condition to those installed to Node 3. This will include cut edge corrosion, missing foam packers and issues relating to missing or damaged fixings. This was also confirmed by our internal inspection where a large amount of light transfer was noted at the eaves and hips.

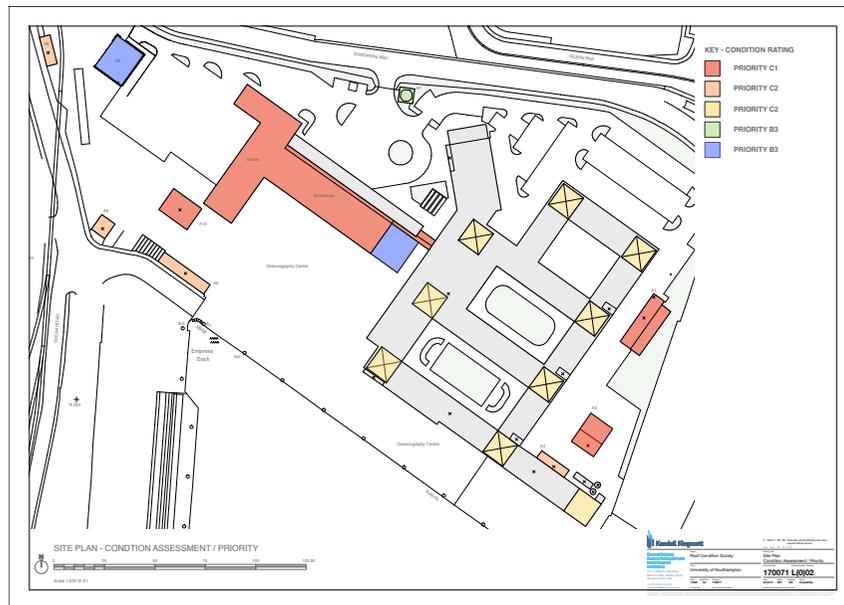
Drawing L(0)02 Showing roof priority groups in detail. Refer to Appendix B for full size

Group A (Condition Rating Category C Priority 1) - This includes the roofs to buildings A1, A3, A10, the Workshops (excluding the newer section) and the Stores. These roofs are generally in the worst condition with:

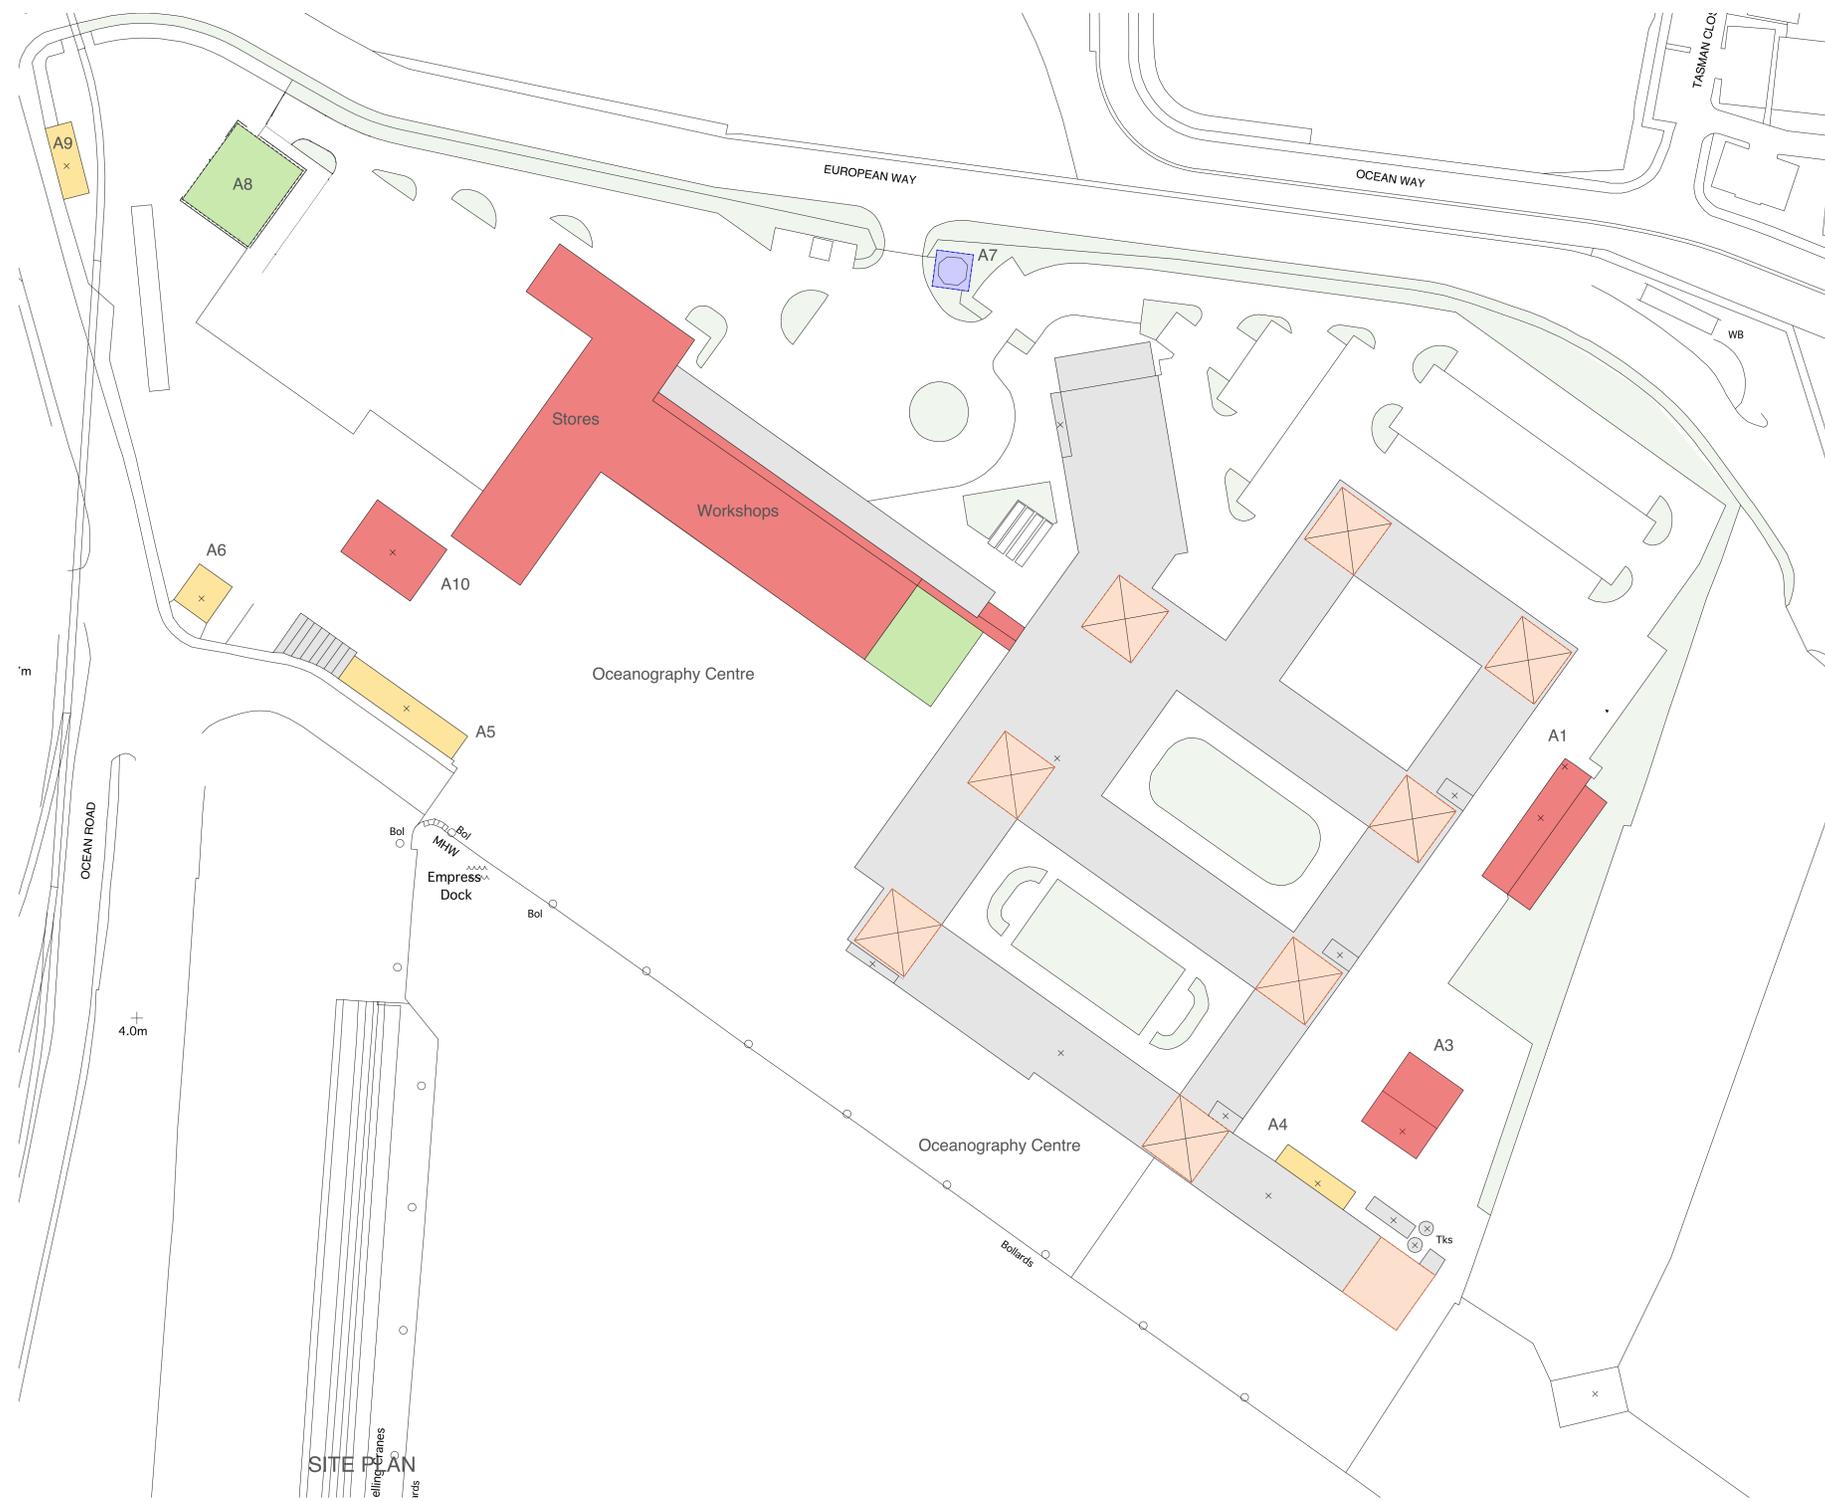
Appendix B: Site Plan - Condition Assessment / Priority

KEY - CONDITION RATING

- Group A: Metal roofs showing significant deterioration.
- Group B: Metal roofs showing signs of deterioration.
- Group C: Metal roofs in a fair condition.
