Specification for the Maintenance of the Counterweights on the Chilbolton Observatory 25m antenna

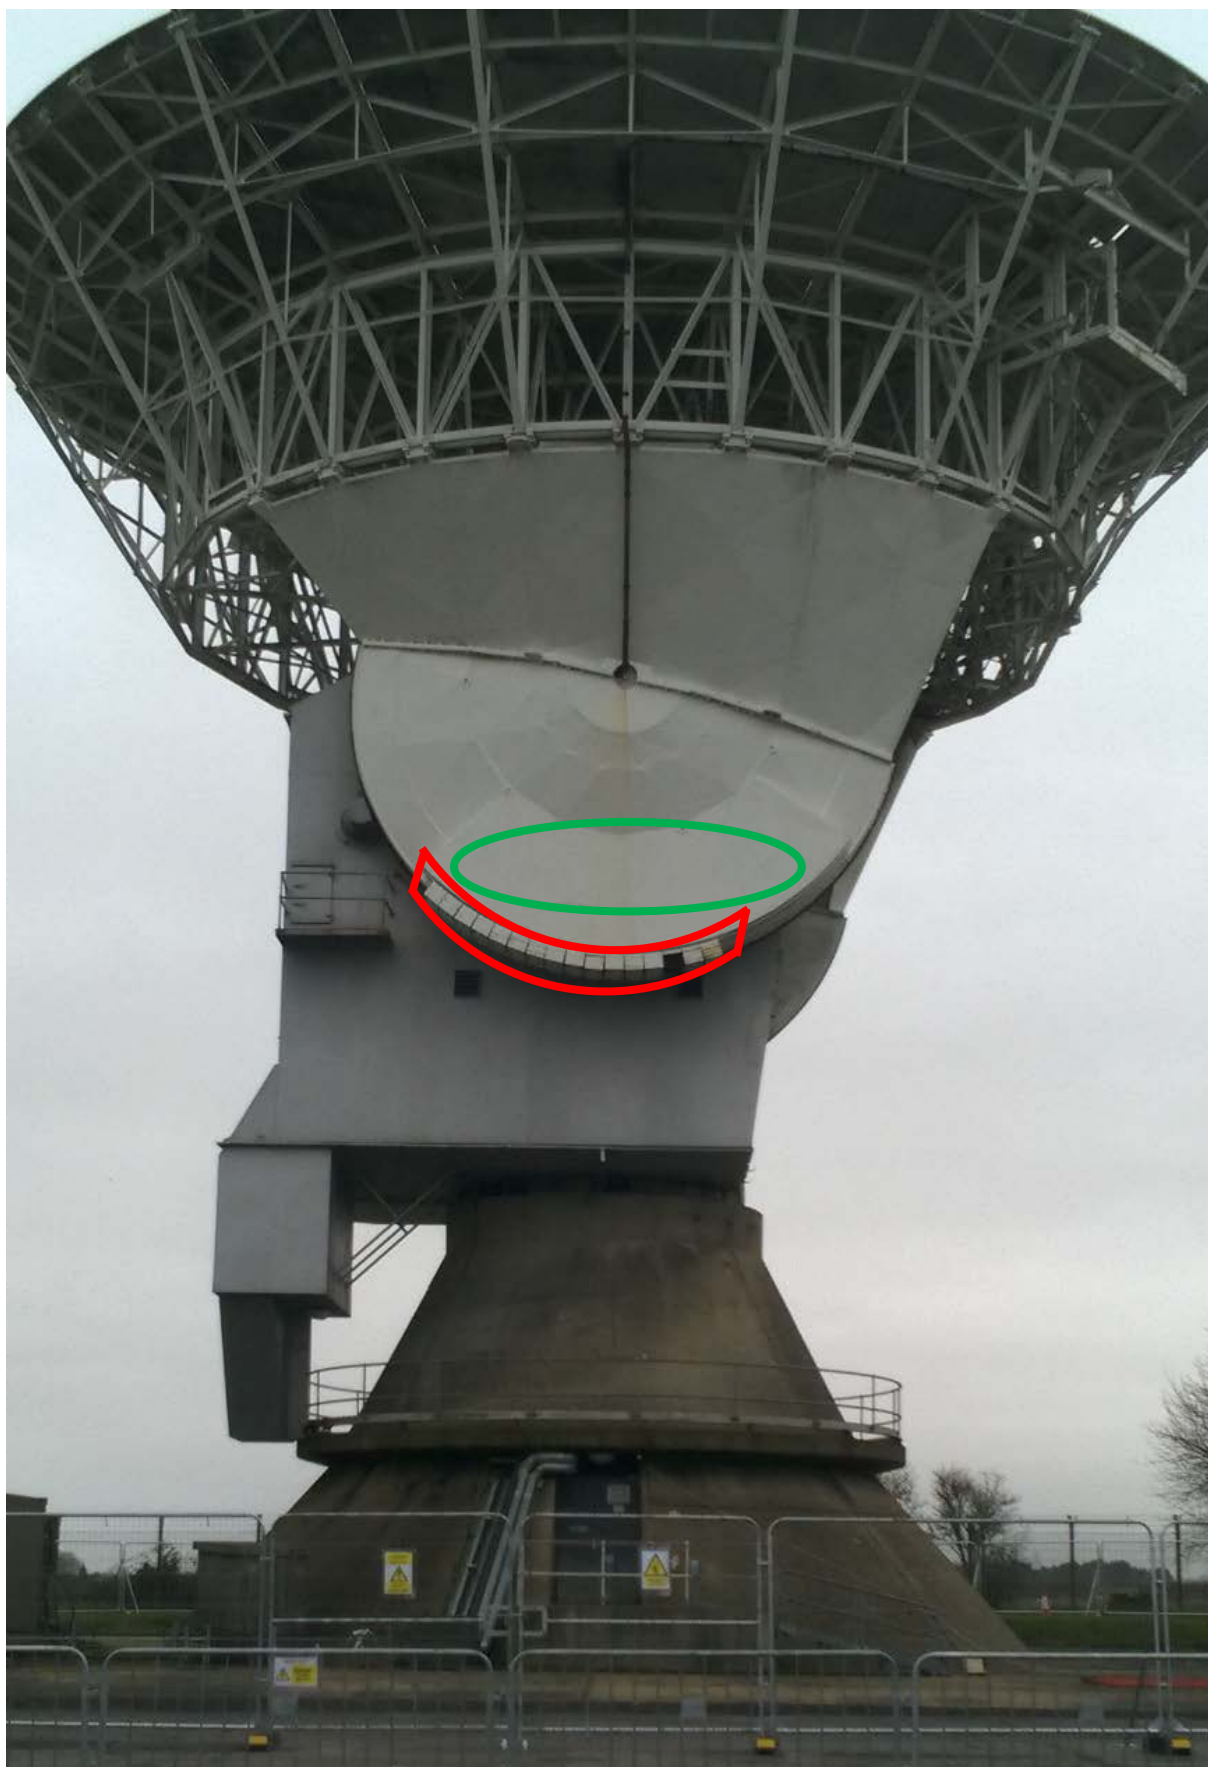
Figure 1 shows the 25m antenna, and the green oval shows the location of the ballast tanks and the red outline shows the counterweight blocks.

Figure 1. View of Chilbolton Observatory 25m Antenna showing the ballast tank (green) and the counterweight blocks (red).

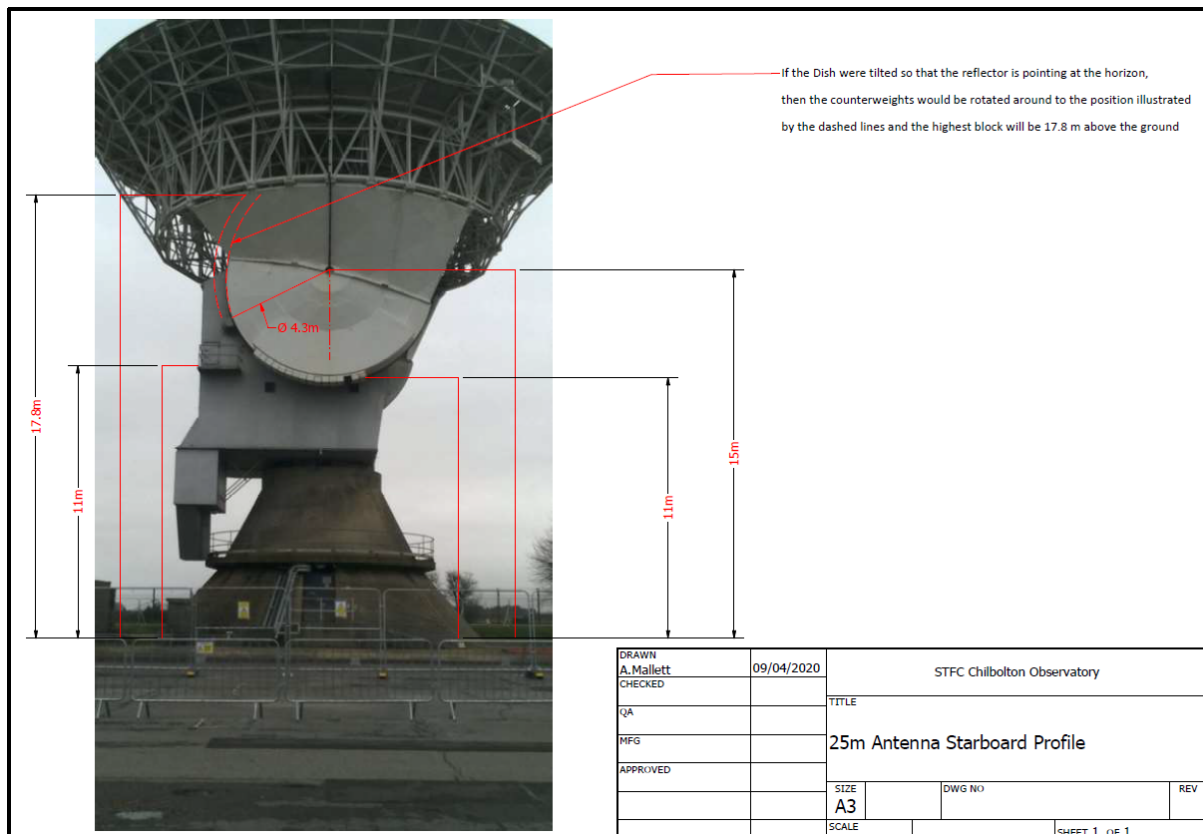
The counterweights will only be accessible by a suitable means of work at height as they are at least 11m above the ground level. The photograph in Figure 5 shows the heights of various points above the ground. There is a platform on the left side of the photograph, but it is to provide access to the elevation rack gears for inspection and greasing. It does not have a load rating. Note that Figure 5 also shows an alternate location of the counterweights if the antenna reflector were to be moved to point at the horizon. This can be clearly seen in Figure 10 and Figure 11. It is a point for consideration that the antenna could be parked in this orientation for the counterweight removal.

Figure 5. Profile of the starboard side of the antenna structure with heights indicated from ground level.

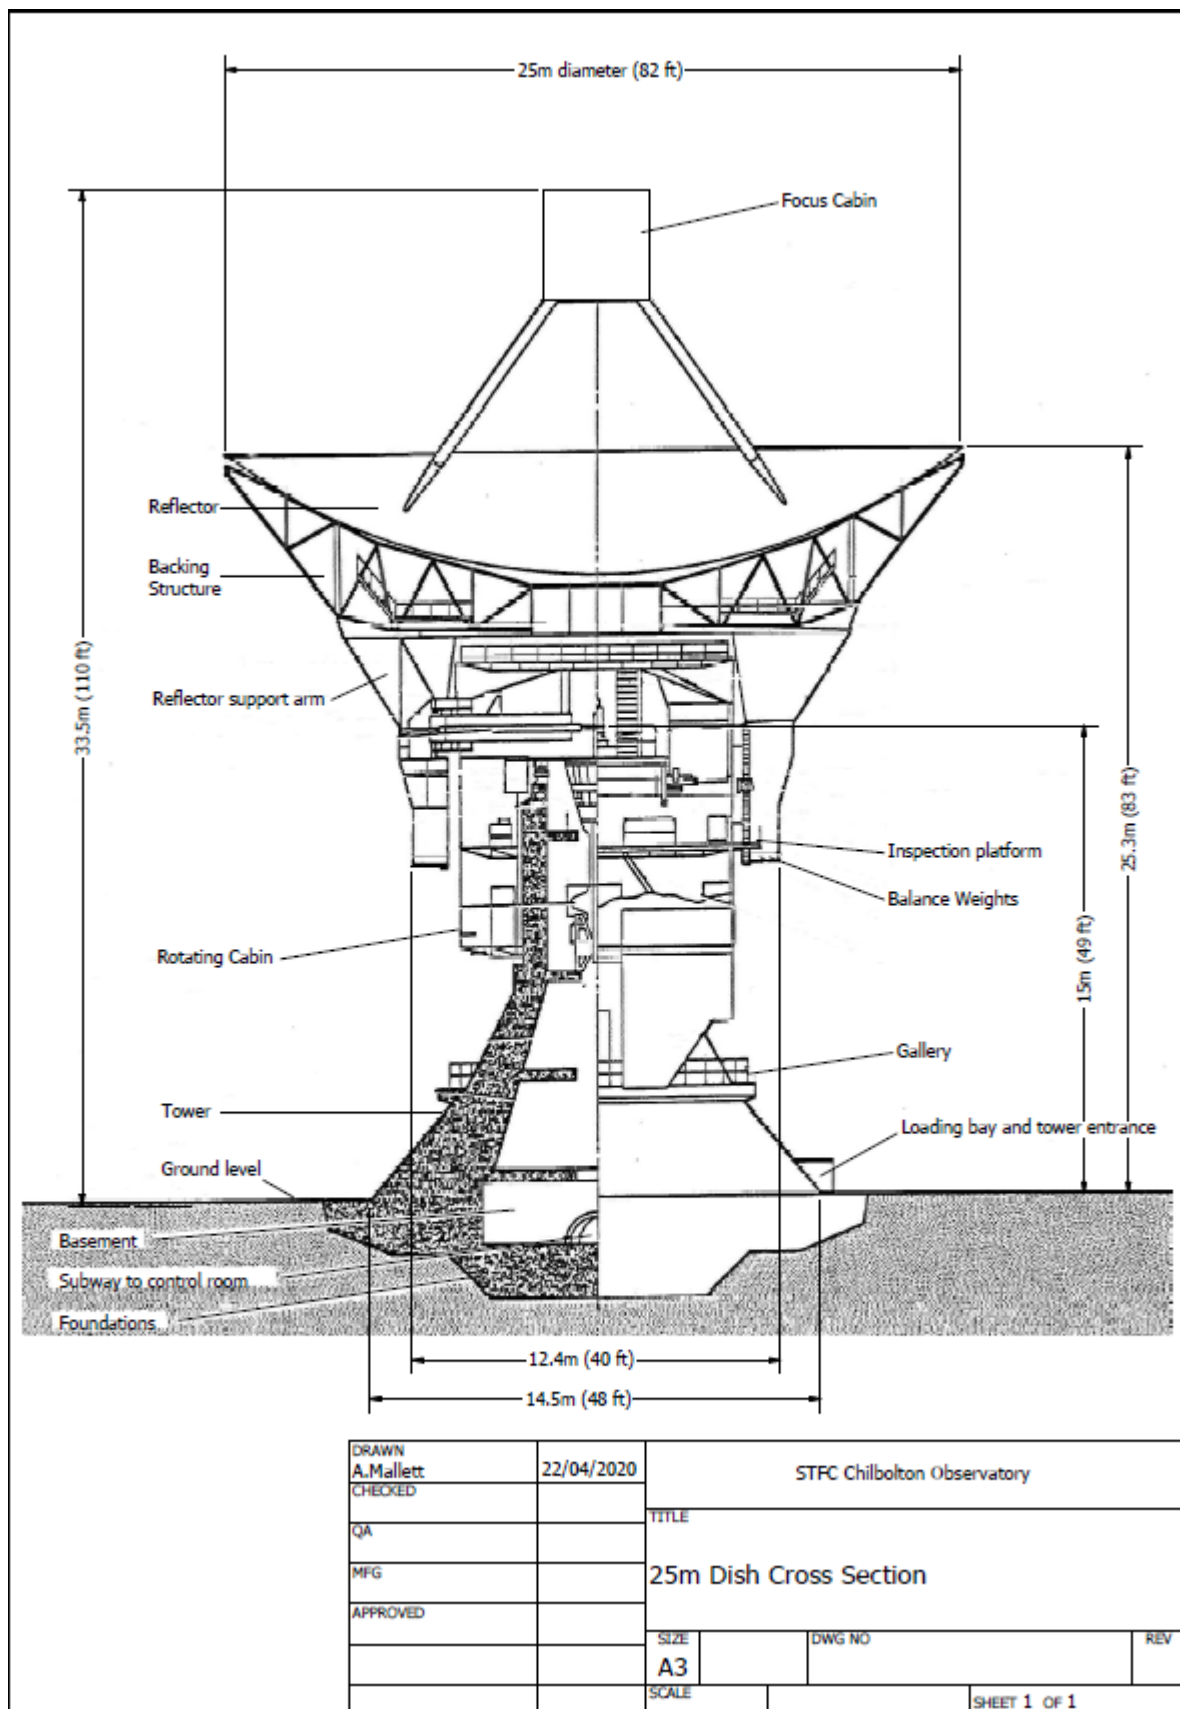
Figure 6. Scaled GA drawing showing the rear profile of the antenna structure with heights indicated from ground level.

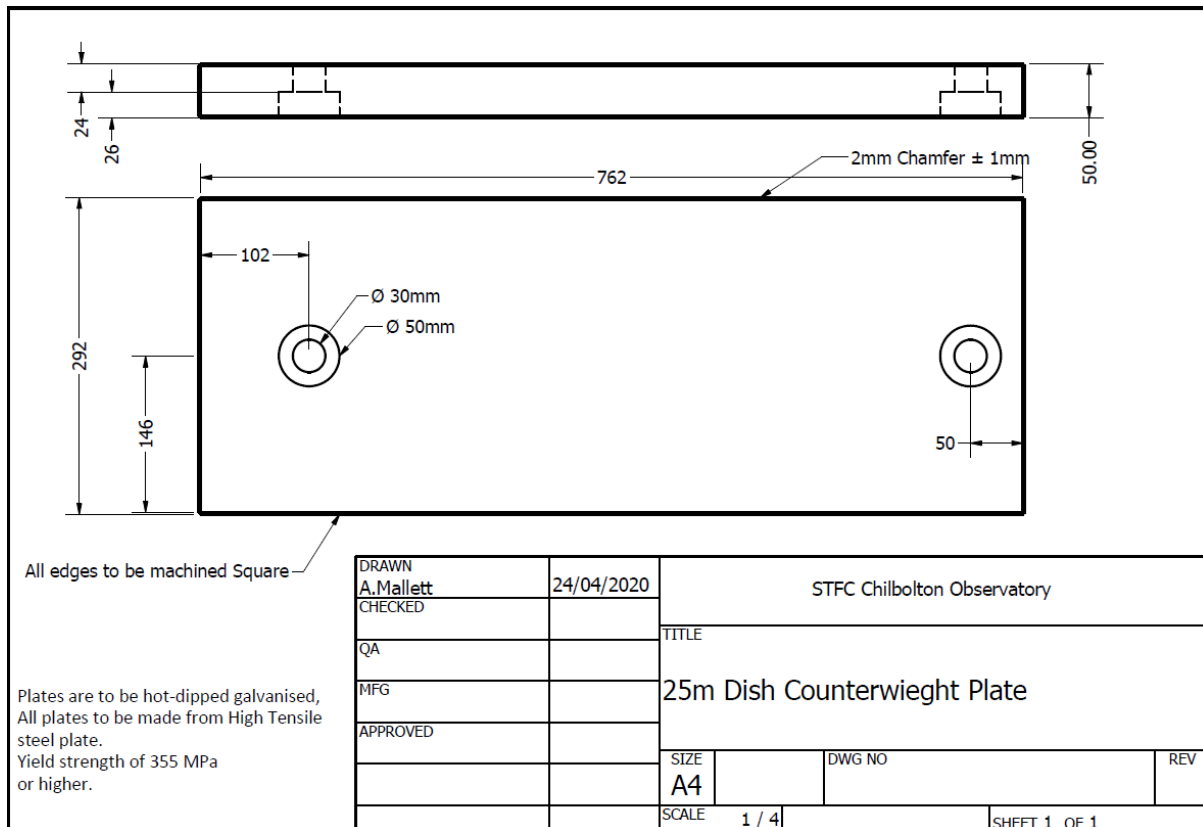
Figure 8 is a drawing of a counterweight plate. Figure 9 is a photograph of an old counterweight plate that was never fitted. The plates are individually held with a pair of nuts, which are recessed into the counter bore on the underside of the plate. Figure 10 is a close up of the nut in the counter bore of the fallen block. The limited clearance around the nut will require a pipe spanner or similar tool to be used to remove the nuts. As each plate is removed, the spanner will need to reach 50 mm further over the stud. The nuts have not been touched in decades and are unlikely to come free easily or if at all. Figure 11 shows that there is obvious evidence of corrosion having weakened the stud, so force on them while removing the plates will potentially result them breaking and the block

Figure 8. Drawing of counterweight plate.

The new plates will be manufactured to be identical in size to the original plates. The plate must be surveyed for accurate dimensions and a drawing approved by the customer prior to manufacture. The hole sizes may vary depending on the thread size of the replacement stud bars and fasteners. Mild steel that is suitable for shot-dip galvanisation to BS EN ISO 1461 shall be used. Figure 8 is a drawing of the counterweight plate measured up from the old one on the ground.

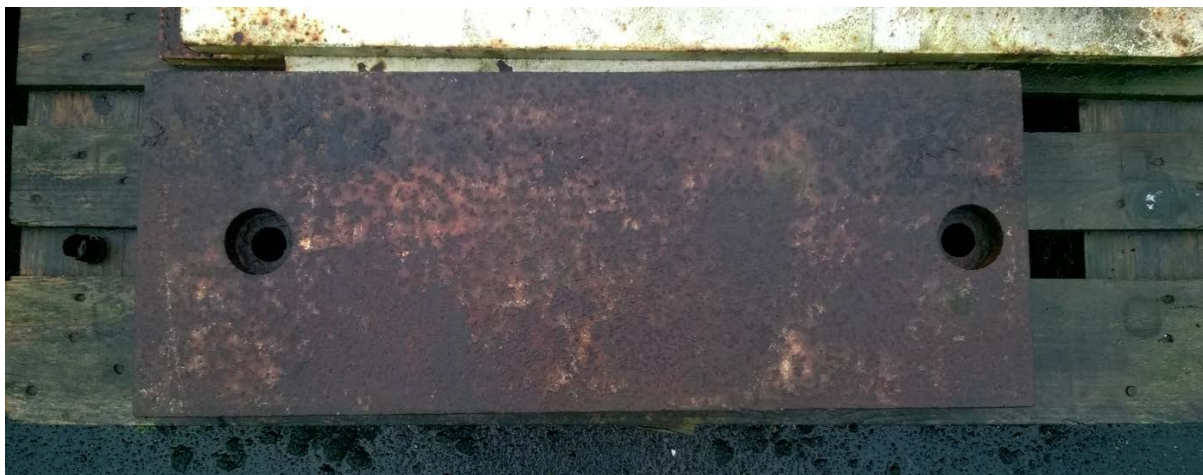
However, examination of the fallen block and plate indicate that they are badly corroded, requiring new ones to be made. It is anticipated that the new plates can be manufactured whilst the old ones are being removed, shortening the timeline for completion.

Figure 9. Photo of old counterweight plate.
