## Asbestos surveys – summary of reports

## Management Survey

Site: The Hub, Civic Approach, Uckfield, TN22 2AL  
Client: Uckfield Town Council  
Report No: J005397  
Survey Date: 30th September 2015  
Report Date: 2nd October 2015  
Surveyors: Paul Veness  
Report Produced By: Report Authorised By:

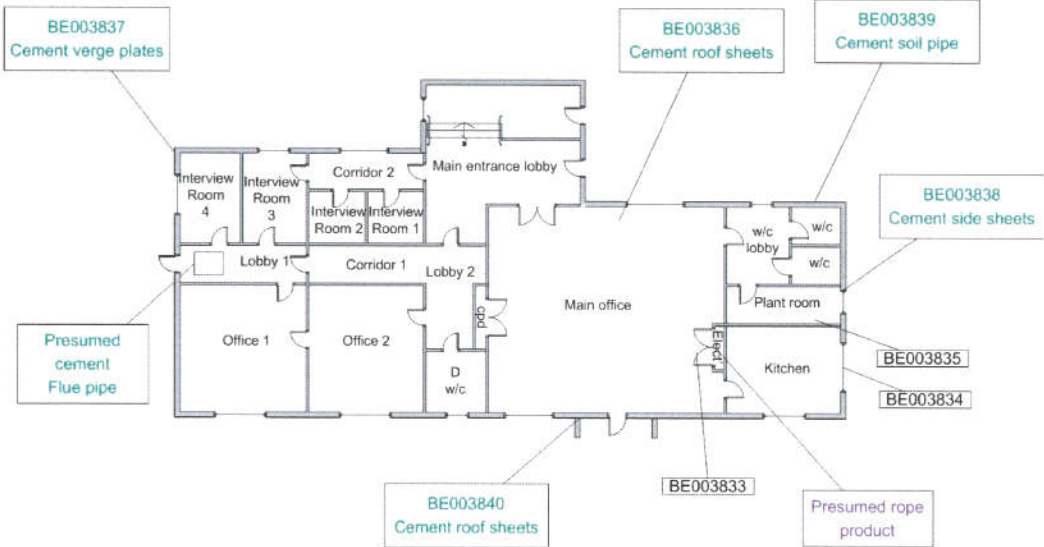
Key  
AIB  
TC  
AC

Client: Uckfield Town Council  
Site Address: The Hub, Civic Approach, Uckfield  
Position: Ground Floor  
Not to Scale
