## Annual Inspection

West Swindon Parish Council

Clayhill

Clayhill Copse, Swindon, Wiltshire, SN5 5AL

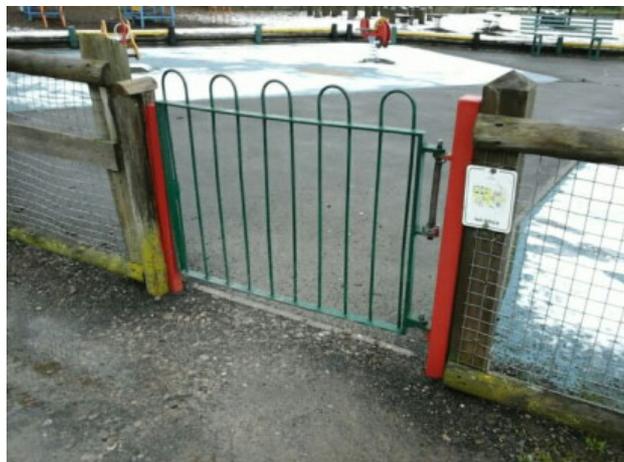
**Item:** Ancillary Items - Gate - Self Closing  
**Manufacturer:** Owner/Operator  
**Surface Type:** N/A  
**Equipment Compliance:** N/A  
**Surface Area Compliance:** N/A  
**Ref/Part Number:**  
**Total Findings:** 1

The gate is closing too quickly (less than 4 seconds) - Take corrective action to ensure that the gate closes in 4-8 seconds

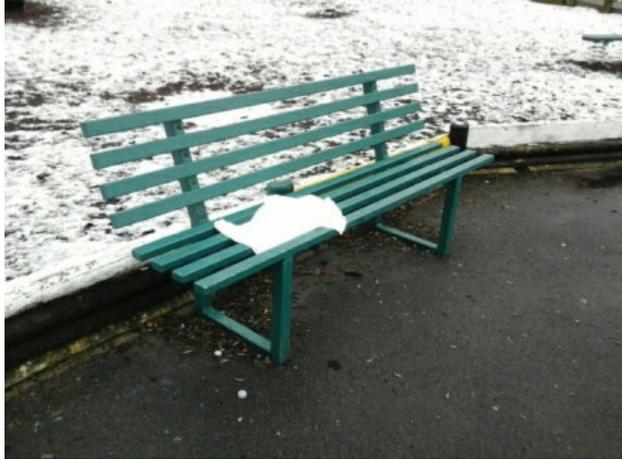
**Item:** Ancillary Items - Bench  
**Manufacturer:** Owner/Operator  
**Surface Type:** N/A  
**Equipment Compliance:** N/A  
**Surface Area Compliance:** N/A  
**Ref/Part Number:**  
**Total Findings:** 1

This item is satisfactory - no work required

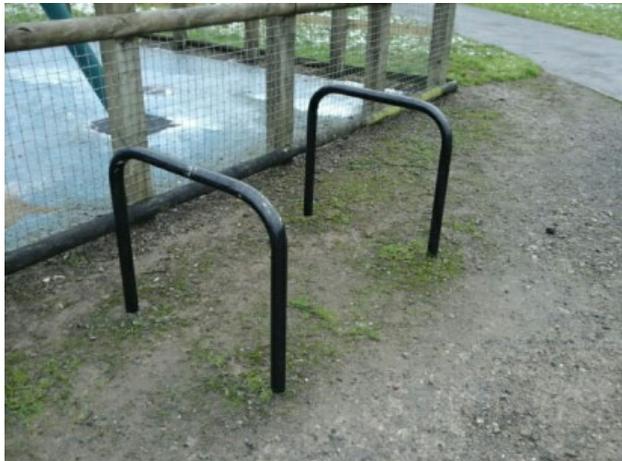
**Item:** Ancillary Items - Cycle Rack  
**Manufacturer:** Owner/Operator  
**Surface Type:** N/A  
**Equipment Compliance:** N/A  
**Surface Area Compliance:** N/A  
**Ref/Part Number:**  
**Total Findings:** 1

This item is satisfactory - no work required

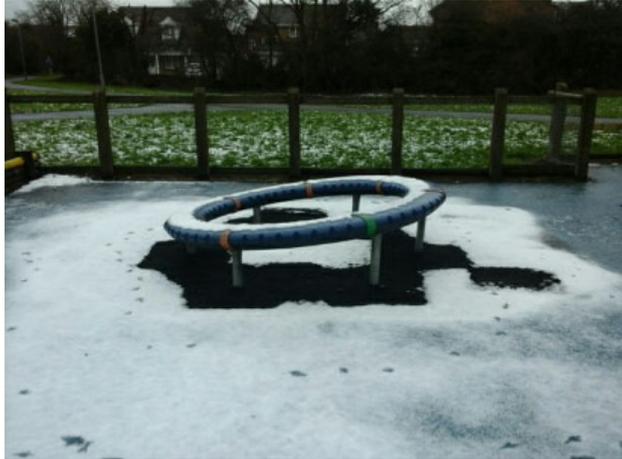
**Item:** Rotor Play - Supanova  
**Manufacturer:** Kompan Ltd  
**Surface Type:** Wet Pour  
**Equipment Compliance:** Yes  
**Surface Area Compliance:** Yes  
**Ref/Part Number:**  
**Total Findings:** 1

This item is satisfactory - no work required

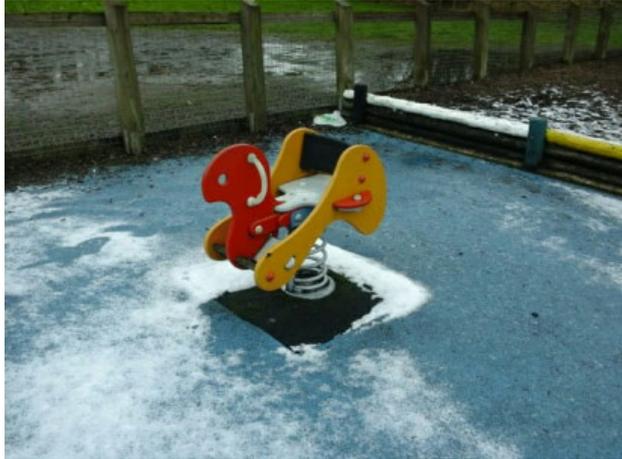
**Item:** Rocking Equipment - Spring Chicken  
**Manufacturer:** Not Identified  
**Surface Type:** Wet Pour  
**Equipment Compliance:** Yes  
**Surface Area Compliance:** Yes  
**Ref/Part Number:**  
**Total Findings:** 1

This item is satisfactory - no work required

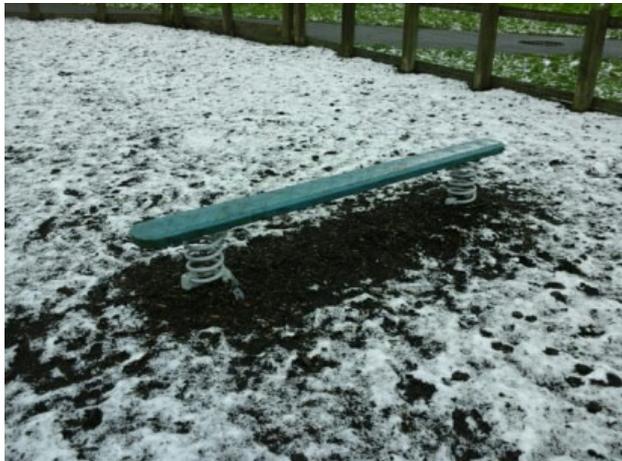
**Item:** Activity Equipment - Spring Balance Beam  
**Manufacturer:** Ledon  
**Surface Type:** Woodchip  
**Equipment Compliance:** Yes  
**Surface Area Compliance:** Yes  
**Ref/Part Number:**  
**Total Findings:** 2

The base mounts are exposed due to low surfacing levels - Top up surface to cover mounts

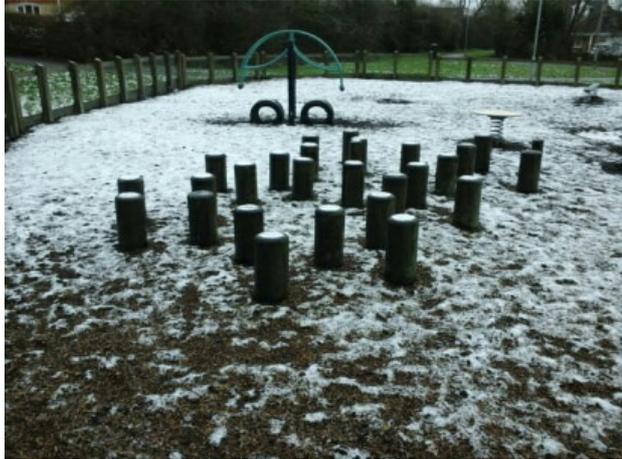
**Item:** Activity Equipment - Stepping Stones  
**Manufacturer:** Not Identified  
**Surface Type:** Woodchip  
**Equipment Compliance:** No  
**Surface Area Compliance:** Yes  
**Ref/Part Number:**  
**Total Findings:** 2

The spring boards form a hard object within the falling space of the equipment in contravention of the requirements of BS EN 1176 Part 1 - Monitor use

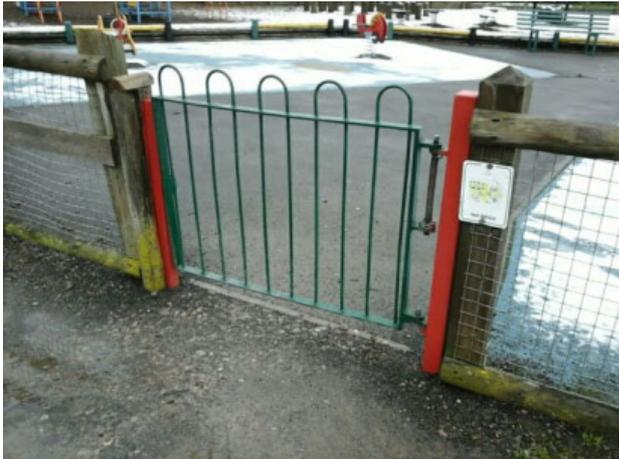
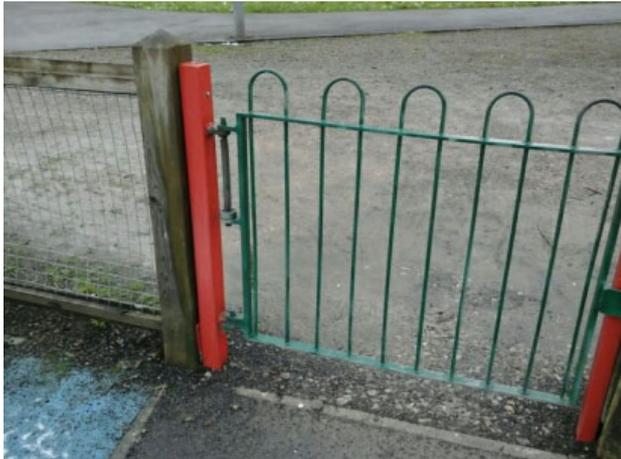
<b>6 - Low Risk (Finding 1)</b>			
<b>Item:</b>	Ancillary Items - Gate - Self Closing	<b>Risk Level:</b>	L - Low Risk
<b>Manufacturer:</b>	Owner/Operator	<b>Surface:</b>	N/A

<b>Finding:</b>	The gate is closing too quickly (less than 4 seconds)	<b>Action:</b>	Take corrective action to ensure that the gate closes in 4-8 seconds

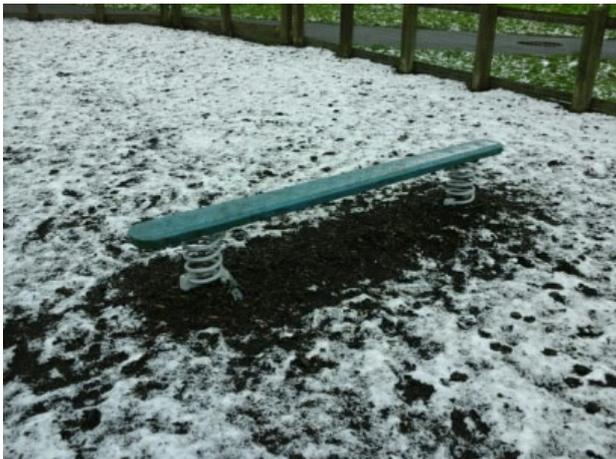
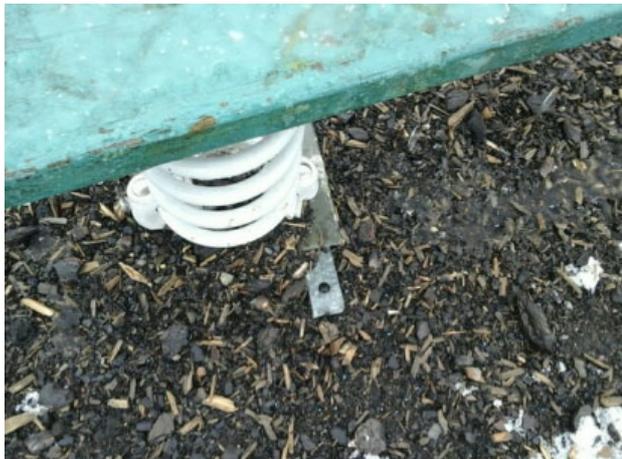
8 - Low Risk (Finding 1)

**Item:** Activity Equipment - Spring Balance Beam **Risk Level:** L - Low Risk  
**Manufacturer:** Ledon **Surface:** Woodchip

**Finding:** The base mounts are exposed due to low surfacing levels

**Action:** Top up surface to cover mounts

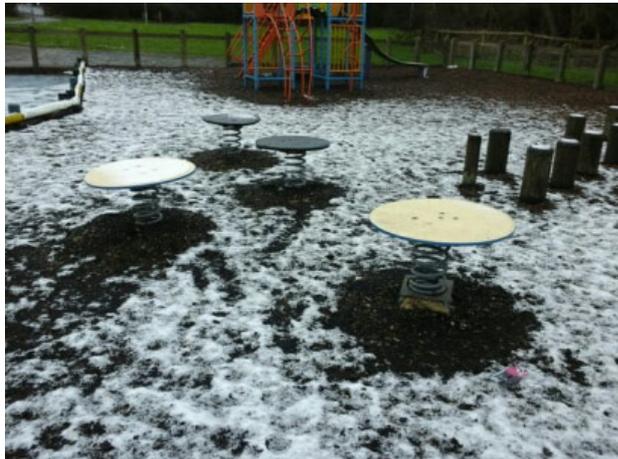
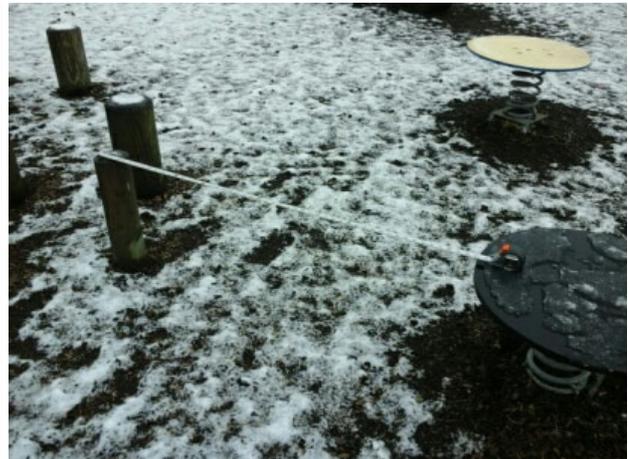
**Item:** Rocking Equipment - Spring Board  
**Manufacturer:** Not Identified

**Finding:** The stepping stones form a hard object within the falling space of the equipment in contravention of the requirements of BS EN 1176 Part 1

**Action:** Monitor use

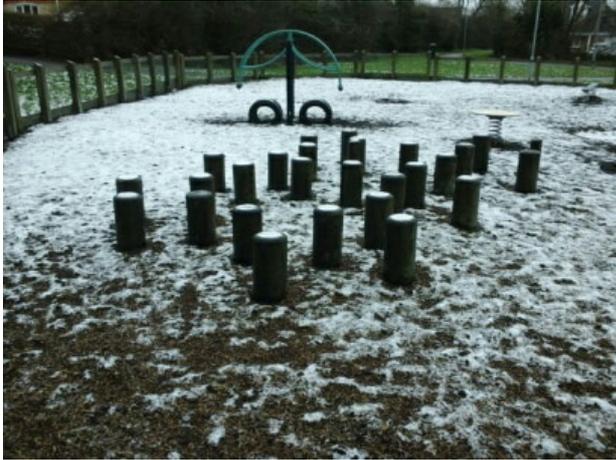
**Item:** Activity Equipment - Stepping Stones  
**Manufacturer:** Not Identified

**Finding:** The spring boards form a hard object within the falling space of the equipment in contravention of the requirements of BS EN 1176 Part 1

**Action:** Monitor use

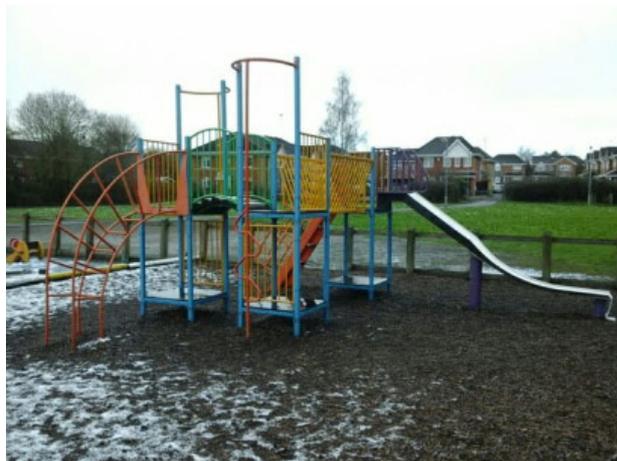
**Item:** Activity Equipment - Multi Play (Junior)  
**Manufacturer:** Not Identified

**Finding:** There are projecting bolt thread(s) present

**Action:** Remove excess thread length and deburr or provide cap

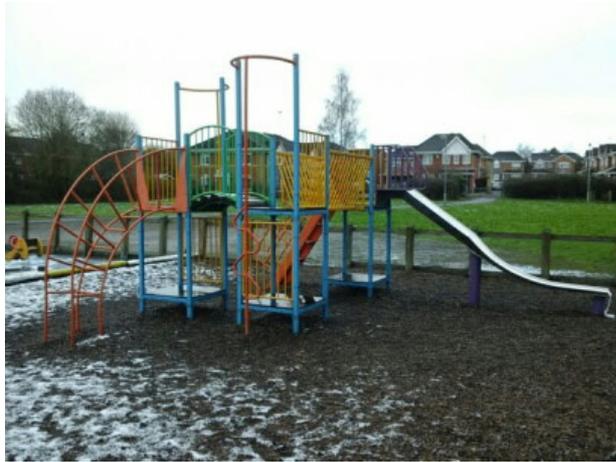
**Item:** Activity Equipment - Multi Play (Junior)  
**Manufacturer:** Not Identified

**Finding:** Parts of the timber are rough or splintered

**Action:** Remove all rough or sharp edges

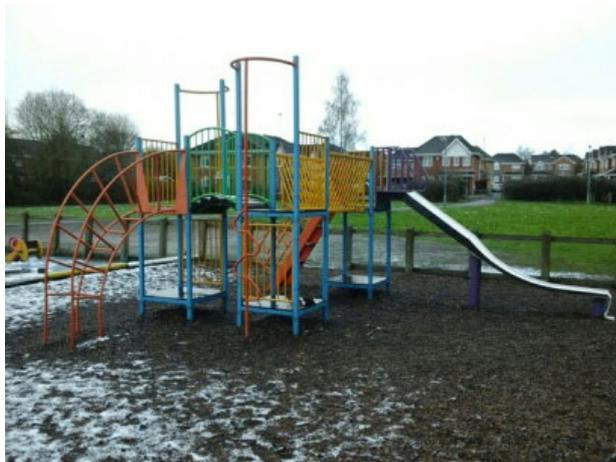
**Item:** Activity Equipment - Multi Play (Junior)  
**Manufacturer:** Not Identified

**Finding:** The plywood has delaminated in some places

**Action:** Remove all rough or splintered edges.

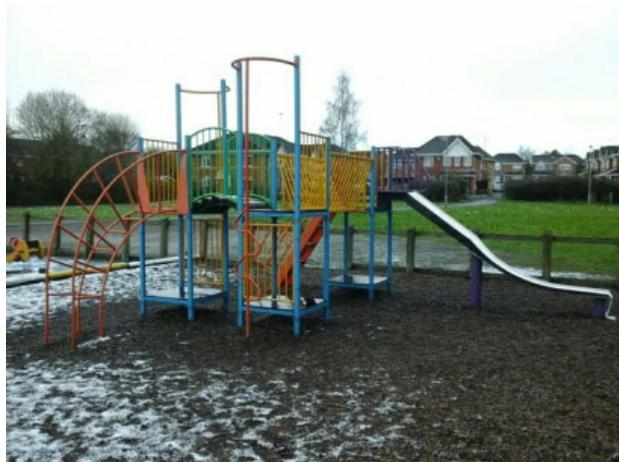
2 - Very Low Risk (Finding 8)

**Item:** Activity Equipment - Multi Play (Junior) **Risk Level:** V - Very Low Risk  
**Manufacturer:** Not Identified **Surface:** Woodchip

**Finding:** There is some graffiti present **Action:** Remove the graffiti
