Annual Inspection

West Swindon Parish Council

Camden Close

Annual Inspection - 27 December 2017 at 09:06 Inspector: Leon Pope RPII Annual Inspector

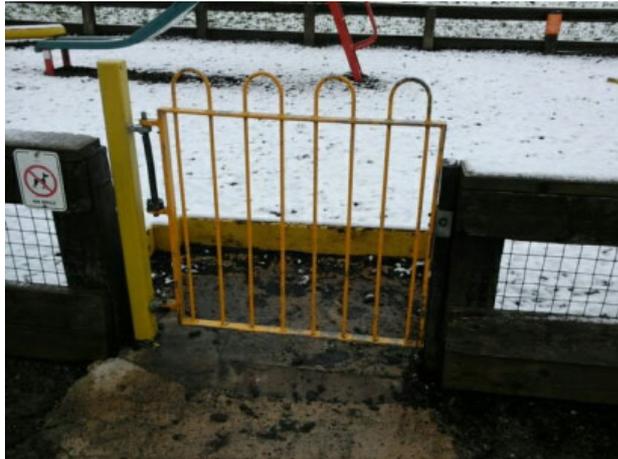
Item: Ancillary Items - Gate - Self Closing
Manufacturer: Owner/Operator

Finding: The gate is closing too quickly (less than 4 seconds)

Action: Take corrective action to ensure that the gate closes in 4-8 seconds

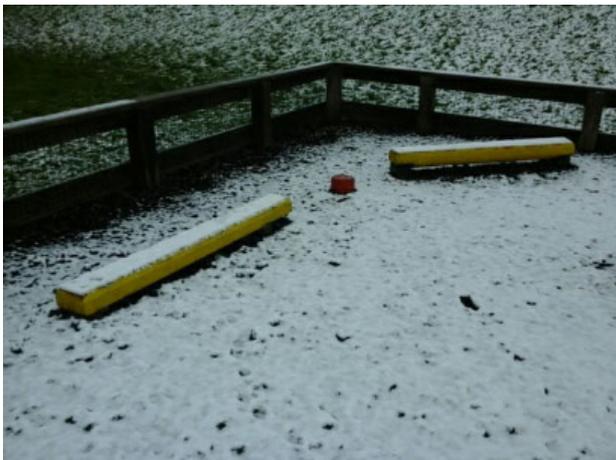
Finding: The fence forms a hard object within the falling space of the equipment in contravention of the requirements of BS EN 1176 Part 1

Action: Monitor use

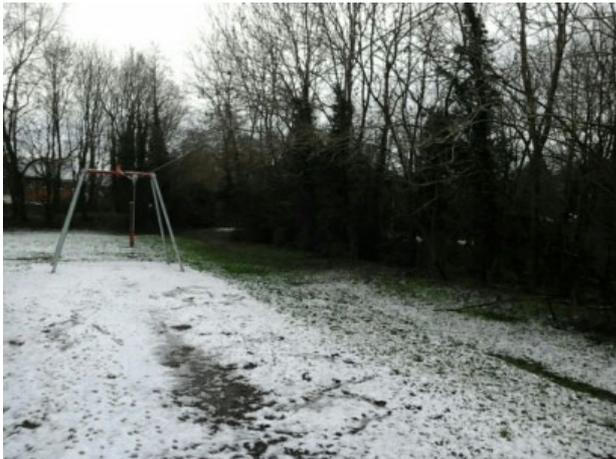
Item: Other - Cable Runway
Manufacturer: Kaiser & Kuhne

Finding: There is some graffiti present

Action: Remove the graffiti

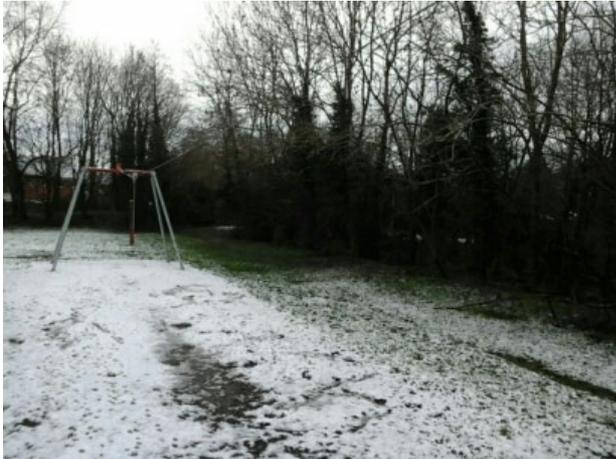
Item: Other - Cable Runway
Manufacturer: Kaiser & Kuhne

Finding: The seat is less than 2.0 metres from the post when extended at 45 degrees at the end of the area of travel

Action: Adjust the cable stop position to ensure the minimum distance is maintained

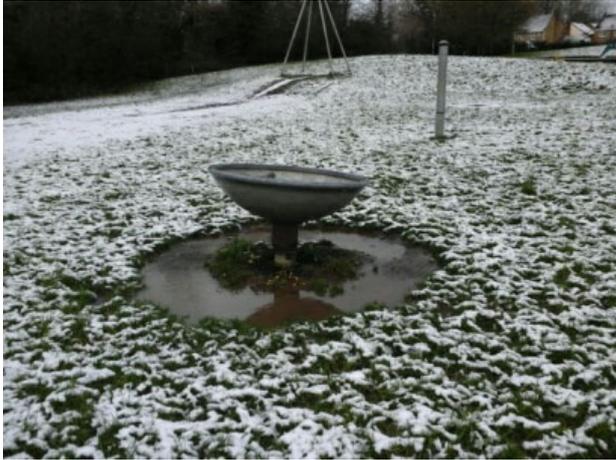
Item: Rotor Play - Spinner Bowl
Manufacturer: Sutcliffe Play Limited

Finding: Fixing Pins have been installed in the impact areas of the grass mats

Action: Remove pins from impact areas

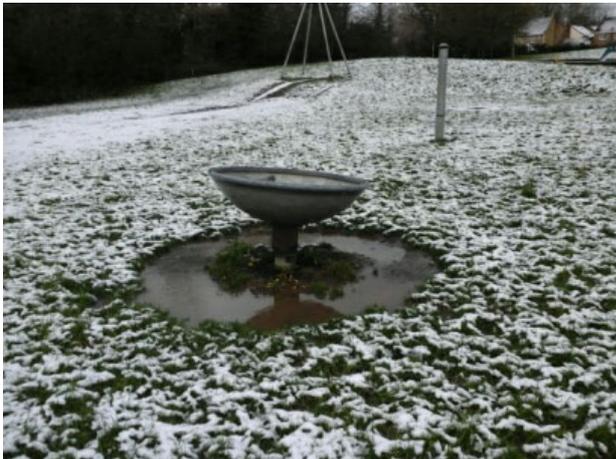
Item: Rotor Play - Spinner Bowl
Manufacturer: Sutcliffe Play Limited

Finding: There is some graffiti present

Action: Remove the graffiti

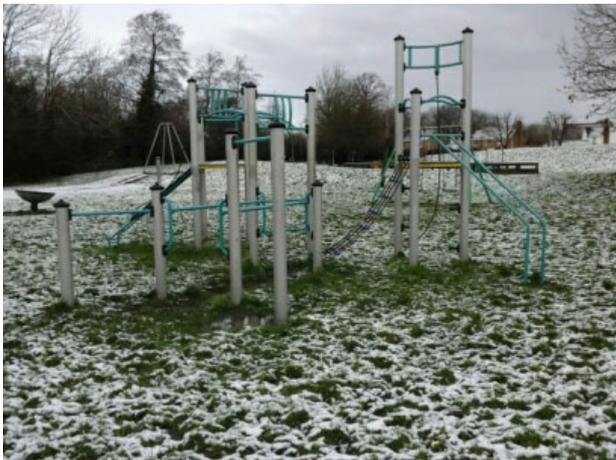
Item: Activity Equipment - Multi Play (Junior)
Manufacturer: Sutcliffe Play Limited

Finding: The lower net mount forms a hard object within the falling space of the equipment in contravention of the requirements of BS EN 1176 Part 1

Action: Monitor use
