**Campbell Park Parish Council**

**Former Springfield Public House  
Springfield Boulevard  
Milton Keynes  
MK6 3JS**

**Asbestos Survey Report Following a Refurbishment Survey in  
Accordance with HSG264**

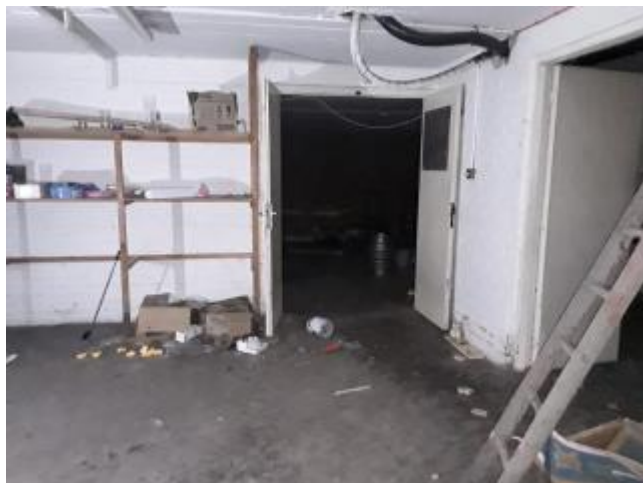
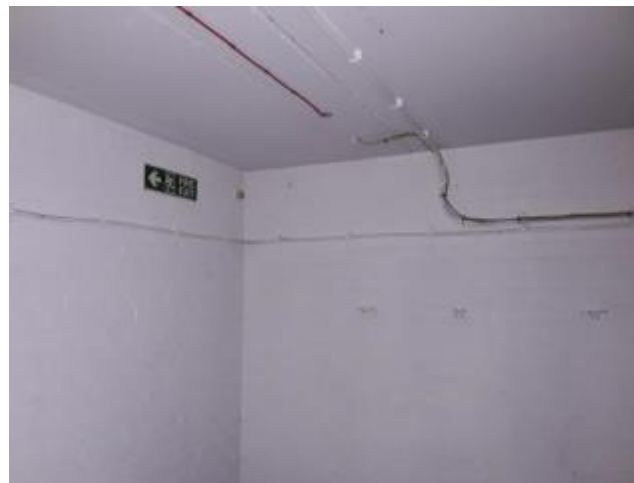
Survey ID	1	Sample No.	N/A
Floor	Basement	Area	Floor, Walls and Ceiling
Room	B.01	Item	General View

Action	N/A	Priority	N/A	Notifiable	N/A	Licensable	N/A
Comments/Recommendations							
Concrete Floor, Brick Walls, Concrete Ceiling, Modern Mechanical and Electrical Installations, Plasterboard Infill Panels, Foam Insulation to Pipework, Plasterboard Boxing to Structural Steel, Metal and Timber Dumb Waiter with a Brick, Render and Board Liner Shaft (runs up to ground floor)

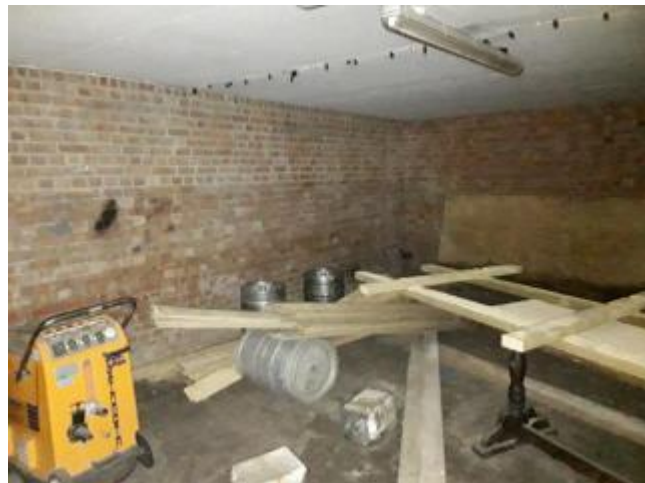
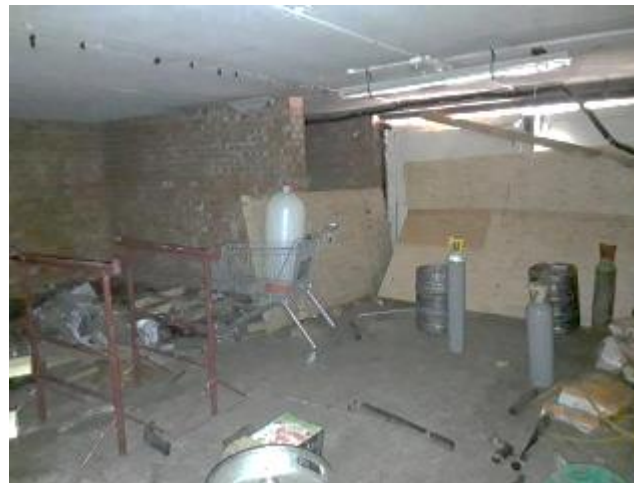
<b>Survey ID</b>	4	<b>Sample No.</b>	N/A
<b>Floor</b>	Basement	<b>Area</b>	Floor, Walls and Ceilings
<b>Room</b>	B.02	<b>Item</b>	General View

<b>Action</b>	N/A	<b>Priority</b>	N/A	<b>Notifiable</b>	N/A	<b>Licensable</b>	N/A
<b>Comments/Recommendations</b>							
Concrete Floor, Brick Walls, Fibreboard Ceiling with Concrete Above, Modern Mechanical and Electrical Installations, Foam Insulation to Pipework

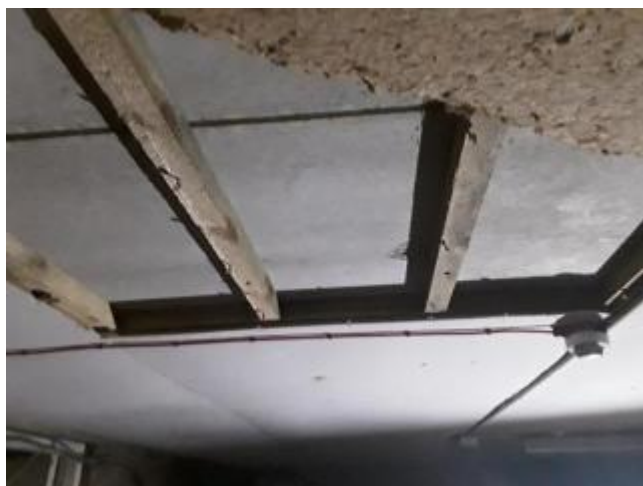
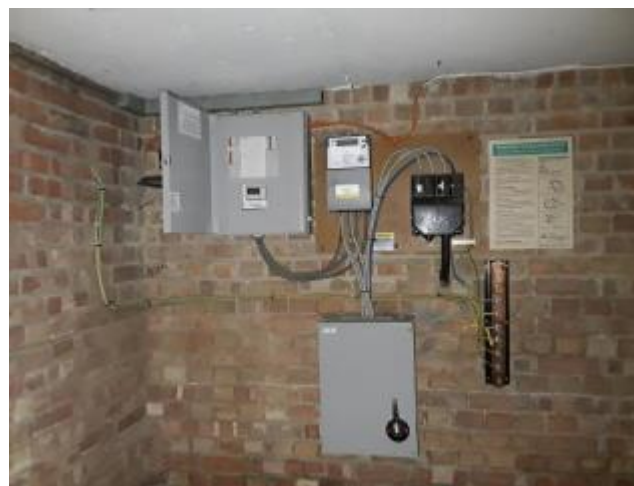
<b>Survey ID</b>	5	<b>Sample No.</b>	N/A
<b>Floor</b>	Basement	<b>Area</b>	Floor, Walls and Ceilings
<b>Room</b>	B.02	<b>Item</b>	General View

<b>Comments/Recommendations</b>							
General Observations – Concrete Ceiling with Timber Grounds and Fibre Board, Modern Electrical Installations

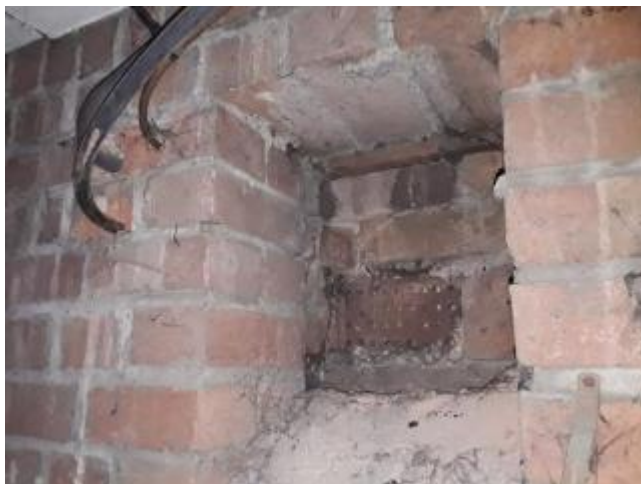
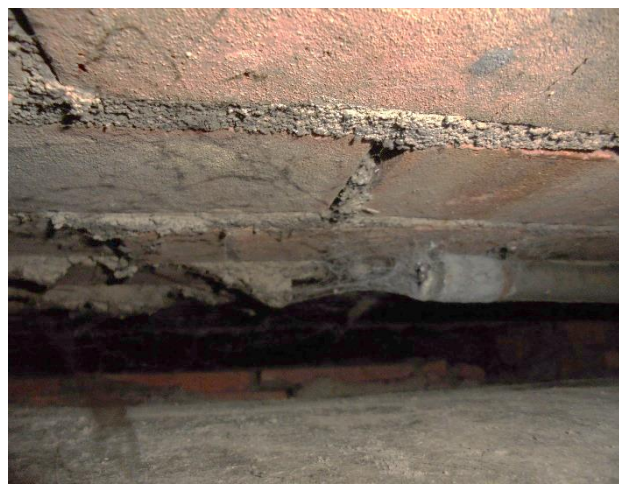
Survey ID	6	Sample No.	N/A
Floor	Basement	Area	Wall Cavity
Room	B.02	Item	General View

Action	N/A	Priority	N/A	Notifiable	N/A	Licensable	N/A
Comments/Recommendations							
Brick External Wall Cavity (no cavity insulation present)

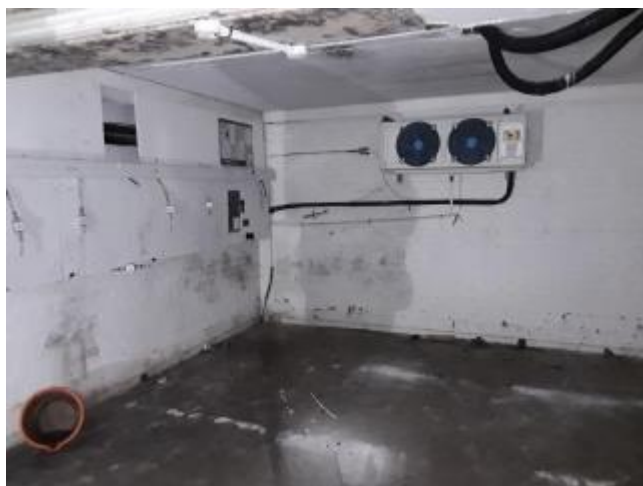
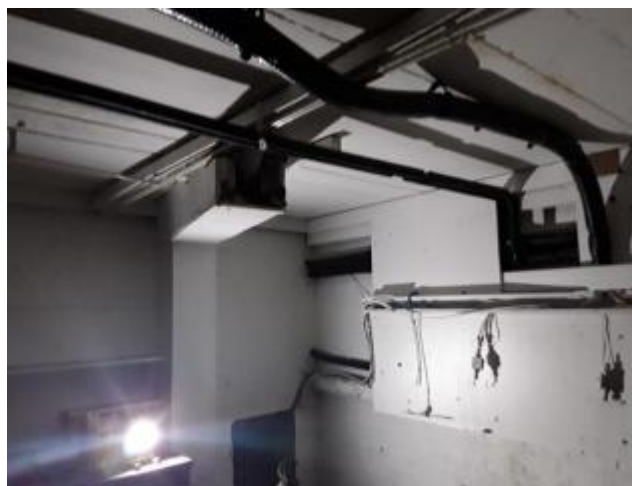
Survey ID	8	Sample No.	N/A
Floor	Basement	Area	Floor, Walls and Ceiling
Room	B.03	Item	General View

Action	N/A	Priority	N/A	Notifiable	N/A	Licensable	N/A
Comments/Recommendations							
Concrete Floor, Brick Walls, Concrete Ceiling, Modern Mechanical and Electrical Installations, Foam Insulation to Pipework, Timber Panels to Walls

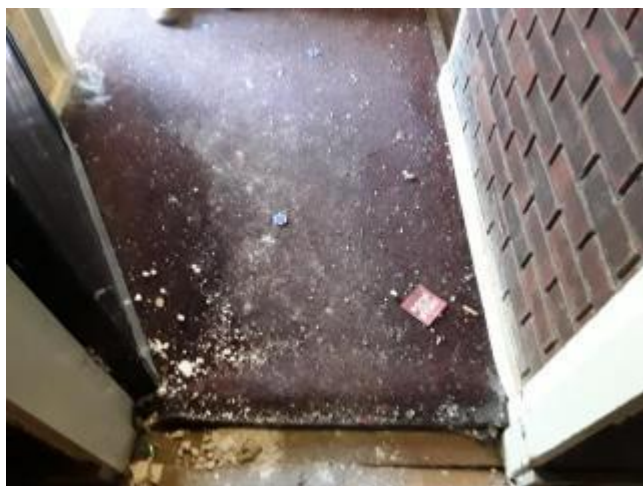
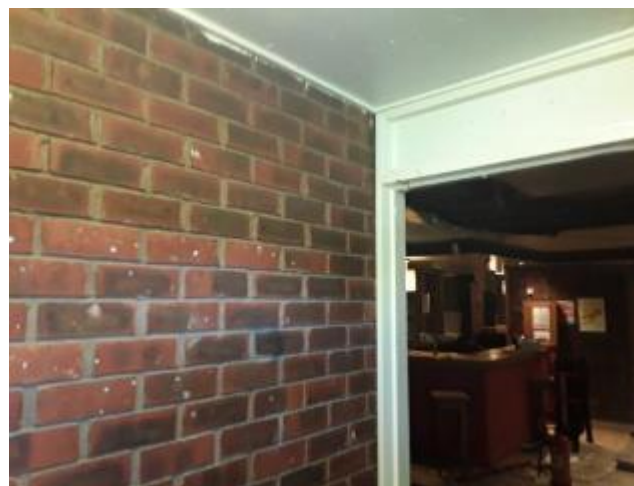
Survey ID	10	Sample No.	N/A
Floor	Ground Floor	Area	Floor, Walls and Ceiling
Room	G.01	Item	General View

Action	N/A	Priority	N/A	Notifiable	N/A	Licensable	N/A
Comments/Recommendations							
Brick Walls, Carpet to Timber and Concrete Floor, Timber and Glass Door Header Panels

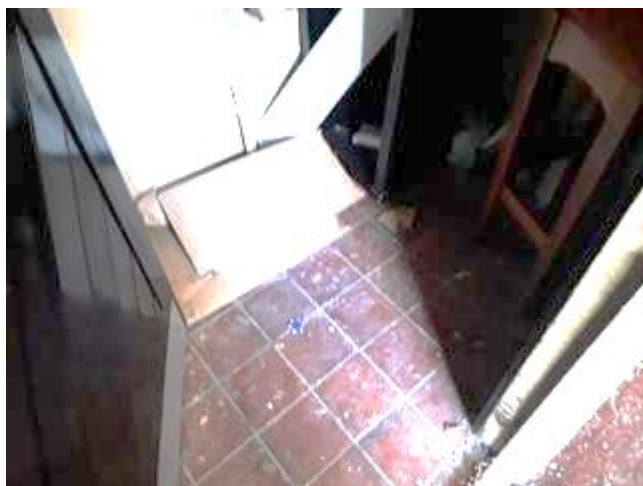
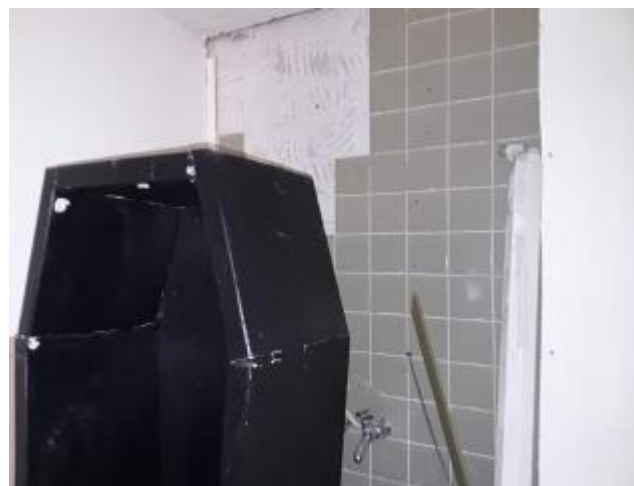
<b>Survey ID</b>	12	<b>Sample No.</b>	N/A
<b>Floor</b>	Ground Floor	<b>Area</b>	Floor, Walls and Ceiling
<b>Room</b>	G.02	<b>Item</b>	General View

<b>Action</b>	N/A	<b>Priority</b>	N/A	<b>Notifiable</b>	N/A	<b>Licensable</b>	N/A
<b>Comments/Recommendations</b>							
Ceramic Tiles to Floor and Walls, Timber Boxing, Ceramic Sink, Plasterboard Wall

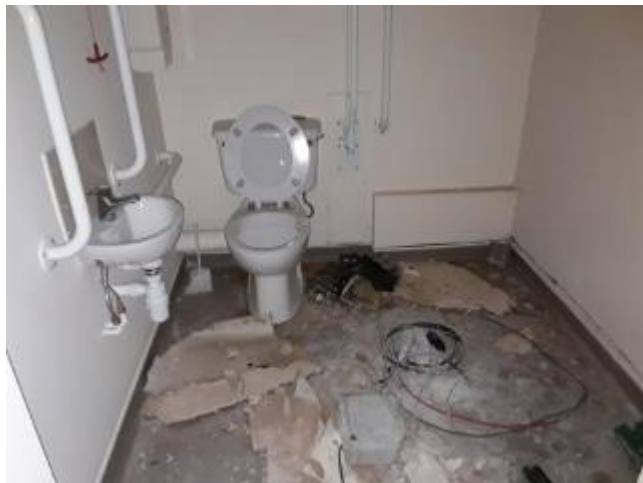
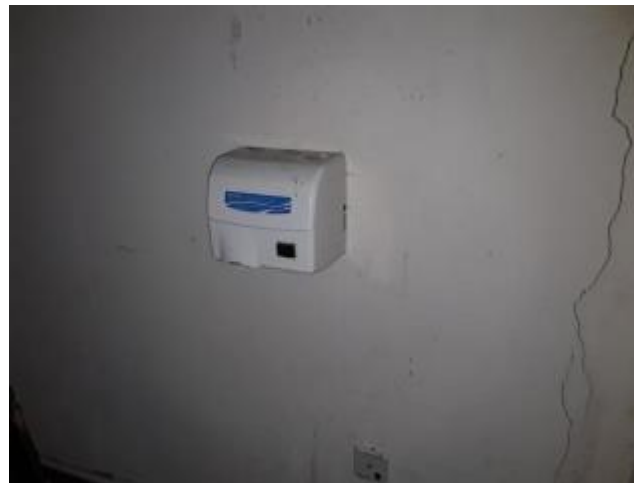
<b>Survey ID</b>	14	<b>Sample No.</b>	N/A
<b>Floor</b>	Ground Floor	<b>Area</b>	Floor, Walls and Ceiling
<b>Room</b>	G.03	<b>Item</b>	General View

<b>Action</b>	N/A	<b>Priority</b>	N/A	<b>Notifiable</b>	N/A	<b>Licensable</b>	N/A
<b>Comments/Recommendations</b>							
Modern Vinyl Floor to Timber and Concrete, Plasterboard Walls and Ceiling, Modern Sanitary Ware

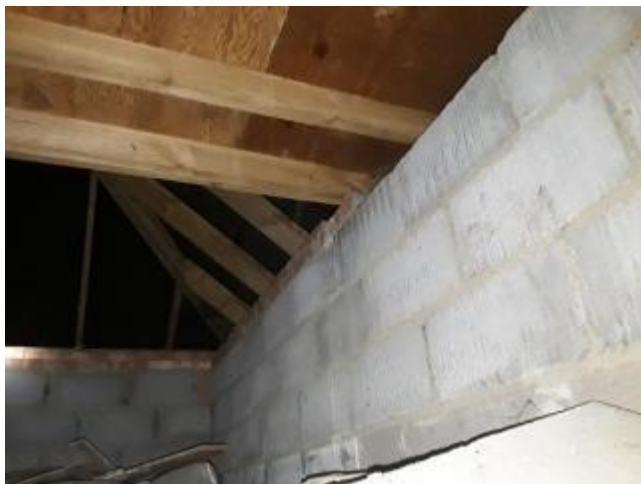
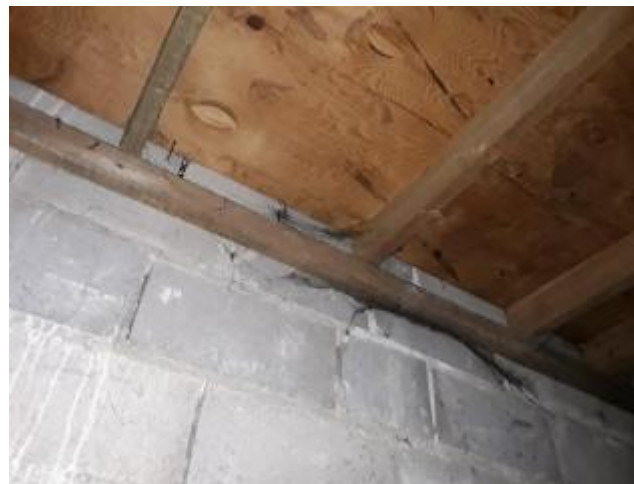
<b>Survey ID</b>	15	<b>Sample No.</b>	N/A
<b>Floor</b>	Ground Floor	<b>Area</b>	Ceiling Void
<b>Room</b>	G.03	<b>Item</b>	General View

<b>Action</b>	N/A	<b>Priority</b>	N/A	<b>Notifiable</b>	N/A	<b>Licensable</b>	N/A
<b>Comments/Recommendations</b>							
Blockwork Walls, Timber Joists, Spars and Plywood Decking, Modern Mechanical and Electrical Installations.							
Covers rooms G.01 to G.06

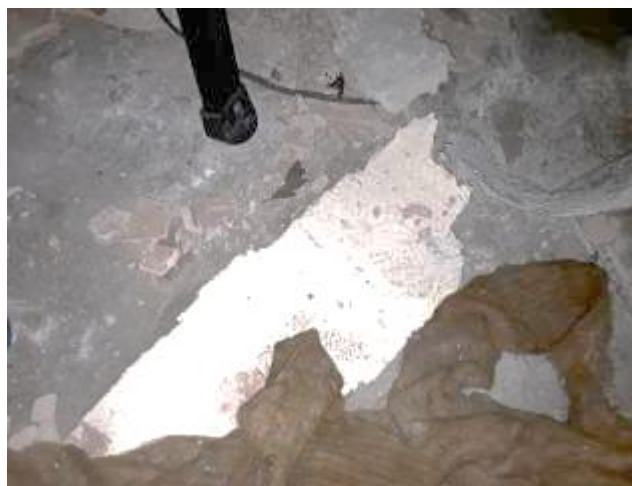
<b>Survey ID</b>	16	<b>Sample No.</b>	As S005
<b>Floor</b>	Ground Floor	<b>Area</b>	Floor
<b>Room</b>	G.03	<b>Item</b>	Textured Coating Debris

<b>Sample Notes.</b>	Debris to Floor
----------------------	-----------------

<u>Material Assessment</u>		Score			Score
Material	Textured Coating	1	Surface Treatment	Composite materials containing asbestos	0
Extent of Damage	High Damage	3	Asbestos Type	Chrysotile	1
Identification	STRONGLY PRESUMED		Material Assessment Total	Low	5
				Quantity	5 m²

<b>Comments/Recommendations</b>
TO BE REMOVED BY A COMPETENT CONTRACTOR AND DISPOSED OF AS HAZARDOUS WASTE, ALL IN ACCORDANCE WITH CURRENT ASBESTOS LEGISLATION/REGULATIONS

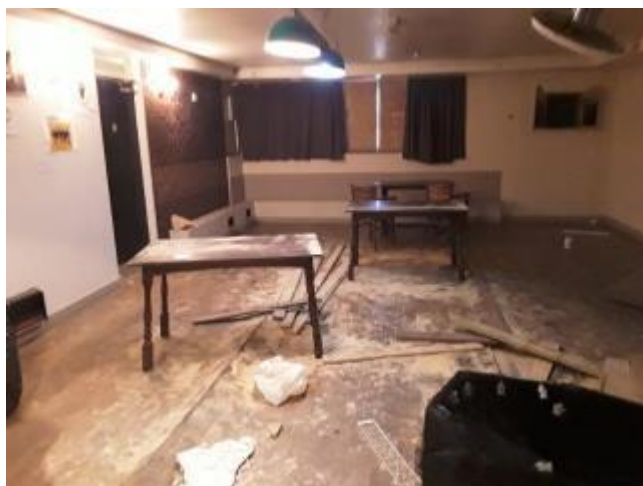
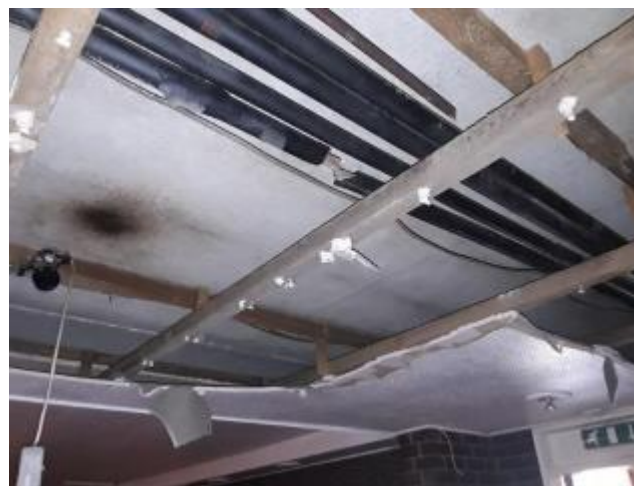
<b>Survey ID</b>	18	<b>Sample No.</b>	N/A
<b>Floor</b>	Ground Floor	<b>Area</b>	Floor, Walls and Ceilings
<b>Room</b>	G.04	<b>Item</b>	General View

<b>Action</b>	N/A	<b>Priority</b>	N/A	<b>Notifiable</b>	N/A	<b>Licensable</b>	N/A
<b>Comments/Recommendations</b>							
Timber to Concrete Floor, Solid Walls, Bare Metal Heating Pipework, Foam Insulation, Timber Boxing, Concrete Deck, Modern Mechanical and Electrical Installations

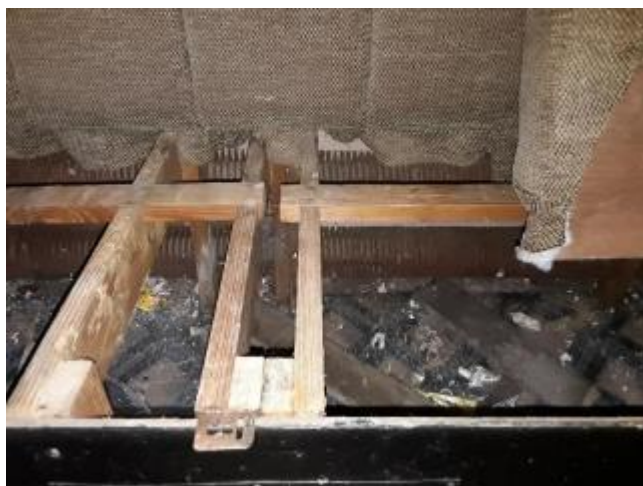
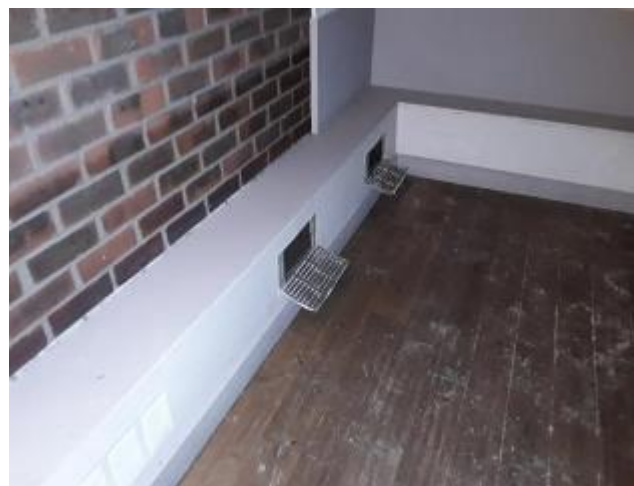
<b>Survey ID</b>	19	<b>Sample No.</b>	N/A
<b>Floor</b>	Ground Floor	<b>Area</b>	Floor, Walls and Ceilings
<b>Room</b>	G.04	<b>Item</b>	General View

<b>Action</b>	N/A	<b>Priority</b>	N/A	<b>Notifiable</b>	N/A	<b>Licensable</b>	N/A
<b>Comments/Recommendations</b>							
General Observations – Brick Walls, Timber Flooring, Timber Heating Boxing, Timber Seating Framework

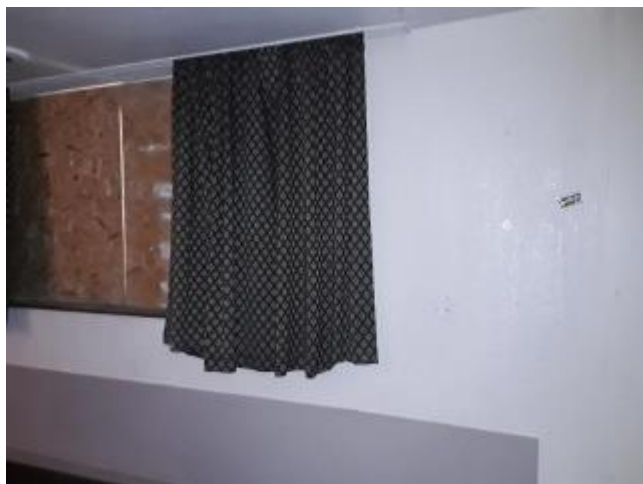
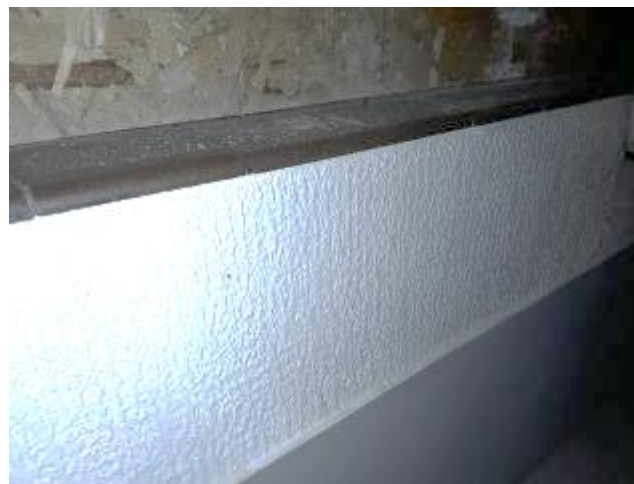
<b>Survey ID</b>	22	<b>Sample No.</b>	S009
<b>Floor</b>	Ground Floor	<b>Area</b>	Walls
<b>Room</b>	G.04	<b>Item</b>	Textured Coating

<b>Sample Notes.</b>	To Concrete
----------------------	-------------

<u>Material Assessment</u>		Score			Score
Material	N/A	N/A	Surface Treatment	N/A	N/A
Extent of Damage	N/A	N/A	Asbestos Type	None Detected	N/A
Identification	SAMPLED		Material Assessment Total	N/A	N/A
				Quantity	N/A

<b>Action</b>	N/A	<b>Priority</b>	N/A	<b>Notifiable</b>	N/A	<b>Licensable</b>	N/A
<b>Comments/Recommendations</b>							
NO FURTHER ACTION REQUIRED

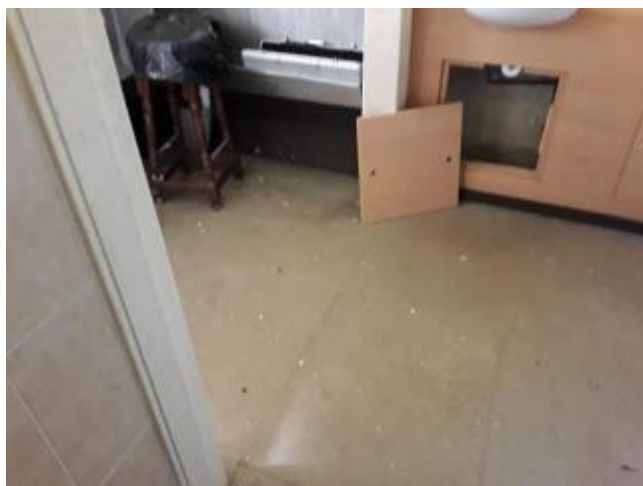
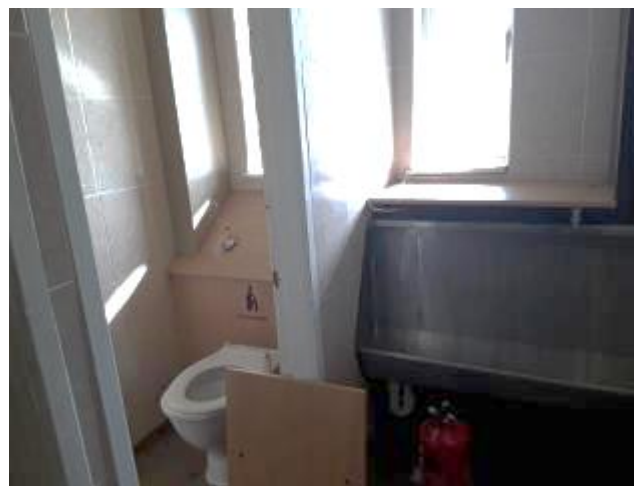
<b>Survey ID</b>	23	<b>Sample No.</b>	N/A
<b>Floor</b>	Ground Floor	<b>Area</b>	Floor, Walls and Ceilings
<b>Room</b>	G.05	<b>Item</b>	General View

<b>Action</b>	N/A	<b>Priority</b>	N/A	<b>Notifiable</b>	N/A	<b>Licensable</b>	N/A
<b>Comments/Recommendations</b>							
Modern Vinyl to Concrete Floor, Ceramic Tiled Walls, Modern Sanitary Ware

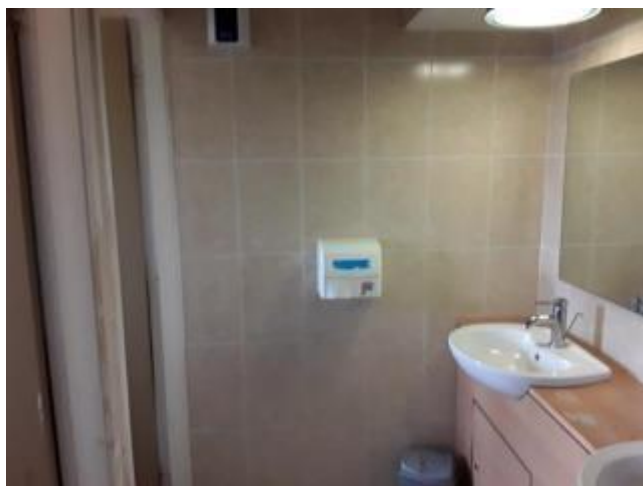
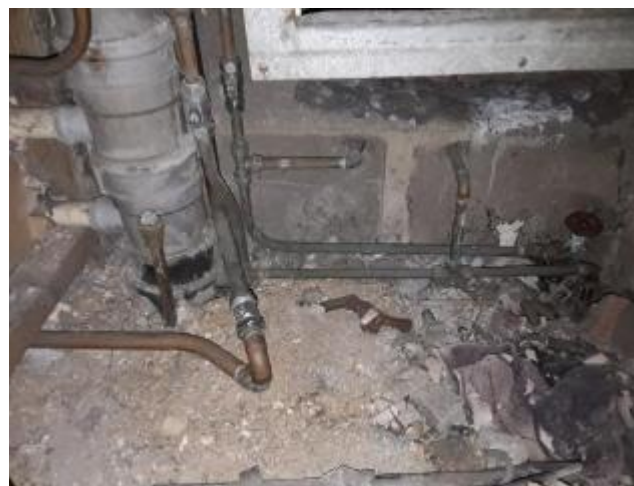
<b>Survey ID</b>	25	<b>Sample No.</b>	N/A
<b>Floor</b>	Ground Floor	<b>Area</b>	Floor, Walls and Ceilings
<b>Room</b>	G.06	<b>Item</b>	General View

<b>Action</b>	N/A	<b>Priority</b>	N/A	<b>Notifiable</b>	N/A	<b>Licensable</b>	N/A
<b>Comments/Recommendations</b>							
Modern Vinyl to Concrete Floor, Ceramic Tiled Walls, Modern Sanitary Ware, Plastic Pipes

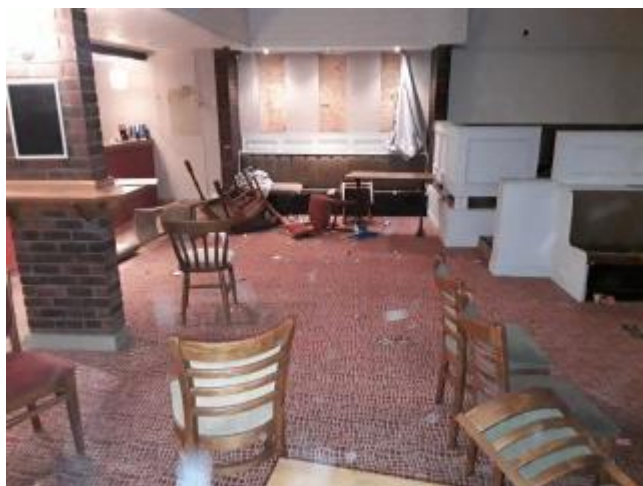
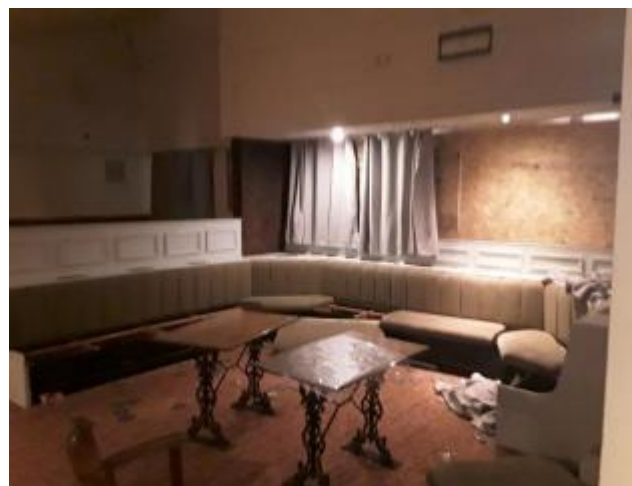
Survey ID	29	Sample No.	N/A
Floor	Ground Floor	Area	Floor, Walls and Ceilings
Room	G.08	Item	General View

Action	N/A	Priority	N/A	Notifiable	N/A	Licensable	N/A
Comments/Recommendations							
Carpet to Concrete Floor, Solid Walls, Bare Metal Heating Pipework, Foam Insulation, Timber Boxing, Concrete Deck, Modern Mechanical and Electrical Installations, Plasterboard Ceiling

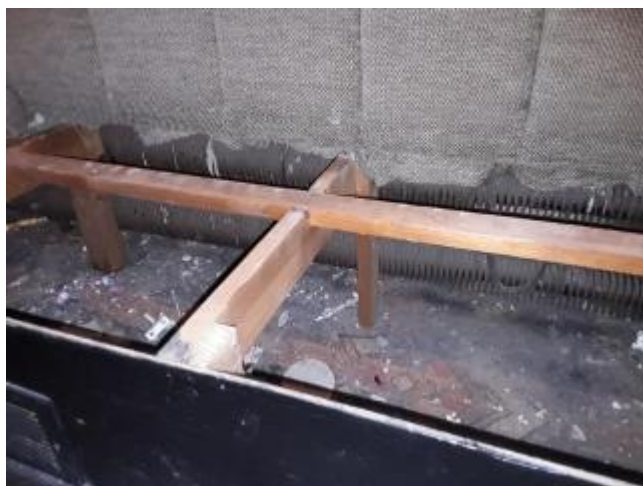
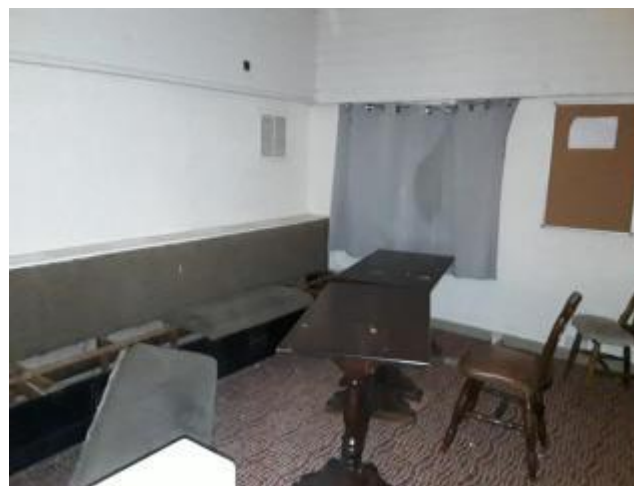
<b>Survey ID</b>	30	<b>Sample No.</b>	N/A
<b>Floor</b>	Ground Floor	<b>Area</b>	Floor, Walls and Ceilings
<b>Room</b>	G.08	<b>Item</b>	General View

<b>Comments/Recommendations</b>
General Observations – Timber Seating Framework, Finned Heating Pipework

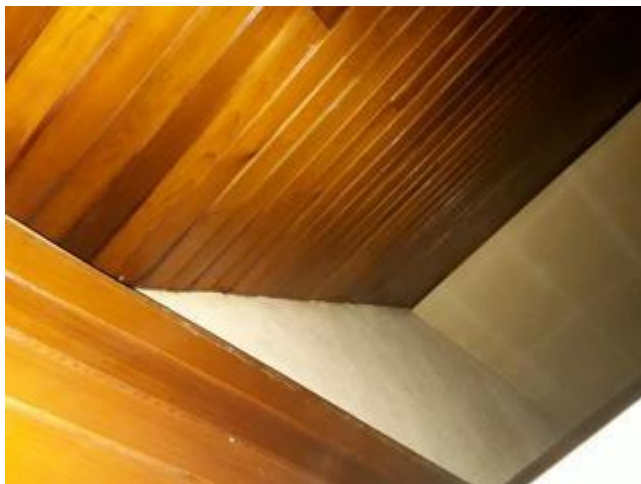
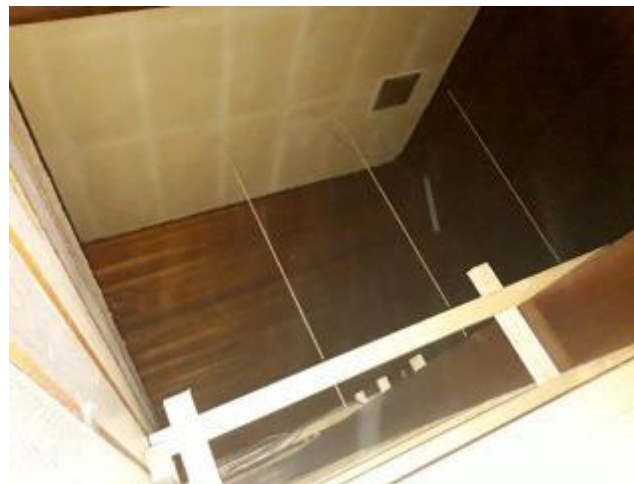
<b>Survey ID</b>	31	<b>Sample No.</b>	N/A
<b>Floor</b>	Ground Floor	<b>Area</b>	Ceiling Void
<b>Room</b>	G.08	<b>Item</b>	General View

<b>Action</b>	N/A	<b>Priority</b>	N/A	<b>Notifiable</b>	N/A	<b>Licensable</b>	N/A
<b>Comments/Recommendations</b>							
Timber Panels to Ceiling and Walls, Timber Stud False Ceiling

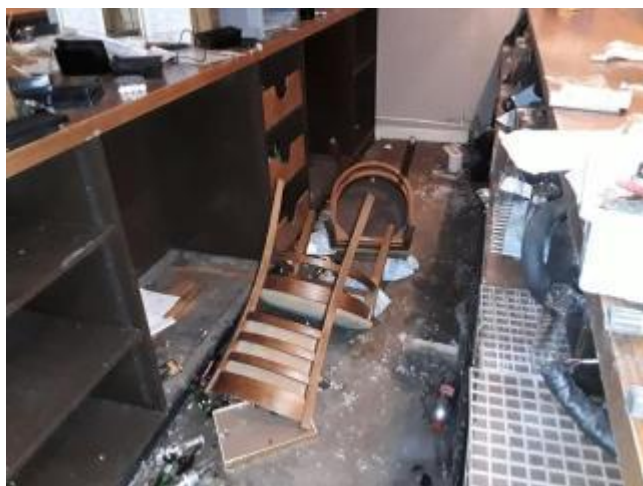
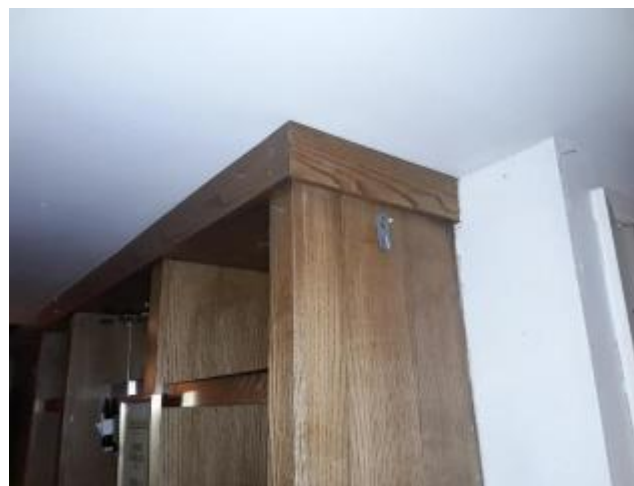
Survey ID	35	Sample No.	N/A
Floor	Ground Floor	Area	Floor, Walls and Ceilings
Room	G.09	Item	General View

Action	N/A	Priority	N/A	Notifiable	N/A	Licensable	N/A
Comments/Recommendations							
Modern Vinyl to Concrete Floor, Solid Walls, Bare Metal Heating Pipework, Foam Insulation, Timber Boxing, Concrete Deck, Modern Mechanical and Electrical Installations, Plasterboard Ceiling, Timber Units

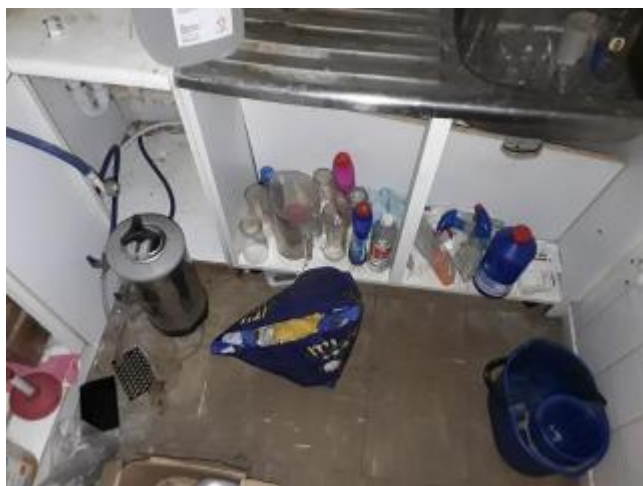
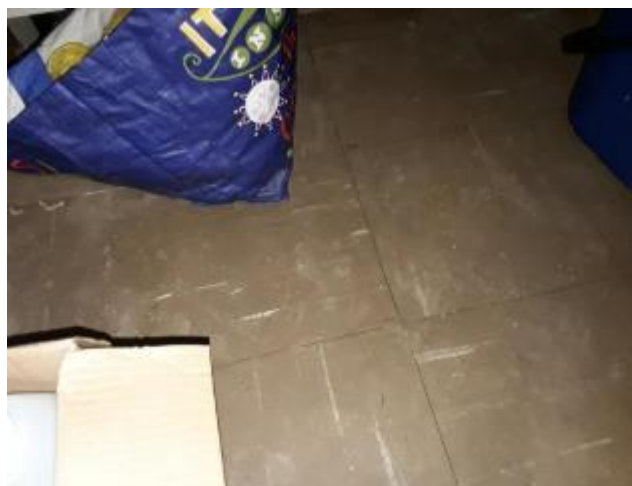
<b>Survey ID</b>	36	<b>Sample No.</b>	S012
<b>Floor</b>	Ground Floor	<b>Area</b>	Floor
<b>Room</b>	G.09	<b>Item</b>	Floor Tiles and Adhesive

<u>Material Assessment</u>		Score			Score
Material	N/A	N/A	Surface Treatment	N/A	N/A
Extent of Damage	N/A	N/A	Asbestos Type	None Detected	N/A
Identification	SAMPLED		Material Assessment Total	N/A	N/A
				Quantity	N/A

<b>Action</b>	N/A	<b>Priority</b>	N/A	<b>Notifiable</b>	N/A	<b>Licensable</b>	N/A
<b>Comments/Recommendations</b>							
NO FURTHER ACTION REQUIRED

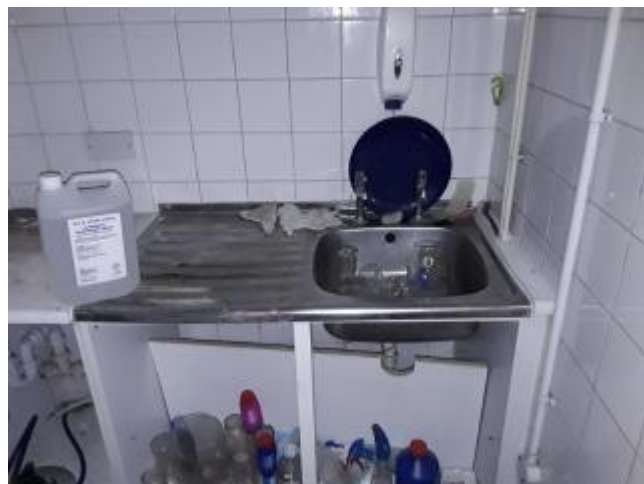
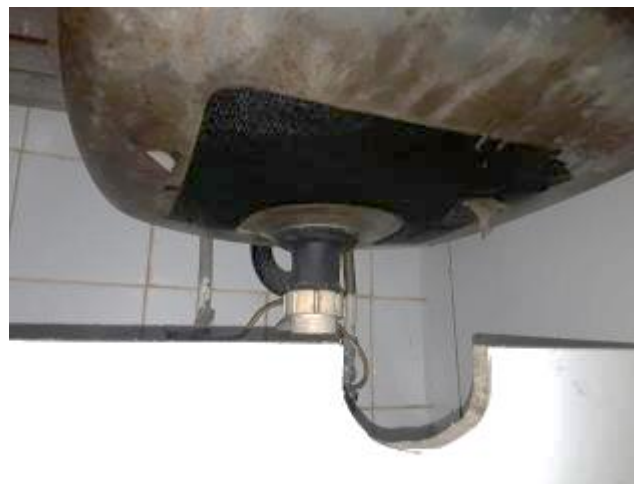
Survey ID	37	Sample No.	S013
Floor	Ground Floor	Area	Sink
Room	G.09	Item	Sink Pad

Material Assessment		Score			Score
Material	N/A	N/A	Surface Treatment	N/A	N/A
Extent of Damage	N/A	N/A	Asbestos Type	None Detected	N/A
Identification	SAMPLED		Material Assessment Total	N/A	N/A
				Quantity	N/A

Action	N/A	Priority	N/A	Notifiable	N/A	Licensable	N/A
Comments/Recommendations							
NO FURTHER ACTION REQUIRED

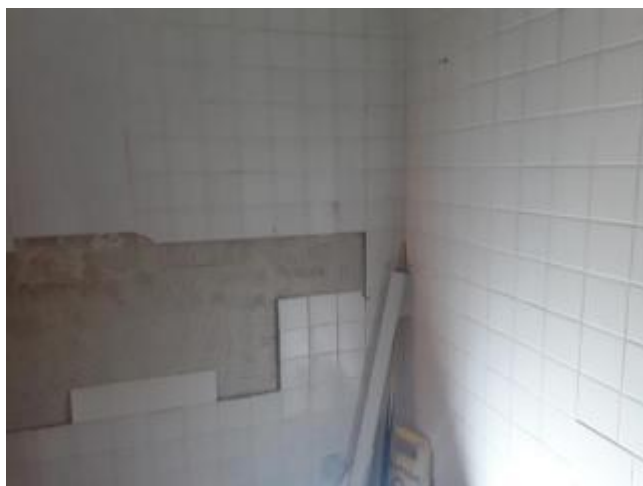
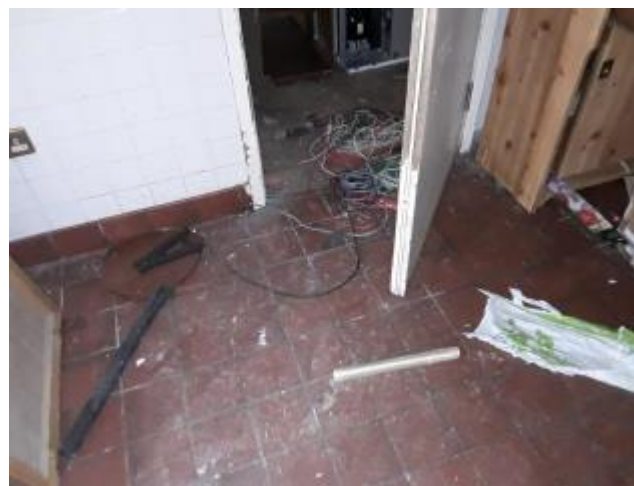
<b>Survey ID</b>	38	<b>Sample No.</b>	N/A
<b>Floor</b>	Ground Floor	<b>Area</b>	Floor, Walls and Ceiling
<b>Room</b>	G.10	<b>Item</b>	General View

<b>Action</b>	N/A	<b>Priority</b>	N/A	<b>Notifiable</b>	N/A	<b>Licensable</b>	N/A
<b>Comments/Recommendations</b>							
Ceramic Tiles to Floor and Walls, Metal Units

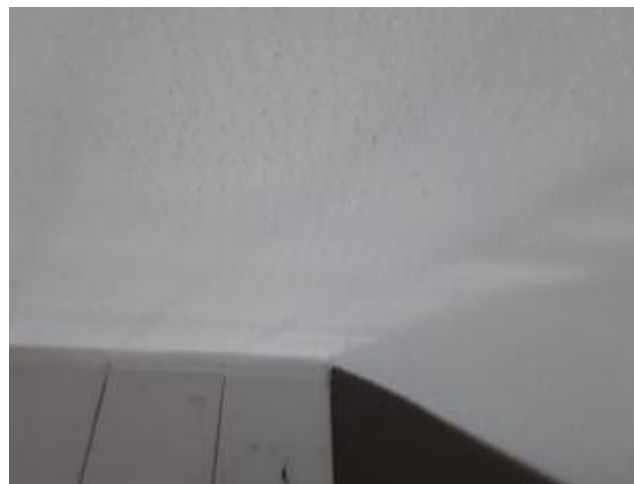
Survey ID	39	Sample No.	As S005
Floor	Ground Floor	Area	Ceiling
Room	G.10	Item	Textured Coating

Sample Notes.	To Plasterboard
---------------	-----------------

Material Assessment		Score			Score
Material	Textured Coating	1	Surface Treatment	Composite materials containing asbestos	0
Extent of Damage	Low Damage	1	Asbestos Type	Chrysotile	1
Identification	STRONGLY PRESUMED		Material Assessment Total	Very Low	3
				Quantity	12 m <sup>2</sup>

Comments/Recommendations
TO BE REMOVED BY A COMPETENT CONTRACTOR AND DISPOSED OF AS HAZARDOUS WASTE, ALL IN ACCORDANCE WITH CURRENT ASBESTOS LEGISLATION/REGULATIONS

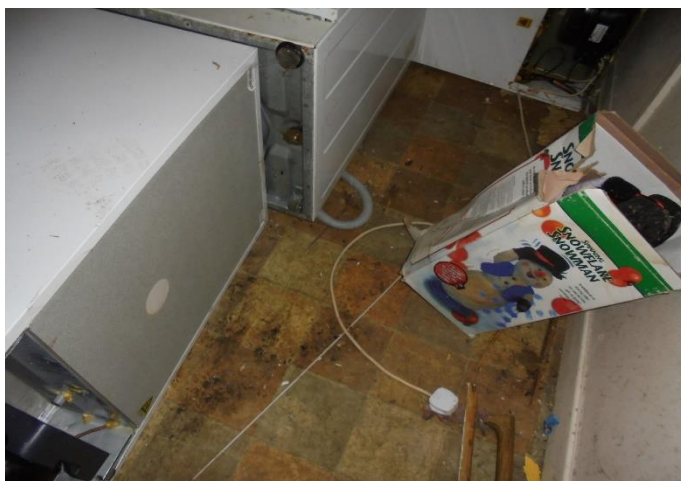
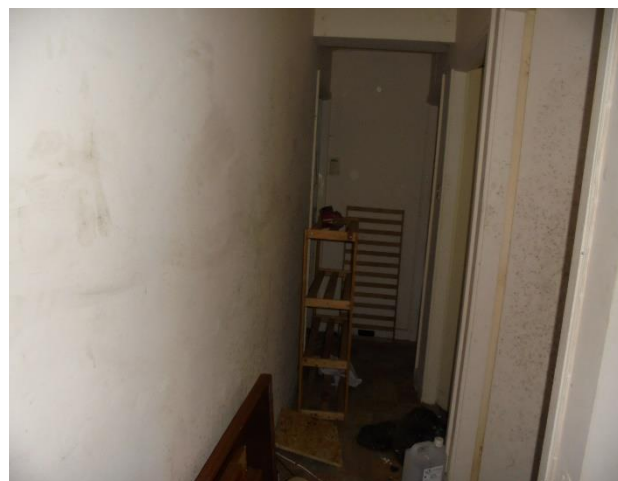
Survey ID	40	Sample No.	N/A
Floor	Ground Floor	Area	Floor, Walls and Ceiling
Room	G.11	Item	General View

Action	N/A	Priority	N/A	Notifiable	N/A	Licensable	N/A
Comments/Recommendations							
Ceramic Tiles to Floor, Solid Walls

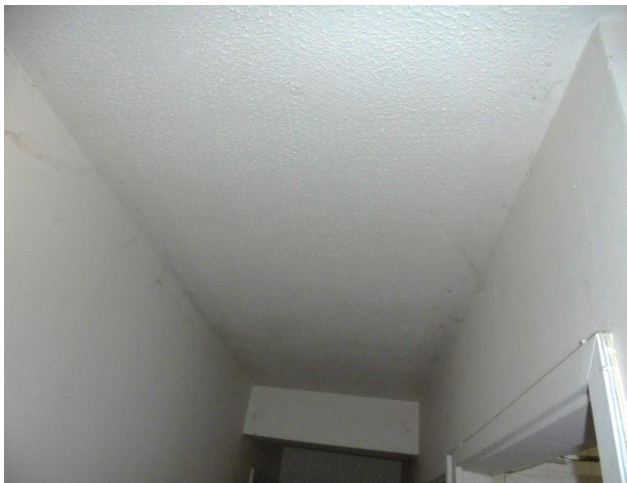
Survey ID	41	Sample No.	As S005
Floor	Ground Floor	Area	Ceiling
Room	G.11	Item	Textured Coating

Sample Notes.	To Plasterboard

Material Assessment		Score			Score
Material	Textured Coating	1	Surface Treatment	Composite materials containing asbestos	0
Extent of Damage	Low Damage	1	Asbestos Type	Chrysotile	1
Identification	STRONGLY PRESUMED		Material Assessment Total	Very Low	3
				Quantity	18 m <sup>2</sup>

Action	Remove	Priority	As soon as possible	Notifiable	No	Licensable	No
<b>Comments/Recommendations</b>  TO BE REMOVED BY A COMPETENT CONTRACTOR AND DISPOSED OF AS HAZARDOUS WASTE, ALL IN ACCORDANCE WITH CURRENT ASBESTOS LEGISLATION/REGULATIONS

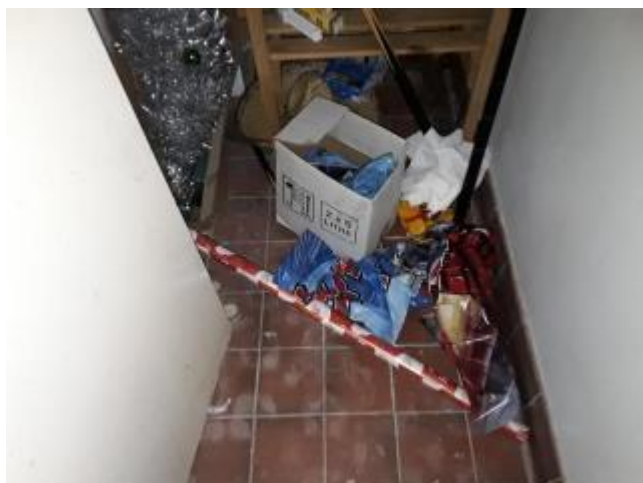
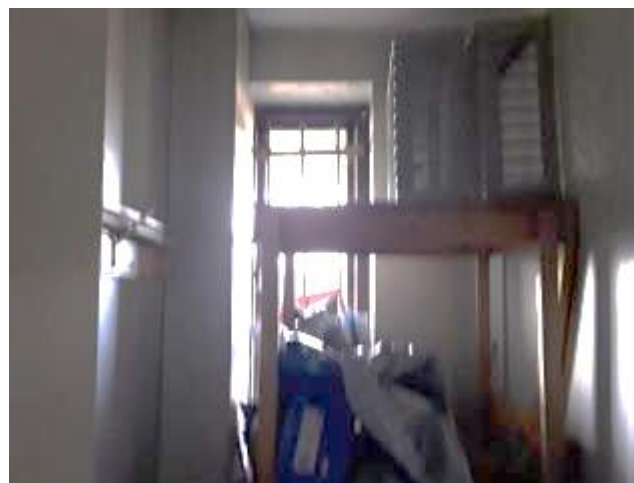
<b>Survey ID</b>	44	<b>Sample No.</b>	N/A
<b>Floor</b>	Ground Floor	<b>Area</b>	Floor, Walls and Ceiling
<b>Room</b>	G.13	<b>Item</b>	General View

<b>Action</b>	N/A	<b>Priority</b>	N/A	<b>Notifiable</b>	N/A	<b>Licensable</b>	N/A
<b>Comments/Recommendations</b>							
Ceramic Tiles to Floor, Solid Walls, Timber Boxing

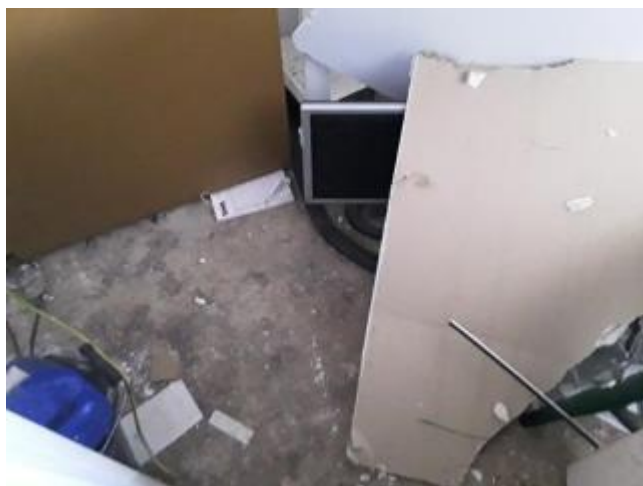
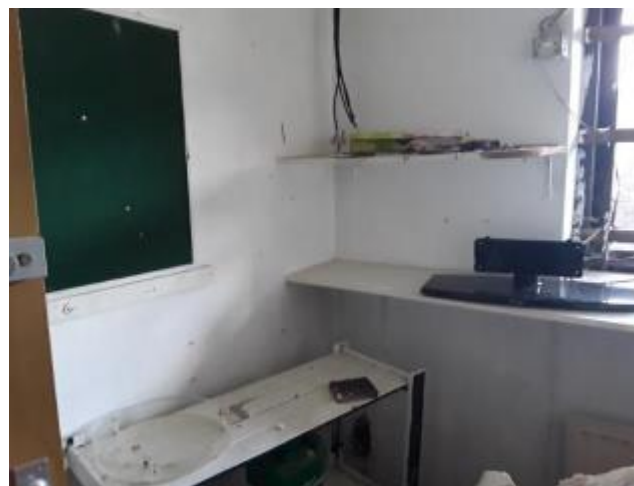
<b>Survey ID</b>	46	<b>Sample No.</b>	N/A
<b>Floor</b>	Ground Floor	<b>Area</b>	Floor, Walls and Ceiling
<b>Room</b>	G.14	<b>Item</b>	General View

<b>Action</b>	N/A	<b>Priority</b>	N/A	<b>Notifiable</b>	N/A	<b>Licensable</b>	N/A
<b>Comments/Recommendations</b>							
Concrete Floor, Solid Walls, Timber Boxing, Same Roof Void as G.03

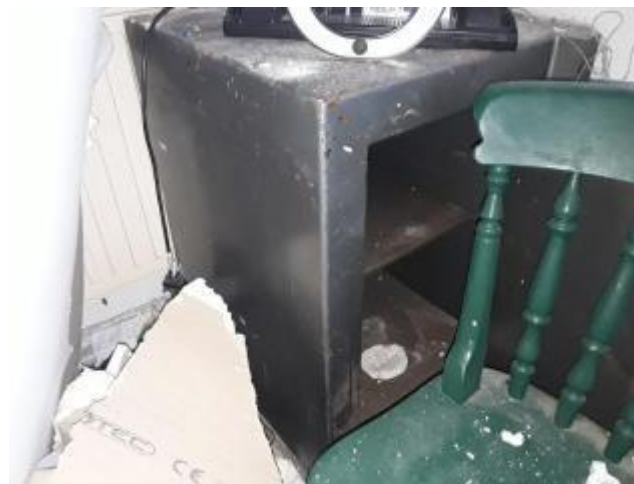
<b>Survey ID</b>	48	<b>Sample No.</b>	P001
<b>Floor</b>	Ground Floor	<b>Area</b>	Safe
<b>Room</b>	G.14	<b>Item</b>	Enclosed Lagging

<b>Material Assessment</b>		<b>Score</b>			<b>Score</b>
<b>Material</b>	Insulation	3	<b>Surface Treatment</b>	Enclosed sprays and lagging	1
<b>Extent of Damage</b>	Low Damage	1	<b>Asbestos Type</b>	Crocidolite	3
<b>Identification</b>	PRESUMED		<b>Material Assessment Total</b>	Medium	8
				<b>Quantity</b>	1 no

<b>Comments/Recommendations</b>
TO BE REMOVED BY A LICENSED CONTRACTOR AND DISPOSED OF AS HAZARDOUS WASTE, ALL IN ACCORDANCE WITH CURRENT ASBESTOS LEGISLATION/REGULATIONS

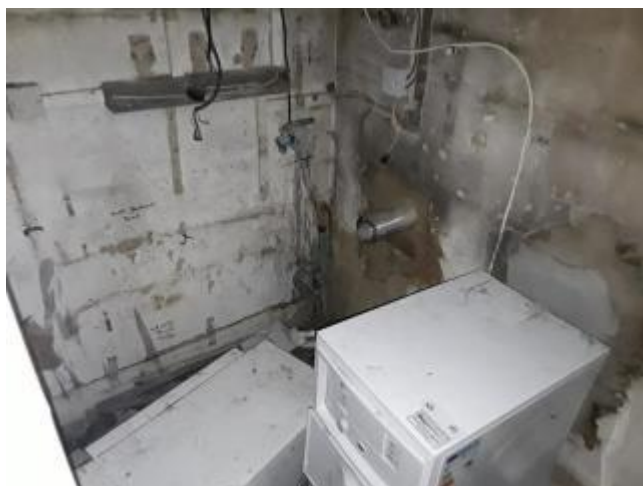
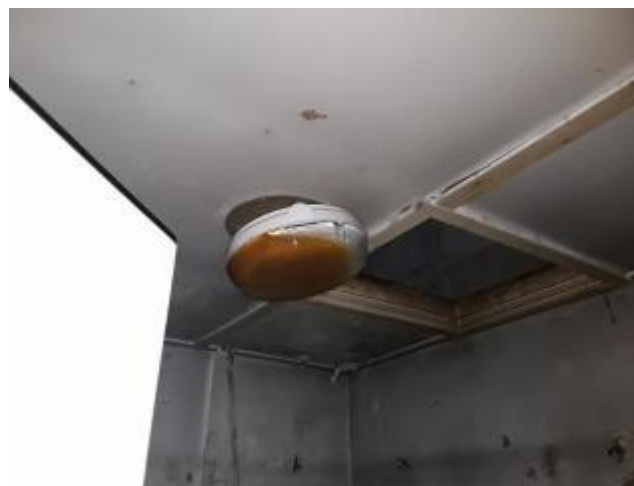
<b>Survey ID</b>	49	<b>Sample No.</b>	N/A
<b>Floor</b>	Ground Floor	<b>Area</b>	Floor, Walls and Ceiling
<b>Room</b>	G.15	<b>Item</b>	General View

<b>Action</b>	N/A	<b>Priority</b>	N/A	<b>Notifiable</b>	N/A	<b>Licensable</b>	N/A
<b>Comments/Recommendations</b>							
Concrete Floor, Solid Walls, Modern Boilers, Plasterboard Ceiling, Loose MMMF (Man Made Mineral Fibre) Insulation to Floor. Same Roof Void as G.03

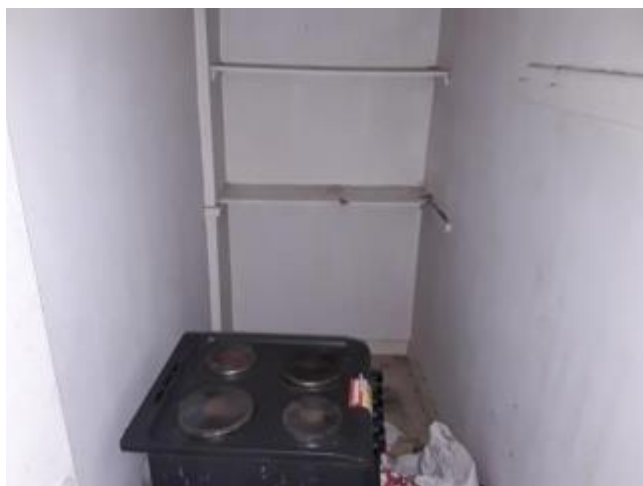
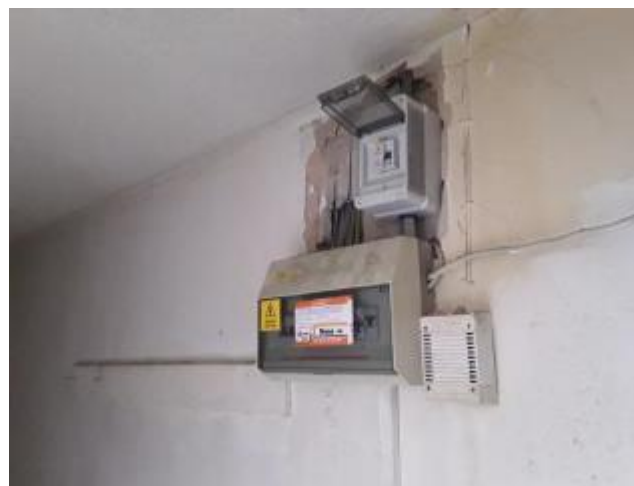
<b>Survey ID</b>	50	<b>Sample No.</b>	N/A
<b>Floor</b>	1st Floor	<b>Area</b>	Floor, Walls and Ceiling
<b>Room</b>	1.01	<b>Item</b>	General View

<b>Action</b>	N/A	<b>Priority</b>	N/A	<b>Notifiable</b>	N/A	<b>Licensable</b>	N/A
<b>Comments/Recommendations</b>							
Concrete Floor, Solid Walls, Modern Electrics

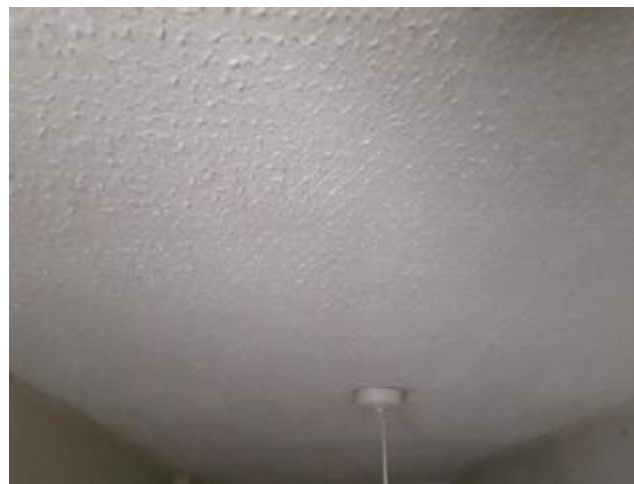
Survey ID	51	Sample No.	As S014
Floor	1st Floor	Area	Ceiling
Room	1.01	Item	Textured Coating

Sample Notes.	To Plasterboard
---------------	-----------------

Material Assessment		Score			Score
Material	Textured Coating	1	Surface Treatment	Composite materials containing asbestos	0
Extent of Damage	Low Damage	1	Asbestos Type	Chrysotile	1
Identification	STRONGLY PRESUMED		Material Assessment Total	Very Low	3
				Quantity	5 m <sup>2</sup>

Comments/Recommendations
TO BE REMOVED BY A COMPETENT CONTRACTOR AND DISPOSED OF AS HAZARDOUS WASTE, ALL IN ACCORDANCE WITH CURRENT ASBESTOS LEGISLATION/REGULATIONS

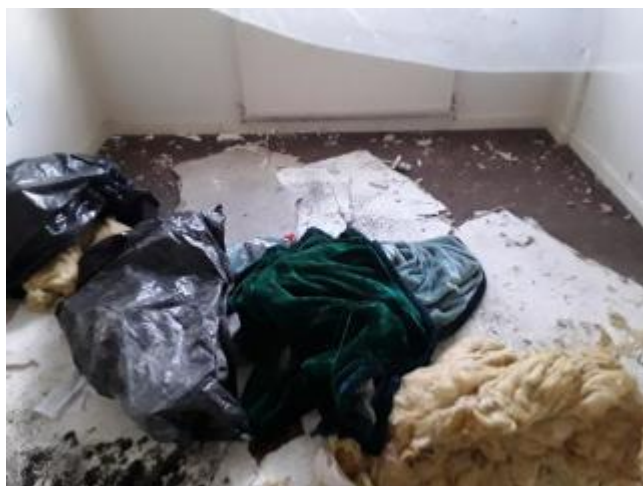
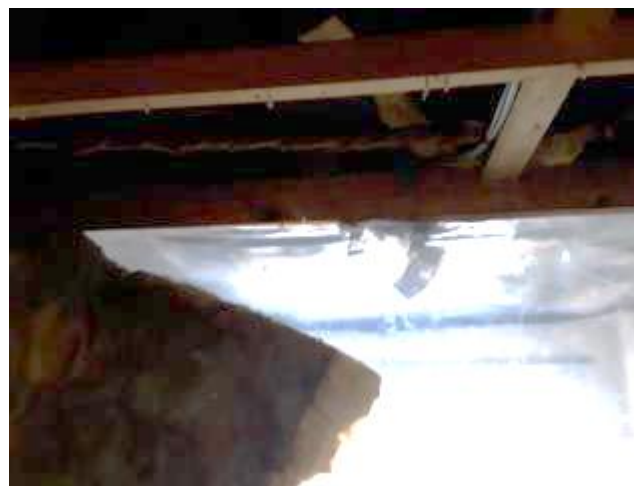
<b>Survey ID</b>	52	<b>Sample No.</b>	N/A
<b>Floor</b>	1st Floor	<b>Area</b>	Floor, Walls and Ceiling
<b>Room</b>	1.02	<b>Item</b>	General View

<b>Action</b>	N/A	<b>Priority</b>	N/A	<b>Notifiable</b>	N/A	<b>Licensable</b>	N/A
<b>Comments/Recommendations</b>							
Concrete Floor, Solid Walls, Timber Beams, MMMF Insulation

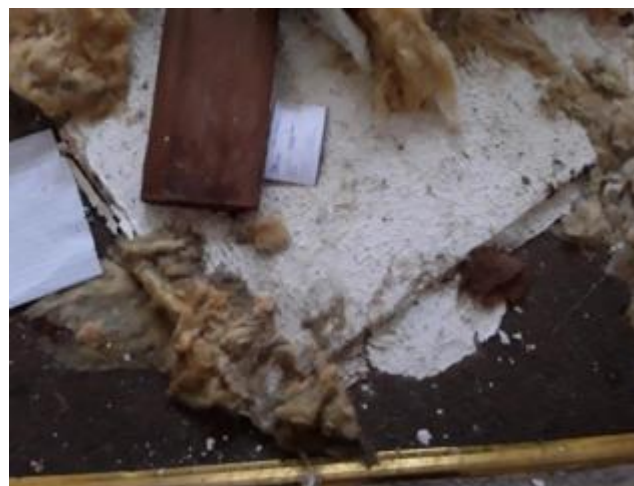
<b>Survey ID</b>	53	<b>Sample No.</b>	As S014
<b>Floor</b>	1st Floor	<b>Area</b>	Floor
<b>Room</b>	1.02	<b>Item</b>	Textured Coating Debris

<u>Material Assessment</u>		Score			Score
Material	Textured Coating	1	Surface Treatment	Composite materials containing asbestos	0
Extent of Damage	High Damage	3	Asbestos Type	Chrysotile	1
Identification	STRONGLY PRESUMED		Material Assessment Total	Low	5
				Quantity	6 + m²

<b>Comments/Recommendations</b>
TO BE REMOVED BY A COMPETENT CONTRACTOR AND DISPOSED OF AS HAZARDOUS WASTE, ALL IN ACCORDANCE WITH CURRENT ASBESTOS LEGISLATION/REGULATIONS
