**Campbell Park Parish Council**

**Former Springfield Public House  
Springfield Boulevard  
Milton Keynes  
MK6 3JS**

**Asbestos Survey Report Following a Refurbishment Survey in  
Accordance with HSG264**

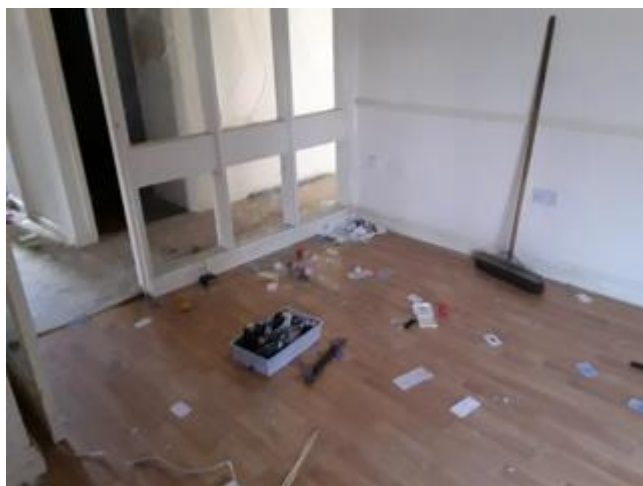
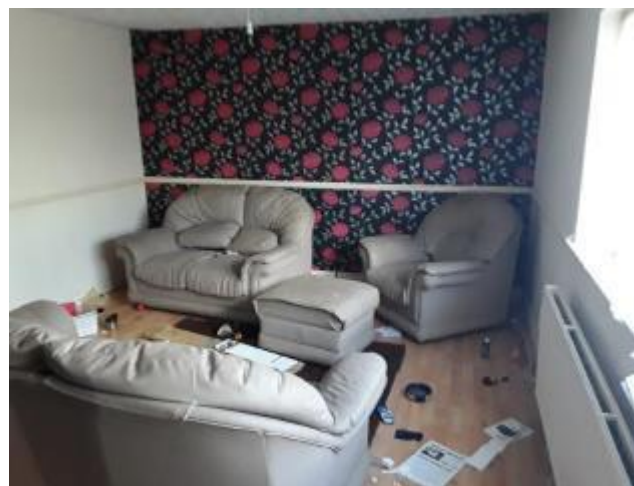
<b>Survey ID</b>	54	<b>Sample No.</b>	N/A
<b>Floor</b>	1st Floor	<b>Area</b>	Floor, Walls and Ceiling
<b>Room</b>	1.03	<b>Item</b>	General View

<b>Action</b>	N/A	<b>Priority</b>	N/A	<b>Notifiable</b>	N/A	<b>Licensable</b>	N/A
<b>Comments/Recommendations</b>							
Laminate Flooring to Concrete Floor, Solid Walls, Modern Mechanical and Electrical Installations

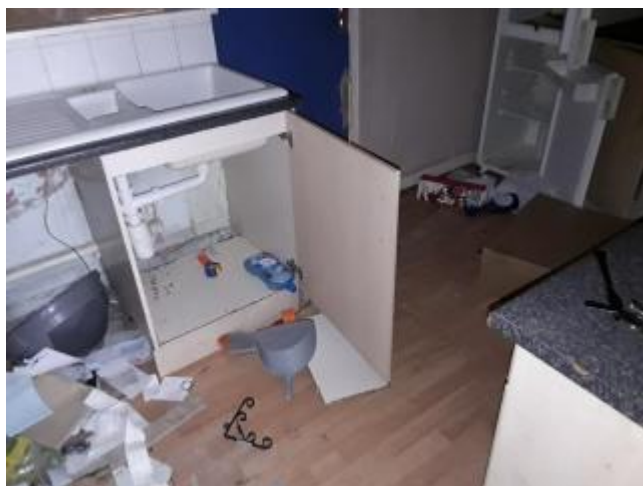
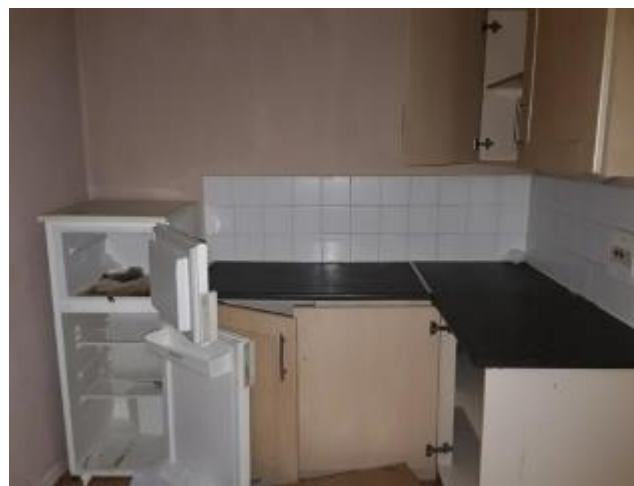
<b>Survey ID</b>	56	<b>Sample No.</b>	N/A
<b>Floor</b>	1st Floor	<b>Area</b>	Floor, Walls and Ceiling
<b>Room</b>	1.04	<b>Item</b>	General View

<b>Action</b>	N/A	<b>Priority</b>	N/A	<b>Notifiable</b>	N/A	<b>Licensable</b>	N/A
<b>Comments/Recommendations</b>							
Laminate to Concrete Floor, Solid Walls, Modern Mechanical and Electrical Installations, Ceramic Tiles to Walls

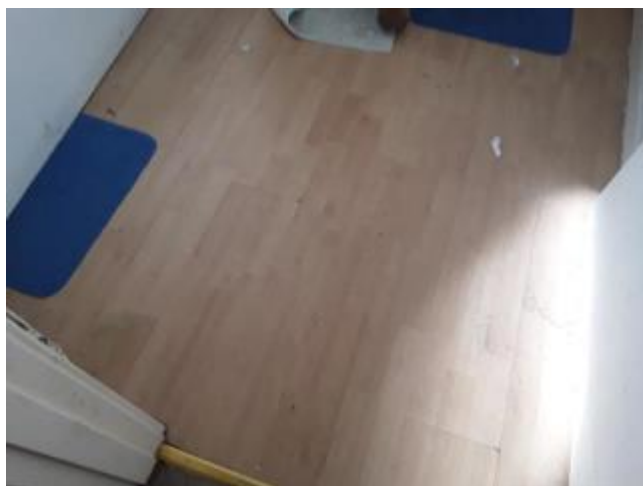
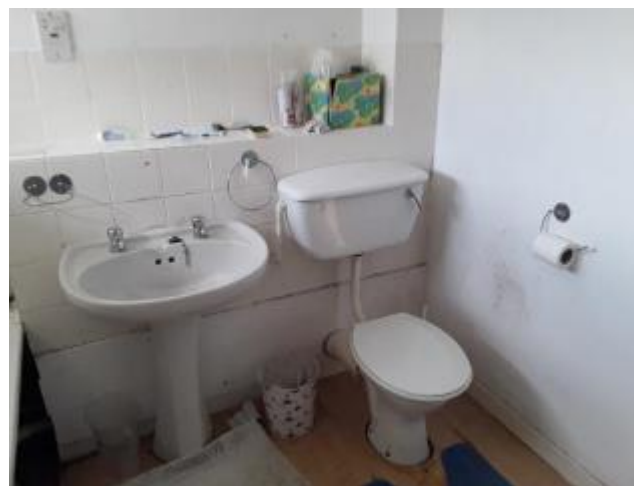
<b>Survey ID</b>	58	<b>Sample No.</b>	N/A
<b>Floor</b>	1st Floor	<b>Area</b>	Floor, Walls and Ceiling
<b>Room</b>	1.05	<b>Item</b>	General View

<b>Action</b>	N/A	<b>Priority</b>	N/A	<b>Notifiable</b>	N/A	<b>Licensable</b>	N/A
<b>Comments/Recommendations</b>							
Laminate to Concrete Floor, Solid Walls, Modern Sanitary Ware, Ceramic Tiles to Walls and Timber Boxing, Timber Bath Panel

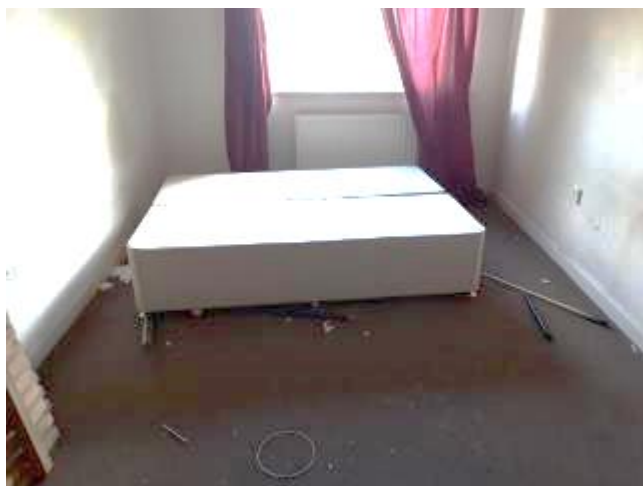
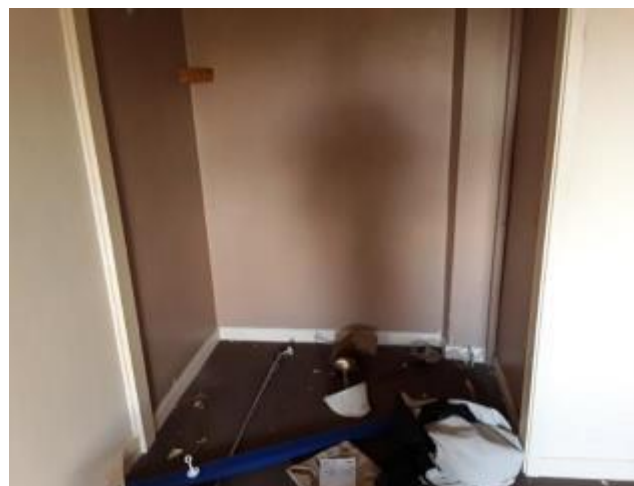
<b>Survey ID</b>	60	<b>Sample No.</b>	N/A
<b>Floor</b>	1st Floor	<b>Area</b>	Floor, Walls and Ceiling
<b>Room</b>	1.06	<b>Item</b>	General View

<b>Action</b>	N/A	<b>Priority</b>	N/A	<b>Notifiable</b>	N/A	<b>Licensable</b>	N/A
<b>Comments/Recommendations</b>							
Carpet to Concrete Floor, Solid Walls, Modern Mechanical and Electrical Installations, Timber Boxing

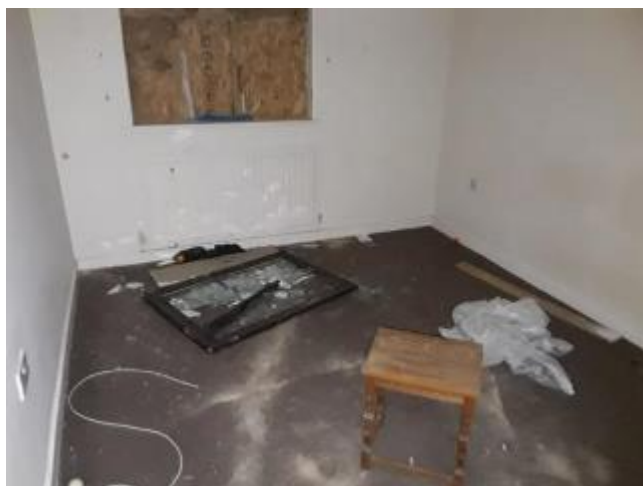
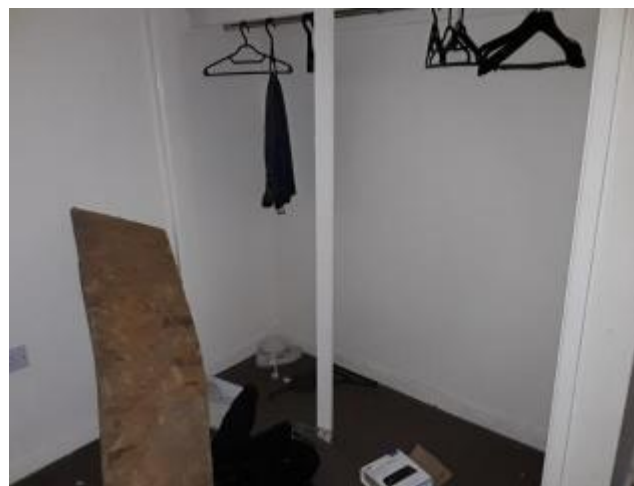
<b>Survey ID</b>	63	<b>Sample No.</b>	N/A
<b>Floor</b>	1st Floor	<b>Area</b>	Floor, Walls and Ceiling
<b>Room</b>	1.07	<b>Item</b>	General View

<b>Action</b>	N/A	<b>Priority</b>	N/A	<b>Notifiable</b>	N/A	<b>Licensable</b>	N/A
<b>Comments/Recommendations</b>							
Carpet to Concrete Floor, Solid Walls, Modern Mechanical and Electrical Installations, Timber Boxing

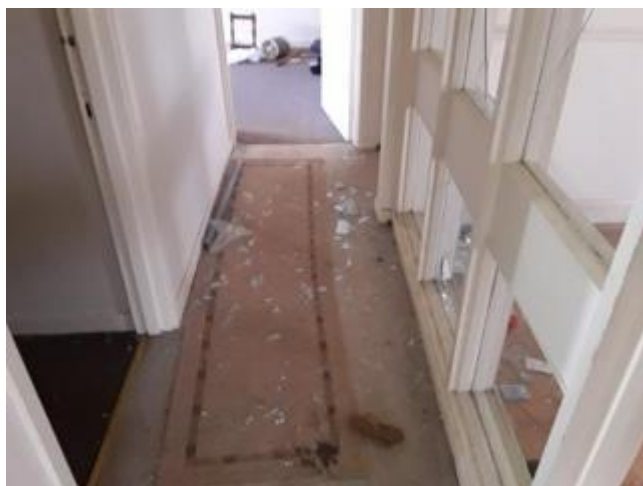
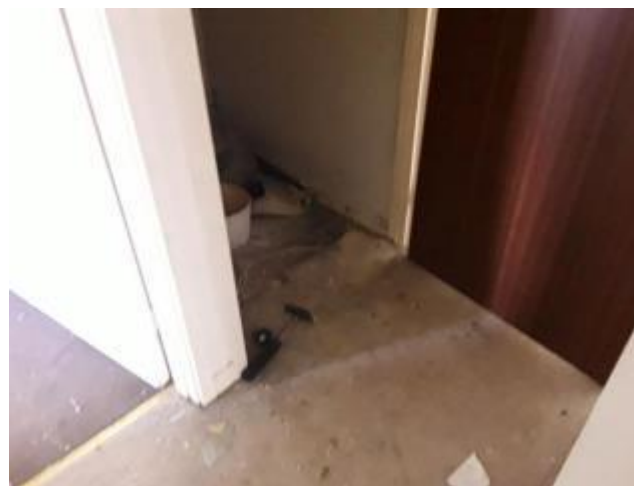
<b>Survey ID</b>	65	<b>Sample No.</b>	N/A
<b>Floor</b>	1st Floor	<b>Area</b>	Floor, Walls and Ceiling
<b>Room</b>	1.08	<b>Item</b>	General View

<b>Action</b>	N/A	<b>Priority</b>	N/A	<b>Notifiable</b>	N/A	<b>Licensable</b>	N/A
<b>Comments/Recommendations</b>							
Carpet to Concrete Floor, Solid Walls, Modern Mechanical and Electrical Installations, Timber Boxing

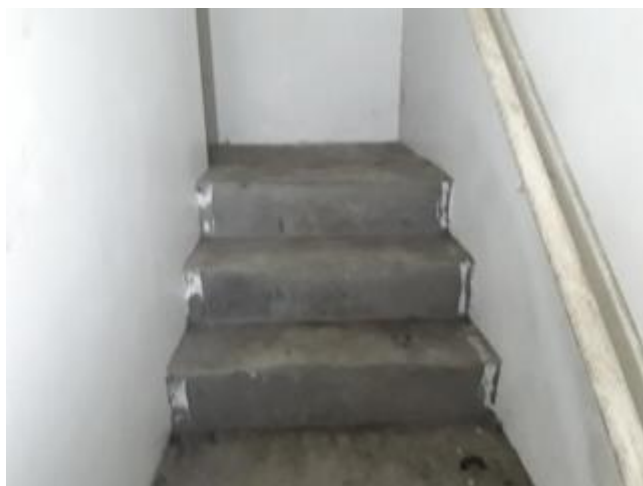
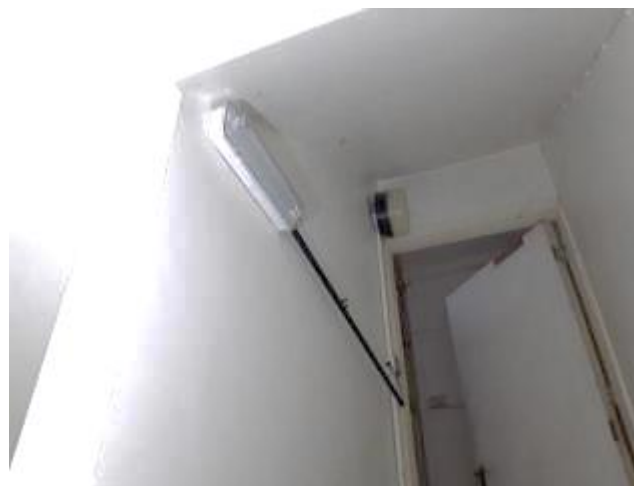
<b>Survey ID</b>	67	<b>Sample No.</b>	N/A
<b>Floor</b>	Stairwell	<b>Area</b>	Floor, Walls and Ceiling
<b>Room</b>	ST.01	<b>Item</b>	General View

<b>Action</b>	N/A	<b>Priority</b>	N/A	<b>Notifiable</b>	N/A	<b>Licensable</b>	N/A
<b>Comments/Recommendations</b>							
Concrete Stairs, Solid Walls and Ceiling, Plasterboard Door Header

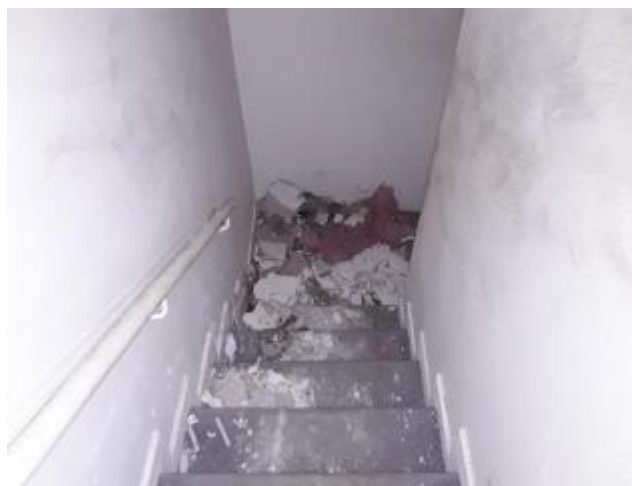
Survey ID	70	Sample No.	As S014
Floor	Stairwell	Area	Floor
Room	ST.02	Item	Textured Coating Debris

Material Assessment		Score			Score
Material	Textured Coating	1	Surface Treatment	Composite materials containing asbestos	0
Extent of Damage	High Damage	3	Asbestos Type	Chrysotile	1
Identification	STRONGLY PRESUMED		Material Assessment Total	Low	5
				Quantity	6 + m <sup>2</sup>

Comments/Recommendations
TO BE REMOVED BY A COMPETENT CONTRACTOR AND DISPOSED OF AS HAZARDOUS WASTE, ALL IN ACCORDANCE WITH CURRENT ASBESTOS LEGISLATION/REGULATIONS

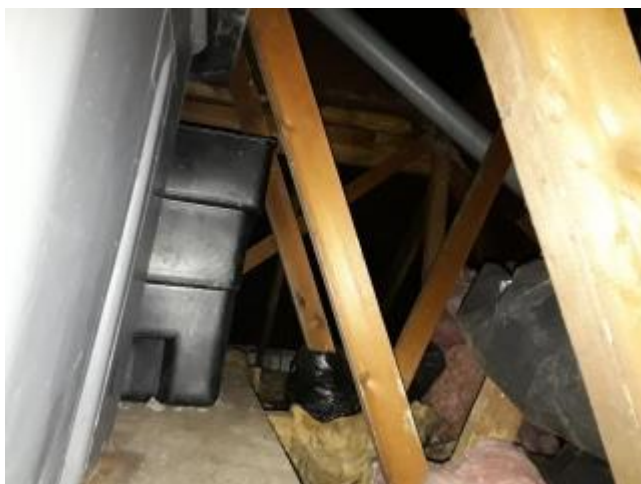
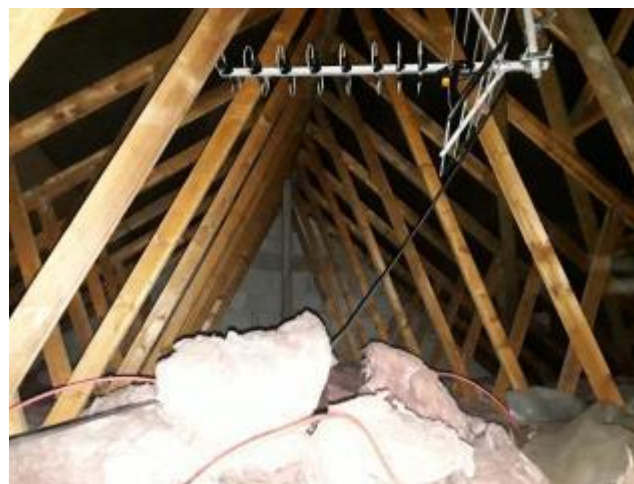
<b>Survey ID</b>	71	<b>Sample No.</b>	N/A
<b>Floor</b>	Roof Void	<b>Area</b>	Floor, Walls and Ceiling
<b>Room</b>	RV.01	<b>Item</b>	General View

<b>Action</b>	N/A	<b>Priority</b>	N/A	<b>Notifiable</b>	N/A	<b>Licensable</b>	N/A
<b>Comments/Recommendations</b>							
MMMF Insulation to Floor, Timber Beams and Joists, Modern Water Tank, Blockwork Walls, Metal and Plastic Pipework

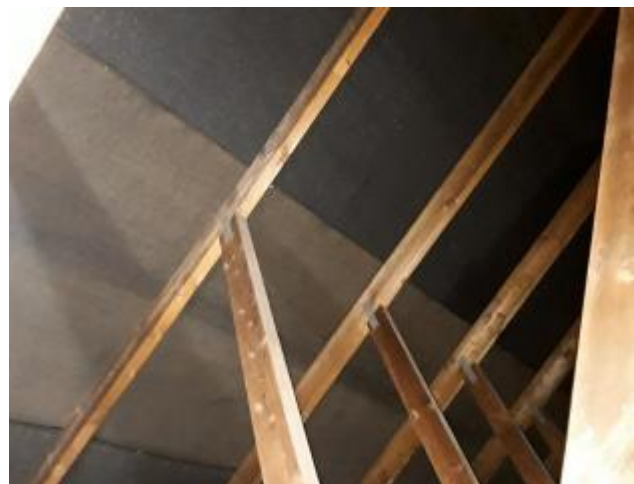
Survey ID	72	Sample No.	As S001
Floor	Roof Void	Area	Ceiling
Room	RV.01	Item	Roof Felt

<u>Material Assessment</u>		Score			Score
Material	N/A	N/A	Surface Treatment	N/A	N/A
Extent of Damage	N/A	N/A	Asbestos Type	None Detected	N/A
Identification	STRONGLY PRESUMED		Material Assessment Total	N/A	N/A
				Quantity	N/A

Action	N/A	Priority	N/A	Notifiable	N/A	Licensable	N/A
Comments/Recommendations							
NO FURTHER ACTION REQUIRED

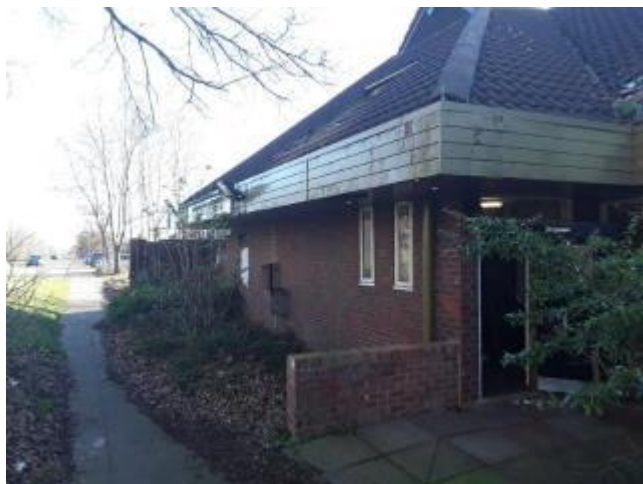
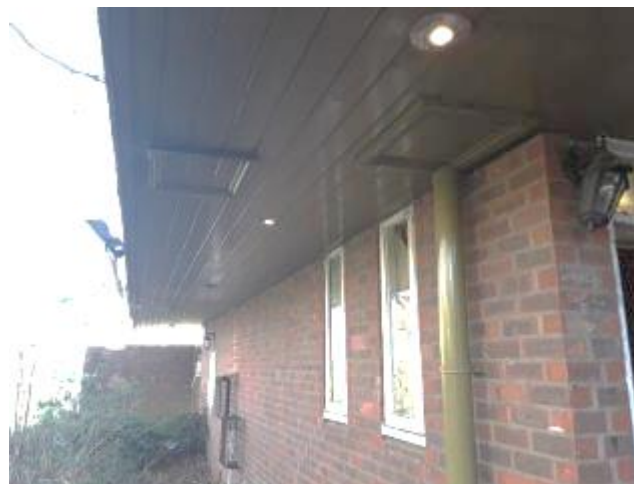
<b>Survey ID</b>	73	<b>Sample No.</b>	N/A
<b>Floor</b>	External	<b>Area</b>	All Externals
<b>Room</b>	EX.01	<b>Item</b>	General View

<b>Action</b>	N/A	<b>Priority</b>	N/A	<b>Notifiable</b>	N/A	<b>Licensable</b>	N/A
<b>Comments/Recommendations</b>							
Brick External Walls, uPVC Windows, Timber Canopy and Fascia, Plastic Rainwater Goods, Modern Mastic to Expansion Joints and Windows, Modern Mechanical and Electrical Installations, Tarmac and Concrete Floors, Pot Roof Tiles, Timber Panels

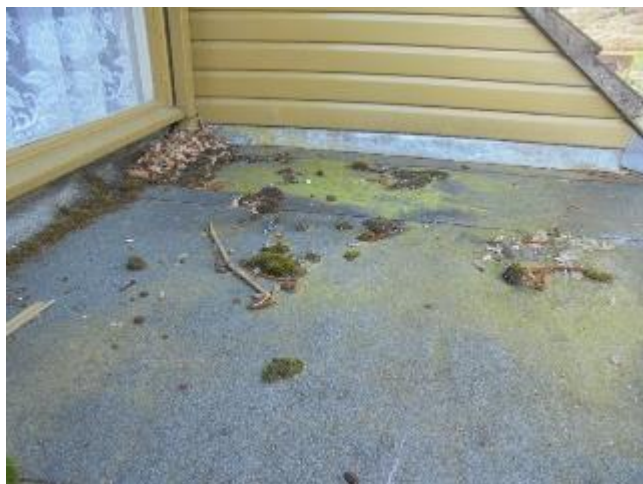
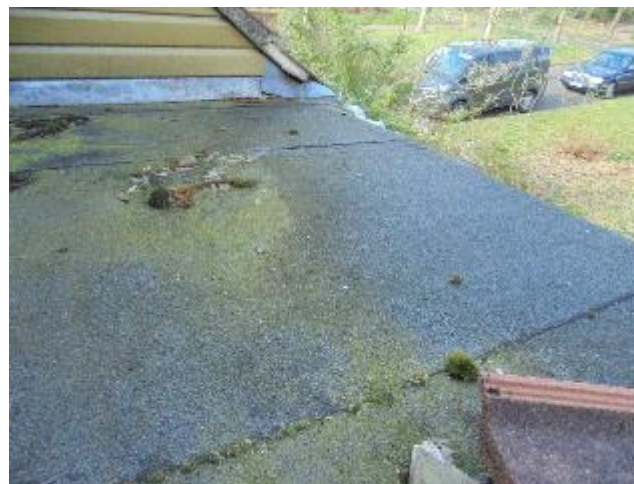
<b>Survey ID</b>	77	<b>Sample No.</b>	S007
<b>Floor</b>	External	<b>Area</b>	Flat Roof
<b>Room</b>	EX.01	<b>Item</b>	Bitumen Covering

<u>Material Assessment</u>		Score			Score
Material	N/A	N/A	Surface Treatment	N/A	N/A
Extent of Damage	N/A	N/A	Asbestos Type	None Detected	N/A
Identification	SAMPLED		Material Assessment Total	N/A	N/A
				Quantity	N/A

<b>Action</b>	N/A	<b>Priority</b>	N/A	<b>Notifiable</b>	N/A	<b>Licensable</b>	N/A
<b>Comments/Recommendations</b>							
NO FURTHER ACTION REQUIRED

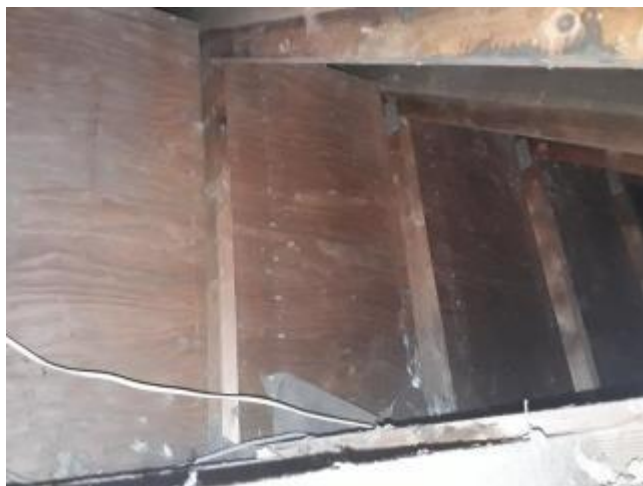
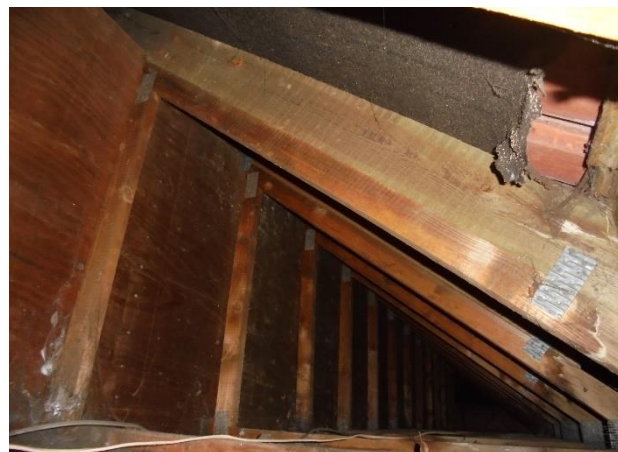
Survey ID	78	Sample No.	N/A
Floor	External	Area	Roof Canopy
Room	EX.02	Item	General View

Action	N/A	Priority	N/A	Notifiable	N/A	Licensable	N/A
Comments/Recommendations							
Timber Beams and Panels, Plastic Pipes

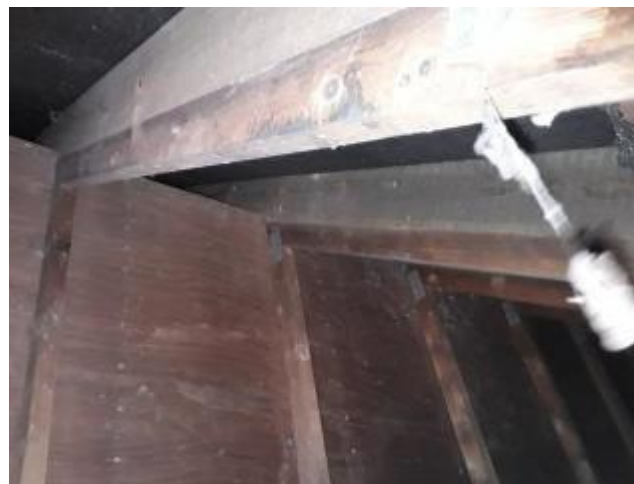
<b>Survey ID</b>	79	<b>Sample No.</b>	S001
<b>Floor</b>	External	<b>Area</b>	Roof Canopy
<b>Room</b>	EX.02	<b>Item</b>	Roof Felt

<u>Material Assessment</u>		Score			Score
Material	N/A	N/A	Surface Treatment	N/A	N/A
Extent of Damage	N/A	N/A	Asbestos Type	None Detected	N/A
Identification	SAMPLED		Material Assessment Total	N/A	N/A
				Quantity	N/A

<b>Action</b>	N/A	<b>Priority</b>	N/A	<b>Notifiable</b>	N/A	<b>Licensable</b>	N/A
<b>Comments/Recommendations</b>							
NO FURTHER ACTION REQUIRED
