Market House Site Layout

CLIENT: Rose-of-Wyke Town Council
PROJECT: Market House
TITLE: South Elevation External Stone Repairs 1 of 2
SCALE: 1:15
DATE: 05/07/22
SHEETING: A1
REF: NW CAB
JOB/DRAWING NUMBER: 1 046 Town Street, Rose-of-Wyke, Notts NG20 9HT
Tel: 01909 280870
Fax: 01909 280870
Email: info@hawkesedwards.com
CIPD: 026

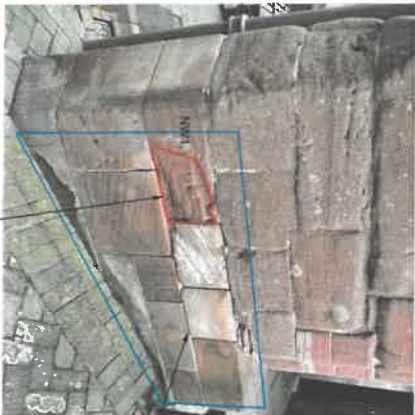
North west corner

Carefully rake out and deep repoint the thin joints between existing stone blocks within the blue outline.

NW 1. Within the red outlined area to the large corner stone block NW1. Apply a sensitive mortar repair to the eroded areas to build the surface level with adjacent blockwork. Approach sensitively, matching the new plastic mortar repair with the host stone in colour, texture and finish. As directed by the architect and in line with the specification.

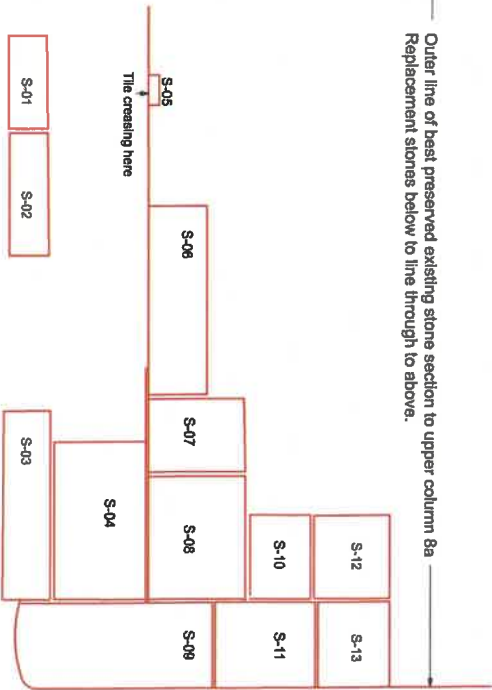
The identified red outlined blocks indicated above require replacing in part or whole, each stone to be treated on an individual basis. As stones are exposed, visual inspections can determine extent of replacement. Ashlar stone replacements of a minimum depth of 150mm.

The area below outlined in BLUE represents earlier previous attempts at stone replacement and for unknown reasons the lime mortar has failed and desintegrated.

Ideally this area should be carefully removed and rebuilt using the same stone blocks. Report this area in line with the specification and above stone replacements. Refer to drawing 560-018

All replacement stone to be treated individually, to replicate the stone size, position and coursing within the wall. New stone to be set in an approved lime mortar. Refer to the specification for proposed lime mortar mix. Selected stone to be approved by the Conservation Architect before any sizing cutting to ensure match and consistency with the entire elevation.

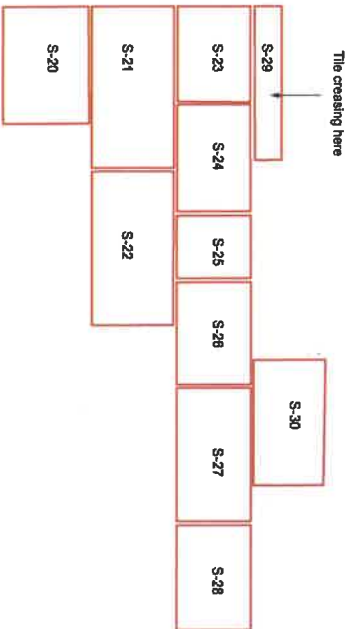
Outer line of best preserved existing stone section to upper column 8a
Replacement stones below to line through to above.

NOTE:
Actual existing stone blocks vary in size, allowances in the drawing should be made for the angle of perspective within the images provided causing deflection to the horizontal and vertical course lines.
