# ROOF CONDITION REPORT

**NORTH NORTHANTS COUNCIL**

**BRIGSTOCK LATHAM PRIMARY SCHOOL, LATHAM STREET,  
KETTERING, NORTHAMPTONSHIRE NN14 3HD**

**Prepared by:** George Husson (CS2) & Andrew Fox (Garland UK)  
**Checked by:** Matthew Cochrane BA(Hons) MSc  
**Date:** 22 September 2023  
**Our reference:** -  
**Revision:** A

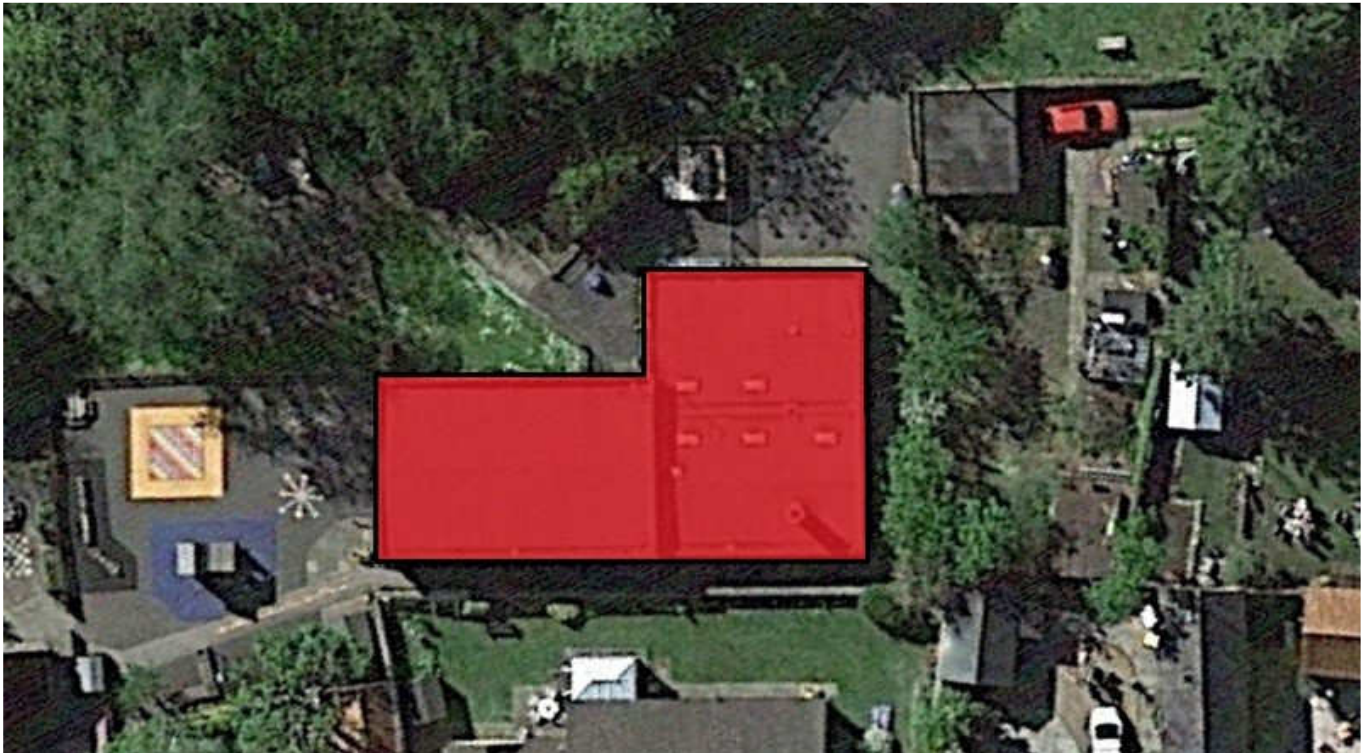
The roof systems are expected to be in excess of 30 years old and are therefore nearing the end of their useful life, this has been confirmed by the increased amount of water ingress being experienced into the school. Roof leaks are leading to the asbestos ceilings becoming wet and vulnerable to collapse, therefore the entire block has been closed until the ceilings are replaced – the roof should also be considered for repair or complete restoration and these options have been detailed below. In their current condition the roofs can be overlaid with the gutters only being stripped and replaced. By overlaying the roof before complete replacement is required this will allow the existing insulation to be utilised which will reduce costs and prevent over 4 tonnes of landfill waste. By overlaying the roofs before the insulation becomes wet and complete replacement is required, the council will save approximately £12,000.
