Columba Cook

Burrard-Neale Monument Lymington

Condition Survey and Cleaning Trials

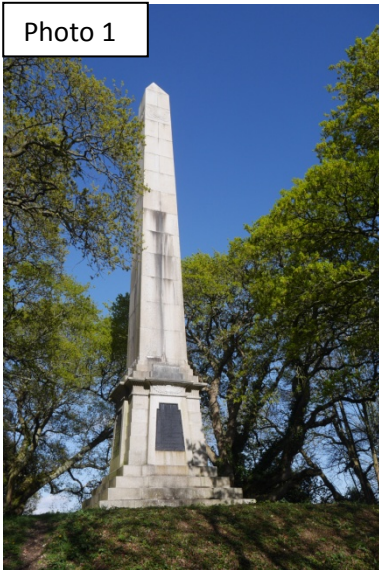
Photo 1

Burrard Neal Monument

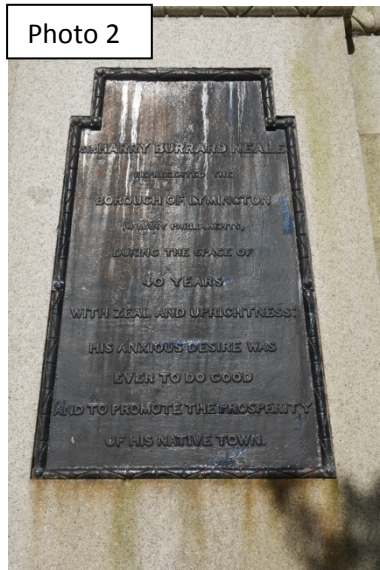
Photo 2

Cast iron plaque on west elevation

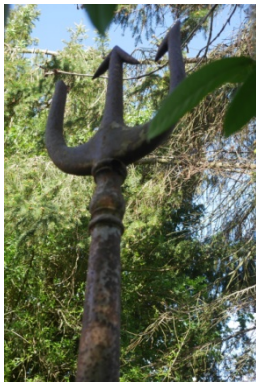
Photo 39

The Burrard Neale Monument was erected in Walhampton, Hampshire between 1840 and 1842 in memory of Sir Harry Burrard Neale (photo 1). The monument, a 22 m tall Egyptionate obelisk, consists of a 17 m tall granite needle sitting on a stepped square plinth topped with an Egyptian cornice. The monument is constructed of large Dartmoor Blue Granite blocks from the Foggintor Quarry. Raised stone tablets with cast iron plaques are placed centrally on each of the faces of the plinth; each plaque provides information about Sir Harry's life (photo 2). A scarab has been carved into each face of the needle just below the pyramidal top. The base of the monument is surrounded by Purbeck limestone paving bounded by granite kerbs containing the stubs of the original railings which were removed during World War II. The railings surrounded the monument on four sides with tall corner posts terminating in a trident, one of which has survived in an adjoining garden (photo 39).

Surviving trident corner post

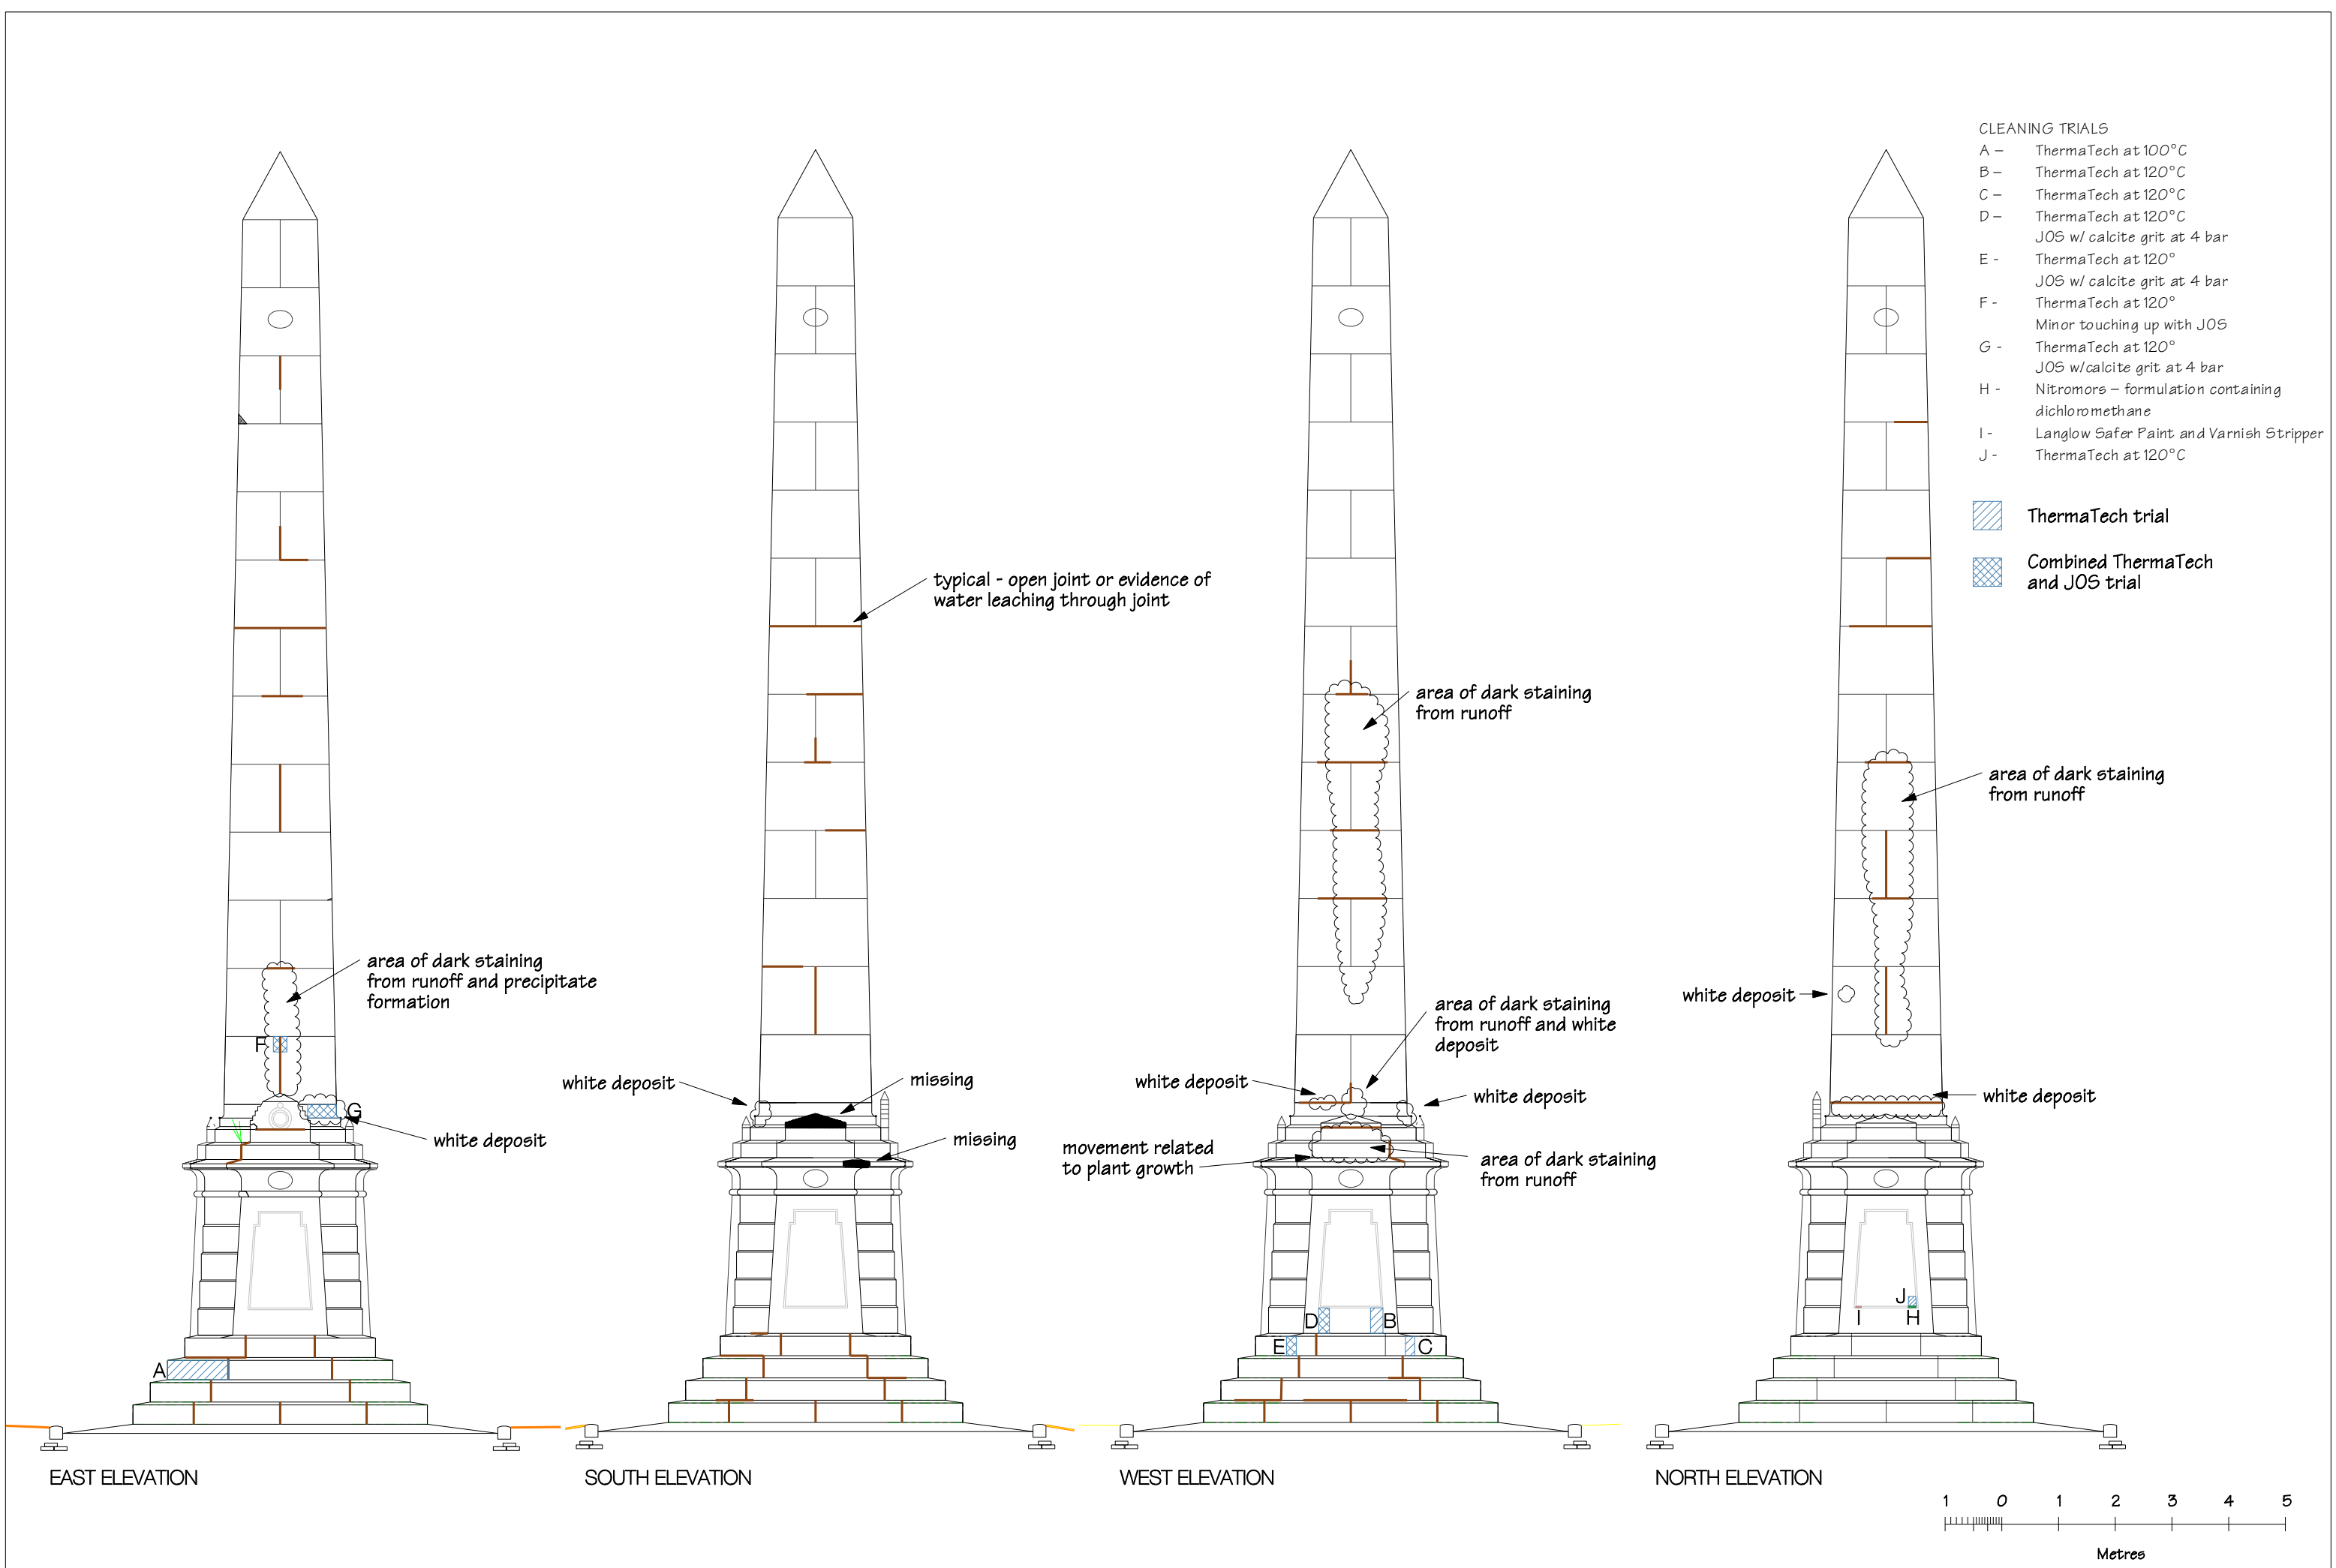
S1 A

- CLEANING TRIALS
- A - ThermaTech at 100°C
 - B - ThermaTech at 120°C
 - C - ThermaTech at 120°C
 - D - ThermaTech at 120°C
 - E - ThermaTech at 120°C
 - F - ThermaTech at 120°C
 - G - ThermaTech at 120°C
 - H - Nitromors - formulation containing dichloromethane
 - I - Langlow Safer Paint and Varnish Stripper
 - J - ThermaTech at 120°C
