NORTH FACING ELEVATION  
Refer to drawing 950-Q18 for full details of all stone repairs to this north elevation.

CLIENT: Ross-on-Wye Town Council  
PROJECT: North Elevation WF-06 Stone Repairs  
TITLE: WTS  
SCALE: 1:20 @ A3  
DATE: 11/04/22  
DRAWN BY: JRM  
CHECKED BY: JRM  
PROJECT NO: 950  
DRAWING NO: 034  
R.D.

CLIENT: Ross-on-Wye Town Council  
PROJECT: Market House  
TITLE: North Elevation WF-07 Stone Repairs  
SCALE: 1/10 (see sheet 950-018) 1/20 (see sheet 950-019)  
DATE: 13/04/2021 (sheet 950-018) 1/20 (see sheet 950-019)  
JOB/CLIENT NUMBER: 950 035  
DRAWN BY: RGT

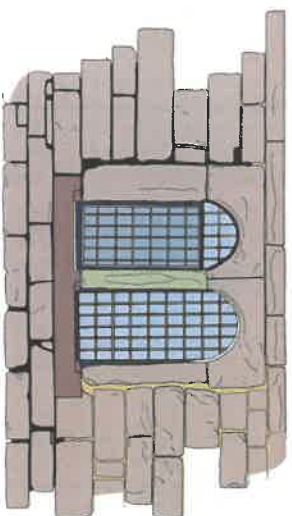
Window WF-03 External

Existing red sandstone sill to be retained and redressed.

Existing leaded lights. Individually sized to suit each individual window opening.  
The existing windows will need to be carefully removed and safely stored for later refitting. Allow for fully reconstructing the existing leaded lights to fit the new reveals with rebated glass lines.  
The repaired leaded lights and metal casements, (WF-03, WF-05, WF-07) are to be offered up and set within the rubble in a lime mortar bed.

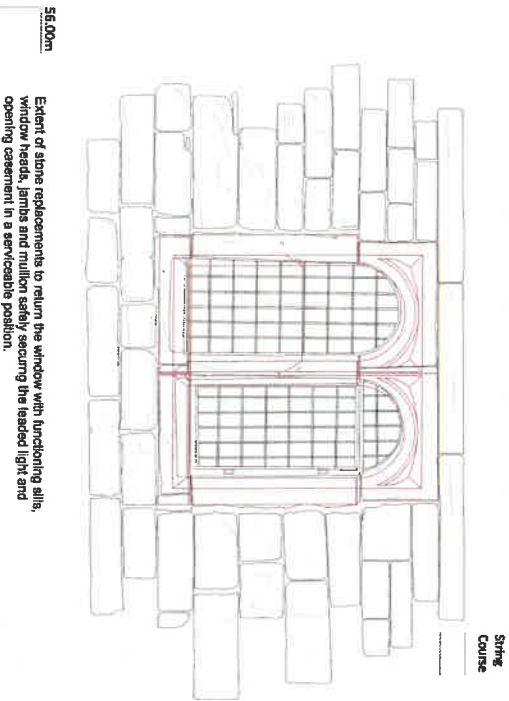
The stone sections forming WF-05 are a mix of a Forest of Dean and Rose Red/Brown sandstone. All stone sections have eroded back to the existing glass line and will require replacement all with approved Rose Brownstone.

Extent of stone replacements to return the window with functioning sills, window heads, jambs and mullion safely securing the leaded light and opening casement in a serviceable position.

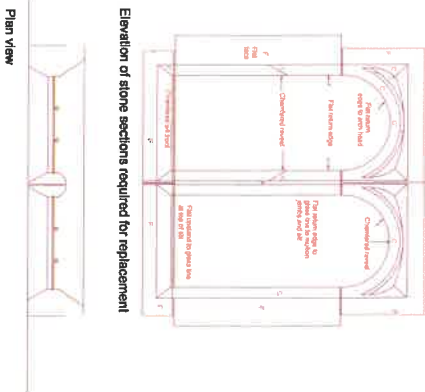
Elevation of stone sections required for replacement

Existing stone sections forming the window jambs, mullion, sills and window heads to be reassessed to determine extent of replacement. As most of the existing stone window reveals to the north elevation have now eroded up to and in parts beyond the glass line.

The stone sections forming WF-06 are a mix of a Forest of Dean and Rose Red/Brown sandstone. All stone sections have eroded back to the existing glass line and will require replacement all with approved Rose Brownstone, sandstone

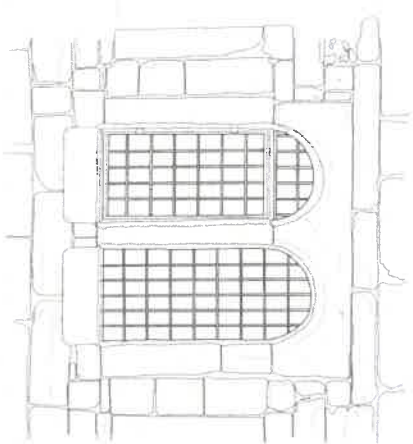
Photographic record of WF-02

Existing head stones appear to be less eroded and  
with a careful assessment

The stone sections forming WF-01 and WF-02 are of a Ross Red/Brown  
sandstone. All stone sections are heavily eroded, some back to the existing glass line.  
Repairs will be required, in parts with an approved suitable mortar mix to match the  
existing Ross red sandstone.

Existing leaded lights. Individually sized to suit each individual window opening.  
The existing windows will need to be carefully removed and safely stored for  
later refitting. Allow for fully reconstructing the existing leaded lights to fit the new  
revels with remade glass lines.

The repaired leaded lights and metal casements, (WF-01 , WF-02) are to  
be offered up and set within the rubble in a lime mortar bed.

Left and right jambs, centre mullion to receive a sensitive  
mortar repair to bring the profile back and reform the edge  
to the glass line.  
The repair must be of the best quality, undertaken correctly  
in accordance to the specification to ensure compatibility with the  
existing existing host stone, matching the colour, texture and finish.  
The applied mortar mix will be approved by Historic England  
and the Conservation Architect and must be undertaken by a suitably  
qualified conservation craftsman familiar with such fine detailed  
plastic mortar applications and techniques.

The existing sills are currently shielded by hand dressing to aid the  
shedding of rainwater, and arrest further erosion.  
Depending on their revealed current condition and further assessment  
allow for placing in clay tiles as shown to form the replacement sill.  
Form the sill in alternating the layers set in lime mortar with fine verticle  
joints, the leading edge extending slightly past the restoration line.  
Form a small verticle mortared upland to the existing glass line.
