The NMRN have concerns regarding the condition of the cofferdam fill drainage and associated structures supported on the fill materials, being the Bow Platform and Forward bow access staircase. From previous surveys and inspection, the following SOR has been developed to address the long-term consequences of a poor drainage system to the cofferdam fill below HMS Alliance.

Background

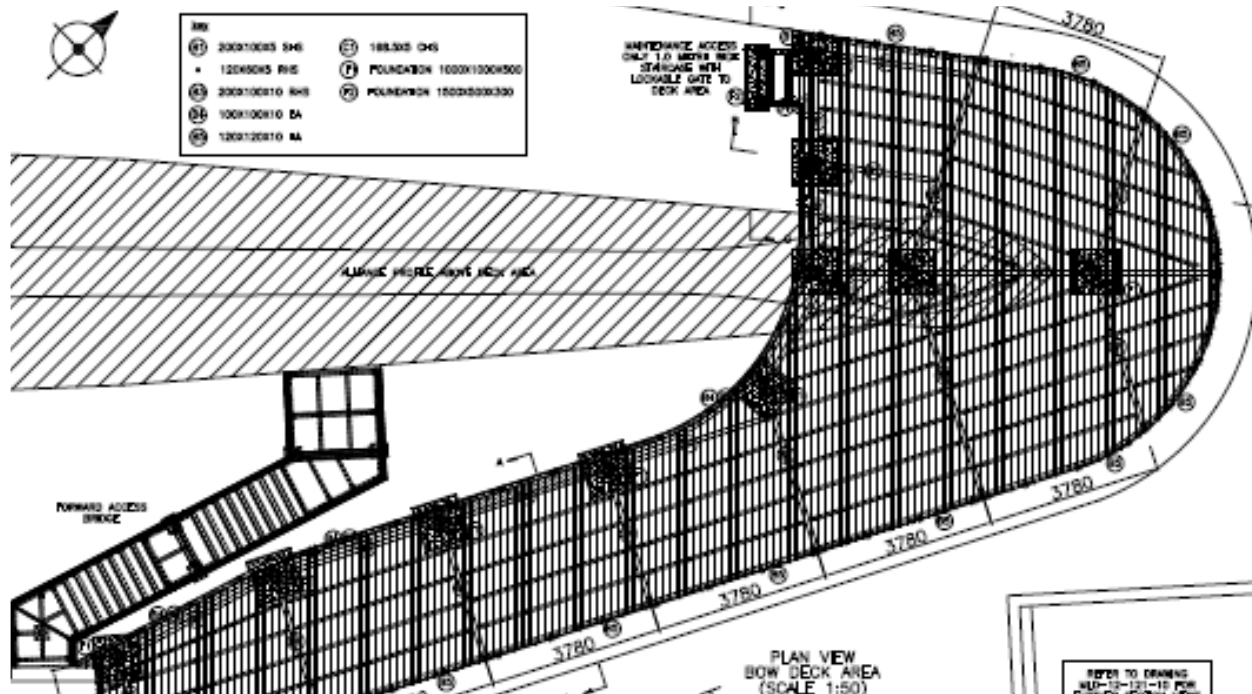
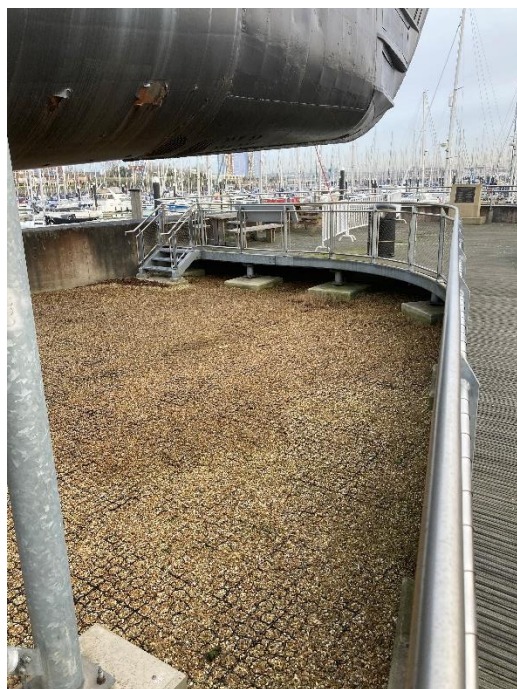
Photo of public viewing platform

To enable safe excavation and temporary shoring works required for the drainage system modifications, the existing public view platform shall be carefully disassembled as necessary, set to one side, then reinstated on completion of the works to which some foundation blocks shall be removed, and new structural steel beams installed to support the reinstated viewing platform.

Due to the current viewing platforms support foundations fluidity, potential movement during the cofferdam drainage works, addition support beams are to be installed in-leu of reinstating the R/C slab foundations.
