**The Springfield Public House
Springfield Boulevard
Milton Keynes
MK6 3HR**

Structural Survey

Revision 0: March 2019

R-11461V-01-0

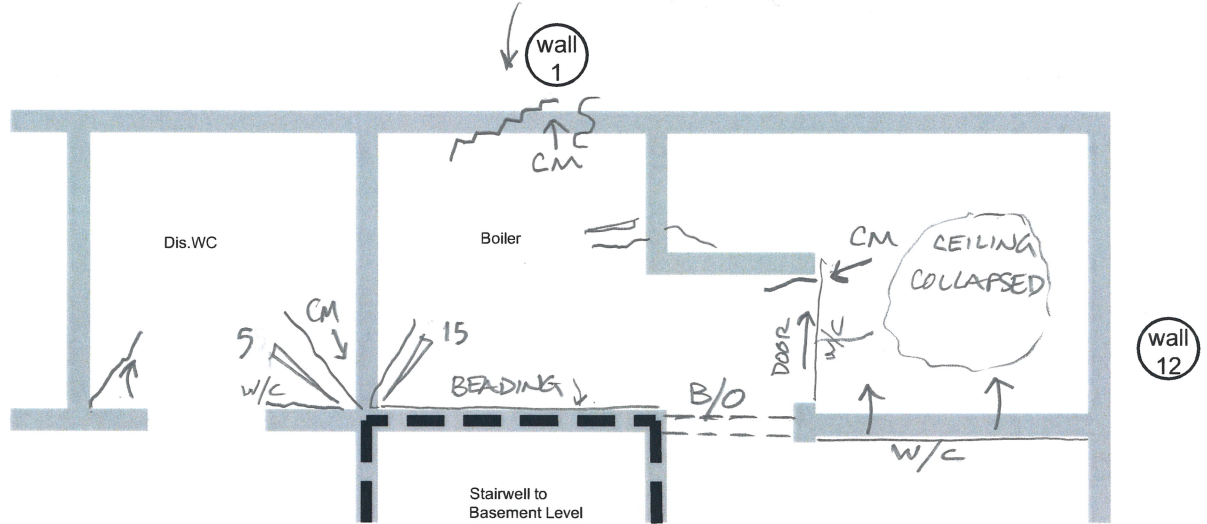
Chkd By:		Project	The Springfield Public House Springfield Boulevard, MK6 3HR					
		Scale @A4:	nts	Title	Sketch Part Ground Floor Layout showing observed crack damage					
		Date:	Mar. 2019	Project No.:	11461V		Drawing No:	SK03	Rev:	0
		Status:	FOR INFORMATION

Internally, within the disabled toilet and old boiler room and adjacent rooms to the north eastern corner, there is evidence of a rotational movement having taken place towards wall 1, with tapering vertical fractures of 15mm at the top, diminishing towards the floor. Adjacent door frames have dropped, such that the top of the door binds on the frame.

There are Avonguard crack monitoring gauges fitted across some of the fractures, also indicating the origin of the crack and movement damage to be longstanding. The gauges were typically fixed with the red cross hairs aligned on the 0-0 axis. You will note that vertical movement in the order of 4mm has taken place since fitting.
