Woodbridge Town Council

Structural Report on Woodbridge Art Club Building, Tide Mill Way, Woodbridge

May 2022

01-05-112552 NPS-R-S-001

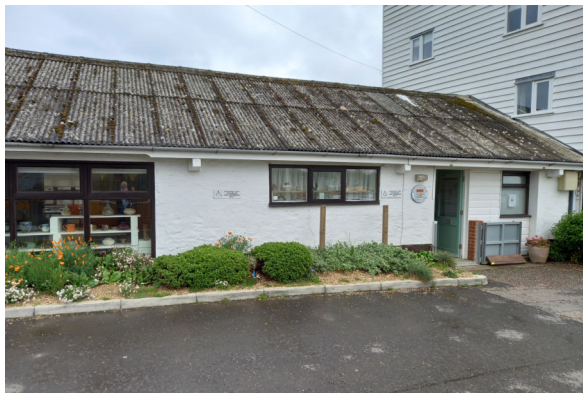
Photograph No. 01

Photograph No.'s 01 & 02 below show general views of the original building externally and internally, and photograph No.'s 03 & 04 show general views of the extension externally and internally.

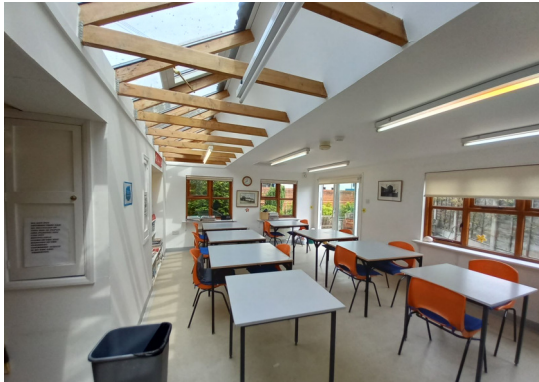
Photograph No. 16

Inspection of the more recent extension did not reveal any significant evidence of structural damage or distress internally. Visible parts of the gang nail roof trusses along the glazed section of the roof valley appeared satisfactory. Wall finishes & walls appear sound and vertical. Door & window head lintels did not show any significant evidence of distress. Photograph No.'s 16 – 17 below show general internal views of the extension looking NW & SE respectively.

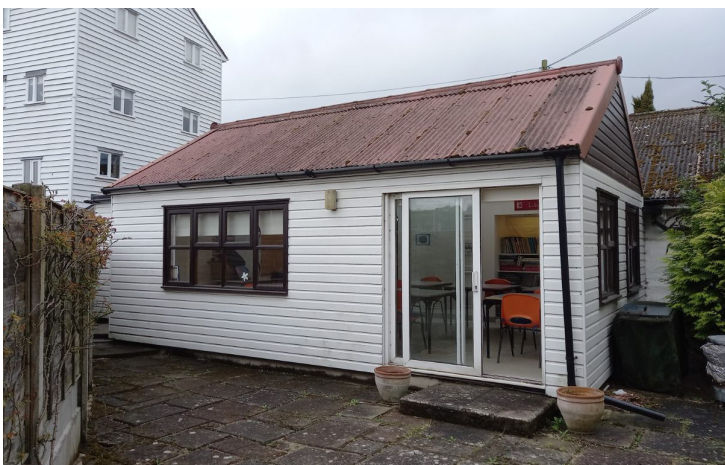
Photograph No. 25

External visual inspection of the extension building did not reveal any noticeable signs of structural distress. Walls appear to be vertical with shiplap timber cladding boards generally in good condition and not showing any signs of underlying structural distress or damage. The roof structure appears to be functioning satisfactorily with no noticeable deflection or evidence of structural distress. Photograph No.'s 25 – 28 show general views of the extension and its roof area.
