the play inspection company

Annual Inspection

Central Swindon North Parish Council

St Marks Park

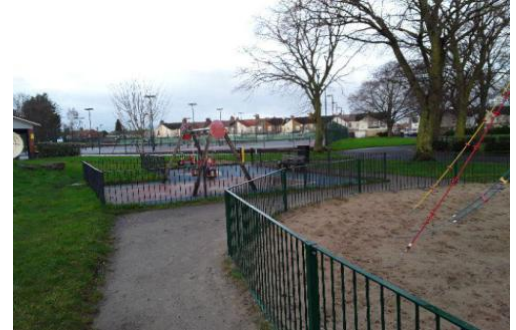
The loose fill surfacing has become displaced around some of the equipment - Reinstate the surface

There are areas or parts of the timber edging that have rotted - Replace all affected timbers

There is algae, silt or moss growth on the surface resulting in slippery conditions - Clean and treat appropriately

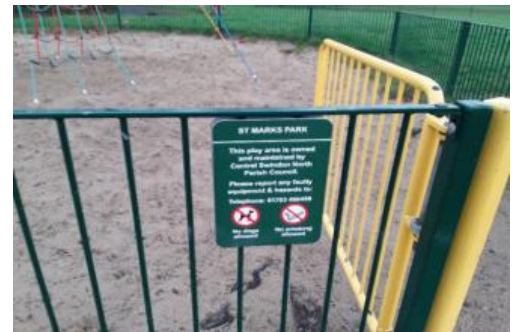
This item is satisfactory - no work required -

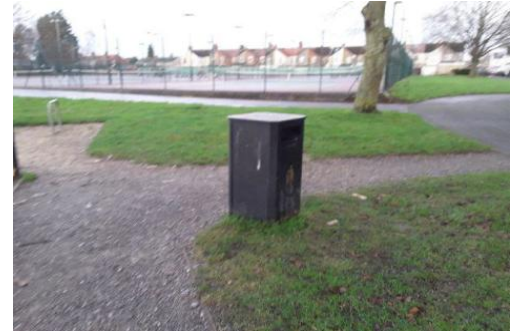
The paintwork on this item has been damaged or worn exposing the metal underneath which is rusting / corroding - Treat affected areas and repaint

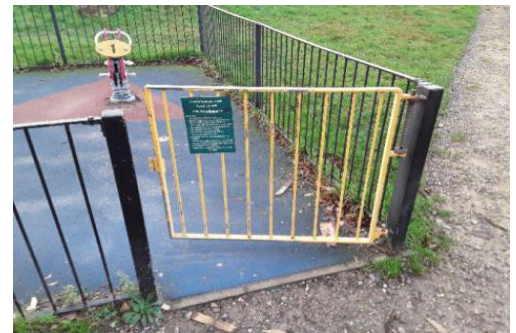
The gate is not operating correctly - Take effective action to ensure the gate closes between 4 and 8 seconds

The rubber buffer is missing from the latch plate - Replace rubber buffer

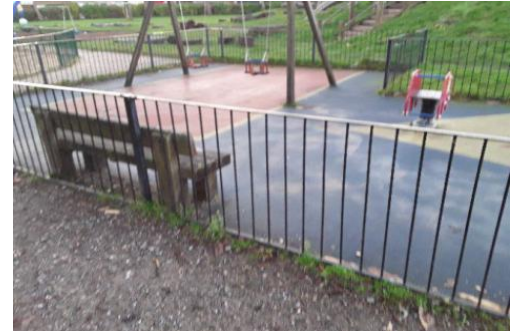
There is some damage to the fence sections - Monitor for any further deterioration and repair as required

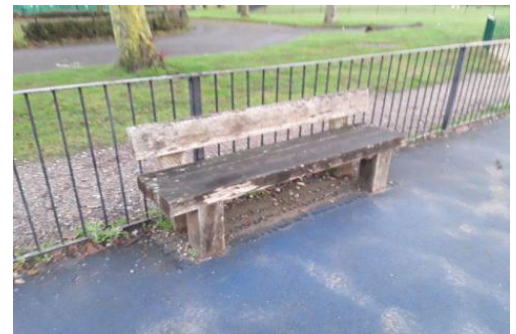
Parts of the timber are rough or splintered - Remove all rough or sharp edges

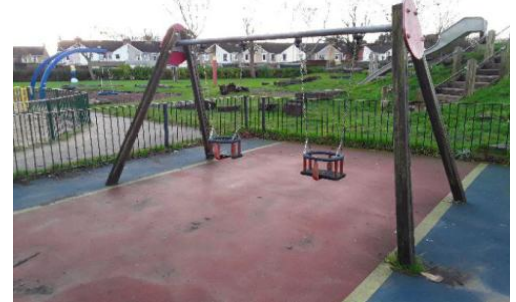
BS EN 1176 requires an additional 0.5m of unobstructed space at each end of the swing surfacing area. This is a relatively low risk finding and no remedial action is recommended at this point. - Monitor - No remedial work recommended

The seat is damaged and requires replacing - Replace damaged seat

There is some notable evidence of chain wear - Monitor for any further deterioration and replace when 40% worn

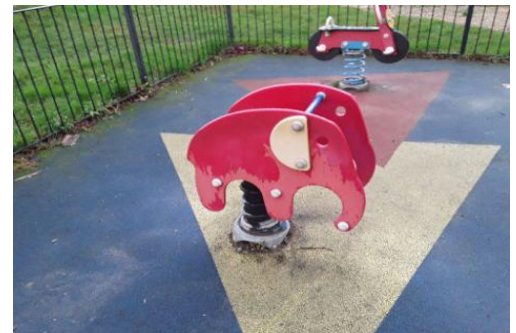
The paintwork on the spring has been damaged or worn exposing the metal underneath which is rusting - Treat any rusting components and repaint

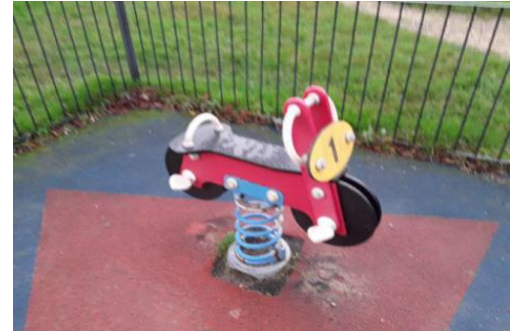
The paintwork on the spring has been damaged or worn exposing the metal underneath which is rusting - Treat any rusting components and repaint

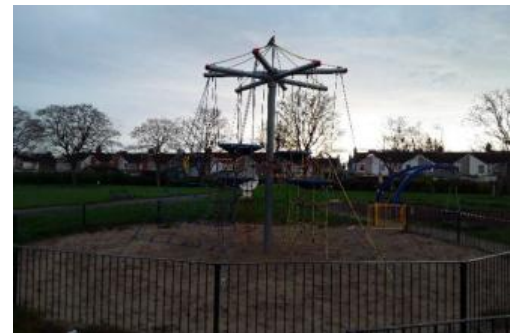
This item is satisfactory - no work required -

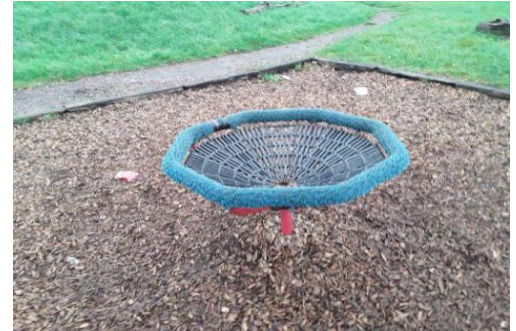
The rubber rim cover is missing exposing sharp edges -
Replace the rim cover

The ropes/nets are worn/damaged in places - Monitor for
any further deterioration and repair or replace as required

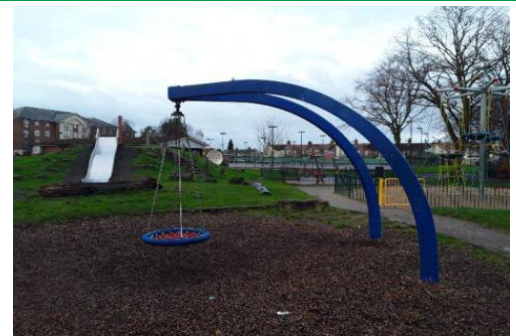
The exposed stone sub base forms a hard object within the
impact area of the equipment in contravention of the
requirements of BS EN 1176 Part 1 - Top up loose fill to
correct levels to cover the sub base

The connecting links are in excess of 8.6mm and less than
12mm and fail the requirements of BS EN 1176 Part 1;
clause 4.2.13, Chains - Monitor - No remedial work
recommended

There is some notable evidence of chain wear - Monitor for
any further deterioration and replace when 40% worn

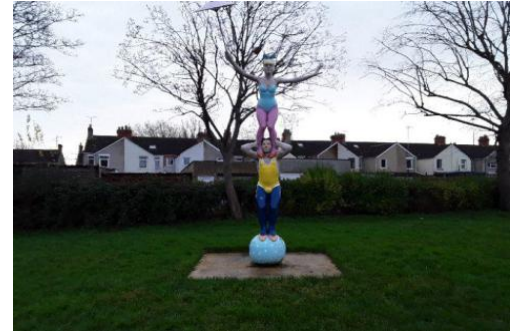
The fixings or components for this item were in excess of 2.5m above the standing surface and could not be fully accessed by the inspector. We have completed a visual inspection of the fixings from ground level but a maintenance inspection should be undertaken to assess the condition, security and wear of the components at intervals in accordance with the manufacturers recommendations. - Inspect in accordance with the manufacturers recommendations

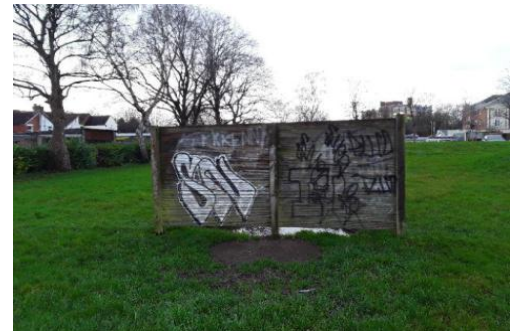
The surface has eroded in some areas and may be slippery in wet conditions - Reinstate the surface

There is some evidence of rot in the timber - Monitor for any further deterioration and replace as required

There is some strimmer / machinery damage apparent on the posts, this can penetrate the preservative applied to the timber and accelerate the rotting process - Monitor for any deterioration (rot) and replace as required

The surface is damaged and subsiding exposing timber edging - Replace

There is or are fixings missing on the item - Replace all missing fixings

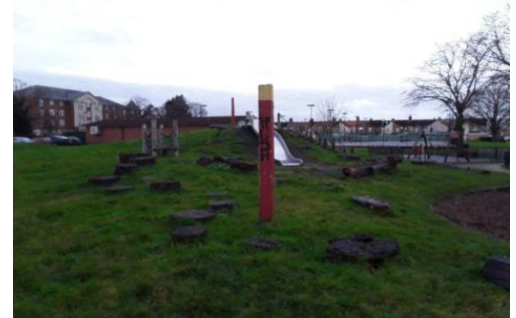
This item of equipment relies on a single post, or a line of posts, for stability and extra care needs to be taken with equipment of this nature to avoid the potential for catastrophic failure - Ensure that regular detailed inspections are undertaken to assess for rot, corrosion and general stability

There are areas or parts of 1x timber post on the that have rotted - Replace all affected timbers

There is some evidence of rot in the timber - Monitor for any further deterioration and replace as required

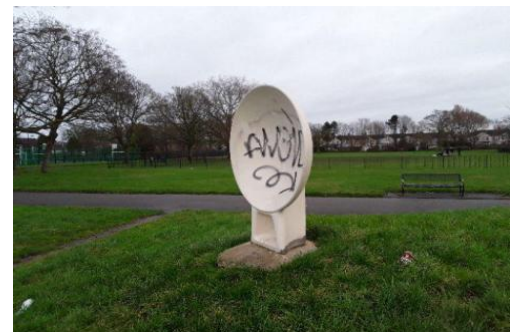
The surface has eroded and the foundations are exposed - Reinstate surrounding surfaces to cover the foundations

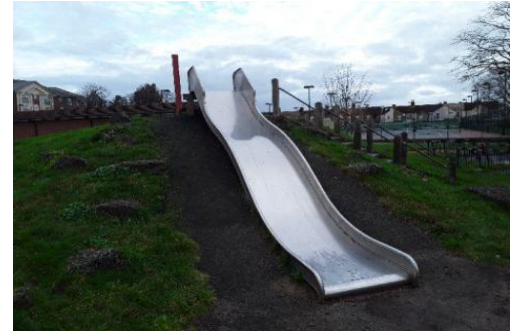
There are trip hazards at the edges of the surface - Reinststate surrounding surface levels to remove the trip points

The boulder forms a hard object within the free space of the equipment in contravention of the requirements of BS EN 1176 Part 1 - Monitor - No remedial work recommended

There are areas or parts of the timber on the structure that have rotted - Replace all affected timbers

There are a number of dents in the slide surface - Monitor for any further deterioration and repair as required

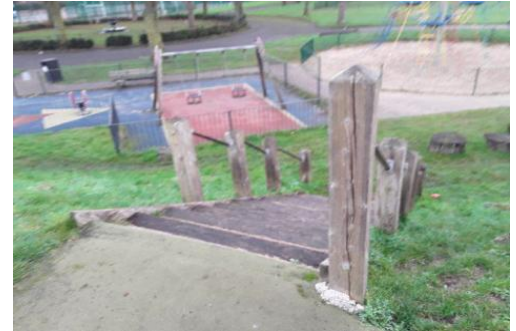
The timber has a number of splits/shakes or air cracks and this may affect the stability or allow water ingress which will accelerate the rotting process - Monitor to ensure the splits do not cross through fixing points of the structure and/or cause any instability

There is some evidence of rot in the timber - Monitor for any further deterioration and replace as required

The surface has eroded and the foundations are exposed - Reinstate surrounding surfaces to cover the foundations

The item is slightly loose in its foundations - Monitor for any further deterioration and repair as required

There are trip hazards present - Reinstate surrounding surfaces to level to remove the trip points

The item has missing component(s) - Consider replacing missing components

There is some evidence of rot in the timber posts - Monitor for any further deterioration and replace as required

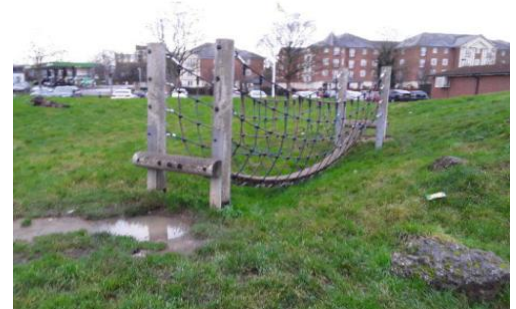
The grass has eroded within the impact area of the equipment and may not provide the necessary impact attenuating properties for the equipment fall height; the surface may also be slippery in wet weather - Reinstate the grass or provide an all weather surface

There is/are bolt cap covers missing or damaged on the item - Replace missing or damaged bolt cap covers

The ropes/nets are worn/damaged in places - Monitor for any further deterioration and repair or replace as required

The adjacent item forms a hard object within the falling space of the equipment in contravention of the requirements of BS EN 1176 Part 1 - Monitor - No remedial work recommended

The timber has a number of splits/shakes or air cracks and this may affect the stability or allow water ingress which will accelerate the rotting process - Monitor to ensure the splits do not cross through fixing points of the structure and/or cause any instability

There are areas or parts of the timber post tops that have rotted - Replace all affected timbers

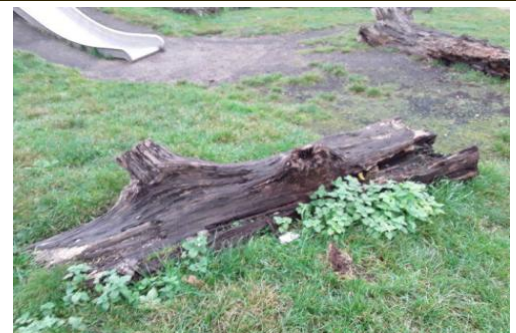
Fungus or algae was found on the equipment - Remove fungi or algae from the equipment

There are areas or parts of the timber on the structure that have rotted - Replace all affected timbers

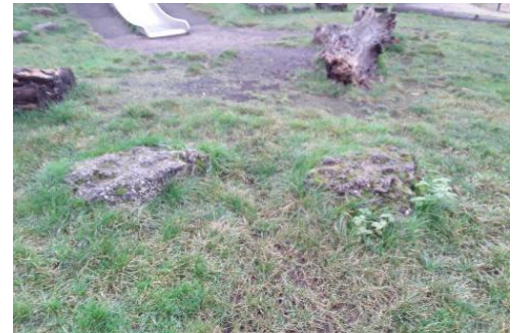
The rocks and/or boulders have moss/algae growth apparent - Clean and maintain

The step between the items is quite large and users may not be able to complete the step without touching ground, the items could therefore be considered to be within the falling space of each other, however the intention of the play activity continuity is easily apparent and foreseeable to the user - Monitor - No remedial work recommended

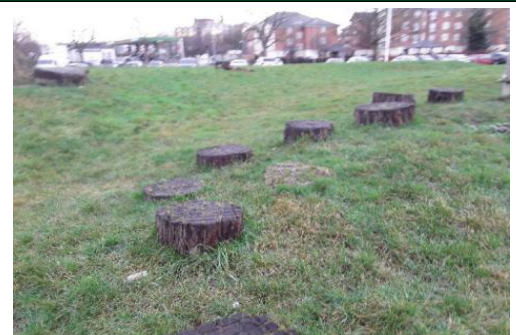
There is algae or moss on the surface of the equipment - Clean and treat appropriately

There are areas or parts of the timber on the structure that have rotted - Replace all affected timbers

The adjacent item forms a hard object within the falling space of the equipment in contravention of the requirements of BS EN 1176 Part 1 - Monitor - No remedial work recommended

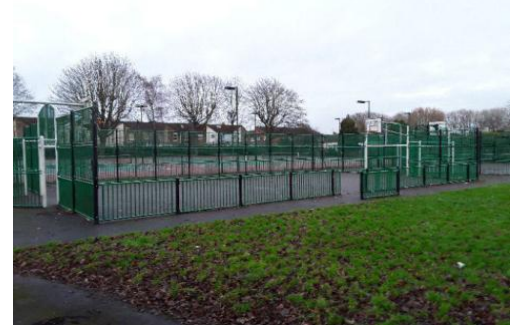
A clearly visible facility sign should be provided in a prominent position with the wording as detailed BS EN 15312- the equipment is not intended for children less than 3 years old- the warning - Do not climb on the framework or nets- the warning - Do not hang on the ring (if provided)- the warning - Do not wear rings or other jewellery- name and telephone number of the administrator- number to call in case of accident - Provide signage to BS EN 15312

There is or are fixings missing on the backboard - Replace all missing fixings

There is/are finger entrapments in the frame due to missing inserts and the item fails to meet the requirements of BS EN 15312 Clause 4.4.2.2 Entrapment of fingers - Replace the missing inserts to remove the entrapment

There is algae, silt or moss growth on the surface resulting in slippery conditions - Clean and treat appropriately

The item fails to meet the requirements of BS EN 15312 4.4.2.1 head and neck entrapment in the frame - Monitor - No remedial work recommended

The fence is severely damaged in places - Repair or replace all affected sections

There is some evidence of fire damage to the surfacing - Monitor for any further deterioration and repair as required

There is/are finger entrapments in the frame and the item fails to meet the requirements of BS EN 15312 Clause 4.4.2.2 Entrapment of fingers - Monitor - No remedial work recommended

There is or are fixings missing on the item - Replace all missing fixings

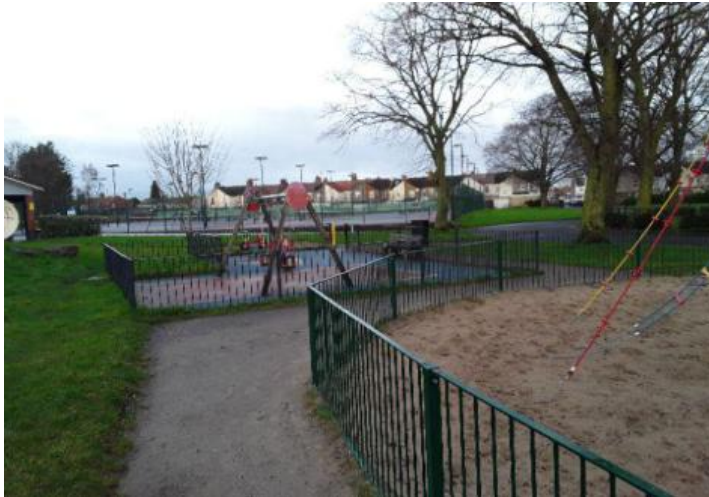
Item: Ancillary Items - Site General
Manufacturer: Owner/Operator

Risk Level: L - Low Risk
Surface: Mixed Surface

Finding: The loose fill surfacing has become displaced around some of the equipment

Action: Reinstall the surface

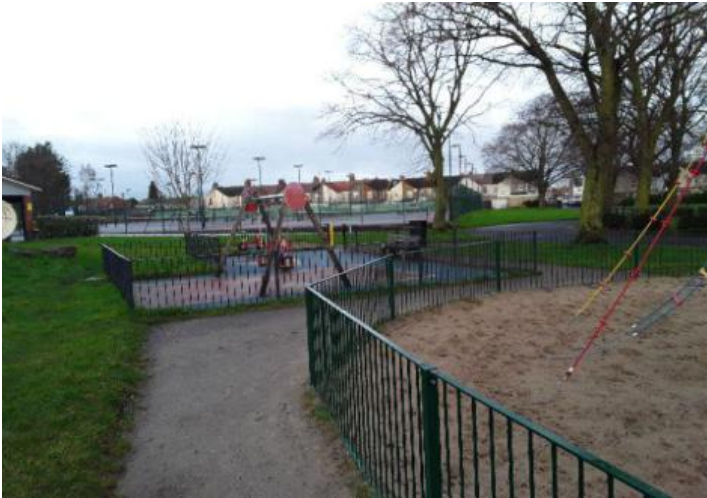
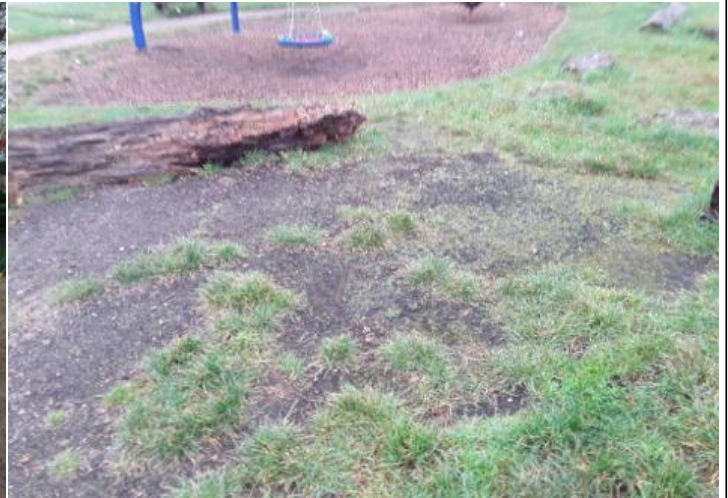
Item: Ancillary Items - Site General
Manufacturer: Owner/Operator

Risk Level: L - Low Risk
Surface: Mixed Surface

Finding: There is weed / vegetation growth on, between, or around the edges of the surfacing
Action: Remove weed / vegetation growth

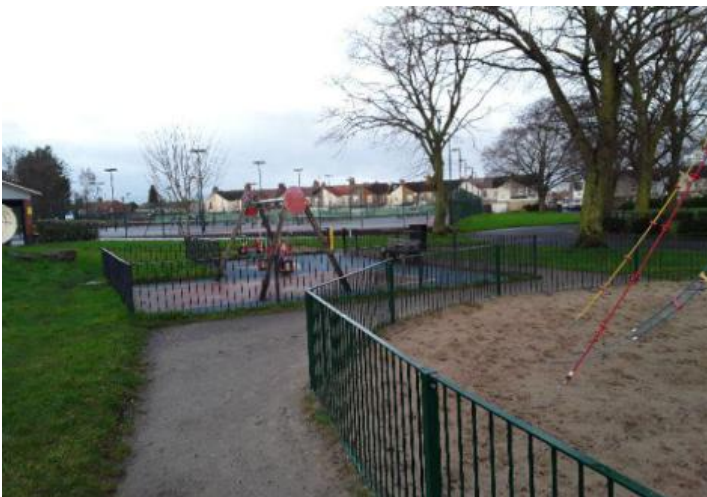
Item: Ancillary Items - Site General
Manufacturer: Owner/Operator

Risk Level: L - Low Risk
Surface: Mixed Surface

Finding: There is algae, silt or moss growth on the surface resulting in slippery conditions
Action: Clean and treat appropriately

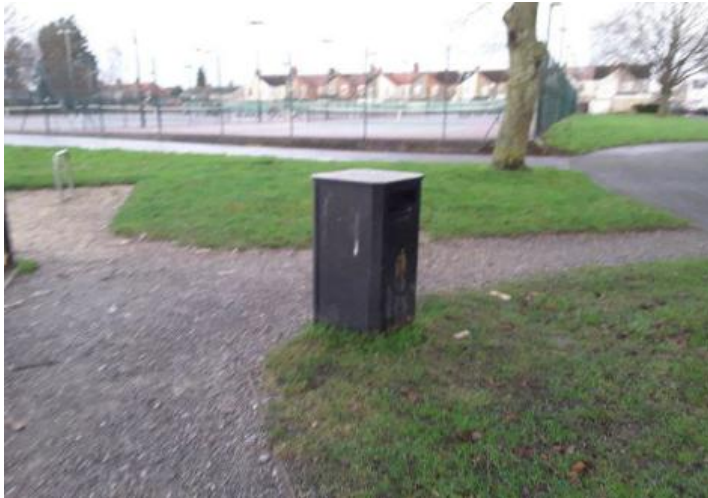
Item: Ancillary Items - Litter Bin
Manufacturer: Broxap

Risk Level: L - Low Risk
Surface: Gravel

Finding: The paintwork on this item has been damaged or worn exposing the metal underneath which is rusting / corroding

Action: Treat affected areas and repaint

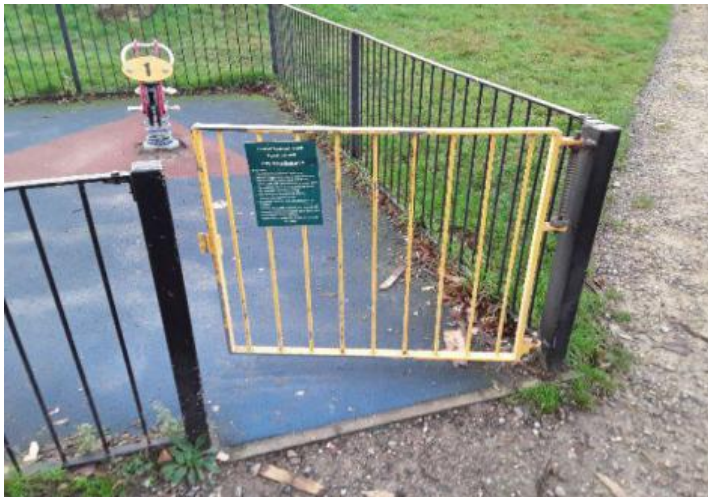
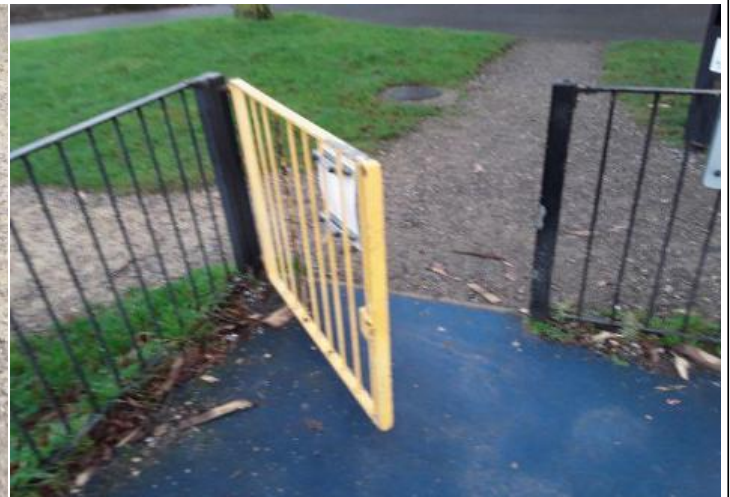
Item: Gates - Gate - Self Closing
Manufacturer: Not Identified

Risk Level: V - Very Low Risk
Surface: Wet Pour

Finding: The gate is not operating correctly

Action: Take effective action to ensure the gate closes between 4 and 8 seconds

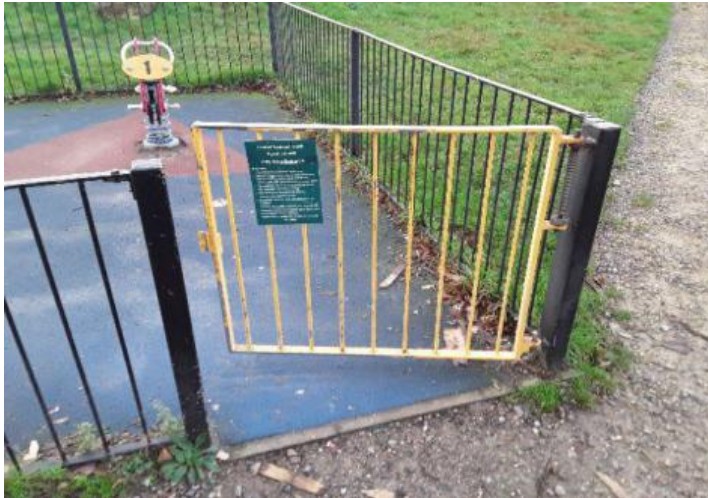
Item: Gates - Gate - Self Closing
Manufacturer: Not Identified

Risk Level: L - Low Risk
Surface: Wet Pour

Finding: The rubber buffer is missing from the latch plate

Action: Replace rubber buffer

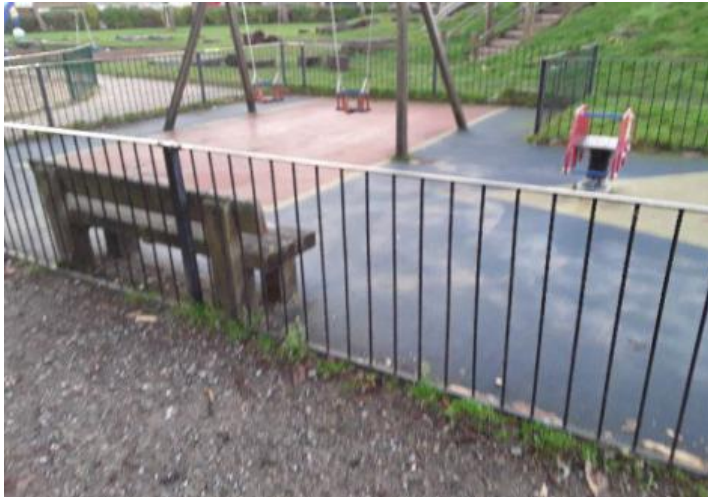
Item: Fences - Fencing - Flat Top
Manufacturer: Not Identified

Risk Level: L - Low Risk
Surface: Grass

Finding: There is some damage to the fence sections

Action: Monitor for any further deterioration and repair as required

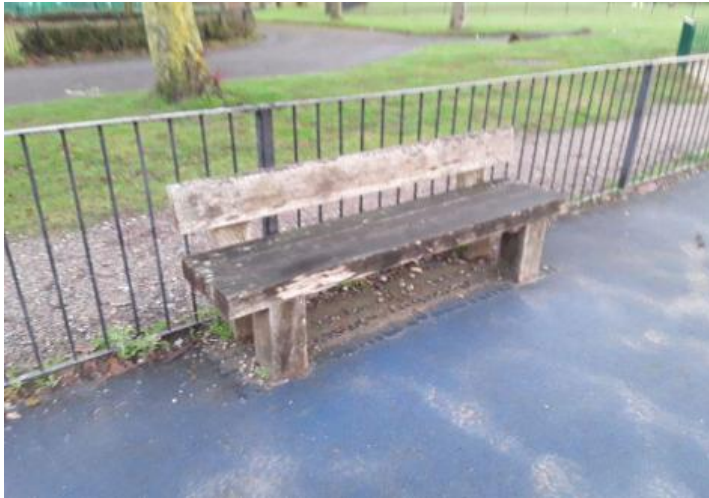
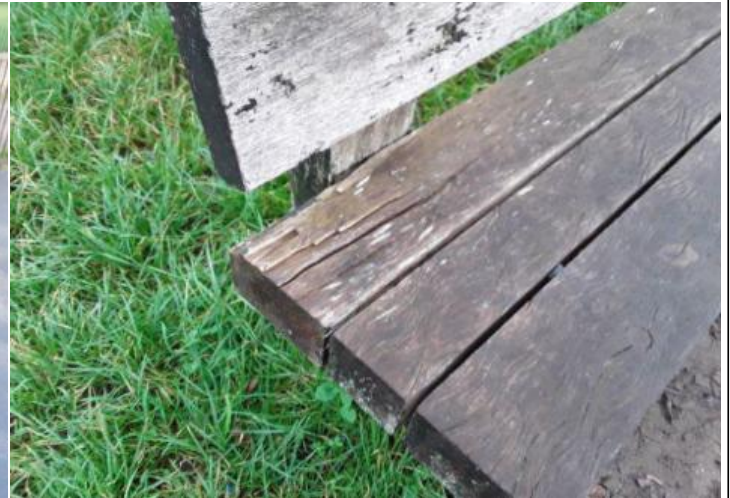
Item: Ancillary Items - Bench
Manufacturer: Not Identified

Risk Level: L - Low Risk
Surface: Wet Pour

Finding: Parts of the timber are rough or splintered

Action: Remove all rough or sharp edges

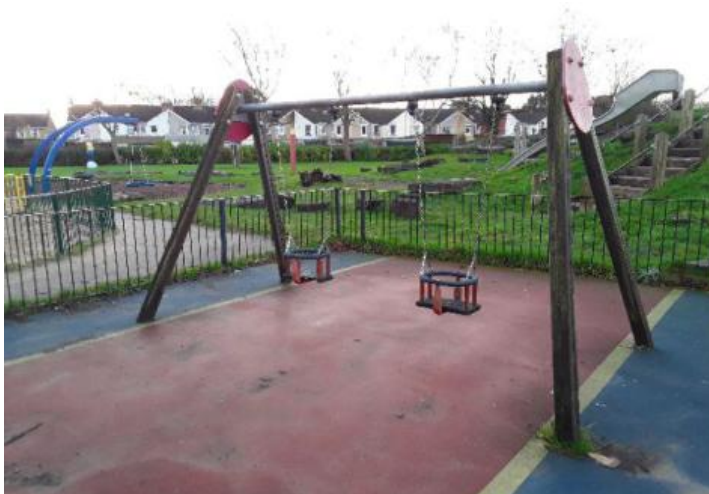
Item: Swings - 1 Bay 1 Seat (Cradle) - Type 1
Manufacturer: Kompan Ltd

Risk Level: V - Very Low Risk
Surface: Wet Pour

Finding: BS EN 1176 requires an additional 0.5m of unobstructed space at each end of the swing surfacing area. This is a relatively low risk finding and no remedial action is recommended at this point.

Action: Monitor - No remedial work recommended

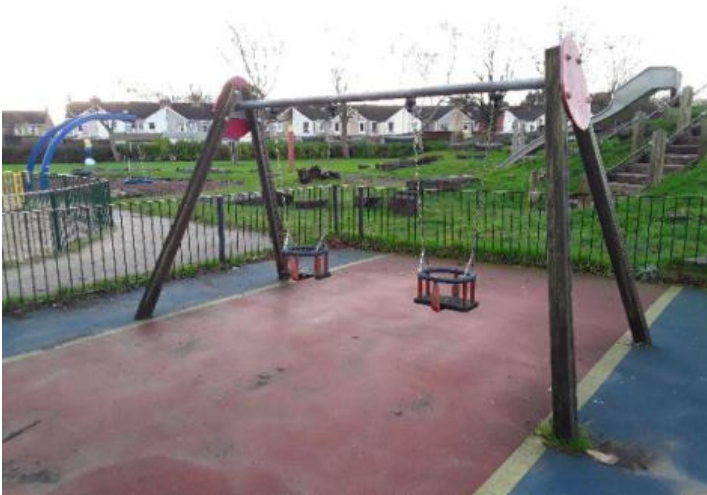
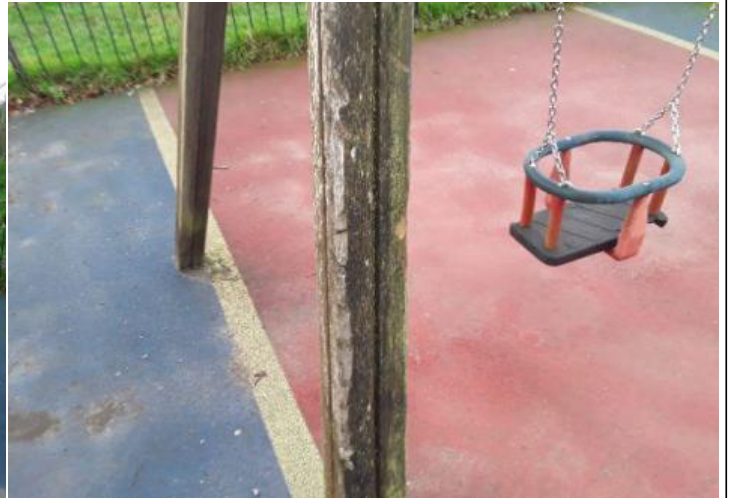
Item: Swings - 1 Bay 1 Seat (Cradle) - Type 1
Manufacturer: Kompan Ltd

Risk Level: L - Low Risk
Surface: Wet Pour

Finding: Parts of the timber are rough or splintered

Action: Remove all rough or sharp edges

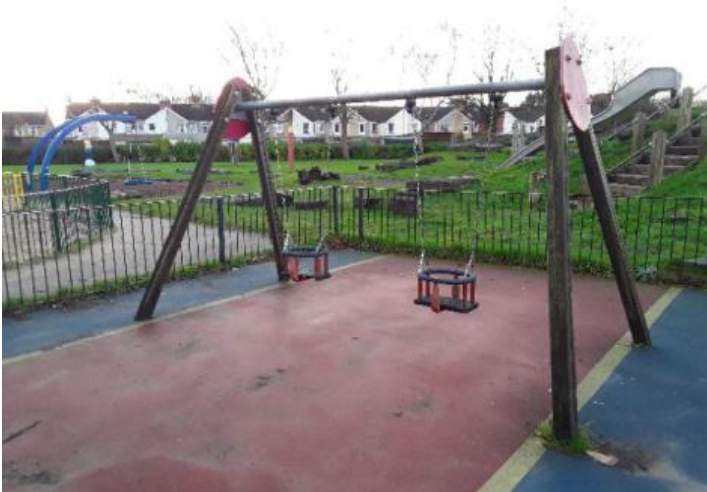
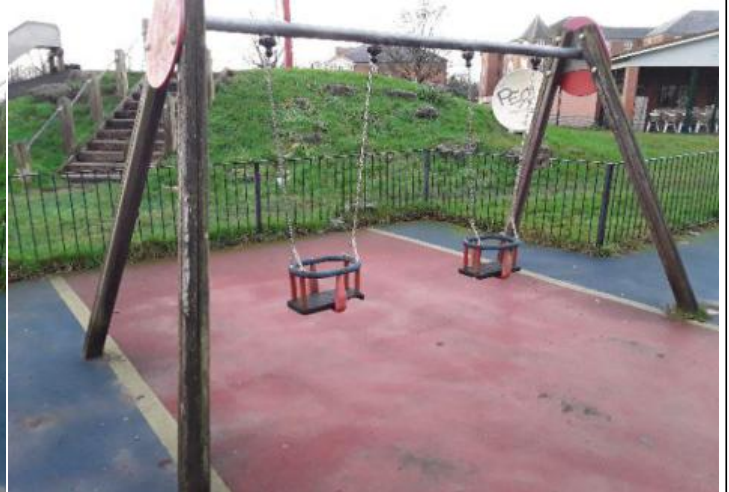
Item: Swings - 1 Bay 1 Seat (Cradle) - Type 1
Manufacturer: Kompan Ltd

Finding: There is algae or moss on the surface of the equipment

Action: Clean and treat appropriately

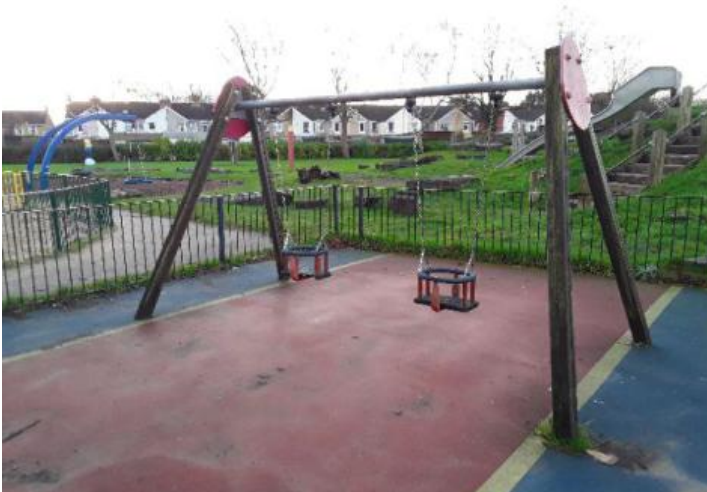
Item: Swings - 1 Bay 1 Seat (Cradle) - Type 1
Manufacturer: Kompan Ltd

Finding: The seat is damaged and requires replacing

Action: Replace damaged seat

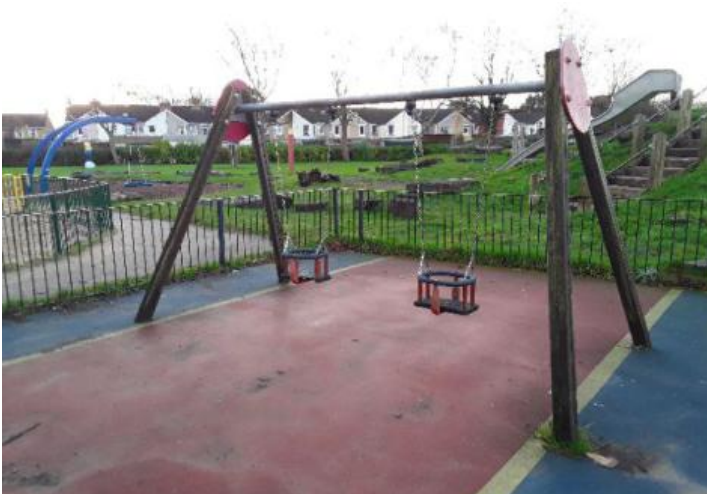
Item: Swings - 1 Bay 1 Seat (Cradle) - Type 1
Manufacturer: Kompan Ltd

Finding: There is some notable evidence of chain wear

Action: Monitor for any further deterioration and replace when 40% worn

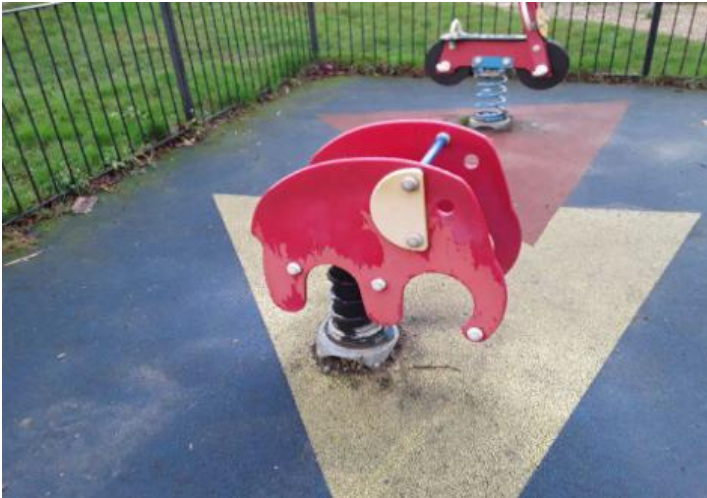
Item: Rocking Equipment - Spring Elephant
Manufacturer: Kompan Ltd

Finding: The paintwork on the spring has been damaged or worn exposing the metal underneath which is rusting
Action: Treat any rusting components and repaint

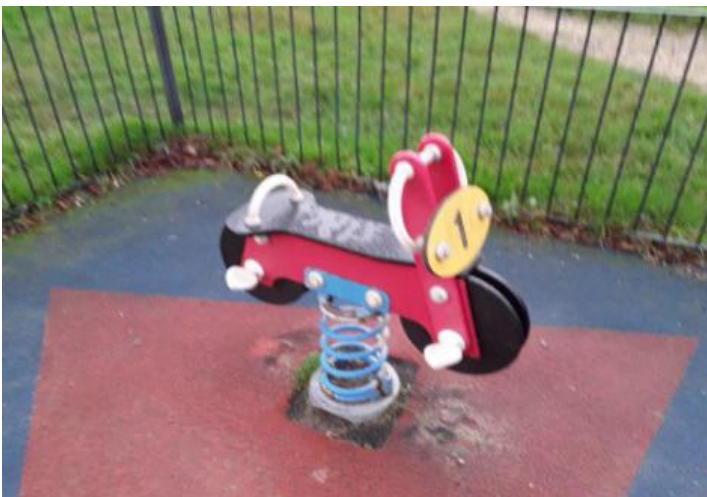
Item: Rocking Equipment - Spring Bike
Manufacturer: Kompan Ltd

Finding: The paintwork on the spring has been damaged or worn exposing the metal underneath which is rusting
Action: Treat any rusting components and repaint

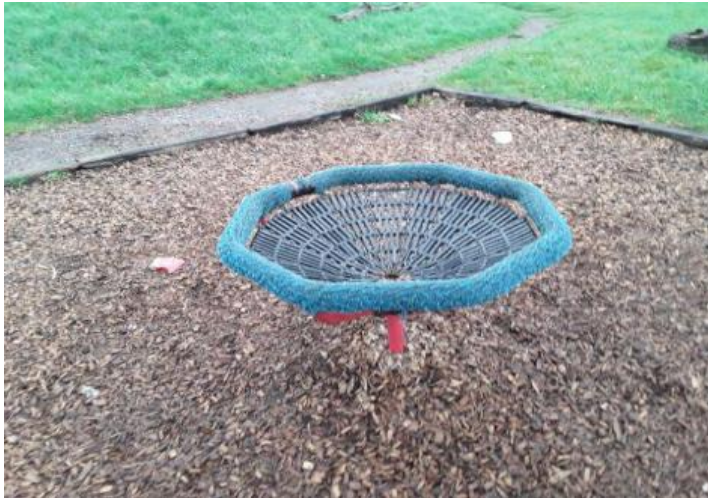
Item: Rotor Play - Basket Roundabout
Manufacturer: Huck Nets (UK) Ltd

Finding: The rubber rim cover is missing exposing sharp edges

Action: Replace the rim cover

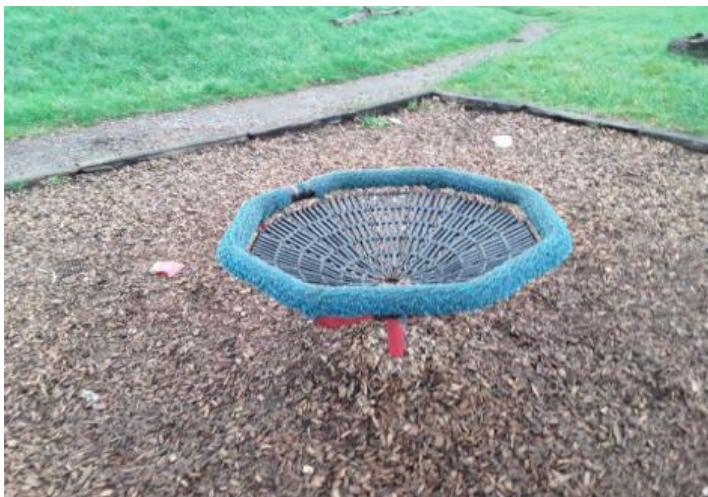
Item: Rotor Play - Basket Roundabout
Manufacturer: Huck Nets (UK) Ltd

Finding: The ropes/nets are worn/damaged in places

Action: Monitor for any further deterioration and repair or replace as required

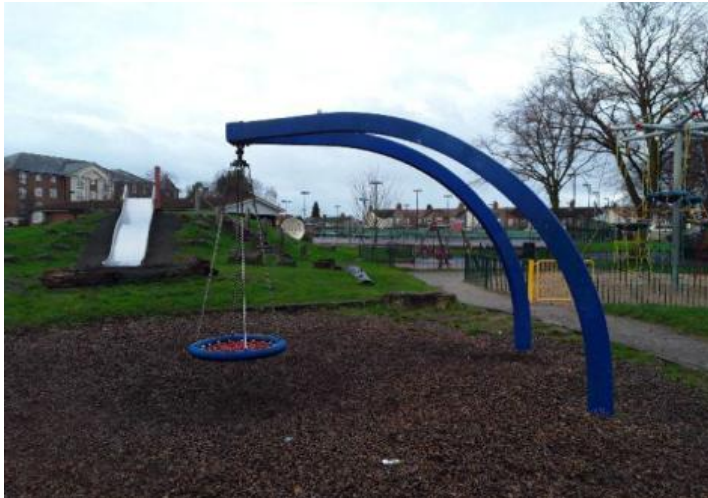
Item: Swings - Single Point Swing - Type 3
Manufacturer: Wicksteed Playgrounds

Finding: The exposed stone sub base forms a hard object within the impact area of the equipment in contravention of the requirements of BS EN 1176 Part 1

Action: Top up loose fill to correct levels to cover the sub base

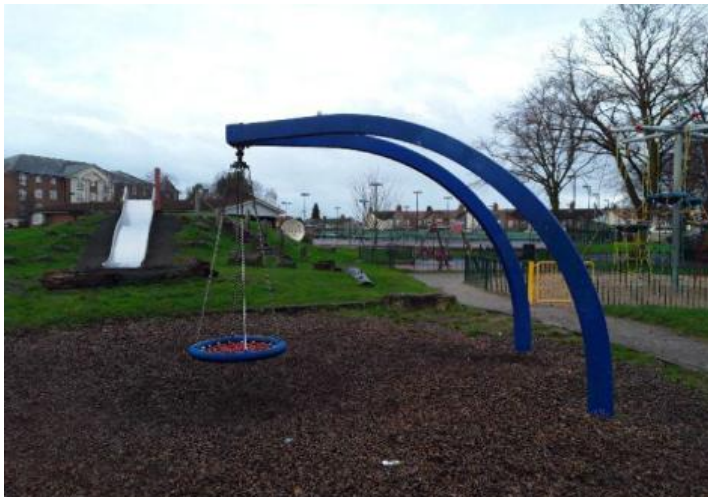
Item: Swings - Single Point Swing - Type 3
Manufacturer: Wicksteed Playgrounds

Finding: The connecting links are in excess of 8.6mm and less than 12mm and fail the requirements of BS EN 1176 Part 1; clause 4.2.13, Chains

Action: Monitor - No remedial work recommended

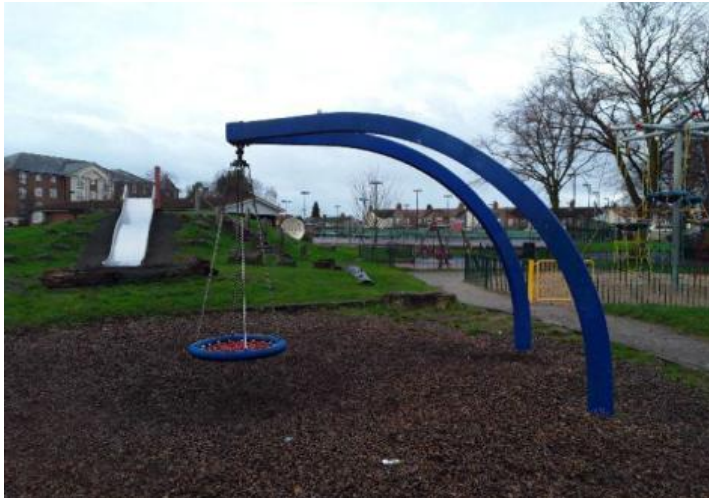
Item: Swings - Single Point Swing - Type 3
Manufacturer: Wicksteed Playgrounds

Finding: There is some notable evidence of chain wear

Action: Monitor for any further deterioration and replace when 40% worn

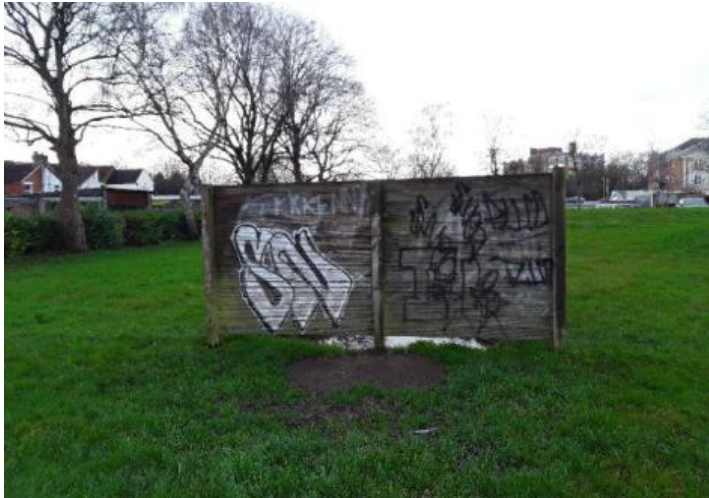
Item: Multi Use Games Area - Kickabout Wall
Manufacturer: Not Identified

Finding: The surface has eroded in some areas and may be slippery in wet conditions
Action: Reinstate the surface

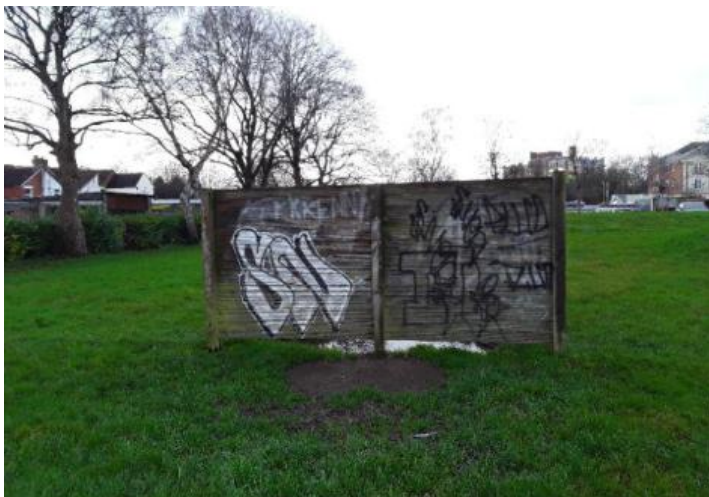
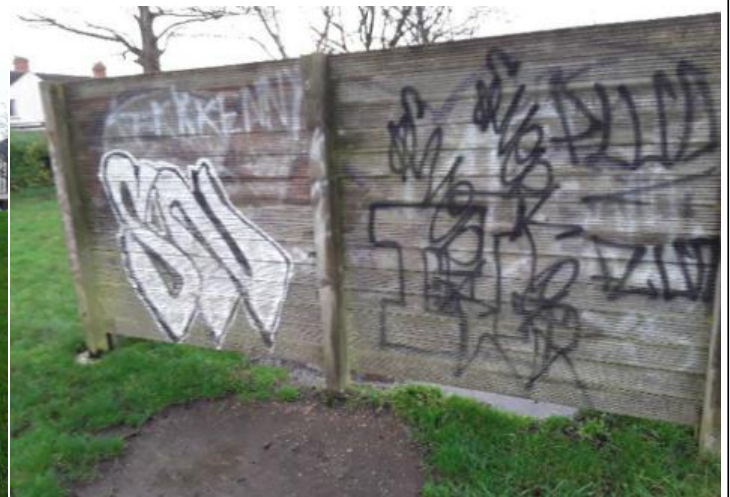
Item: Multi Use Games Area - Kickabout Wall
Manufacturer: Not Identified

Finding: There is algae or moss on the surface of the equipment
Action: Clean and treat appropriately

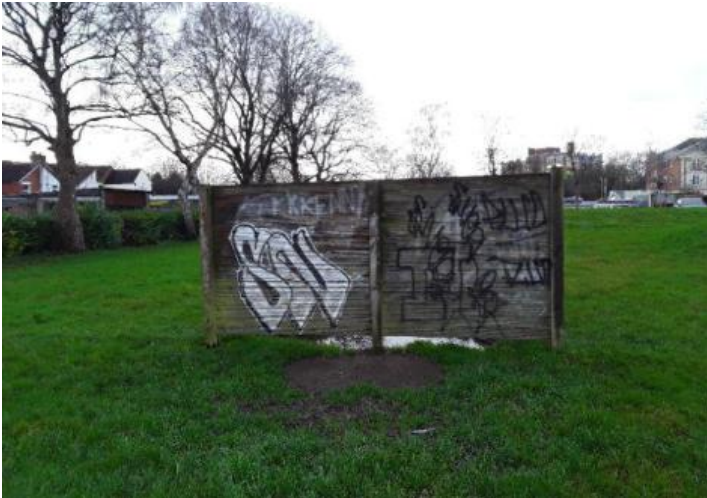
Item: Multi Use Games Area - Kickabout Wall
Manufacturer: Not Identified

Finding: There is some evidence of rot in the timber

Action: Monitor for any further deterioration and replace as required

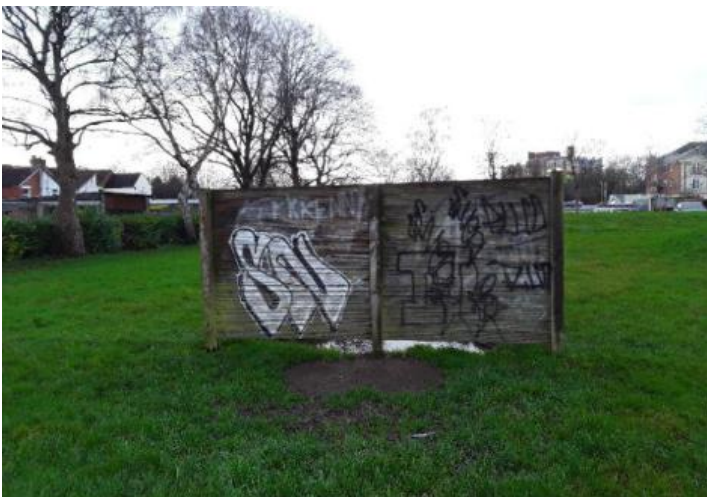
Item: Multi Use Games Area - Kickabout Wall
Manufacturer: Not Identified

Finding: The surface is damaged and subsiding exposing timber edging

Action: Replace

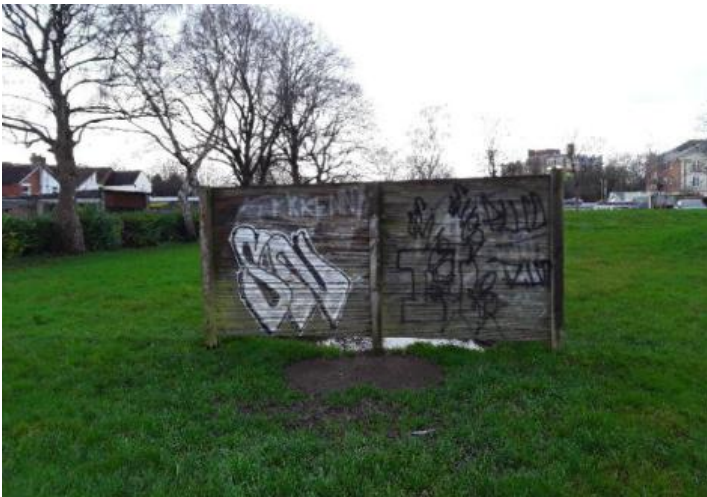
Item: Multi Use Games Area - Kickabout Wall
Manufacturer: Not Identified

Finding: There is or are fixings missing on the item

Action: Replace all missing fixings

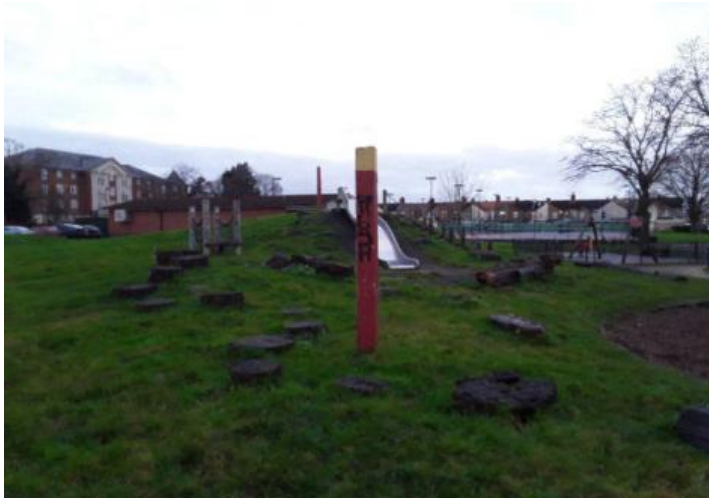
Item: Other - Totem Pole
Manufacturer: Not Identified

Finding: This item of equipment relies on a single post, or a line of posts, for stability and extra care needs to be taken with equipment of this nature to avoid the potential for catastrophic failure
Action: Ensure that regular detailed inspections are undertaken to assess for rot, corrosion and general stability

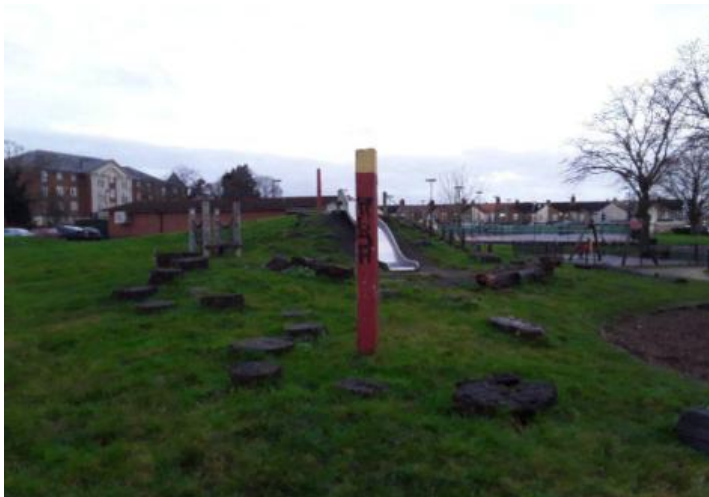
Item: Other - Totem Pole
Manufacturer: Not Identified

Finding: There is some evidence of rot in the timber
Action: Monitor for any further deterioration and replace as required

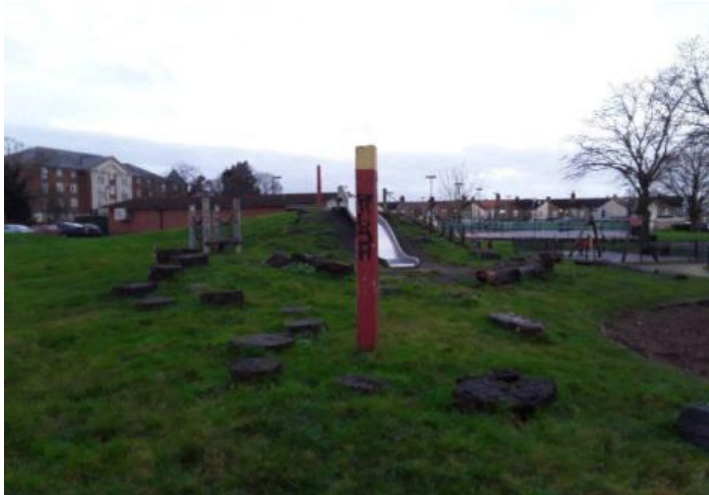
Item: Other - Totem Pole
Manufacturer: Not Identified

Finding: There are areas or parts of 1x timber post on the that have rotted

Action: Replace all affected timbers

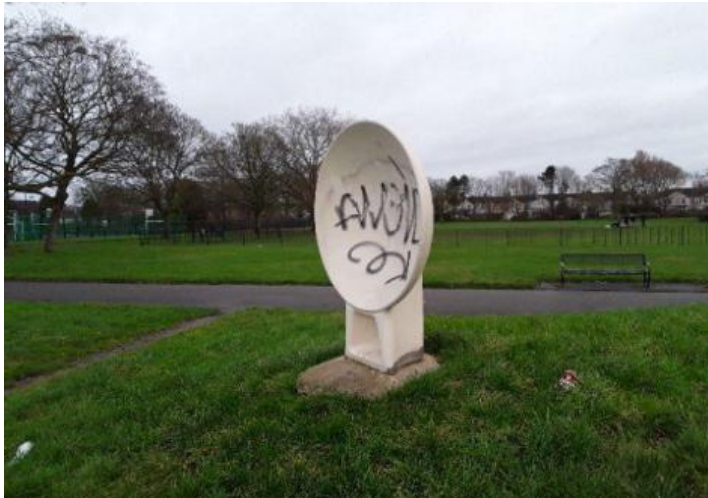
Item: Other - Misc Item
Manufacturer: Richter Spielgerate GmbH (DE)

Finding: The surface has eroded and the foundations are exposed

Action: Reinstate surrounding surfaces to cover the foundations

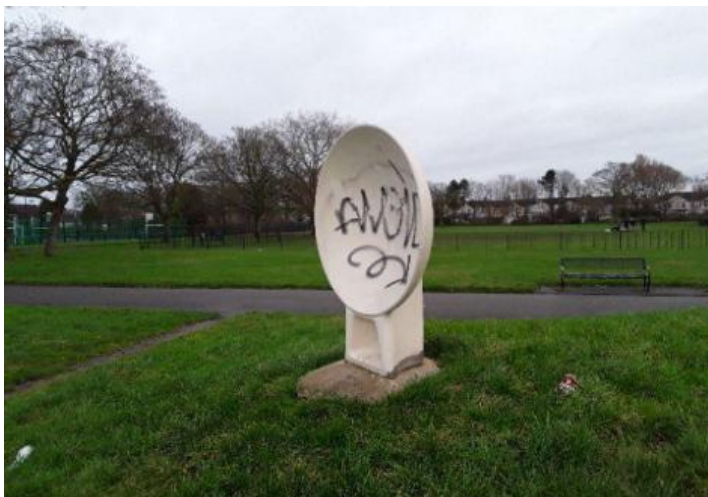
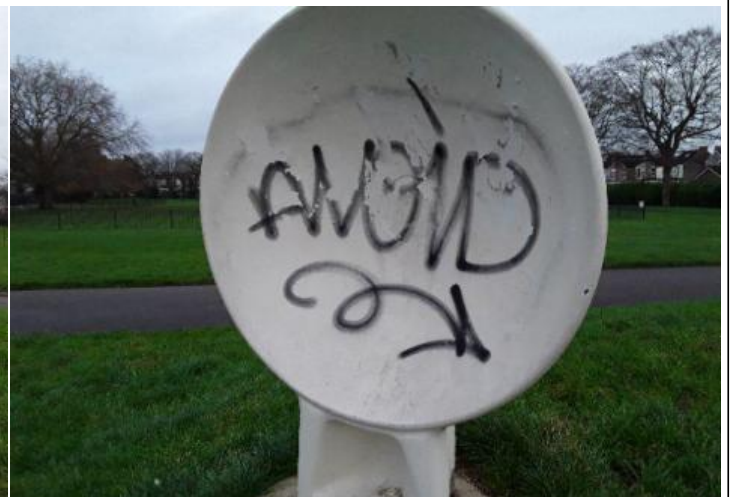
Item: Other - Misc Item
Manufacturer: Richter Spielgerate GmbH (DE)

Finding: There is some graffiti present

Action: Remove the graffiti

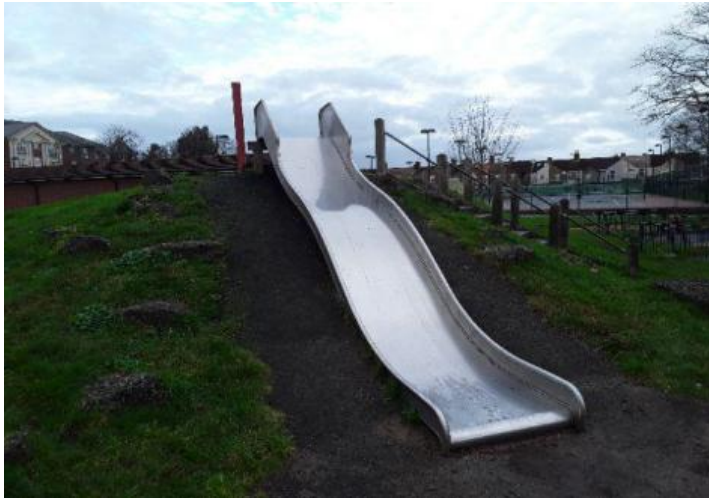
Item: Other - Embankment Slide
Manufacturer: Richter Spielgerate GmbH (DE)

Finding: There are trip hazards at the edges of the surface

Action: Reinstate surrounding surface levels to remove the trip points

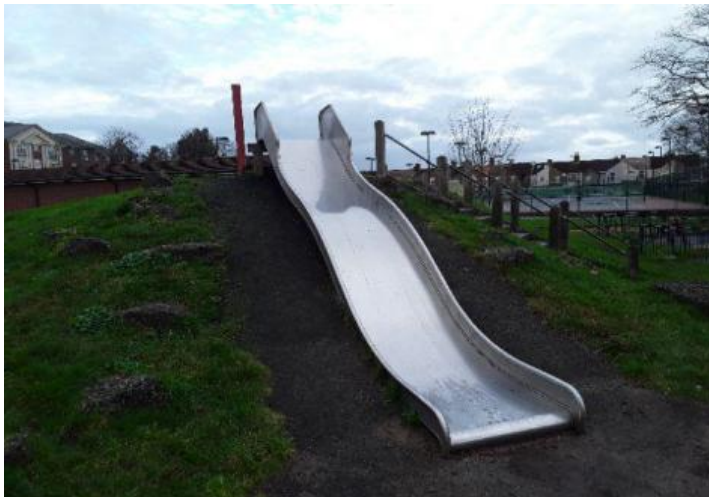
Item: Other - Embankment Slide
Manufacturer: Richter Spielgerate GmbH (DE)

Finding: There are areas or parts of the timber on the structure that have rotted

Action: Replace all affected timbers

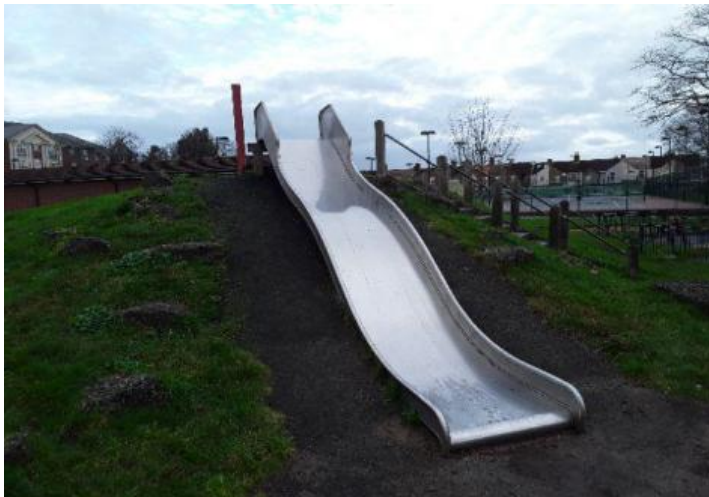
Item: Other - Embankment Slide
Manufacturer: Richter Spielgerate GmbH (DE)

Finding: There are a number of dents in the slide surface

Action: Monitor for any further deterioration and repair as required
