the play inspection company

Annual Inspection

Central Swindon North Parish Council

St Marks Park

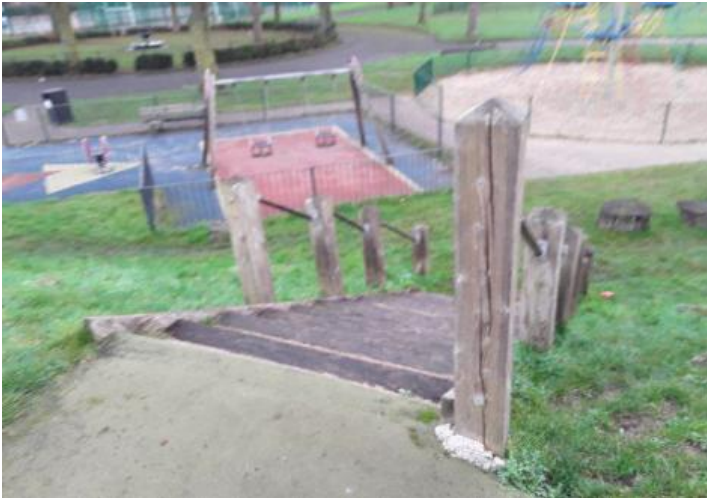
The timber has a number of splits/shakes or air cracks and this may affect the stability or allow water ingress which will accelerate the rotting process - Monitor to ensure the splits do not cross through fixing points of the structure and/or cause any instability

Item: Ancillary Items - Steps
Manufacturer: Owner/Operator

Finding: The timber has a number of splits/shakes or air cracks and this may affect the stability or allow water ingress which will accelerate the rotting process

Action: Monitor to ensure the splits do not cross through fixing points of the structure and/or cause any instability

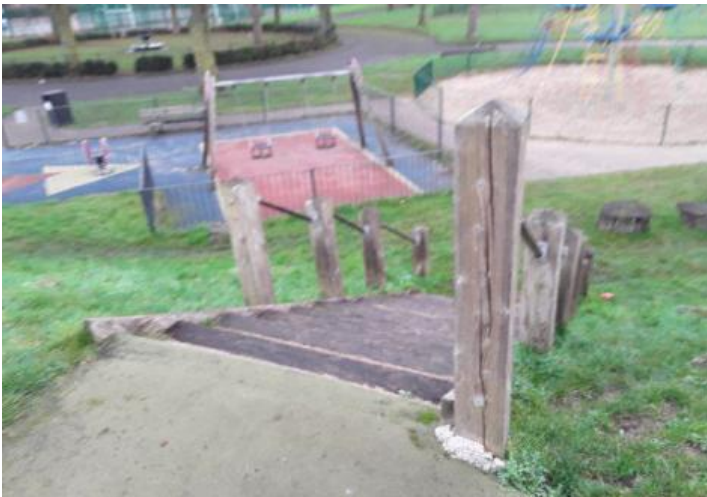
There are trip hazards present - Reinstate surrounding surfaces to level to remove the trip points

Item: Ancillary Items - Steps
Manufacturer: Owner/Operator

Finding: There are trip hazards present

Action: Reinstate surrounding surfaces to level to remove the trip points

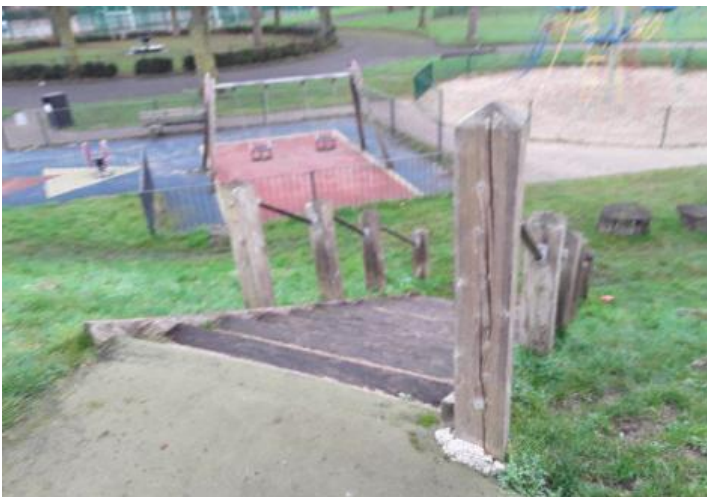
The item has missing component(s) - Consider replacing missing components

Item: Ancillary Items - Steps
Manufacturer: Owner/Operator

Finding: The item has missing component(s)

Action: Consider replacing missing components

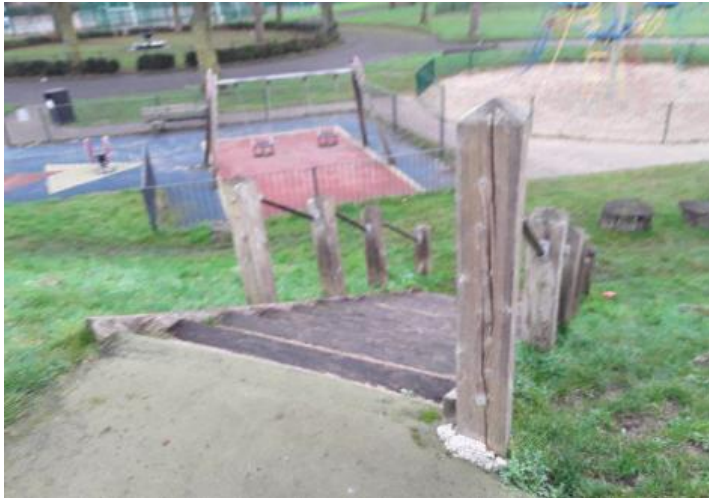
The item is slightly loose in its foundations - Monitor for any further deterioration and repair as required

Item: Ancillary Items - Steps
Manufacturer: Owner/Operator

Finding: The item is slightly loose in its foundations

Action: Monitor for any further deterioration and repair as required

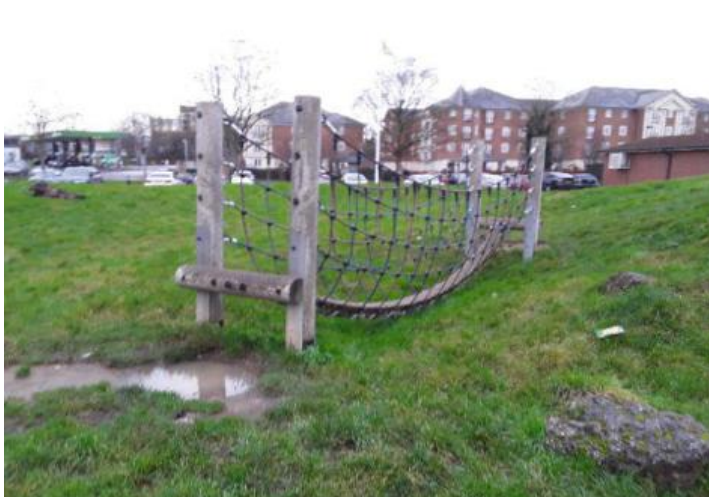
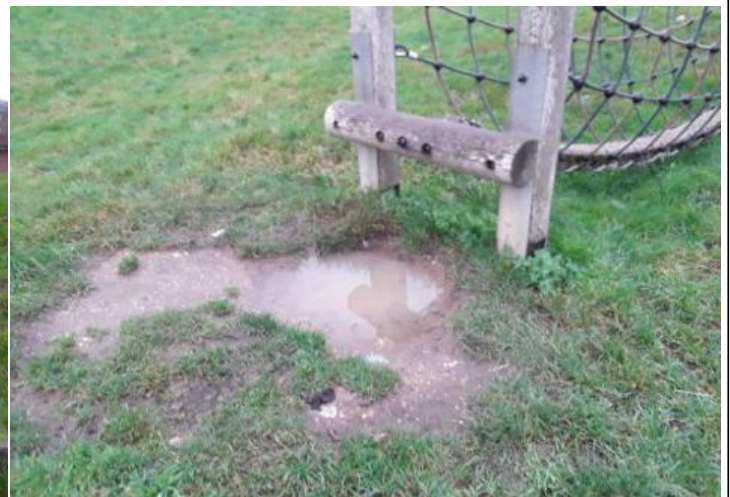
Item: Activity Equipment - Bridge
Manufacturer: Richter Spielgerate GmbH (DE)

Finding: The grass has eroded within the impact area of the equipment and may not provide the necessary impact attenuating properties for the equipment fall height; the surface may also be slippery in wet weather

Action: Reinstate the grass or provide an all weather surface

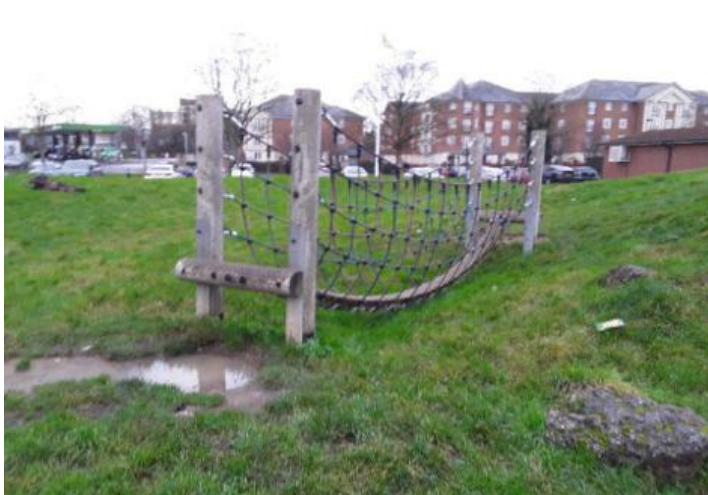
There is/are bolt cap covers missing or damaged on the item - Replace missing or damaged bolt cap covers

Item: Activity Equipment - Bridge
Manufacturer: Richter Spielgerate GmbH (DE)

Finding: There is/are bolt cap covers missing or damaged on the item

Action: Replace missing or damaged bolt cap covers

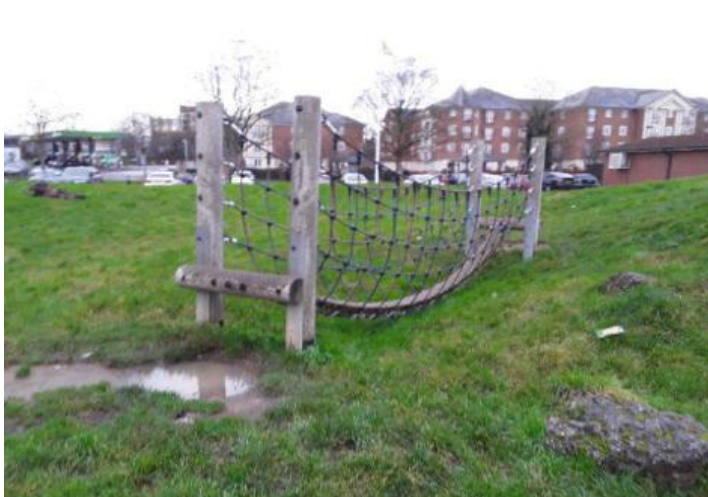
The ropes/nets are worn/damaged in places - Monitor for any further deterioration and repair or replace as required

Item: Activity Equipment - Bridge
Manufacturer: Richter Spielgerate GmbH (DE)

Finding: The ropes/nets are worn/damaged in places

Action: Monitor for any further deterioration and repair or replace as required

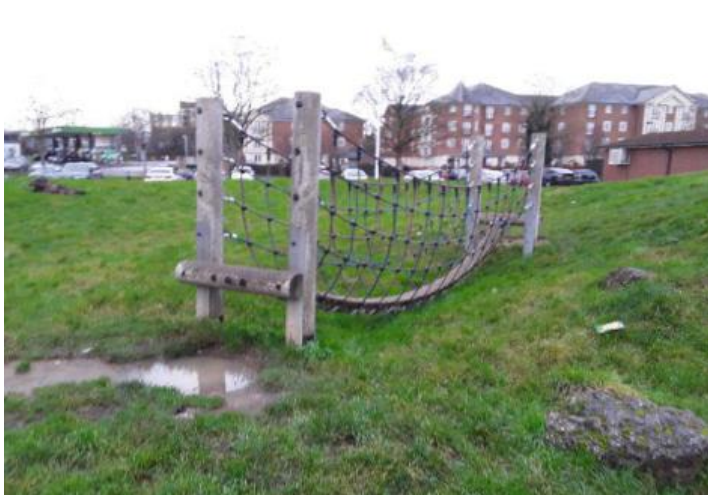
The timber has a number of splits/shakes or air cracks and this may affect the stability or allow water ingress which will accelerate the rotting process - Monitor to ensure the splits do not cross through fixing points of the structure and/or cause any instability

Item: Activity Equipment - Bridge
Manufacturer: Richter Spielgerate GmbH (DE)

Finding: The timber has a number of splits/shakes or air cracks and this may affect the stability or allow water ingress which will accelerate the rotting process

Action: Monitor to ensure the splits do not cross through fixing points of the structure and/or cause any instability

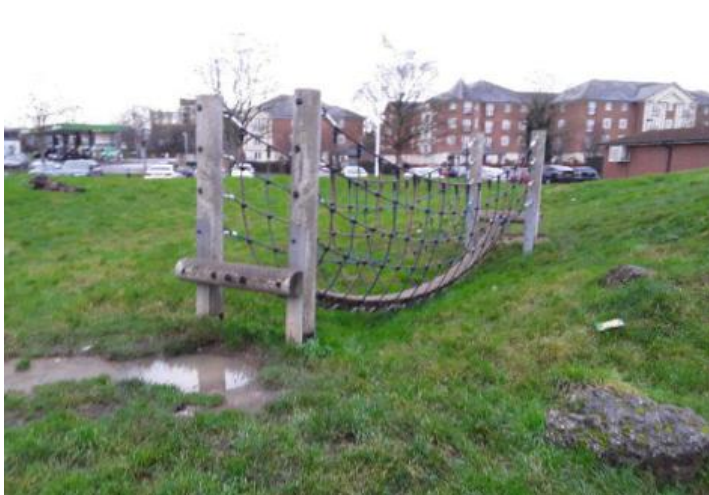
There are areas or parts of the timber post tops that have rotted - Replace all affected timbers

Item: Activity Equipment - Bridge
Manufacturer: Richter Spielgerate GmbH (DE)

Finding: There are areas or parts of the timber post tops that have rotted

Action: Replace all affected timbers

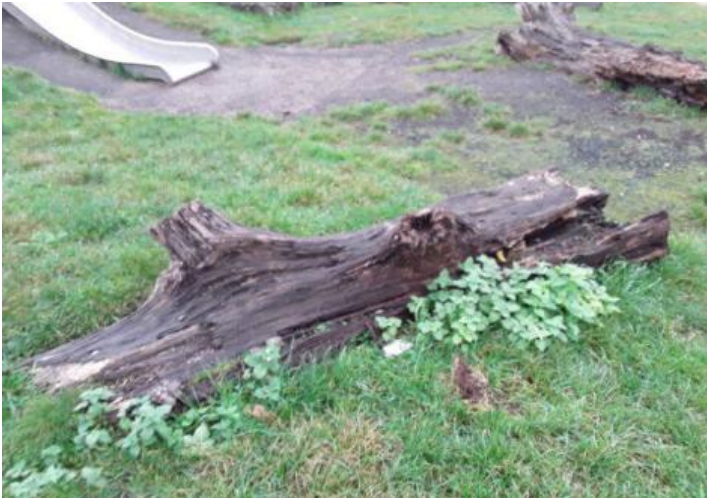
Fungus or algae was found on the equipment - Remove fungi or algae from the equipment

Item: Other - Tree Trunk
Manufacturer: Owner/Operator

Finding: Fungus or algae was found on the equipment

Action: Remove fungi or algae from the equipment

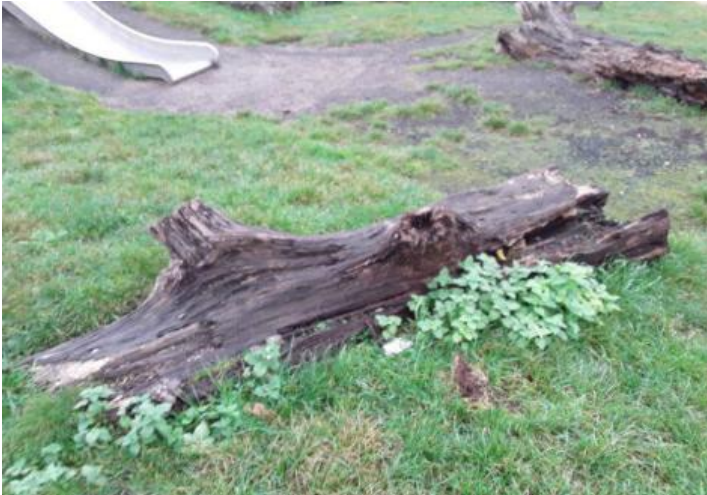
There are areas or parts of the timber on the structure that have rotted - Replace all affected timbers

Item: Other - Tree Trunk
Manufacturer: Owner/Operator

Finding: There are areas or parts of the timber on the structure that have rotted

Action: Replace all affected timbers

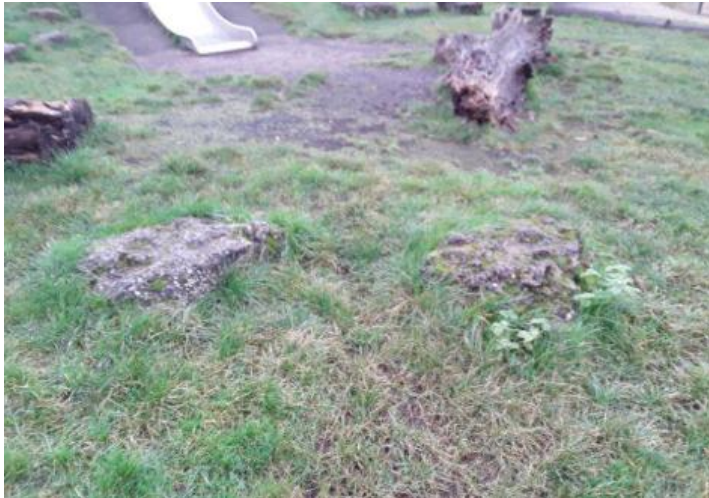
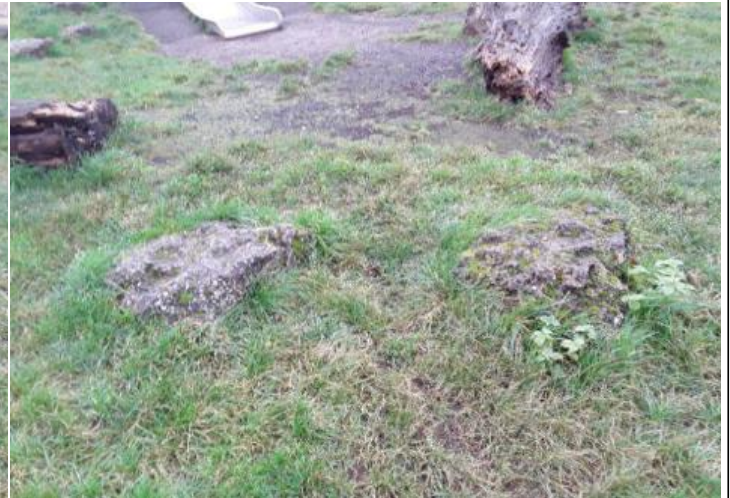
Item: Other - Boulders
Manufacturer: Natural Feature

Finding: The rocks and/or boulders have moss/algae growth apparent

Action: Clean and maintain

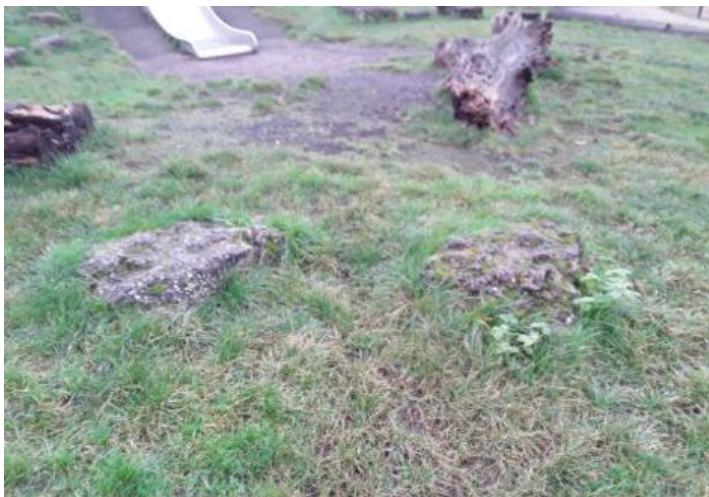
Item: Other - Boulders
Manufacturer: Natural Feature

Finding: The step between the items is quite large and users may not be able to complete the step without touching ground, the items could therefore be considered to be within the falling space of each other, however the intention of the play activity continuity is easily apparent and foreseeable to the user

Action: Monitor - No remedial work recommended

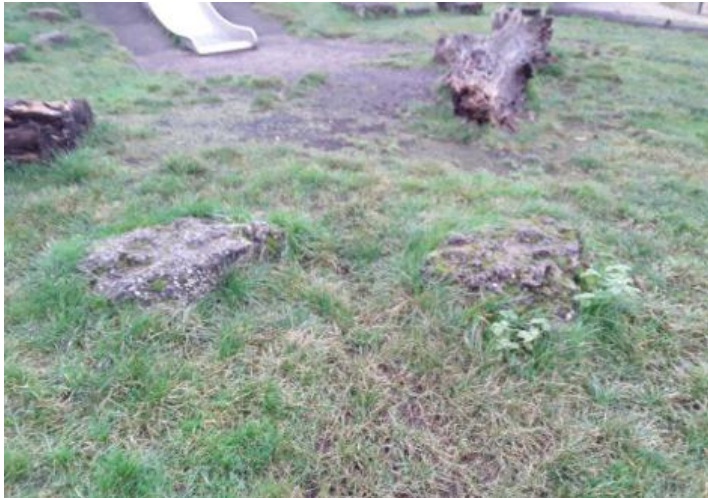
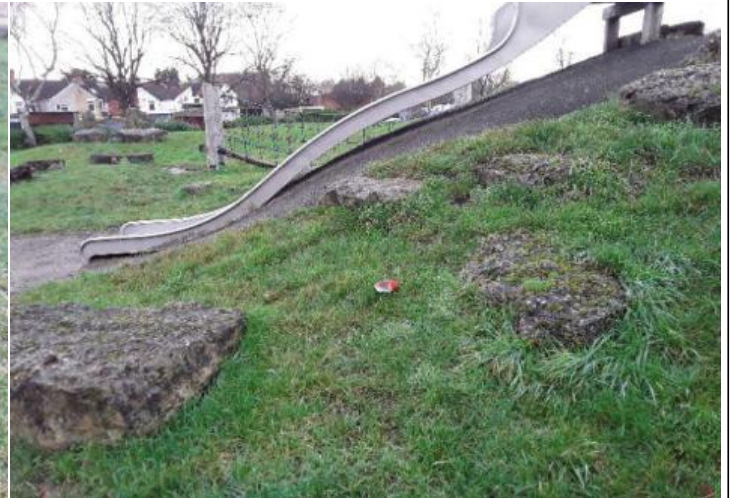
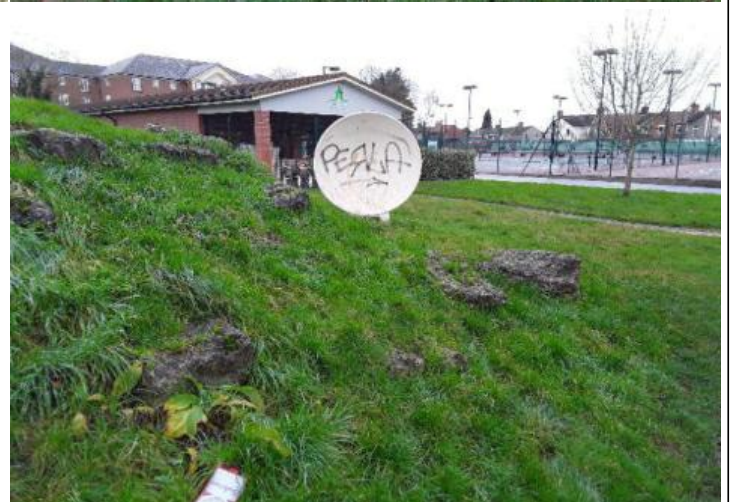
Item: Other - Boulders
Manufacturer: Natural Feature

Finding: There are multiple areas where adjacent boulders form hard objects in the impact area of other boulders in contravention of BS EN 1176 Part 1

Action: Monitor the risk assessment regularly and modify the design if required

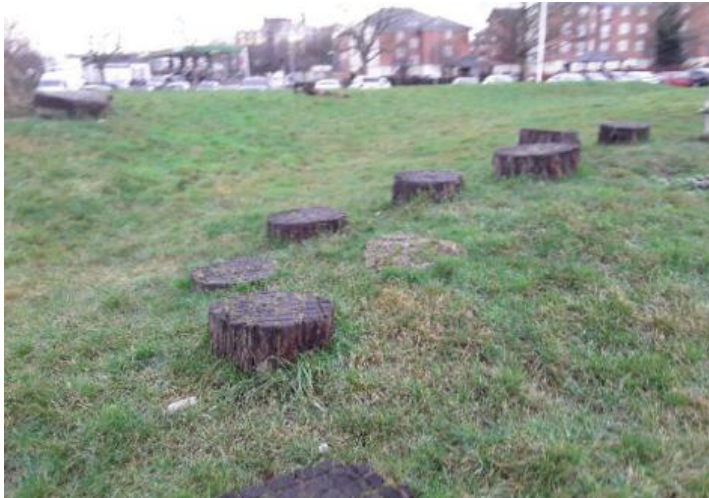
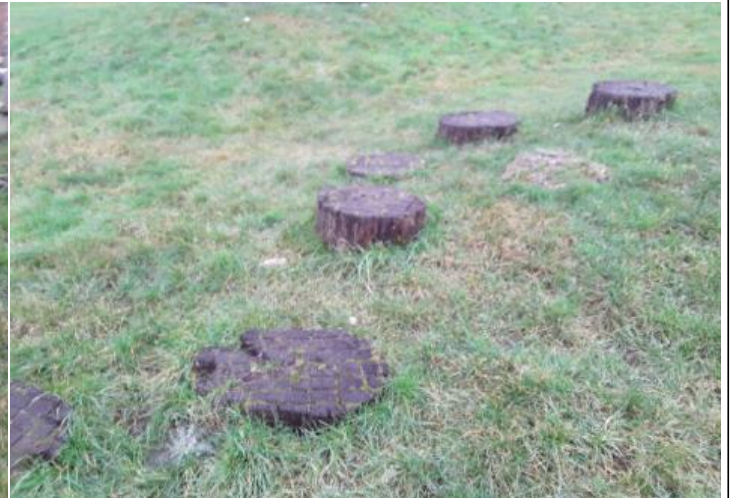
Item: Activity Equipment - Stepping Stones
Manufacturer: Owner/Operator

Finding: There is algae or moss on the surface of the equipment

Action: Clean and treat appropriately

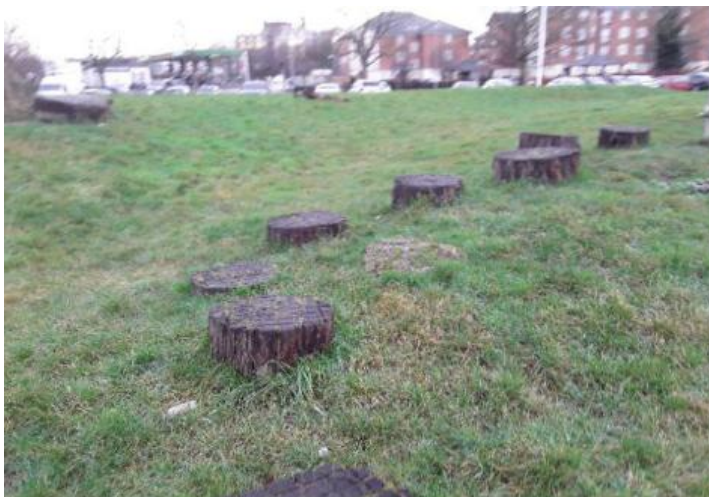
Item: Activity Equipment - Stepping Stones
Manufacturer: Owner/Operator

Finding: There are areas or parts of the timber on the structure that have rotted

Action: Replace all affected timbers

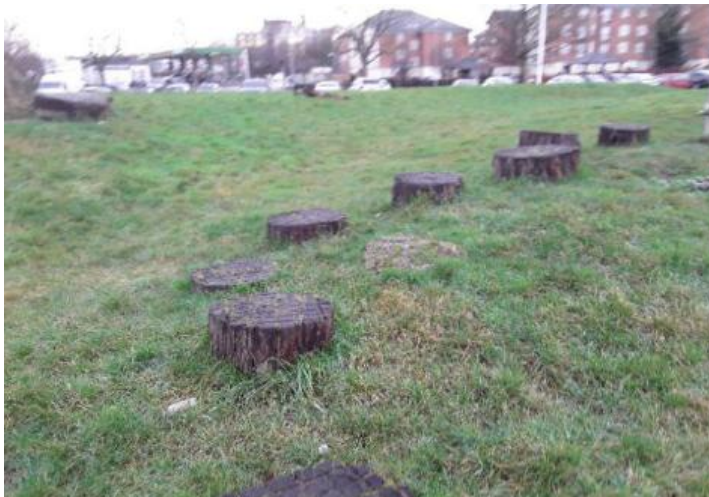
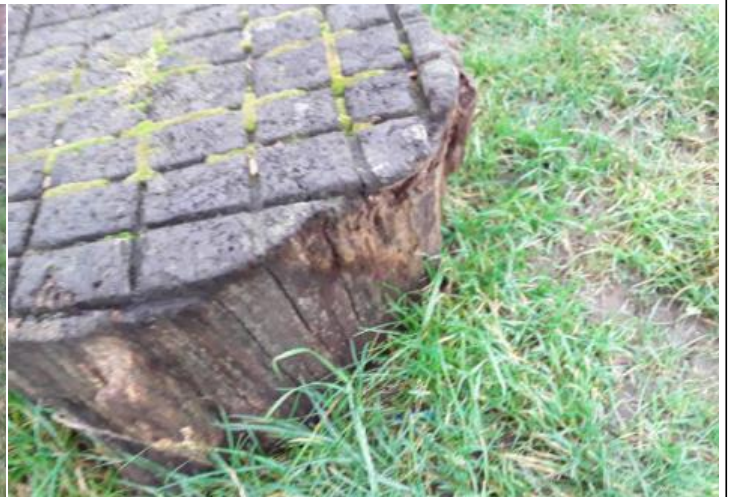
Item: Activity Equipment - Stepping Stones
Manufacturer: Owner/Operator

Finding: Parts of the timber are rough or splintered

Action: Remove all rough or sharp edges

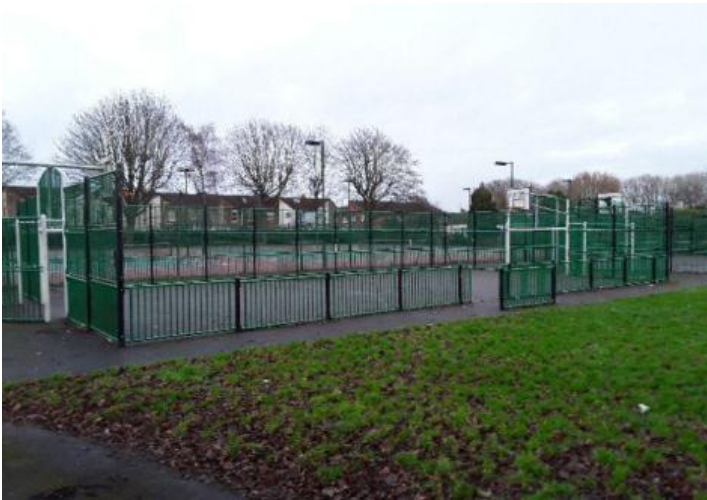
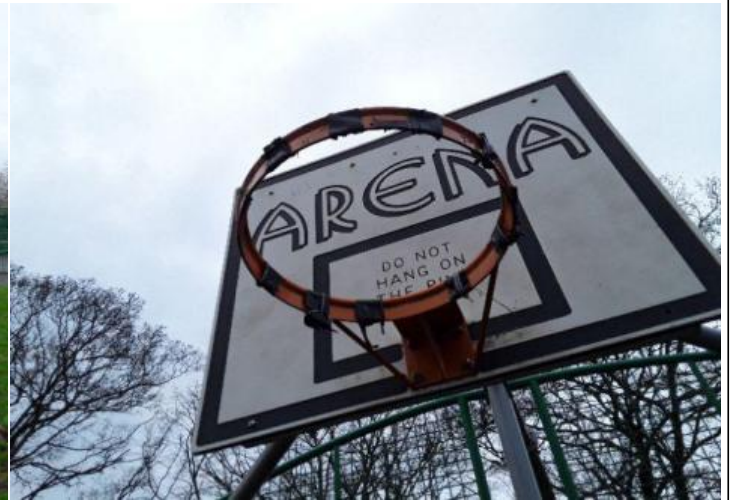
12 - Moderate Risk (Finding 4)

Item: Multi Use Games Area - Multi Use Games Area (MUGA)
Manufacturer: S M P (Playgrounds Ltd)
Risk Level: M - Moderate Risk
Surface: Bitmac

Finding: Cable ties have been used on the hoops

Action: Remove

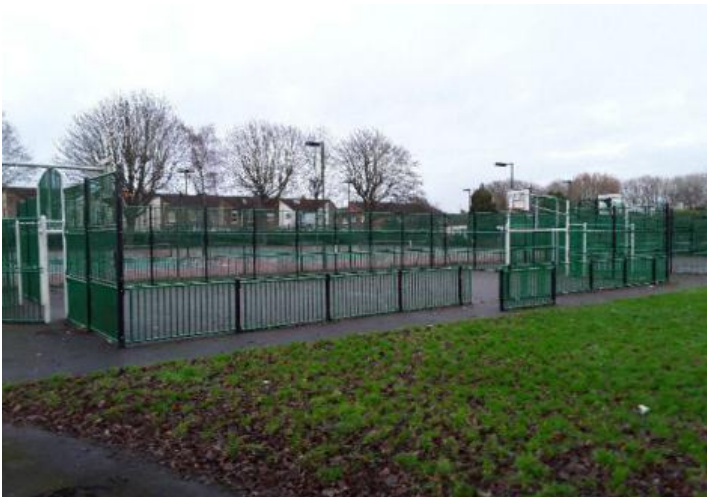
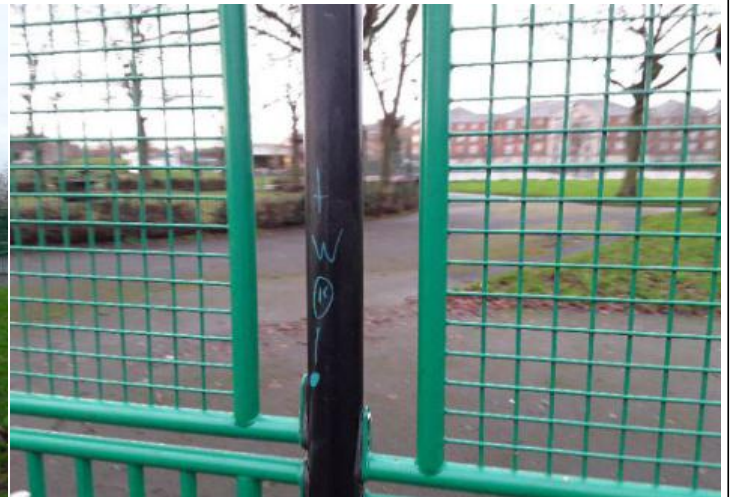
0 - Risk Assessment not Undertaken (Finding 5)

Item: Multi Use Games Area - Multi Use Games Area (MUGA)
Manufacturer: S M P (Playgrounds Ltd)
Risk Level: N - Risk Assessment not Undertaken
Surface: Bitmac

Finding: There is some graffiti present

Action: Remove the graffiti

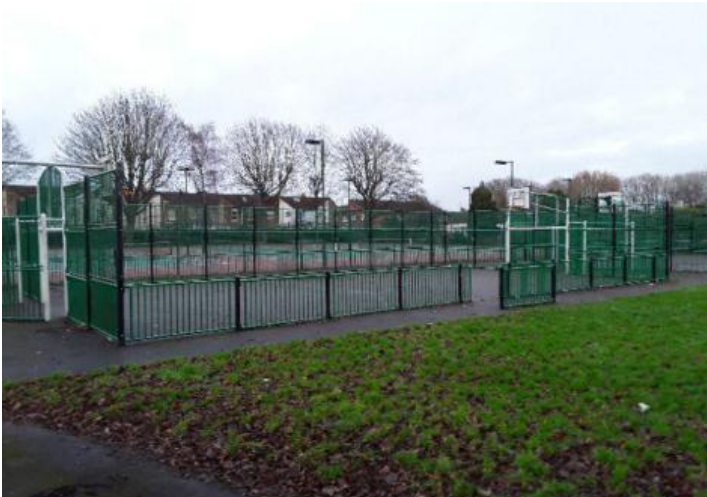
Item: Multi Use Games Area - Multi Use Games Area (MUGA)
Manufacturer: S M P (Playgrounds Ltd)

Finding: There is/are finger entrapments in the frame and the item fails to meet the requirements of BS EN 15312 Clause 4.4.2.2 Entrapment of fingers

Action: Monitor - No remedial work recommended

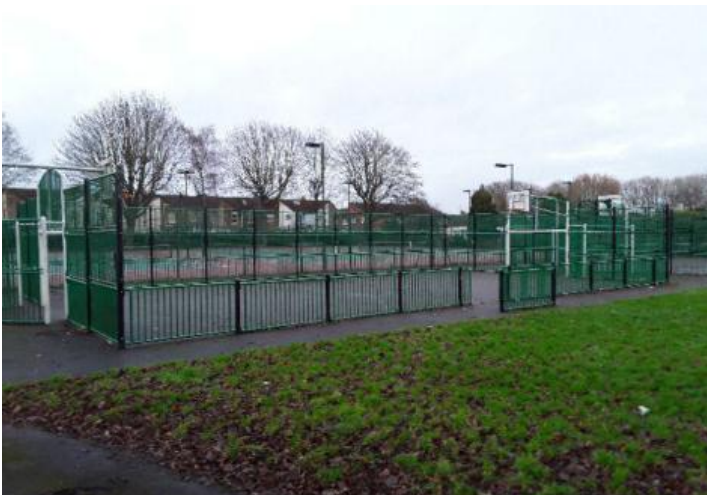
Item: Multi Use Games Area - Multi Use Games Area (MUGA)
Manufacturer: S M P (Playgrounds Ltd)

Finding: There is/are finger entrapments in the frame due to missing inserts and the item fails to meet the requirements of BS EN 15312 Clause 4.4.2.2 Entrapment of fingers

Action: Replace the missing inserts to remove the entrapment

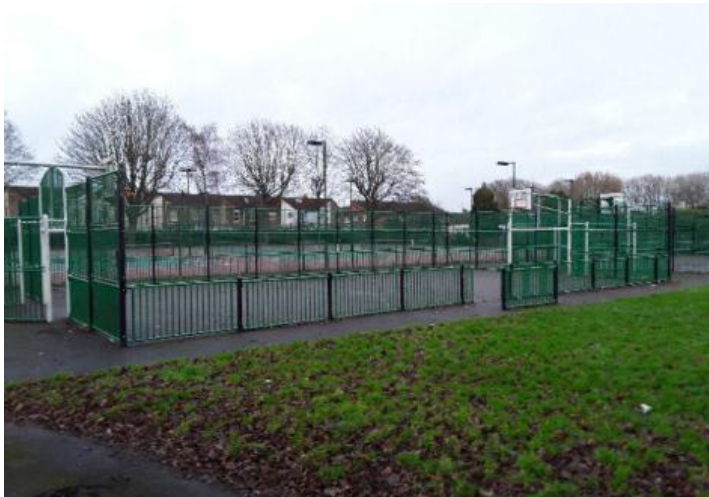
12 - Moderate Risk (Finding 8)

Item: Multi Use Games Area - Multi Use Games Area (MUGA)
Manufacturer: S M P (Playgrounds Ltd)
Risk Level: M - Moderate Risk
Surface: Bitmac

Finding: There is or are fixings missing on the backboard
Action: Replace all missing fixings

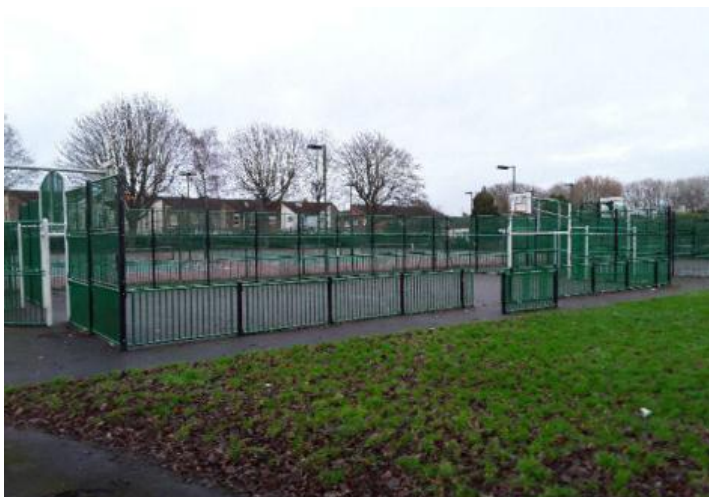
8 - Low Risk (Finding 9)

Item: Multi Use Games Area - Multi Use Games Area (MUGA)
Manufacturer: S M P (Playgrounds Ltd)
Risk Level: L - Low Risk
Surface: Bitmac

Finding: There is algae, silt or moss growth on the surface resulting in slippery conditions
Action: Clean and treat appropriately

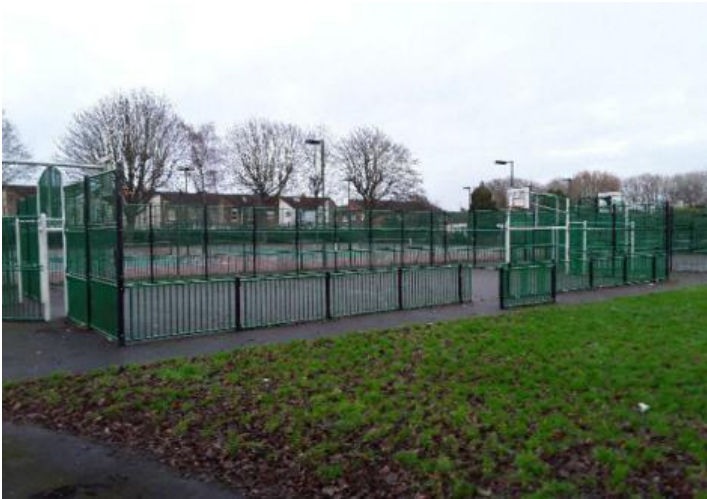
i 10 - Low Risk (Finding 10)

Item: Multi Use Games Area - Multi Use Games Area (MUGA)
Manufacturer: S M P (Playgrounds Ltd)

Finding: The fence is severely damaged in places

Action: Repair or replace all affected sections

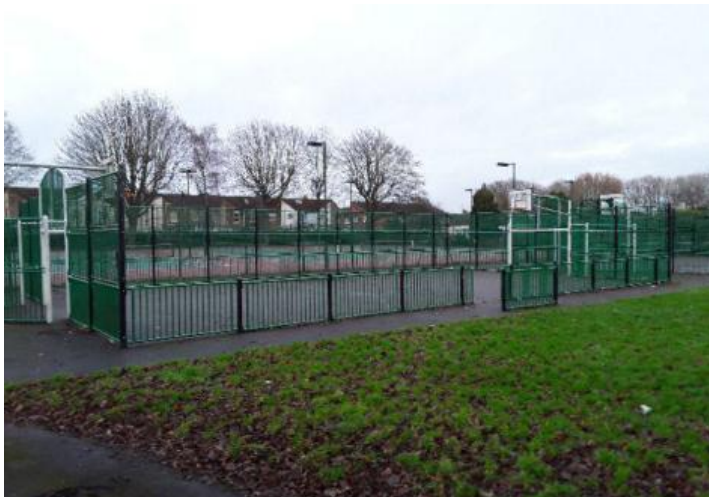
Finding: There is or are fixings missing on the item

Action: Replace all missing fixings

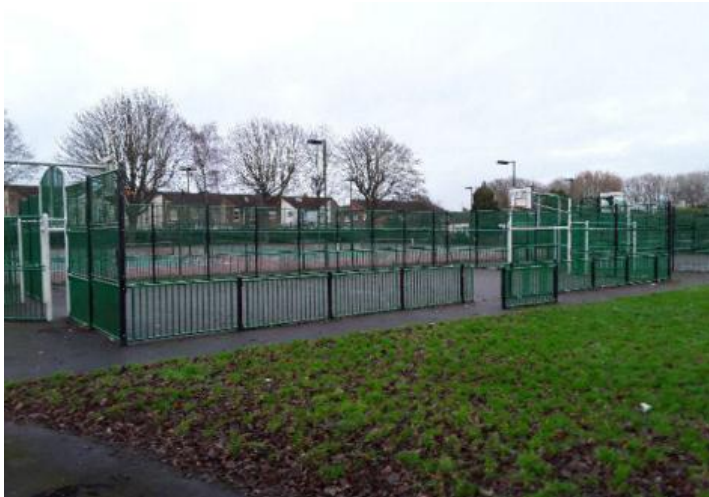
Finding: The fence is severely damaged in places

Action: Repair or replace all affected sections

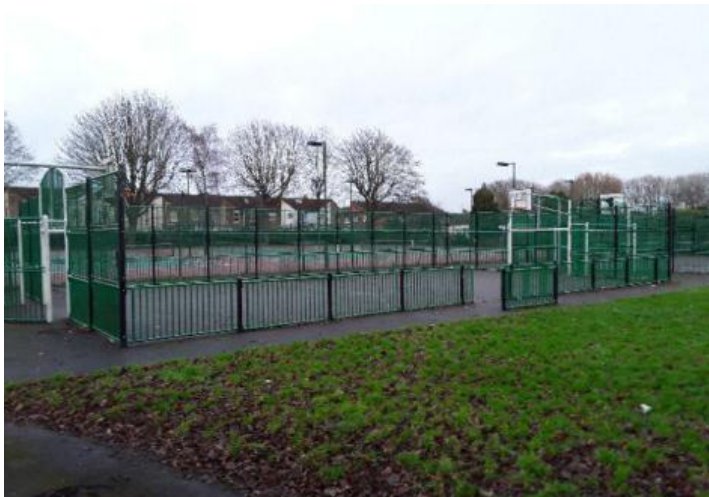
Finding: There are a number of fixings missing from the fence

Action: Replace missing fixings
