ASBESTOS REFURBISHMENT SURVEY REPORT

Site: Street Parish Rooms, 6 Leigh Road, Street, Somerset, BA16 0HA

Job Number: J104332

Survey Date: 10th December 2019

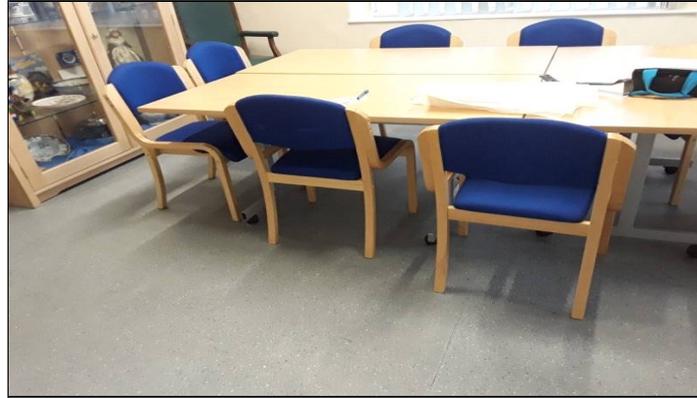
Sample No.	ZS002501	Description	Blue vinyl
-------------------	----------	--------------------	------------

Location ID	001	Position	to timber floorboards below		
Building	01 Main Building	Floor	1st Floor	Room/Area	Office (001)
Last Inspection Date	10/12/2019	Next Inspection Date	N/A

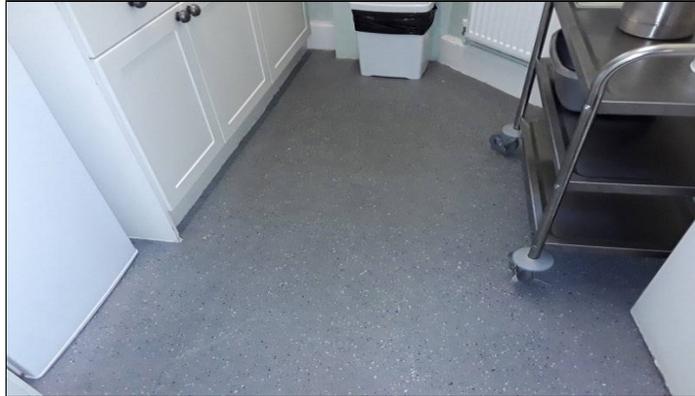
Sample No.	Ref ZS002501	Description	Blue vinyl
-------------------	--------------	--------------------	------------

Location ID	002	Position	to timber floorboards below		
Building	01 Main Building	Floor	1st Floor	Room/Area	Kitchenette (002)
Last Inspection Date		10/12/2019	Next Inspection Date	N/A

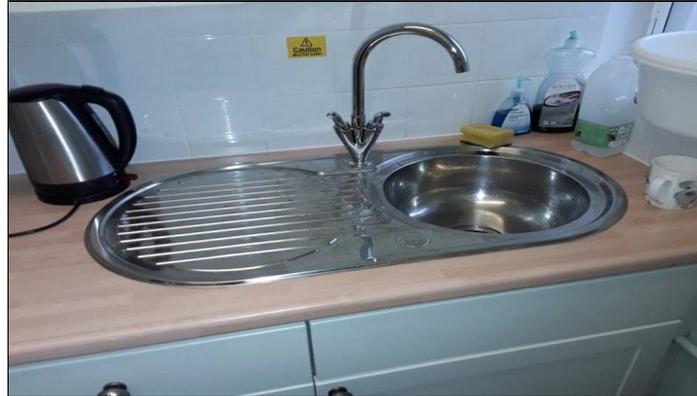
Comments	
Recommendations	No further action required

Sample No.	ZS002502	Description	Mastic pad
-------------------	----------	--------------------	------------

Location ID	002	Position	to underside of metal sink and metal tray		
Building	01 Main Building	Floor	1st Floor	Room/Area	Kitchenette (002)
Last Inspection Date		10/12/2019	Next Inspection Date	N/A

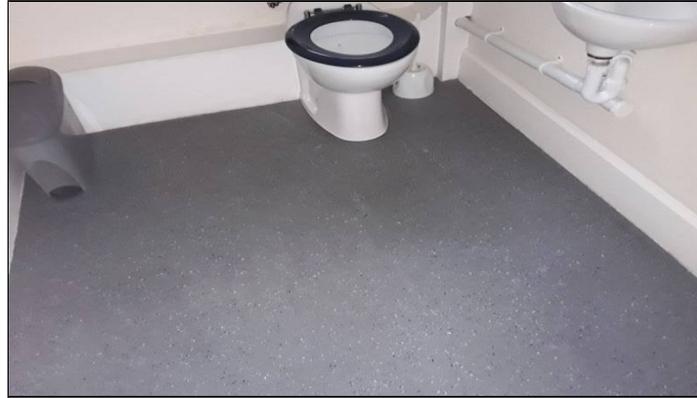
Sample No.	Ref ZS002501	Description	Blue vinyl
-------------------	--------------	--------------------	------------

Location ID	003	Position	to timber floorboards below		
Building	01 Main Building	Floor	1st Floor	Room/Area	Unisex WC (003)
Last Inspection Date		10/12/2019	Next Inspection Date	N/A

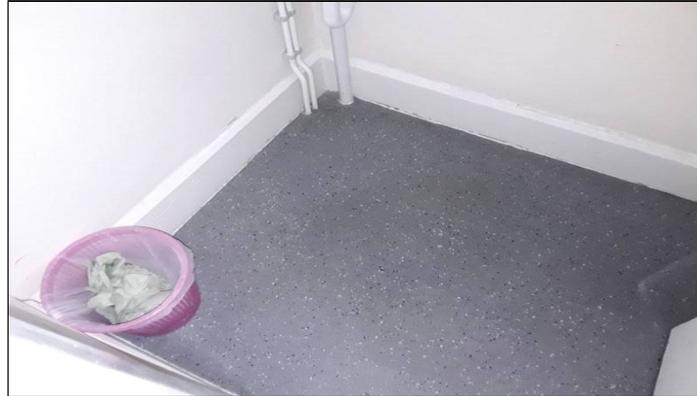
Sample No.	Ref ZS002501	Description	Blue vinyl
-------------------	--------------	--------------------	------------

Location ID	004	Position	to timber floorboards below		
Building	01 Main Building	Floor	1st Floor	Room/Area	Male WC (004)
Last Inspection Date	10/12/2019	Next Inspection Date	N/A

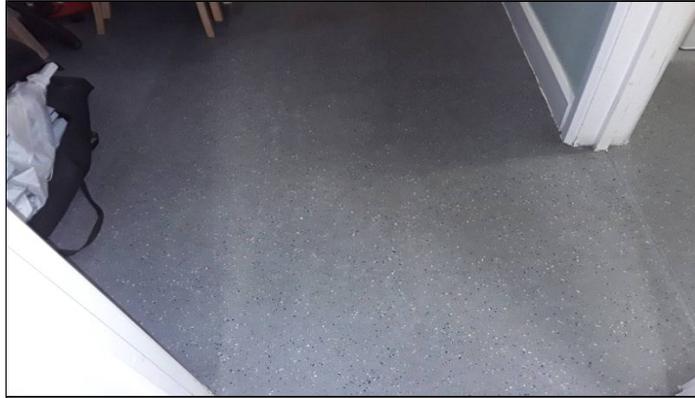
Sample No.	Ref ZS002501	Description	Blue vinyl
-------------------	--------------	--------------------	------------

Location ID	005	Position	to timber floorboards below		
Building	01 Main Building	Floor	1st Floor	Room/Area	Landing (005)
Last Inspection Date		10/12/2019	Next Inspection Date	N/A

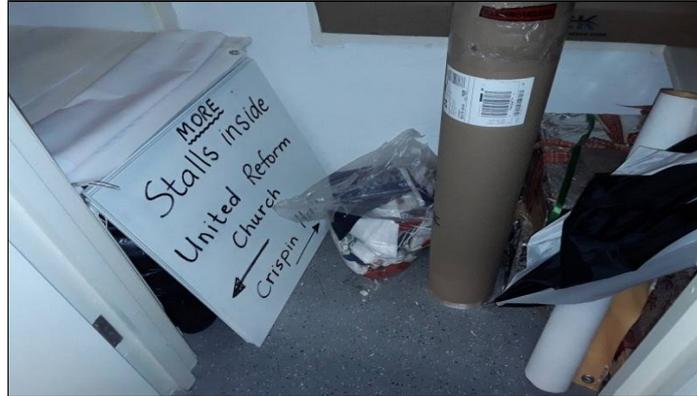
Sample No.	Ref ZS002501	Description	Blue vinyl
-------------------	--------------	--------------------	------------

Location ID	006	Position	to timber floorboards below		
Building	01 Main Building	Floor	1st Floor	Room/Area	Cupboard (006)
Last Inspection Date	10/12/2019	Next Inspection Date	N/A

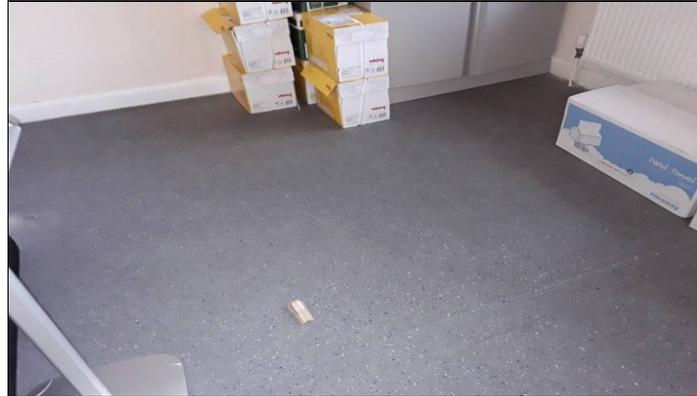
Sample No.	Ref ZS002501	Description	Blue vinyl
-------------------	--------------	--------------------	------------

Location ID	008	Position	to timber floorboards below		
Building	01 Main Building	Floor	1st Floor	Room/Area	Hall (008)
Last Inspection Date		10/12/2019	Next Inspection Date	N/A

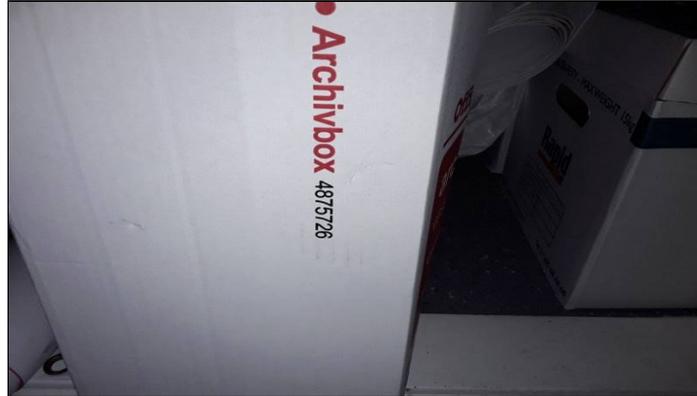
Sample No.	Ref ZS002501	Description	Blue vinyl
-------------------	--------------	--------------------	------------

Location ID	009	Position	to timber floorboards below		
Building	01 Main Building	Floor	1st Floor	Room/Area	Cupboard (009)
Last Inspection Date	10/12/2019	Next Inspection Date	N/A

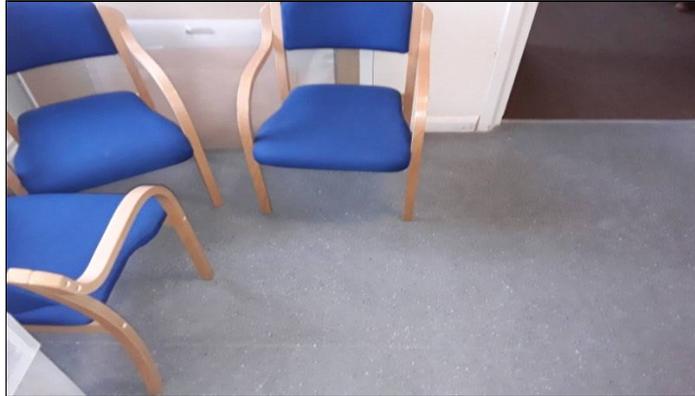
Sample No.	Ref ZS002501	Description	Blue vinyl
-------------------	--------------	--------------------	------------

Location ID	010	Position	to timber floorboards below		
Building	01 Main Building	Floor	1st Floor	Room/Area	Hall (010)
Last Inspection Date	10/12/2019	Next Inspection Date	N/A

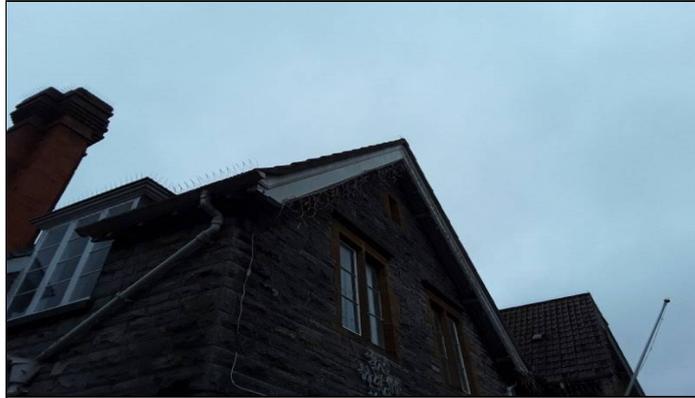
Sample No.	ZS002503	Description	Cement
-------------------	----------	--------------------	--------

Location ID	001	Position	undercloak		
Building	01 Main Building	Floor	External	Room/Area	External (001)
Last Inspection Date		10/12/2019	Next Inspection Date	N/A

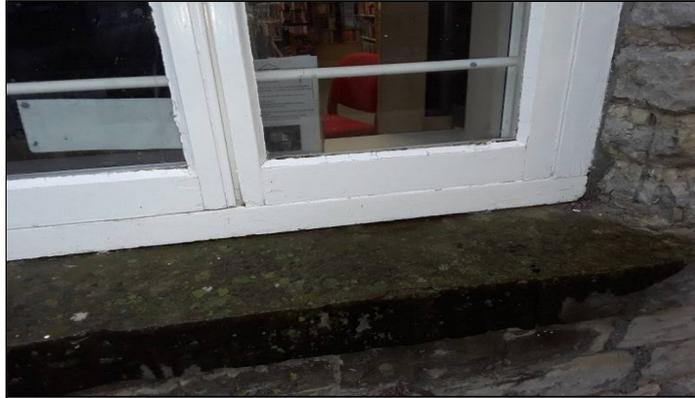
Sample No.	ZS002504	Description	Putty seal
-------------------	----------	--------------------	------------

Location ID	001	Position	to timber windows		
Building	01 Main Building	Floor	External	Room/Area	External (001)
Last Inspection Date		10/12/2019	Next Inspection Date	N/A
