REFURBISHMENT SURVEY FOR ASBESTOS-CONTAINING MATERIALS

CLIENT: DDS Environmental

SITE: Radford House, 18-20 Effingham Street, Ramsgate, Kent, CT11 9AT

TYPE OF SURVEY: Refurbishment

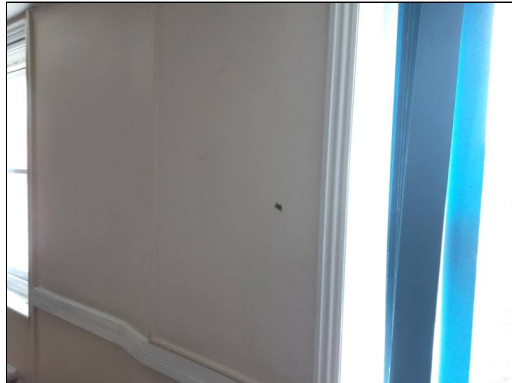
Building	Radford House	Floor/ room	2nd Floor / 2.01		
Assessment no.	0001	Accessibility			
Material Risk					
Identification	Identified	Condition			
Extent		Asbestos Type	No Asbestos Detected		
Location/ position	Board to window wall				
Surface treatment					
Product type	n/a				
Material risk		Material risk score			
Action	No further action required

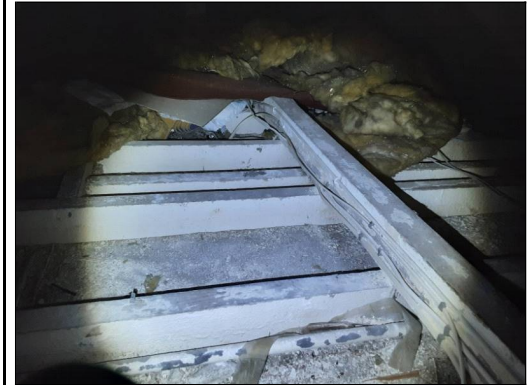
Building	Radford House	Floor/ room	Roof Void / 2.04 roof void		
Assessment no.	0002	Accessibility	Usually inaccessible or unlikely to be disturbed		
Material Risk					
Identification	Identified	Condition	Low Damage		
Extent	15m²	Asbestos Type	Chrysotile		
Location/ position	Cement lining to ceiling above 2.03 in roof void				
Surface treatment	Surface Sealed				
Product type	Cement				
Material risk	Very low	Material risk score	4		
Action	Remove

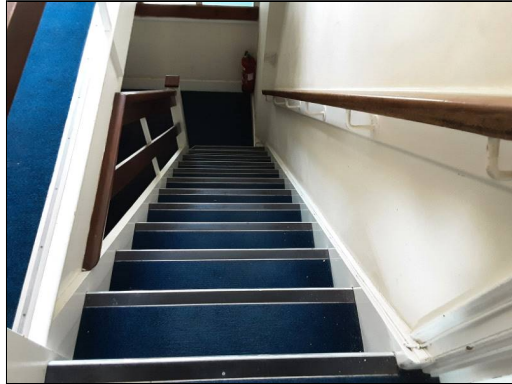
Assessment details				Comments	Photograph
Building	Radford House	Floor/ room	2nd Floor / 2.04	1 lm per step

Assessment no.	0003	Accessibility			
Material Risk					
Identification	Identified	Condition			
Extent		Asbestos Type	No Asbestos Detected		
Location/ position	Stairnosing to staircase				
Surface treatment					
Product type	n/a				
Material risk		Material risk score			
Action	No further action required

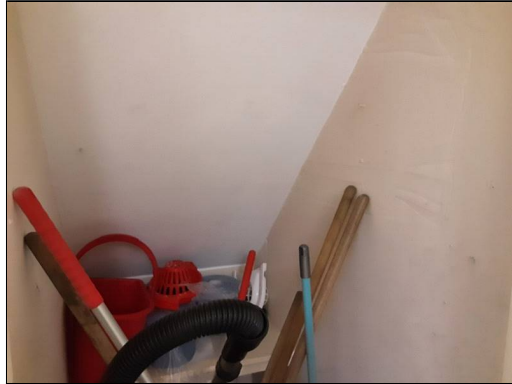
Building	Radford House	Floor/ room	1st Floor / 1.07		
Assessment no.	0004	Accessibility			
Material Risk					
Identification	Identified	Condition			
Extent		Asbestos Type	No Asbestos Detected		
Location/ position	Board pitched ceiling to underside of staircase				
Surface treatment					
Product type	n/a				
Material risk		Material risk score			
Action	No further action required

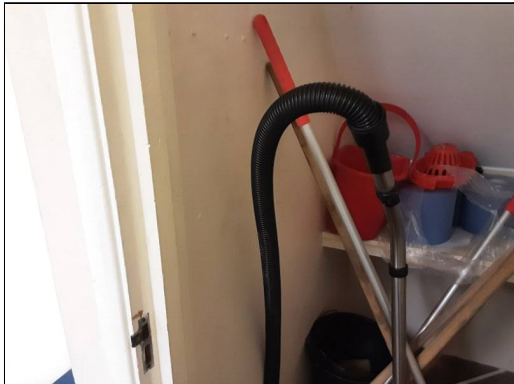
Building	Radford House	Floor/ room	1st Floor / 1.07		
Assessment no.	0005	Accessibility			
Material Risk					
Identification	Identified	Condition			
Extent		Asbestos Type	No Asbestos Detected		
Location/ position	Board to walls within cupboard under staircase				
Surface treatment					
Product type	n/a				
Material risk		Material risk score			
Action	No further action required

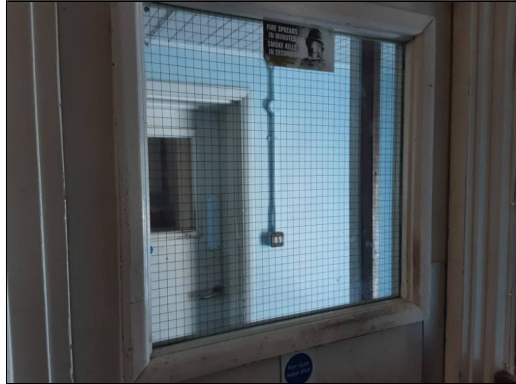
Building	Radford House	Floor/ room	1st Floor / 1.07		
Assessment no.	0006	Accessibility			
Material Risk					
Identification	Identified	Condition			
Extent		Asbestos Type	No Asbestos Detected		
Location/ position	Board door beading around door window				
Surface treatment					
Product type	n/a				
Material risk		Material risk score			
Action	No further action required

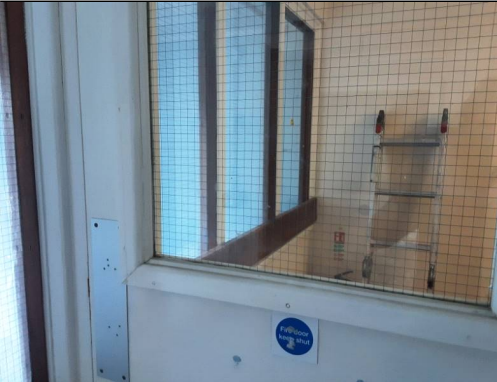
Building	Radford House	Floor/ room	1st Floor / 1.08		
Assessment no.	0007	Accessibility			
Material Risk					
Identification	Strongly Presumed (006)	Condition			
Extent		Asbestos Type	No Asbestos Detected		
Location/ position	Board Door beading to window between rooms 1.07 and 1.08				
Surface treatment					
Product type	n/a				
Material risk		Material risk score			
Action	No further action required

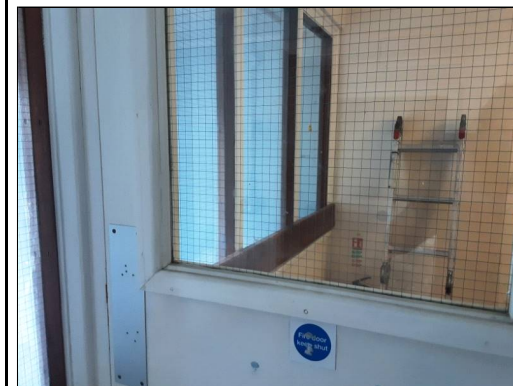
</div>
Building	Radford House	Floor/ room	1st Floor / 1.08		
Assessment no.	0008	Accessibility	Easily disturbed		
Material Risk					
Identification	Identified	Condition	Low Damage		
Extent	2lm	Asbestos Type	Amosite		
Location/ position	Board door beading to window between rooms 1.08 and 1.09				
Surface treatment	Surface Sealed				
Product type	Board				
Material risk	Low	Material risk score	6		
Action	Remove

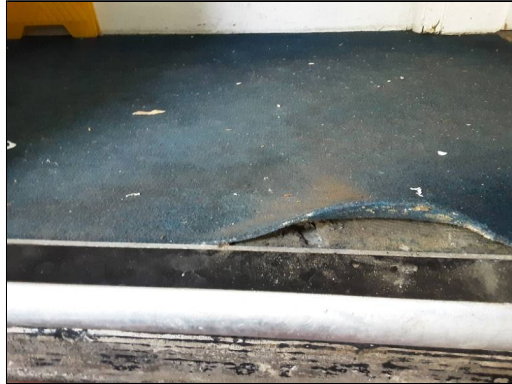
Building	Radford House	Floor/ room	1st Floor / 1.08		
Assessment no.	0009	Accessibility			
Material Risk					
Identification	Identified	Condition			
Extent		Asbestos Type	No Asbestos Detected		
Location/ position	Screed under carpet				
Surface treatment					
Product type	n/a				
Material risk		Material risk score			
Action	No further action required

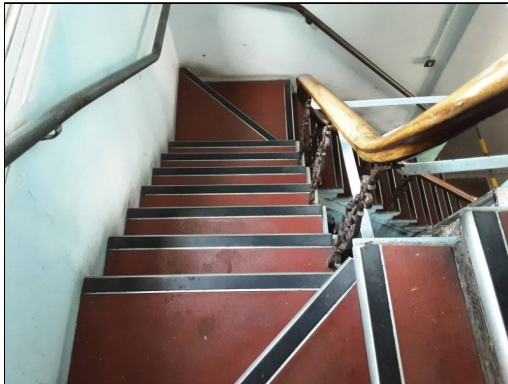
Assessment details				Comments	Photograph
Building	Radford House	Floor/ room	1st Floor / 1.08	1lm per step

Assessment no.	0010	Accessibility			
Material Risk					
Identification	Identified	Condition			
Extent		Asbestos Type	No Asbestos Detected		
Location/ position	Stairnosing to staircase				
Surface treatment					
Product type	n/a				
Material risk		Material risk score			
Action	No further action required

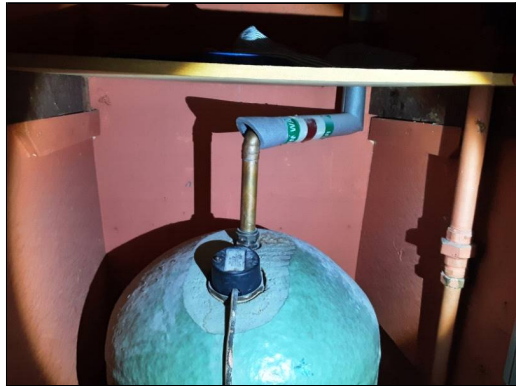
Building	Radford House	Floor/ room	1st Floor / 1.09		
Assessment no.	0012	Accessibility			
Material Risk					
Identification	Identified	Condition			
Extent		Asbestos Type	No Asbestos Detected		
Location/ position	Board to walls within cupboard				
Surface treatment					
Product type	n/a				
Material risk		Material risk score			
Action	No further action required

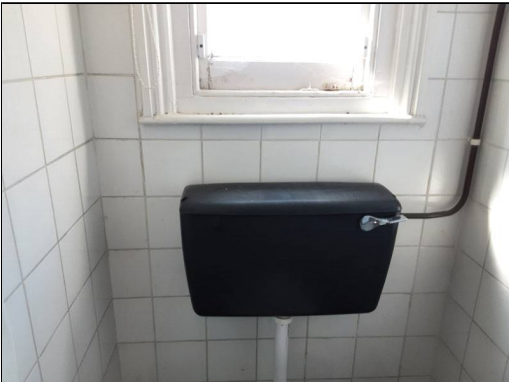
Building	Radford House	Floor/ room	1st Floor / 1.11		
Assessment no.	0013	Accessibility			
Material Risk					
Identification	Identified	Condition			
Extent		Asbestos Type	No Asbestos Detected		
Location/ position	Cistern to window wall				
Surface treatment					
Product type	n/a				
Material risk		Material risk score			
Action	No further action required

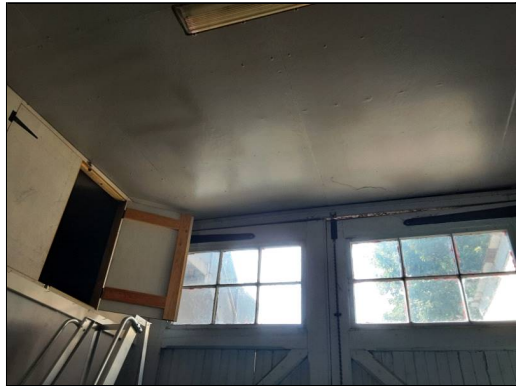
Assessment details				Comments	Photograph
Building	Radford House	Floor/ room	Ground Floor / G.01	Also in high level timber cupboard

Assessment no.	0014	Accessibility			
Material Risk					
Identification	Identified	Condition			
Extent		Asbestos Type	No Asbestos Detected		
Location/ position	Board to ceiling next to large double timber doors				
Surface treatment					
Product type	n/a				
Material risk		Material risk score			
Action	No further action required

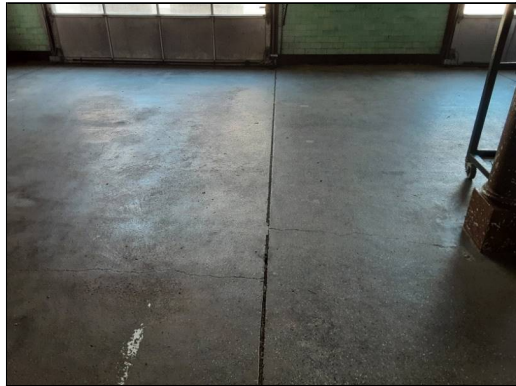
Identification	Identified	Condition				
Extent		Asbestos Type	No Asbestos Detected			
Location/ position	Floor joints to solid floor					
Surface treatment						
Product type	n/a					
Material risk		Material risk score				
Action	No further action required

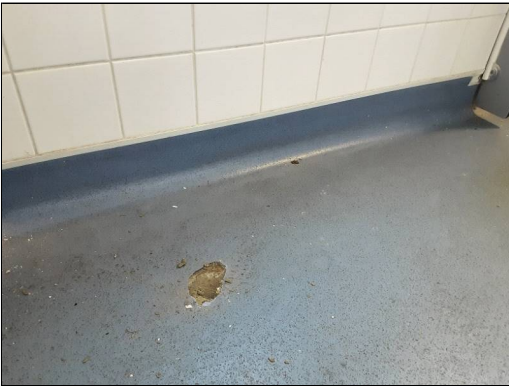
Building	Radford House	Floor/ room	Ground Floor / G.02		
Assessment no.	0016	Accessibility			
Material Risk					
Identification	Strongly Presumed (009)	Condition			
Extent		Asbestos Type	No Asbestos Detected		
Location/ position	Screed To solid floor below vinyl flooring				
Surface treatment					
Product type	n/a				
Material risk		Material risk score			
Action	No further action required

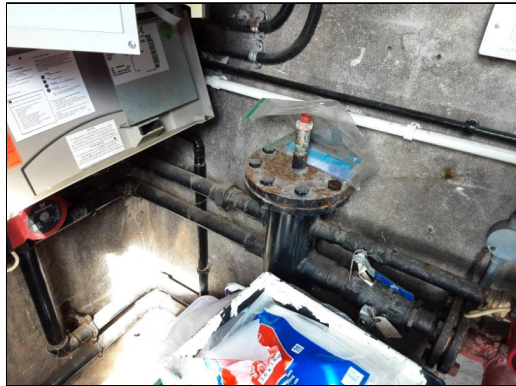
Building	Radford House	Floor/ room	Ground Floor / G.05		
Assessment no.	0018	Accessibility			
Material Risk					
Identification	Identified	Condition			
Extent		Asbestos Type	No Asbestos Detected		
Location/ position	Yellow gasket to large flange				
Surface treatment					
Product type	n/a				
Material risk		Material risk score			
Action	No further action required

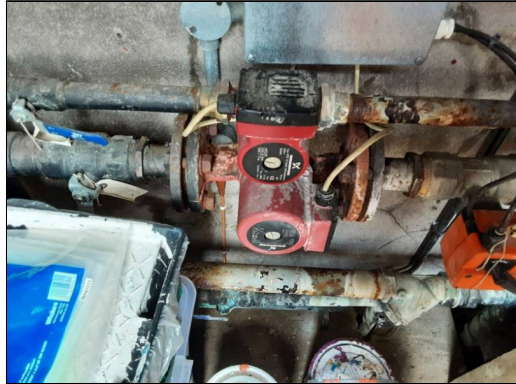
Building	Radford House	Floor/ room	Ground Floor / G.05		
Assessment no.	0019	Accessibility			
Material Risk					
Identification	Identified	Condition			
Extent		Asbestos Type	No Asbestos Detected		
Location/ position	Green gasket small flanges				
Surface treatment					
Product type	n/a				
Material risk		Material risk score			
Action	No further action required

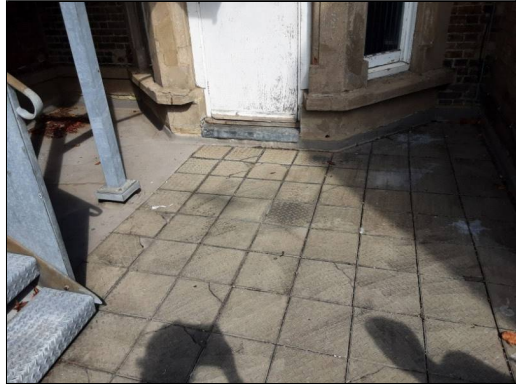
Building	Radford House	Floor/ room	External / Externals		
Assessment no.	0021	Accessibility			
Material Risk					
Identification	Identified	Condition			
Extent		Asbestos Type	No Asbestos Detected		
Location/ position	Promenade tiles flat roof above G.01				
Surface treatment					
Product type	n/a				
Material risk		Material risk score			
Action	No further action required

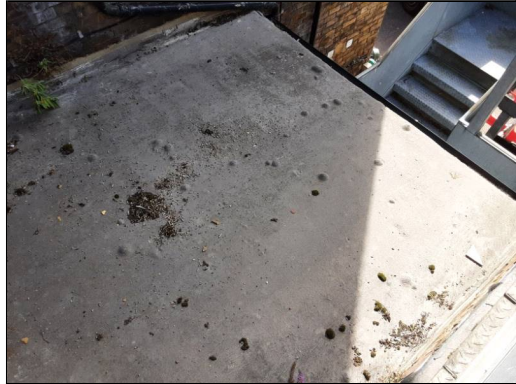
Building	Radford House	Floor/ room	External / Externals		
Assessment no.	0022	Accessibility			
Material Risk					
Identification	Identified	Condition			
Extent		Asbestos Type	No Asbestos Detected		
Location/ position	Asphalt flat roof above G.01 and G.02				
Surface treatment					
Product type	n/a				
Material risk		Material risk score			
Action	No further action required

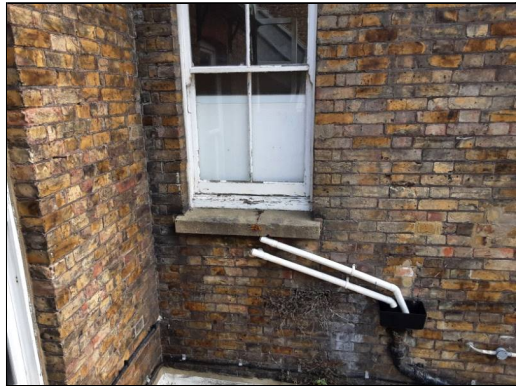
Assessment details				Comments	Photograph
Building	Radford House	Floor/ room	External / Externals	Also to window of outbuilding 2

Assessment no.	0023	Accessibility			
Material Risk					
Identification	Identified	Condition			
Extent		Asbestos Type	No Asbestos Detected		
Location/ position	Putty to all windows				
Surface treatment					
Product type	n/a				
Material risk		Material risk score			
Action	No further action required

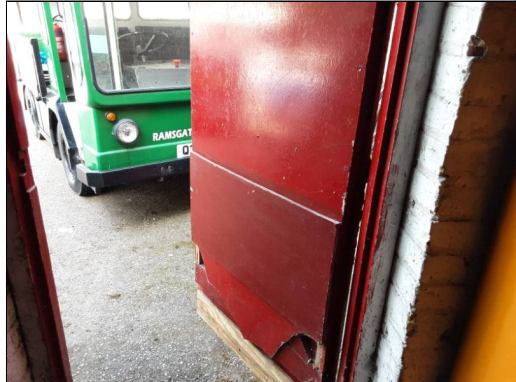
Assessment no.	0025	Accessibility			
Material Risk					
Identification	Identified	Condition			
Extent		Asbestos Type	No Asbestos Detected		
Location/ position	Board door lining to internal side of door				
Surface treatment					
Product type	n/a				
Material risk		Material risk score			
Action	No further action required

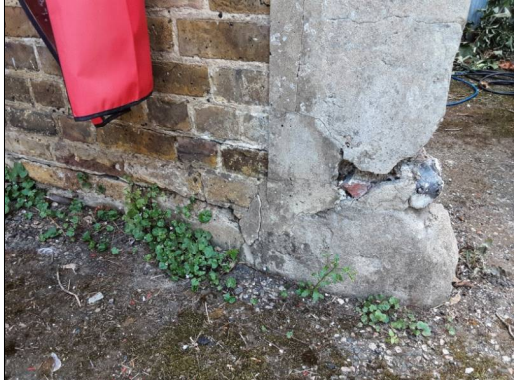
Assessment no.	0026	Accessibility			
Material Risk					
Identification	Identified	Condition			
Extent		Asbestos Type	No Asbestos Detected		
Location/ position	Bitumen damp proof course to brick walls				
Surface treatment					
Product type	n/a				
Material risk		Material risk score			
Action	No further action required
