Asbestos Management with Targeted Refurbishment Survey Front elevation windows/ Front Shop Fascia

Church Street Shops
Church Street
Stoke on Trent
ST4 1BU

Survey Report Reference:	P-245860
Client:	Karen Copeland
Survey Date:	29 March 2017

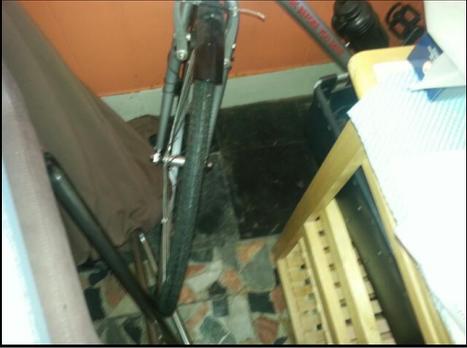
Building:	110/112 Cutting Matters	Floor:	Ground Floor				
Location:	001 - Salon	Sample Number:	P-245860/027				
Sample Details

Item Description:	Black floor tiles to corner					
	Material description:	Thermoplastic product					
	Quantity / Extent:	N/A					
	Accessibility	Easy Access					
	Analysis:	No asbestos detected					
	Conf. of Product Type:	Non-asbestos material					
Material Assessment Scoring:							
Product Type:	-	Condition:	-	Surface Treatment:	-	Asbestos Type:	-
Priority Assessment Scoring:							
Occupant Activity:	-	Disturbance:	-	Human Exposure:	-	Maintenance activity:	-
Total Scores:							
Material score:	-	Priority score	-	Total score:	-	Risk Cat.:	N/A
Recommended action:	-						
Recommendation comments:	-						
Surveyors Comments:	-

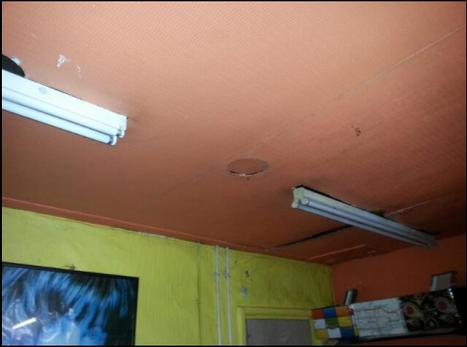
Building:	110/112 Cutting Matters	Floor:	Ground Floor				
Location:	001 - Salon	Sample Number:	P-245860/028				
Sample Details

Item Description:	Textured coating to timber panelled ceiling to rear of salon					
	Material description:	Textured coatings					
	Quantity / Extent:	N/A					
	Accessibility	Medium Access					
	Analysis:	No asbestos detected					
	Conf. of Product Type:	Non-asbestos material					
Material Assessment Scoring:							
Product Type:	-	Condition:	-	Surface Treatment:	-	Asbestos Type:	-
Priority Assessment Scoring:							
Occupant Activity:	-	Disturbance:	-	Human Exposure:	-	Maintenance activity:	-
Total Scores:							
Material score:	-	Priority score	-	Total score:	-	Risk Cat.:	N/A
Recommended action:	-						
Recommendation comments:	-						
Surveyors Comments:	-

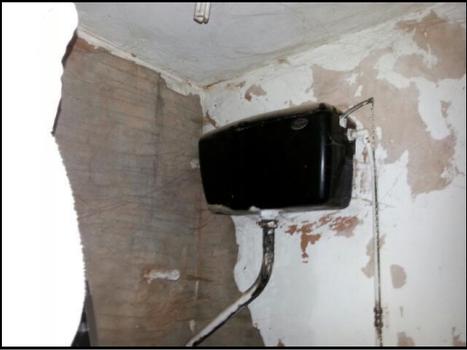
Building:	112 Hand made	Floor:	Ground Floor				
Location:	003 - WC	Sample Number:	P-245860/021				
Sample Details

Item Description:	Toilet cistern					
	Material description:	Reinforced plastic					
	Quantity / Extent:	1 Number					
	Accessibility	Easy Access					
	Analysis:	Amosite					
	Conf. of Product Type:	Asbestos reinforced plastic					
Material Assessment Scoring:							
Product Type:	1	Condition:	0	Surface Treatment:	0	Asbestos Type:	2
Priority Assessment Scoring:							
Occupant Activity:	0	Disturbance:	0	Human Exposure:	0	Maintenance activity:	0
Total Scores:							
Material score:	3	Priority score	-	Total score:	3	Risk Cat.:	Very Low
Recommended action:	Monitor condition.						
Recommendation comments:	-						
Surveyors Comments:	-

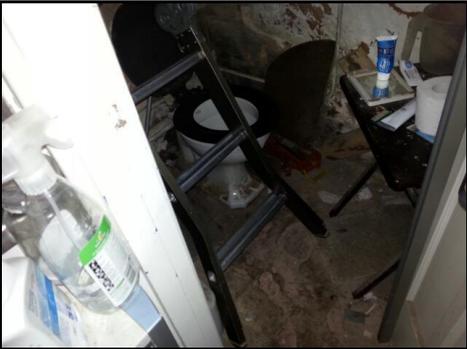
Building:	112 Hand made	Floor:	Ground Floor				
Location:	003 - WC	Sample Number:	P-245860/As 018				
Sample Details

Item Description:	Adhesive to floor					
	Material description:	Bituminous products					
	Quantity / Extent:	N/A					
	Accessibility	Easy Access					
	Analysis:	Strongly Presumed No asbestos detected					
	Conf. of Product Type:	Strongly Presumed Non-asbestos material					
Material Assessment Scoring:							
Product Type:	-	Condition:	-	Surface Treatment:	-	Asbestos Type:	-
Priority Assessment Scoring:							
Occupant Activity:	-	Disturbance:	-	Human Exposure:	-	Maintenance activity:	-
Total Scores:							
Material score:	-	Priority score	-	Total score:	-	Risk Cat.:	N/A
Recommended action:	-						
Recommendation comments:	-						
Surveyors Comments:	-

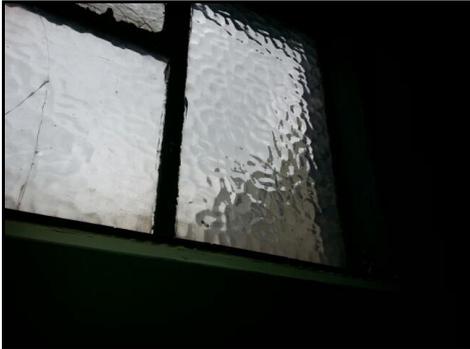
Building:	116 One one six	Floor:	Ground Floor				
Location:	005 - Stairs	Sample Number:	P-245860/As 002				
Sample Details

Item Description:	Mastic to window					
	Material description:	Mastics					
	Quantity / Extent:	N/A					
	Accessibility	Easy Access					
	Analysis:	Strongly Presumed No asbestos detected					
	Conf. of Product Type:	Strongly Presumed Non-asbestos material					
Material Assessment Scoring:							
Product Type:	-	Condition:	-	Surface Treatment:	-	Asbestos Type:	-
Priority Assessment Scoring:							
Occupant Activity:	-	Disturbance:	-	Human Exposure:	-	Maintenance activity:	-
Total Scores:							
Material score:	-	Priority score	-	Total score:	-	Risk Cat.:	N/A
Recommended action:	-						
Recommendation comments:	-						
Surveyors Comments:	-

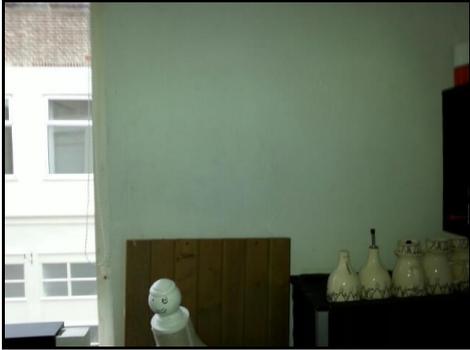
Building:	116 One one six	Floor:	First Floor				
Location:	003 - Kitchen	Sample Number:	P-245860/003				
Sample Details

Item Description:	Textured coating to walls					
	Material description:	Textured coatings					
	Quantity / Extent:	N/A					
	Accessibility	Easy Access					
	Analysis:	No asbestos detected					
	Conf. of Product Type:	Non-asbestos material					
Material Assessment Scoring:							
Product Type:	-	Condition:	-	Surface Treatment:	-	Asbestos Type:	-
Priority Assessment Scoring:							
Occupant Activity:	-	Disturbance:	-	Human Exposure:	-	Maintenance activity:	-
Total Scores:							
Material score:	-	Priority score	-	Total score:	-	Risk Cat.:	N/A
Recommended action:	-						
Recommendation comments:	-						
Surveyors Comments:	-

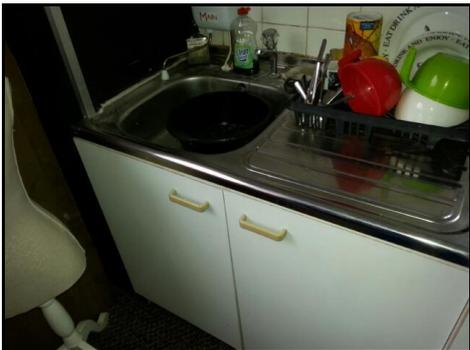
Building:	116 One one six	Floor:	First Floor				
Location:	003 - Kitchen	Sample Number:	P-245860/004				
Sample Details

Item Description:	Sink pad					
	Material description:	Bituminous products					
	Quantity / Extent:	N/A					
	Accessibility	Medium Access					
	Analysis:	No asbestos detected					
	Conf. of Product Type:	Non-asbestos material					
Material Assessment Scoring:							
Product Type:	-	Condition:	-	Surface Treatment:	-	Asbestos Type:	-
Priority Assessment Scoring:							
Occupant Activity:	-	Disturbance:	-	Human Exposure:	-	Maintenance activity:	-
Total Scores:							
Material score:	-	Priority score	-	Total score:	-	Risk Cat.:	N/A
Recommended action:	-						
Recommendation comments:	-						
Surveyors Comments:	-

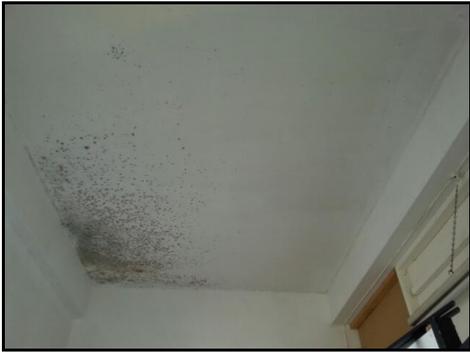
Building:	116 One one six	Floor:	First Floor				
Location:	003 - Kitchen	Sample Number:	P-245860/058				
Sample Details

Item Description:	Textured coating to ceiling					
	Material description:	Textured coatings					
	Quantity / Extent:	N/A					
	Accessibility	Medium Access					
	Analysis:	No asbestos detected					
	Conf. of Product Type:	Non-asbestos material					
Material Assessment Scoring:							
Product Type:	-	Condition:	-	Surface Treatment:	-	Asbestos Type:	-
Priority Assessment Scoring:							
Occupant Activity:	-	Disturbance:	-	Human Exposure:	-	Maintenance activity:	-
Total Scores:							
Material score:	-	Priority score	-	Total score:	-	Risk Cat.:	N/A
Recommended action:	-						
Recommendation comments:	-						
Surveyors Comments:	-

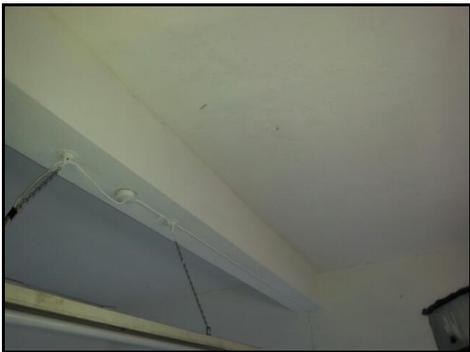
Building:	116 One one six	Floor:	First Floor				
Location:	004 - Studio	Sample Number:	P-245860/059				
Sample Details

Item Description:	Textured coating to ceiling					
	Material description:	Textured coatings					
	Quantity / Extent:	N/A					
	Accessibility	Medium Access					
	Analysis:	No asbestos detected					
	Conf. of Product Type:	Non-asbestos material					
Material Assessment Scoring:							
Product Type:	-	Condition:	-	Surface Treatment:	-	Asbestos Type:	-
Priority Assessment Scoring:							
Occupant Activity:	-	Disturbance:	-	Human Exposure:	-	Maintenance activity:	-
Total Scores:							
Material score:	-	Priority score	-	Total score:	-	Risk Cat.:	N/A
Recommended action:	-						
Recommendation comments:	-						
Surveyors Comments:	-

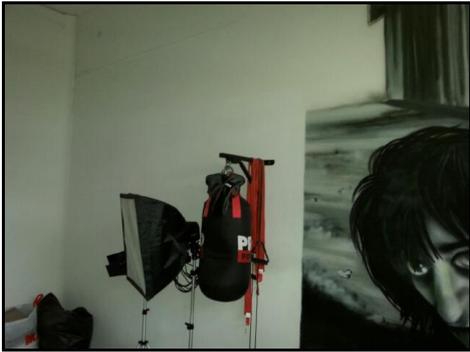
Building:	116 One one six	Floor:	First Floor				
Location:	004 - Studio	Sample Number:	P-245860/As 003				
Sample Details

Item Description:	Textured coating to walls					
	Material description:	Textured coatings					
	Quantity / Extent:	N/A					
	Accessibility	Easy Access					
	Analysis:	Strongly Presumed No asbestos detected					
	Conf. of Product Type:	Strongly Presumed Non-asbestos material					
Material Assessment Scoring:							
Product Type:	-	Condition:	-	Surface Treatment:	-	Asbestos Type:	-
Priority Assessment Scoring:							
Occupant Activity:	-	Disturbance:	-	Human Exposure:	-	Maintenance activity:	-
Total Scores:							
Material score:	-	Priority score	-	Total score:	-	Risk Cat.:	N/A
Recommended action:	-						
Recommendation comments:	-						
Surveyors Comments:	Sandtex to walls

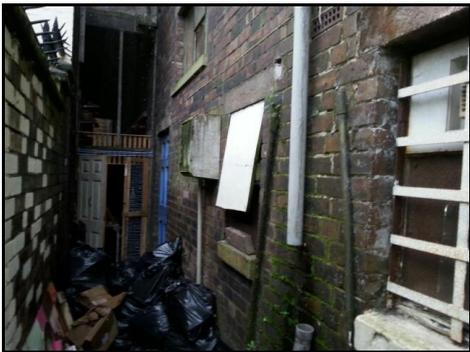
Building:	116 One one six	Floor:	External				
Location:	006 - External	Sample Number:	P-245860/005				
Sample Details

Item Description:	Bitumen wrap to pipe					
	Material description:	Bituminous products					
	Quantity / Extent:	N/A					
	Accessibility	Easy Access					
	Analysis:	No asbestos detected					
	Conf. of Product Type:	Non-asbestos material					
Material Assessment Scoring:							
Product Type:	-	Condition:	-	Surface Treatment:	-	Asbestos Type:	-
Priority Assessment Scoring:							
Occupant Activity:	-	Disturbance:	-	Human Exposure:	-	Maintenance activity:	-
Total Scores:							
Material score:	-	Priority score	-	Total score:	-	Risk Cat.:	N/A
Recommended action:	-						
Recommendation comments:	-						
Surveyors Comments:	-

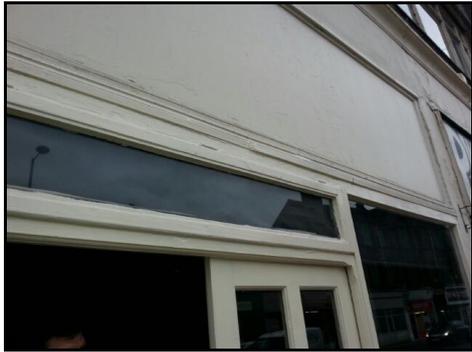
Building:	116 One one six	Floor:	External				
Location:	006 - External	Sample Number:	P-245860/006				
Sample Details

Item Description:	Mastic to window above door					
	Material description:	Mastics					
	Quantity / Extent:	N/A					
	Accessibility	Difficult Access					
	Analysis:	No asbestos detected					
	Conf. of Product Type:	Non-asbestos material					
Material Assessment Scoring:							
Product Type:	-	Condition:	-	Surface Treatment:	-	Asbestos Type:	-
Priority Assessment Scoring:							
Occupant Activity:	-	Disturbance:	-	Human Exposure:	-	Maintenance activity:	-
Total Scores:							
Material score:	-	Priority score	-	Total score:	-	Risk Cat.:	N/A
Recommended action:	-						
Recommendation comments:	-						
Surveyors Comments:	-

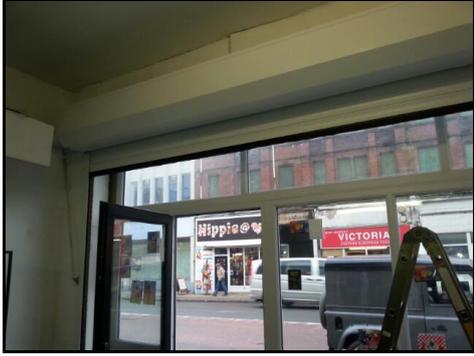
Building Name:	104 Vapour Shop	Floor Level:	Ground Floor
Location Number / ID:	001	Location Description:	Shop
Room Data / Observations:

General Comments:	
		<p>Area had solid plastered walls, fibreboard panels, UPVC windows with a timber panel above that was inspected behind at one point to find an empty void, timber panels that were inspected behind to find non suspect debris and timber panels to exterior, plasterboard bulkheads and a lathe and plaster ceiling</p>

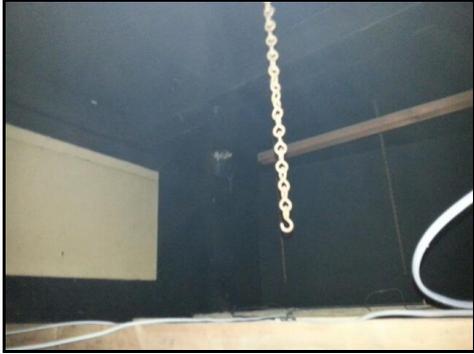
Building Name:	104 Vapour Shop	Floor Level:	Ground Floor
Location Number / ID:	002	Location Description:	Ceiling void
Room Data / Observations:

General Comments:	
		<p>Area has a plasterboard ceiling, solid plastered walls, fibreboard and plasterboard panels and plaster debris.</p> <p style="color: red;">Inspections were made from the hatch area only due to it being too small to access.</p>

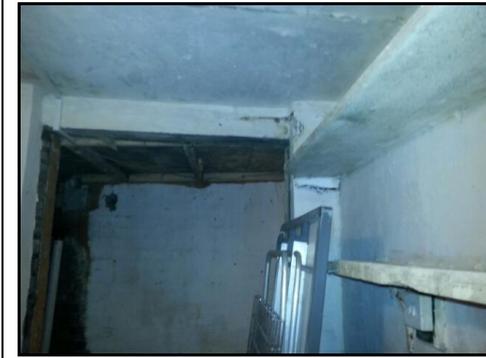
Building Name:	104 Vapour Shop	Floor Level:	Ground Floor
Location Number / ID:	003	Location Description:	Store

Area has a concrete floor, solid plastered walls, metal waste and downpipes, lathe and plaster and timber ceilings.

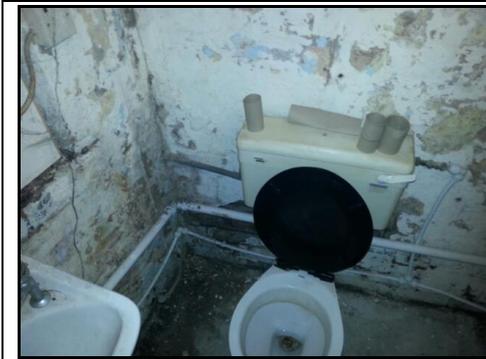
Building Name:	104 Vapour Shop	Floor Level:	Ground Floor
Location Number / ID:	004	Location Description:	WC

Area has a concrete floor, solid plastered walls, plastic cistern, timber panel to the window and a plasterboard ceiling

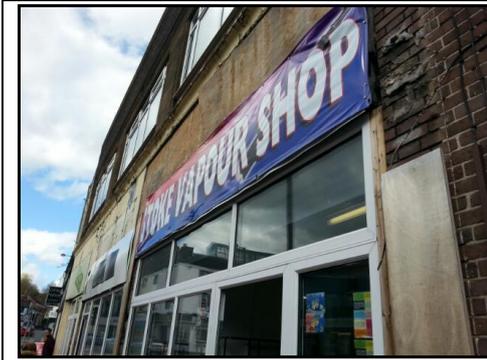
Building Name:	104 Vapour Shop	Floor Level:	External
Location Number / ID:	011	Location Description:	External

Frontage has UPVC windows, plastic fascia that was inspected behind to find timber studs and beams and timber panels with a solid plaster reveal around.

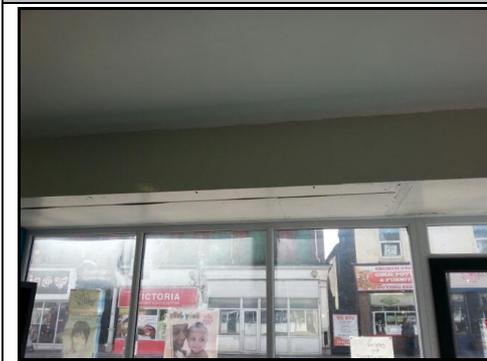
Building Name:	106 Beauty Spot	Floor Level:	Ground Floor
Location Number / ID:	001	Location Description:	Salon

Area has a modern vinyl floor covering, solid plastered and plasterboard lined walls, UPVC windows, internal timber fascia, solid plastered ceiling, timber bulkhead that was inspected within at one point to find a steel beam another timber soffit that was inspected above to find another timber panel.

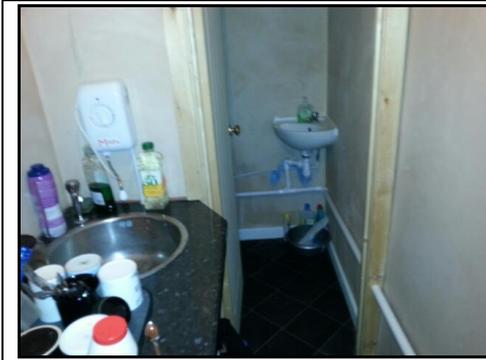
Building Name:	106 Beauty Spot	Floor Level:	Ground Floor
Location Number / ID:	002	Location Description:	WC

Area has a modern vinyl with quarry tiled floor beneath, plasterboard lined walls and a plasterboard ceiling.

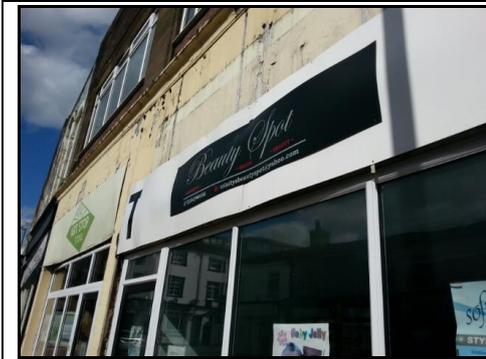
Building Name:	106 Beauty Spot	Floor Level:	External
Location Number / ID:	004	Location Description:	External

Frontage has UPVC windows and infill panels, timber fascia panels that were inspected behind to find a timber bulkhead to the interior.

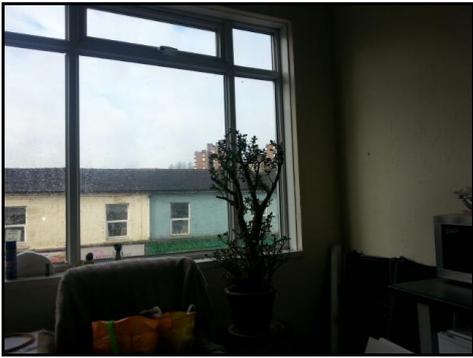
Building Name:	108 Art City	Floor Level:	First Floor
Location Number / ID:	001	Location Description:	Kitchen
Room Data / Observations:

General Comments:	
		<p>Area has a concrete floor with a modern screed, solid plastered walls, UPVC sills and reveals to window that were inspected behind to find timber internal soffits to brick and a ceramic tiled sill to brickwork, timber panels to lift that is lined with Asbestos Insulating Board to the opposite side and a solid plastered ceiling and beam</p>

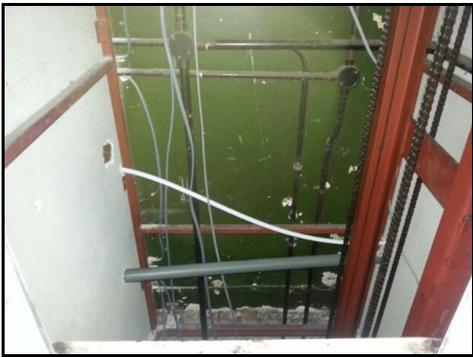
Building Name:	108 Art City	Floor Level:	First Floor
Location Number / ID:	002	Location Description:	Lift
Room Data / Observations:

Item Description:	Panels lining the lift					
	Material description:	Insulating board					
	Quantity / Extent:	9 m ²					
	Accessibility	Easy Access					
	Analysis:	Amosite Chrysotile					
	Conf. of Product Type:	Asbestos insulating board					
Material Assessment Scoring:							
Product Type:	2	Condition:	2	Surface Treatment:	2	Asbestos Type:	2
Priority Assessment Scoring:							
Occupant Activity:	0	Disturbance:	0	Human Exposure:	0	Maintenance activity:	0
Total Scores:							
Material score:	8	Priority score	-	Total score:	8	Risk Cat.:	Medium
Recommended action:	Remedial – Encapsulate and then monitor condition.						
Recommendation comments:	-						
Surveyors Comments:	Panels lining the lift are unsealed and damaged in one area, it is recommended that the panels are encapsulated or access restricted to persons

General Comments:	
		<p>Area is constructed from AIB panels and a solid plastered wall</p>

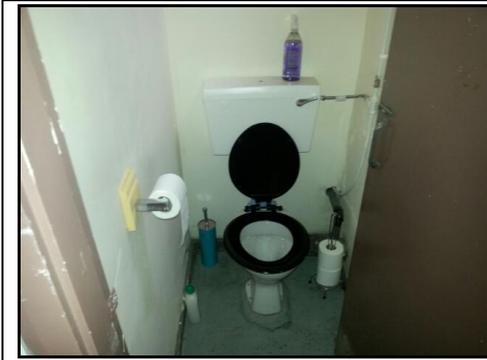
Building Name:	108 Art City	Floor Level:	First Floor
Location Number / ID:	003	Location Description:	WC

Area has a concrete floor, solid plastered walls, plastic cistern, lead waste pipe and a solid plastered ceiling

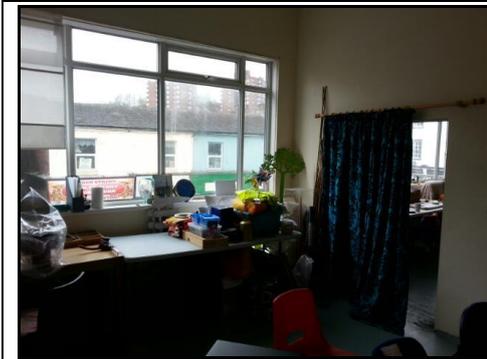
Building Name:	108 Art City	Floor Level:	First Floor
Location Number / ID:	004	Location Description:	Studio

Area has a concrete and timber floor, solid plastered walls, UPVC reveals to window that were inspected behind to find timber soffits with a corroded steel beam above, ceramic tiled sill with brickwork above, solid plastered ceiling and beam

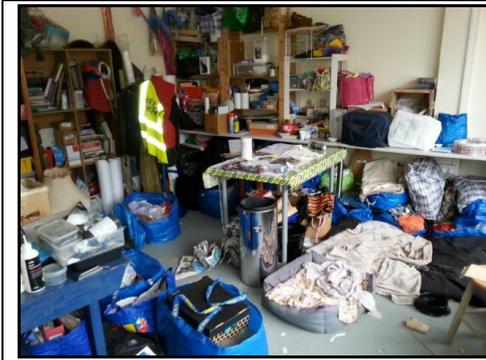
Building Name:	108 Art City	Floor Level:	First Floor
Location Number / ID:	005	Location Description:	Studio

Area has a concrete and timber floor, solid plastered walls, UPVC reveals to window that were inspected behind to find timber soffits with a corroded steel beam above, ceramic tiled sill with brickwork above, solid plastered ceiling and beam

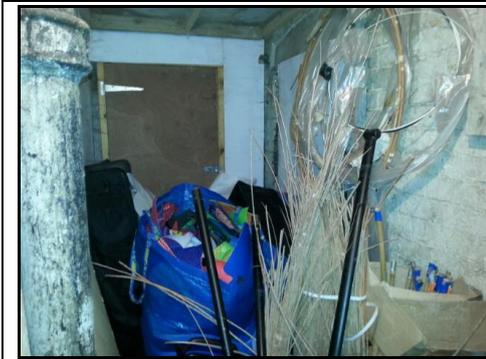
Building Name:	108 Art City	Floor Level:	Ground Floor
Location Number / ID:	006	Location Description:	Store

Area has a quarry tiled floor, brickwork walls, metal waste pipe, timber panels in appearance and a timber panelled ceiling

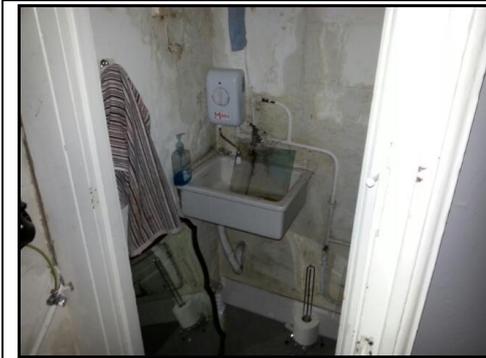
Building Name:	108 Art City	Floor Level:	Ground Floor
Location Number / ID:	008	Location Description:	WC

Area has a concrete floor, solid plastered walls, timber panels, ceramic cistern, lathe and plaster ceiling and underdrawing to stairs.

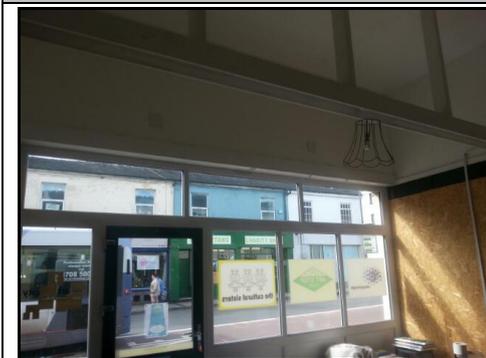
Building Name:	108 Art City	Floor Level:	Ground Floor
Location Number / ID:	010	Location Description:	Shop

Area has a modern vinyl floor, solid plastered walls with timber linings, timber panels surrounding the lift, timber partition wall, timber panels to the stairs, solid plastered ceiling, timber internal soffits, timber fascia above the window that was inspected behind to find timber cladding and a timber board above the door.

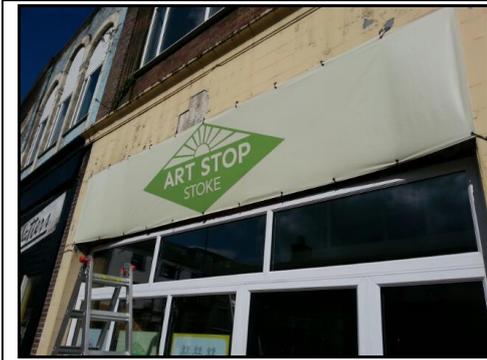
Building Name:	108 Art City	Floor Level:	External
Location Number / ID:	011	Location Description:	External

Area has UPVC windows and infill panels, steel fascia that could not be accessed behind and ceramic tiles to a solid plaster reveal

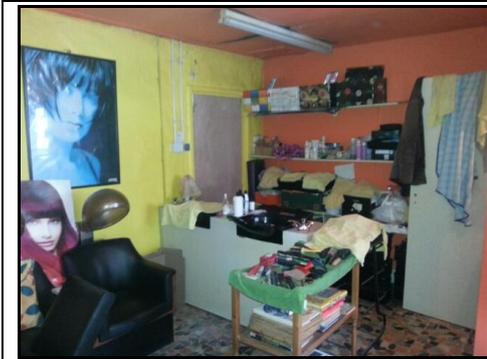
Building Name:	110/112 Cutting Matters	Floor Level:	Ground Floor
Location Number / ID:	001	Location Description:	Salon

Area has a quartz tile floor timber panelled walls, plasterboard lined walls to bulkhead, solid plastered walls, timber frame windows with timber panels that were inspected behind to find brickwork and electric cables, timber internal soffit and plaster bulkhead to a timber beam and a solid plastered ceiling.

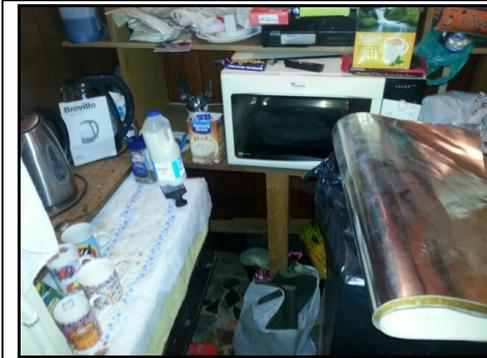
Building Name:	110/112 Cutting Matters	Floor Level:	Ground Floor
Location Number / ID:	003	Location Description:	Store

Area has a quartz tile floor, timber panelled walls and a timber panelled ceiling.

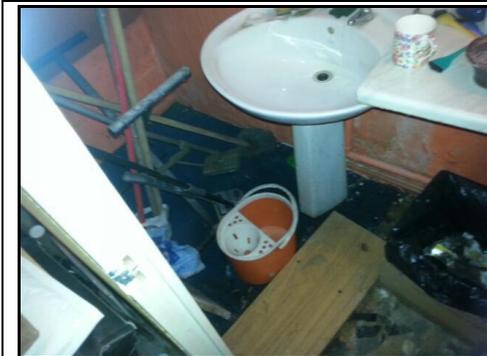
Building Name:	110/112 Cutting Matters	Floor Level:	Ground Floor
Location Number / ID:	004	Location Description:	Understairs

Area has a quartz tile floor, timber lined and solid plastered walls

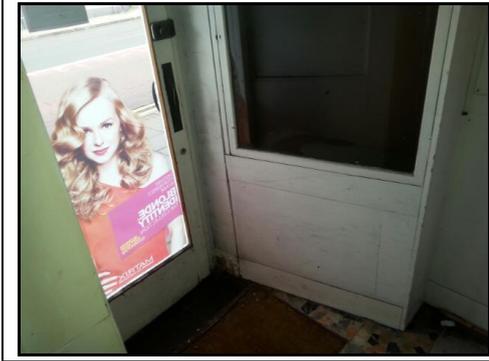
Building Name:	110/112 Cutting Matters	Floor Level:	Ground Floor
Location Number / ID:	005	Location Description:	Entrance

Area has a quartz tile floor, timber and glass panels, glass panels and a timber frame around the door, timber panels to display unit, fibroboard panels to wall and a solid plaster ceiling.

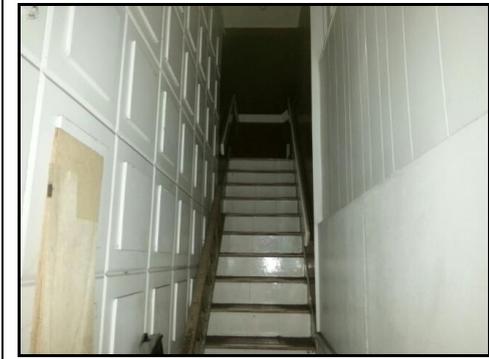
Building Name:	110/112 Cutting Matters	Floor Level:	Ground Floor
Location Number / ID:	006	Location Description:	Stairs

Area has a concrete floor, timber panels and fibroboard panels to walls and a lathe and plaster and solid plastered ceiling.

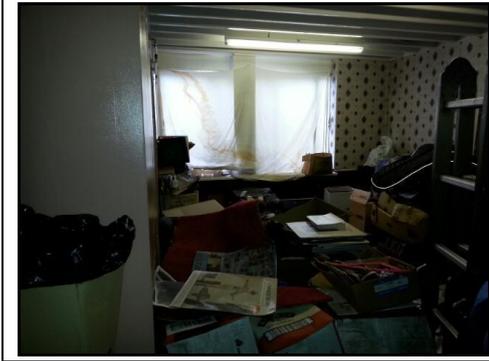
Building Name:	110/112 Cutting Matters	Floor Level:	First Floor
Location Number / ID:	007	Location Description:	Store

Area has solid plastered and timber lined walls, timber boxings that were not inspected within, timber panels around the window with solid plaster behind, timber sill with brickwork beneath and a timber header panel.

Inspections were highly limited due to the amount of boxes and store items highly restricting access. TR was limited to windows due to asbestos sprayed coating debris in poor condition

035	110/112 Cutting Matters	1st Floor	007 - Store	Sprayed coating debris on top of ceiling tiles	Sprayed coating	10 m ²	10	-	10	High	Remove.
036	110/112 Cutting Matters	1st Floor	007 - Store	Floor tiles	Thermoplastic product	45 m ²	2	-	2	Very Low	Monitor condition.
037	110/112 Cutting Matters	1st Floor	007 - Store	Paper backed linoleum beneath carpet	Paper backed linoleum	N/A	0	-	0	N/A	-

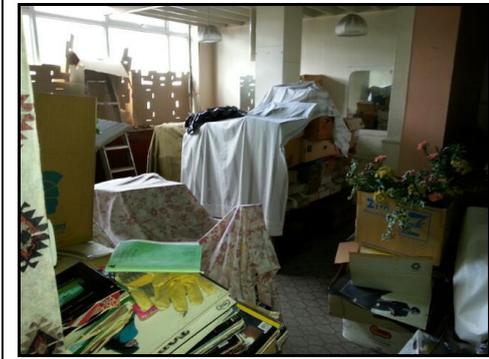
Building Name:	110/112 Cutting Matters	Floor Level:	First Floor
Location Number / ID:	008	Location Description:	Store

Area has a quartz tile floor to the rear, solid plastered walls, timber panels forming walls, timber sill to window with brickwork beneath, timber header panel, metal water tanks, polystyrene ceiling tiles with visually non suspect debris, copper cylinder with MMMF insulation and a metal roof to the rear.

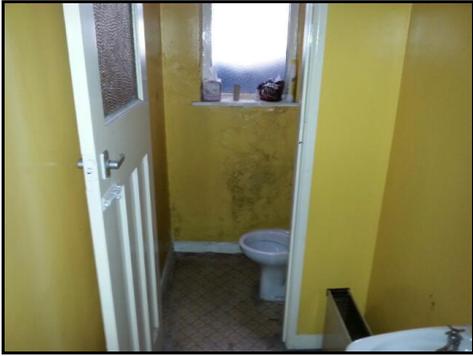
Building Name:	110/112 Cutting Matters	Floor Level:	First Floor
Location Number / ID:	009	Location Description:	WC
Room Data / Observations:

General Comments:		
	Area has solid plastered walls, metal cistern and a metal tank and a solid plastered ceiling

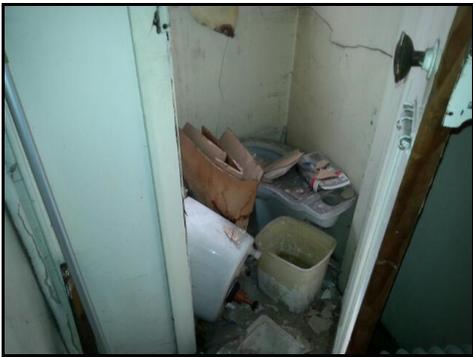
Building Name:	110/112 Cutting Matters	Floor Level:	First Floor
Location Number / ID:	010	Location Description:	WC
Room Data / Observations:

General Comments:		
	Area has solid plastered walls, metal cistern and a metal tank and a solid plastered ceiling

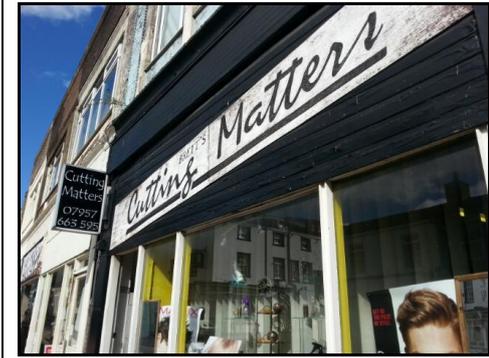
Building Name:	110/112 Cutting Matters	Floor Level:	External
Location Number / ID:	011	Location Description:	External

Area has a solid plaster surround, timber panels at the base that were inspected behind to find various layers of timber and mosaic tiles, upper timber panels with glass behind and concrete.

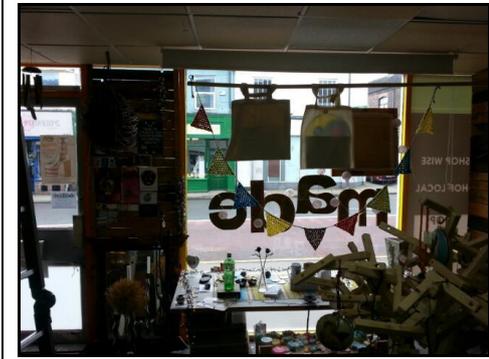
Building Name:	112 Hand made	Floor Level:	Ground Floor
Location Number / ID:	001	Location Description:	Shop

Area has a concrete floor, MDF and timber lined walls that were inspected behind from above to find solid plastered walls, metal window frames, modern ceiling tiles that were inspected above to find a single timber fascia above the window, plaster bulkhead that was inspected within to find a steel beam and timber panels with plaster and a plaster ceiling.

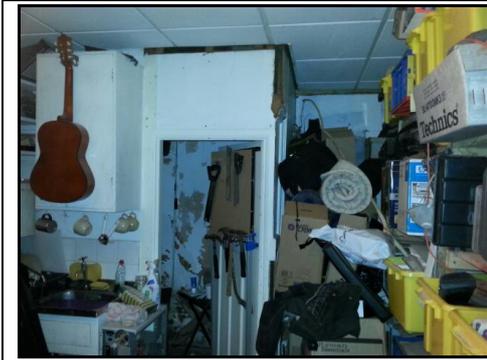
Building Name:	112 Hand made	Floor Level:	Ground Floor
Location Number / ID:	002	Location Description:	Workshop

Area has timber lined walls, solid plastered walls, modern ceiling tiles that were inspected above to find a lathe and plaster ceiling and solid plastered walls

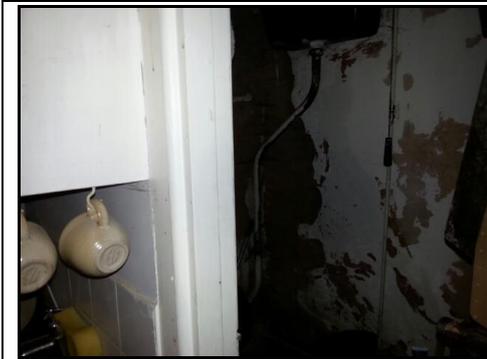
Building Name:	112 Hand made	Floor Level:	First Floor
Location Number / ID:	003	Location Description:	WC

Area has solid plastered walls, timber panels and a fibreboard panelled ceiling.

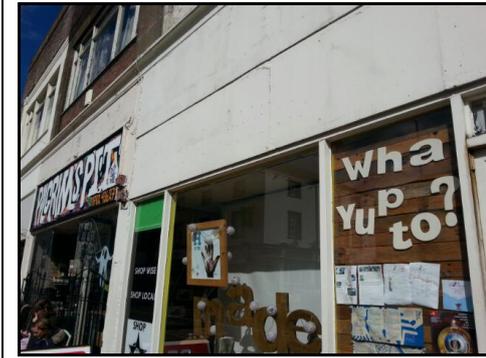
Building Name:	112 Hand made	Floor Level:	External
Location Number / ID:	004	Location Description:	External

Frontage has a plaster reveal, timber frame windows, timber fascia panels that were inspected above to find the interior of the shop and solid plaster.

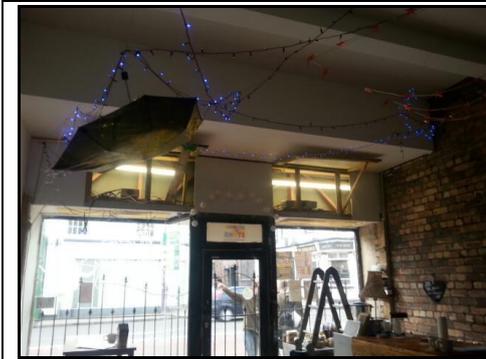
Building Name:	114 Pilgrim Pitt	Floor Level:	Ground Floor
Location Number / ID:	001	Location Description:	Shop

Area has solid plastered and brickwork walls, plasterboard lined walls, steel column, solid plastered ceiling and beams, plasterboard bulk head above the windows that was inspected above to find timber fascia panels, lathe and plaster bulkhead inspected within to find a steel beam and timber panels

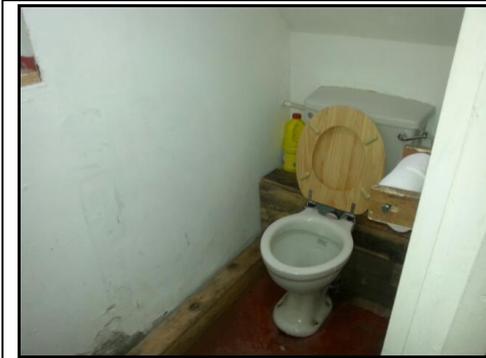
Building Name:	114 Pilgrim Pitt	Floor Level:	Ground Floor
Location Number / ID:	002	Location Description:	WC

Area has solid plastered and plasterboard lined walls, timber panel, plasterboard ceiling, lathe and plaster underdrawing and a timber boxing that was not inspected within to prevent damage

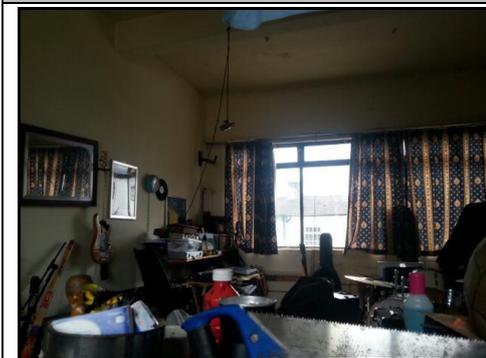
Building Name:	114 Pilgrim Pitt	Floor Level:	First Floor
Location Number / ID:	003	Location Description:	Store

Area has solid plastered walls and timber frame windows

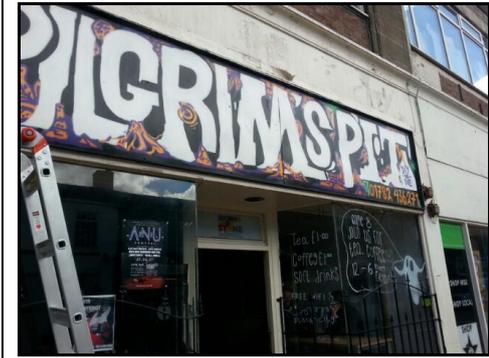
Building Name:	114 Pilgrim Pitt	Floor Level:	External
Location Number / ID:	004	Location Description:	External

Frontage has a solid plaster surround, timber frames, timber canopy, timber sign that was inspected behind to find glass.

Inspections were limited to prevent damage to sign

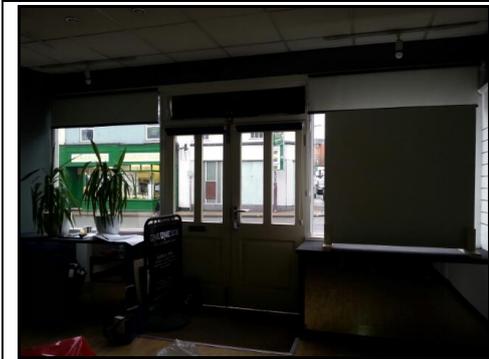
Building Name:	116 One one six	Floor Level:	Ground Floor
Location Number / ID:	001	Location Description:	Shop floor

Area has a laminate floor that was not inspected beneath to prevent damage, solid plastered walls, timber boxing to external walls that were inspected behind further to find timber and solid plastered walls, timber sills with plaster beneath, timber framed windows with a modern mastic and an MDF panel above, timber panels to stairs and modern ceiling tiles that were inspected above to find solid plastered ceiling, lathe and plaster bulkhead that was inspected within to find a concrete slab ceiling, timber panel and packers and a steel beam, timber internal soffit, timber infill panel and a single timber fascia.

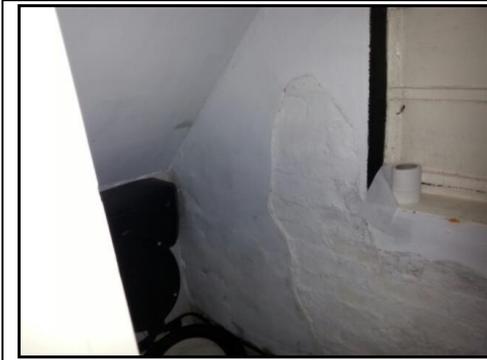
Building Name:	116 One one six	Floor Level:	Ground Floor
Location Number / ID:	002	Location Description:	WC

Area has a concrete floor with paint, solid plastered walls, plaster underdrawing to stairs, timber infill panel and a plaster ceiling.

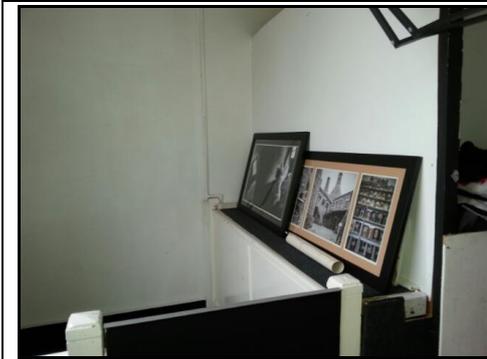
Building Name:	116 One one six	Floor Level:	First Floor
Location Number / ID:	003	Location Description:	Kitchen

Area has a concrete floor beneath carpet, solid plastered walls, timber boxing that was not inspected within to prevent damage and a solid plaster ceiling.

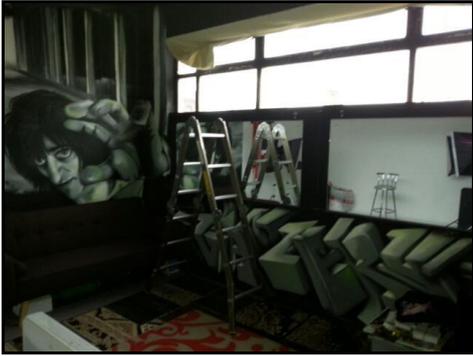
Building Name:	116 One one six	Floor Level:	First Floor
Location Number / ID:	004	Location Description:	Studio
Room Data / Observations:

<p>General Comments:</p> <p>Area has a concrete floor beneath carpet, solid plastered walls, ceramic tiled sill that was not inspected beneath, timber panel to top of windows, timber framed windows and a solid plastered ceiling and beam</p> <p style="color: red;">Inspections to window was limited due to mirrors being fixed to the frames</p>

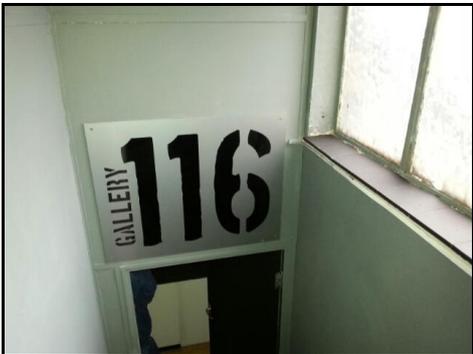
Building Name:	116 One one six	Floor Level:	Ground Floor
Location Number / ID:	005	Location Description:	Stairs
Room Data / Observations:

<p>General Comments:</p> <p>Area has solid plastered walls, timber stairs with timber panels, ceramic tiled sill and plasterboard panels to walls</p>

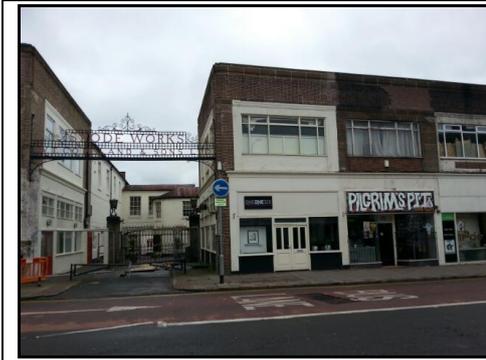
Building Name:	116 One one six	Floor Level:	External
Location Number / ID:	006	Location Description:	External

Building is constructed from brickwork with concrete reveals around windows, timber fascias and infill panels and timber sills.
