ASBESTOS MANAGEMENT PLAN

TOWN GARDENS, QUARRY ROAD, SWINDON, SN1 4EN

Asbestos Management Survey Report

Town Gardens, Quarry Road, Swindon, SN1 4EN

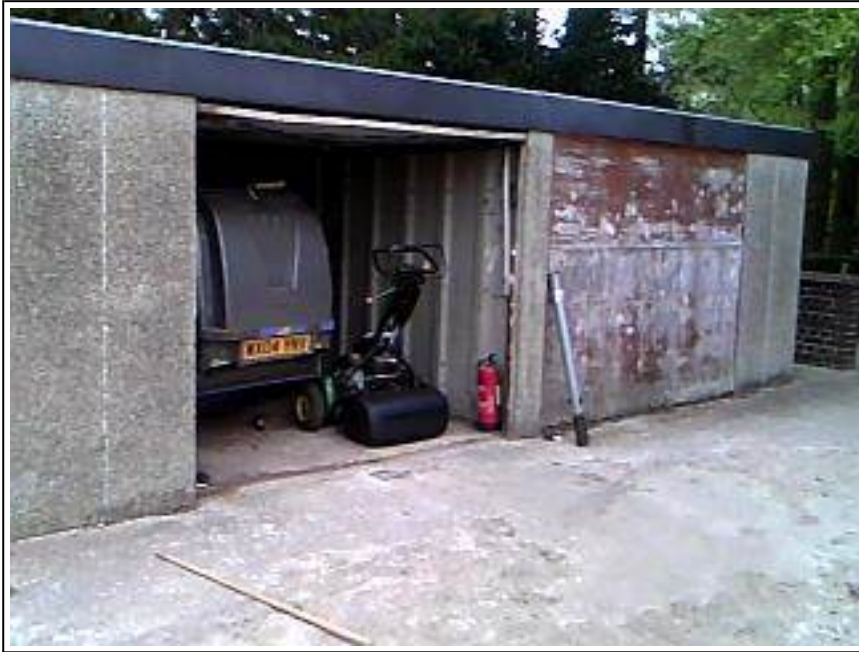
Survey Data Sheet: Conclusions & Recommendations
 Site Location: Town Gardens, Quarry Road, Swindon, SN1 4EN
 Building Designation: Main Building
 Unique item Number: 6

Sample Ref	Fl	Location	Description	Qty	Analysis Result	Total M.A.S	Licensed Material Y/N
Surveyed	Ground Floor	Garage (mess area). 005	No asbestos detected -		N/A		N

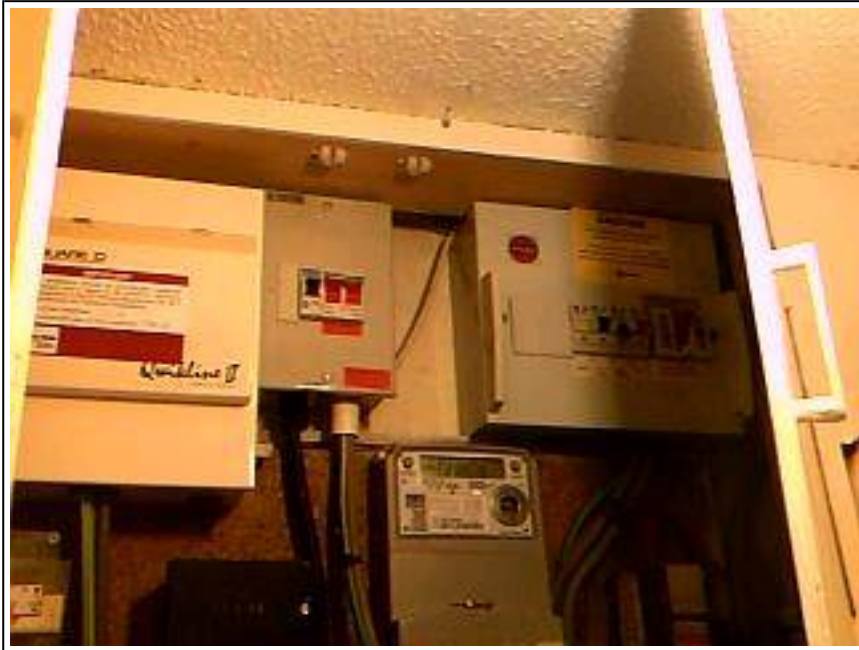
Survey Data Sheet: Conclusions & Recommendations
 Site Location: Town Gardens, Quarry Road, Swindon, SN1 4EN
 Building Designation: Main Building
 Unique item Number: 11

Sample Ref	FI	Location	Description	Qty	Analysis Result	Total M.A.S	Licensed Material Y/N
Surveyed	Ground Floor	Store (bowls pavillion). 007	Wall - Wylex and square d switchgear, no asbestos detected -		N/A		N

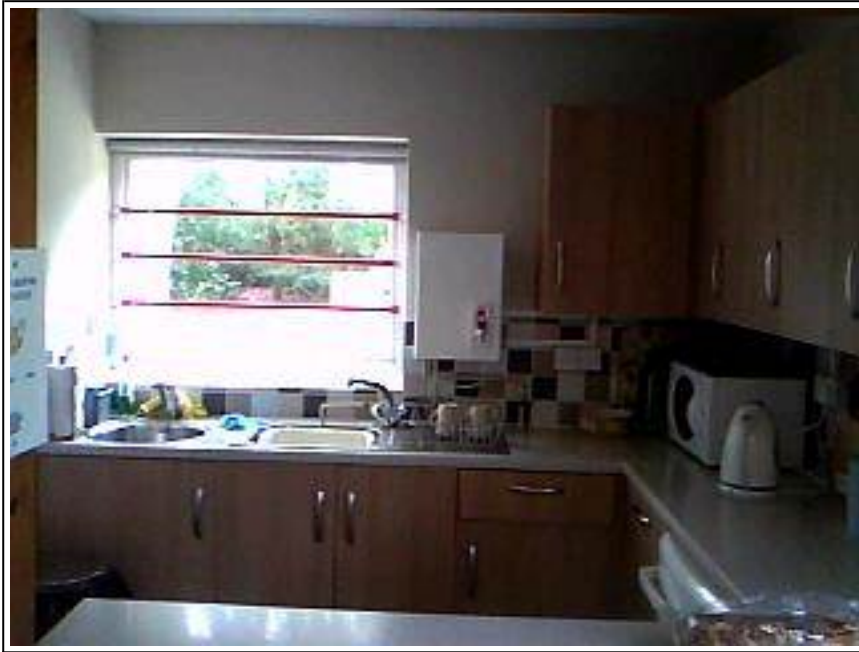
Survey Data Sheet: Conclusions & Recommendations
 Site Location: Town Gardens, Quarry Road, Swindon, SN1 4EN
 Building Designation: Main Building
 Unique item Number: 17

Sample Ref	Fl	Location	Description	Qty	Analysis Result	Total M.A.S	Licensed Material Y/N
Surveyed	Ground Floor	Kitchen (bowls pavillion). 013	No asbestos detected -		N/A		N

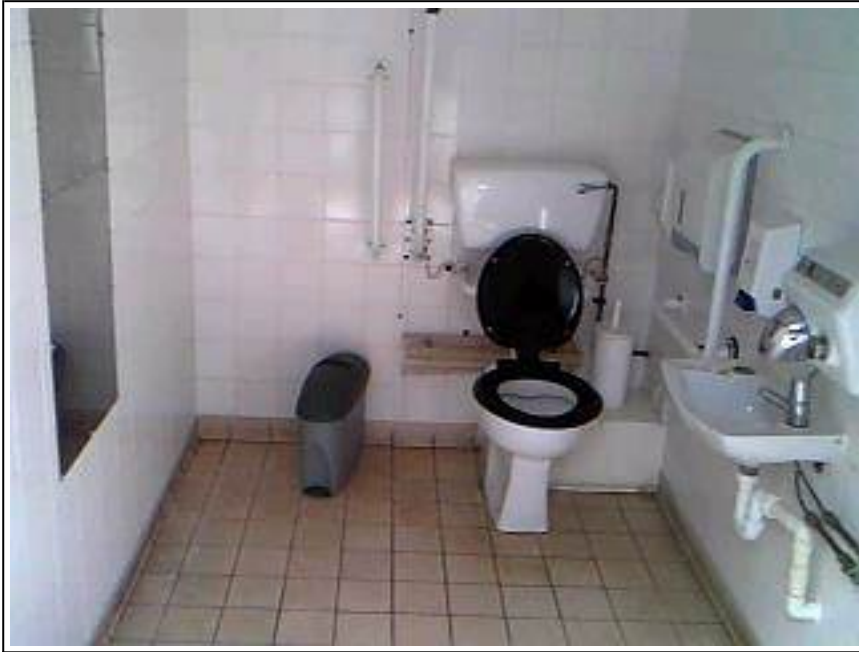
Survey Data Sheet: Conclusions & Recommendations
 Site Location: Town Gardens, Quarry Road, Swindon, SN1 4EN
 Building Designation: Main Building
 Unique item Number: 18

Sample Ref	Fl	Location	Description	Qty	Analysis Result	Total M.A.S	Licensed Material Y/N
Surveyed	Ground Floor	Disabled WC One (disabled WC block). 014	No asbestos detected -	-	N/A		N

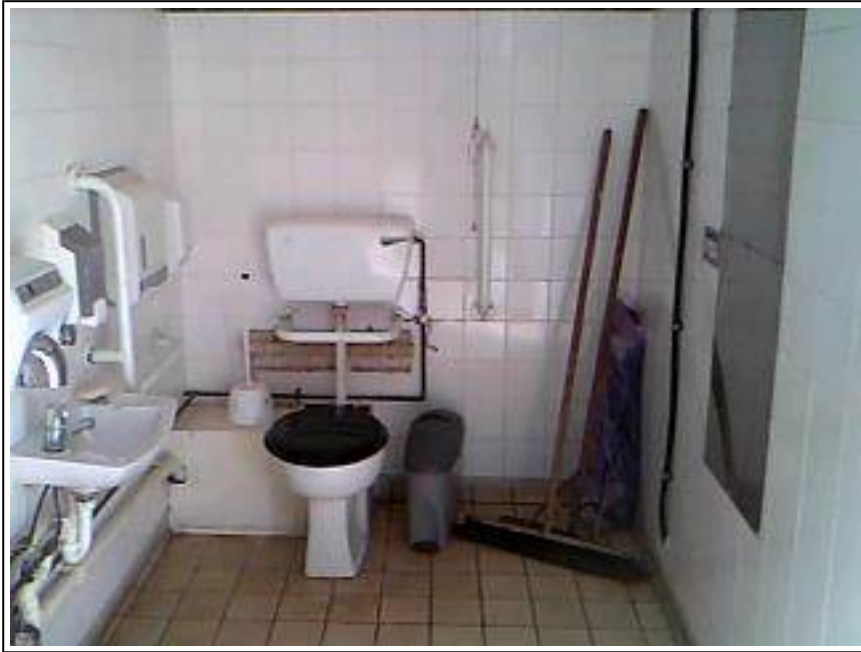
Survey Data Sheet: Conclusions & Recommendations
 Site Location: Town Gardens, Quarry Road, Swindon, SN1 4EN
 Building Designation: Main Building
 Unique item Number: 19

Sample Ref	Fl	Location	Description	Qty	Analysis Result	Total M.A.S	Licensed Material Y/N
Surveyed	Ground Floor	Disabled WC Two (disabled WC block). 015	No asbestos detected -		N/A		N

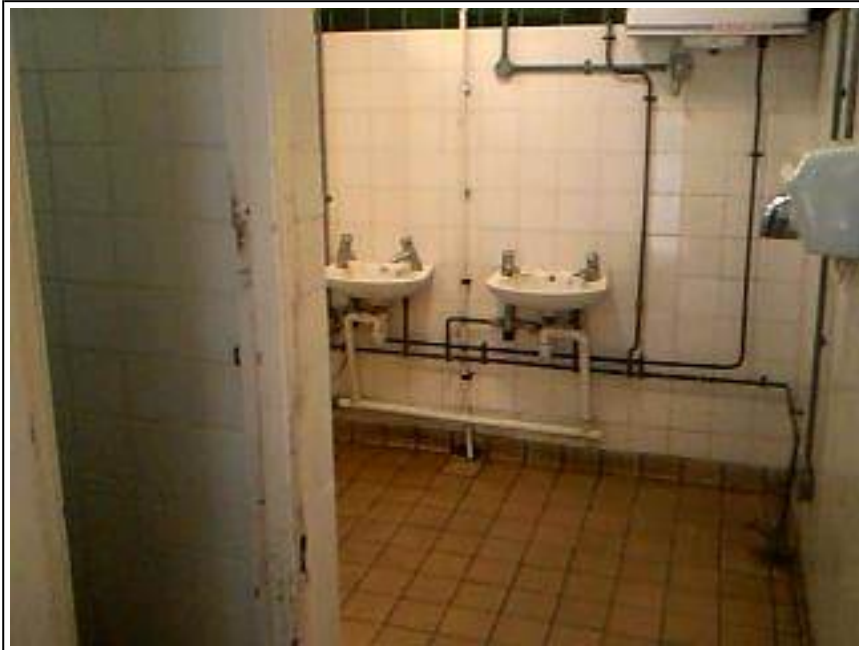
Survey Data Sheet: Conclusions & Recommendations
 Site Location: Town Gardens, Quarry Road, Swindon, SN1 4EN
 Building Designation: Main Building
 Unique item Number: 20

Sample Ref	Fl	Location	Description	Qty	Analysis Result	Total M.A.S	Licensed Material Y/N
Surveyed	Ground Floor	Female WC (female WC block). 016	No asbestos detected -		N/A		N

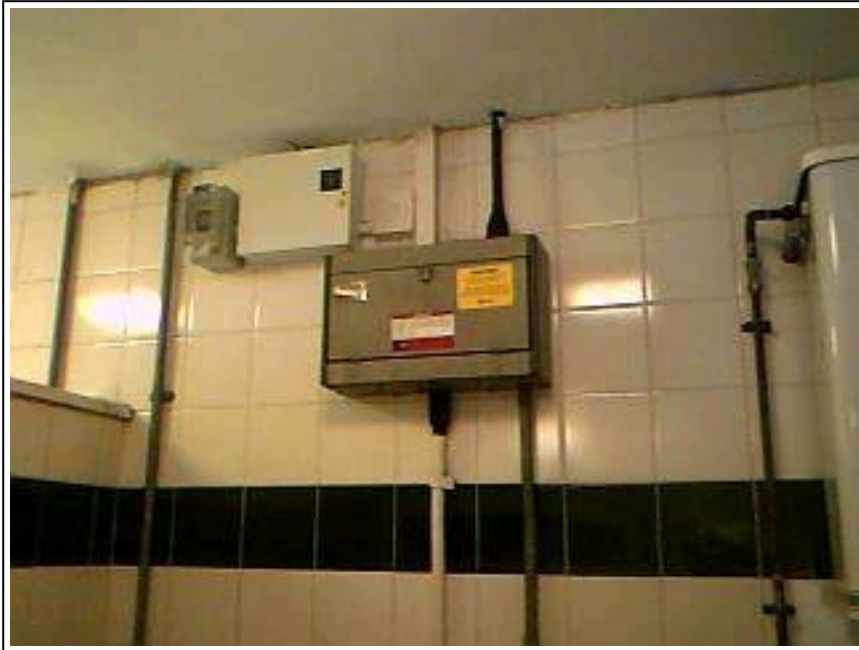
Survey Data Sheet: Conclusions & Recommendations
 Site Location: Town Gardens, Quarry Road, Swindon, SN1 4EN
 Building Designation: Main Building
 Unique item Number: 21

Sample Ref	FI	Location	Description	Qty	Analysis Result	Total M.A.S	Licensed Material Y/N
Surveyed	Ground Floor	Female WC (female WC block). 016	Wall - MEM consumer unit and cable route, no asbestos detected -		N/A		N

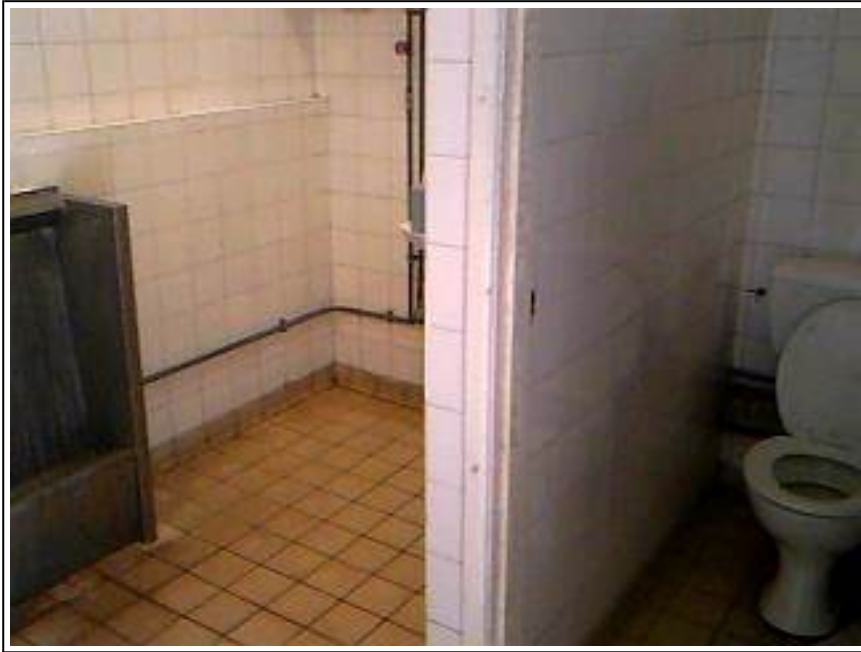
Survey Data Sheet: Conclusions & Recommendations
 Site Location: Town Gardens, Quarry Road, Swindon, SN1 4EN
 Building Designation: Main Building
 Unique item Number: 22

Sample Ref	Fl	Location	Description	Qty	Analysis Result	Total M.A.S	Licensed Material Y/N
Surveyed	Ground Floor	Male WC (male WC block). 017	No asbestos detected -		N/A		N

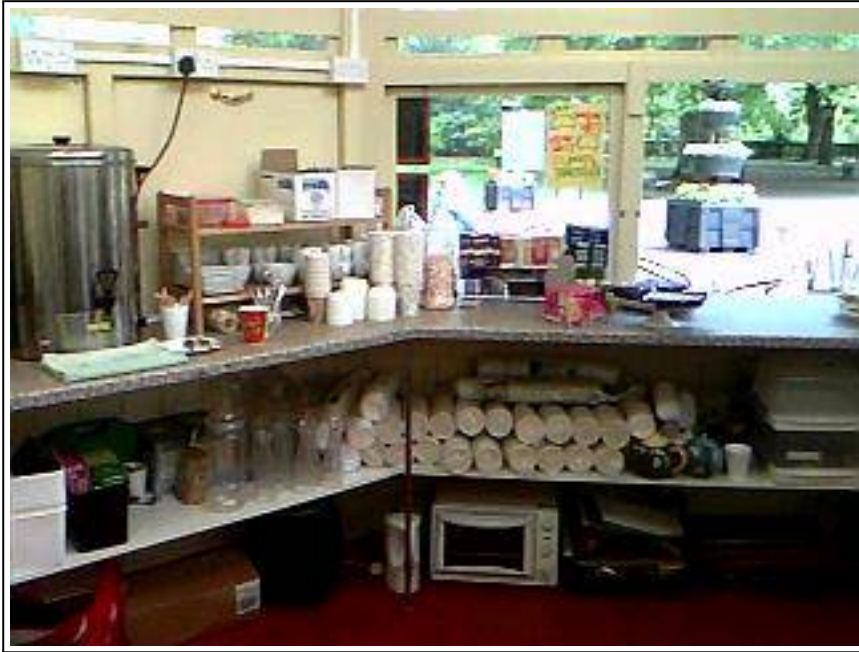
Survey Data Sheet: Conclusions & Recommendations
 Site Location: Town Gardens, Quarry Road, Swindon, SN1 4EN
 Building Designation: Main Building
 Unique item Number: 23

Sample Ref	Fl	Location	Description	Qty	Analysis Result	Total M.A.S	Licensed Material Y/N
Surveyed	Ground Floor	Kitchen (cafe block). 018	No asbestos detected -		N/A		N

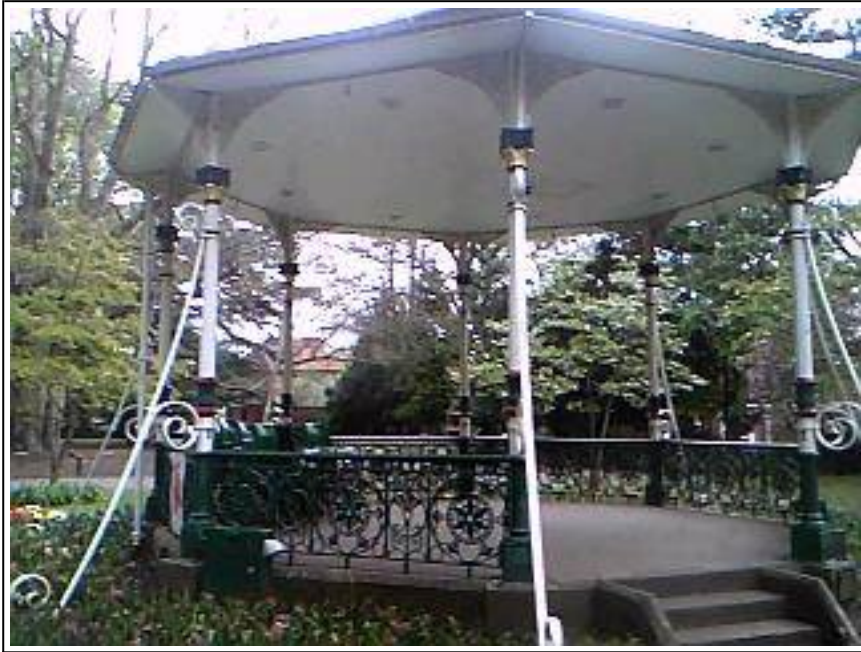
Survey Data Sheet: Conclusions & Recommendations
 Site Location: Town Gardens, Quarry Road, Swindon, SN1 4EN
 Building Designation: Main Building
 Unique item Number: 24

Sample Ref	FI	Location	Description	Qty	Analysis Result	Total M.A.S	Licensed Material Y/N
Surveyed	Ground Floor	Bandstand. 019	No asbestos detected -		N/A		N

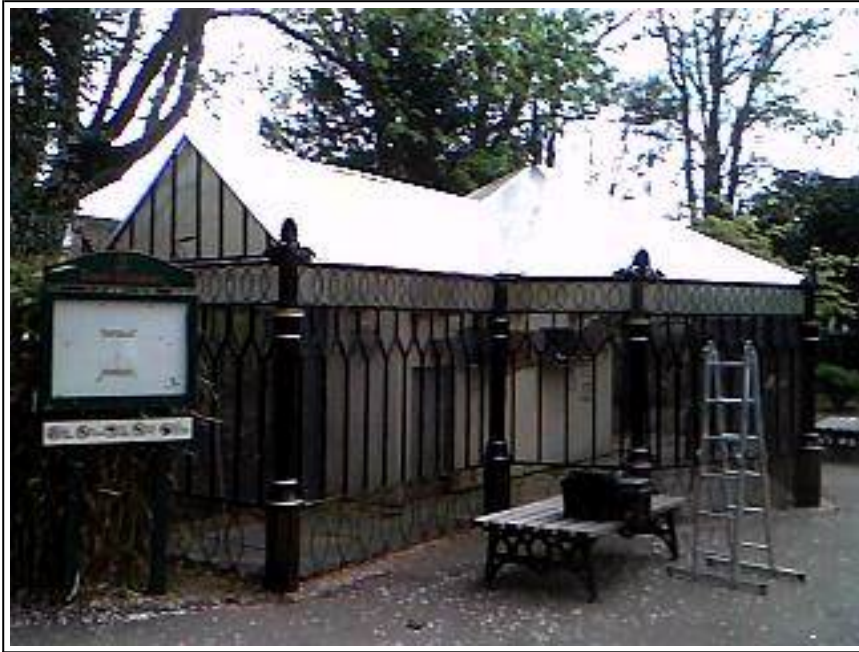
Survey Data Sheet: Conclusions & Recommendations
 Site Location: Town Gardens, Quarry Road, Swindon, SN1 4EN
 Building Designation: Main Building
 Unique item Number: 25

Sample Ref	Fl	Location	Description	Qty	Analysis Result	Total M.A.S	Licensed Material Y/N
Surveyed	Ground Floor	Aviary. 020	No asbestos detected -		N/A		N

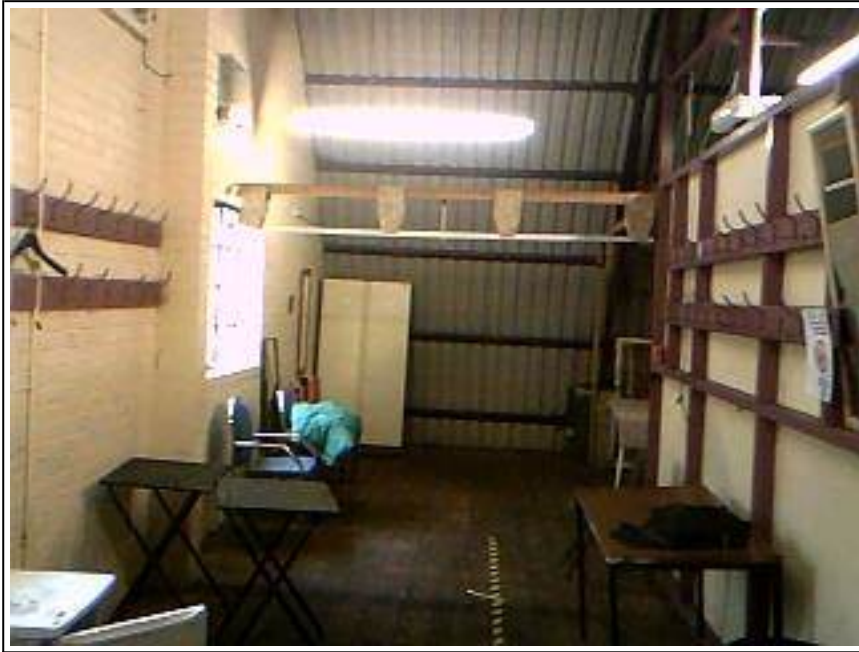
Survey Data Sheet: Conclusions & Recommendations
 Site Location: Town Gardens, Quarry Road, Swindon, SN1 4EN
 Building Designation: Main Building
 Unique item Number: 27

Sample Ref	Fl	Location	Description	Qty	Analysis Result	Total M.A.S	Licensed Material Y/N
Surveyed	Ground Floor	Backstage Area (bowl). 022	No asbestos detected -		N/A		N

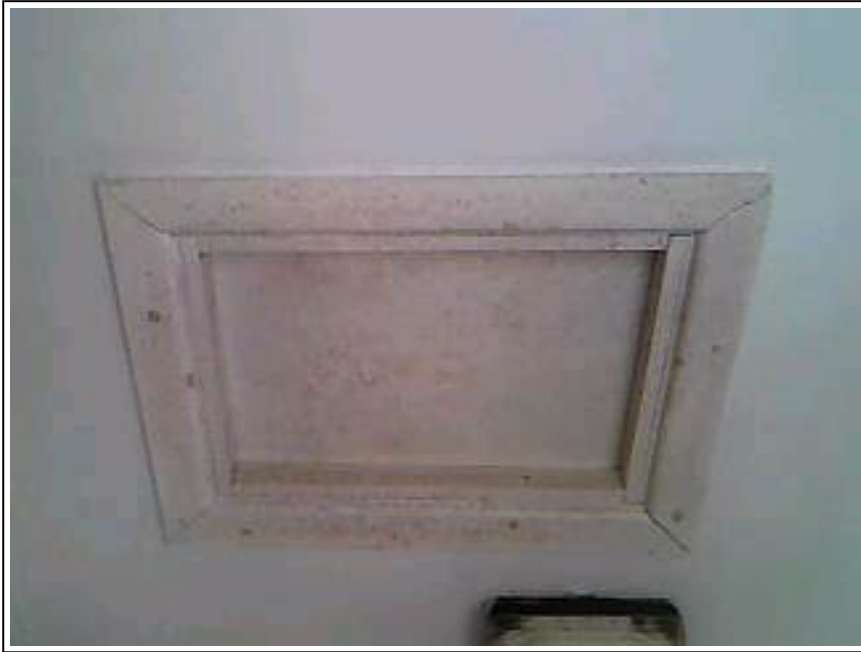
Survey Data Sheet: Conclusions & Recommendations
 Site Location: Town Gardens, Quarry Road, Swindon, SN1 4EN
 Building Designation: Main Building
 Unique item Number: 33

Sample Ref	FI	Location	Description	Qty	Analysis Result	Total M.A.S	Licensed Material Y/N
Surveyed	Roof Void	Attic (disabled WC block). A02	No asbestos detected -		N/A		N

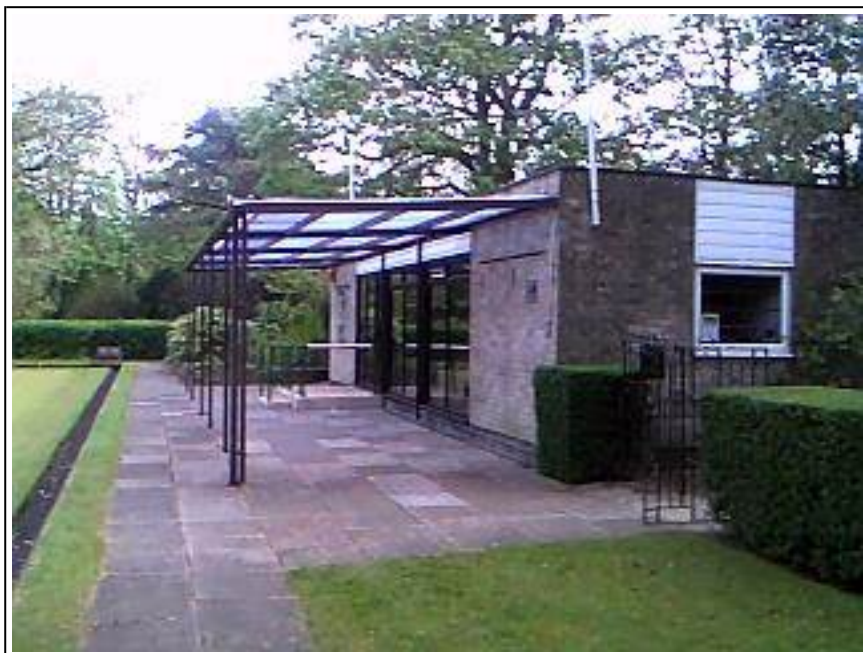
Survey Data Sheet: Conclusions & Recommendations
 Site Location: Town Gardens, Quarry Road, Swindon, SN1 4EN
 Building Designation: Main Building
 Unique item Number: 38

Sample Ref	FI	Location	Description	Qty	Analysis Result	Total M.A.S	Licensed Material Y/N
Surveyed	External	External (bowls pavillion)	No asbestos detected -		N/A		N

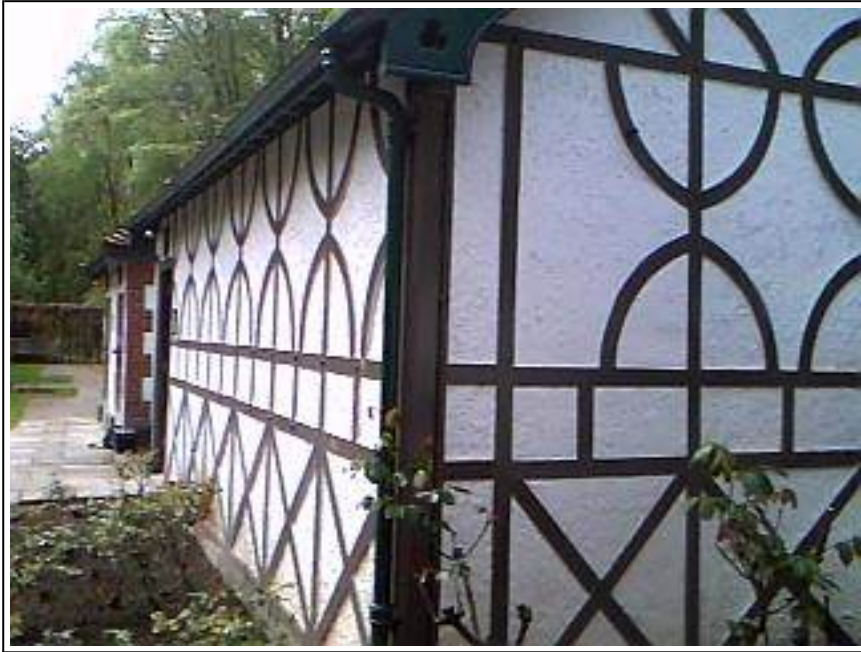
Survey Data Sheet: Conclusions & Recommendations
 Site Location: Town Gardens, Quarry Road, Swindon, SN1 4EN
 Building Designation: Main Building
 Unique item Number: 40

Sample Ref	FI	Location	Description	Qty	Analysis Result	Total M.A.S	Licensed Material Y/N
Surveyed	External	External (female WC block)	No asbestos detected -		N/A		N

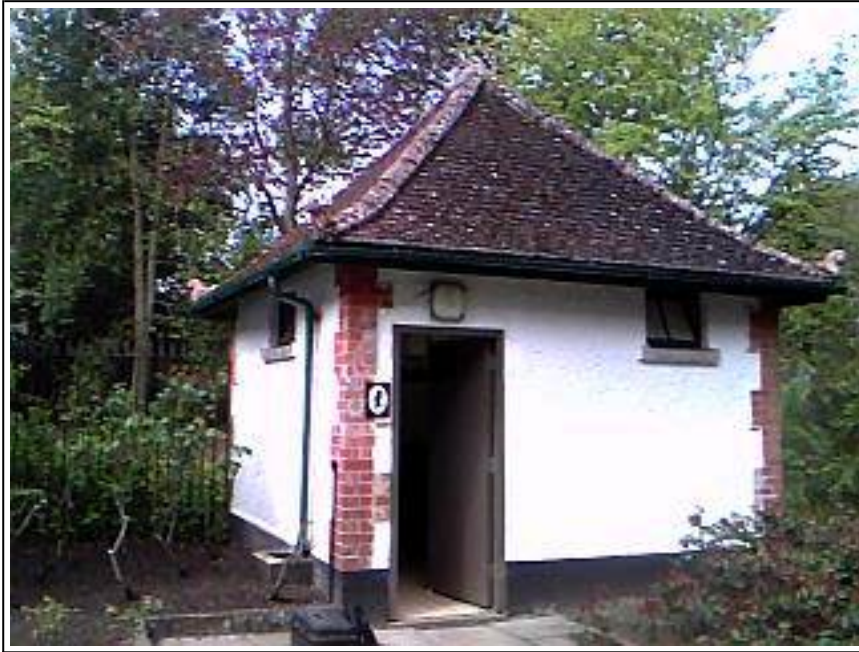
Survey Data Sheet: Conclusions & Recommendations
 Site Location: Town Gardens, Quarry Road, Swindon, SN1 4EN
 Building Designation: Main Building
 Unique item Number: 41

Sample Ref	Fl	Location	Description	Qty	Analysis Result	Total M.A.S	Licensed Material Y/N
Surveyed	External	External (male WC block)	No asbestos detected -		N/A		N

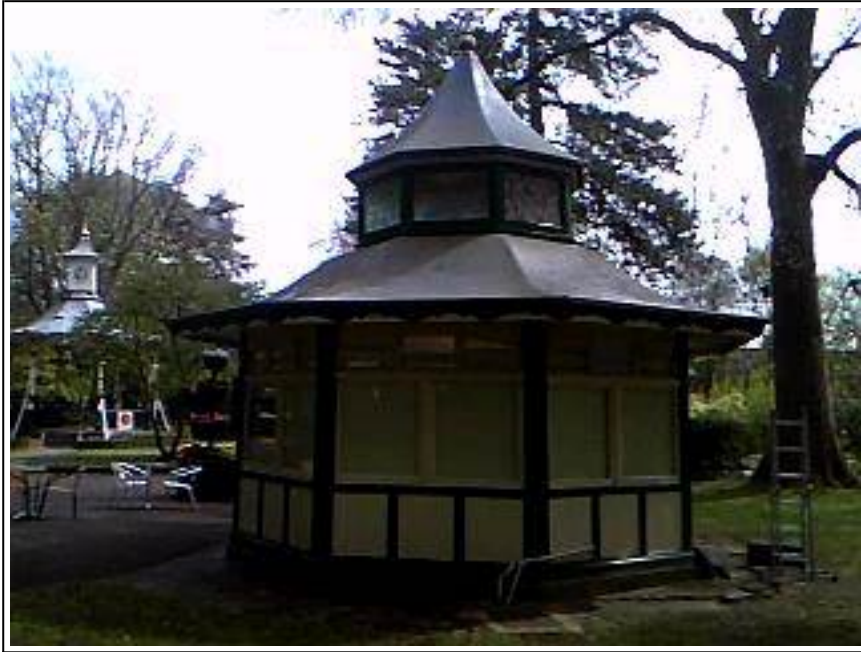
Survey Data Sheet: Conclusions & Recommendations
 Site Location: Town Gardens, Quarry Road, Swindon, SN1 4EN
 Building Designation: Main Building
 Unique item Number: 42

Sample Ref	FI	Location	Description	Qty	Analysis Result	Total M.A.S	Licensed Material Y/N
Surveyed	External	External (cafe)	No asbestos detected -		N/A		N

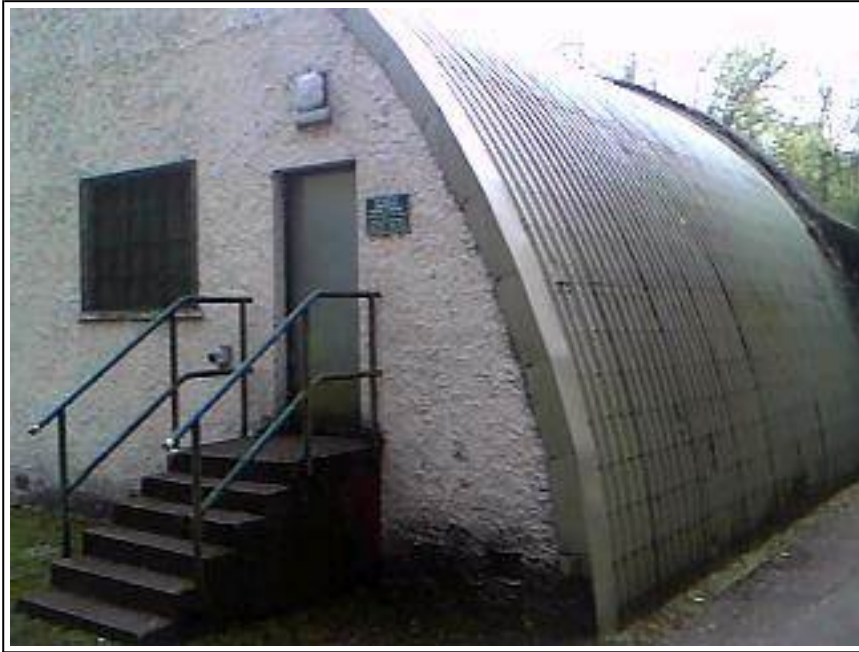
Survey Data Sheet: Conclusions & Recommendations
 Site Location: Town Gardens, Quarry Road, Swindon, SN1 4EN
 Building Designation: Main Building
 Unique item Number: 43

Sample Ref	FI	Location	Description	Qty	Analysis Result	Total M.A.S	Licensed Material Y/N
Surveyed	External	External (bowl)	No asbestos detected -		N/A		N

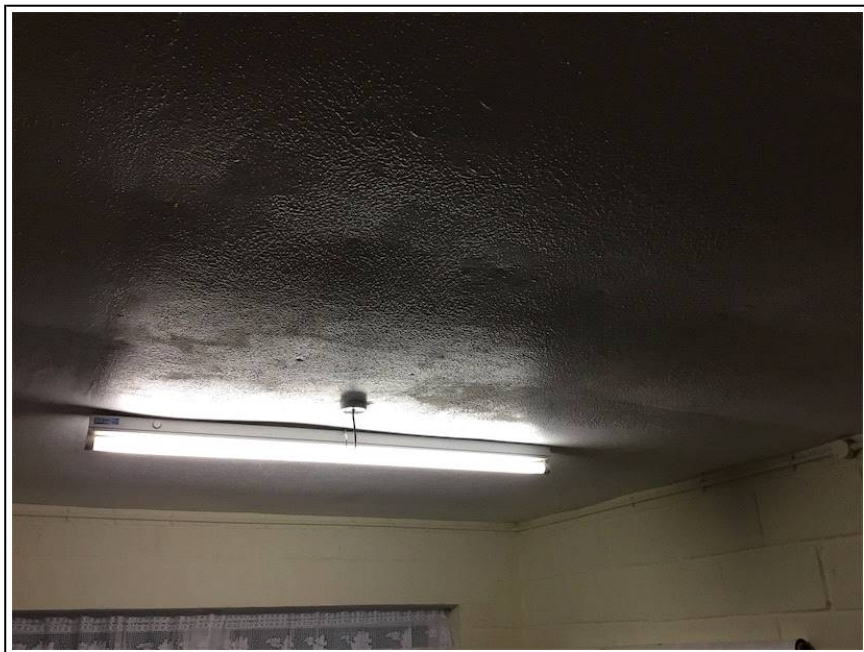
Survey Data Sheet: Conclusions & Recommendations
 Site Location: Town Gardens, Quarry Road, Swindon, SN1 4EN
 Building Designation: Main Building
 Unique item Number: 16
 Unique Job Number: J011170

Sample Ref	FI	Location	Description	Qty	Analysis Result	Total M.A.S	Licensed Material Y/N
ENS B18 {AD005880}*	Ground Floor	Ladies Changing Rooms (bowls pavillion). 008	Ceiling - Decorative coating - Textured Coating	12m ²	Chrysotile	2	N

Recommended Action:
 Leave & Manage

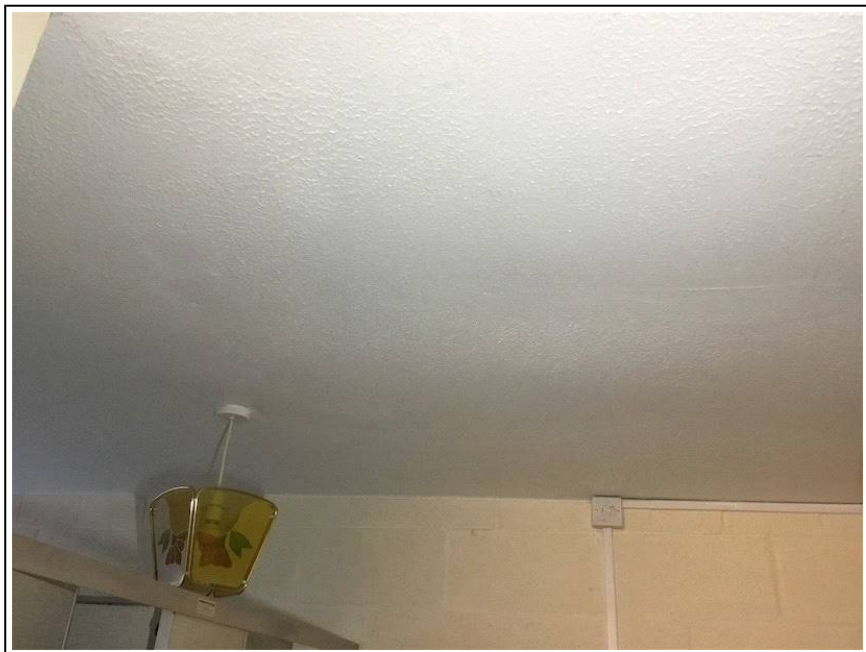
Survey Data Sheet: Conclusions & Recommendations
 Site Location: Town Gardens, Quarry Road, Swindon, SN1 4EN
 Building Designation: Main Building
 Unique item Number: 17
 Unique Job Number: J011170

Sample Ref	FI	Location	Description	Qty	Analysis Result	Total M.A.S	Licensed Material Y/N
REFER (ENS B18 {AD005880}*)	Ground Floor	Ladies Toilets (bowls pavillion). 009	Ceiling - Decorative coating - Textured Coating	6m ²	Chrysotile	2	N

Recommended Action:
 Leave & Manage

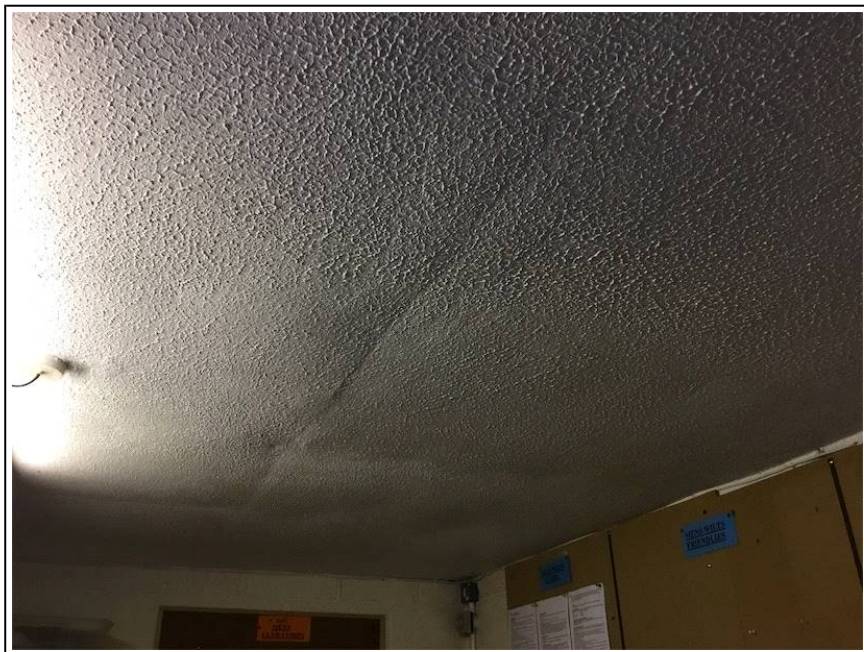
Survey Data Sheet: Conclusions & Recommendations
 Site Location: Town Gardens, Quarry Road, Swindon, SN1 4EN
 Building Designation: Main Building
 Unique item Number: 18
 Unique Job Number: J011170

Sample Ref	FI	Location	Description	Qty	Analysis Result	Total M.A.S	Licensed Material Y/N
ENS B17 {AD005881}*	Ground Floor	Mens Changing Rooms (bowls pavillion). 010	Ceiling - Decorative coating - Textured Coating	12m ²	Chrysotile	2	N

Recommended Action:
 Leave & Manage

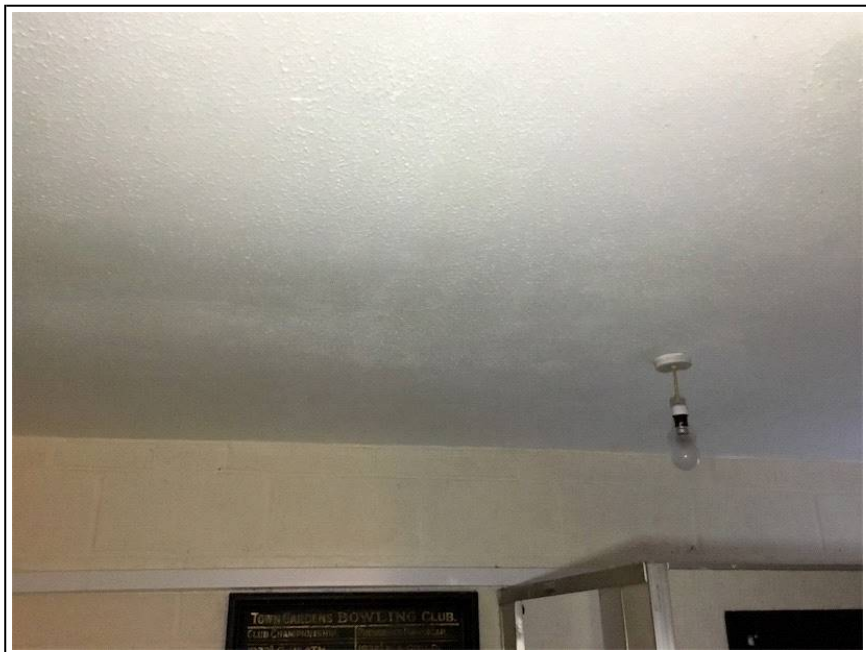
Survey Data Sheet: Conclusions & Recommendations
 Site Location: Town Gardens, Quarry Road, Swindon, SN1 4EN
 Building Designation: Main Building
 Unique item Number: 19
 Unique Job Number: J011170

Sample Ref	FI	Location	Description	Qty	Analysis Result	Total M.A.S	Licensed Material Y/N
REFER (ENS B17 {AD005881}*)	Ground Floor	Mens Toilets (bowls pavillion). 011	Ceiling - Decorative coating - Textured Coating	6m ²	Chrysotile	2	N

19	Ref AD005881	G	Men's Toilets (Bowls Pavilion) 011	Ceiling	Decorative Coating	Textured Coating	6sqm	Chrysotile	2	5	7	Very Low	Leave & manage	12 months		
20	AD005882	G	Cylinder Cupboard (Bowls Pavilion) 012	Floor (under carpet)	Adhesive Residue	Adhesive	2sqm	Chrysotile	3	4	7	Very Low	Leave & manage until uncovered	12 months

Recommended Action:
 Leave & Manage

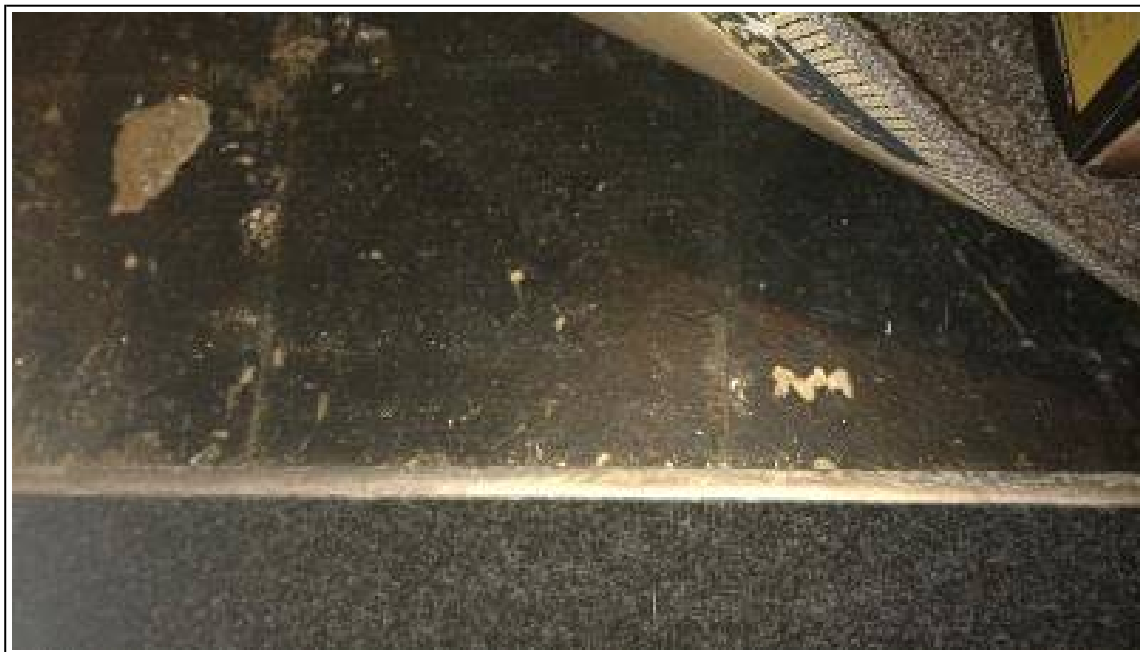
Survey Data Sheet: Conclusions & Recommendations
 Site Location: Town Gardens, Quarry Road, Swindon, SN1 4EN
 Building Designation: Main Building
 Unique item Number: 20
 Unique Job Number: J011170

Sample Ref	FI	Location	Description	Qty	Analysis Result	Total M.A.S	Licensed Material Y/N
AD005882*	Ground Floor	Cylinder Cupboard (bowls pavillion). 012	Floor - Adhesive residue under carpet - Well Bound Material	2m ²	Chrysotile	3	N

Recommended Action:
 Door locked; key holder unavailable - Leave and manage until uncovered

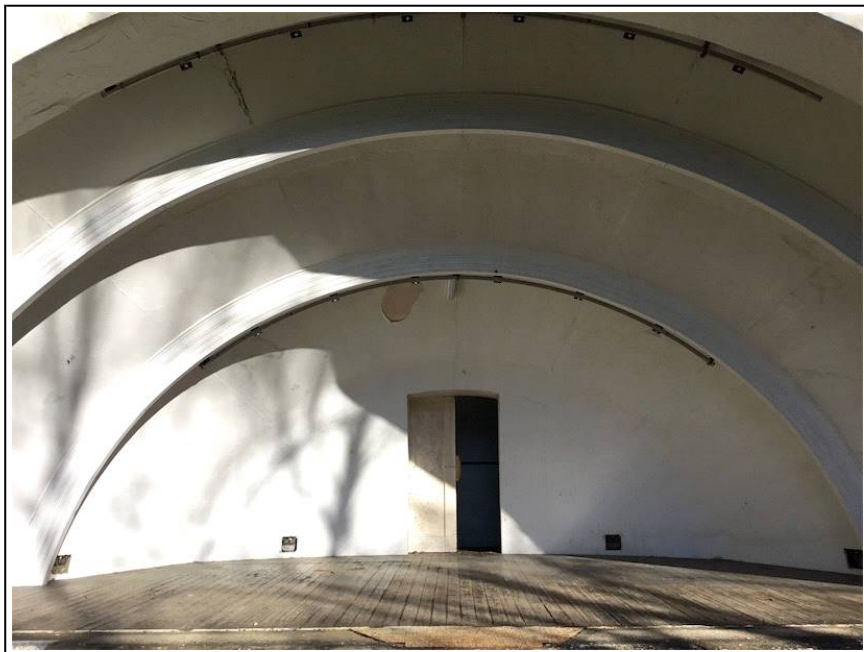
Survey Data Sheet: Conclusions & Recommendations
 Site Location: Town Gardens, Quarry Road, Swindon, SN1 4EN
 Building Designation: Main Building
 Unique item Number: 39
 Unique Job Number: J011170

Sample Ref	Fl	Location	Description	Qty	Analysis Result	Total M.A.S	Licensed Material Y/N
ENS B03 {AD005886}*	Ground Floor	Stage (bowl). 021	Walls and ceiling - Cement panels - Cement	50m ²	Chrysotile	4	N

Recommended Action:
 Paint flaking in places - Repair/Encapsulate

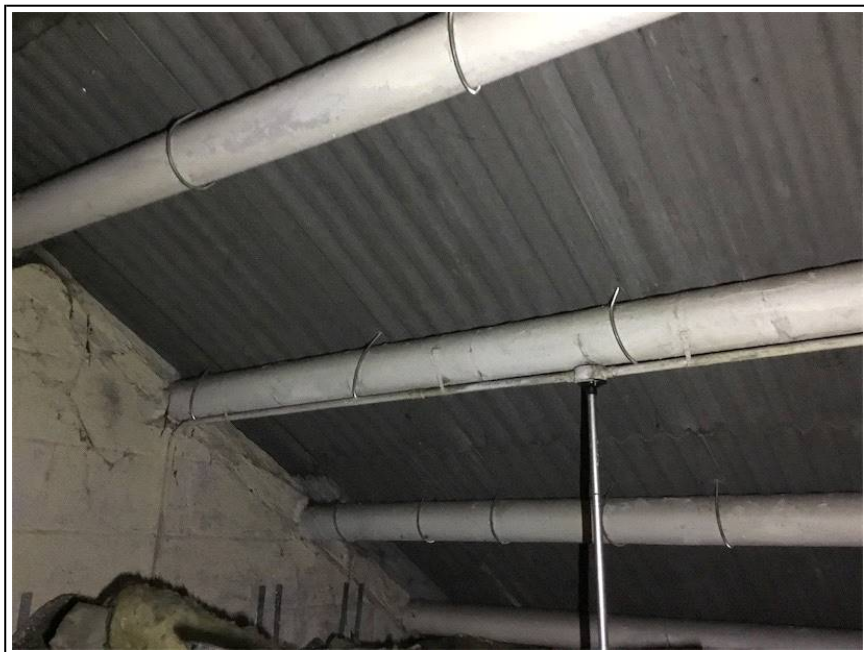
Survey Data Sheet: Conclusions & Recommendations
 Site Location: Town Gardens, Quarry Road, Swindon, SN1 4EN
 Building Designation: Main Building
 Unique item Number: 8
 Unique Job Number: J011170

Sample Ref	FI	Location	Description	Qty	Analysis Result	Total M.A.S	Licensed Material Y/N
REFER (ENS B07 {AD005874} *)	Roof Void	Attic (mess). A01	Roof supports - Cement surrounds - Cement	12lm	Chrysotile	3	N

Recommended Action:
 Leave & Manage

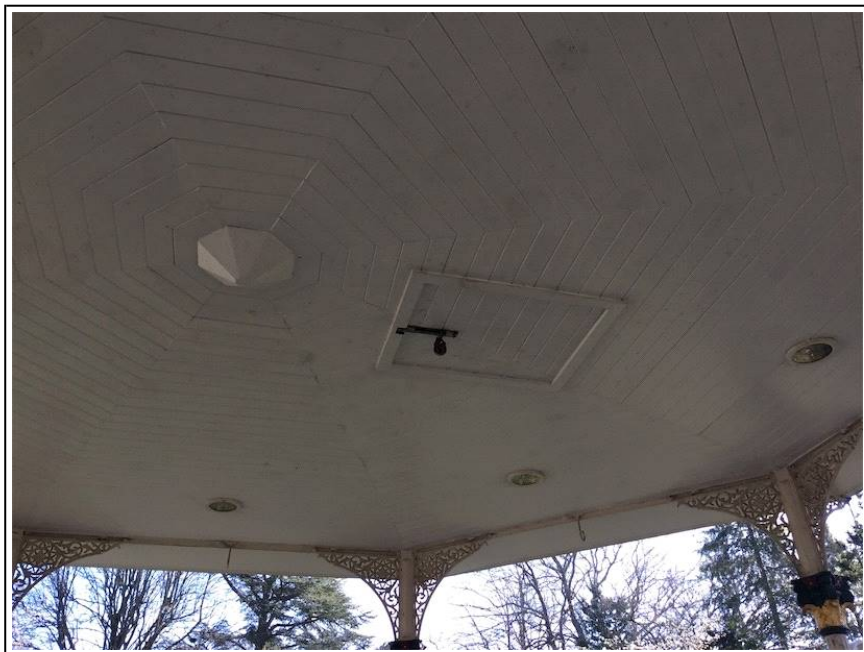
Survey Data Sheet: Conclusions & Recommendations
 Site Location: Town Gardens, Quarry Road, Swindon, SN1 4EN
 Building Designation: Main Building
 Unique item Number: 37
 Unique Job Number: J011170

Sample Ref	FI	Location	Description	Qty	Analysis Result	Total M.A.S	Licensed Material Y/N
No Access	Roof Void	Attic (bandstand). A04			No Access

Recommended Action:
 Further investigation required when appropriate

Product Type	Extent of Damage	Surface Treatment	Asbestos Type	Total M.A.S	Accessibility/Vulnerability	Combined Total for Advised Timescale
0	0	0	0		0
