Annual Inspection

West Swindon Parish Council

Claypit/Plattes

Annual Inspection - 19 December 2017 at 10:20 Inspector: Leon Pope RPII Annual Inspector

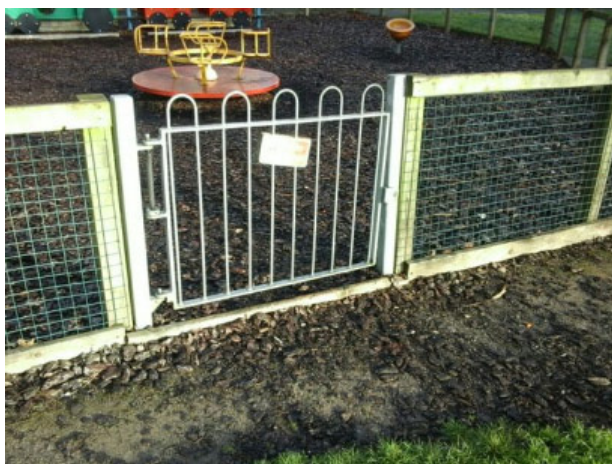
Item: Ancillary Items - Gate - Self Closing
Manufacturer: Owner/Operator
Surface Type: N/A
Equipment Compliance: N/A
Surface Area Compliance: N/A
Ref/Part Number:
Total Findings: 2

The gate is closing too quickly (less than 4 seconds) - Take corrective action to ensure that the gate closes in 4-8 seconds

There are trip hazards at the entrance / exit to the play area - Reinstate surrounding surfaces to level to remove the trip points

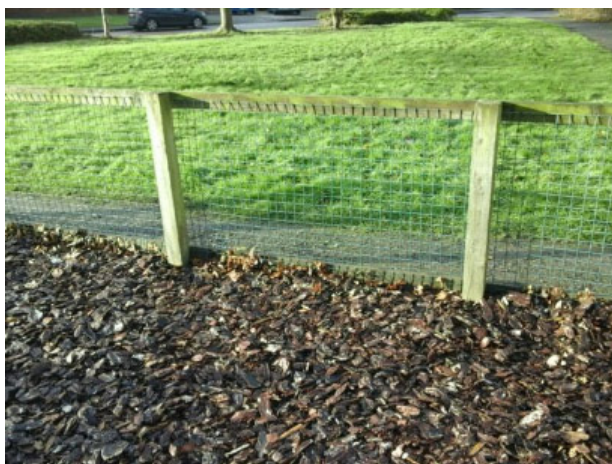
Item: Ancillary Items - Fence - Timber & Mesh Infill
Manufacturer: Owner/Operator
Surface Type: N/A
Equipment Compliance: N/A
Surface Area Compliance: N/A
Ref/Part Number:
Total Findings: 2

There are areas or parts of the timber on the structure that have rotted - Replace all affected timbers

There are a number of loose posts around the fence - Monitor for any further deterioration and reset as required

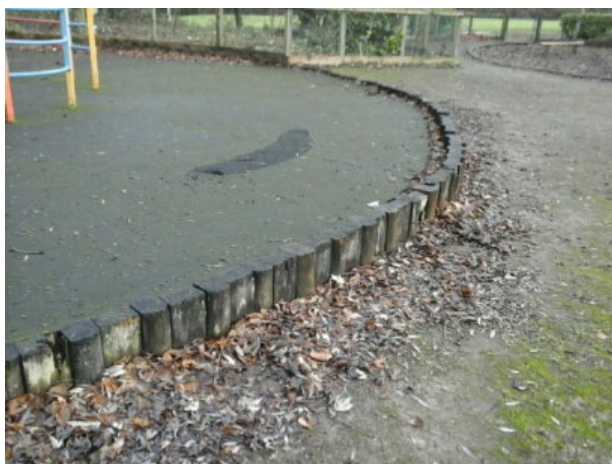
Item: Ancillary Items - Palisade Logs
Manufacturer: Owner/Operator
Surface Type: N/A
Equipment Compliance: N/A
Surface Area Compliance: N/A
Ref/Part Number:
Total Findings: 2

There are areas or parts of the timber on the structure that have rotted - Replace all affected timbers

There are missing posts - Replace as required

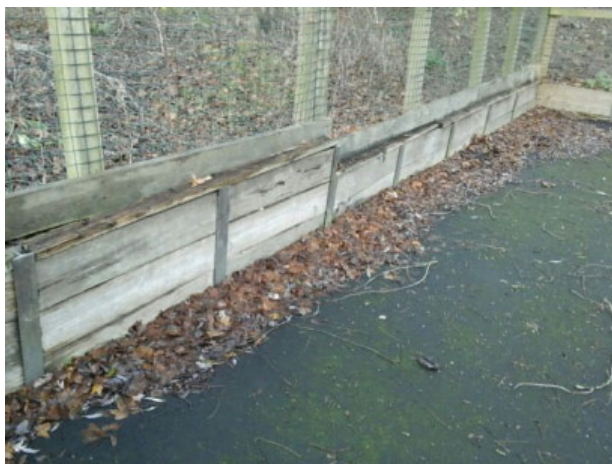
Item: Ancillary Items - Sleepers
Manufacturer: Owner/Operator
Surface Type: N/A
Equipment Compliance: N/A
Surface Area Compliance: N/A
Ref/Part Number:
Total Findings: 1

There are areas or parts of the timber on the structure that have rotted - Replace all affected timbers

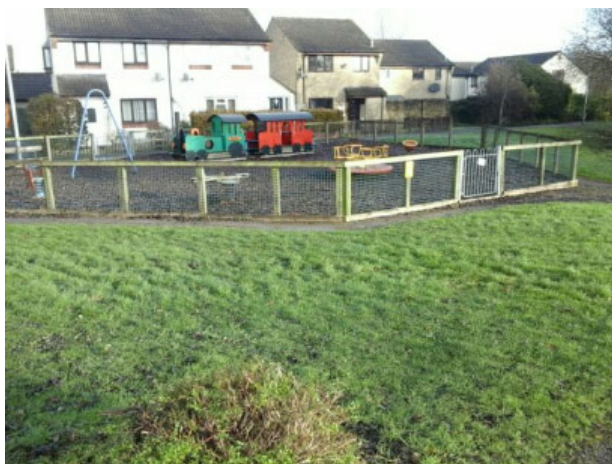
Item: Ancillary Items - Site General
Manufacturer: Owner/Operator
Surface Type: N/A
Equipment Compliance: N/A
Surface Area Compliance: N/A
Ref/Part Number:
Total Findings: 6

There are gaps opening between the wet pour surfacing and the edging surround or between the joints in the surfacing - Monitor for any further deterioration and repair as required

There is algae or moss growth on the wet pour surfacing resulting in slippery conditions - Clean and treat appropriately

The wet pour surfacing is lifting at the edges and creating trip points - Repair perimeter of surfacing to remove trip points

There are trip hazards at the edges of the wet pour surfacing - Reinstate surrounding surface levels to remove the trip points

There is excrement on site - Clean and maintain area

There is a vast amount of leaf litter within the play area - Clean and maintain area

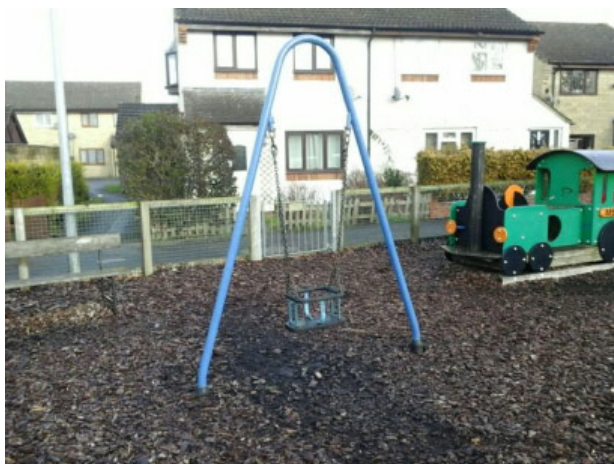
Item: Swings - 1 Bay Swing
Manufacturer: S M P (Playgrounds Ltd)
Surface Type: Bark Mulch
Equipment Compliance: No
Surface Area Compliance: Yes
Ref/Part Number:
Total Findings: 6

There are caps missing from the underside of the seats - Replace missing caps under the seats

The item is slightly loose in its foundations - Monitor for any further deterioration and repair as required

The seat has minor damage or wear - Monitor for any further deterioration and replace as required

There is some notable evidence of chain wear - Monitor for any further deterioration and replace when 40% worn

There is some wear to the connecting links - Monitor for any further deterioration and replace when 40% worn

The chain openings are in excess of the 8.6mm as recommended by BS EN 1176 - Monitor use and replace with compliant chains during next maintenance cycle.

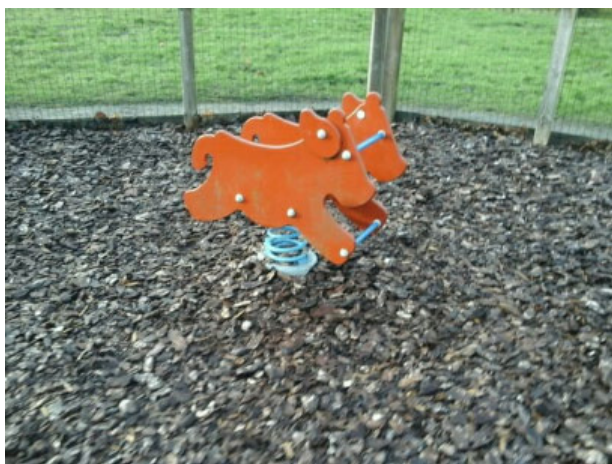
Item: Rocking Equipment - Spring Cow
Manufacturer: Not Identified
Surface Type: Bark Mulch
Equipment Compliance: Yes
Surface Area Compliance: Yes
Ref/Part Number:
Total Findings: 1

The paintwork on the spring has been damaged or worn exposing the metal underneath which is rusting - Treat any rusting components and repaint

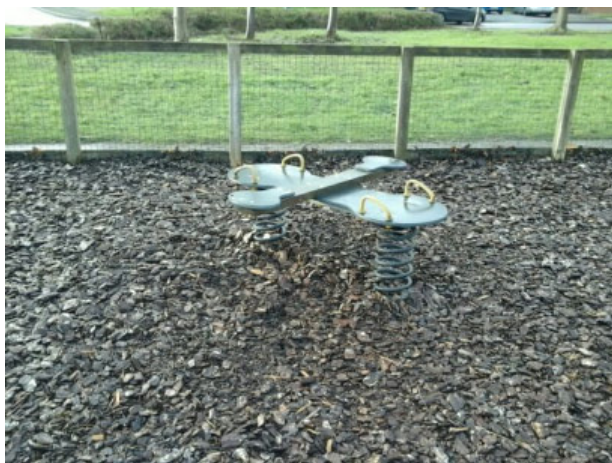
Item: Rocking Equipment - Spring See-Saw
Manufacturer: Kompan Ltd
Surface Type: Bark Mulch
Equipment Compliance: Yes
Surface Area Compliance: Yes
Ref/Part Number:
Total Findings: 1

There is/are bolt cap covers missing or damaged on the item - Replace missing or damaged bolt cap covers

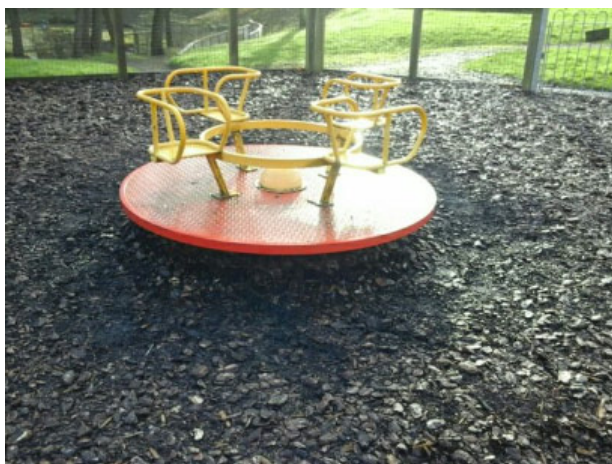
Item: Rotor Play - Roundabout
Manufacturer: Record RSS
Surface Type: Bark Mulch
Equipment Compliance: No
Surface Area Compliance: Yes
Ref/Part Number:
Total Findings: 1

The distance between the underside of the roundabout platform and the playing surface is in excess of 110mm and contravenes the requirements of BS EN 1176 Part 5 which requires that the distance be maintained between 60mm-110mm - for the entire circumference of the roundabout - Monitor use

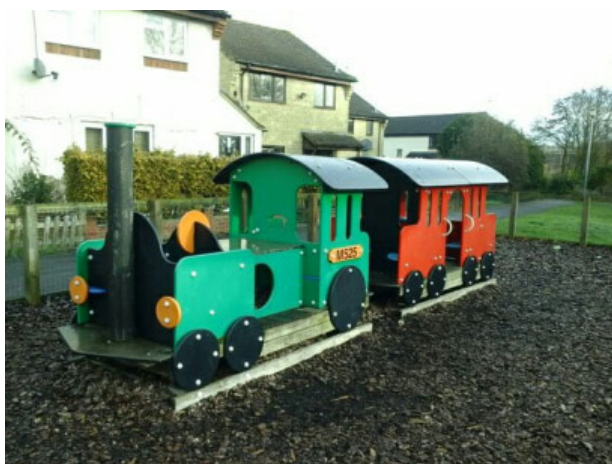
Item: Activity Equipment - Train
Manufacturer: Kompan Ltd
Surface Type: Bark Mulch
Equipment Compliance: Yes
Surface Area Compliance: Yes
Ref/Part Number:
Total Findings: 2

There is some graffiti present on site - Remove the graffiti

Parts of the timber are rough or splintered - Remove all rough or sharp edges and repaint affected areas

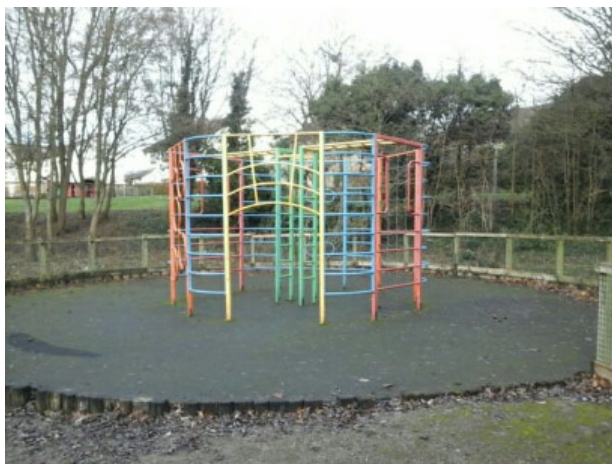
Item: Activity Equipment - Climbing Frame
Manufacturer: Not Identified
Surface Type: Bark Mulch
Equipment Compliance: No
Surface Area Compliance: Yes
Ref/Part Number:
Total Findings: 4

There is algae or moss on the surface of the equipment - Clean and treat appropriately

A number of fixing(s) have worked loose - Secure all loose fixings

The paintwork on this item has been damaged or worn exposing the metal underneath which is rusting - Treat any rusting components and repaint

The chain openings are in excess of the 8.6mm as recommended by BS EN 1176 - Monitor use and replace with compliant chains during next maintenance cycle.

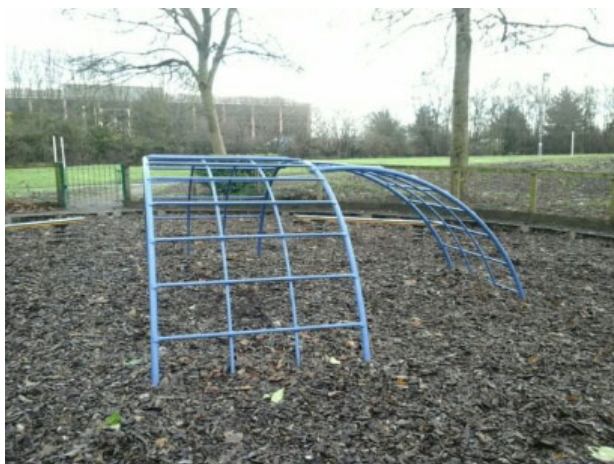
Item: Activity Equipment - Climbing Frame
Manufacturer: Record RSS
Surface Type: Wet Pour
Equipment Compliance: Yes
Surface Area Compliance: Yes
Ref/Part Number:
Total Findings: 2

The framework join is not flush - Monitor for any further deterioration and repair as required

There is some minor damage to the framework - Monitor for any further deterioration and repair as required

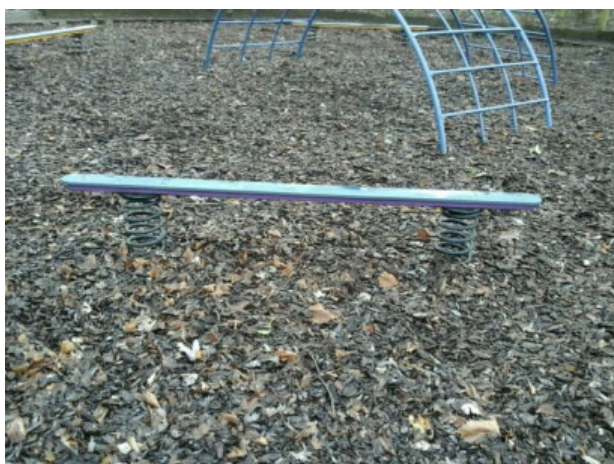
Item: Activity Equipment - Spring Balance Beam
Manufacturer: Not Identified
Surface Type: Bark Mulch
Equipment Compliance: Yes
Surface Area Compliance: Yes
Ref/Part Number:
Total Findings: 2

A number of spring mount fixing(s) have worked loose - Secure all loose fixings

There is/are bolt cap covers missing or damaged on the item - Replace missing or damaged bolt cap covers

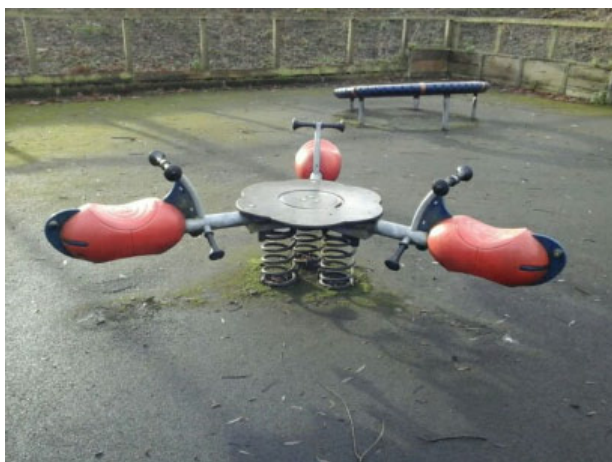
Item: Rocking Equipment - Three Way Springer
Manufacturer: Kompan Ltd
Surface Type: Wet Pour
Equipment Compliance: Yes
Surface Area Compliance: Yes
Ref/Part Number:
Total Findings: 1

The paintwork on the spring has been damaged or worn exposing the metal underneath which is rusting - Treat any rusting components and repaint

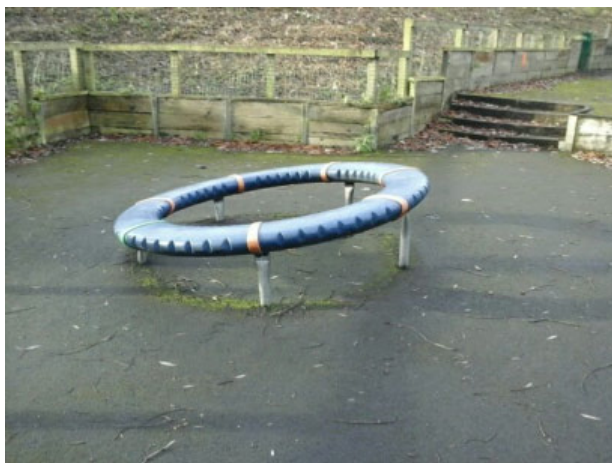
Item: Rotor Play - Supanova
Manufacturer: Kompan Ltd
Surface Type: Wet Pour
Equipment Compliance: Yes
Surface Area Compliance: Yes
Ref/Part Number:
Total Findings: 2

There is some minor damage to the item - Monitor for any further deterioration and remove any rough or sharp edges

There is/are bolt cap covers missing or damaged on the item - Replace missing or damaged bolt cap covers

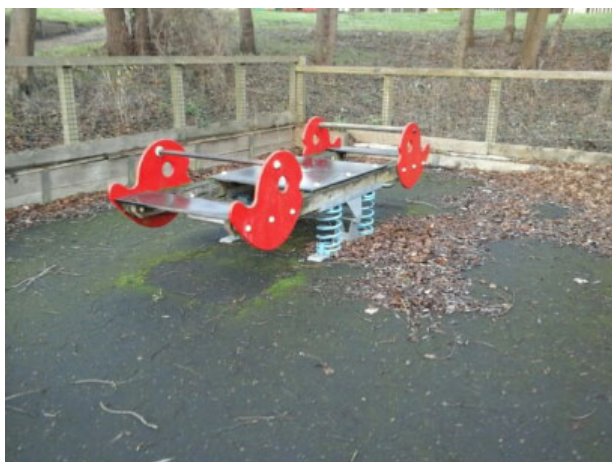
Item: Rocking Equipment - Spring See-Saw
Manufacturer: Kompan Ltd
Surface Type: Wet Pour
Equipment Compliance: No
Surface Area Compliance: Yes
Ref/Part Number:
Total Findings: 6

The paintwork on the spring has been damaged or worn exposing the metal underneath which is rusting - Treat any rusting components and repaint

The paintwork on this item has been damaged or worn exposing the metal underneath which is rusting - Treat any rusting components and repaint

There is algae or moss on the surface of the equipment - Clean and treat appropriately

A number of fixing(s) have worked loose and the handgrip is not secured - Secure all loose fixings

The spring mounting plates are slightly loose in the ground - Monitor for any further deterioration and repair as required

The safety surface under or around this unit has been damaged - Monitor for any further deterioration and repair as required

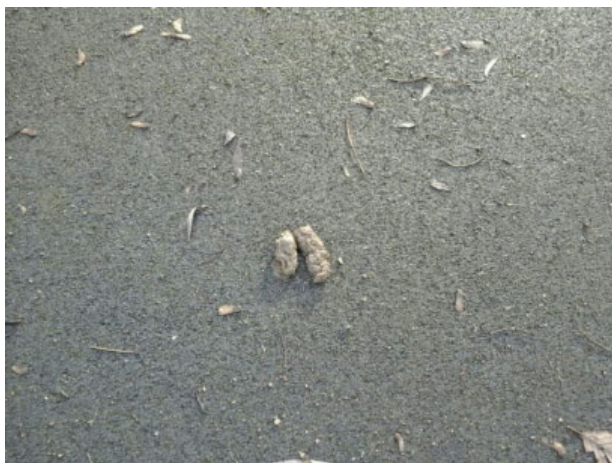
Finding: There is excrement on site
Action: Clean and maintain area

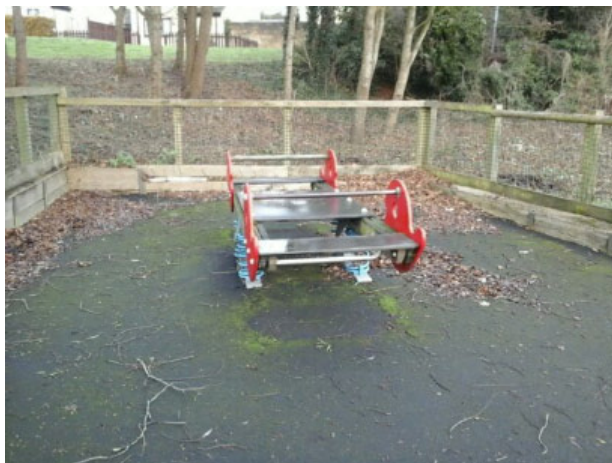
Finding: There is a vast amount of leaf litter within the play area

Action: Clean and maintain area

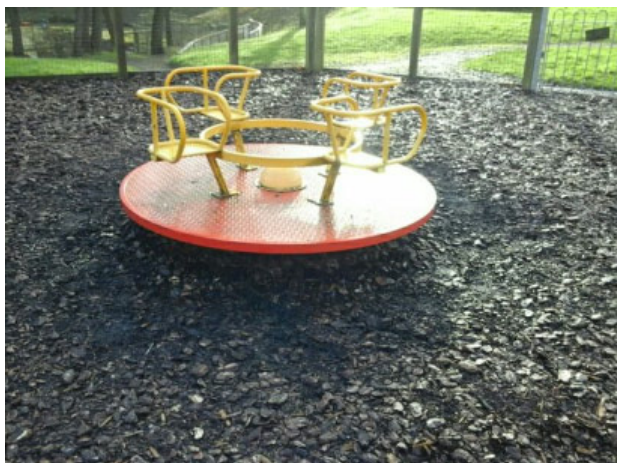
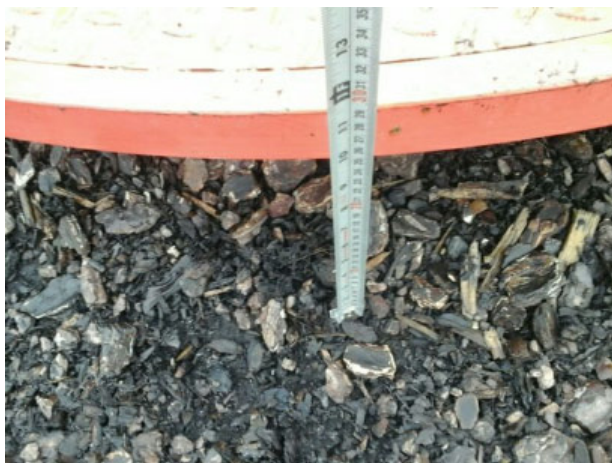
Finding: The distance between the underside of the roundabout platform and the playing surface is in excess of 110mm and contravenes the requirements of BS EN 1176 Part 5 which requires that the distance be maintained between 60mm-110mm - for the entire circumference of the roundabout

Action: Monitor use

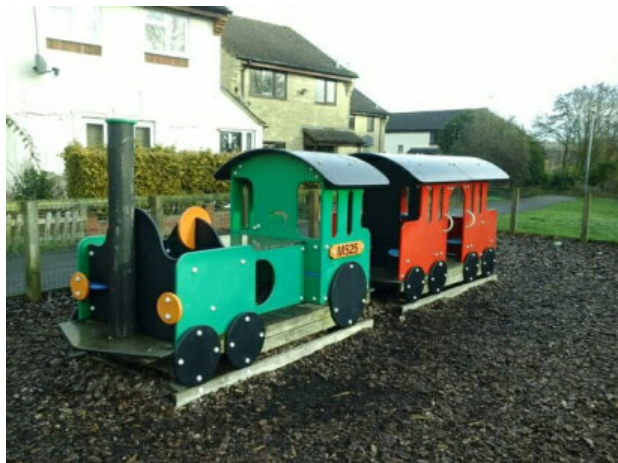
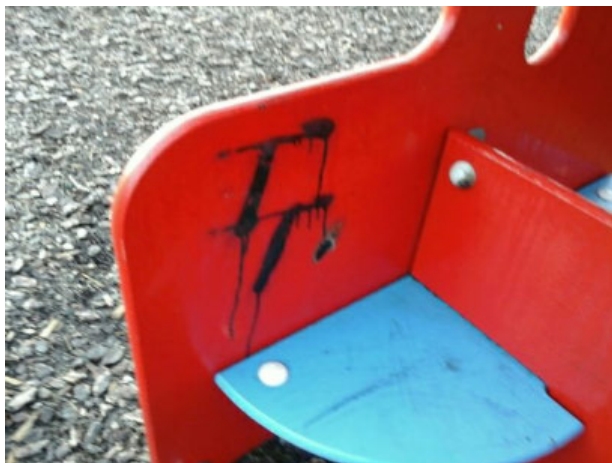
Finding: There is some graffiti present on site

Action: Remove the graffiti

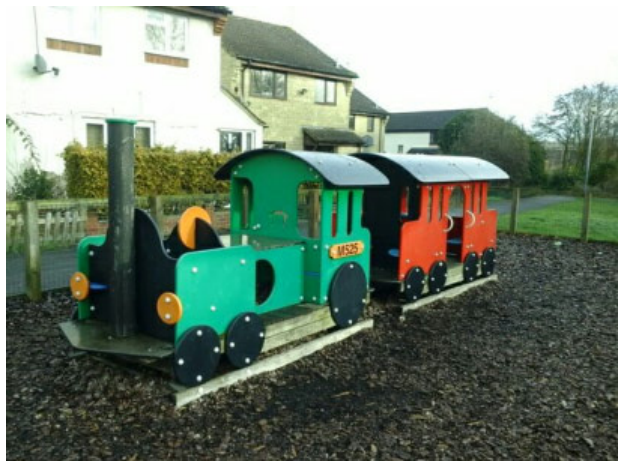
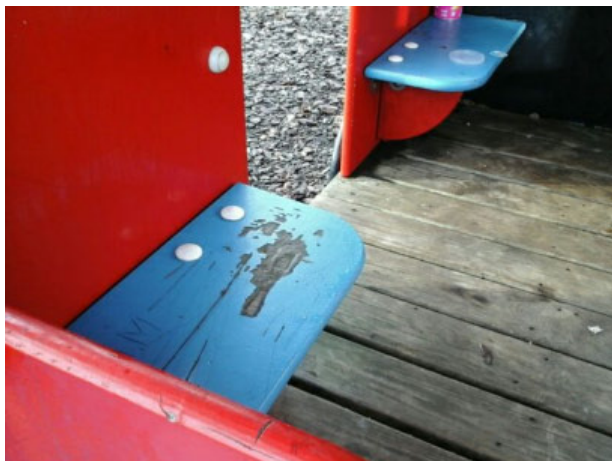
Finding: Parts of the timber are rough or splintered

Action: Remove all rough or sharp edges and repaint affected areas

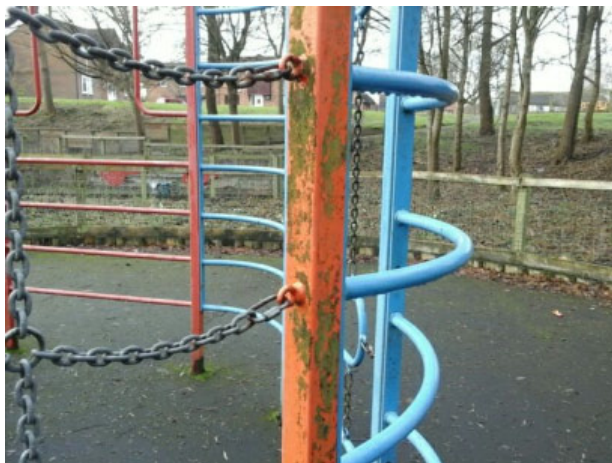
Finding: There is algae or moss on the surface of the equipment

Action: Clean and treat appropriately

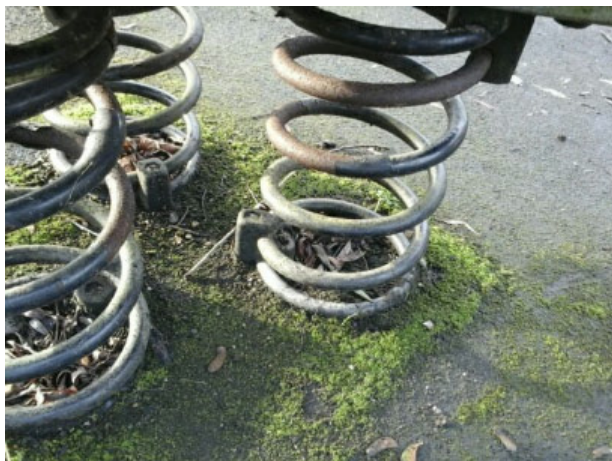
Finding: The paintwork on the spring has been damaged or worn exposing the metal underneath which is rusting

Action: Treat any rusting components and repaint

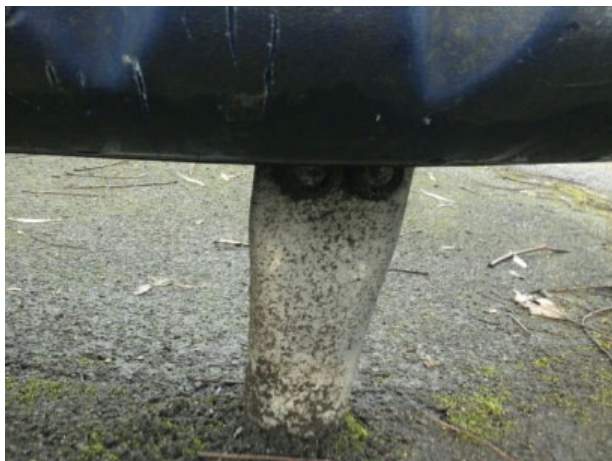
Finding: There is/are bolt cap covers missing or damaged on the item

Action: Replace missing or damaged bolt cap covers

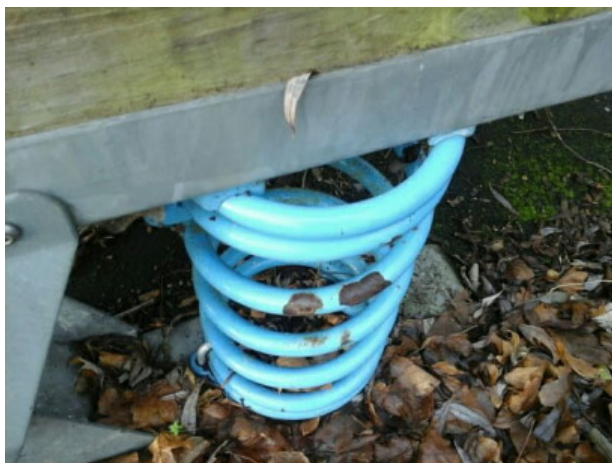
Finding: The paintwork on the spring has been damaged or worn exposing the metal underneath which is rusting

Action: Treat any rusting components and repaint

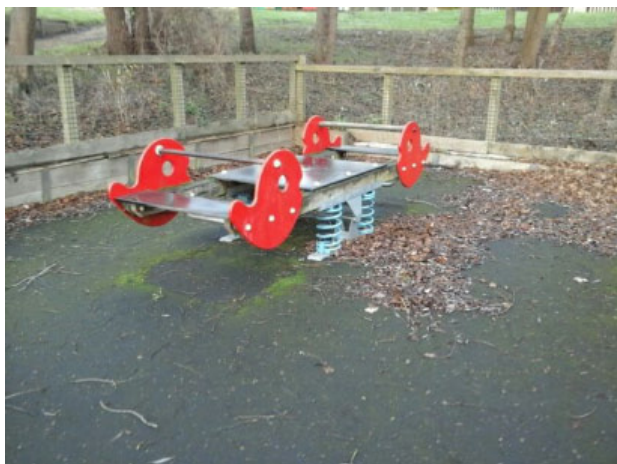
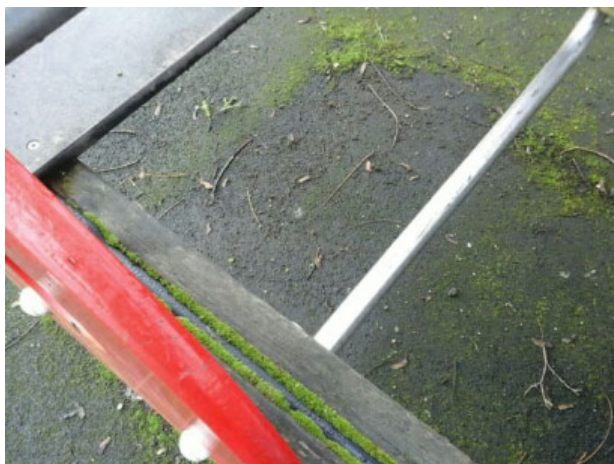
Finding: There is algae or moss on the surface of the equipment

Action: Clean and treat appropriately

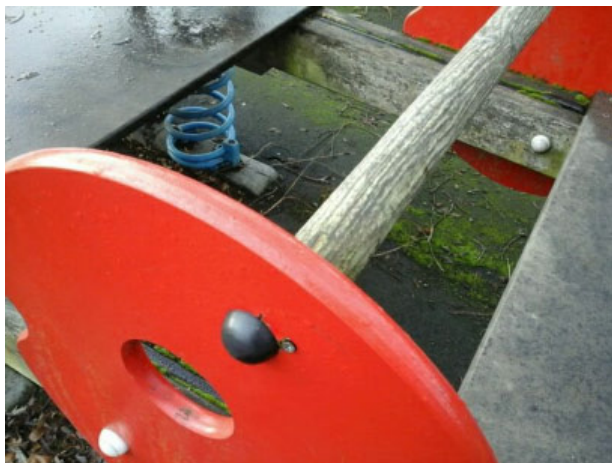
Finding: A number of fixing(s) have worked loose and the handgrip is not secured

Action: Secure all loose fixings

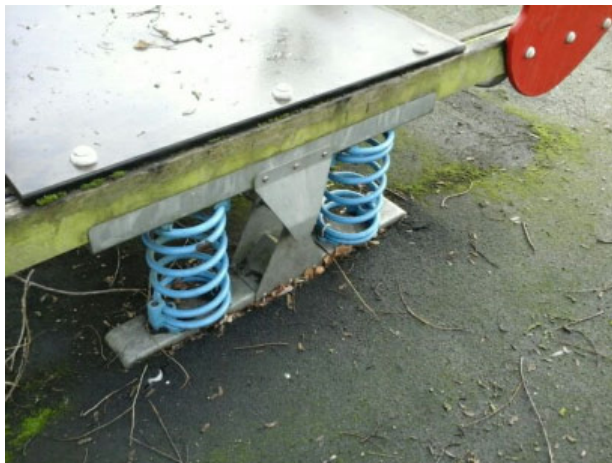
Finding: The spring mounting plates are slightly loose in the ground

Action: Monitor for any further deterioration and repair as required

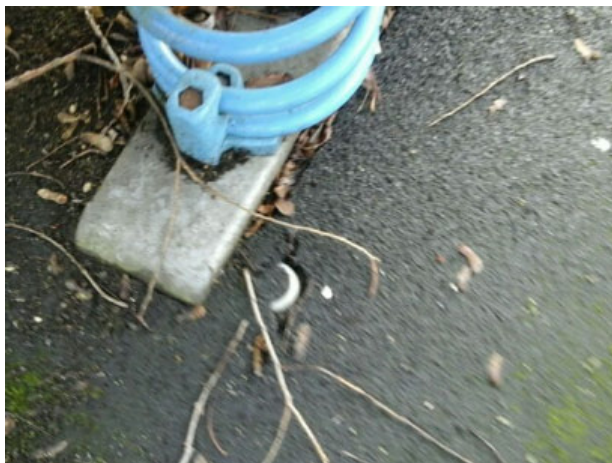
Finding: The safety surface under or around this unit has been damaged

Action: Monitor for any further deterioration and repair as required
