Swanage

The Bandstand

**Background, condition report, specification & methodology
for specialist restoration: Lost Art Ltd with supporting information
from Industrial Heritage Consulting**

Swanage Bandstand Condition report

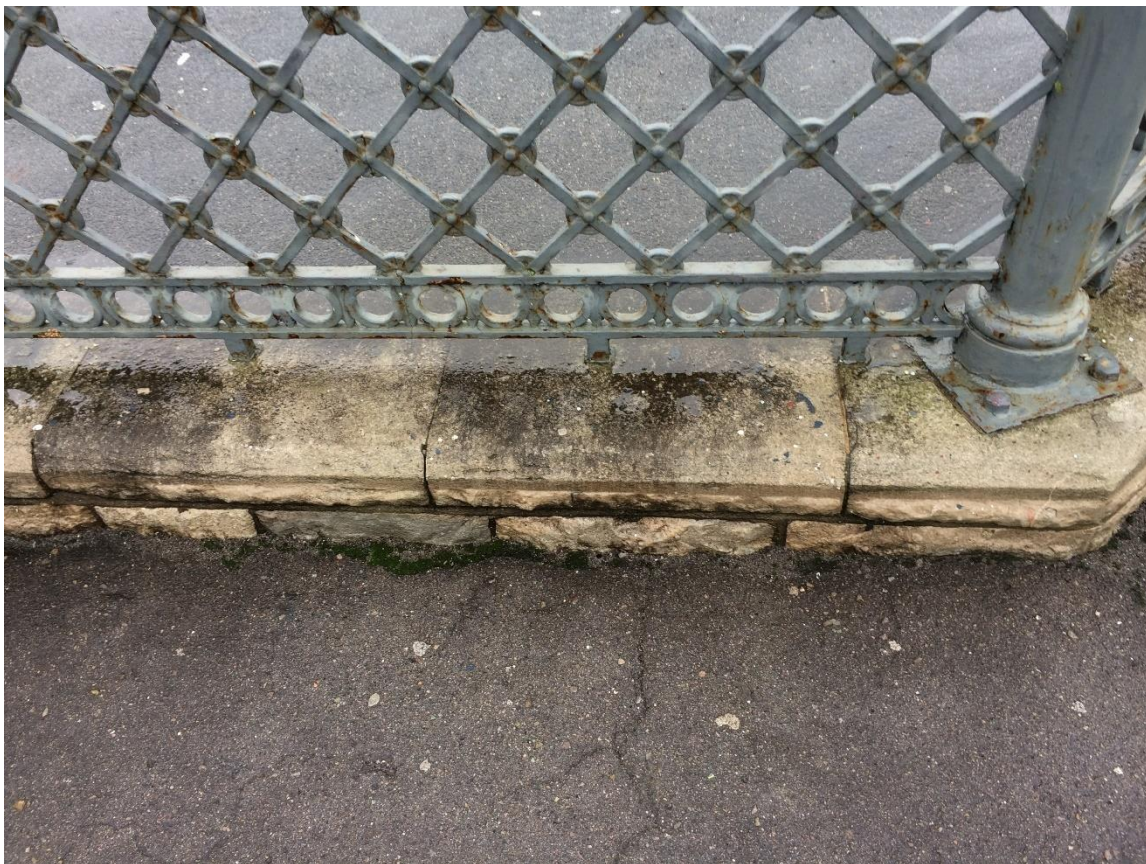
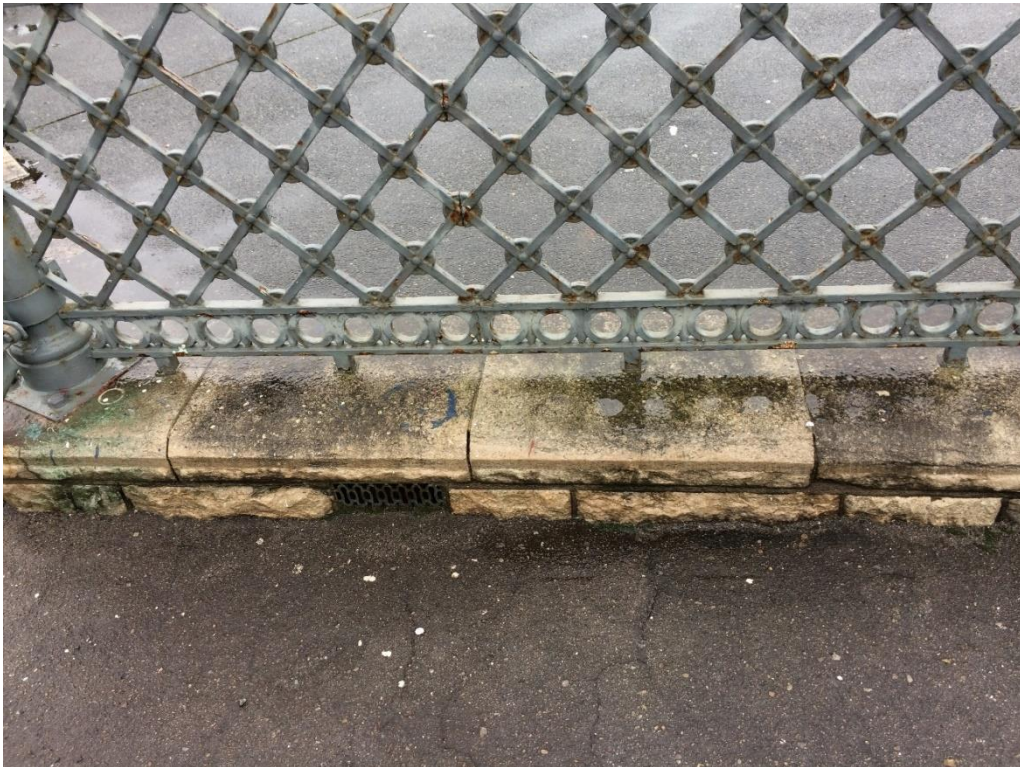
Images show the copings in Section A – B and include the air grille located under coping 4.

Section A – B: All copings appear sound.

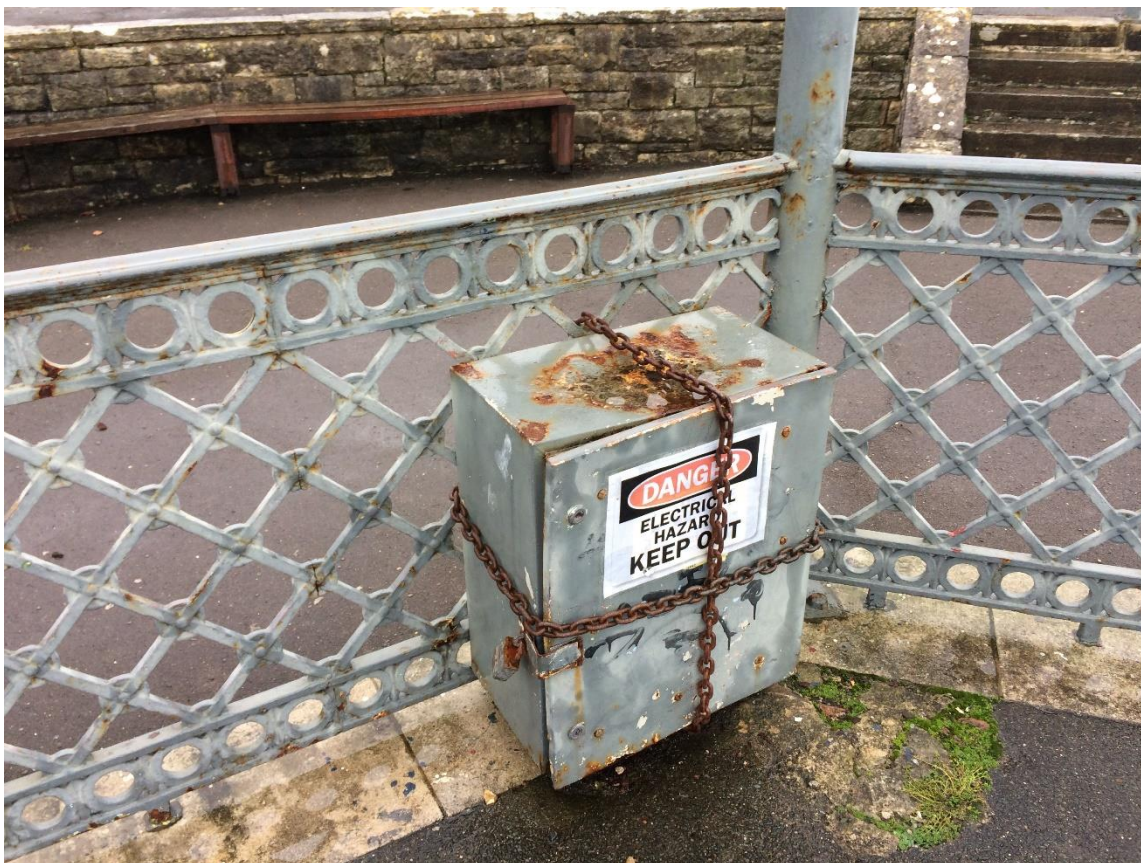
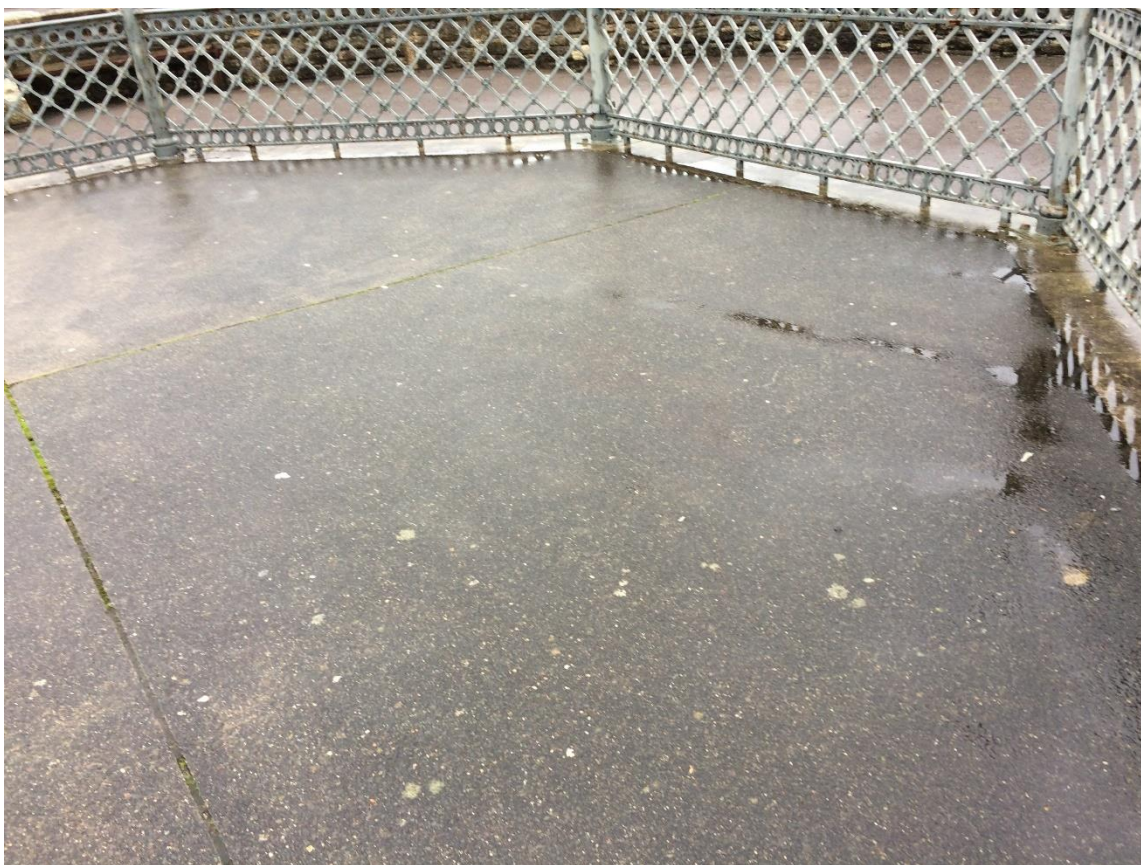
The electricity box shown to the top of the image above requires removal and an alternative location should be agreed. There is some damage to the surface in the area of the electricity box and this will require full reassessment once the electricity box has been removed. Any irregularities in the surface will constitute a Health and Safety risk and should be addressed as a matter of priority.

The electricity supply currently present is intrusive and unsuitable in the current position. It will require removal and replacement. Consideration should be given to the location and type of electrical supply, with options for a buried/raised type being explored.

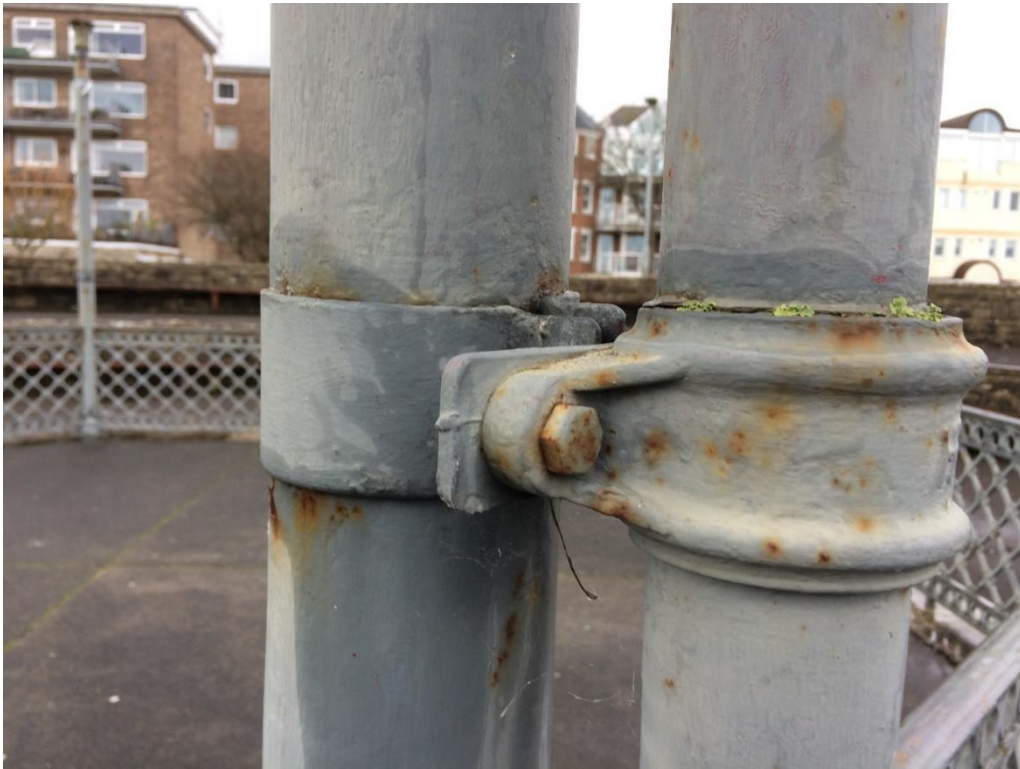
Image shows downpipe for drainage fixed to column B. The fixings for the drainage (also pictured below) are not original.

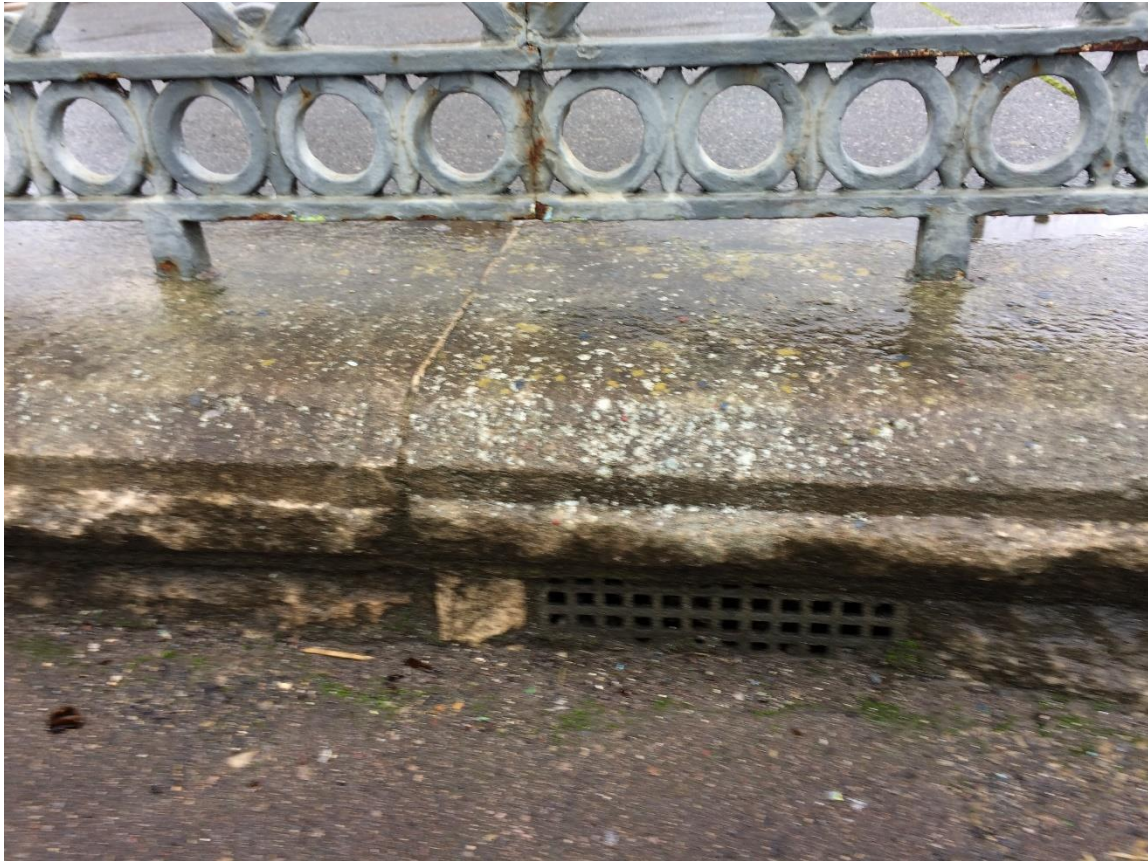
The cast iron air grilles located below the coping provide drainage, although this would not be the original intention and alternatives should be explored. There are 2 styles and all examples appear to be in sound condition.

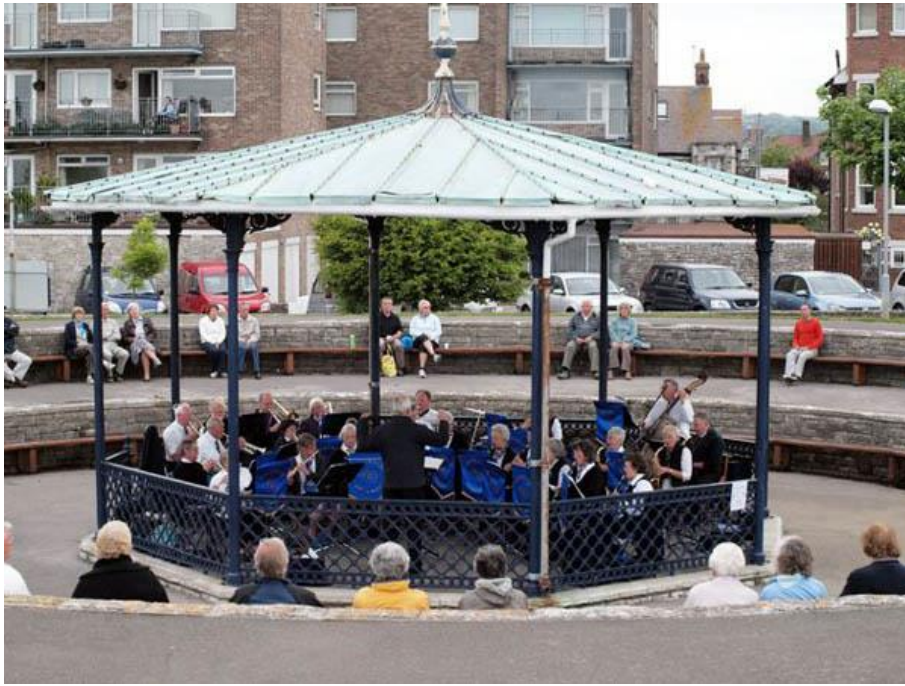
Located at the top of the columns, for each column there will be a Right and a Left column (as viewed from the outside). All the spandrels are currently missing and assuming that they have not been placed into storage, then they will require replacing with new castings that match the original. Additionally, further investigation will be required at the point at which the spandrels are fixed to the columns in order to determine the extent of any deterioration following exposure of the fitting sites to the weather following removal of the spandrels.

The image below shows the same pattern of spandrel as originally installed on the Swanage bandstand. These are pictured on the MacFarlane 224 pattern bandstand in Wandle Park, Croydon. The image also shows the roof and gutter embellishments, the corner antifixae and lions head gutter adornments. These had already been removed from the Swanage bandstand in 2010 and the non-original guttering is shown above.

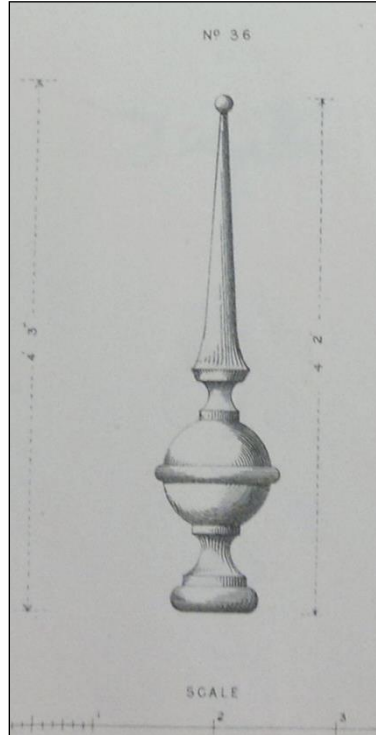
This cast iron component is missing and requires replacement. See illustration from the original Macfarlane catalogue below and can be seen in both images of the original Swanage bandstand and also remaining examples of the 224 pattern bandstands.
