## ASBESTOS MANAGEMENT SURVEY REPORT

**Site:** Street Parish Council, Street Parish Rooms, 6 Leigh Road, Street, Somerset, BA16 0HA

**Job Number:** J091121

**Survey Date:** 25th September 2018

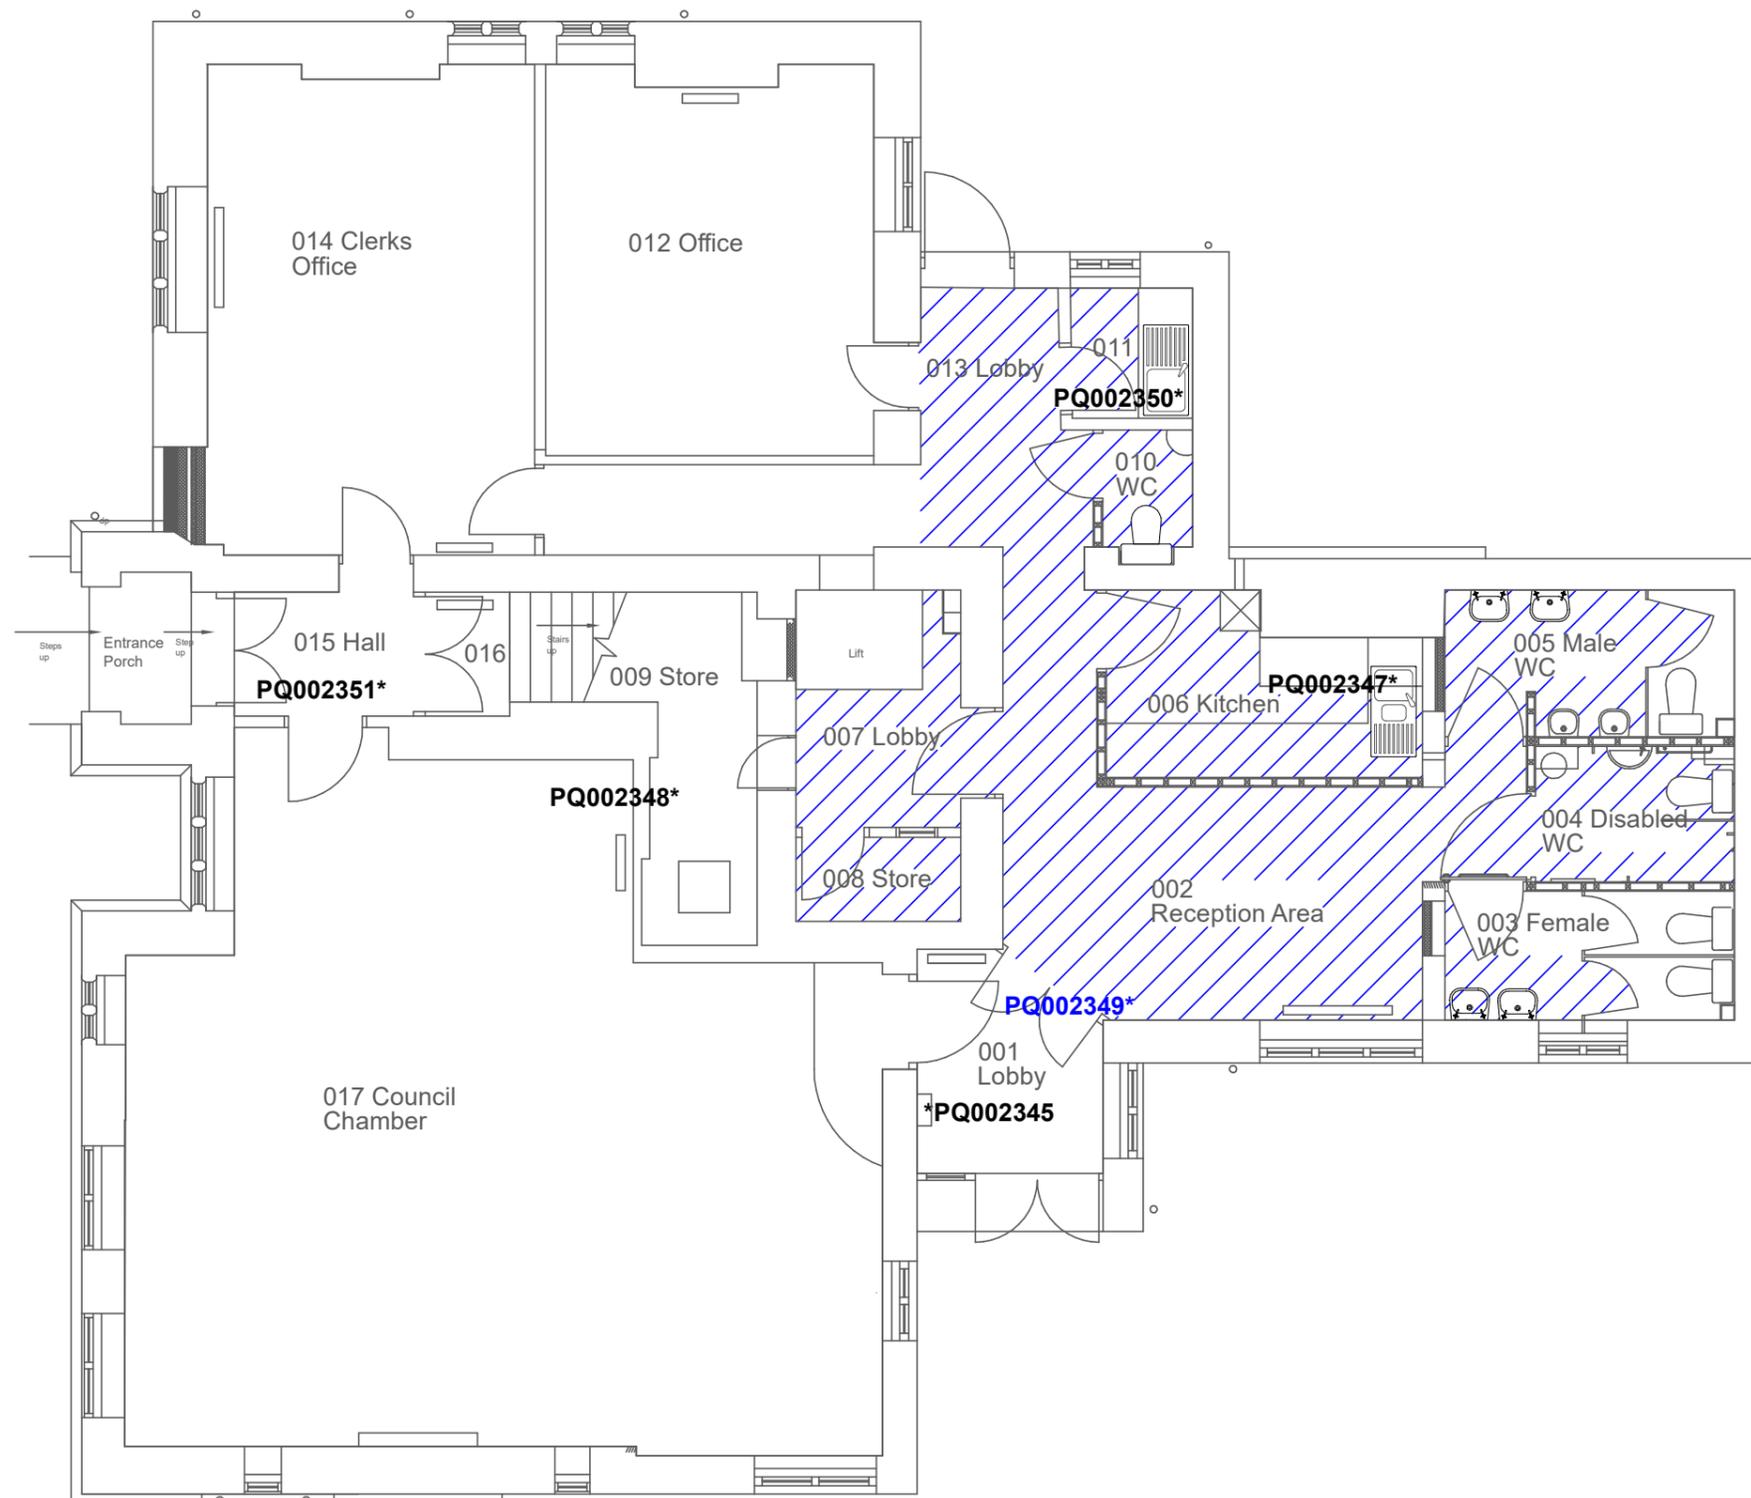
Sample Number	Building	Floor	Room	Material	Location Description	Recommendation	MA Score	PA Score	Overall Risk
PQ002349	01 Main Building	Ground Floor	Reception Area (002)	Bitumen / felt	Bitumen residue to underside of vinyl sheeting to floor	The material was in a generally good condition and should therefore be managed, it may be prudent to consider labelling where necessary	3	6	Low Risk
Visual 017	01 Main Building	External	External (001)	Cement	Cement undercloak to high level roof	The material was in a generally good condition and should therefore be managed, it may be prudent to consider labelling where necessary	6	2	Low Risk
