Basset Community Hub

Architectural Enabling Schedule of Works

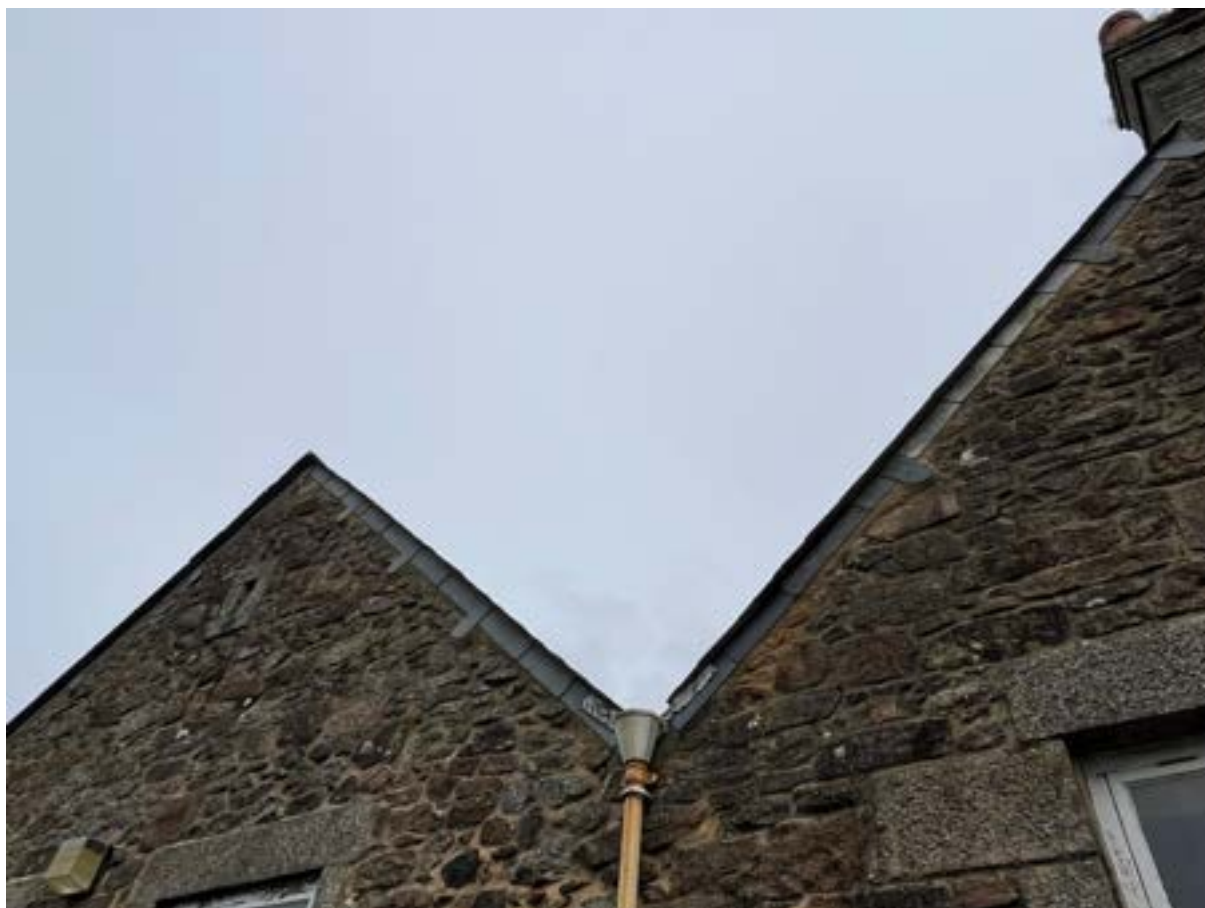
Some verges on Bassets House have external rafters exposed and are covered with slates known as scrips. In the photo below there are some decorative scrips, these will need to be replicated. Scrips are pinned to the rafter with copper nails.

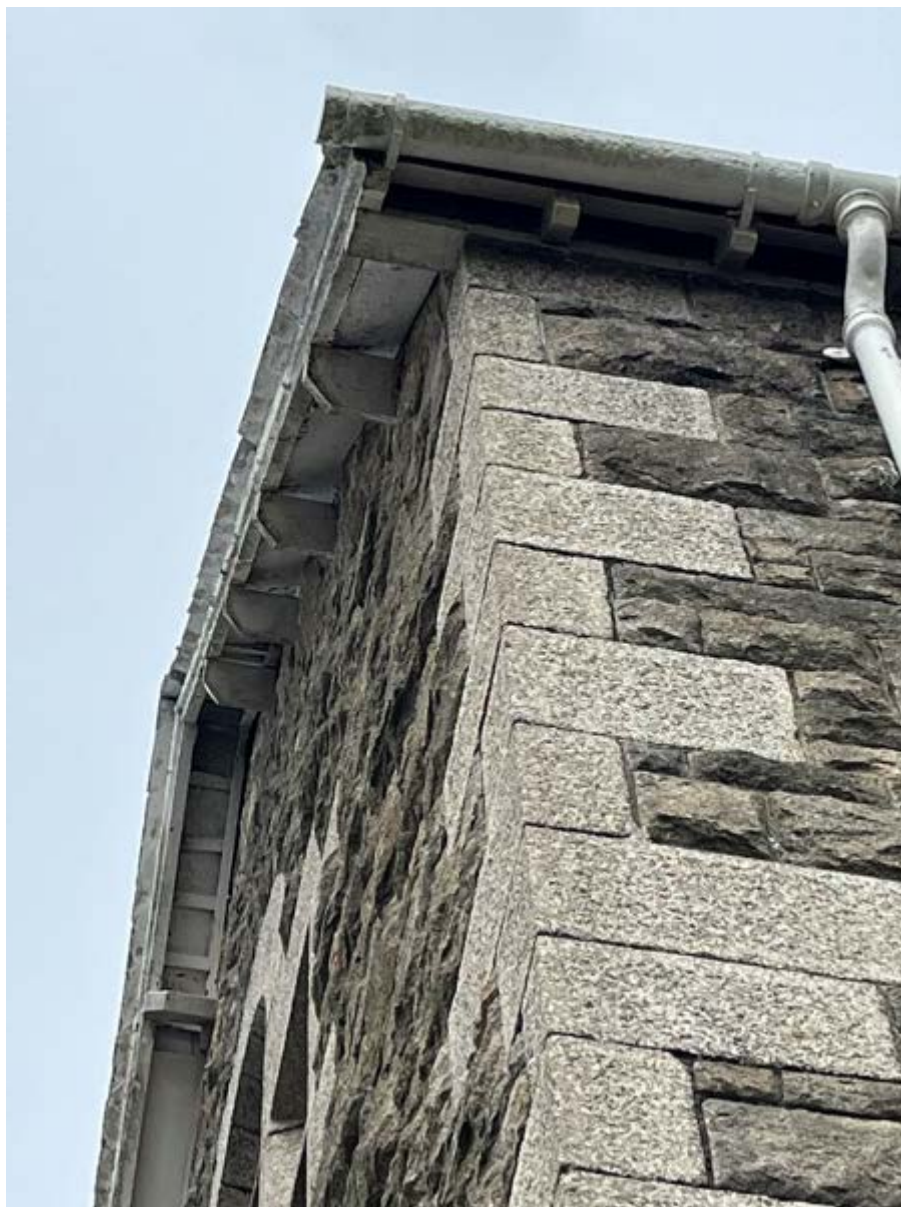
Bassets verge detail where purlin ends are exposed, detail to be confirmed when intrusive survey can be carried out.

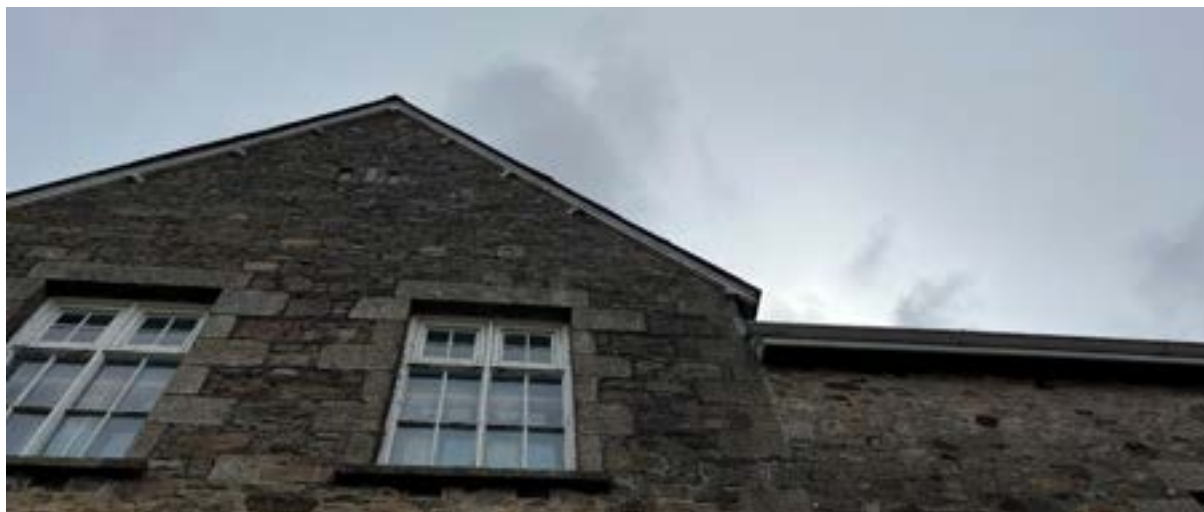
Basset House eaves with board finish, detail to be confirmed when intrusive survey can be carried out.

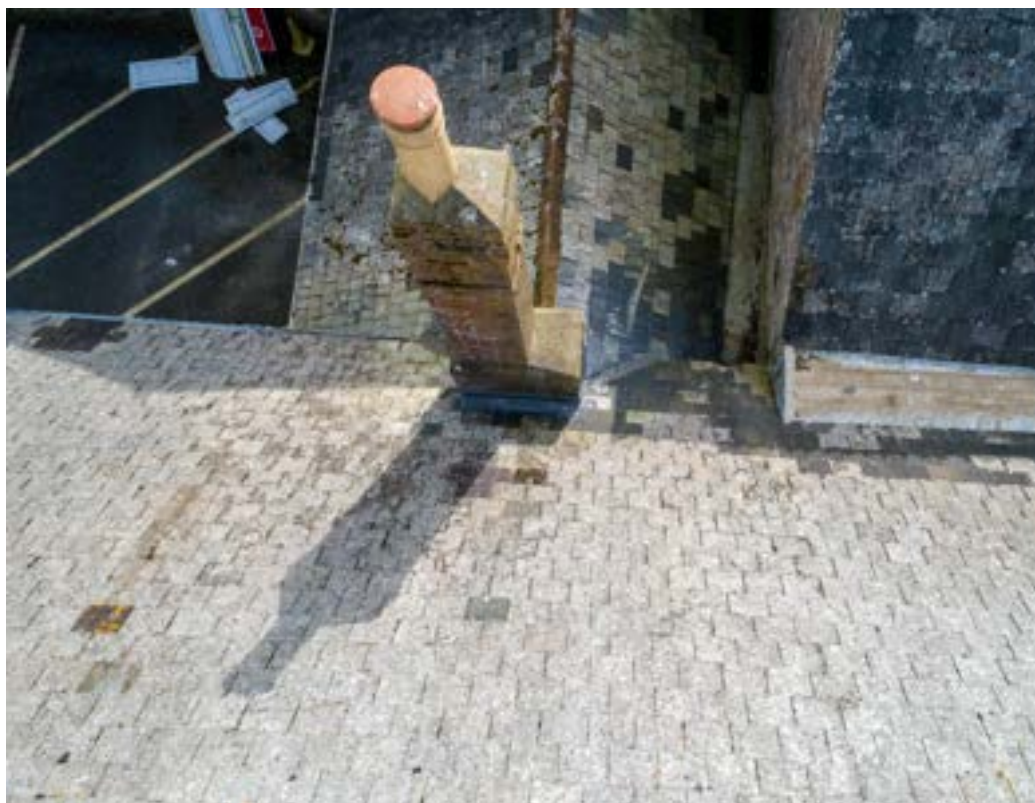
It appears that this chimney has already been altered, the single flue structure has been built off of an original two flue stack. The current flue that that has been flaunched over is currently unvented and it a potential source of dampness.

If chimney is not in service, demolish to below roof level, if chimney has no remaining external walls (as it appears from the roof photos), then cap both flues with concrete capping. Make good to roof timbers and covering over.

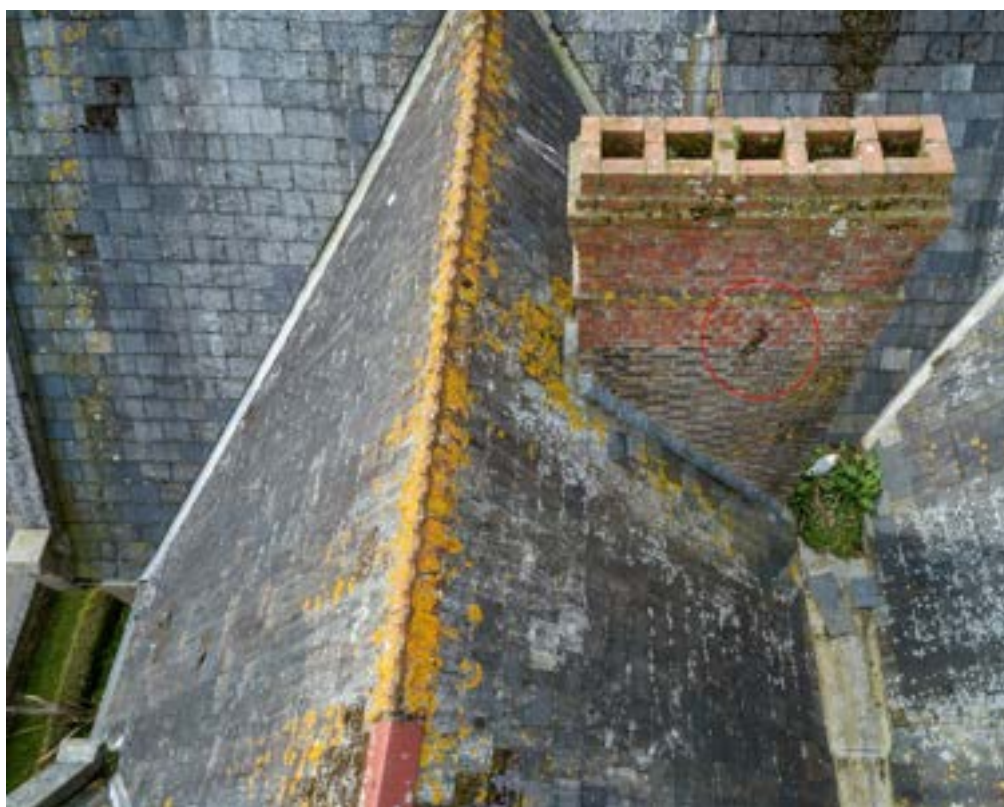
Inspect mortar, significant vegetation growth, mortar maybe friable. Remove vegetation and repoint top of stack.

Allow for replacement flashings to chimney with flashings pointed with lead pointing sealant.

Extra over cost for taking down and re-building top 6 courses, to match existing.

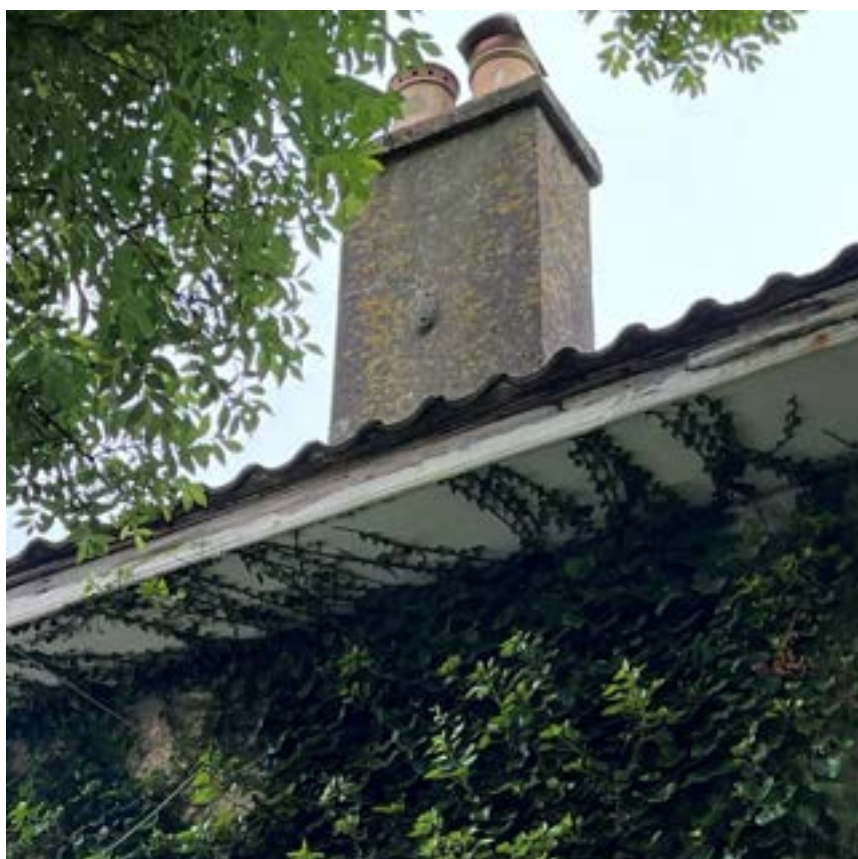
NOTE: There has been no drone survey of the White House roof, so following specification is based on ground level inspection.

Allow for replacement flashings to chimney with flashings pointed with lead pointing sealant.

Extra over cost for any repairs required to the render.

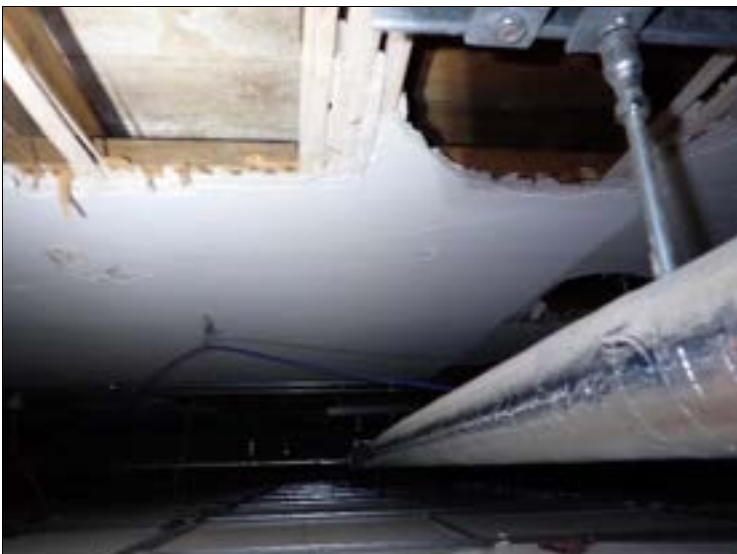
Photo Number	9	Sample Reference	For reference
	Plan Ref	GF01		
	Location	Office		
	Position / Description	Ceiling void		
	Note / Comments	No Action Required

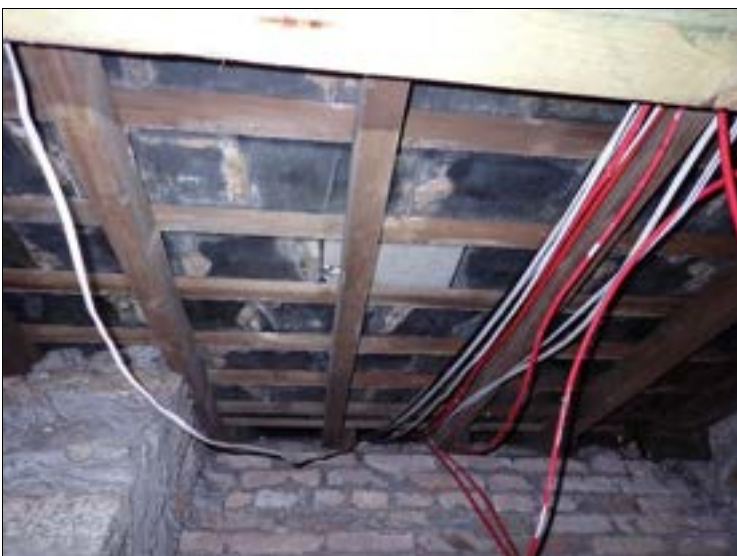
Photo Number	21	Sample Reference	S01
	Plan Ref	Loft		
	Location	Accessed from 1F02 Store		
	Position / Description	Replacement roof tiles		
	Note / Comments	No Action Required

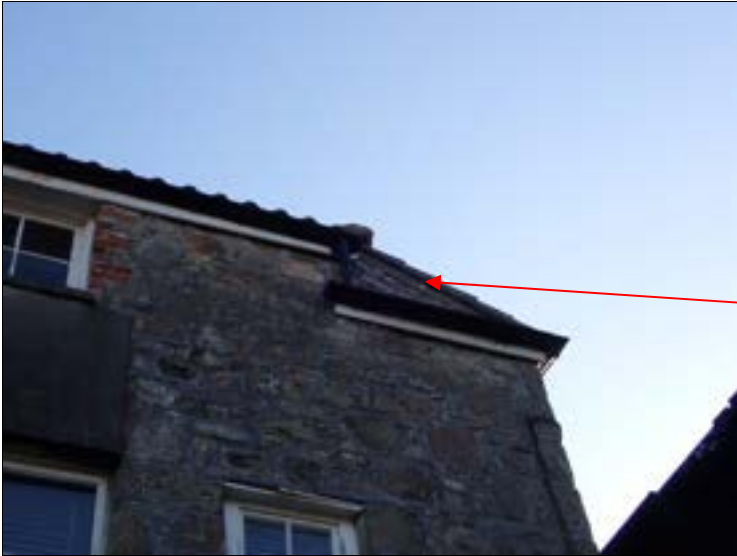
Photo Number	4	Sample Reference	Strongly Presumed
	Plan Ref	External		
	Location	Main Building		
	Position / Description	Asbestos Cement Undercloaking		
	Note / Comments	Manage and re-inspect or remove by an Unlicensed Asbestos Removal Contractor who has the appropriate insurance, training and following a safe system of work

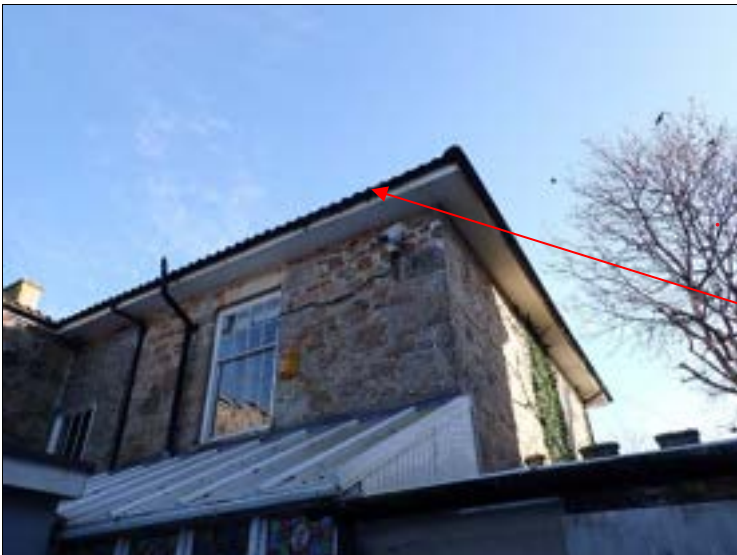
Photo Number	5	Sample Reference	No Access
	Plan Ref	External		
	Location	Main Building		
	Position / Description	Guttering		
	Note / Comments	No Access due to height

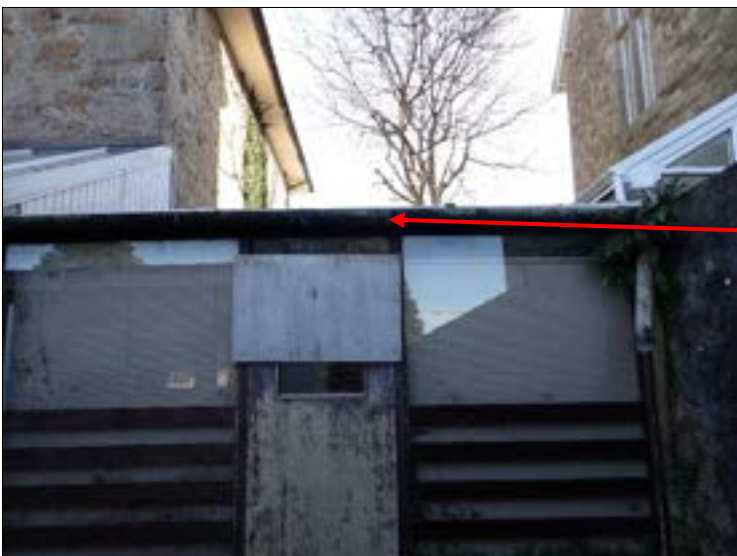
Photo Number	6	Sample Reference	S16
	Plan Ref	External		
	Location	Store		
	Position / Description	Asbestos Cement rain water goods		
	Note / Comments	Remove by an Unlicensed Asbestos Removal Contractor who has the appropriate insurance, training and following a safe system of work

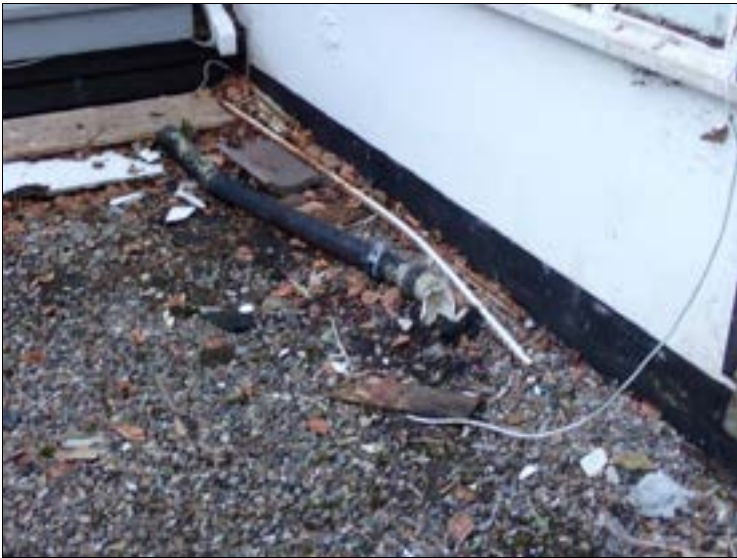
Photo Number	7	Sample Reference	S16
	Plan Ref	External		
	Location	Store		
	Position / Description	Asbestos Cement rain water goods debris		
	Note / Comments	Remove by an Unlicensed Asbestos Removal Contractor who has the appropriate insurance, training and following a safe system of work

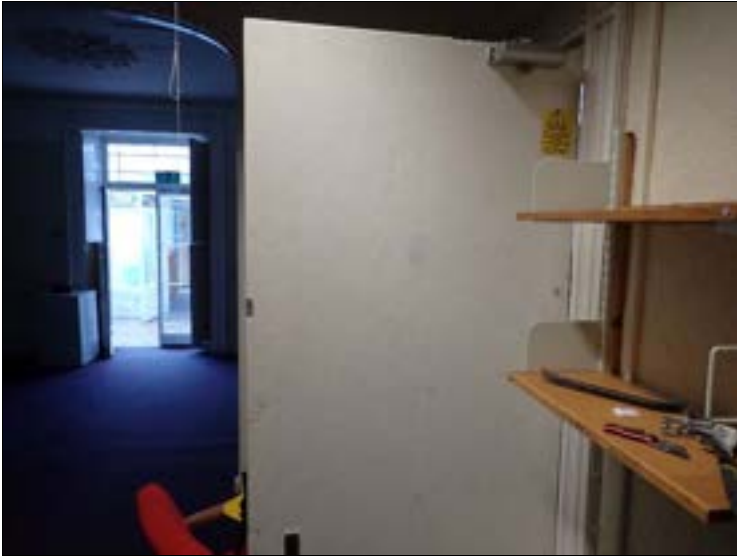
Photo Number	16	Sample Reference	S03
	Plan Ref	GF02		
	Location	Office		
	Position / Description	Asbestos Insulating Board panel to door		
	Note / Comments	Remove by an Unlicensed Asbestos Contractor who has the appropriate insurance, training and following a safe system of work (subject to risk assessment)

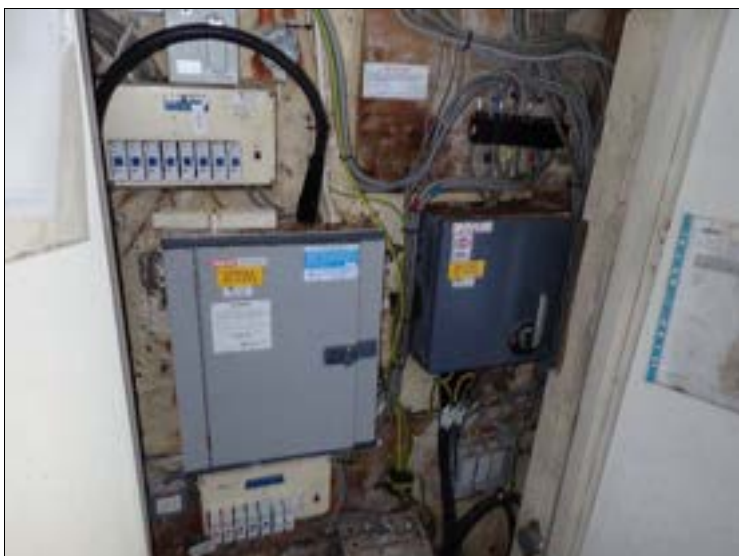
Photo Number	21	Sample Reference	No Access
	Plan Ref	GF14		
	Location	Electrical Room		
	Position / Description	Electrical switchgear		
	Note / Comments	No Access Gained

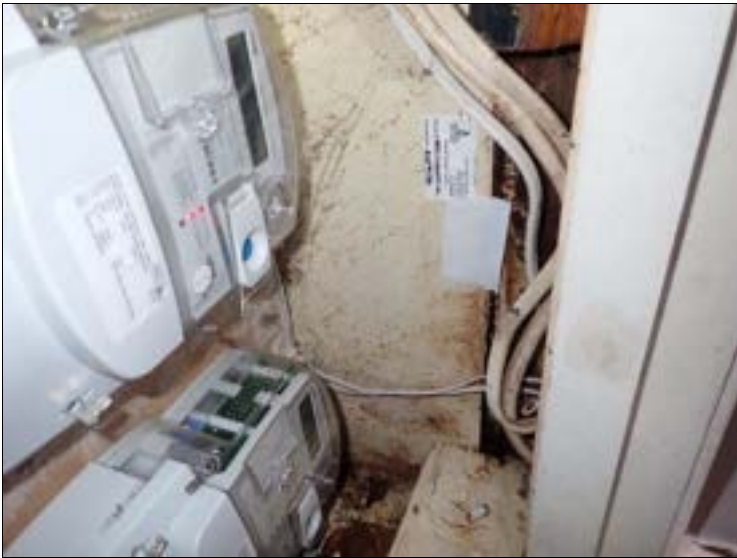
Photo Number	22	Sample Reference	S06
	Plan Ref	GF14		
	Location	Electrical Room		
	Position / Description	Asbestos Cement panel above electrical switchgear		
	Note / Comments	Remove by an Unlicensed Asbestos Contractor who has the appropriate insurance, training and following a safe system of work

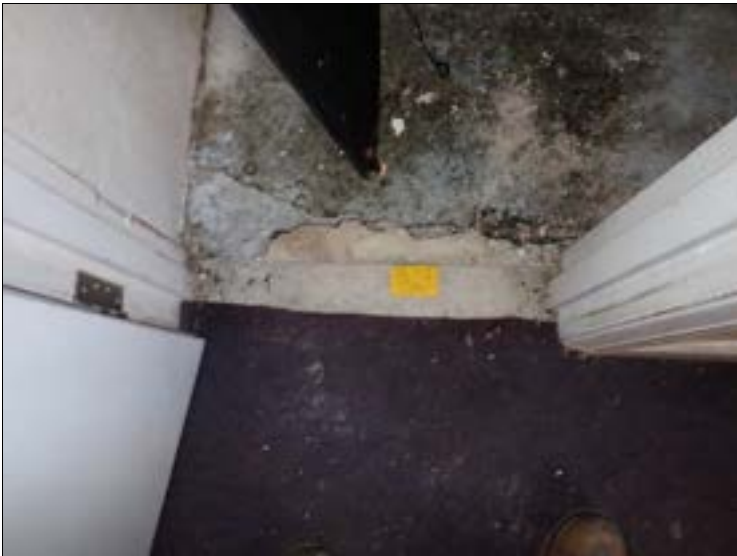
Photo Number	25	Sample Reference	AWS07
	Plan Ref	GF16		
	Location	Store		
	Position / Description	Vinyl floor tiles		
	Note / Comments	Remove by an Unlicensed Asbestos Contractor who has the appropriate insurance, training and following a safe system of work

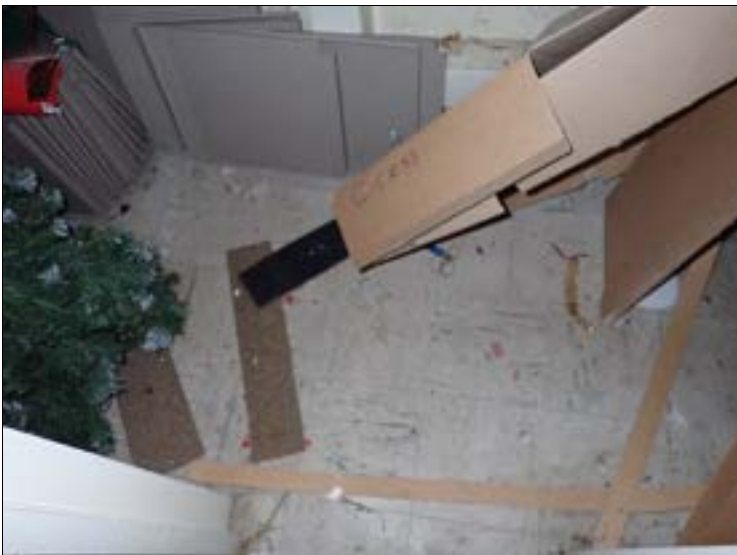
Photo Number	26	Sample Reference	AWS07
	Plan Ref	GF18		
	Location	Under stairs cupboard		
	Position / Description	Vinyl floor tiles		
	Note / Comments	Remove by an Unlicensed Asbestos Contractor who has the appropriate insurance, training and following a safe system of work

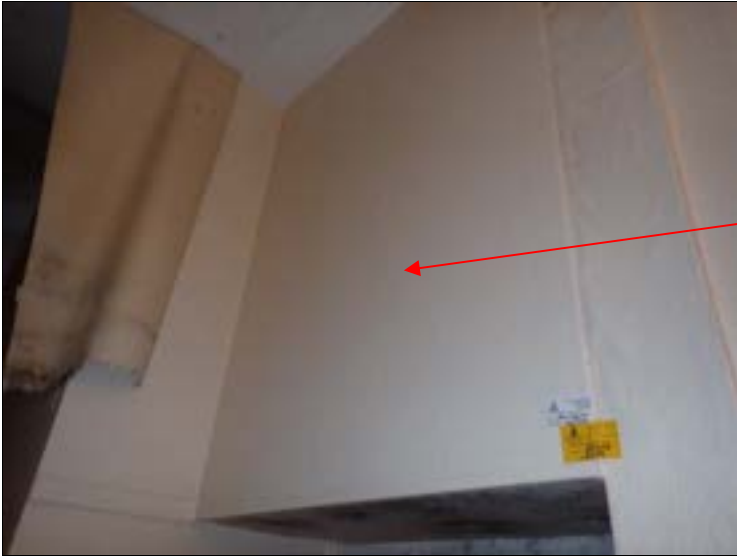
Photo Number	31	Sample Reference	S09
	Plan Ref	1F07		
	Location	Corridor		
	Position / Description	Asbestos Insulating Board panel to corridor		
	Note / Comments	Remove by a Licensed Asbestos Removal Contractor who has submitted a 14-day notification to the HSE

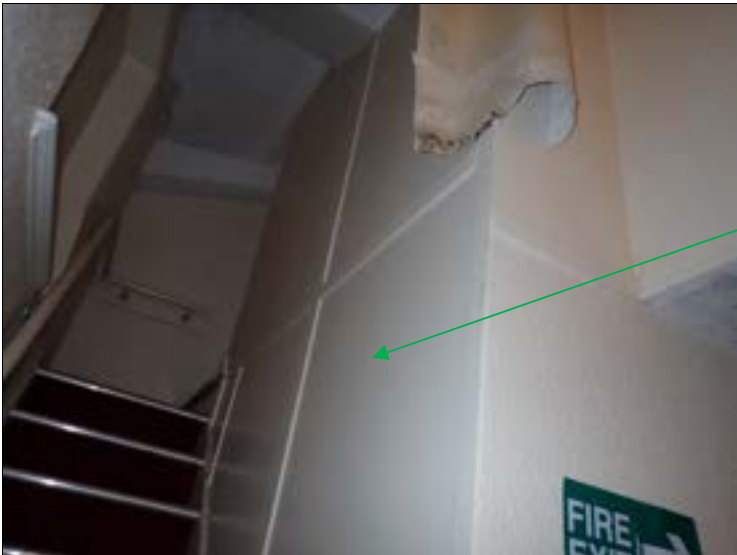
Photo Number	32	Sample Reference	S11
	Plan Ref	1F07		
	Location	Corridor		
	Position / Description	Panels to stairs		
	Note / Comments	No Action Required

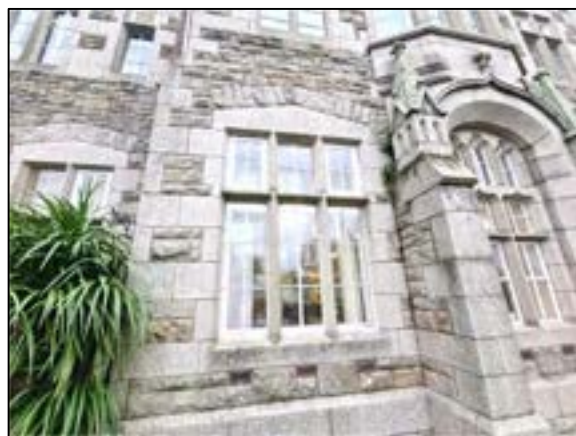
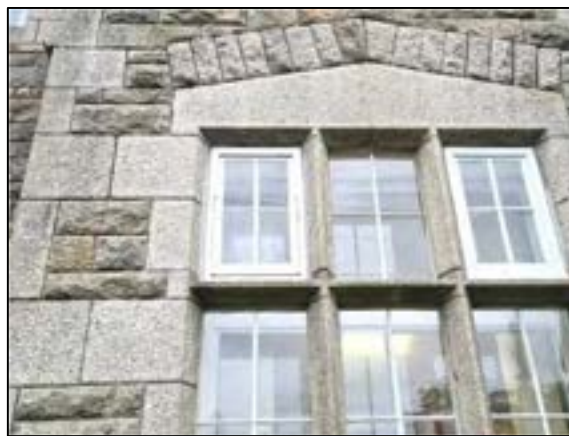
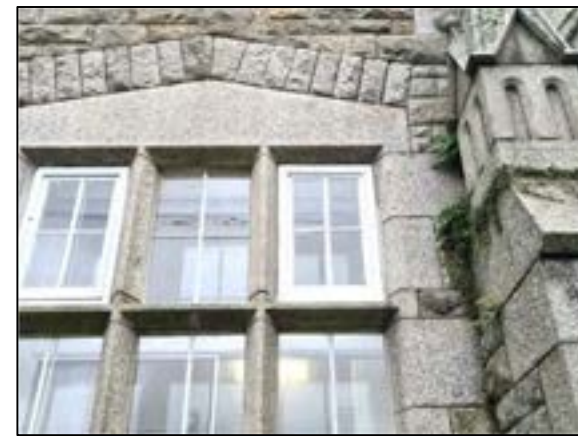
Type:	Secondary glazing:	Condition of glazing and glazing bars:	Condition of putty:	Jambs, stiles, rails, transoms and mullions:
Metal frame with timber subframe.	Provided.	A.	A.	B.

Cills:	Frame:	Hinges, cords, opening mechanisms, etc:	Paint:	Photos:
B.	B.	B.	C - Oxidised fixings.	5,6,7

Comments: This window is outside the scope of our survey however, for the purpose of thoroughness we include the timber sub frames to the top right and left hand sides. We recommend that these subframes are sanded, filled and decorated. We suggest that rusted fixings are removed and replaced with non-ferrous fixings.

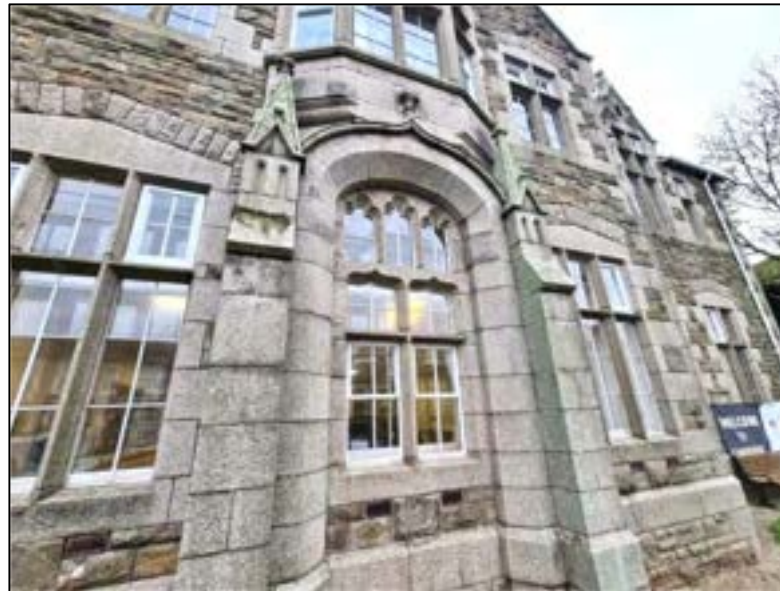
WINDOW NUMBER: BC-W04

Type:	Secondary glazing:	Condition of glazing and glazing bars:	Condition of putty:	Jambs, stiles, rails, transoms and mullions:
Metal frame.	Provided.

Cills:	Frame:	Hinges, cords, opening mechanisms, etc:	Paint:	Photos
				8

Comments: This window is outside the scope of our survey.

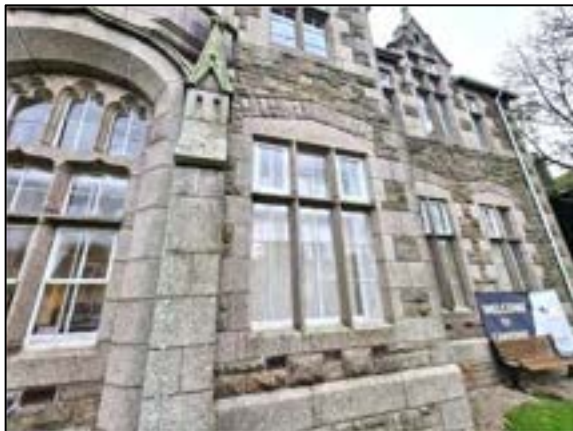
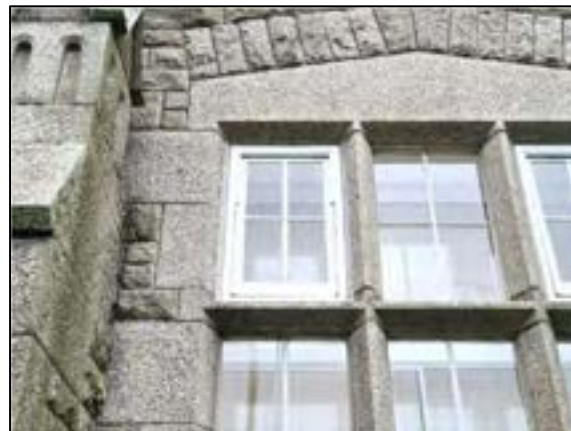
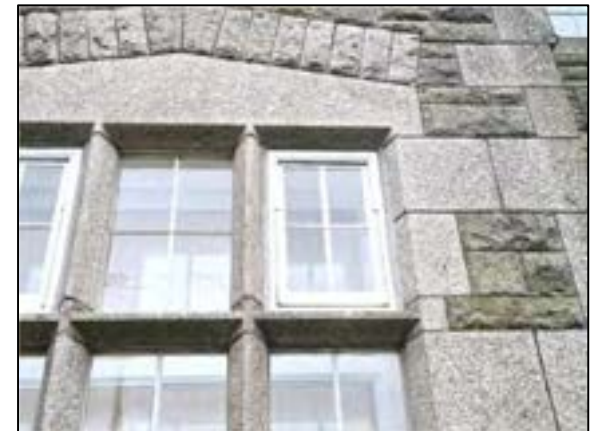
WINDOW NUMBER: BC-W05

Type:	Secondary glazing:	Condition of glazing and glazing bars:	Condition of putty:	Jambs, stiles, rails, transoms and mullions:
Metal frame with timber subframe.	Provided.	B.	A.	B.

Cills:	Frame:	Hinges, cords, opening mechanisms, etc:	Paint:	Photos:
B.	B.	C - Left hand side does not open. Right hand side does.	B.	9,10,11

Comments: This window is outside the scope of our survey however, for the purpose of thoroughness we include the timber sub frames to the top right and left hand sides. We recommend that these subframes are sanded, filled and decorated. Stone mullions require pointing.

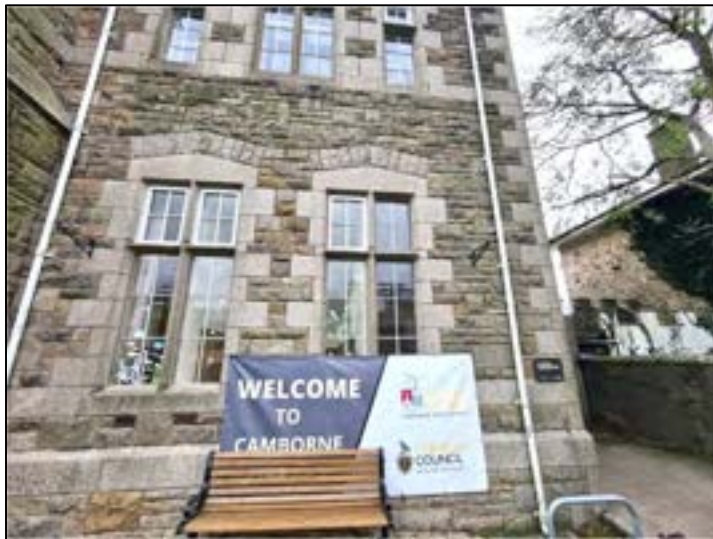
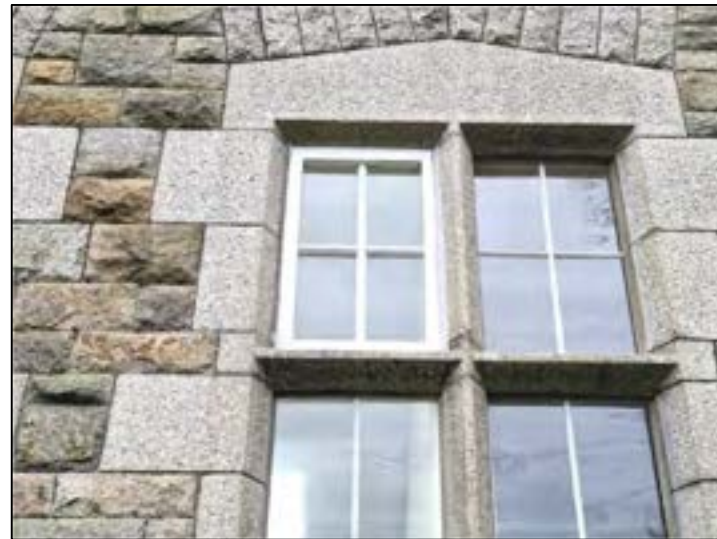
Type:	Secondary glazing:	Condition of glazing and glazing bars:	Condition of putty:	Jambs, stiles, rails, transoms and mullions:
Metal frame with timber subframe.	Not provided.	B.	A.	D - Left hand side poor.

Cills:	Frame:	Hinges, cords, opening mechanisms, etc:	Paint:	Photos:
C.	B.	No operable section.	C.	14,15

Comments: This window is outside the scope of our survey however, for the purpose of thoroughness we include the timber sub frame to the top left hand side. We recommend that this subframe is sanded, filled and decorated but is generally in good serviceable condition.

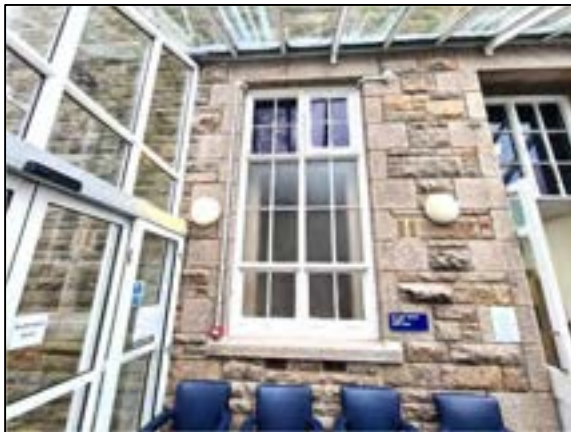
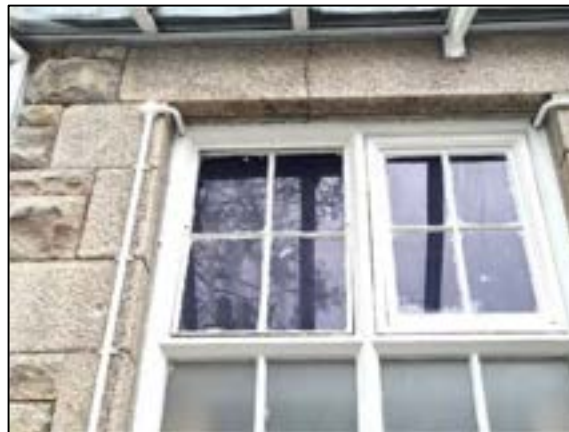
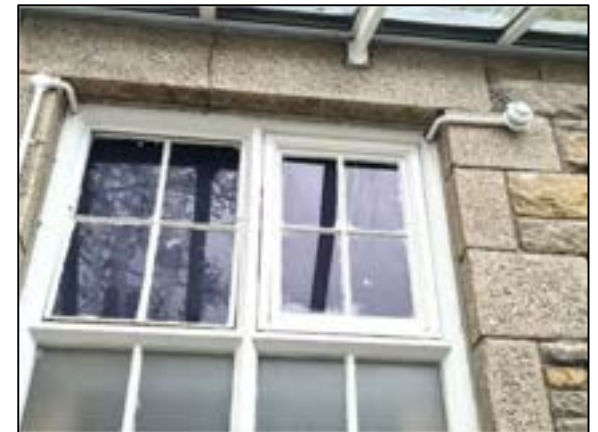
WINDOW NUMBER: BC – W08

Type:	Secondary glazing:	Condition of glazing and glazing bars:	Condition of putty:	Jambs, stiles, rails, transoms and mullions:
Timber frame with timber and metal subframes.	Not provided.	B.	A - Steel crittal sub frame window - D.	C - Top mullion slight rot.

Cills:	Frame:	Hinges, cords, opening mechanisms, etc:	Paint:	Photos:
B.	C - Scarf present to left hand side.	D - Painted shut.	C.	16,17,18,19,20,21,22,23,24,25

Comments: The granite lintel has cracked to the left of centre, replacement of the lintel is recommended. Shrinkage noted around the render externally, therefore requires sealant externally. The top mullion section may be repaired in situ, depending on the extent of the rot. Bottom windows do not open (painted shut). We note an existing scarf joint to the frame on the left hand side. The window would benefit from sanding, filling and painting. The upper section of windows could not be opened as they are within a void separated by a suspended ceiling however, the steel crittal window is ajar and is generally in a tired condition, this window would benefit from new putty and general maintenance works.

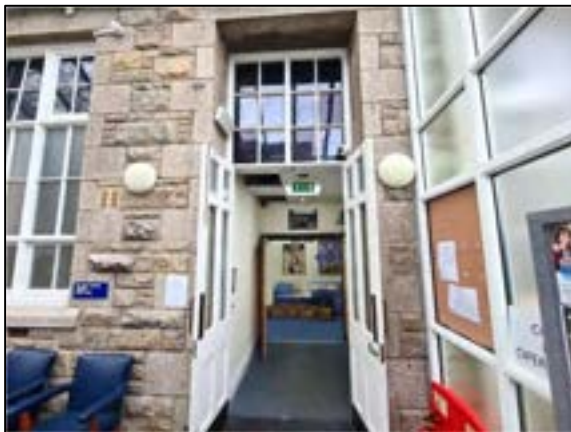
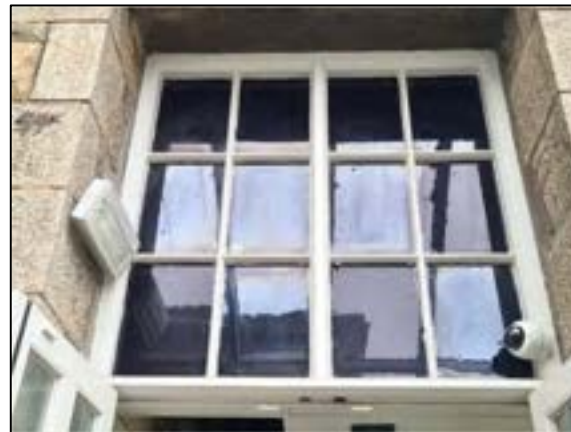
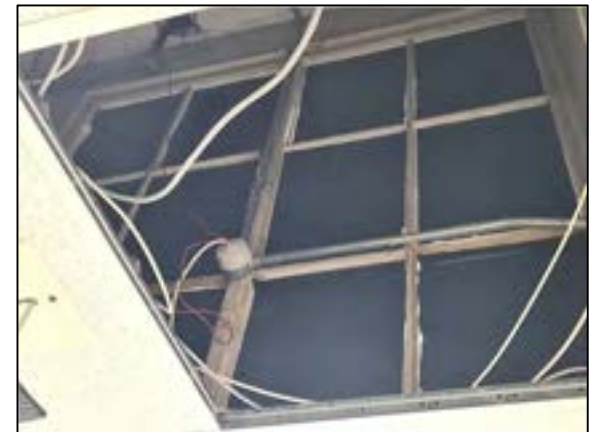
WINDOW NUMBER: BC – W09

Type:	Secondary glazing:	Condition of glazing and glazing bars:	Condition of putty:	Jambs, stiles, rails, transoms and mullions:
Timber frame with door below.	Not provided.	B.	C.	C - Deflection of transom by approx. 10mm.

Cills:	Frame:	Hinges, cords, opening mechanisms, etc:	Paint:	Photos:
N/A	B.	No operable section.	D.	26,27,28,29

Comments: Timber deflection to the transom of approx. 10mm. Therefore, we would recommend that the transom is replaced. Adjustment of the glazing bars may be required when carrying out the repair to the transom. General shrinkage around the external render and therefore would benefit from an external sealant application. General sanding, filling and painting required.

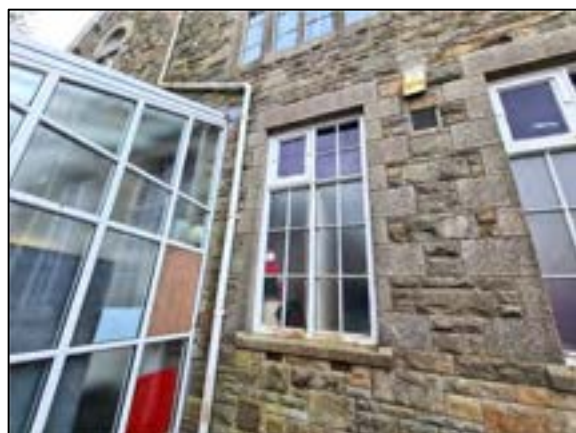
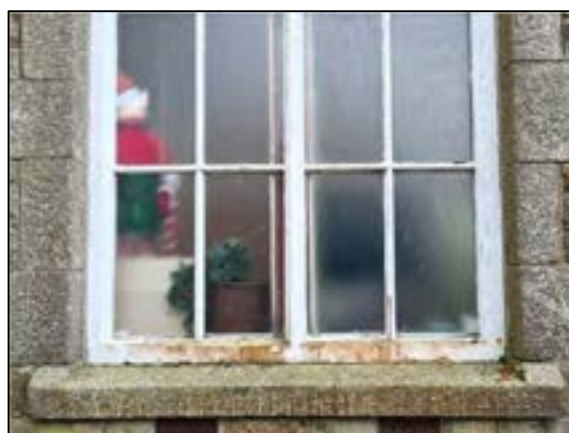
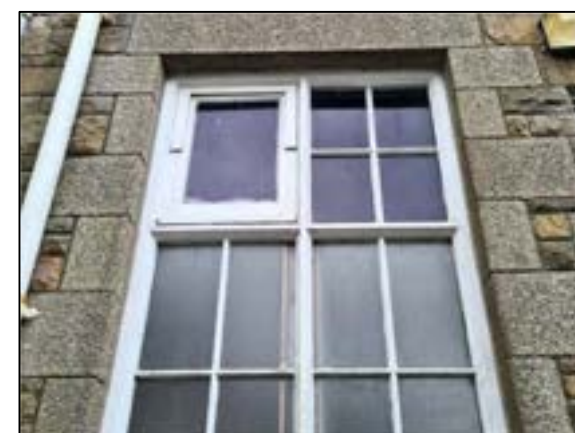
WINDOW NUMBER: BC – W10

Type:	Secondary glazing:	Condition of glazing and glazing bars:	Condition of putty:	Jambs, stiles, rails, transoms and mullions:
Timber frame – openable section to top left.	Not provided.	C - Only top left externally. Remainder internally.	C.	C - Scarf bottom left and right hand side.

Cills:	Frame:	Hinges, cords, opening mechanisms, etc:	Paint:	Photos:
D – rot to left and right hand side.	C.	With in suspended ceiling – not checked.	D.	30,31,32,33,34,35,36,37

Comments: Cill is in poor condition with rot throughout, recommend replacement in its entirety. Mullion at low level requires replacement with a scarfed piece, say approx., 300mm. Some moss/algae build up behind panes at low level. Would benefit from panes being removed, clean algae and apply external sealant. General sanding, filling and painting following remedial works. Seal between external render and window. The openable section could not be checked as this is within a ceiling void separated by a suspended ceiling.

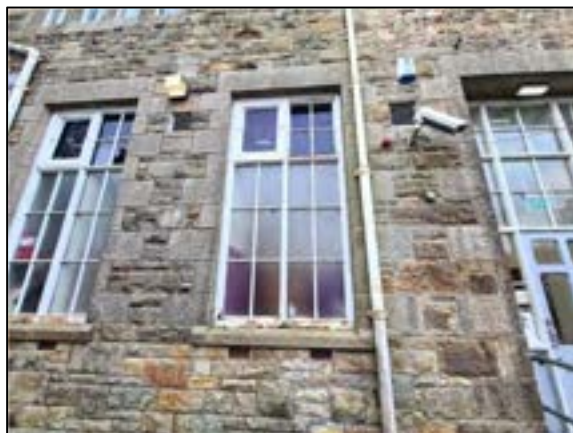
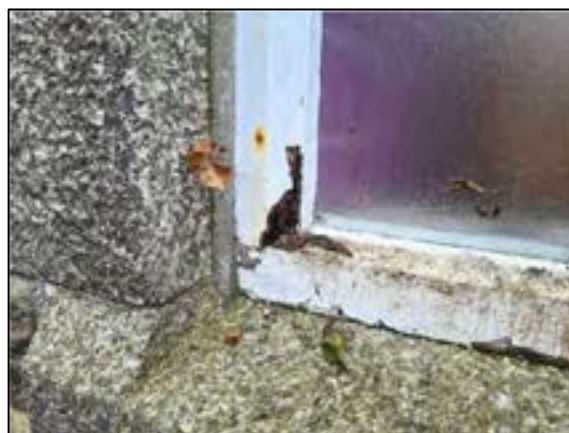
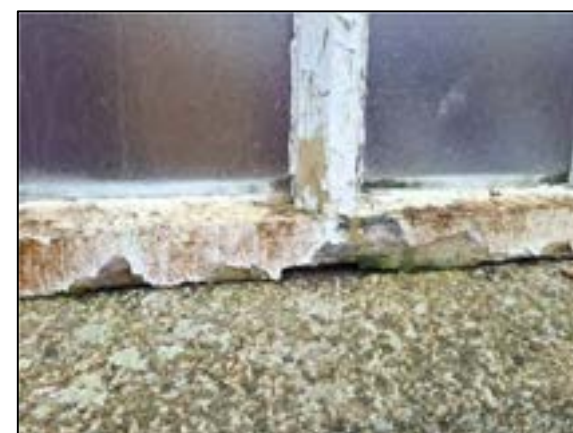
WINDOW NUMBER: BC – W11

Type:	Secondary glazing:	Condition of glazing and glazing bars:	Condition of putty:	Jambs, stiles, rails, transoms and mullions:
Timber frame – Metal subframe to top to right hand side. Top left hand side openable.	Not provided.	C - Only top left externally.	C – putty bottom.	D - Scarf bottom left and right hand side. Needs new scarf bottom left approx. 600mm.

Cills:	Frame:	Hinges, cords, opening mechanisms, etc:	Paint:	Photos:
E.	C.	Within suspended ceiling – not checked.	D.	38,39,40,41,42,43,44,45,46

Comments: Steel crittal subframe in very poor condition with extensive delamination of the steel elements. To the timber frame, an existing timber scarf to the left hand side has rotten and requires replacement approx. 600mm. The cill should be replaced in its entirety. General sanding, filling and painting required following remedial works. The openable widows could not be checked internally as they are within a suspended ceiling void. The steel crittal window has been left ajar and should be closed unless it has been left ajar for ventilation purposes.

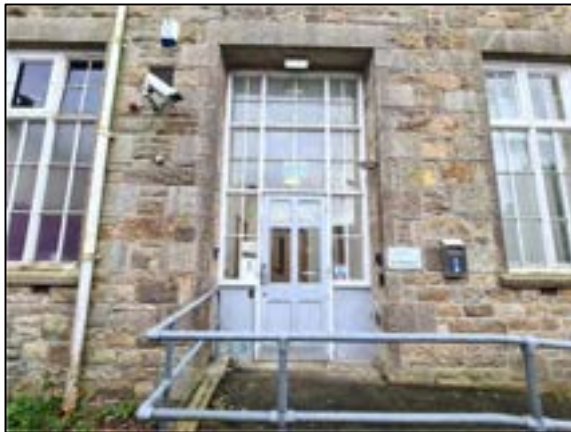
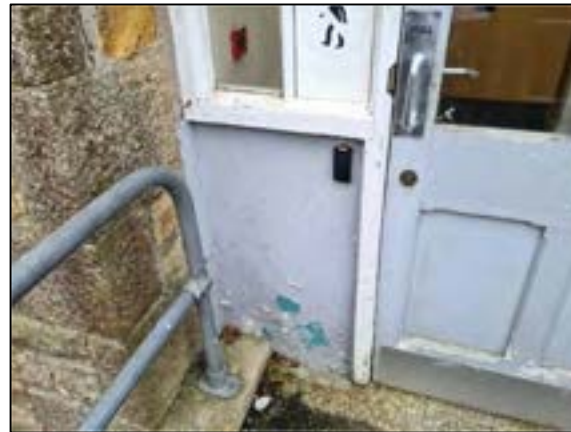
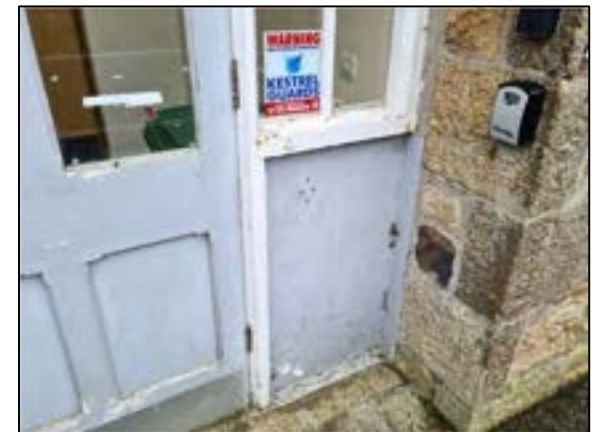
WINDOW NUMBER: BC – W12

Type:	Secondary glazing:	Condition of glazing and glazing bars:	Condition of putty:	Jambs, stiles, rails, transoms and mullions:
Timber frame with timber door below and dwarf wall panelling.	Not provided.	B.	A.	B.

Cills:	Frame:	Hinges, cords, opening mechanisms, etc:	Paint:	Photos:
B.	B.	No openable section.	D.	47,48,49,50,51,52,53,54,55

Comments: Generally, in good condition with minor rust staining penetrating timber sections, replace with non-ferrous fixings. We recommend the timber elements are sanded, filled and painted. External sealant should be applied between the render/pointing and frame. We note that the dwarf walling either side of the door would also benefit from external decoration works.

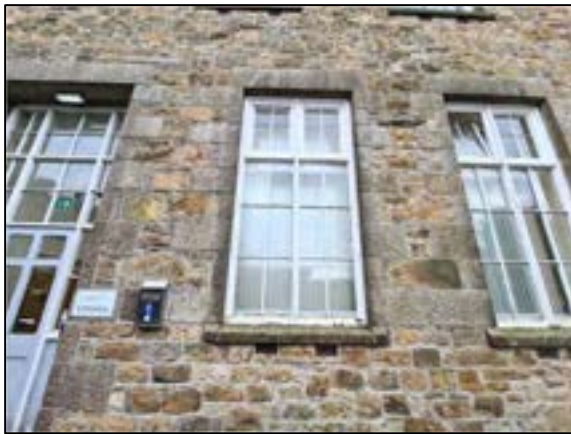
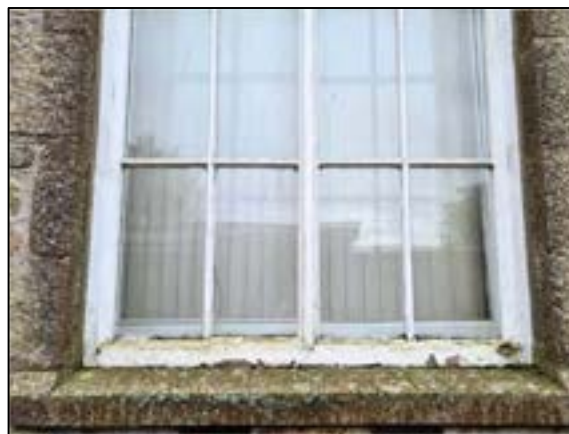
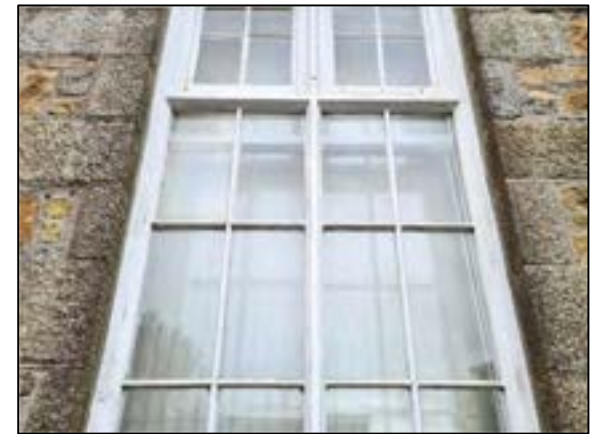
WINDOW NUMBER: BC – W13

Type:	Secondary glazing:	Condition of glazing and glazing bars:	Condition of putty:	Jambs, stiles, rails, transoms and mullions:
Timber frame with two openable sections to top.	Provided.	D - Internal only, glazing pane broken top left.	C – Apply sealant to bottom externally.	B.

Cills:	Frame:	Hinges, cords, opening mechanisms, etc:	Paint:	Photos:
B - Beginning to soften where paint is absent.	B.	C - Does not open, cord is slipping, requires servicing. Timber top – screw mech with cord on left hand side.	D - Rust staining.	56,57,58,59,60,61

Comments: Cill is beginning to deteriorate but considered salvageable. Some algae build up behind bottom panes. Remove panes, clean and refit with new putty, seal externally. Replace broken pane at top left. Some rust staining at top level. Fixings should be of galvanised or stainless steel (non-ferrous). Generally, requires sanding, filling and painting following remedial works.

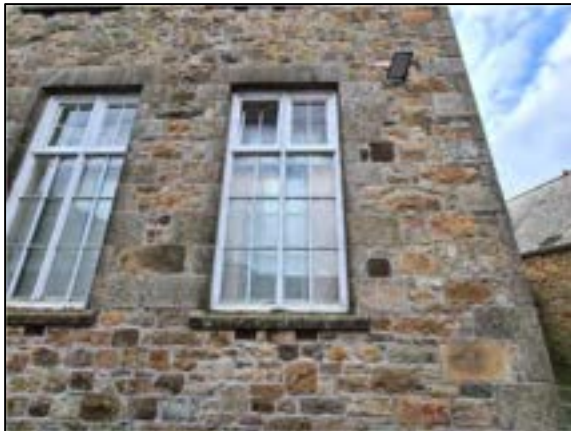
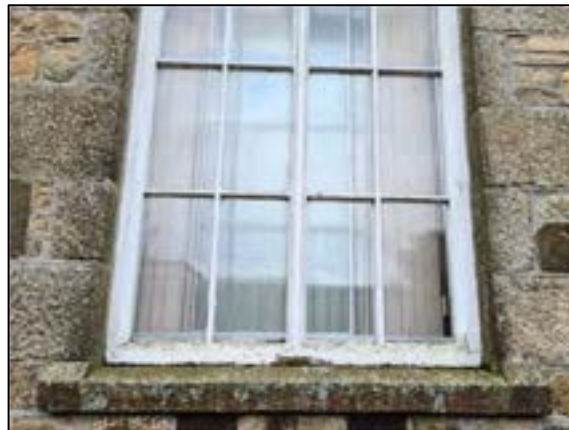
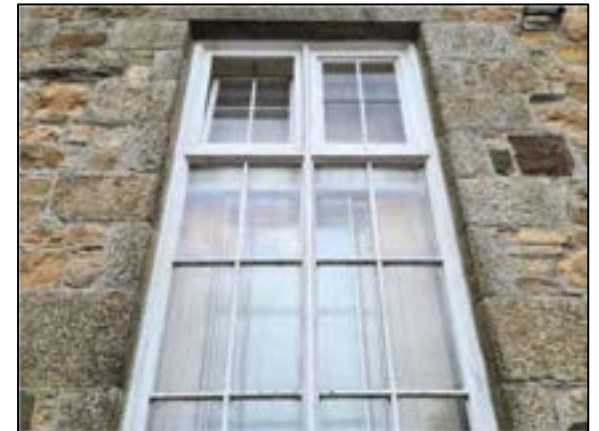
WINDOW NUMBER: BC – W14

Type:	Secondary glazing:	Condition of glazing and glazing bars:	Condition of putty:	Jambs, stiles, rails, transoms and mullions:
Timber frame - top left opens.	Provided. Difficult to manoeuvre.	D -Left hand side broken pane.	C – apply putty to bottom externally.	B.

Cills:	Frame:	Hinges, cords, opening mechanisms, etc:	Paint:	Photos:
C.	C - scarf to left hand side.	D - Difficult to open, requires servicing.	D.	62,63,64,65,66

Comments: Scarf required to left hand side of cill approx. 300mm and bottom left frame say 600mm. Replace broken pane to upper left hand side. The opening mechanism is difficult to operate and requires servicing. Would benefit from external sealant applied to bottom of panes at low level. General sanding, filling and painting following remedial works.
