Basset Community Hub

Architectural Enabling Schedule of Works

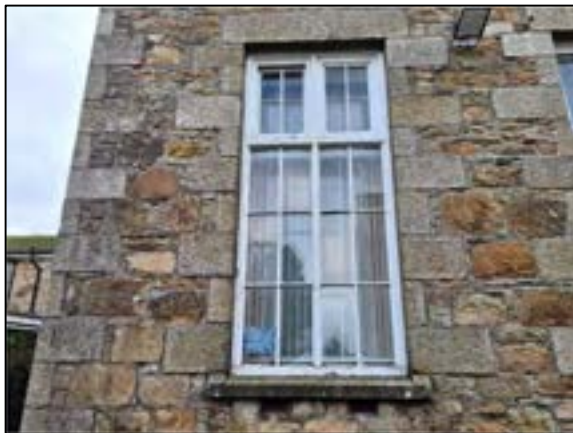
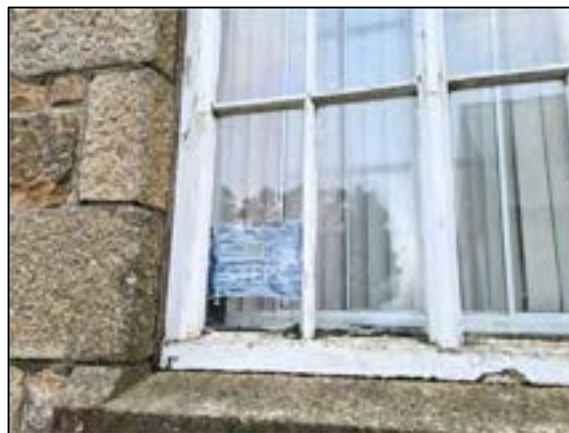
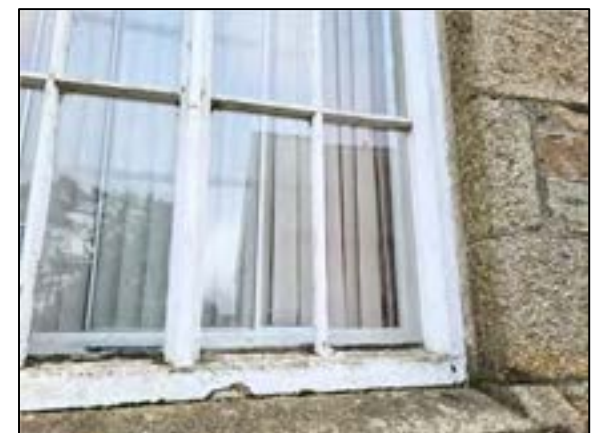
Type:	Secondary glazing:	Condition of glazing and glazing bars:	Condition of putty:	Jambs, stiles, rails, transoms and mullions:
Timber frame – top left opens.	Provided.	D - Bottom panes left and right side are broken.	D/C - Generally poor, putty to top is moderate.	C - Lower section of mullion previously scarfed.

Cills:	Frame:	Hinges, cords, opening mechanisms, etc:	Paint:	Photos:
C - left hand side 200mm and right side 100mm.	D - Poor to left and right hand side at low level approx. 500mm.	B.	D.	67,68,69,70,71,72,73,74,75,76,77

Comments: Putty in moderate condition, rake out and replace. Frame to left and right hand side require scarfs say approx. 500mm. Cill also requires replacement to left and right hand side, consider replacing whole cill. Two broken panes, replace before application of putty and remove algae/moss. Seal lower section of panes externally. Sand, fill and paint following remedial works.

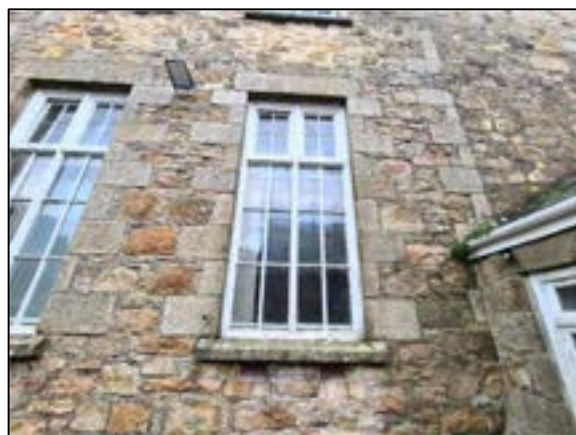
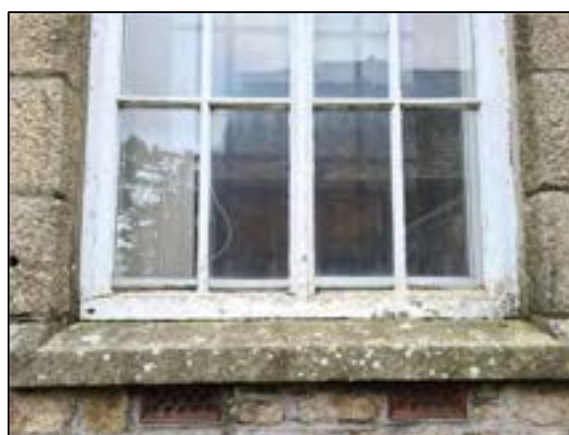
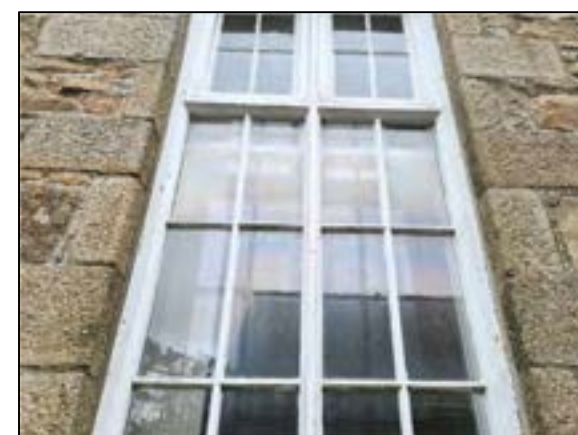
WINDOW NUMBER: BC – W16

Type:	Secondary glazing:	Condition of glazing and glazing bars:	Condition of putty:	Jambs, stiles, rails, transoms and mullions:
Timber frame – top left opens.	Provided.	B - Glazing.	C - Requires putty to bottom of window and putty to top.	D - Mullion is poor, requires 500mm scarf.

Cills:	Frame:	Hinges, cords, opening mechanisms, etc:	Paint:	Photos:
B - Requires painting. Additional render required to left hand side.	D - Left hand side is poor and requires 500mm scarf.	D - Difficult to open, requires servicing.	D.	78,79,80,81,82,83

Comments: To the left hand side of frame install 500mm scarf. Install 500mm scarf to lower section of mullion. Remove lower panes and clean algae/moss. Seal externally with sealant. Also, seal pointing with flexible sealant. Rake out putty and replace. Sand, fill and paint following remedial works. Some rust staining evident, fixings should be of galvanised or stainless steel (non-ferrous).

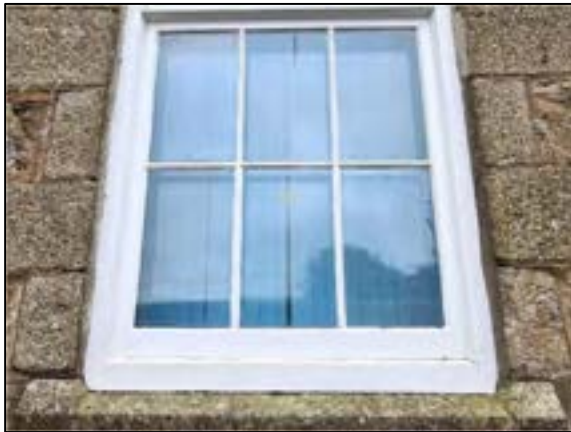
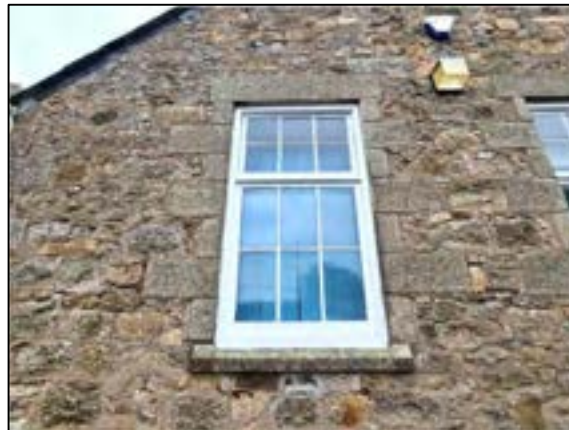
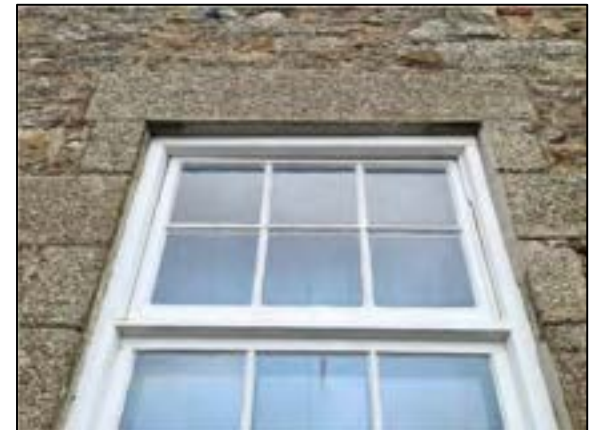
Type:	Secondary glazing:	Condition of glazing and glazing bars:	Condition of putty:	Jambs, stiles, rails, transoms and mullions:
Timber frame.	Provided.	A.	A.	A.

Cills:	Frame:	Hinges, cords, opening mechanisms, etc:	Paint:	Photos:
A.	A.	A.	A.	88,89,90

Comments: Recommend application of external flexible sealant around pointing and cill. Otherwise in good condition with minor rust staining to left hand side near transom. Slight gap (approx. 10mm) to openable section to right hand side when closed.

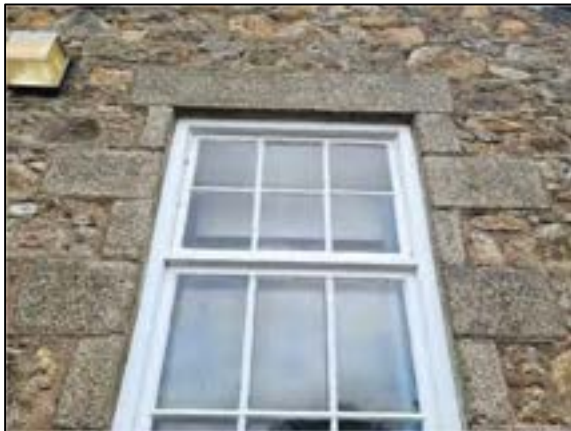
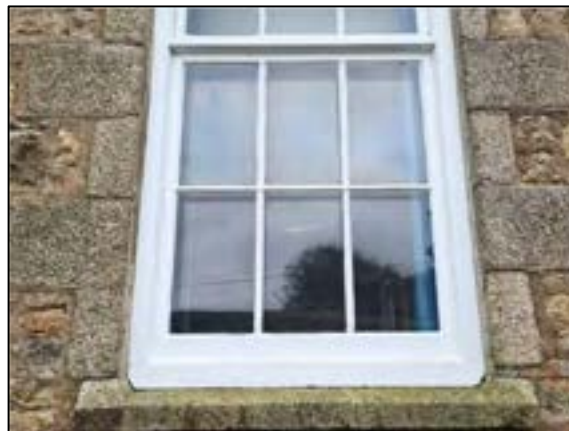
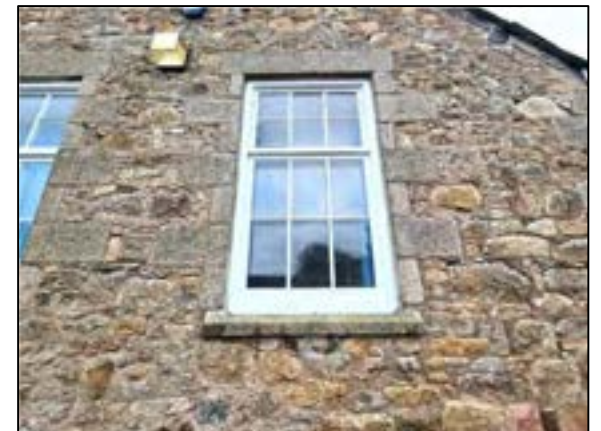
WINDOW NUMBER: BC - W22

Type:	Secondary glazing:	Condition of glazing and glazing bars:	Condition of putty:	Jambs, stiles, rails, transoms and mullions:
Timber frame.	Provided.	A.	A.	A.

Cills:	Frame:	Hinges, cords, opening mechanisms, etc:	Paint:	Photos:
A.	A.	A.	A.	91,92,93

Comments: Recommend application of external grade flexible sealant around pointing and cill. Generally, in good serviceable condition subject to periodic painting.

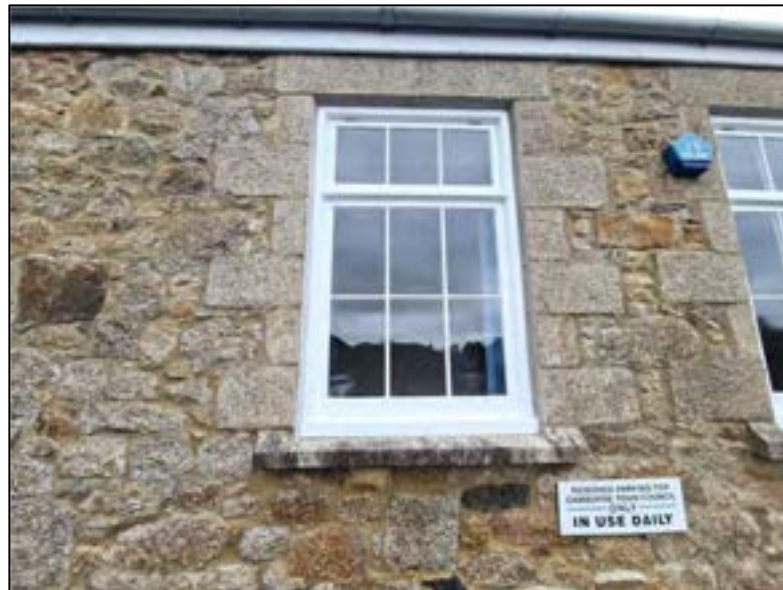
WINDOW NUMBER: BC - W23

Type:	Secondary glazing:	Condition of glazing and glazing bars:	Condition of putty:	Jambs, stiles, rails, transoms and mullions:
Timber frame.	Not provided.	A.	A.	A.

Cills:	Frame:	Hinges, cords, opening mechanisms, etc:	Paint:	Photos:
A.	A.	A.	A.	94

Comments: New window in good serviceable condition subject to periodic maintenance and painting.

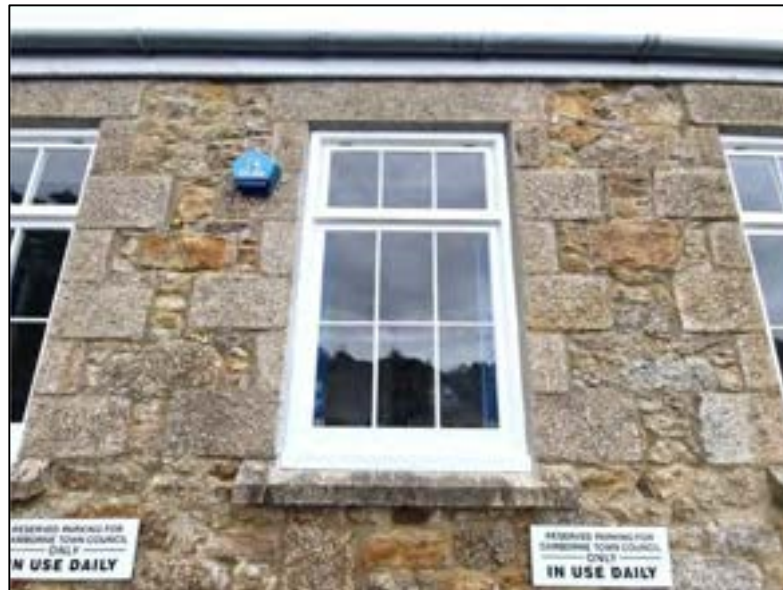
WINDOW NUMBER: BC – W24

Type:	Secondary glazing:	Condition of glazing and glazing bars:	Condition of putty:	Jambs, stiles, rails, transoms and mullions:
Timber frame.	Not provided.	A.	A.	A.

Cills:	Frame:	Hinges, cords, opening mechanisms, etc:	Paint:	Photos:
A.	A.	A.	A.	95

Comments: New window in good serviceable condition subject to periodic maintenance and painting.

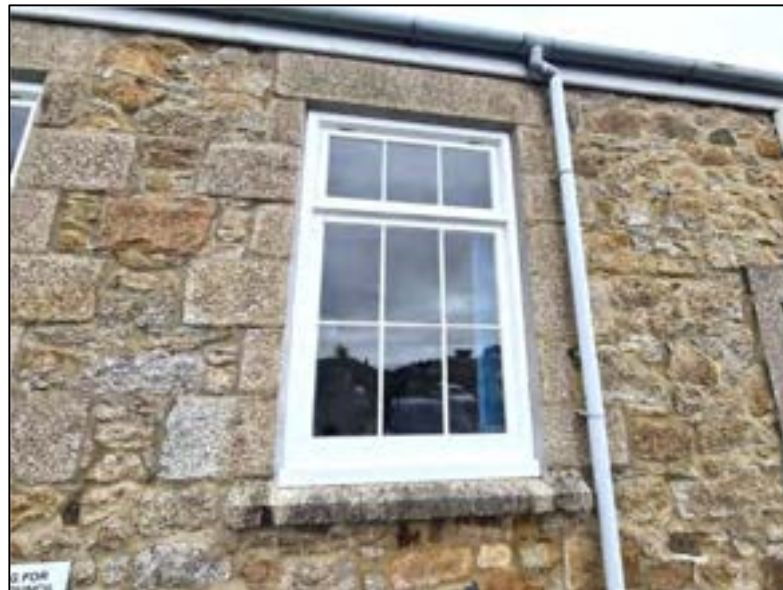
WINDOW NUMBER: BC – W25

Type:	Secondary glazing:	Condition of glazing and glazing bars:	Condition of putty:	Jambs, stiles, rails, transoms and mullions:
Timber frame.	Not provided.	A.	A.	A.

Cills:	Frame:	Hinges, cords, opening mechanisms, etc:	Paint:	Photos:
A.	A.	A.	A.	96

Comments: New window in good serviceable condition subject to periodic maintenance and painting.

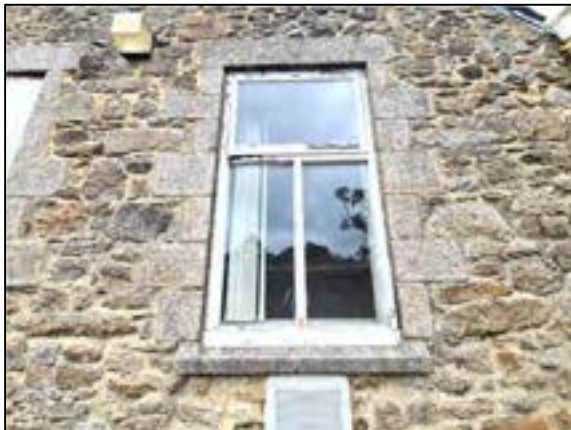
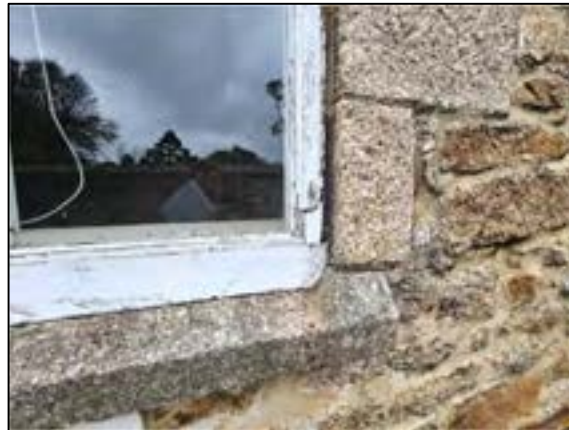
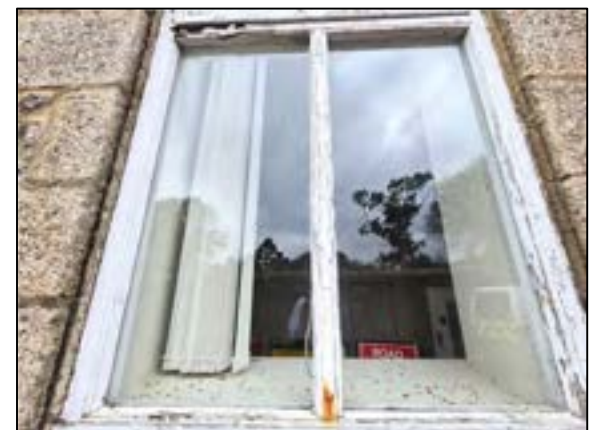
Type:	Secondary glazing:	Condition of glazing and glazing bars:	Condition of putty:	Jambs, stiles, rails, transoms and mullions:
Timber frame.	Not provided.	D.	C.	D.

Cills:	Frame:	Hinges, cords, opening mechanisms, etc:	Paint:	Photos:
C.	D.	Cord broken.	D.	98,99,100,101,102

Comments: Consider replacing whole window, cill maybe salvageable. Extensive rot throughout, beyond the point of economical repair.

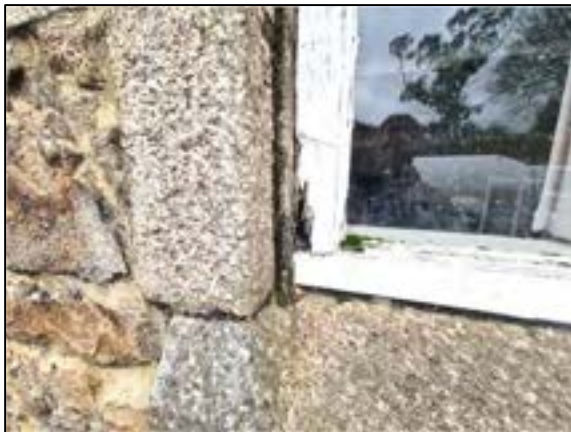
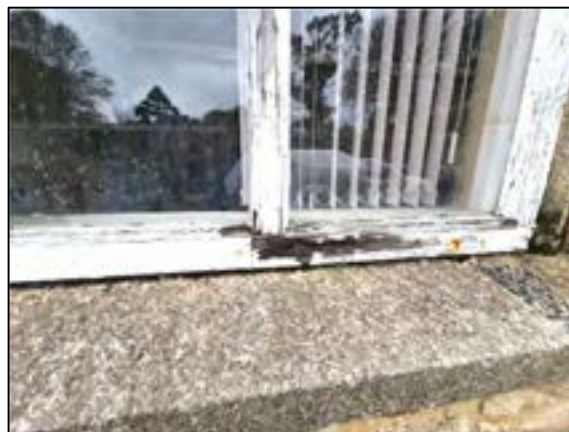
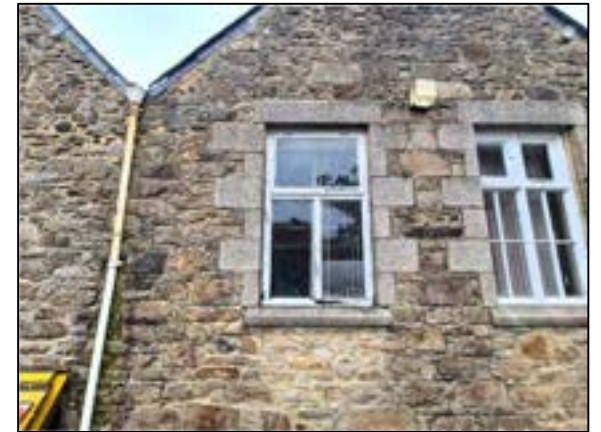
WINDOW NUMBER: BC – W28

Type:	Secondary glazing:	Condition of glazing and glazing bars:	Condition of putty:	Jambs, stiles, rails, transoms and mullions:
Timber frame. Openable section to top.	Not provided.	D.	D.	E.

Cills:	Frame:	Hinges, cords, opening mechanisms, etc:	Paint:	Photos:
E.	E.	C - Cord needs adjustment, does not shut.	D.	103,104,105,106

Comments: Extensive rot throughout. Beyond the point of economical repair. Replace whole window, glazing and hinges maybe salvageable. Opening mechanism requires adjustment, suggest replacement. Replace pointing with NHL3.5 and seal with flexible external graded silicone.

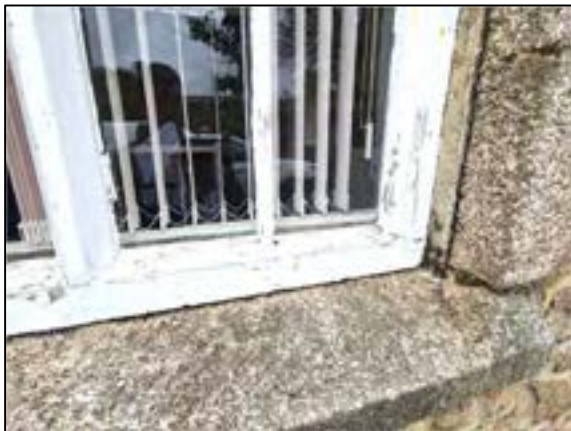
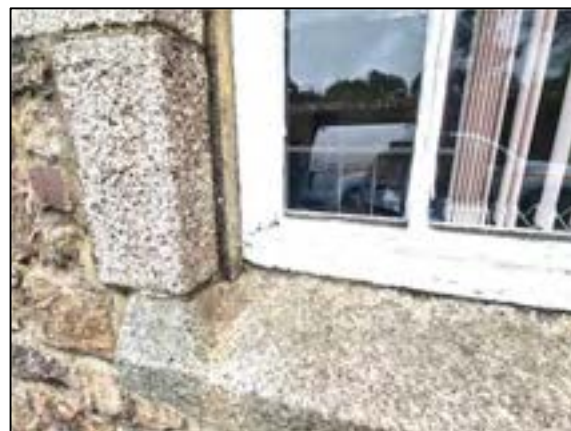
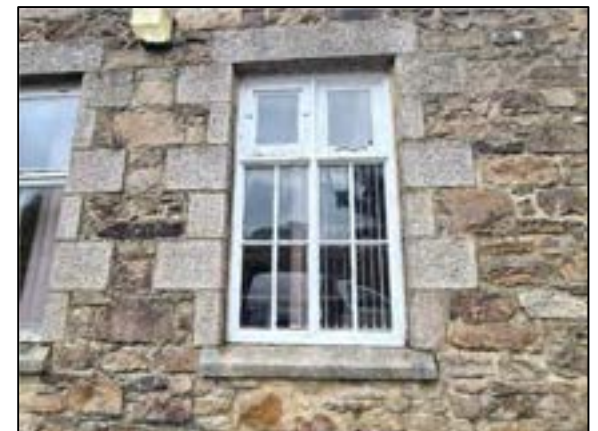
WINDOW NUMBER: BC – W29

Type:	Secondary glazing:	Condition of glazing and glazing bars:	Condition of putty:	Jambs, stiles, rails, transoms and mullions:
Timber frame – left hand side opens.	Not provided.	B.	D.	E - Right hand side stile. Right hand side existing scarf to replace.

Cills:	Frame:	Hinges, cords, opening mechanisms, etc:	Paint:	Photos:
B.	D - Poor to right hand side.	B – NB. Brass turn screw.	D.	107,108,109,110

Comments: Remove pointing to both sides. Replace right hand side of frame and scarf 500mm to the left hand side. To the openable section replace the top and bottom rails and provide new trickle vent to right hand side. Replace right hand side of cill, consider whole replacement of cill. Sand whole window after carrying out timber repairs and fill where required. Rake out all putty and apply new, allow to cure and paint. Repoint in NHL3.5 and apply flexible externally graded silicone to pointing and bottom panes.

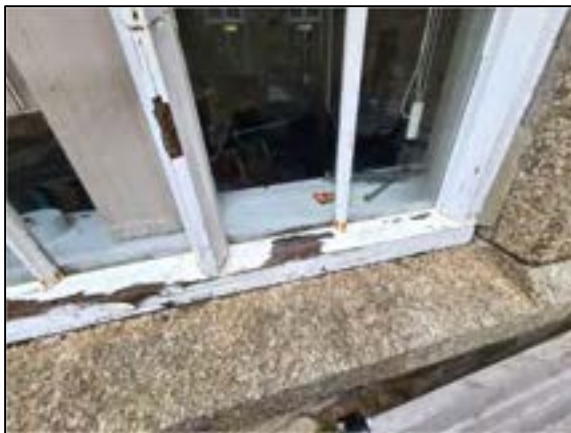
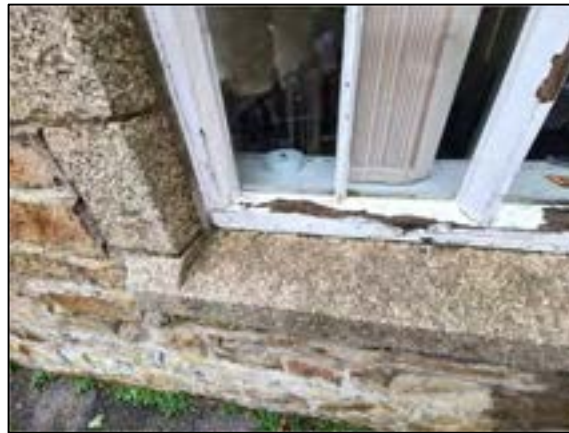
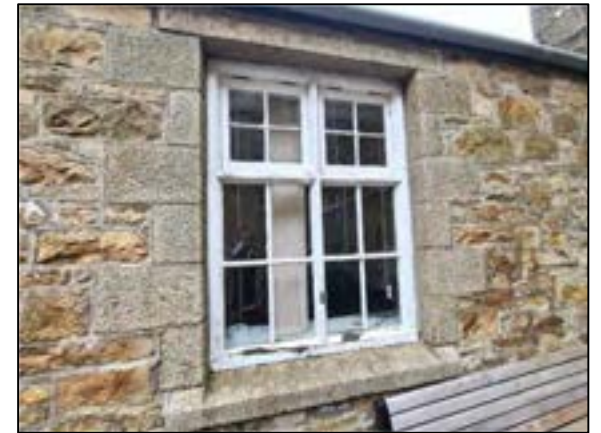
WINDOW NUMBER: BC – W30

Type:	Secondary glazing:	Condition of glazing and glazing bars:	Condition of putty:	Jambs, stiles, rails, transoms and mullions:
Timber frame – two openable sections.	Not provided.	B - Glazing C – Glazing bars.	C.	C - Replace existing scarf mullion by 500mm to bottom.

Cills:	Frame:	Hinges, cords, opening mechanisms, etc:	Paint:	Photos:
E.	C - Left and right existing scarfs to replace.	B – Metal latch lift and extend x 2.	E.	111,112,113,114,115

Comments: Rake out existing pointing and remove window. Replace entire cill. Replace existing scarfs to right and left hand side of frame and replace scarfed mullion. Rake out all putty and replace, allow to cure. Refit window, apply NHL3.5 pointing and seal externally with flexible graded silicone. Note: Pointing missing to right hand side of cill. General sanding, filling and painting as required. Also note rust staining in numerous locations. Consider removal or iron fixings and replace with galvanised or stainless steel (non-ferrous) fixings. Sand, fill and paint following remedial works.

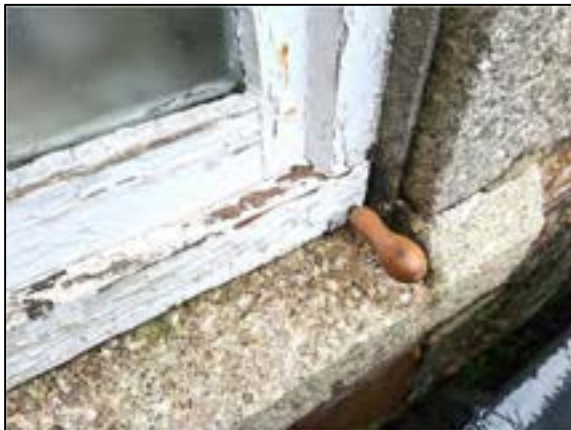
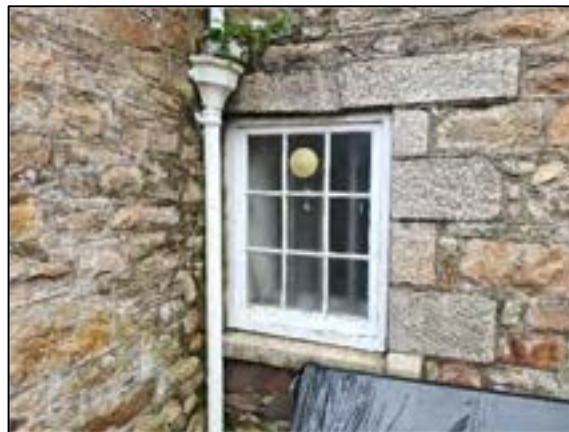
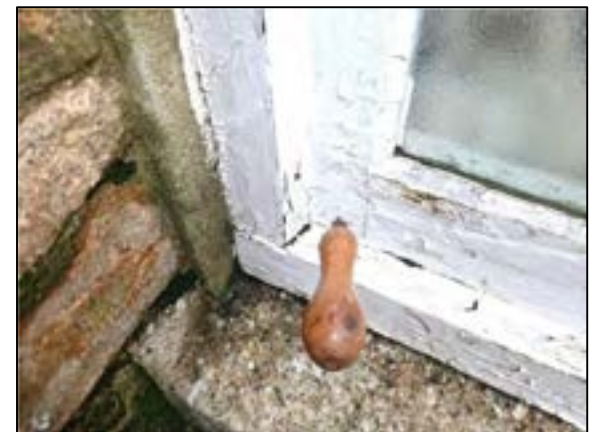
WINDOW NUMBER: BC – W31

Type:	Secondary glazing:	Condition of glazing and glazing bars:	Condition of putty:	Jambs, stiles, rails, transoms and mullions:
Timber frame.	Not provided.	C.	C.	D - Left hand side stile requires 100mm scarf.

Cills:	Frame:	Hinges, cords, opening mechanisms, etc:	Paint:	Photos:
D - 100mm right hand side.	B.	No openable section.	D.	116,117,118

Comments: Lintel has cracked and dropped significantly. Lintel requires replacement. Recommend replacement of entire cill however, only 100m to the right hand side has rotted. Stile to left hand side has rotted to lower section, recommend replacement of whole left hand stile. Sand, fill and paint following timber remedial works and application of flexible externally graded silicone. Note flora growth in rainwater hopper requires removal.

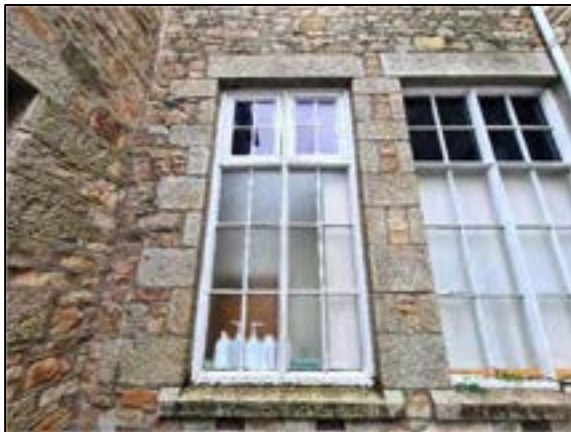
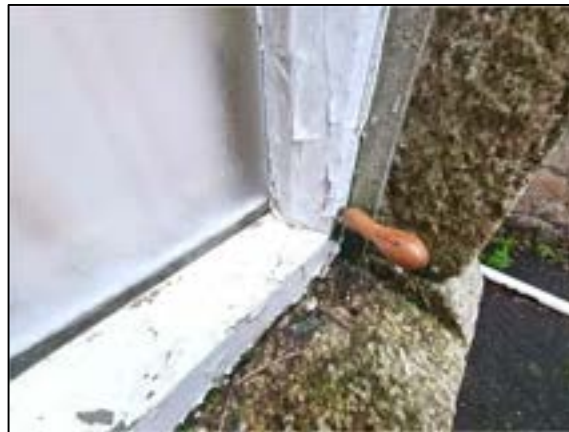
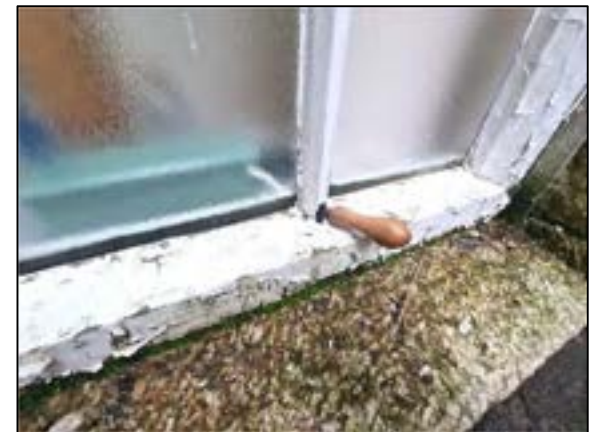
WINDOW NUMBER: BC – W32

Type:	Secondary glazing:	Condition of glazing and glazing bars:	Condition of putty:	Jambs, stiles, rails, transoms and mullions:
Timber frame – top right opens.	Not provided.	Replace bottom right and central glazing bars.	C.	D - Scarf 300mm to bottom of mullion. B - Transom.

Cills:	Frame:	Hinges, cords, opening mechanisms, etc:	Paint:	Photos:
B.	D - Poor at bottom. Scarf 300mm to left and right hand sides and	Within suspended ceiling – not checked.	D.	124,125,126,127,128

Comments: Scarf left and right hand sides of the frame and the mullion by approx. 300mm. Minor rust staining to the left hand side of the openable section. Replace with non-ferrous fixings. Sand and fill prior to painting. Seal external pointing with flexible silicone suitable for external use.

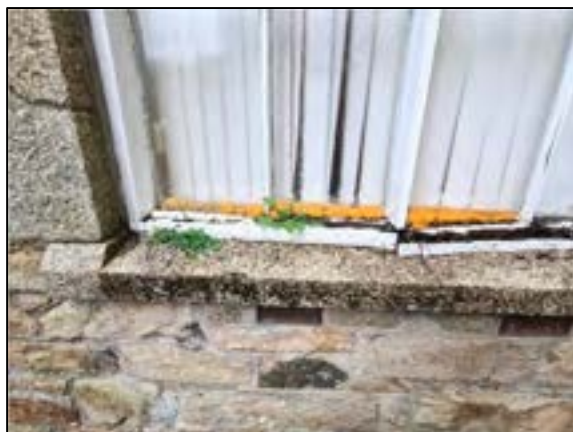
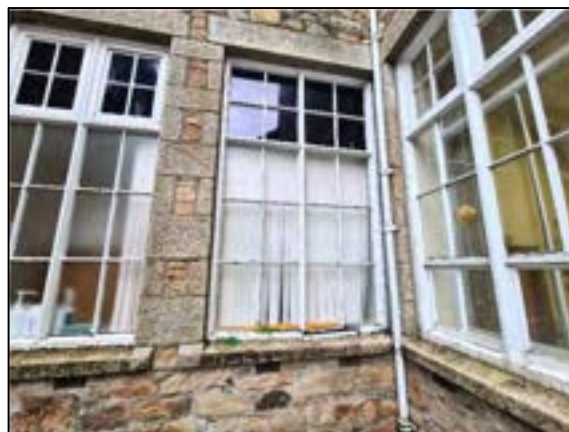
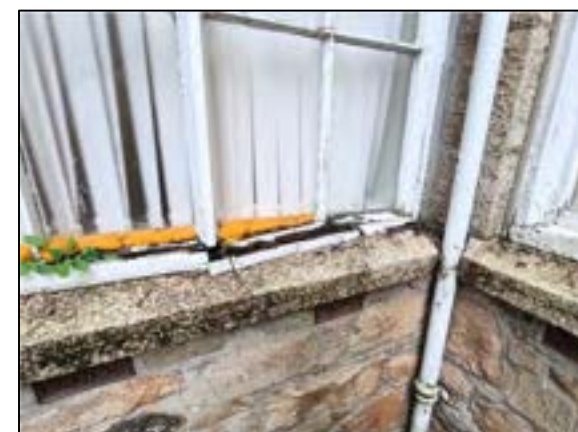
WINDOW NUMBER: BC – W33

Type:	Secondary glazing:	Condition of glazing and glazing bars:	Condition of putty:	Jambs, stiles, rails, transoms and mullions:
Timber frame.	Not provided.	D - Lower section has dropped.	C – internally.	D - Mullion requires 500mm scarf to lower section.

Cills:	Frame:	Hinges, cords, opening mechanisms, etc:	Paint:	Photos:
E - Replace entire cill.	D - Stile to the left and right hand side requires 500mm scarf to lower sections.	Within suspended ceiling – not checked.	D.	129,130,131,132,133,134, 135,136,137,138,139,140

Comments: Extensive rot to the lower sections including complete failure of the cill. This has resulted in deflection of the remaining glazing bars and therefore recommend that the entire window is removed and rebuilt. The cill requires complete replacement, and the left and right hand sides of the frame should be replaced at a minimum of 500mm to the lower sections although complete replacement of the left and right hand sections of frame would be preferable. Deflection to the glazing bars requires all panes to be removed and glazing bars adjusted/replaced prior to installing the panes and applying putty. Sanding, filling and painting should be carried out extensively. Alternatively, it is likely that the entire window should be replaced given that this window is likely to be beyond economical repair.

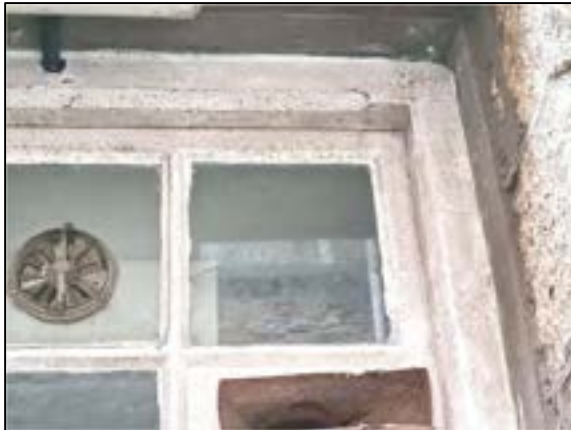
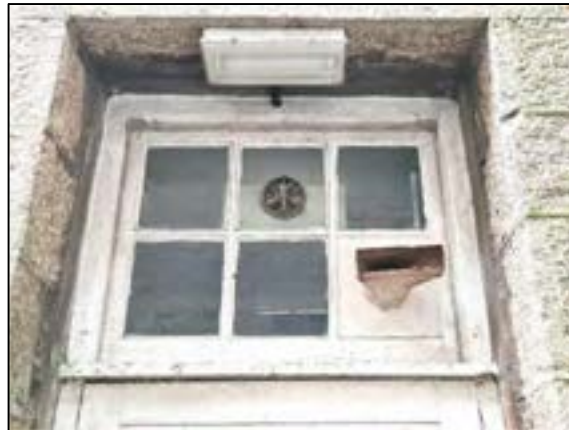
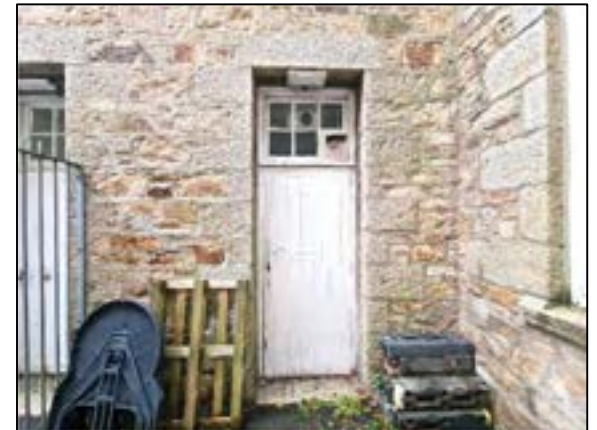
Type:	Secondary glazing:	Condition of glazing and glazing bars:	Condition of putty:	Jambs, stiles, rails, transoms and mullions:
Timber door with fanlight above.	Not provided.	D -Right hand side pane broken.	C.	B.

Cills:	Frame:	Hinges, cords, opening mechanisms, etc:	Paint:	Photos:
B.	B.	No operable section.	C.	121,122,123

Comments: Recommend extract duct incorporates insect mesh, the cowl provided is not considered fit for purpose. The fanlight would benefit from a clean down prior to sanding, filling and painting. Pointing should be sealed with an external graded flexible sealant.

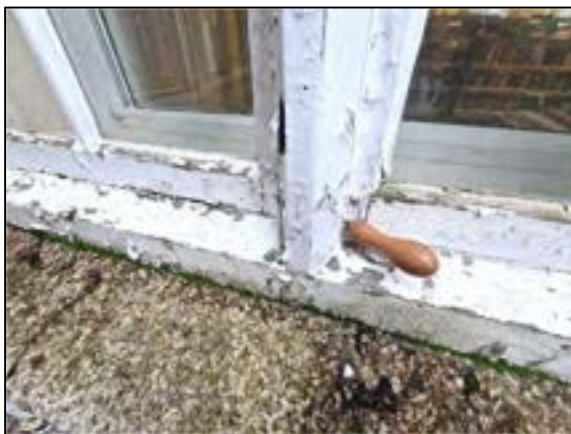
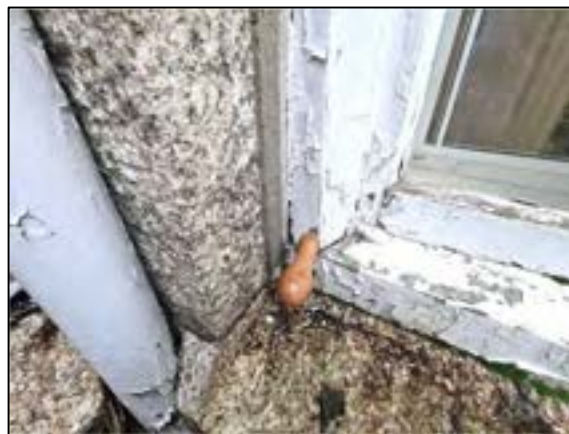
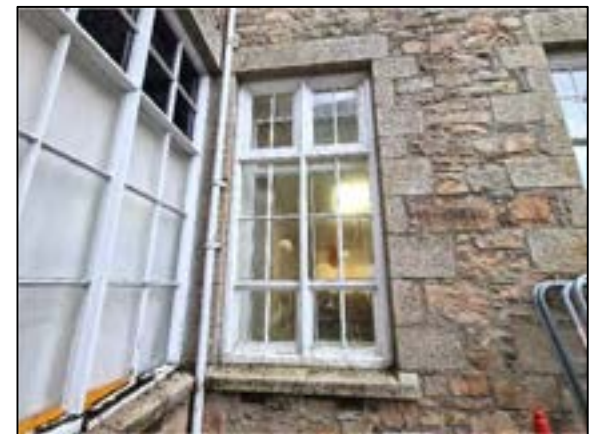
WINDOW NUMBER: BC – W35

Type:	Secondary glazing:	Condition of glazing and glazing bars:	Condition of putty:	Jambs, stiles, rails, transoms and mullions:
Timber frame – left hand openable but sealed shut.	Provided.	C.	C.	B.

Cills:	Frame:	Hinges, cords, opening mechanisms, etc:	Paint:	Photos:
C - timber decay to far sides.	B.	D - Left hand side mechanism broken, hinges have been removed.	D.	146,147,148,149,150

Comments: Openable section sealed shut. Small amount of timber decay to far sides of cill, cut out and fill with resin. Remove lower sections of glazing, clean out algae/moss. Install glazing and seal externally with external graded flexible silicone. Sand, fill and paint ensuring openable sections are not sealed shut.

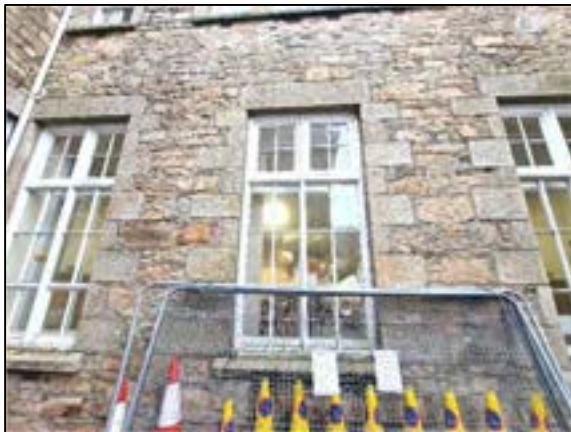
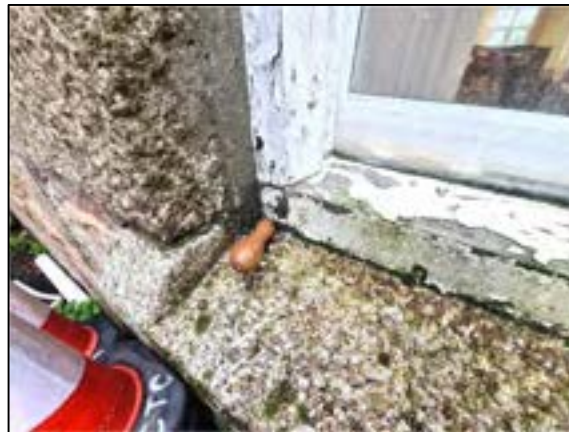
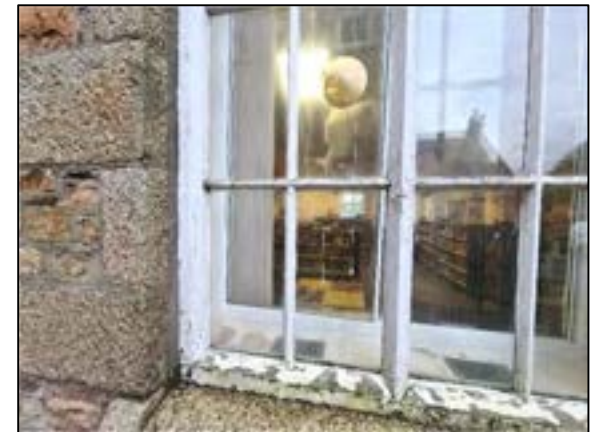
WINDOW NUMBER: BC – W36

Type:	Secondary glazing:	Condition of glazing and glazing bars:	Condition of putty:	Jambs, stiles, rails, transoms and mullions:
Timber frame – top section opens but sealed shut.	Provided.	B.	C.	B.

Cills:	Frame:	Hinges, cords, opening mechanisms, etc:	Paint:	Photos:
D - Replace cill.	B.	D - Both mechanisms broken – sealed shut.	D.	151,152,153,154, 155,156,157,158

Comments: Rake out pointing to both sides and remove window and replace entire cill. Remove lower glazing panes and clean out algae/moss. Reinstall window and apply NHL3.5 mortar to seal window. Additionally, apply exterior graded flexible sealant between pointing and timber. Sand, fill and paint entire window following remedial works ensuring openable section is not sealed shut.

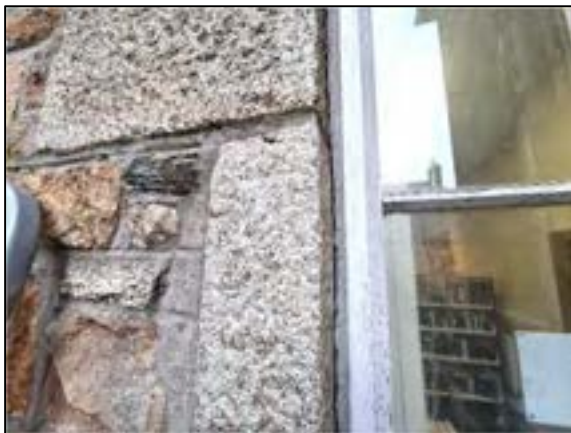
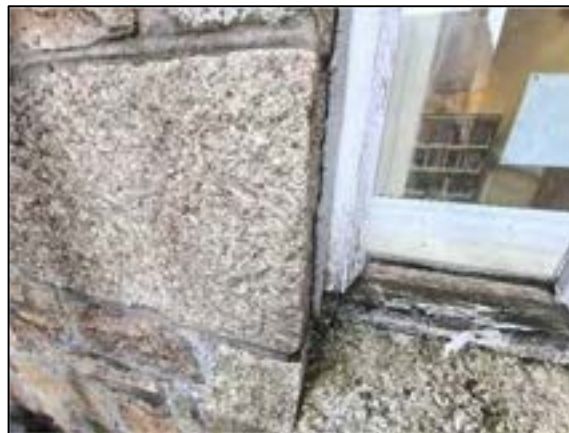
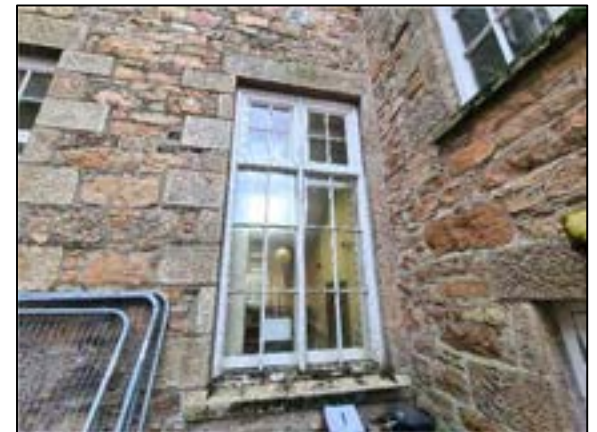
WINDOW NUMBER: BC – W37

Type:	Secondary glazing:	Condition of glazing and glazing bars:	Condition of putty:	Jambs, stiles, rails, transoms and mullions:
Timber frame.	Not provided.	C.	C. NB: Moss build-up internally.	D - Mullion rotten 300mm scarf new section.

Cills:	Frame:	Hinges, cords, opening mechanisms, etc:	Paint:	Photos:
D - Replace cill.	D - Scarf 500mm to right hand side and 300mm to the left hand side.	No openable section.	D.	159,160,161,162, 163,164,165,166

Comments: Remove bottom panes and clear out moss. Reinstall glazing and seal externally with exterior graded flexible sealant. Replace cill. Scarf mullion and left hand side of frame by approx., 300mm and right hand side of frame by 500mm. Sand, fill and paint following remedial works.

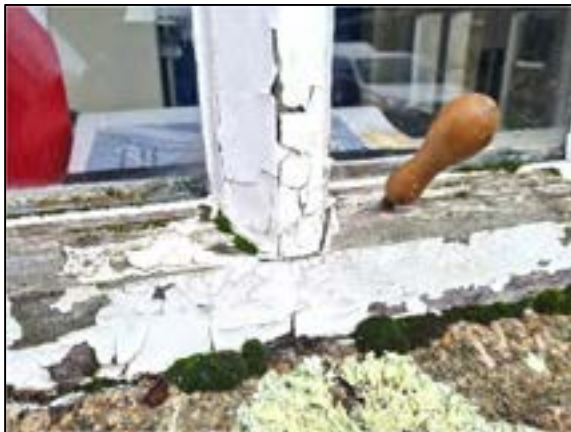
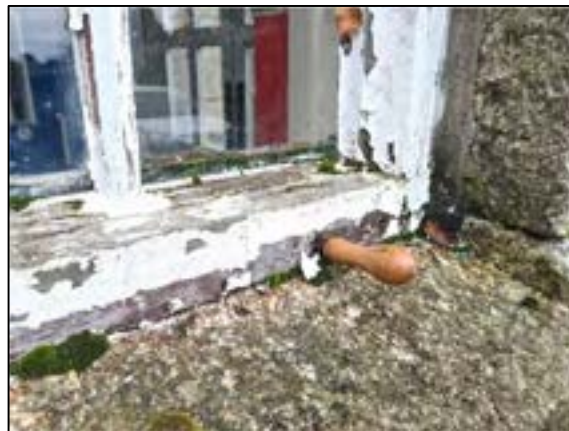
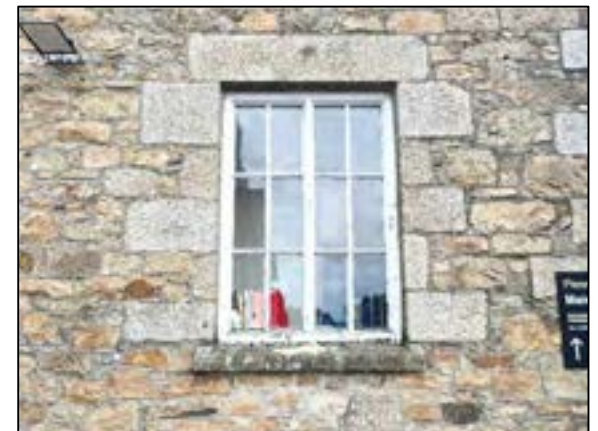
WINDOW NUMBER: BC – W38

Type:	Secondary glazing:	Condition of glazing and glazing bars:	Condition of putty:	Jambs, stiles, rails, transoms and mullions:
Timber frame fanlight – door below.	Not provided.	B.	A – Minor cracking to paint surface.	B.

Cills:	Frame:	Hinges, cords, opening mechanisms, etc:	Paint:	Photos:
B.	B.	No operable section.	C.	167,168

Comments: Sand, fill and paint. Apply exterior graded flexible sealant around pointing.

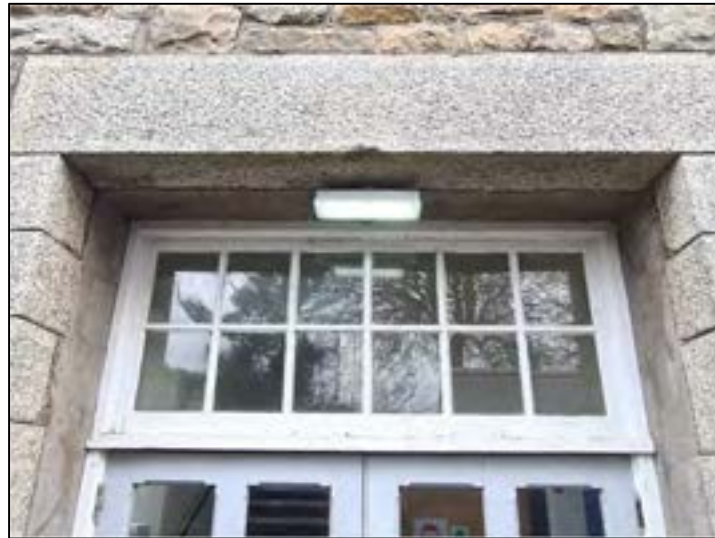
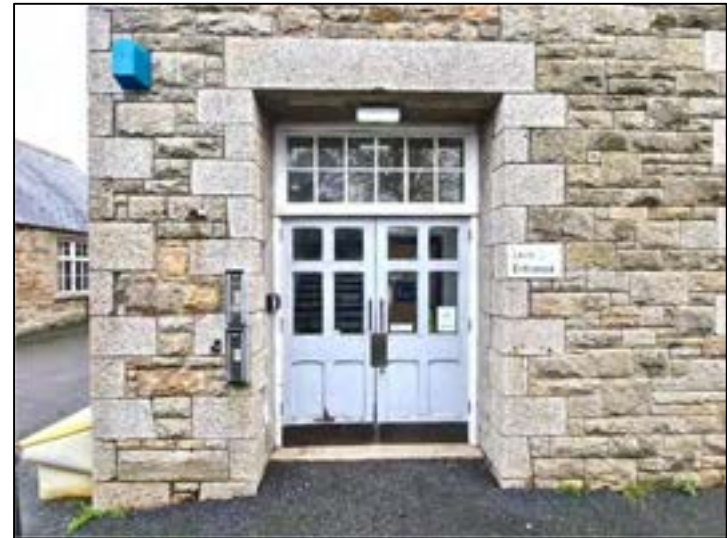
WINDOW NUMBER: BC – W39

Type:	Secondary glazing:	Condition of glazing and glazing bars:	Condition of putty:	Jambs, stiles, rails, transoms and mullions:
Timber frame.	Not provided.	A.	A.	A.

Cills:	Frame:	Hinges, cords, opening mechanisms, etc:	Paint:	Photos:
A.	A.	A – Nb. Brass turn screw.	A.	169,170,171

Comments: New window. Provided periodic maintenance works are carried out, the window should have a good life expectancy.

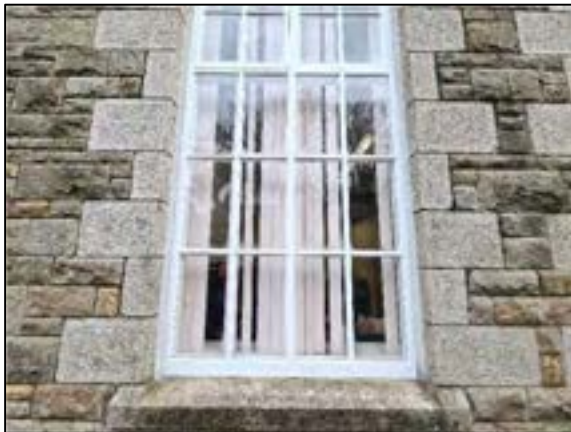
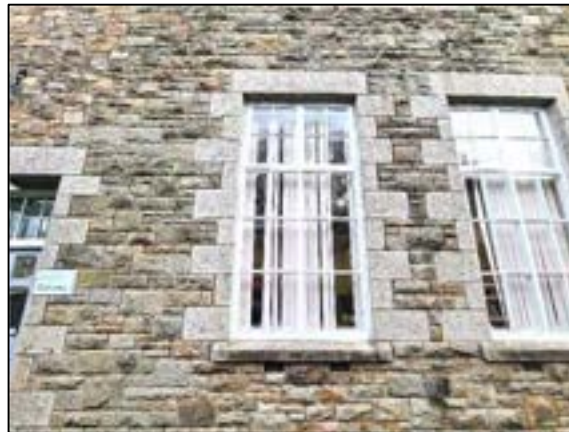
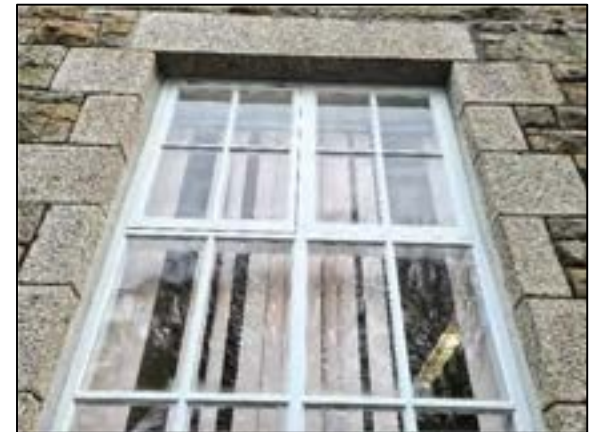
WINDOW NUMBER: BC – W40

Type:	Secondary glazing:	Condition of glazing and glazing bars:	Condition of putty:	Jambs, stiles, rails, transoms and mullions:
Timber frame.	Not provided.	A.	A.	A.

Cills:	Frame:	Hinges, cords, opening mechanisms, etc:	Paint:	Photos:
A.	A.	A – Nb. Brass turn screw.	A.	172,173,174

Comments: New window. Provided periodic maintenance works are carried out, the window should have a good life expectancy.

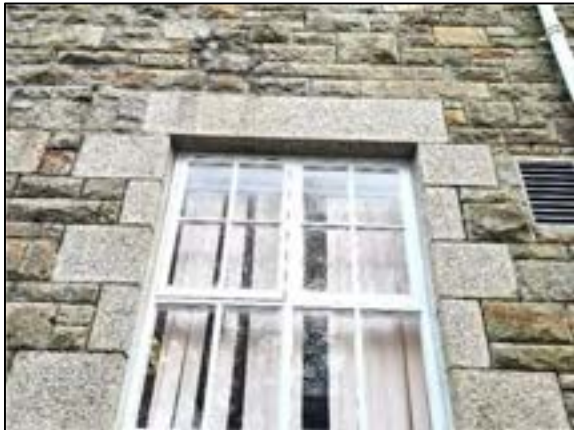
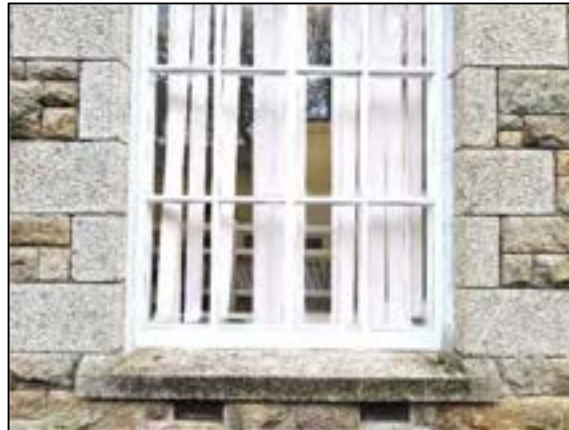
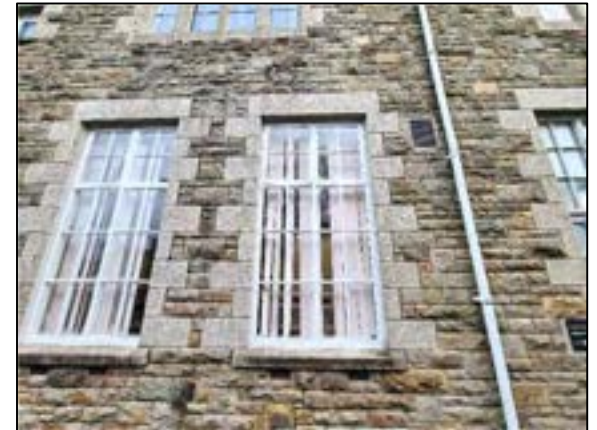
WINDOW NUMBER: BC – W41

Type:	Secondary glazing:	Condition of glazing and glazing bars:	Condition of putty:	Jambs, stiles, rails, transoms and mullions:
Timber frame with door below.	Not provided.	B.	C.	B.

Cills:	Frame:	Hinges, cords, opening mechanisms, etc:	Paint:	Photos:
B.	B.	No operable section.	D.	175,176,177

Comments: Sand, fill and paint. Seal around top of frame with external graded flexible sealant.

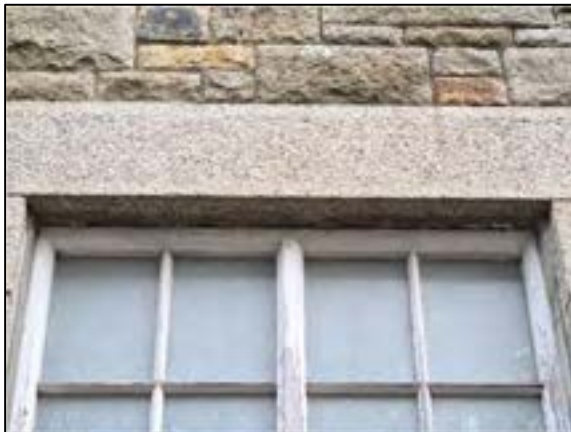
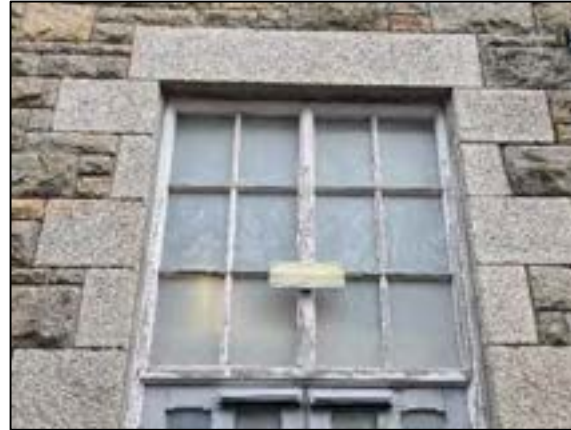
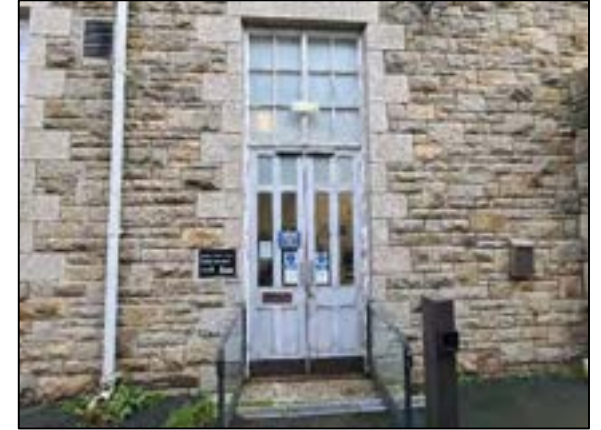
WINDOW NUMBER: BC – W42

Type:	Secondary glazing:	Condition of glazing and glazing bars:	Condition of putty:	Jambs, stiles, rails, transoms and mullions:
Metal frame with timber top separated by granite transom.	Provided.	A.	A.	A – Assumed.

Cills:	Frame:	Hinges, cords, opening mechanisms, etc:	Paint:	Photos:
A – Assumed.	A.	A – Assumed.	A.	178,179

Comments: This window is outside the scope of our survey however, for the purpose of thoroughness we include the timber sub frame to the top. This top section appears in good serviceable condition provided periodic maintenance works are carried out.

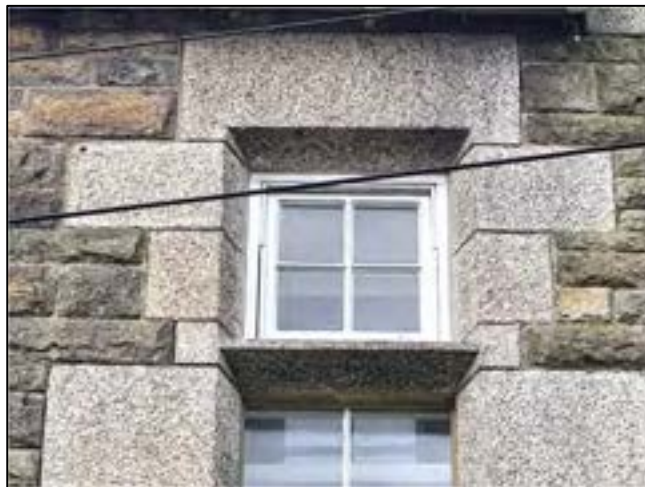
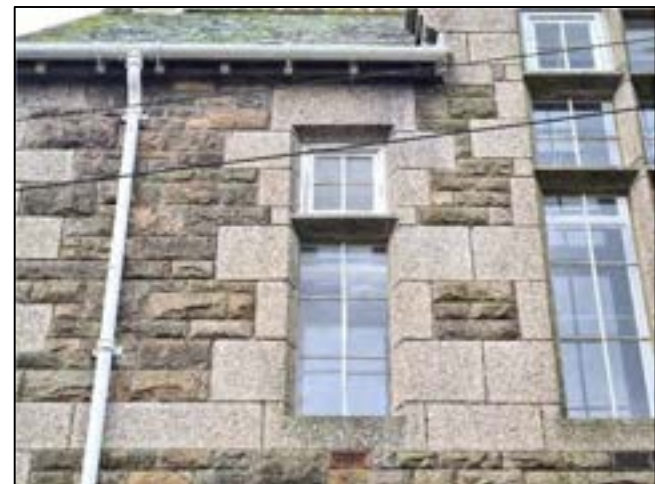
WINDOW NUMBER: BC – W43

Type:	Secondary glazing:	Condition of glazing and glazing bars:	Condition of putty:	Jambs, stiles, rails, transoms and mullions:
Metal frame with timber top to left hand side.	Provided.	A.	A.	A – Assumed.

Cills:	Frame:	Hinges, cords, opening mechanisms, etc:	Paint:	Photos:
A – Assumed.	A.	A.	A.	180,181

Comments: This window is outside the scope of our survey however, for the purpose of thoroughness we include the timber sub frame to the top left hand side. This top section appears in good serviceable condition provided periodic maintenance works are carried out.

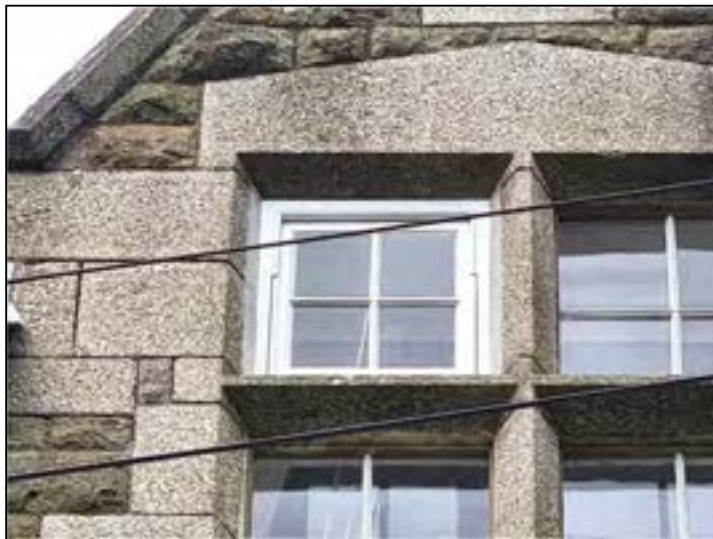
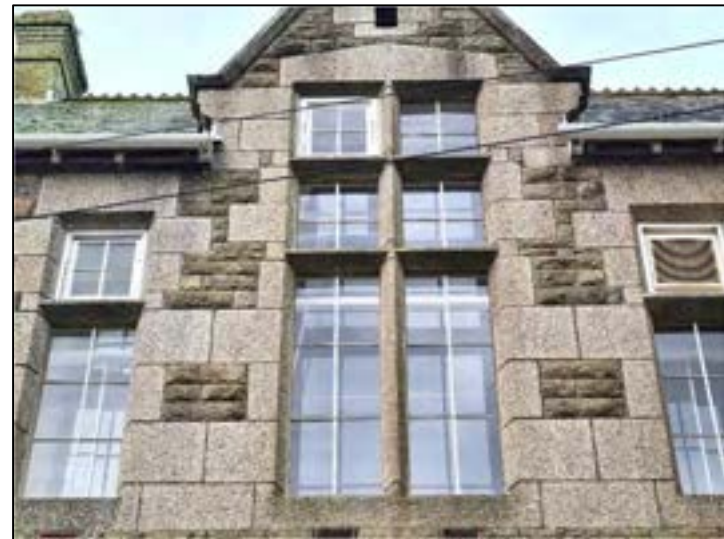
WINDOW NUMBER: BC – W44

Type:	Secondary glazing:	Condition of glazing and glazing bars:	Condition of putty:	Jambs, stiles, rails, transoms and mullions:
Metal frame with timber section above granite transom housing extraction vent.	Provided.	N/A.	N/A.	A – Assumed.

Cills:	Frame:	Hinges, cords, opening mechanisms, etc:	Paint:	Photos:
A – Assumed.	B.	N/A.	A.	182,183

Comments: This window is outside the scope of our survey however, for the purpose of thoroughness we include the timber sub frame to the top above the granite transom. This top section appears in good serviceable condition provided periodic maintenance works are carried out. Note: the cill/bottom rail was not visible given the limitations of the survey.
