Basset Community Hub

Architectural Enabling Schedule of Works

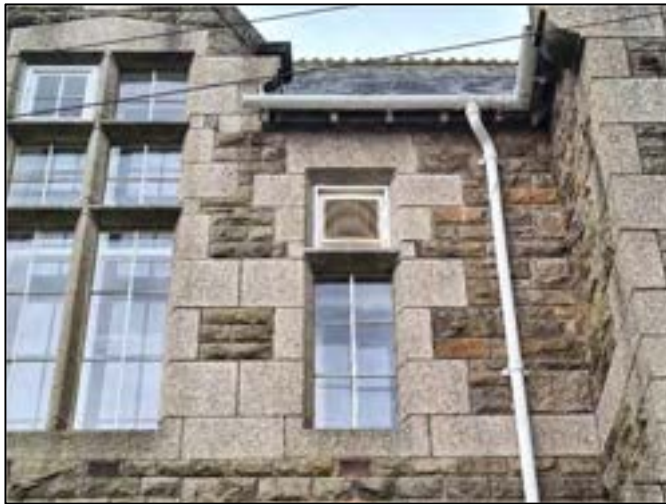
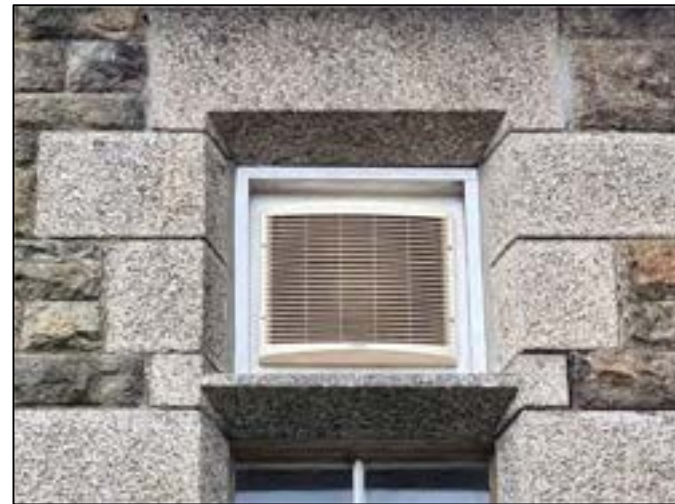
WINDOW NUMBER: BC – W45

Type:	Secondary glazing:	Condition of glazing and glazing bars:	Condition of putty:	Jambs, stiles, rails, transoms and mullions:
Metal frame.

Comments: This window is outside the scope of our survey.

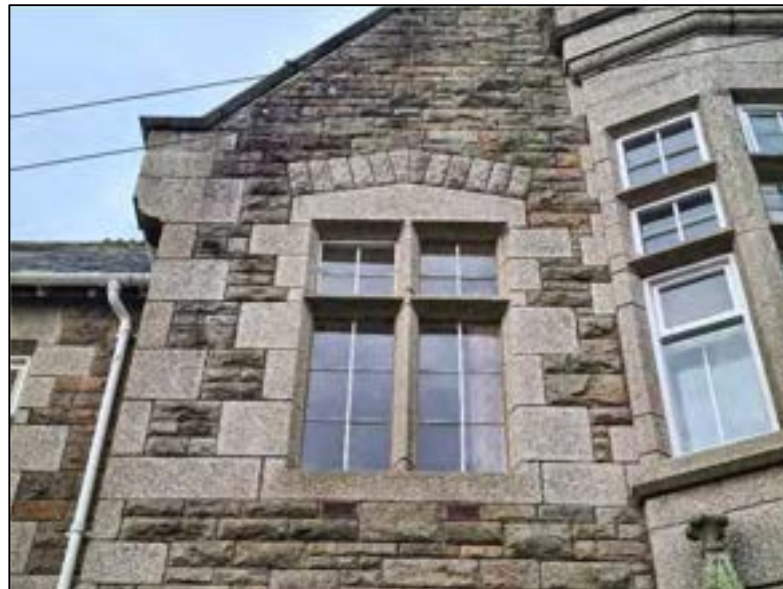
WINDOW NUMBER: BC – W46

Type:	Secondary glazing:	Condition of glazing and glazing bars:	Condition of putty:	Jambs, stiles, rails, transoms and mullions:
Metal frame with multiple timber sections.	Provided.	A.	A.	A -Assumed.

Cills:	Frame:	Hinges, cords, opening mechanisms, etc:	Paint:	Photos:
A – Assumed.	A.	B.	B.	185,186,187,188,189

Comments: This window is outside the scope of our survey however, for the purpose of thoroughness we include the timber sub frames, all appear in good serviceable condition – openable sections were not tested but appear functional. We note flora growth to the right hand side around the parapet detail and generally the window granite surrounds would benefit from repointing.

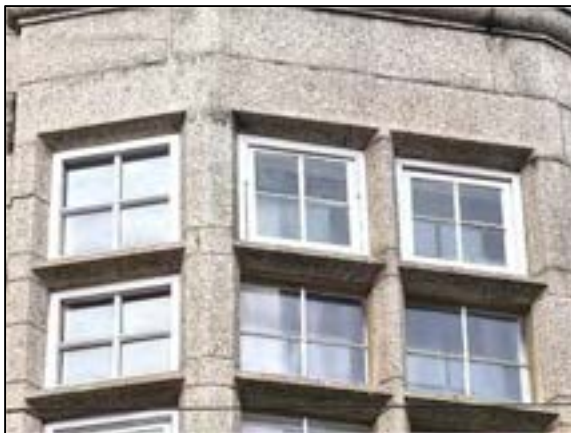
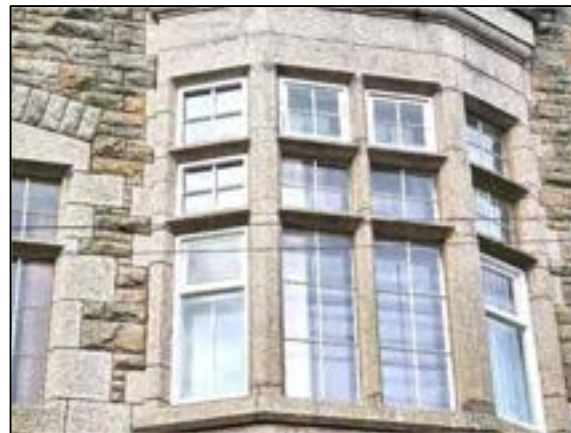
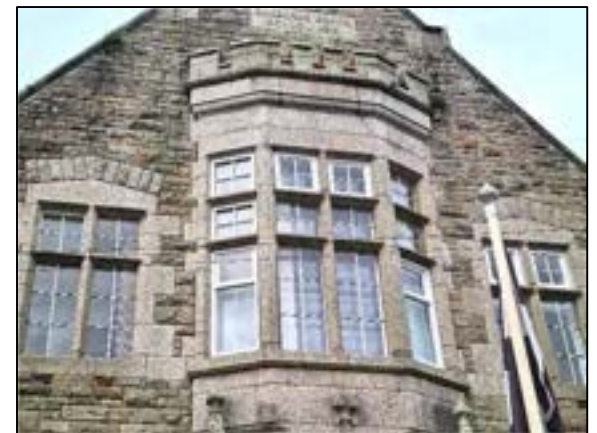
WINDOW NUMBER: BC – W47

Type:	Secondary glazing:	Condition of glazing and glazing bars:	Condition of putty:	Jambs, stiles, rails, transoms and mullions:
Metal frame with multiple timber sections.	Provided.	A.	A.	A – Assumed.

Cills:	Frame:	Hinges, cords, opening mechanisms, etc:	Paint:	Photos:
A – Assumed.	A.	A.	A.	190,191

Comments: This window is outside the scope of our survey however, for the purpose of thoroughness we include the timber sub frames to the upper sections. Generally, these are in good serviceable condition with no significant defects noted however, similar to BC-W46 the granite stone surround would benefit from repointing. Periodic painting following sanding down is advised, fill as required.

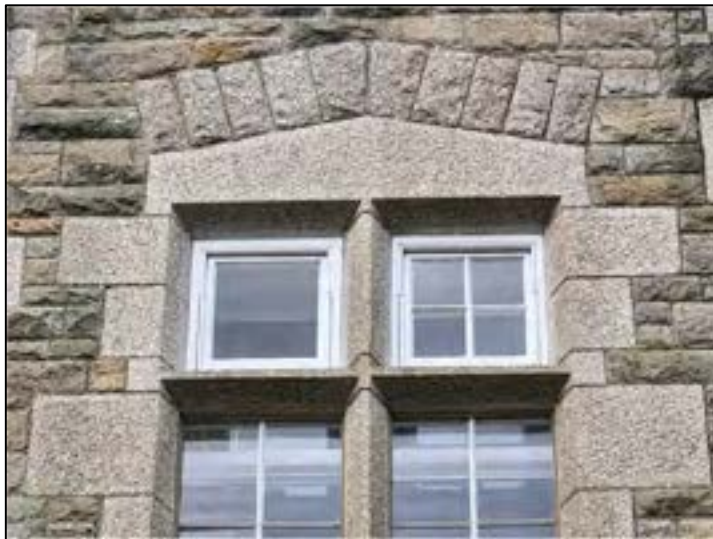
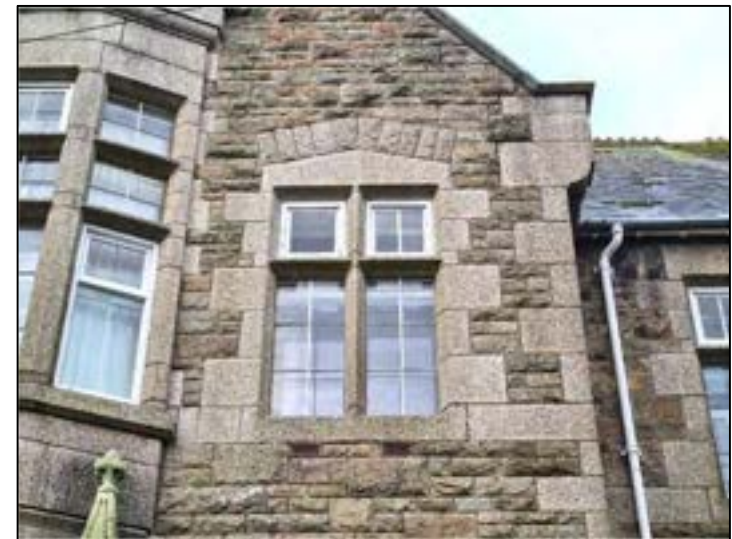
WINDOW NUMBER: BC – W48

Type:	Secondary glazing:	Condition of glazing and glazing bars:	Condition of putty:	Jambs, stiles, rails, transoms and mullions:
Metal frame with timber top.	Provided.	A.	A.	A.

Cills:	Frame:	Hinges, cords, opening mechanisms, etc:	Paint:	Photos:
A – Assumed.	A.	A.	A.	192,193

Comments: This window is outside the scope of our survey however, for the purpose of thoroughness we include the timber sub frame to the upper section. Top section openable and operated, generally, in good condition subject to periodic maintenance and painting following sand down and filling as required.

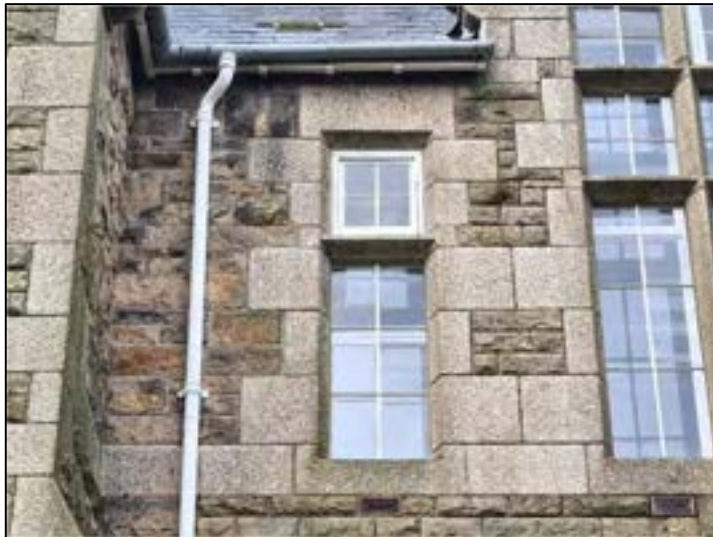
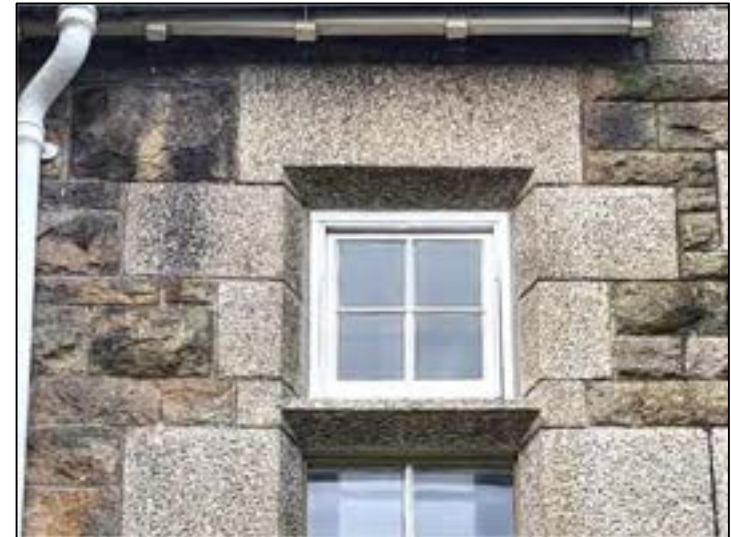
WINDOW NUMBER: BC – W49

Type:	Secondary glazing:	Condition of glazing and glazing bars:	Condition of putty:	Jambs, stiles, rails, transoms and mullions:
Metal frame with timber top above granite transom to right hand side.	Provided.	A.	A.	A.

Cills:	Frame:	Hinges, cords, opening mechanisms, etc:	Paint:	Photos:
A – Assumed.	A.	A.	A.	194,195

Comments: This window is outside the scope of our survey however, for the purpose of thoroughness we include the timber sub frame to the upper section. This section is openable but was not tested. Assumed to be in good condition given limitations of inspection. Assumed to be in good serviceable condition subject to periodic maintenance and painting following sanding down and filling as required.

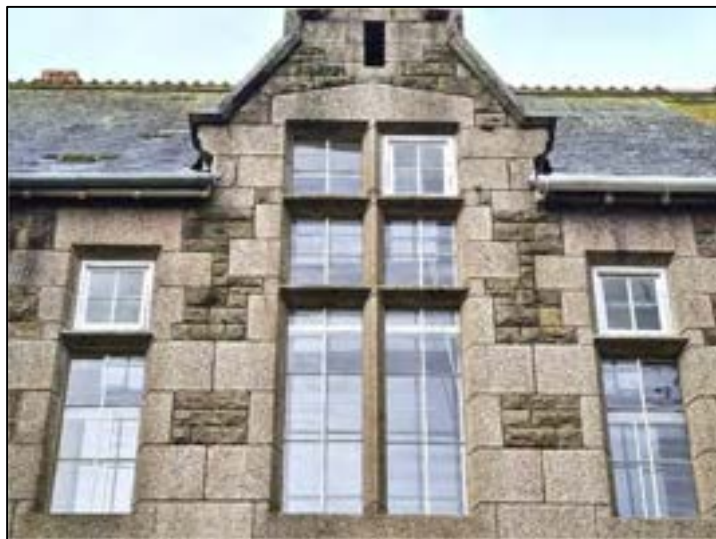
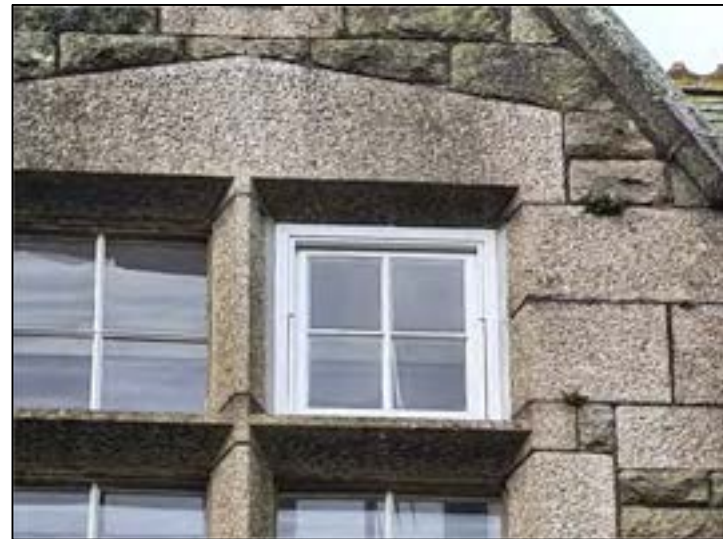
WINDOW NUMBER: BC – W50

Type:	Secondary glazing:	Condition of glazing and glazing bars:	Condition of putty:	Jambs, stiles, rails, transoms and mullions:
Metal frame with timber top.	Provided.	A.	A.	A - Assumed.

Comments: This window is outside the scope of our survey however, for the purpose of thoroughness we include the timber sub frame to the upper section. This section is openable and operated satisfactorily. Generally, in good serviceable condition provided periodic maintenance and painting works are carried out with sand down and filling as required. Given the limitations of the survey we were unable to fully inspect the bottom rail, granite transom and cill.

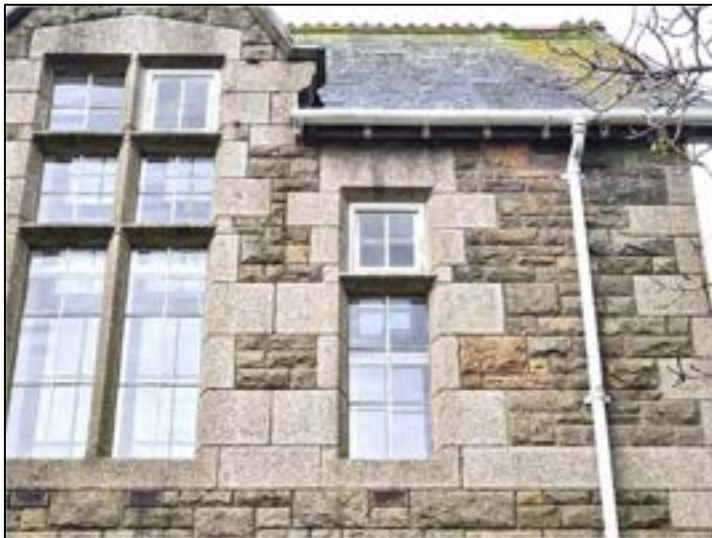
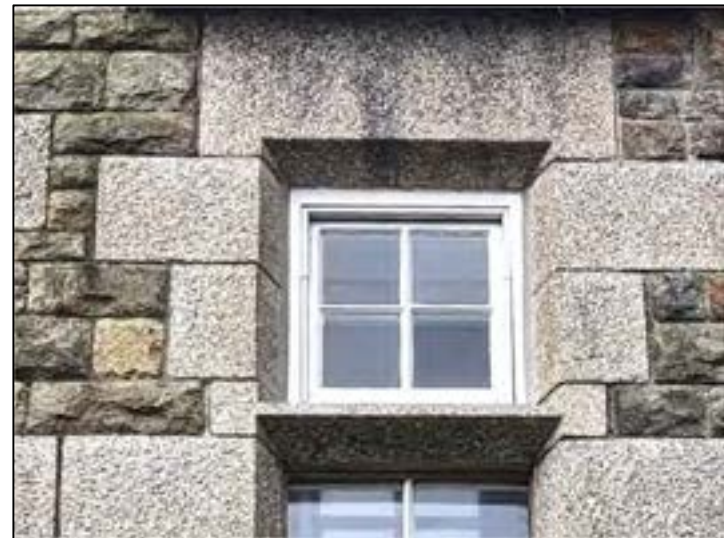
WINDOW NUMBER: BC – W51

Type:	Secondary glazing:	Condition of glazing and glazing bars:	Condition of putty:	Jambs, stiles, rails, transoms and mullions:
Metal frame with timber top.	Provided.	A.	A.	A – Assumed.

Cills:	Frame:	Hinges, cords, opening mechanisms, etc:	Paint:	Photos:
A – Assumed.	A.	A.	B.	198,199

Comments: This window is outside the scope of our survey however, for the purpose of thoroughness we include the timber sub frame to the central section beneath the fanlight to the right hand side. This window was opened at the time of inspection and appears in good serviceable condition provided periodic maintenance works are carried out. Given the limitations of the survey we were unable to fully inspect the bottom rail, granite transom and cill.

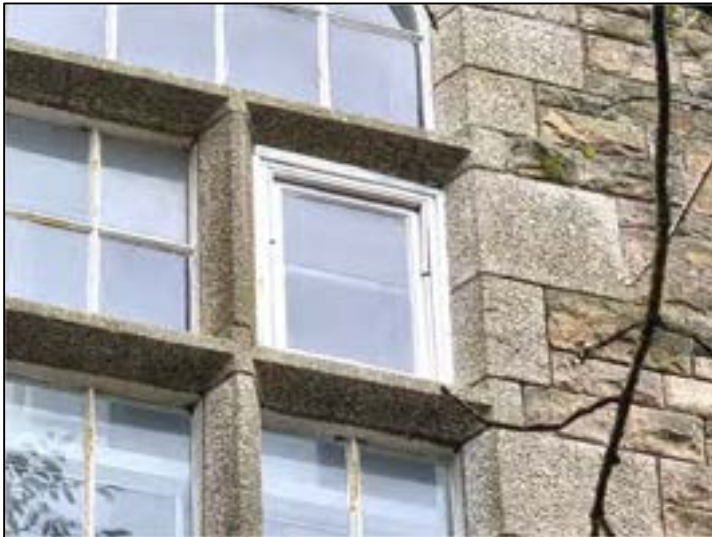
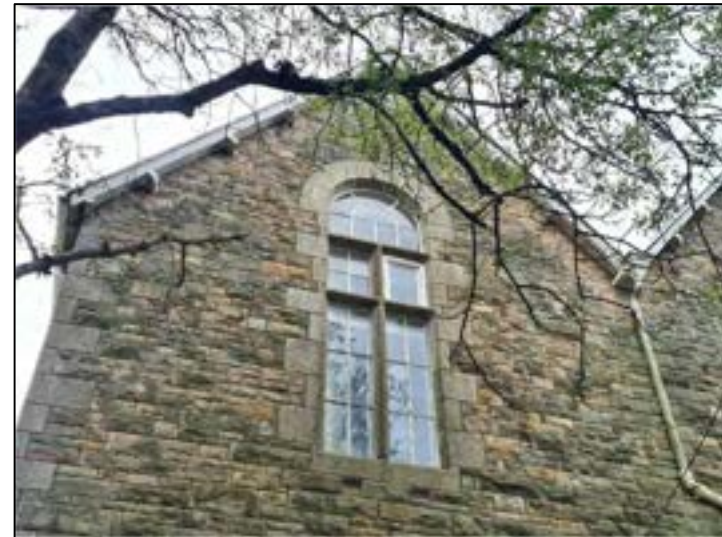
WINDOW NUMBER: BC – W52

Type:	Secondary glazing:	Condition of glazing and glazing bars:	Condition of putty:	Jambs, stiles, rails, transoms and mullions:
Metal frame with timber top.	Provided.	B.	C.	A – Assumed.

Cills:	Frame:	Hinges, cords, opening mechanisms, etc:	Paint:	Photos:
A – Assumed.	A.	A – Assumed. Not openable due to secondary glazing.	B.	200,201,202

Comments: This window is outside the scope of our survey however, for the purpose of thoroughness we include the timber sub frame to the upper section beneath the fanlight. These sections are openable but were not tested as the secondary glazing prevented access. Appears in moderate condition in need of general servicing and maintenance, particularly to the secondary glazing element. Given the limitations of the survey we were unable to fully inspect the bottom rail, granite transom and cill.

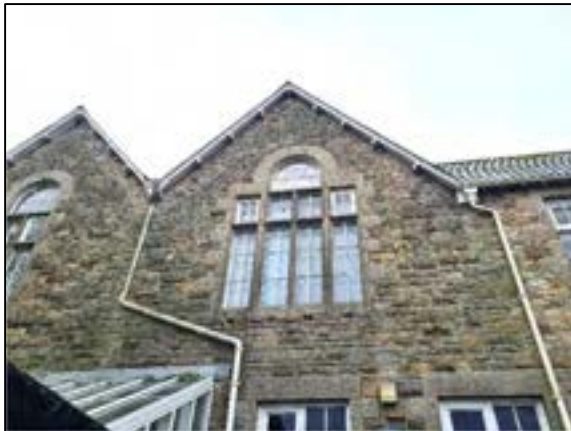
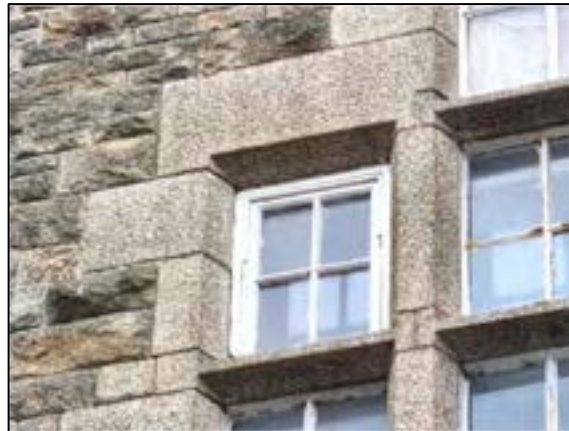
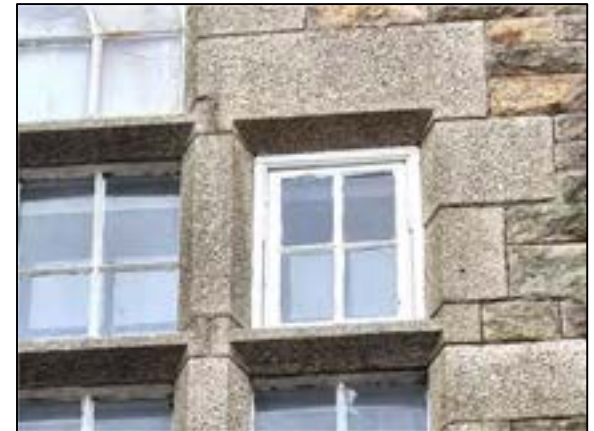
WINDOW NUMBER: BC – W53

Type:	Secondary glazing:	Condition of glazing and glazing bars:	Condition of putty:	Jambs, stiles, rails, transoms and mullions:
Timber frame with top openable.	Provided.	B.	A.	B – Assumed.

Cills:	Frame:	Hinges, cords, opening mechanisms, etc:	Paint:	Photos:
B - Assumed.	B.	A.	C.	203,204,205

Comments: Generally, in good condition albeit inspection of the cill was limited due to the limitations of the inspection. Some algae/flora growth to lower sections that would benefit from a fungicidal wash. In good condition provided periodic maintenance works are carried out. To sand, fill and paint within the short term period. Given the limitations of the survey we were unable to fully inspect the bottom rail, jambs, mullion and cill.

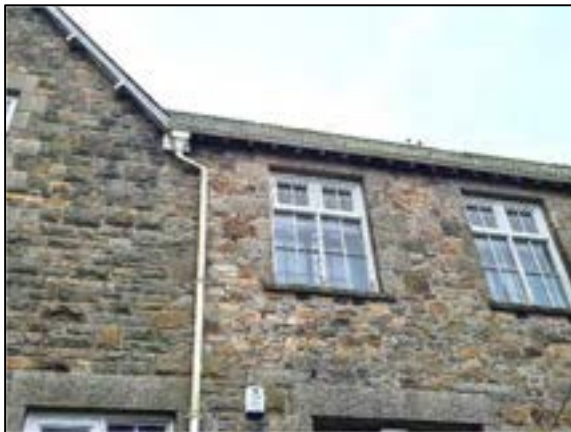
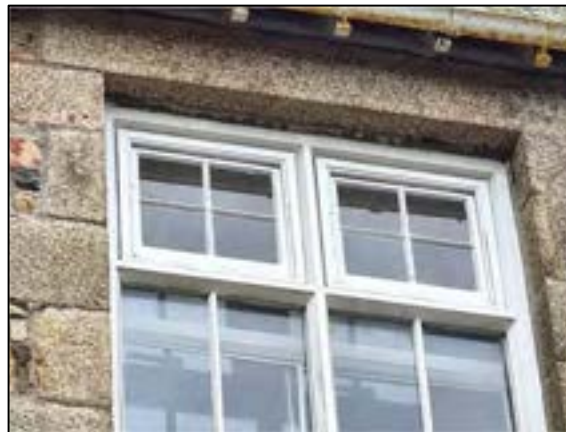
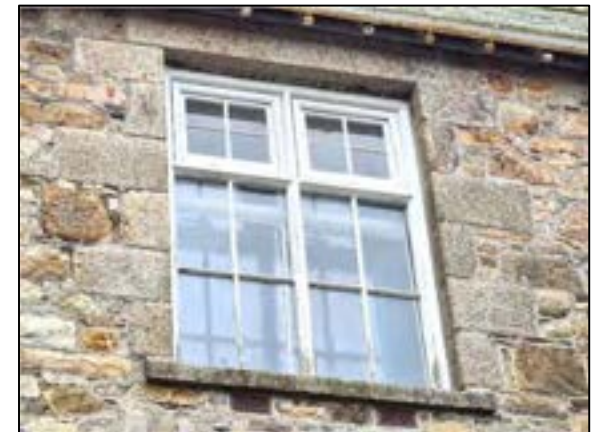
WINDOW NUMBER: BC – W54

Type:	Secondary glazing:	Condition of glazing and glazing bars:	Condition of putty:	Jambs, stiles, rails, transoms and mullions:
Timber frame with top openable.	Provided.	B.	A.	B – Assumed.

Cills:	Frame:	Hinges, cords, opening mechanisms, etc:	Paint:	Photos:
B -Assumed.	B.	A.	C.	206,207,208

Comments: Generally, in good condition. Some algae/flora growth to lower sections that would benefit from a fungicidal wash. In good condition provided periodic maintenance works are carried out. To sand, fill and paint within the short term period. Given the limitations of the survey we were unable to fully inspect the bottom rail, jambs, mullion and cill.

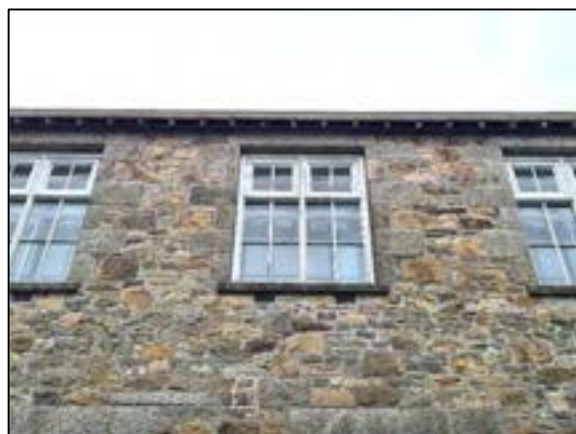
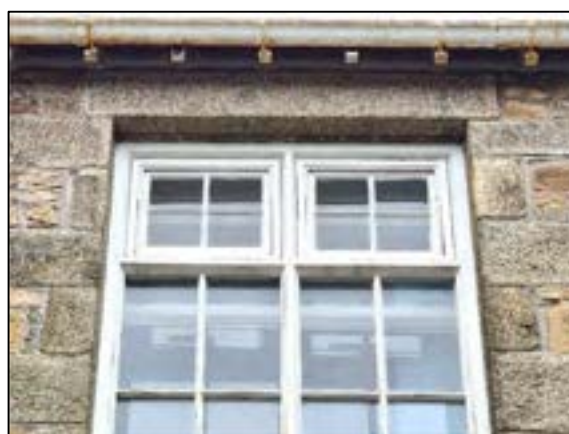
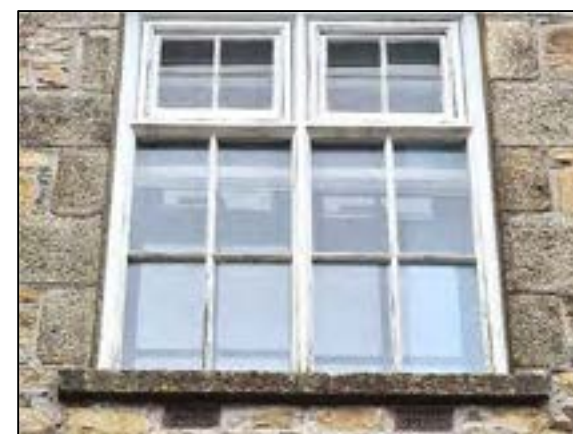
WINDOW NUMBER: BC – W55

Type:	Secondary glazing:	Condition of glazing and glazing bars:	Condition of putty:	Jambs, stiles, rails, transoms and mullions:
Timber frame with top openable.	Provided.	B.	C.	B – Assumed.

Cills:	Frame:	Hinges, cords, opening mechanisms, etc:	Paint:	Photos:
B – Assumed.	B.	A.	C.	209,210,211

Comments: Generally, in good condition. Some algae/flora growth to lower sections that would benefit from a fungicidal wash. To sand, fill and paint within the short term period with particular attention to the top of the frame and rust staining to left hand side openable section. Recommend iron fixings are replaced with galvanised or stainless steel (non-ferrous) fixings. Apply putty to right hand side internally. Given the limitations of the survey we were unable to fully inspect the bottom rail, jambs, mullion and cill.

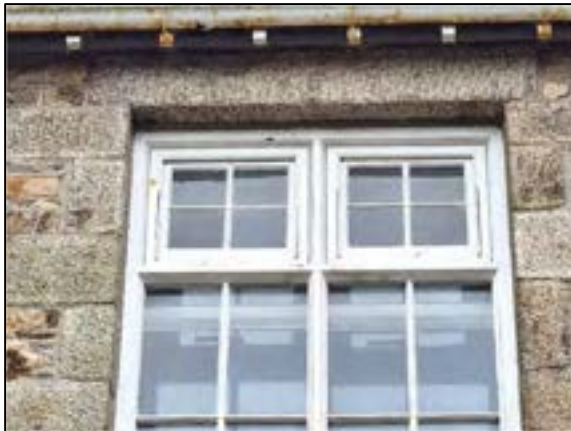
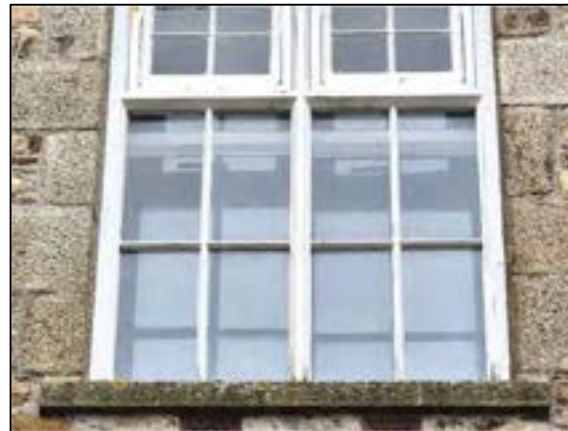
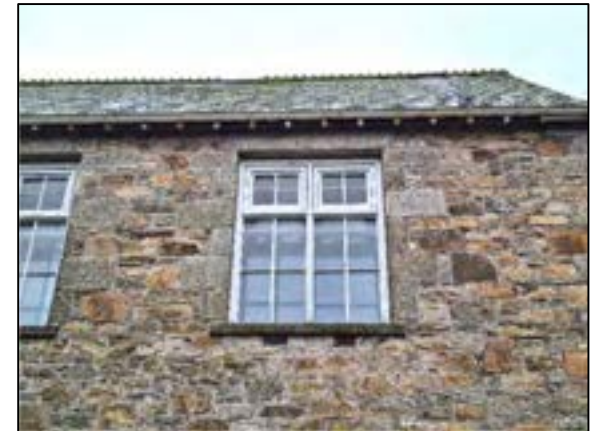
WINDOW NUMBER: BC – W56

Type:	Secondary glazing:	Condition of glazing and glazing bars:	Condition of putty:	Jambs, stiles, rails, transoms and mullions:
Timber frame with top openable.	Provided.	D - Left hand side internally broken glazing bar.	C.	C - Left hand side.

Cills:	Frame:	Hinges, cords, opening mechanisms, etc:	Paint:	Photos:
C/D – Where visible.	C.	B.	D.	212,213,214

Comments: Generally tired, in need of paint to protect timber elements. Suspected scarf joint to lower section of mullion but not confirmed due to limitations of inspection. Requires full sand down, removal of any degraded timber and application of resin. Remove oxidised fixings and replace with non-ferrous fixings. Replace glazing bar internally. Prime and paint. Given the limitations of the survey we were unable to fully inspect the bottom rail, jambs, mullion and cill.

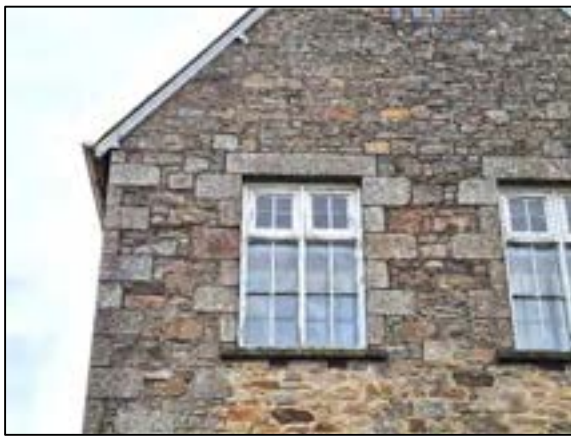
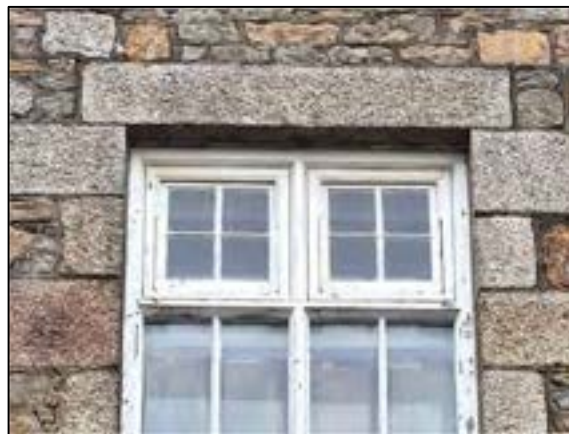
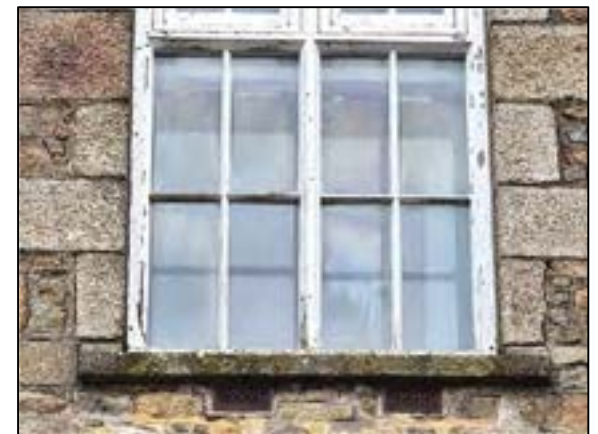
WINDOW NUMBER: BC – W57

Type:	Secondary glazing:	Condition of glazing and glazing bars:	Condition of putty:	Jambs, stiles, rails, transoms and mullions:
Timber frame with top openable.	Provided.	C - One glazing bar in poor condition.	C.	D - Mullion rotten 500mm requires scarf.

Cills:	Frame:	Hinges, cords, opening mechanisms, etc:	Paint:	Photos:
D.	D - Left hand side 500mm scarf required.	B.	C.	215,216,217

Comments: Carry out 500mm scarfs to both mullion and left hand side of frame. Glazing bar requires replacement. Recommend raking out putty, remove panes, full sand down and replacement of degraded timber elements with new scarf sections. Remove oxidised fixings and replace with non-ferrous fixings. Prime and paint once new putty has cured. Given the limitations of the survey we were unable to fully inspect the bottom rail, jambs, mullion and cill.

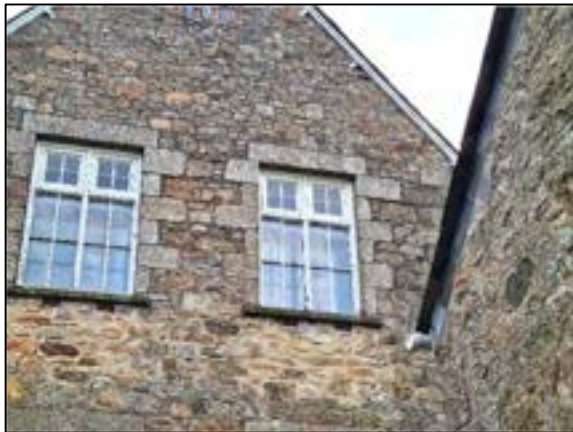
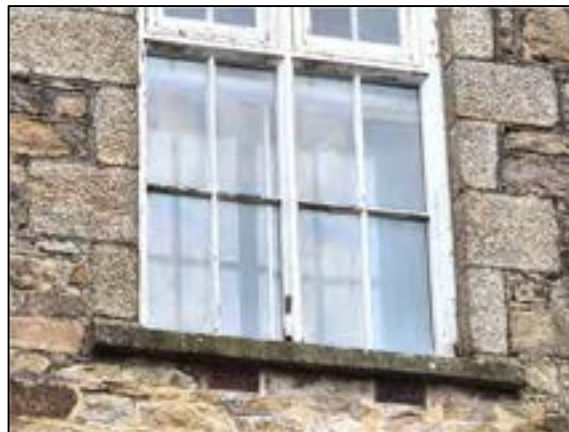
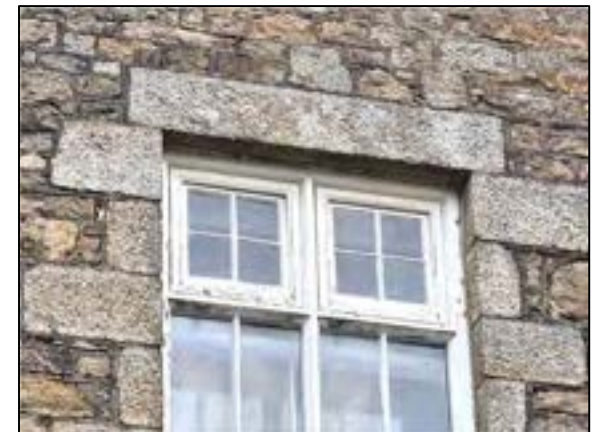
WINDOW NUMBER: BC – W58

Type:	Secondary glazing:	Condition of glazing and glazing bars:	Condition of putty:	Jambs, stiles, rails, transoms and mullions:
Timber frame window hinged on left hand side.	Not provided.	D - Top pane broken.	A.	D - Slight rot on bottom rail of upper section. Movement to left hand stile.

Cills:	Frame:	Hinges, cords, opening mechanisms, etc:	Paint:	Photos:
B -Where visible.	D - Slight rot to left and right hand side.	B.	C.	218,219,220,221

Comments: Broken pane to replace to top section. Consider complete replacement of bottom rail of upper section. Timber decay to both sides of frame. Therefore, recommend that the entire window is removed, putty raked out, new sections of timber installed and new putty allowed to cure fully prior to priming and painting following complete sand down. Nb: Movement to left hand stile when opened and therefore recommend that the window is kept closed until remedial works are carried out.

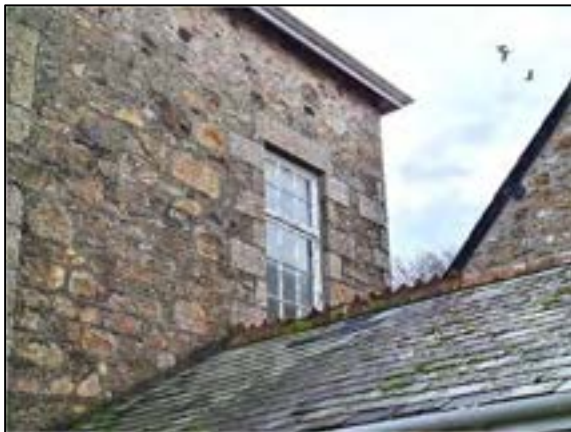
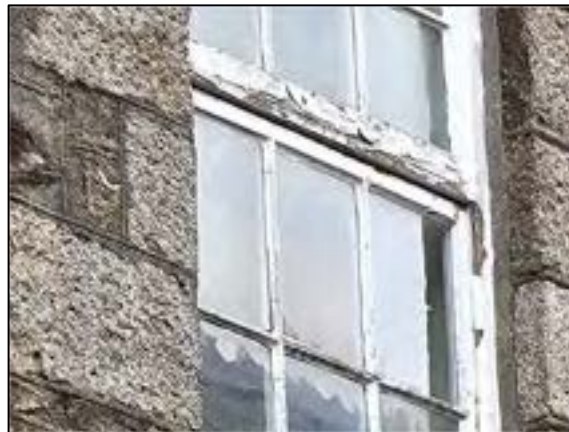
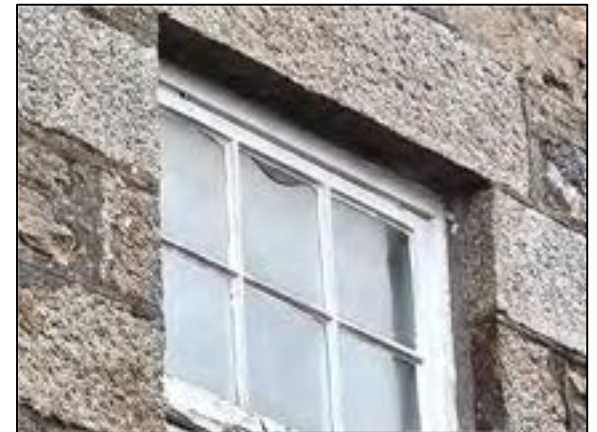
WINDOW NUMBER: BC – W59

Type:	Secondary glazing:	Condition of glazing and glazing bars:	Condition of putty:	Jambs, stiles, rails, transoms and mullions:
Timber frame with top openable.	Not provided.	B.	A.	B.

Cills:	Frame:	Hinges, cords, opening mechanisms, etc:	Paint:	Photos:
B – Where visible.	B.	C - Replace locking arm.	D.	222,223,224

Comments: Generally, in serviceable condition with a defective locking mechanism and deteriorated paint noted. Replace locking arm. Sand, fill and paint. Given the limitations of the survey we were unable to fully inspect the bottom rail, jambs, stiles, glazing bar and cill.

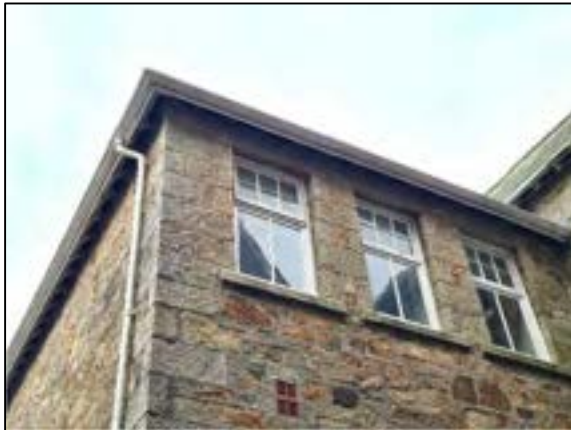
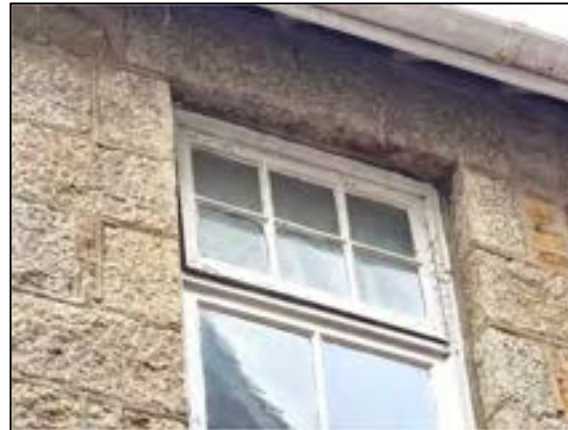
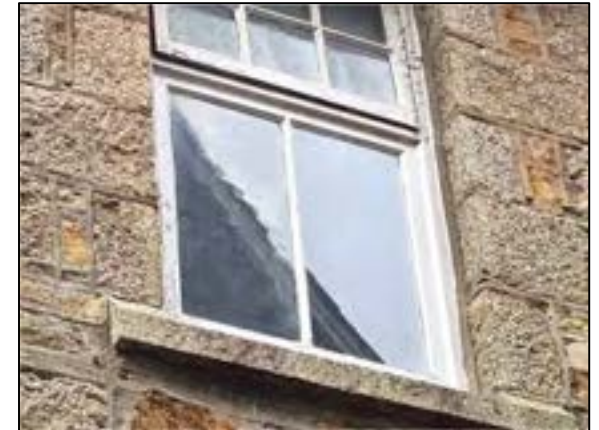
WINDOW NUMBER: BC – W60

Type:	Secondary glazing:	Condition of glazing and glazing bars:	Condition of putty:	Jambs, stiles, rails, transoms and mullions:
Timber frame with top openable.	Not provided.	B.	C.	C – Some decay around locking fixings.

Cills:	Frame:	Hinges, cords, opening mechanisms, etc:	Paint:	Photos:
B – Assumed - Difficult to inspect.	B.	C - Replace hinges, screws missing to hinge on right hand side.	C.	225,226,227

Comments: Missing screws may be a result of defective timber to transom, may require filler prior to installation of new fixings. Replace hinges, sand, fill and paint. Pivot knob (locking mechanism) broken, replace. Given the limitations of the survey we were unable to fully inspect the bottom rail, jambs, stiles, glazing bar and cill.

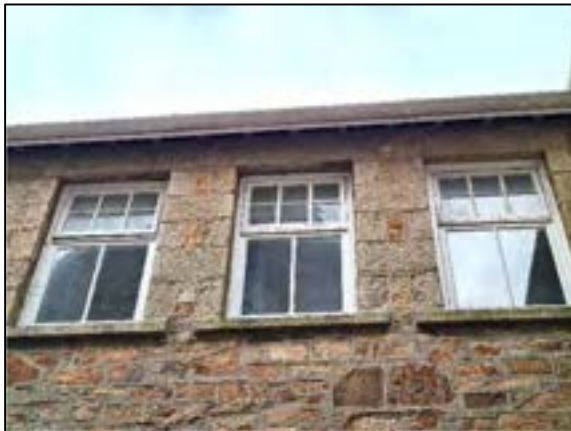
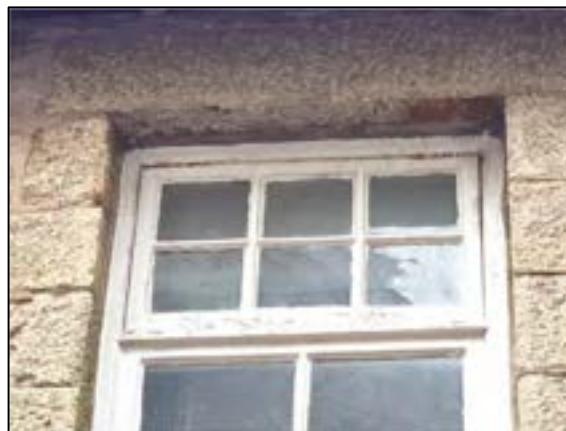
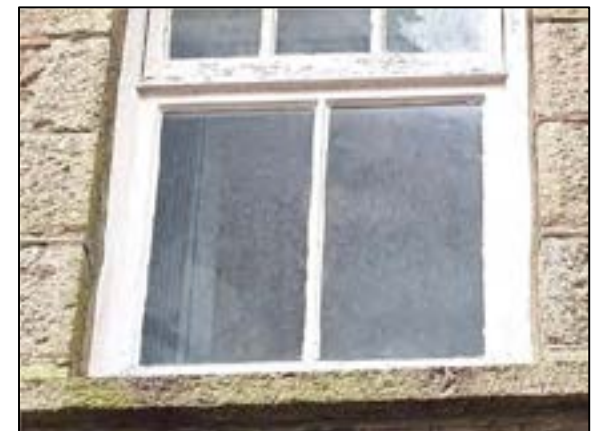
WINDOW NUMBER: BC – W61

Type:	Secondary glazing:	Condition of glazing and glazing bars:	Condition of putty:	Jambs, stiles, rails, transoms and mullions:
Timber frame with top openable.	Not provided.	B.	C.	B.

Cills:	Frame:	Hinges, cords, opening mechanisms, etc:	Paint:	Photos:
B – Assumed - Difficult to inspect.	D - To head of frame.	D - Replace hinges.	C.	228,229,230

Comments: Replace head of frame. Replace hinges. Sand, fill and paint. Filler may be required for new fixings to hinges. NB: Difficult to shut due to poor condition of hinges. Given the limitations of the survey we were unable to fully inspect the bottom rail, jambs, stiles, glazing bar and cill.

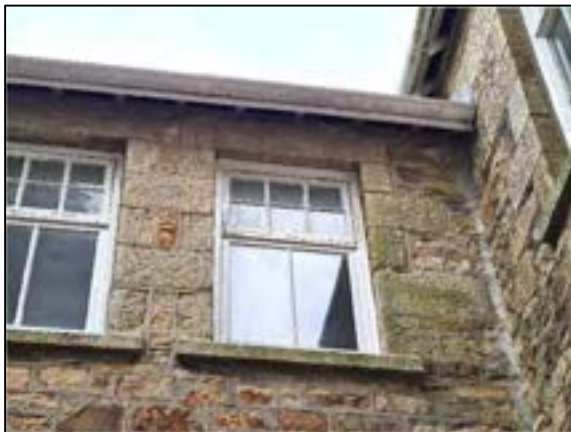
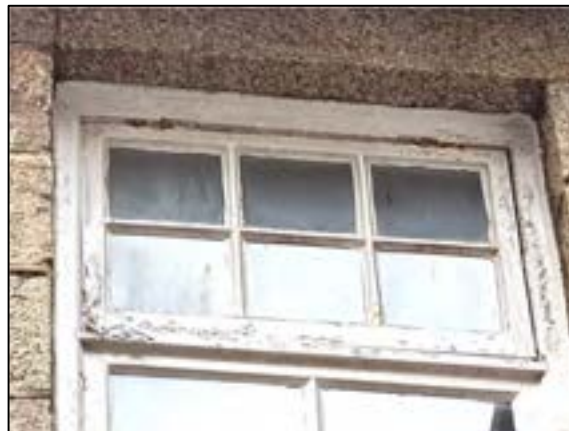
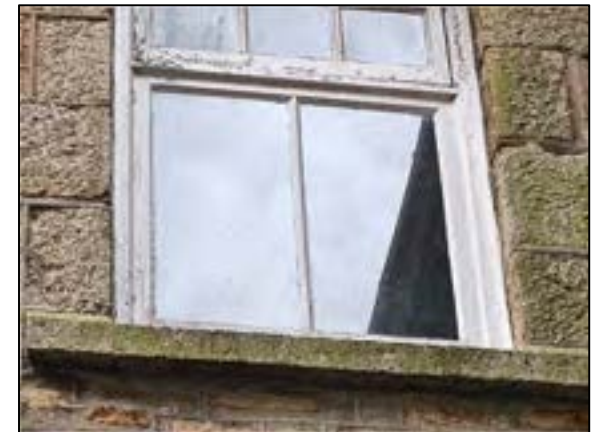
WINDOW NUMBER: BC – W62

Type:	Secondary glazing:	Condition of glazing and glazing bars:	Condition of putty:	Jambs, stiles, rails, transoms and mullions:
Timber frame with top openable sections.	Provided.	B.	D.	C – Assumed - Poor to lower sections.

Cills:	Frame:	Hinges, cords, opening mechanisms, etc:	Paint:	Photos:
C – Assumed – Difficult to inspect. Nb: Secondary cill to right hand openable section.	C - Assumed poor to lower sections.	B.	C.	231,232,233

Comments: Sections of putty have cracked and therefore recommend that all putty is raked out and replaced. Rust staining evident to left hand openable section and therefore recommend that ferrous fixings are replaced with non-ferrous types. Lower sections of frame, mullion and cill are assumed to be in poor condition and should anticipate resin applications. Sand entire window down carry out resin repairs, apply putty and allow to cure, prime and paint. Given the limitations of the survey we were unable to fully inspect the bottom rail, jambs, glazing bars, mullion and cill.

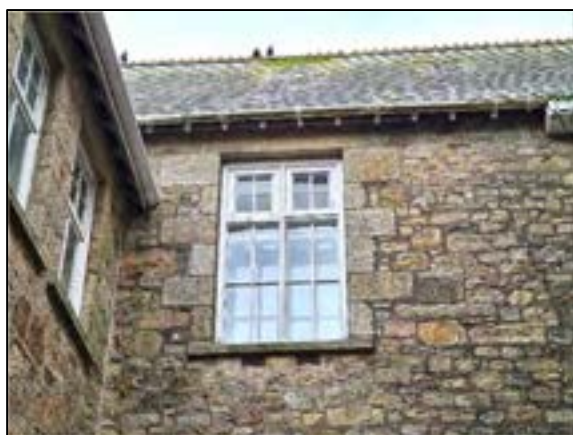
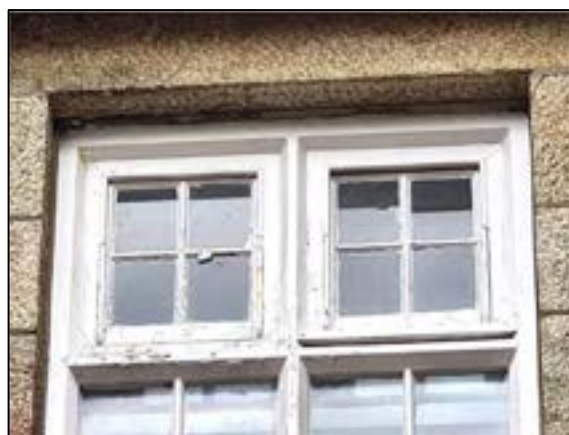
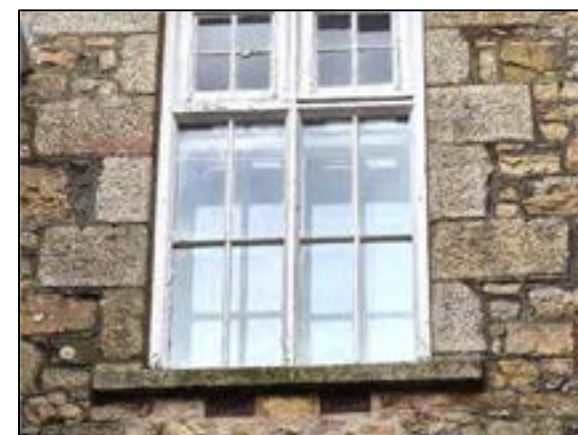
WINDOW NUMBER: BC – W63

Type:	Secondary glazing:	Condition of glazing and glazing bars:	Condition of putty:	Jambs, stiles, rails, transoms and mullions:
Timber frame.	Not provided.	D - Glazing bar to right hand side is broken. Appears pane is broken to left hand side.	D.	C. Upper transom - D.

Cills:	Frame:	Hinges, cords, opening mechanisms, etc:	Paint:	Photos:
C – Assumed.	C.	No opening section.	D.	234,235,236,237

Comments: Rake out all putty and replace broken pane. Transoms appear in poor condition and therefore replacement/resin application is required to both. Repairs are required to right hand glazing bar suggest replacing whole bar. Sand down following timber repairs, install glazing and apply putty. Allow to cure, prime and paint. Given the limitations of the survey we were unable to fully inspect the bottom rail, jambs, glazing bar and cill.

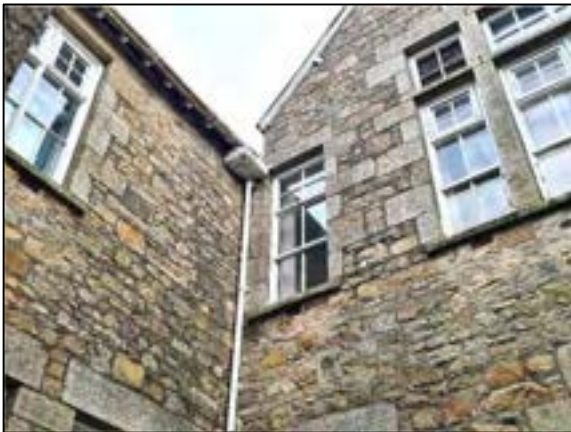
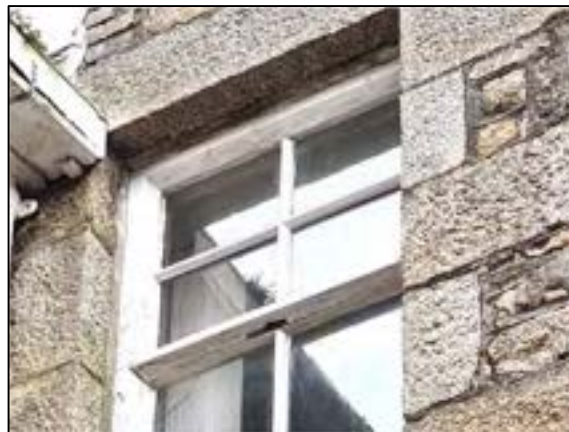
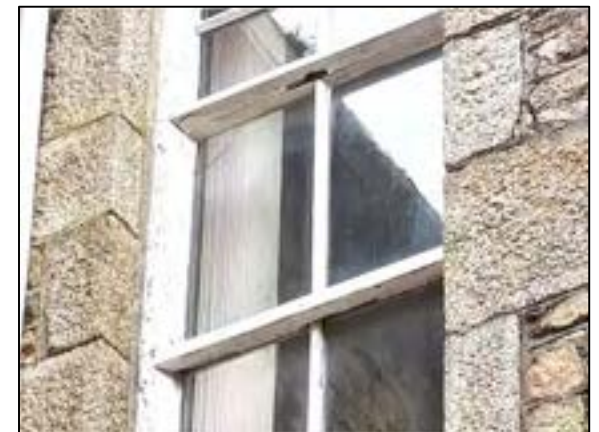
WINDOW NUMBER: BC – W64

Type:	Secondary glazing:	Condition of glazing and glazing bars:	Condition of putty:	Jambs, stiles, rails, transoms and mullions:
Timber frame – timber top to right, left and central (No.4).	Not provided.	D - Bottom left pane broken. D - Central transom.	D.	C - Granite transoms and mullions require repointing. D - Timber mullions poor to lower sections.

Comments: Rake out putty and remove broken pane. Extend of timber decay could not be determined given the limitations of the inspection. However, we assume scarf replacement sections will be required to the lower sections of the frames and mullions. Sand down window following timber remedial works. Apply putty and allow to cure before priming and painting. Carry out repointing works to granite mullions, transoms and lintels. Given the limitations of the survey we were unable to fully inspect the bottom rails, jambs, glazing bars and cills.

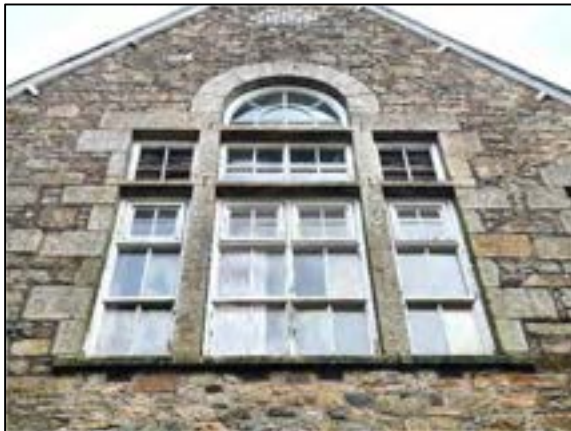
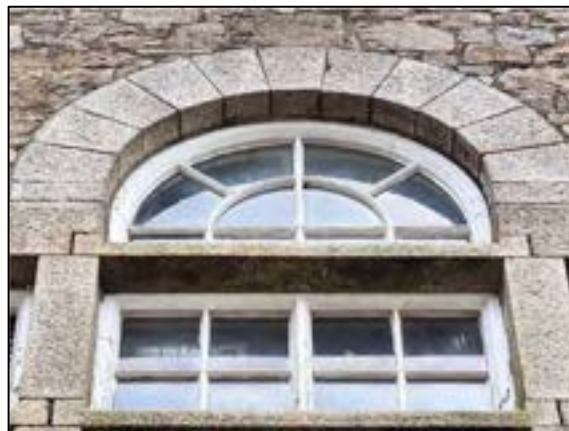
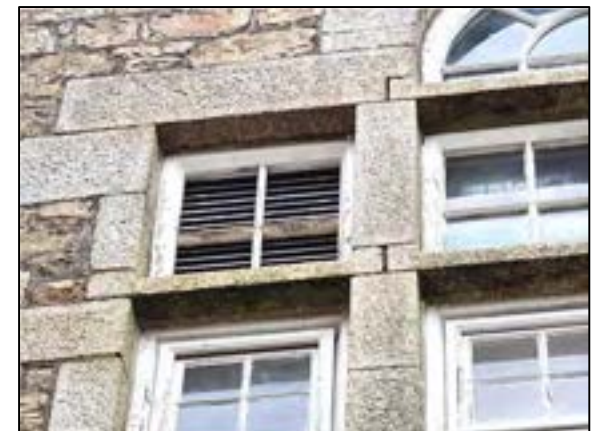
Cills:	Frame:	Hinges, cords, opening mechanisms, etc:	Paint:	Photos:
C.	C.	B.	D.	238,239,240,241,242,243,244,245,246,247,248

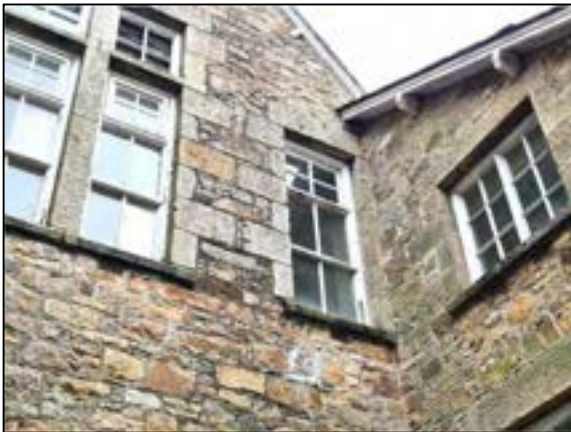
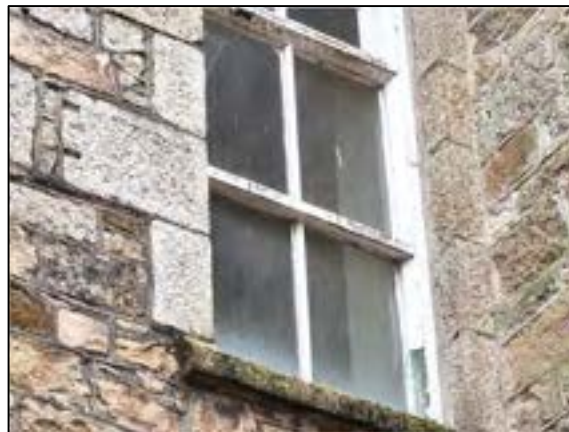
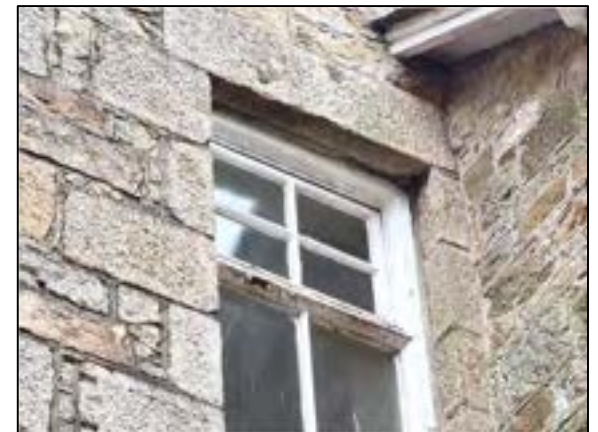
WINDOW NUMBER: BC – W65

Type:	Secondary glazing:	Condition of glazing and glazing bars:	Condition of putty:	Jambs, stiles, rails, transoms and mullions:
Timber frame – timber top, hinges to bottom.	Not provided.	D - Assumed - poor to the left hand side. Difficult to inspect.	C.	C - Transom appears in poor condition, but timber decay could not be determined.

Cills:	Frame:	Hinges, cords, opening mechanisms, etc:	Paint:	Photos:
B – Assumed.	C.	D - Rusted, not opened.	D.	249,250,251

Comments: Replace hinges and we suspect some resin application will be required to the transom. The bottom rail to the openable section appears in poor condition and replacement should be anticipated. Sand down following remedial works, prime and paint. Given the limitations of the survey we were unable to fully inspect the bottom rail, jambs, glazing bar and cill.

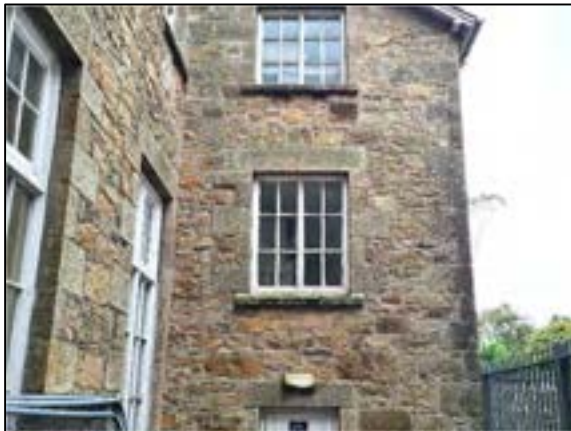
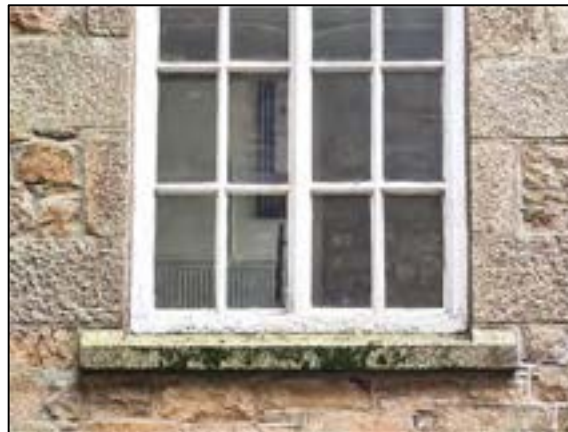
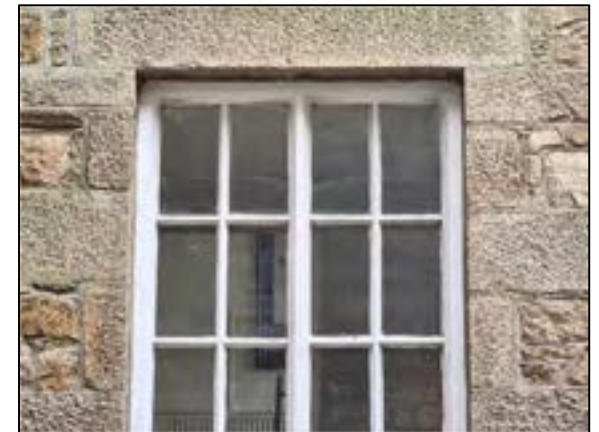
WINDOW NUMBER: BC – W66

Type:	Secondary glazing:	Condition of glazing and glazing bars:	Condition of putty:	Jambs, stiles, rails, transoms and mullions:
Timber frame.	Not provided.	D -One pane broken to upper section.	A.	B.

Cills:	Frame:	Hinges, cords, opening mechanisms, etc:	Paint:	Photos:
B.	B.	No operable section.	C.	252,253,254

Comments: Rake out putty and replace broken pane. Sand down window and fill where required. Apply putty and allow to cure prior to priming and painting. To the granite cill, we would recommend that the moss is brushed away and a fungicidal wash is applied.

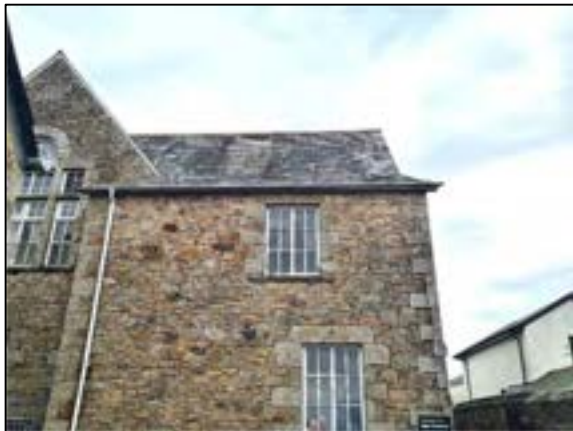
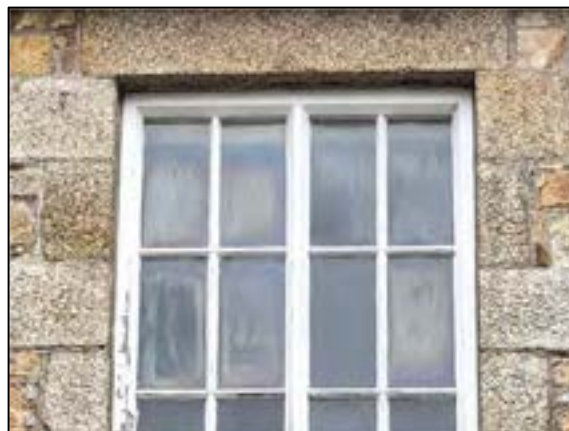
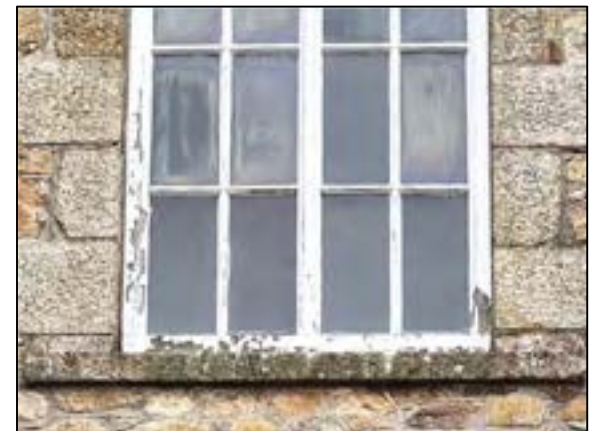
Type:	Secondary glazing:	Condition of glazing and glazing bars:	Condition of putty:	Jambs, stiles, rails, transoms and mullions:
Timber frame.	Not provided.	B.	C.	B.

Cills:	Frame:	Hinges, cords, opening mechanisms, etc:	Paint:	Photos:
C.	B.	No operable section.	D.	257,258,259

Comments: In moderate condition with significant deterioration to the paint finishes at low level. Recommend that the window is sanded down and timber elements to the lower portions are inspected and filled with resin if required. Prime and paint following remedial works. A fungicidal wash is recommended to the granite cill. Given the limitations of the survey we were unable to fully inspect the bottom rail, jambs, glazing bars and cill.
