Basset Community Hub

Architectural Enabling Schedule of Works

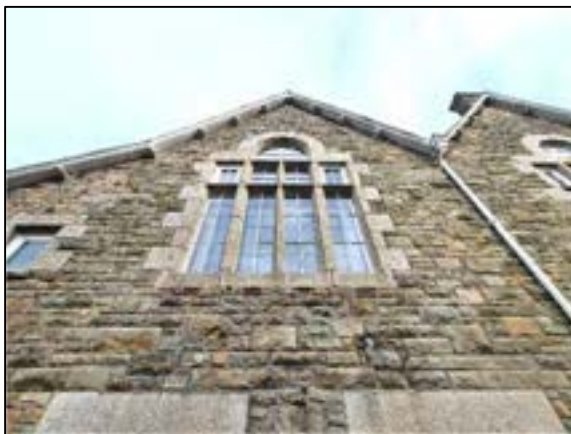
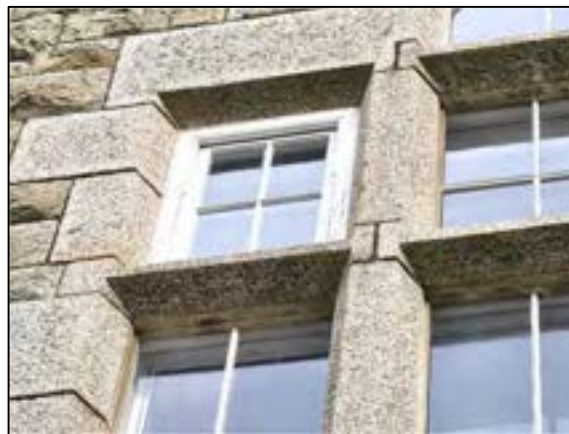
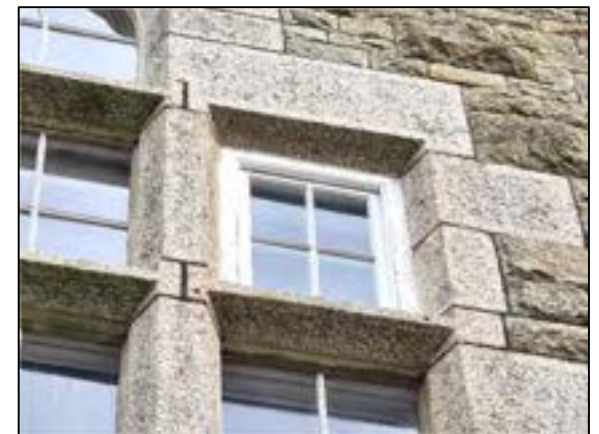
Type:	Secondary glazing:	Condition of glazing and glazing bars:	Condition of putty:	Jambs, stiles, rails, transoms and mullions:
Metal frame with timber openable sections top left and right.	Provided.	A.	A.	A - Repointing required around granite mullions.

Cills:	Frame:	Hinges, cords, opening mechanisms, etc:	Paint:	Photos:
A – Assumed.	A.	A.	C.	264,265,266,267,268,279,280

Comments: This window is outside the scope of our survey however, for the purpose of thoroughness we include the timber sub frames to the upper left and right hand sections beneath the fanlight. These windows appear in good serviceable condition provided periodic maintenance works are carried out. We would recommend that repointing works are carried out around the granite stone surrounds, transoms, mullions and cills. Fixing holes should be filled. Sanding down and painting should be carried out in the short term period.

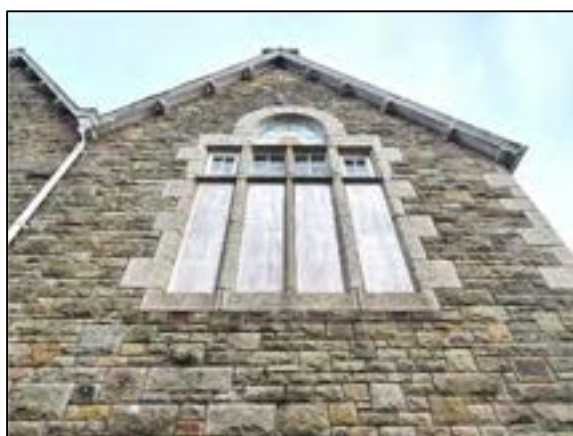
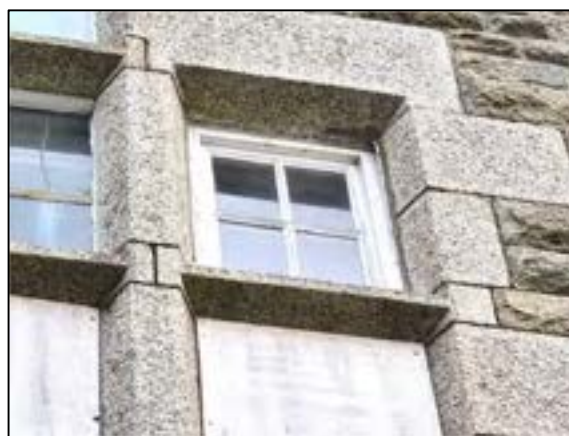
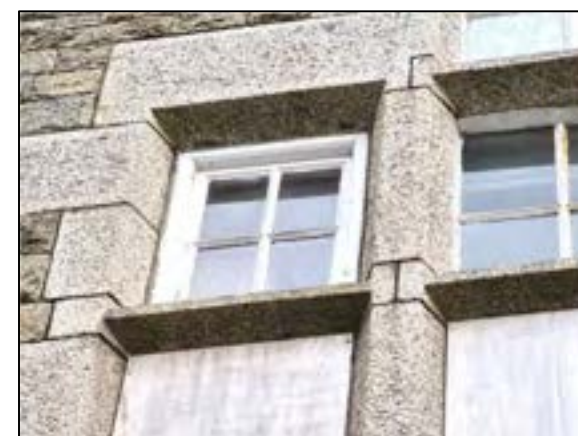
WINDOW NUMBER: BC – W72

Type:	Secondary glazing:	Condition of glazing and glazing bars:	Condition of putty:	Jambs, stiles, rails, transoms and mullions:
Metal frame – timber sub frames to the top left and right beneath fanlight.	Provided.	B.	C.	B – Where visible.

Cills:	Frame:	Hinges, cords, opening mechanisms, etc:	Paint:	Photos:
B – Where visible.	B – Where visible.	Not openable.	C.	269,270,271,272,273

Comments: This window is outside the scope of our survey however, for the purpose of thoroughness we include the timber sub frames to the upper left and right hand sections beneath the fanlight. These windows appear in moderate condition and require general maintenance works. We would recommend that the ferrous fixings are removed and replaced with non-ferrous fixings. Similar to BC-W71, raking out of the mortar joints and repointing is advised. Sanding down and painting should be carried out in the short term period. Nb: The metal windows to the lower sections have been boarded over. Given the limitations of the survey we were unable to fully inspect the bottom rails, jambs, stiles, glazing bars and cill.

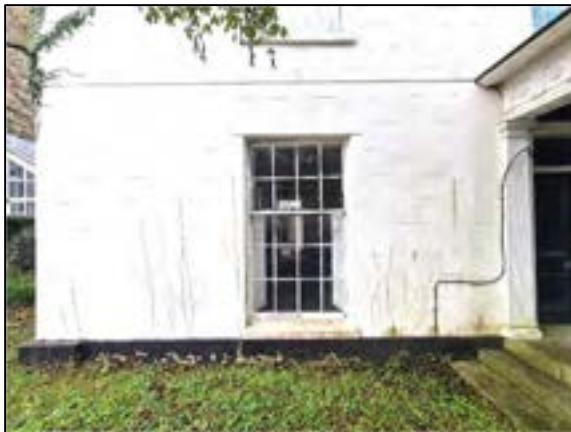
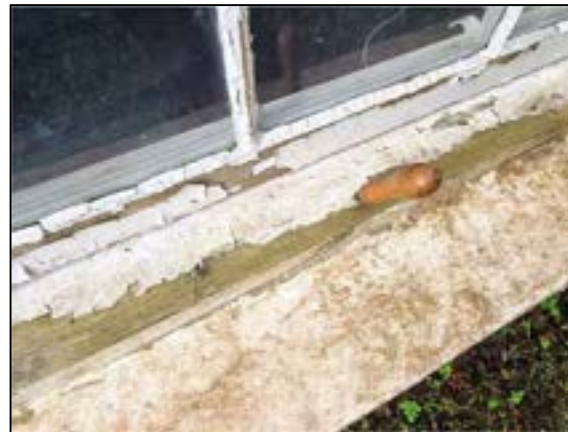
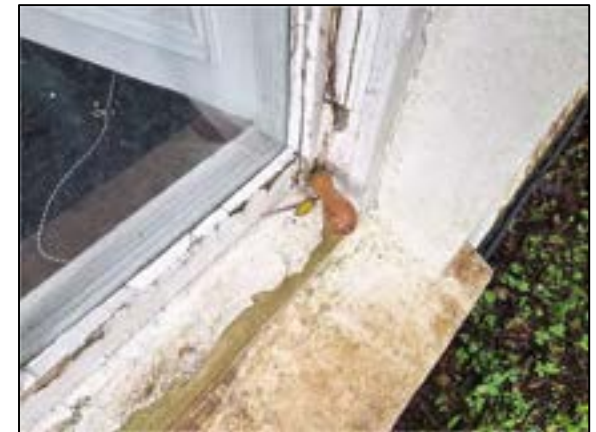
WINDOW NUMBER: WH – W01

Type:	Openable Section:	Condition of glazing and glazing bars:	Condition of putty:	Heads, rails, stiles etc:
Vertical sliding sash window.	Top and bottom.	C - One pane broken, glazing bars in moderate condition.	D – Sections missing.	B - Unable to open due to brass lock being seized. Internally, the top rail has separated from the stile.

Cills:	Linings:	Frame:	Hinges, cords, counterweights:	Paint:	Photos:
D - Rotten to the RHS.	C.	D - RHS 300mm rotten.	D - Assumed, unable to open. Assume replacement of all pulleys, counters, cords etc. Top hinge to the left hand shutter is broken.	D.	274,275,276,277, 278,279,280

Comments: Significant degradation particularly to the lower sections. Unable to open due to defective locking mechanism. Requires full strip down and rebuild with new scarf joint to cill however, new cill is advised. The frame and linings to the right hand side are in poor condition as are the glazing bars. One broken pane. Likely to be more economical to replace whole window than carry out extensive remedial works. Crack through stucco requires further investigation to left hand side of lintel.

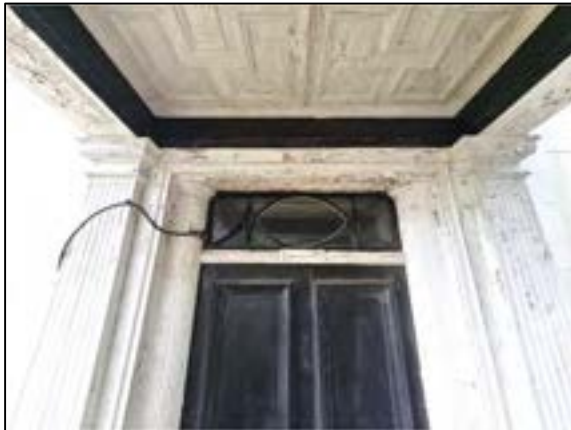
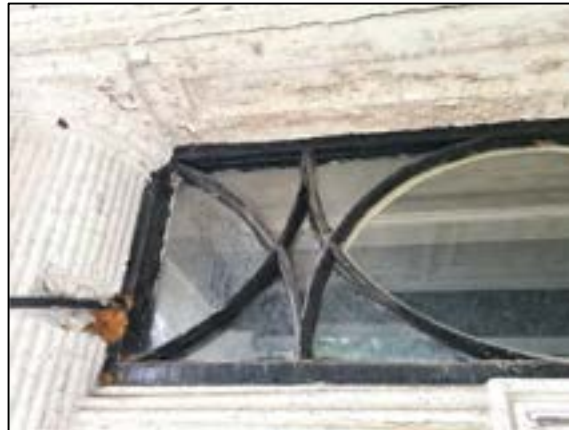
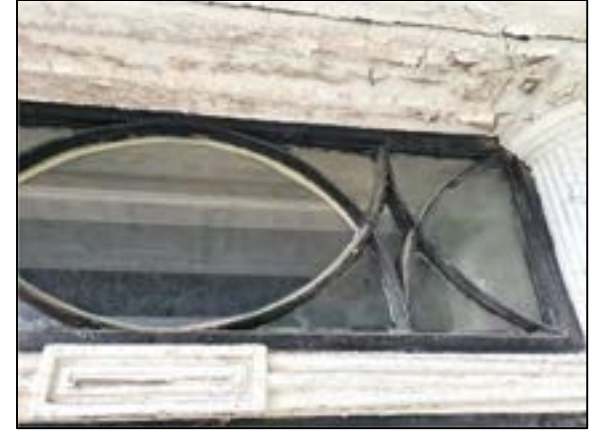
WINDOW NUMBER: WH – W02

Type:	Secondary glazing:	Condition of glazing and glazing bars:	Condition of putty:	Jambs, stiles, rails, transoms and mullions:
Timber frame – above door – fanlight.	Not provided.	B.	C.	B.

Cills:	Frame:	Hinges, cords, opening mechanisms, etc:	Paint:	Photos:
N/A.	B.	N/A	A - Would benefit from being cleaned.	281,282,283,284

Comments: Steel Wired Armoured (SWA) cable running through fanlight to the left hand side. Poor installation of SWA generally and therefore suggest removal of the SWA, filling the hole with resin and making good. Light sanding of the glazing bars to paint in top coat to match existing colour.

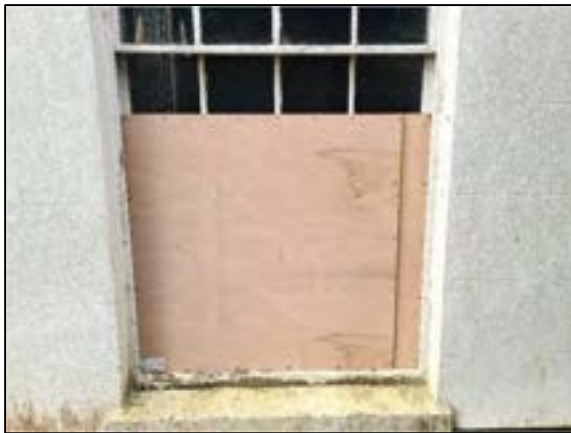
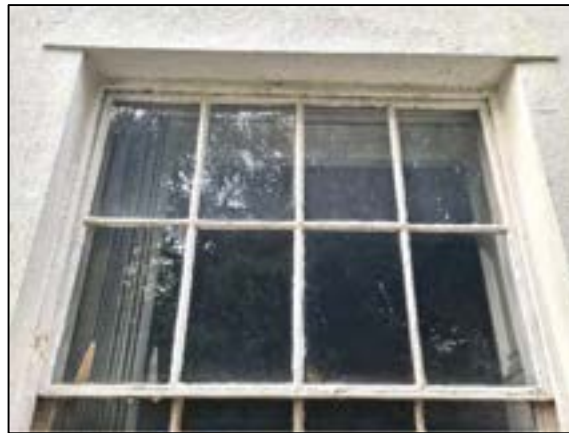
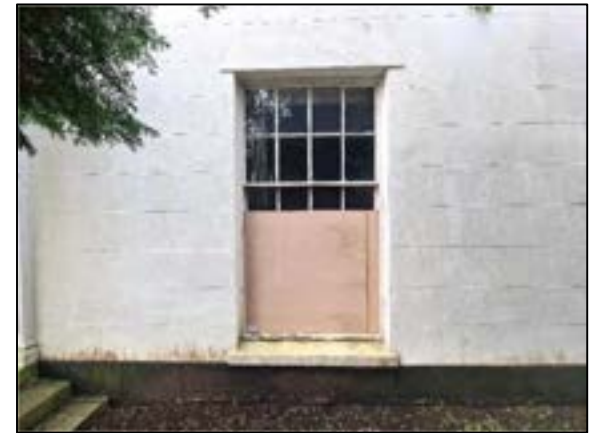
WINDOW NUMBER: WH – W03

Type:	Openable Section:	Condition of glazing and glazing bars:	Condition of putty:	Heads, rails, stiles etc:
Vertical sliding sash window.	Top and bottom.	D - 1 pane broken.	D - Cracked in places.	D – Assumed - Not opened.

Cills:	Linings:	Frame:	Hinges, cords, counterweights:	Paint:	Photos:
D – replace the whole cill.	B.	B. NB: scarf to bottom right hand side 100mm.	D - Not opened, assume cords require replacement.	D.	285,286,287, 288,289,290

Comments: Window boarded - pane broken. Rake out all putty and replace broken pane. Replace whole cill and scarf new section of lining to the right hand side. Sand down window, prime and paint once putty has cured. Counterweights, pulleys and cords should be checked when boarding has been removed.

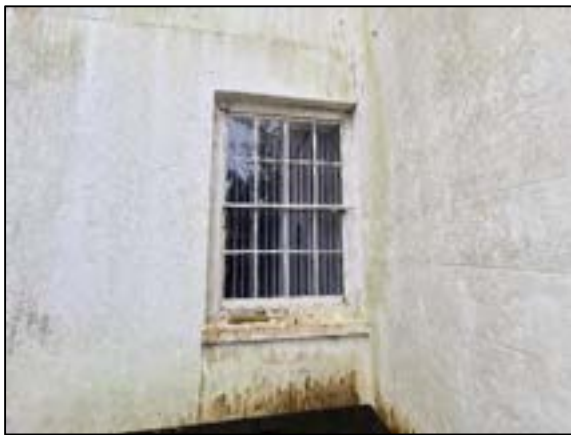
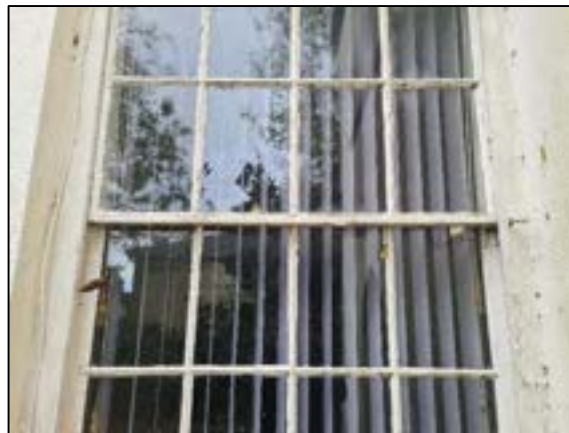
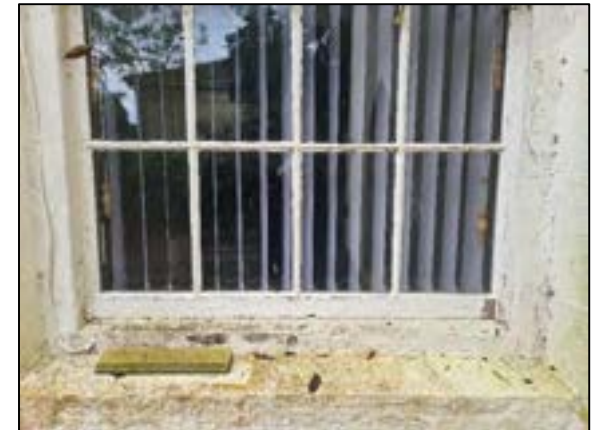
WINDOW NUMBER: WH – W04

Type:	Openable Section:	Condition of glazing and glazing bars:	Condition of putty:	Heads, rails, stiles etc:
Vertical sliding sash window.	Top and bottom.	B.	D.	D – Assumed - Not opened.

Cills:	Linings:	Frame:	Hinges, cords, counterweights:	Paint:	Photos:
D - Left hand side is rotten approx., 500mm.	D - Right hand side scarf 200mm.	D - Right hand side approx., 200mm.	D - Cords have perished. Require replacement, assume counterweights are present but not connected. Locking brass turn screw pulling out of fixings. Rot to rail around fixings.	D.	291,292,293,294,295, 296,297,298,299,300

Comments: Left hand side of cill is rotten by approx. 500mm, suggest replacement of whole cill. To the right hand side both the lining and frame are rotten to the lower section, approx. 200mm, scarf new sections beyond defective timber, say min 350mm. Rake out and apply new putty, allow to cure. Sand, fill, prime and paint. Replace pulleys and cords, and connect to counterweights. Given the extent of repairs required we would recommend that the entire window is removed in order to carry out these works, full strip down and rebuild.

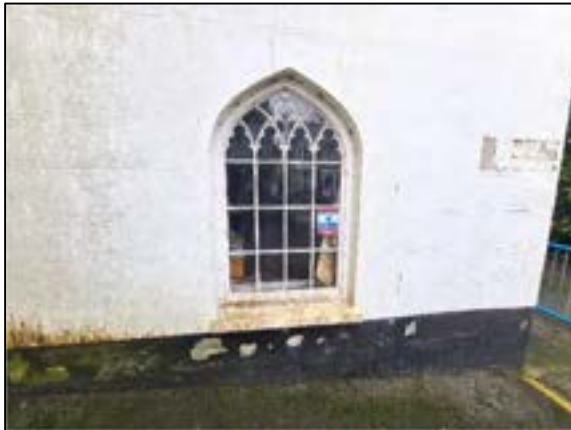
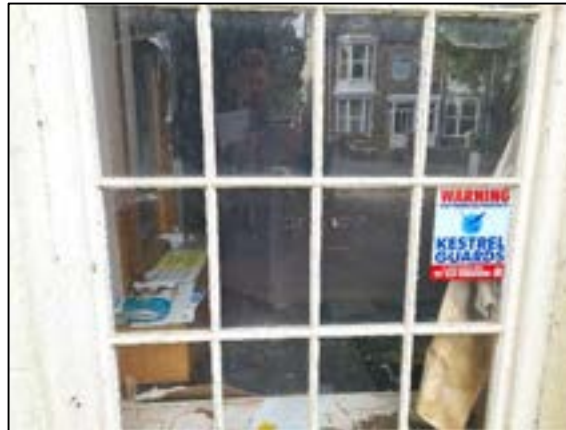
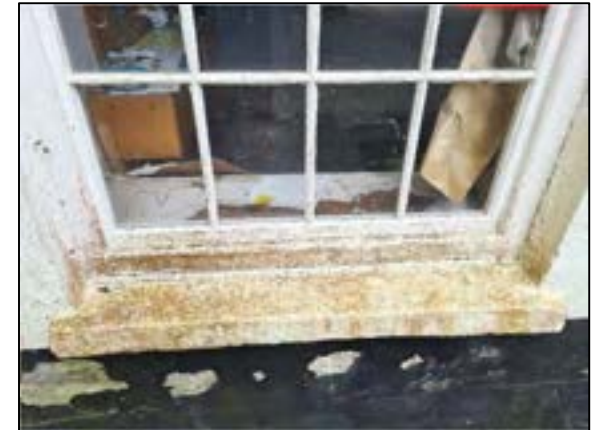
WINDOW NUMBER: WH – W05

Type:	Secondary glazing:	Condition of glazing and glazing bars:	Condition of putty:	Jambs, stiles, rails, transoms and mullions:
Timber frame.	Not provided.	Glazing - B, glazing bars - C.	C.	C - bottom rail poor.

Cills:	Frame:	Hinges, cords, opening mechanisms, etc:	Paint:	Photos:
B.	D - Bottom rotten.	B.	C.	301,302,303,304,305

Comments: Replace bottom of frame in its entirety. Sand down window and check condition of bottom rail, fill if feasible but anticipate replacement of bottom rail. Sand down following timber repairs, prime and paint. Stone cill and lower sections would benefit from fungicidal wash prior to painting as would the masonry wall to the left hand side.

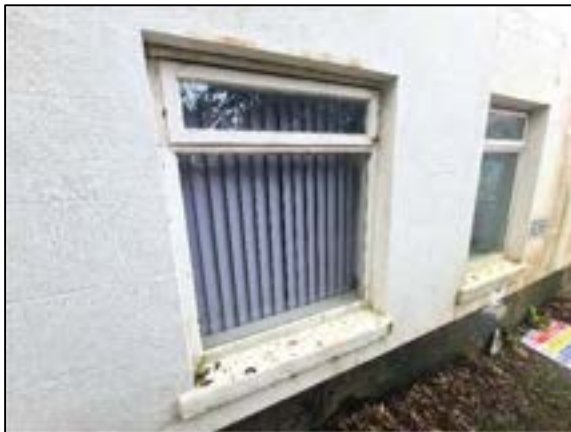
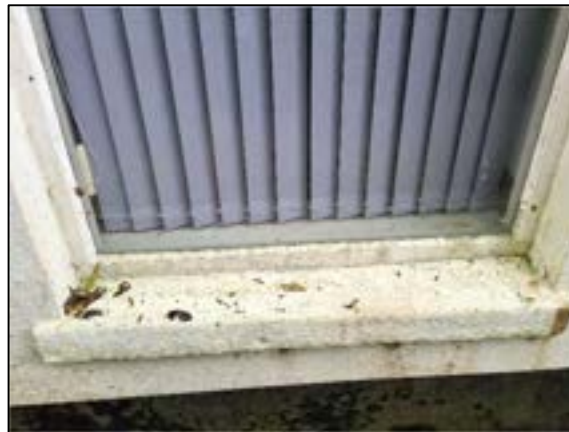
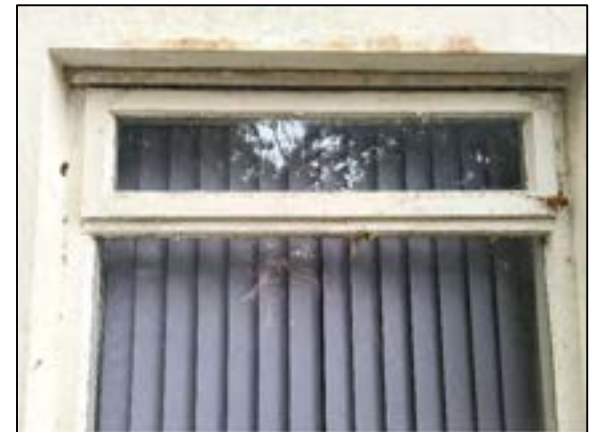
WINDOW NUMBER: WH – W06

Type:	Secondary glazing:	Condition of glazing and glazing bars:	Condition of putty:	Jambs, stiles, rails, transoms and mullions:
Timber frame with timber casement top.	Not provided.	B.	C.	B.

Cills:	Frame:	Hinges, cords, opening mechanisms, etc:	Paint:	Photos:
B.	B.	C - Rust to hinges.	C.	306,307,308

Comments: Rake out putty and sand down window. Remove hinges from top casement. Fill where required apply putty and allow to cure. Replace hinges. Prime and apply top coats. Fungicidal wash recommended to cill and surround.

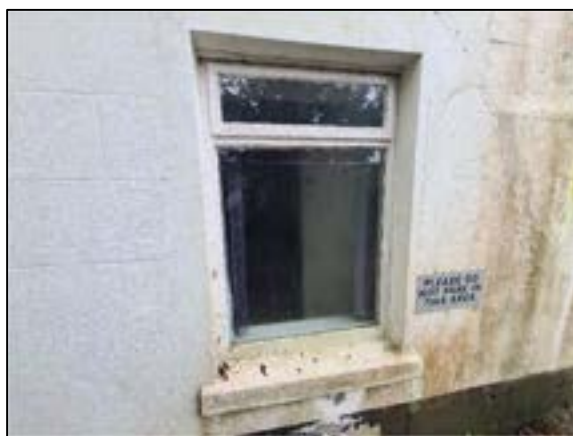
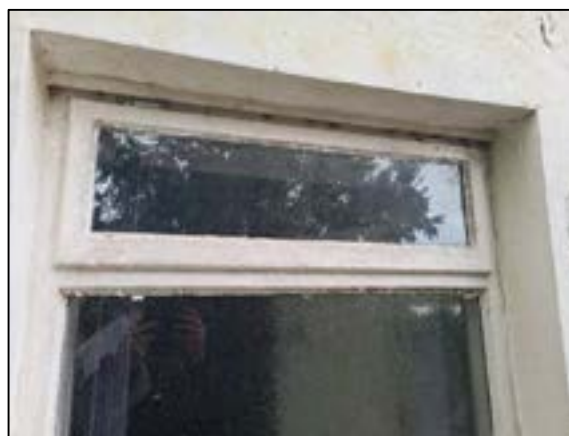
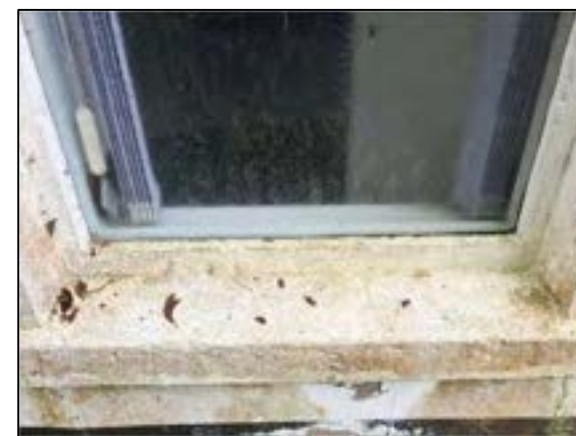
WINDOW NUMBER: WH – W07

Type:	Secondary glazing:	Condition of glazing and glazing bars:	Condition of putty:	Jambs, stiles, rails, transoms and mullions:
Timber frame with timber casement top.	Not provided.	C - Staining noted to bottom left hand side.	C.	C - Some rot to lower sections.

Cills:	Frame:	Hinges, cords, opening mechanisms, etc:	Paint:	Photos:
B.	C - Slight rot to left and right land sides at bottom. Scarf 100mm +.	C - Lever arm requires replacement.	C.	309,310,311,312,313,314

Comments: Scarf in new sections to left and right hand stile. Replace bottom rail. Sand down window and rake out putty. Replace putty and allow to cure prior to primer and top coat applications. Replace locking mechanism internally (locking arm). NB: Excessive condensation internally, background heating within White House recommended to prevent further building fabric degradation. Apply fungicidal wash externally to stone cill and surround.

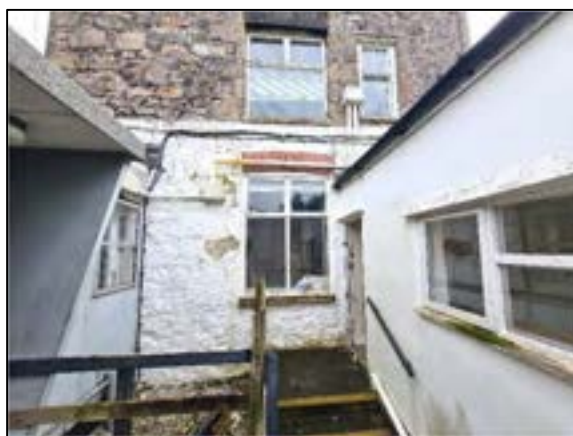
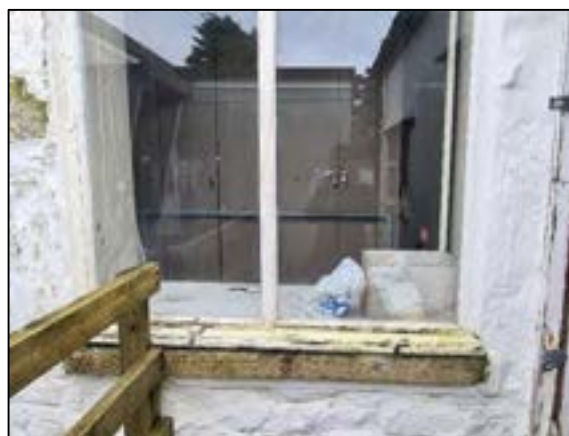
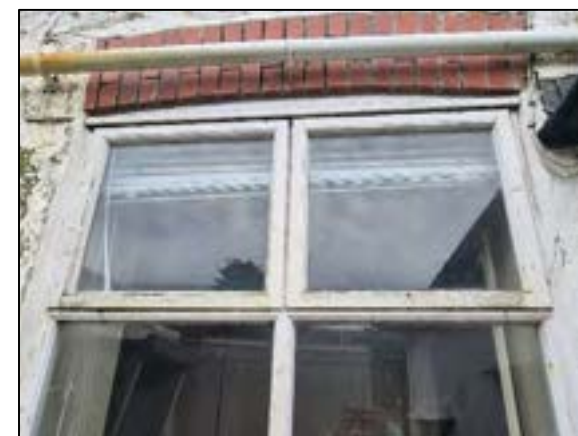
WINDOW NUMBER: WH – W09

Type:	Secondary glazing:	Condition of glazing and glazing bars:	Condition of putty:	Jambs, stiles, rails, transoms and mullions:
Timber frame fanlight with door below.	Not provided.	A.	C – Slight deterioration.	B.

Cills:	Frame:	Hinges, cords, opening mechanisms, etc:	Paint:	Photos:
B - Transom.	B.	N/A.	C.	327,328

Comments: Generally, in good condition. Sand down, inspect putty and replace if required. Apply top coats. Nb: Multiple cable entries.

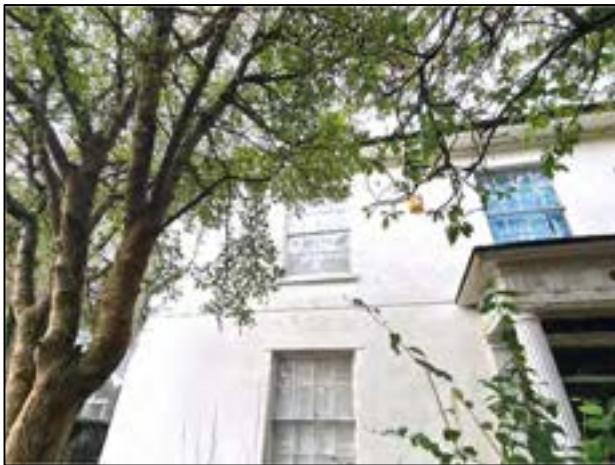
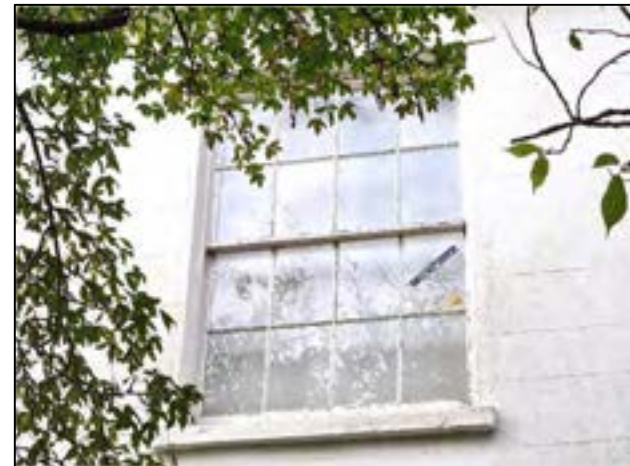
WINDOW NUMBER: WH – W11

Type:	Openable Section:	Condition of glazing and glazing bars:	Condition of putty:	Heads, rails, stiles etc:
Vertical Sliding sash window.	Top and bottom.	B.	C/D.	C.

Cills:	Linings:	Frame:	Hinges, cords, counterweights:	Paint:	Photos:
B.	B.	C - Replacement piece noted to left hand side approx. 20 x 400mm.	D - Cord broken to left hand side, assume counter weight present but not connected.	C.	331,332,333

Comments: Replace cords and connect to counterweights. Check cover replacement piece within frame is of hardwood, replace if required. Rake out all putty and replace. Sand down whole window and once putty has cured, prime and paint. Hairline crack noted to stucco to right hand side of lintel.

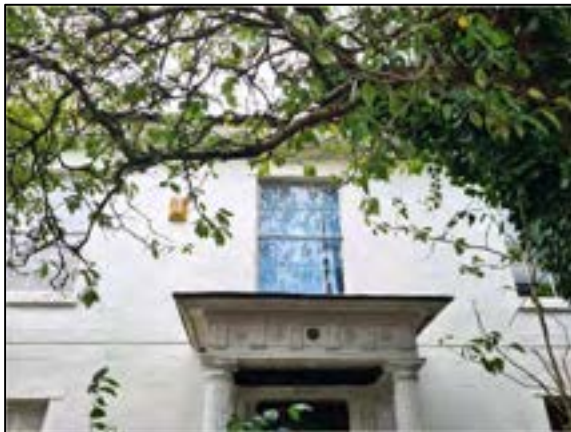
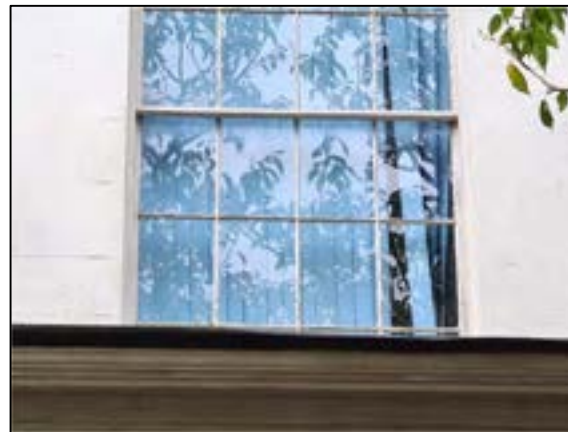
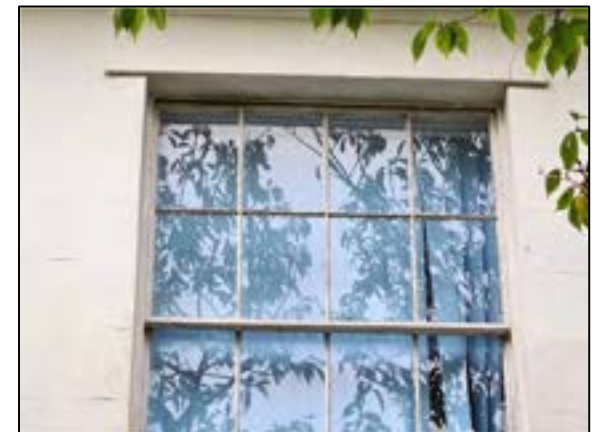
WINDOW NUMBER: WH – W12

Type:	Openable Section:	Condition of glazing and glazing bars:	Condition of putty:	Heads, rails, stiles etc:
Vertical sliding sash window.	Top and bottom.	B.	C/D.	B.

Cills:	Linings:	Frame:	Hinges, cords, counterweights:	Paint:	Photos:
B.	B.	D - Slight rot to lower sections generally.	B.	C.	334,335,336

Comments: Replace approx. 20x300mm section to left and right hand side of frames (cover piece). Rake out all putty and replace with new and allow to cure. Full sand down and inspection of glazing bars prior to priming and application of top coats.

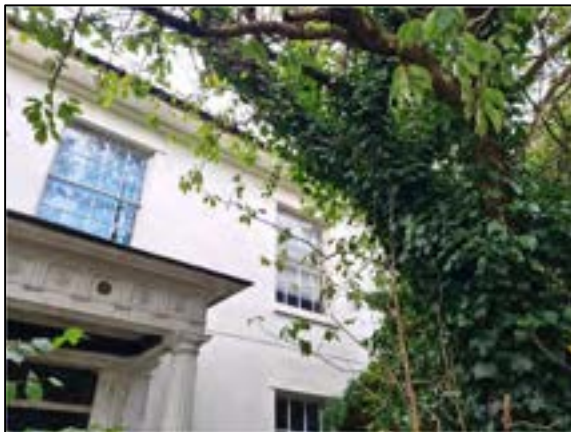
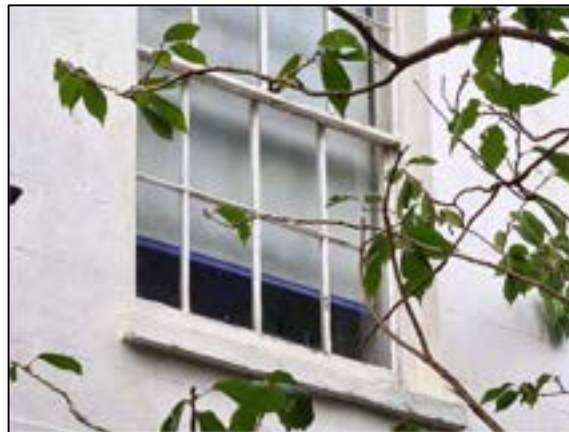
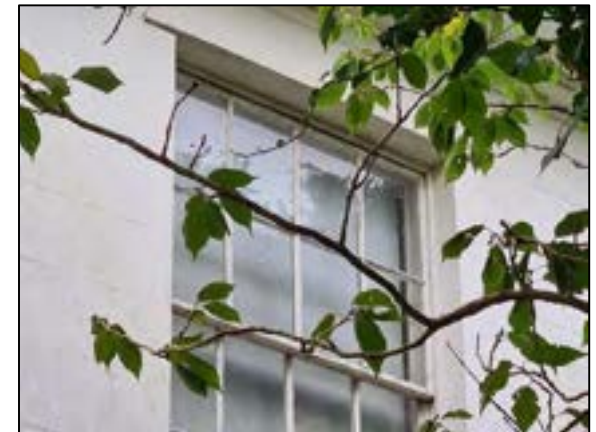
WINDOW NUMBER: WH – W13

Type:	Openable Section:	Condition of glazing and glazing bars:	Condition of putty:	Heads, rails, stiles etc:
Vertical sliding sash window.	Top and bottom.	B.	C/D.	D - Right hand side is poor.

Cills:	Linings:	Frame:	Hinges, cords, counterweights:	Paint:	Photos:
B.	D - Right hand side is poor, relace whole of right hand side.	B.	B.	C.	337,338,339

Comments: Replace lining to the right hand side. Sand down, rake out putty and inspect glazing bars, replace if necessary. Sand down entire window, apply putty and allow to cure. Prime and paint. Hairline crack noted to left hand side of lintel, this requires further investigation.

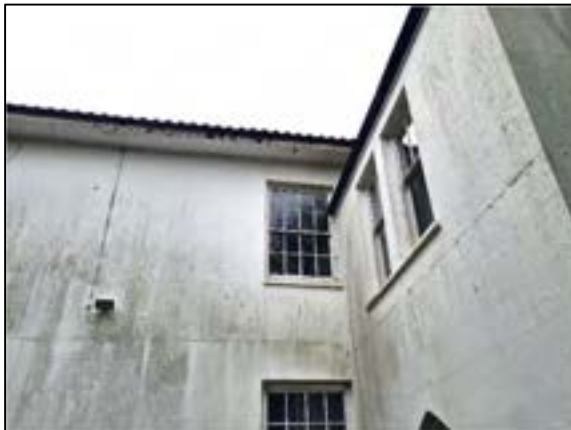
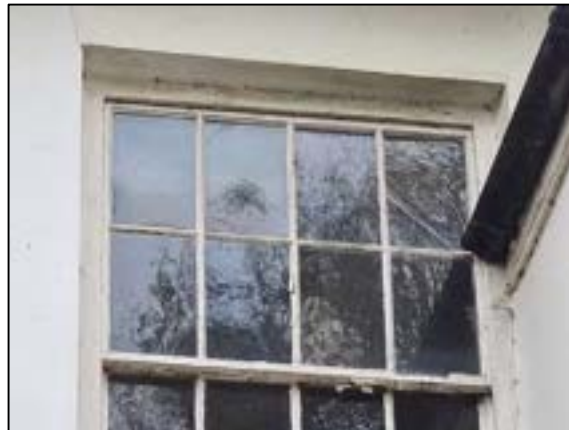
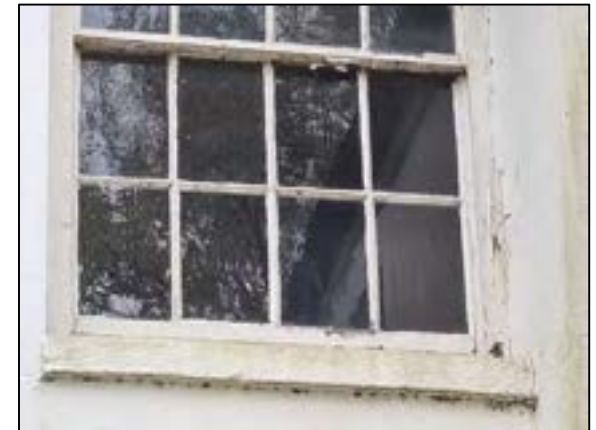
WINDOW NUMBER: WH – W14

Type:	Openable Section:	Condition of glazing and glazing bars:	Condition of putty:	Heads, rails, stiles etc:
Vertical sliding sash window.	Top and bottom, but bottom won't open.	B.	C.	D.

Cills:	Linings:	Frame:	Hinges, cords, counterweights:	Paint:	Photos:
E - Replace whole cill.	D - Scarf 200mm to both sides or replace both.	C.	D.	D.	340,341,342

Comments: We would recommend replacing both linings externally or at a minimum scarf 300mm sections to both sides. Slight shrinkage around stiles and bottom rail and suspect that the glazing bar will require replacement. Therefore, rake out putty, replace glazing bar, separate stiles and apply new glue, clamp and allow to set. Sand down entire window. Apply putty and allow putty to cure, prime and paint.

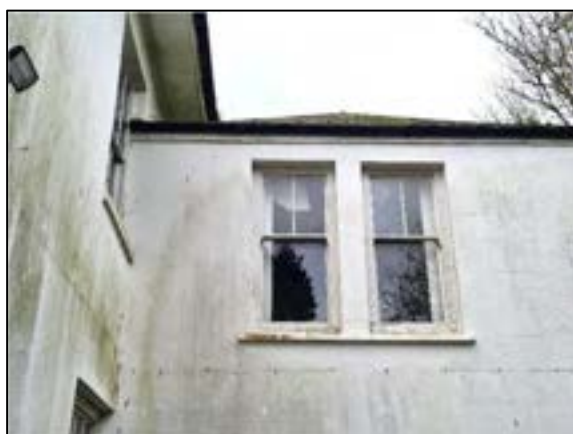
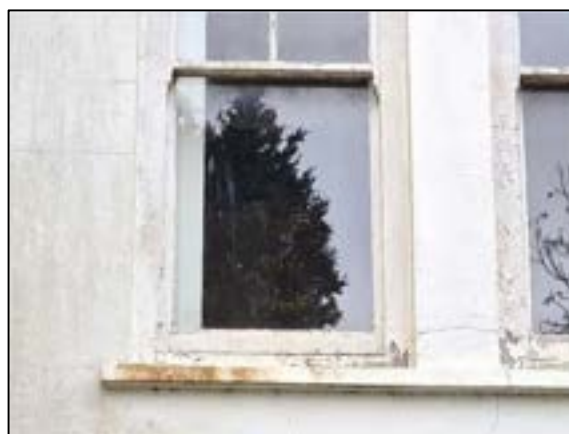
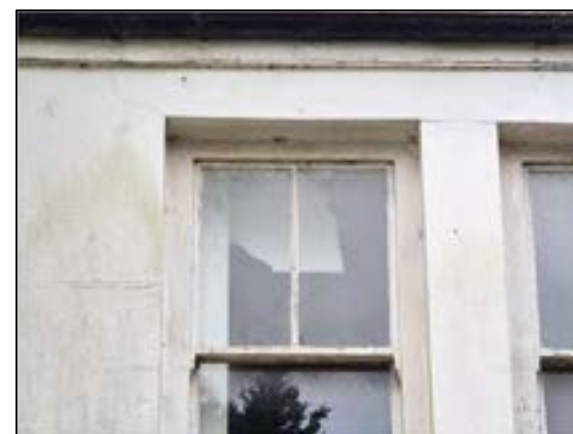
WINDOW NUMBER: WH – W15

Type:	Openable Section:	Condition of glazing and glazing bars:	Condition of putty:	Heads, rails, stiles etc:
Vertical sliding sash window.	Bottom opens.	C.	C.	D.

Cills:	Linings:	Frame:	Hinges, cords, counterweights:	Paint:	Photos:
E - Replace whole cill.	D - scarf 200mm to both sides or replace both.	C.	C.	D.	343,344,345

Comments: The cill requires complete replacement. Slight shrinkage around stiles and bottom rail and therefore recommend that the window is dismantled and new glue is applied, clamp down and allow to set. Glazing bar replacement is recommended. Sand down window following timber repairs. Apply putty and allow to cure. Prime and paint. Replace locking latch.

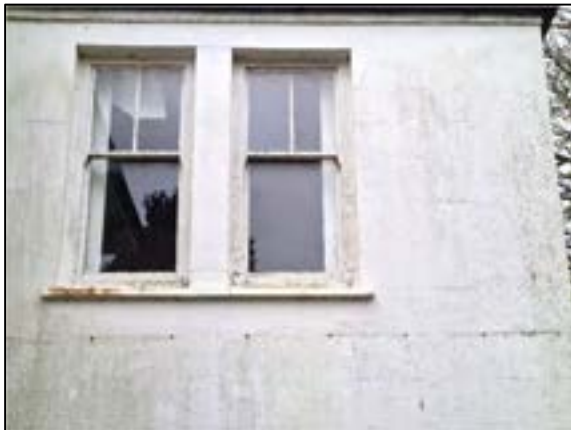
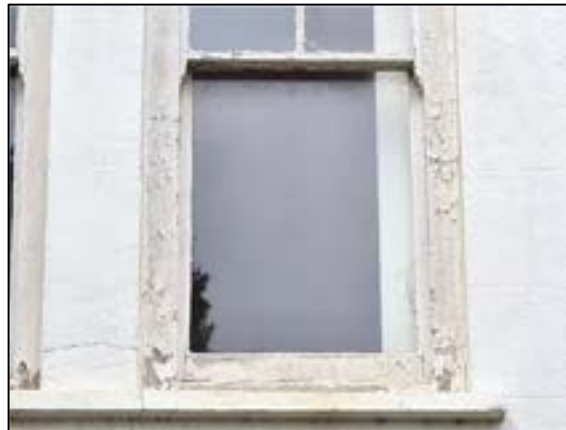
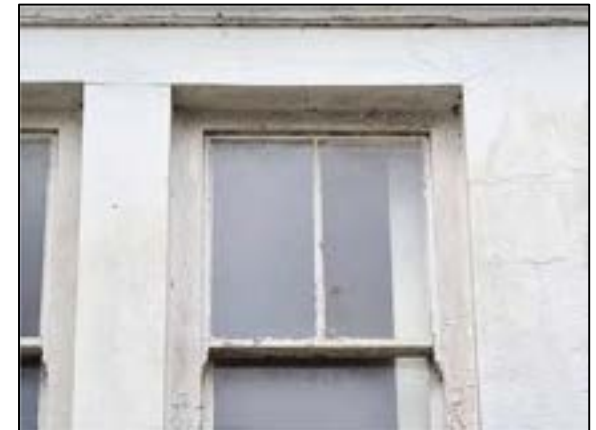
WINDOW NUMBER: WH – W16

Type:	Openable Section:	Condition of glazing and glazing bars:	Condition of putty:	Heads, rails, stiles etc:
Vertical sliding sash window.	Bottom opens.	B.	A.	B.

Cills:	Linings:	Frame:	Hinges, cords, counterweights:	Paint:	Photos:
C - Requires fungicidal wash.	D - Previous scarf to left hand side approx. 100mm. Right hand side approx. 200mm.	D - Right hand side, replace 200mm.	B.	C.	346,347,348

Comments: Generally, in moderate condition however, we would recommend that the previous scarf to left hand side, is inspected and replaced, if required. Sand down window, fill and paint. Replace locking latch. Apply fungicidal wash to cill and surrounding stucco.

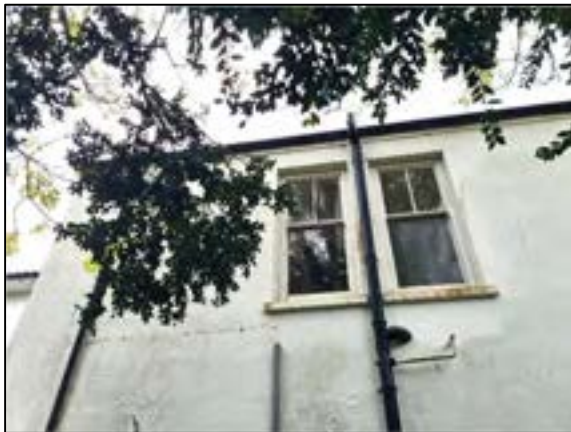
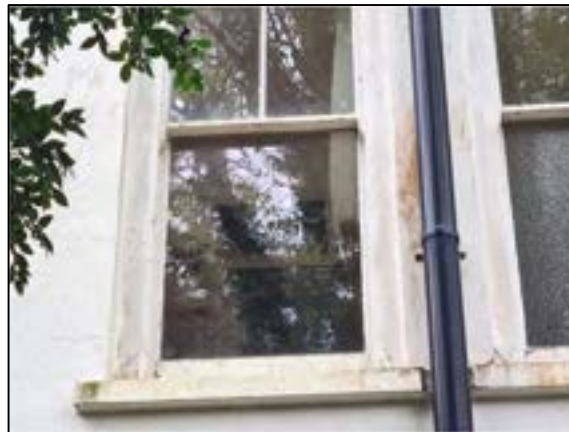
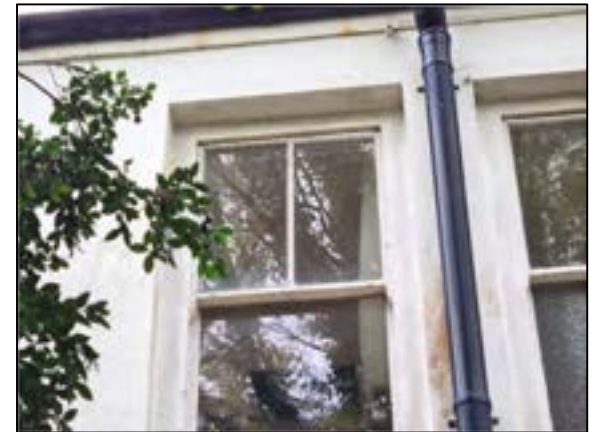
WINDOW NUMBER: WH – W17

Type:	Openable Section:	Condition of glazing and glazing bars:	Condition of putty:	Heads, rails, stiles etc:
Vertical sliding sash window.	Bottom opens.	B.	A.	B - but bottom rail requires replacement.

Cills:	Linings:	Frame:	Hinges, cords, counterweights:	Paint:	Photos:
C - Requires fungicidal wash.	C - Previous scarf to right hand side approx. 100mm.	D - Left hand side approx. 300mm, scarf section.	B.	C.	349,350,351

Comments: Replace bottom rail. Replace 300mm of frame and lining to left hand side. Locking latch is broken, replace. Sand down, prime and paint. Apply fungicidal wash to cill.

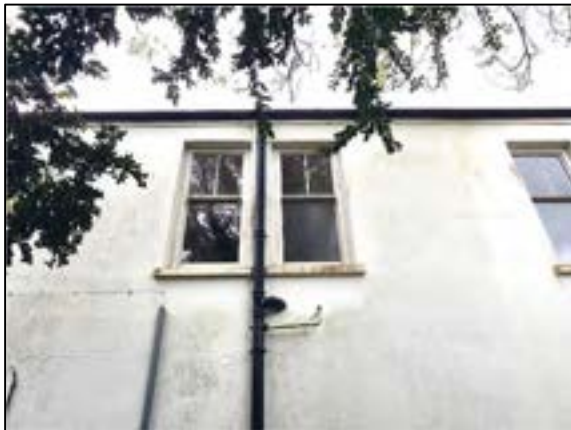
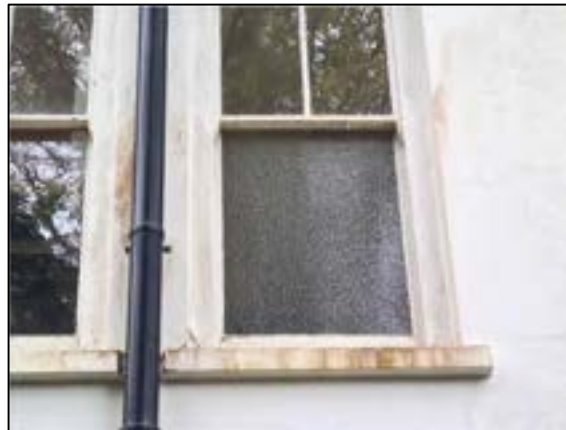
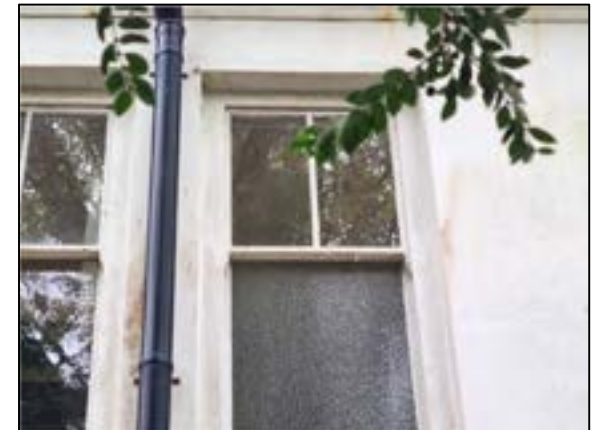
WINDOW NUMBER: WH – W18

Type:	Openable Section:	Condition of glazing and glazing bars:	Condition of putty:	Heads, rails, stiles etc:
Vertical sliding sash window.	Bottom opens but very difficult to open. Only opened approx. 100mm.	B.	C.	B.

Cills:	Linings:	Frame:	Hinges, cords, counterweights:	Paint:	Photos:
D - Left hand side approx. 100mm.	D - Note: left hand side scarf 300mm.	D - Left hand side approx. 300mm.	D - Cord broken to left hand side, assume counter weight present but not connected.	C.	352,353,354

Comments: Extensive rot to left hand side, recommend replacing whole lining to the left hand side. Inspect scarf to right hand side and replace if required. Scarf new frame sections to left hand side approx. 300mm. Cord to left hand side is broken and therefore requires replacement with connection made to counterweight. Recommend full strip down of window and replace timber elements where necessary. Nb: Electrical junction box to right hand side.

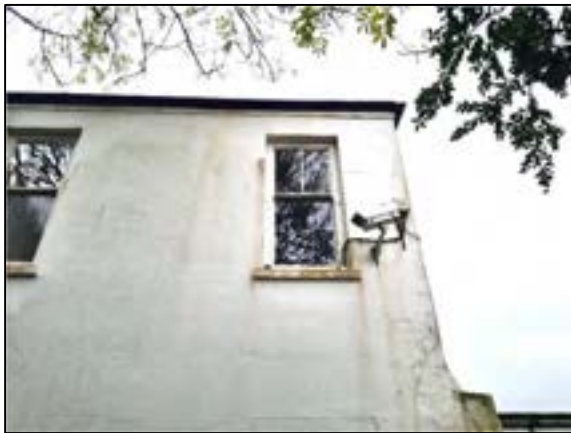
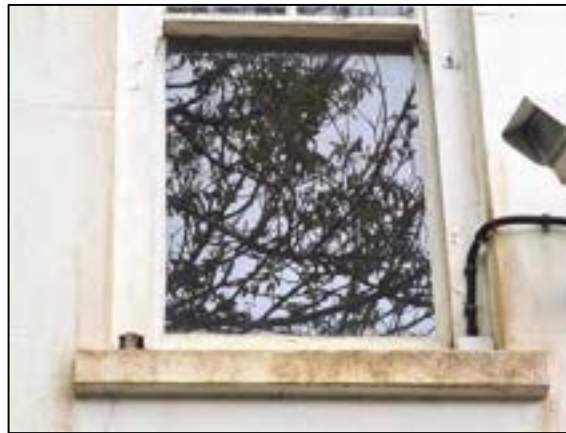
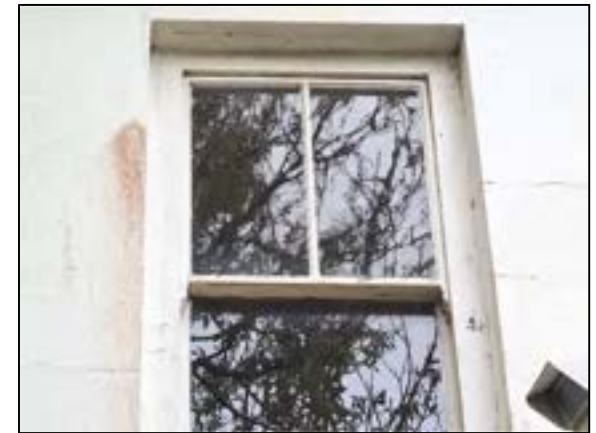
WINDOW NUMBER: WH – W19

Type:	Secondary glazing:	Condition of glazing and glazing bars:	Condition of putty:	Jambs, stiles, rails, transoms and mullions:
Timber frame with timber casement top x 2 openable sections.	Not provided.	Glazing – lower section has dropped leaving gap between the pane and transom.	D.	D.

Cills:	Frame:	Hinges, cords, opening mechanisms, etc:	Paint:	Photos:
E - Rotten.	E - To left and right hand side.	E - Locking arms are in very poor condition.	D.	355,356,357

Comments: In very poor condition with the lower sections completely rotten. Consider complete replacement as generally considered to be beyond the point of economical repair and being of softwood construction not of historical value.

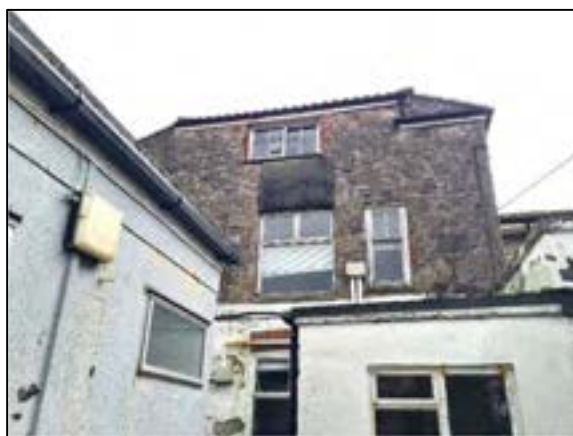
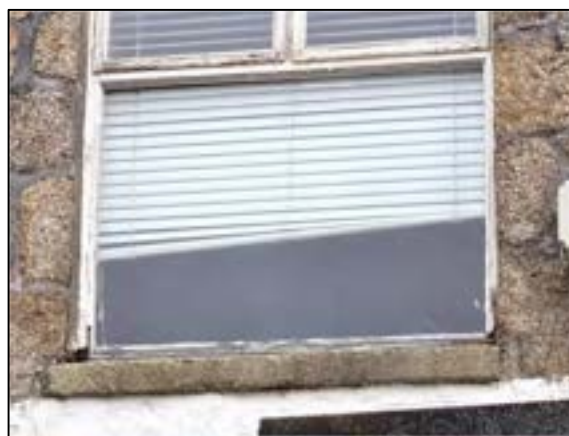
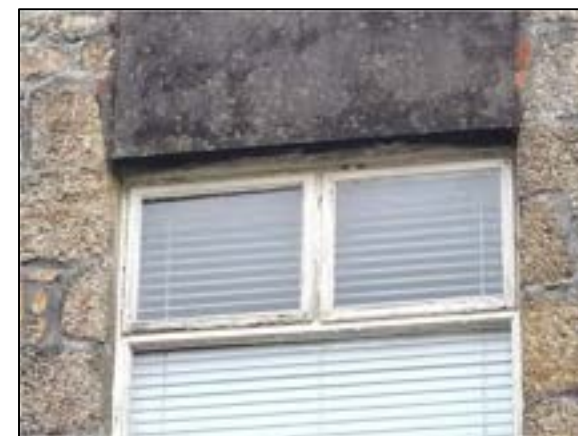
WINDOW NUMBER: WH – W20

Type:	Openable Section:	Condition of glazing and glazing bars:	Condition of putty:	Heads, rails, stiles etc:
Vertical sliding sash window.	Bottom opens.	B.	C.	C. Transom - D.

Cills:	Linings:	Frame:	Hinges, cords, counterweights:	Paint:	Photos:
C.	E - To left and right hand side.	D - External guide runner loose.	B.	D.	358,359,360

Comments: Defective lintel, we suspect that a metal element has been installed retrospectively that is now delaminated and failing. Ideally the masonry course above should be replaced by a single granite lintel and the metal element removed. The mortar between the frame and metal has displaced and a section is missing. To the window we would recommend that the window is removed to allow for the works to the lintel. Full strip down and replacement of the timber elements where necessary. We recommend that the linings and transom require replacement and suspect that the cill should also be replaced. Full sand down, rake out putty, reapply, prime and paint. Extensive remedial works required.

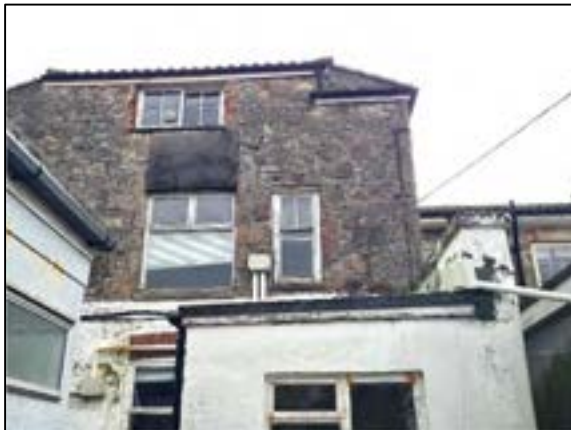
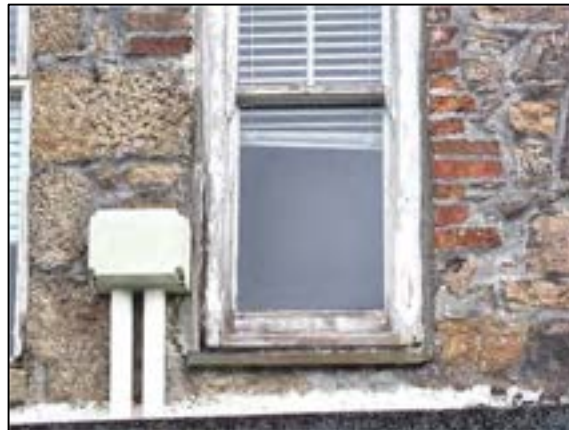
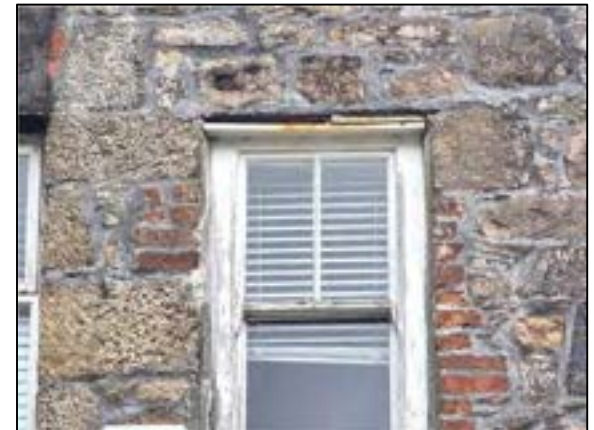
WINDOW NUMBER: WH – W21

Type:	Openable Section:	Condition of glazing and glazing bars:	Condition of putty:	Heads, rails, stiles etc:
Vertical sliding sash window.	Top and bottom but neither open.	C.	D.	C.

Cills:	Linings:	Frame:	Hinges, cords, counterweights:	Paint:	Photos:
E. Replace.	D - Right hand side lining in poor condition.	C.	D - Cords are tired. Replace.	C.	361,362,363

Comments: Full strip down recommended. Difficult to open and given the defects noted to the cill and lining anticipate extensive remedial works. Replacement of glazing bars should be anticipated however, given the limitations of the inspection we were unable to confirm the condition of these elements. Full sand down following timber remedial works, fill, prime and paint.

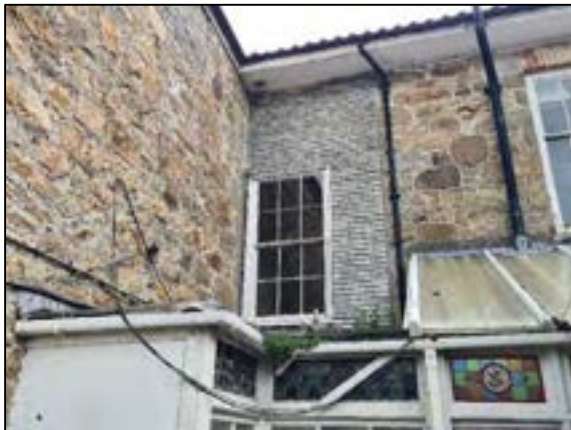
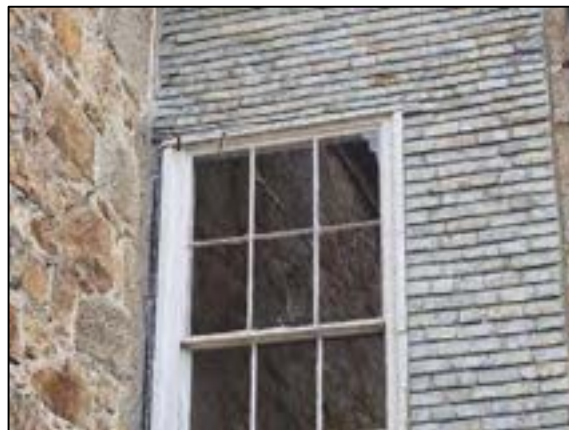
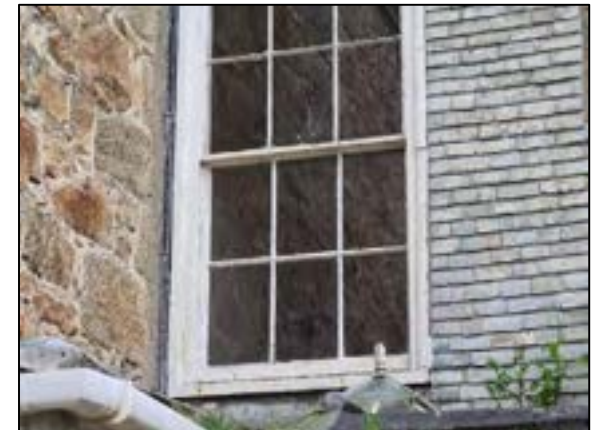
WINDOW NUMBER: WH – W22

Type:	Openable Section:	Condition of glazing and glazing bars:	Condition of putty:	Heads, rails, stiles etc:
Vertical sliding sash window.	Top section is sealed shut. NB: Cables to right hand side. Bottom only opens 300mm.	C.	D.	D.

Cills:	Linings:	Frame:	Hinges, cords, counterweights:	Paint:	Photos:
E - Replace whole cill.	D.	D - to right hand side.	D - Only bottom opens.	D.	364,365,366

Comments: Extensive repairs similar to WH-W21. Recommend that the window is removed and full strip down is carried out. Replace whole cill and lining to the right hand side. The bottom rail to the left hand side also appears in poor condition. Replacement of some of the glazing bars should be anticipated once putty has been raked out. Full sand down following timber remedial works, fill, apply putty, allow to cure, prime and paint.

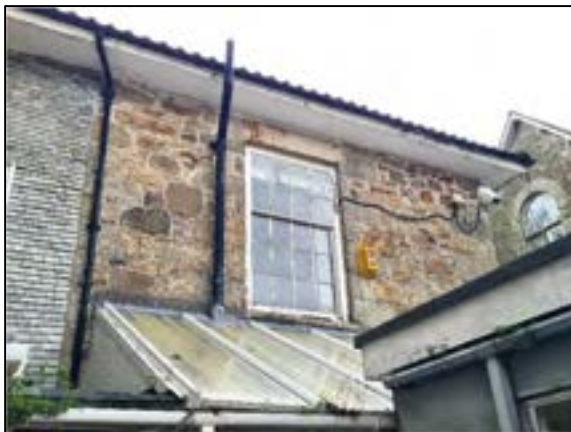
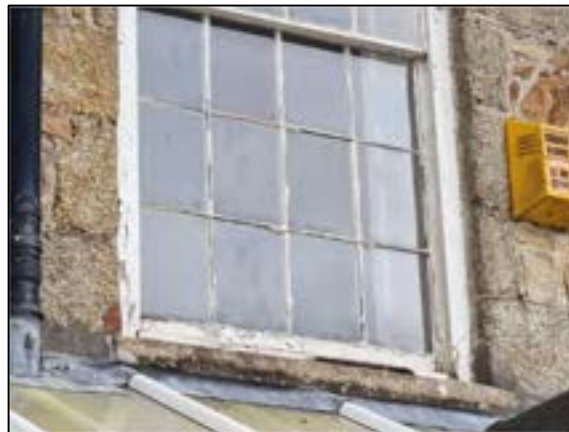
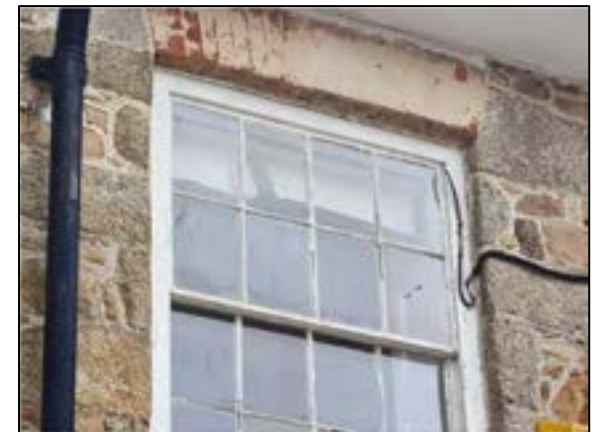
WINDOW NUMBER: WH – W23

Type:	Secondary glazing:	Condition of glazing and glazing bars:	Condition of putty:	Jambs, stiles, rails, transoms and mullions:
Timber frame with sliding section (screwed shut). Vent extraction incorporated.	Not provided.	E - Glazing bars very poor and rotten internally. One pane broken.	D.	C.

Comments: Rake out putty and replace broken pane. Sand down window and remove screws that are keeping opening section from sliding. Inspect sliding rail once openable. Apply resin/fill as required and allow to cure. Apply primer and top coats following remedial works. Given the extent of the works it is advisable to remove the window in its entirety.
