Simon Bastone Associates Ltd

**Structural Inspection Report
on
Various Structures
at
Goss Moor National Nature Reserve
For
Natural England
Part 1**

Reference R210348/SI/00

03 June 2021

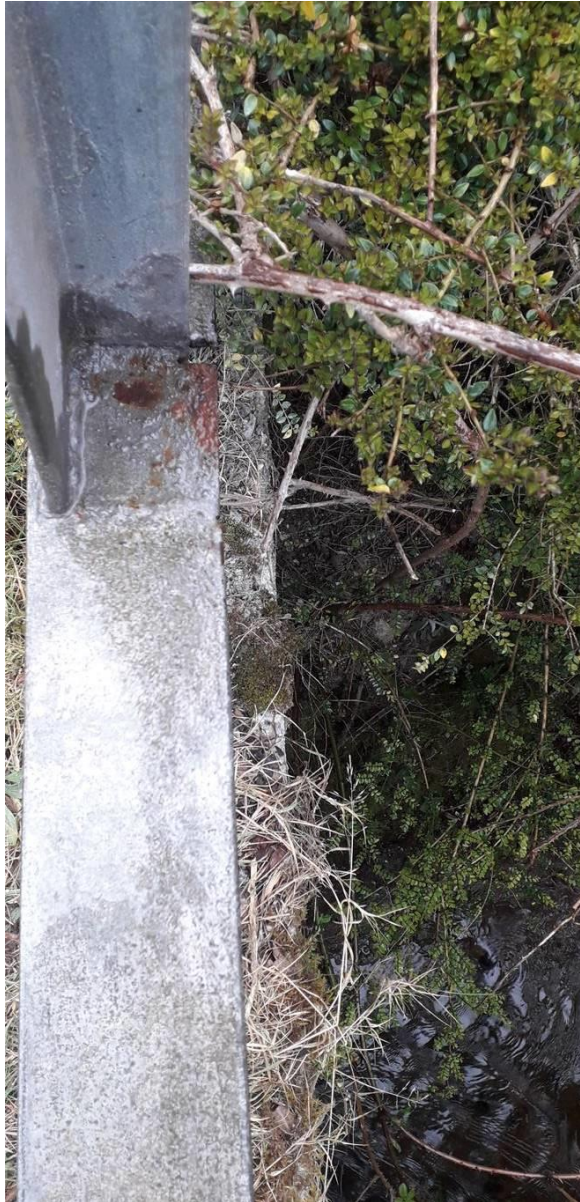
3.1.8

- 3.1.10 The Northwest baluster was loose. The fixings should be tightened or replaced.

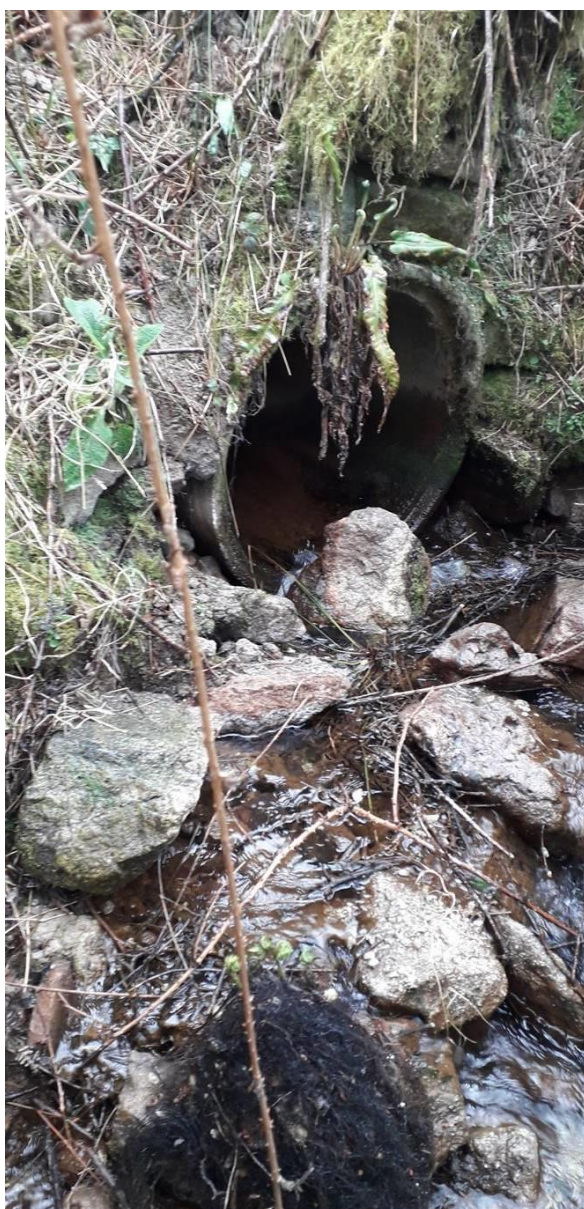
3.2.4

3.2.5 The North Headwall had partly collapsed. This should be rebuilt.

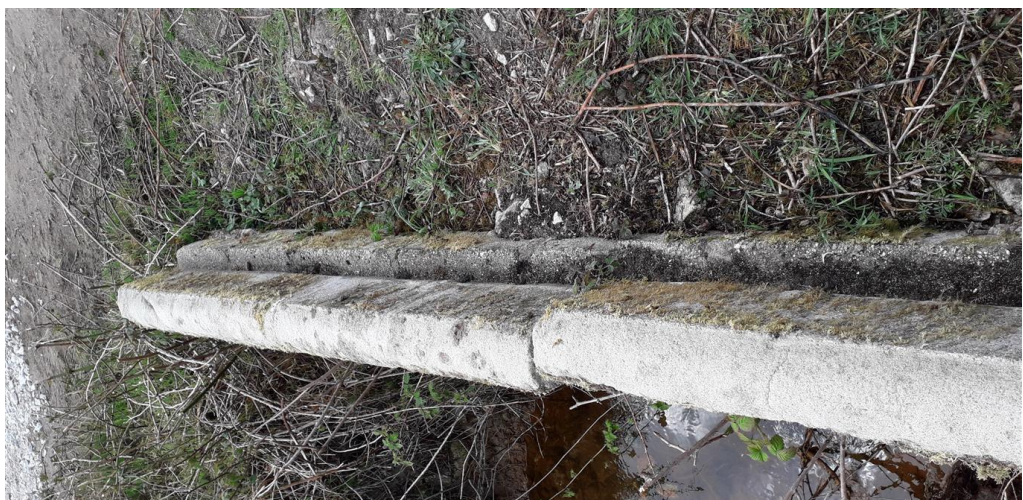
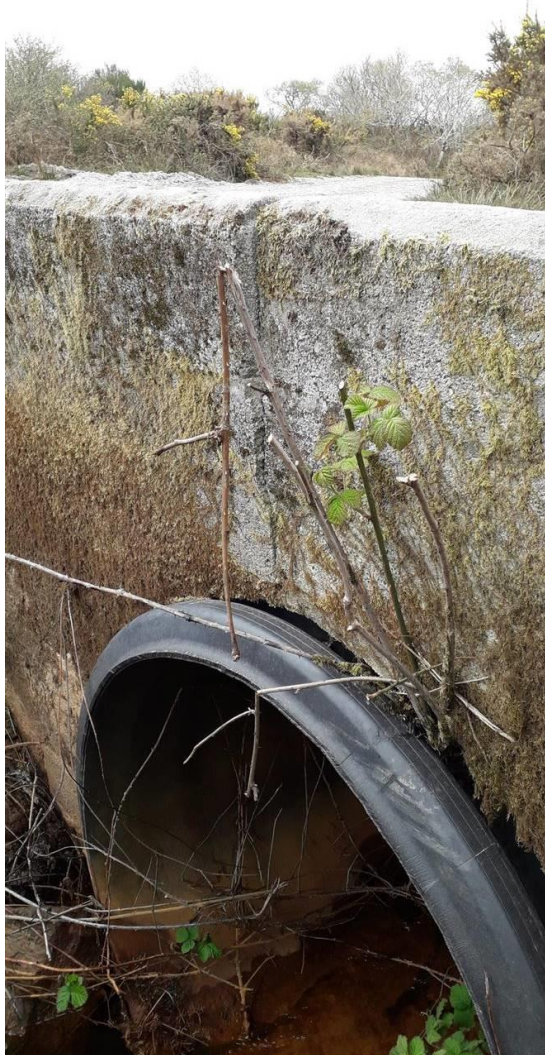
3.3.6

3.3.8 Slight cracking was noted on the North Headwall. This should be repaired.

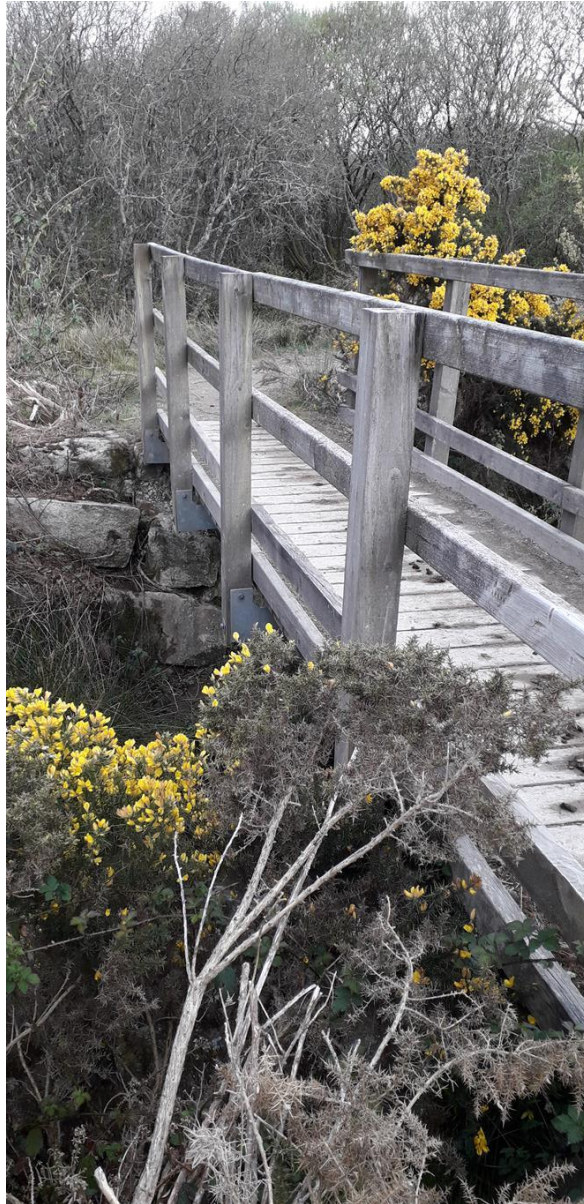
3.4.3

- 3.4.5 The handrails were loose. The nuts on most of the fixing bolts were not tight. Nuts should be replaced with galvanised nylock nuts and tightened to secure the handrails.

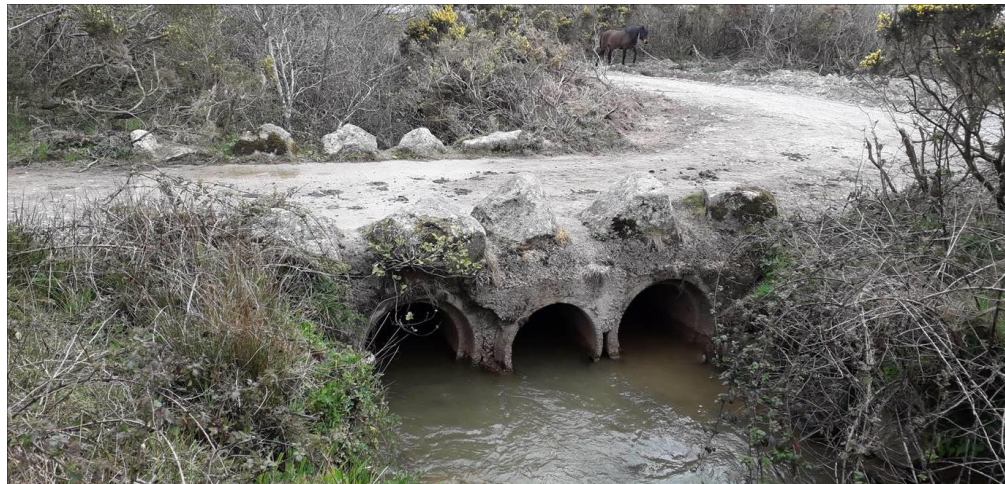
3.5.3

3.5.5 The upstream end of the culvert was clogged with branches. These should be removed.

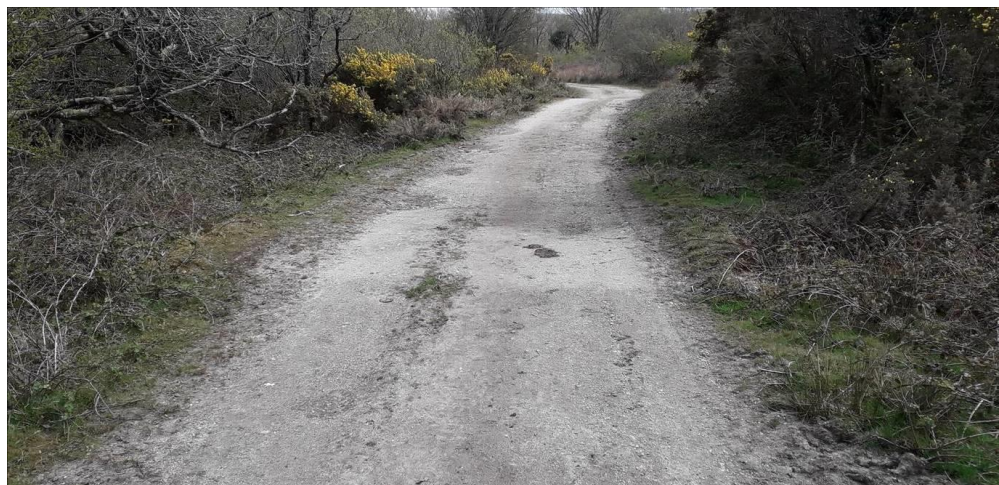
3.6.2

- 3.6.4 The ditch either side of the track was very overgrown. The vegetation should be cut back and the culvert re-inspected.

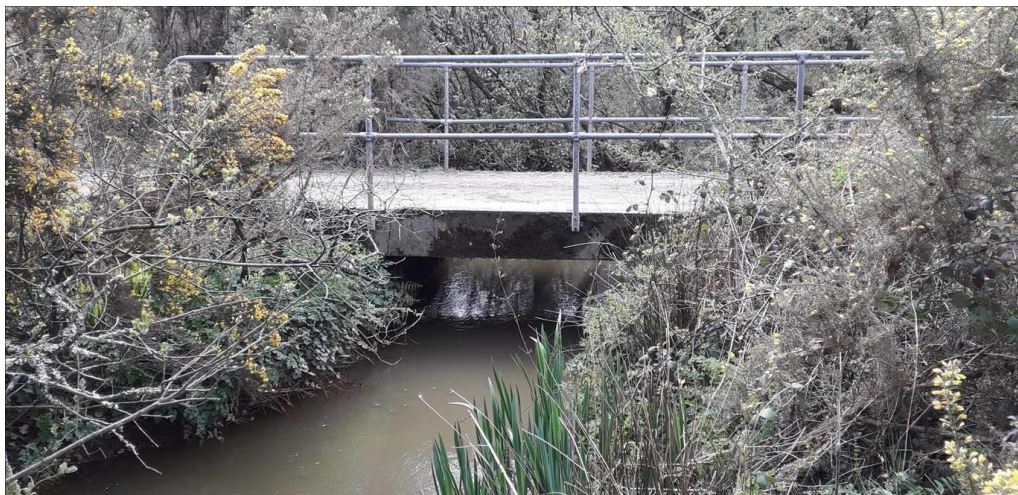
3.7.3

- 3.7.5 The handrail could be moved easily which indicates it lacks adequate strength to resist lateral loads. The two bolt fixing detail was suitable for bolting to steelwork rather than concrete. No other defects were noted.

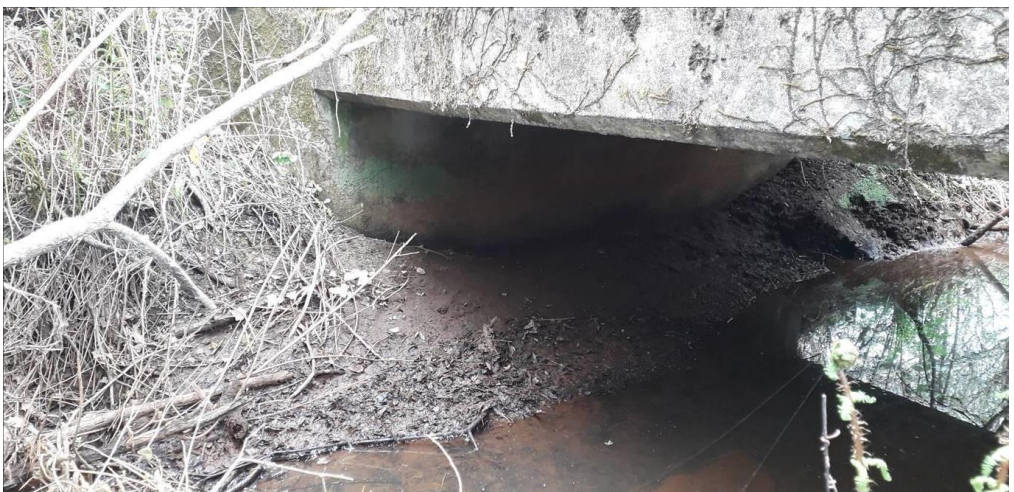
3.8.6

There was some damage to the parapets from farm vehicles. The worst damage was on the West side of the bridge. Damage should be repaired using concrete repair mortar.

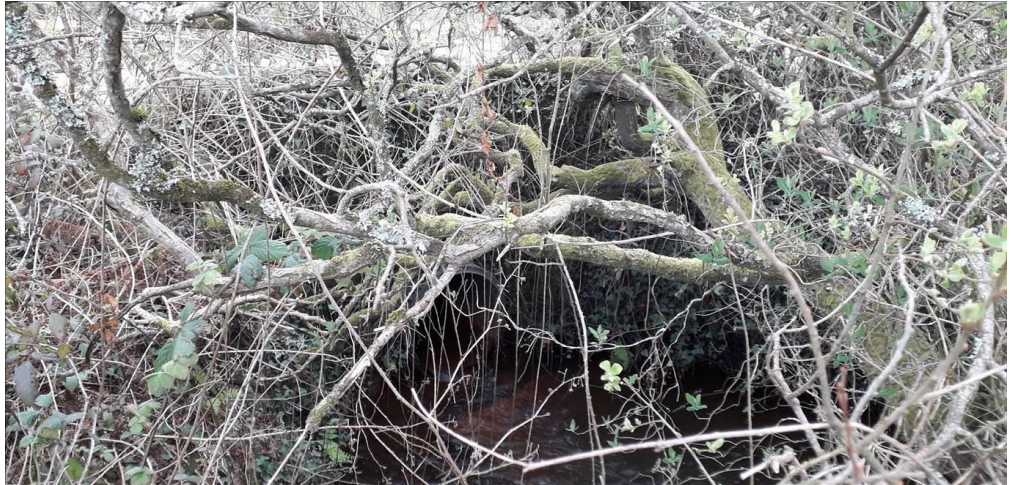
3.9.5

3.9.6 The copings had been damaged by farm vehicles. Copings should be set onto a strong mortar bed to protect the parapet masonry beneath.

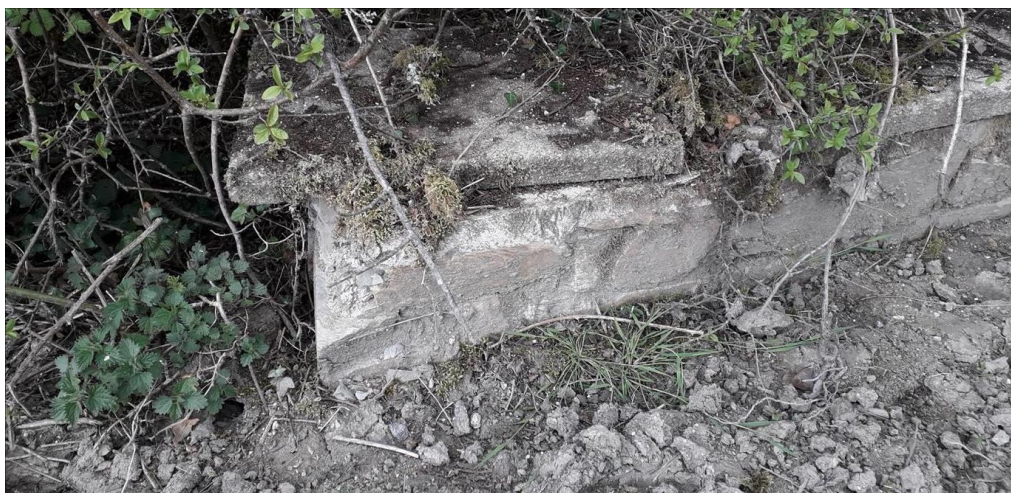
3.9.8

3.9.9 The West side of the culvert was obscured by trees and brambles. This should be cleared and the culvert re-inspected.

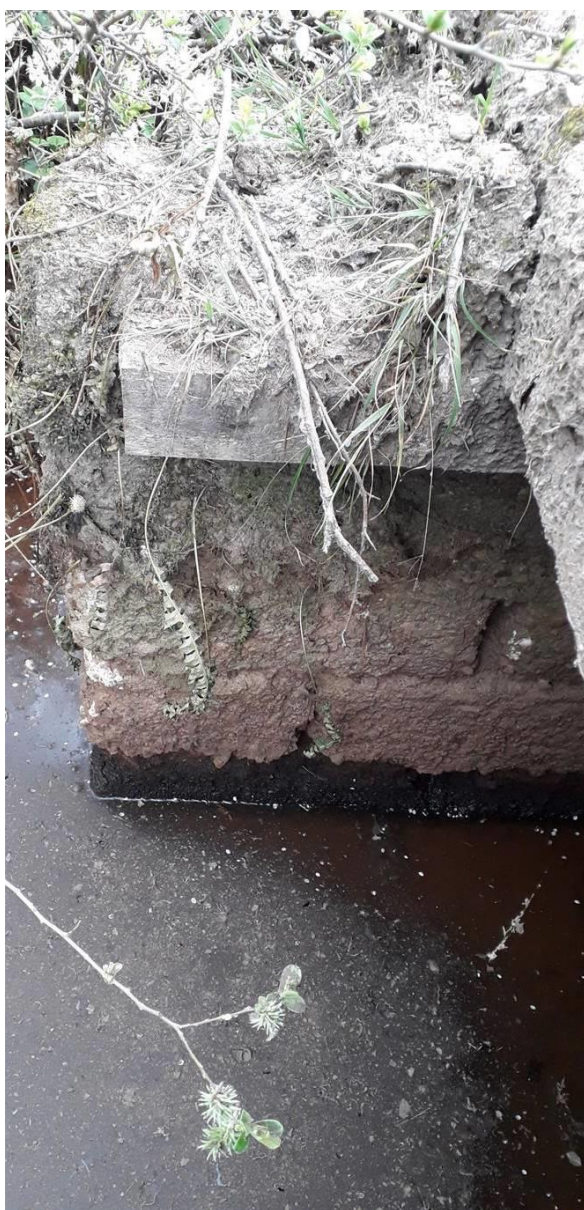
- 3.10.3 The deck was covered in mud and could not be inspected but where visible the timber appeared sound. The mud should be cleared and the sleepers inspected for rot.

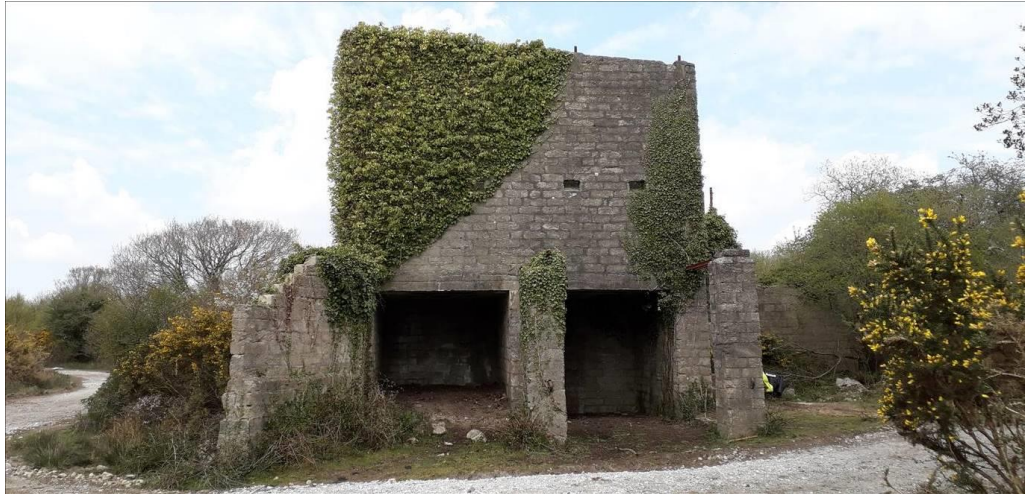
3.12.8 Many of the structure were covered with ivy and other vegetation which will damage the masonry. This should be removed.

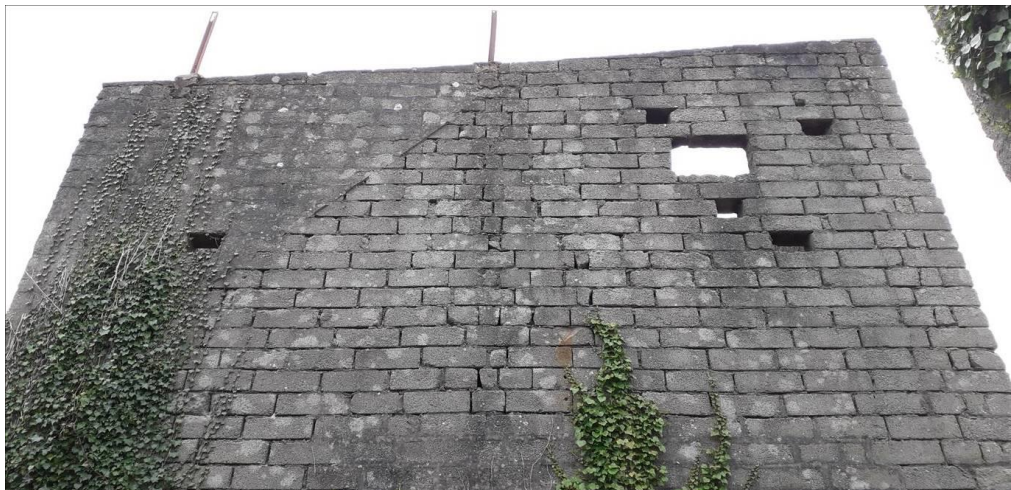
3.12.9 The upper parts of the silo walls had lost much of the pointing because of frost damage. Walls affected should be repointed.

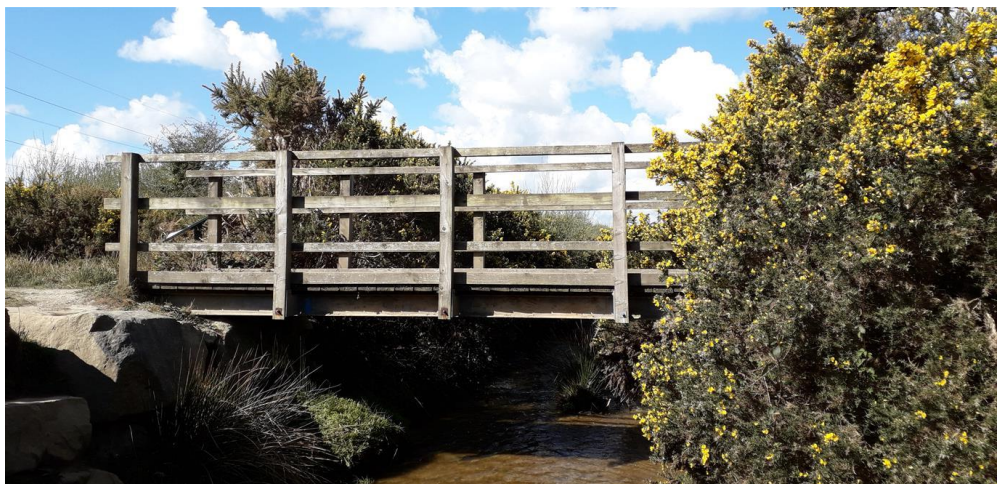
3.13.6 The handrails were loose. The nuts on most of the fixing bolts were not tight. Nuts and washers were rusty. Nuts and washers should be replaced with galvanised nylock nuts and washers and tightened to secure the handrails.

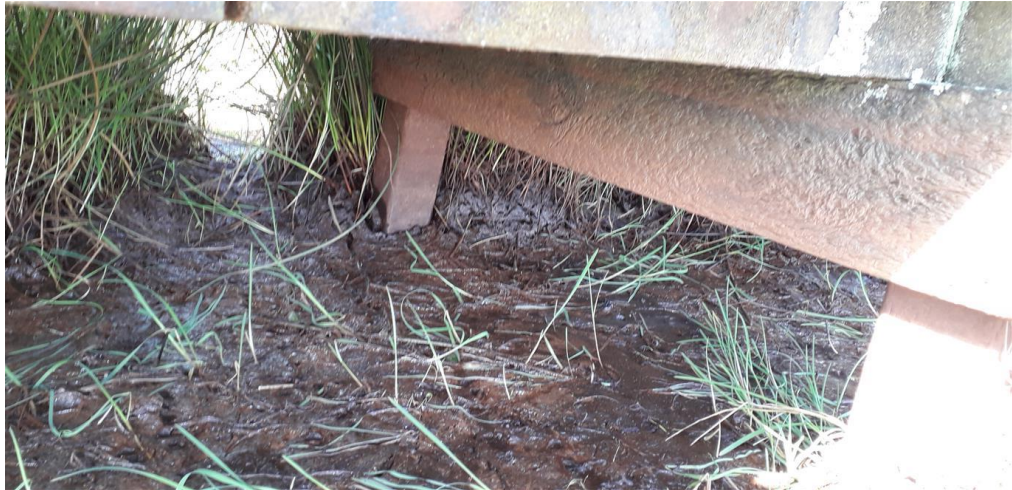
3.16.7 Some undulation was noted in the boardwalk which may indicate some settlement of the posts.
