CBC Asbestos Re-Inspection Report Saxilby Boxing Club, Corby 22nd May 2020

Reference:				
Issue			Prepared by	Verified by
V1	May 20	JF

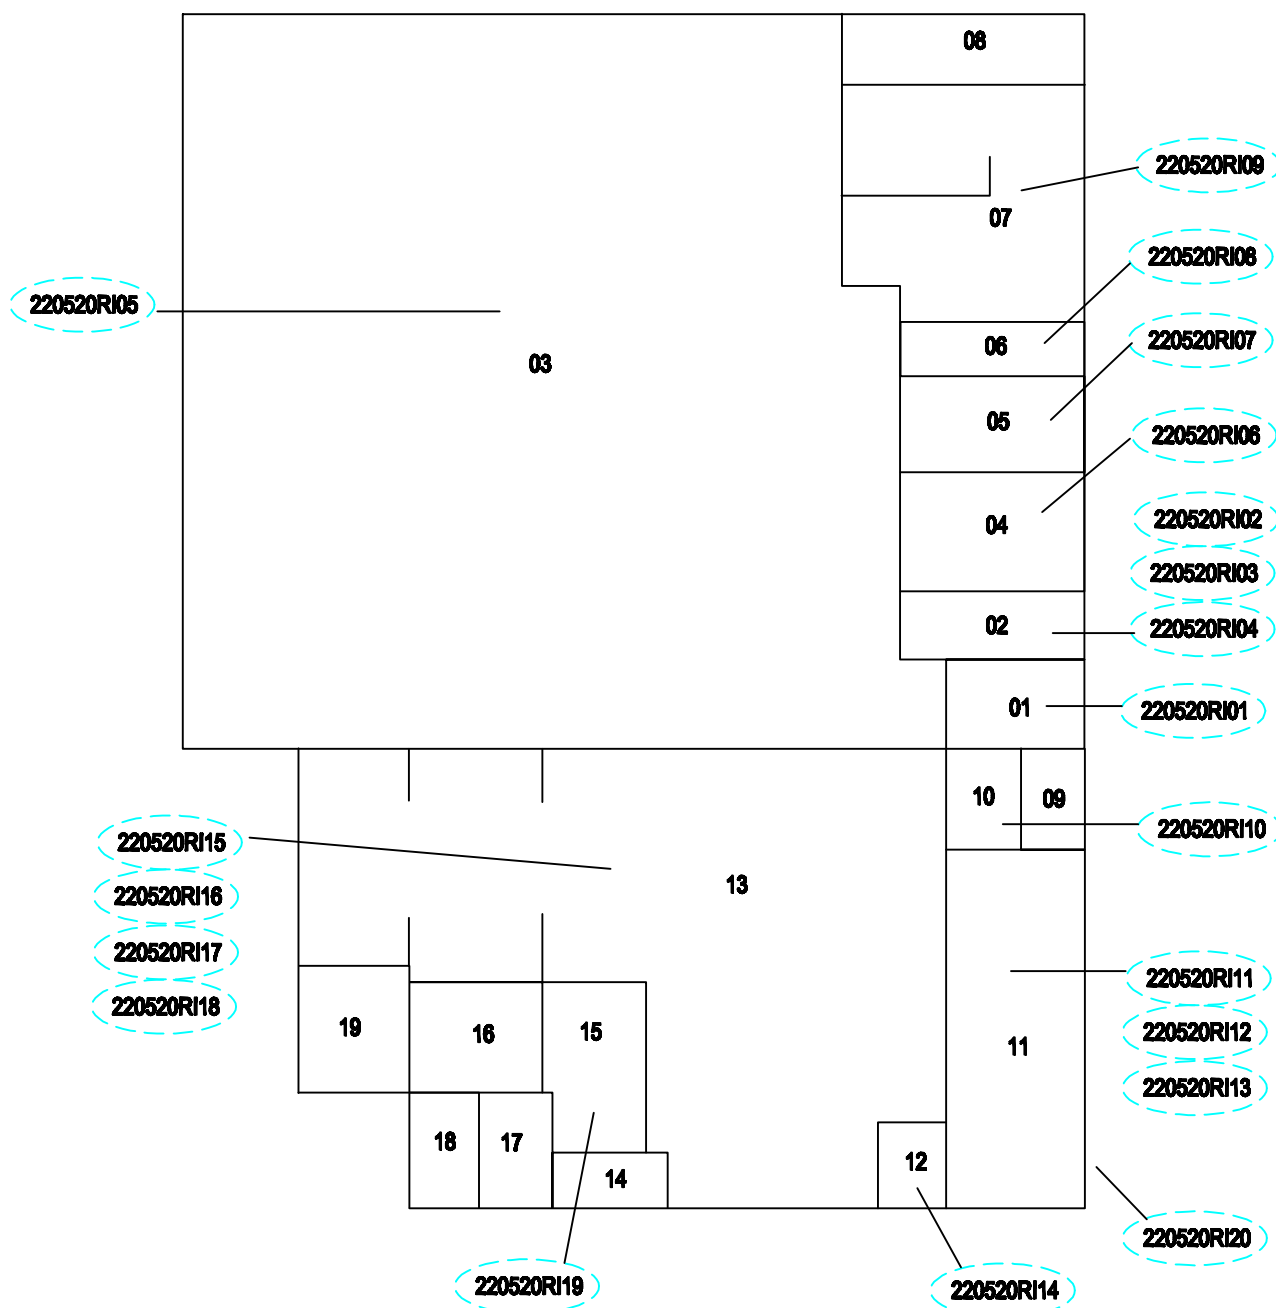
NOTE: SKETCH TO BE READ IN CONJUNCTION WITH THE REPORT

No asbestos was detected following analysis after the survey at this property
