Refurbishment Survey

Horsforth Town Council
3 The Green
Town Street Horsforth
LS18 4RH

Site Address	Building Designation	Building Description	Age of building
Horsforth Town Council 3 The Green Town Street Horsforth	Horsforth Town Council	Council Offices	1800s
General Building Construction Type <small>*Individual room construction can be found within Appendix 3 of this report</small>			
Mixed

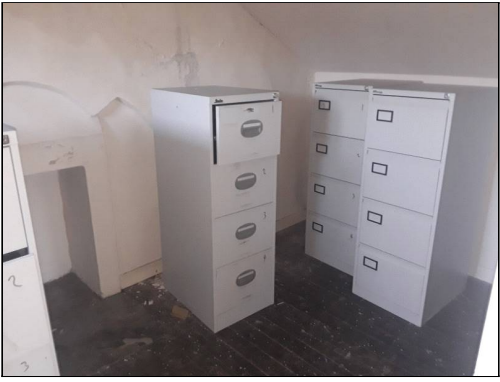
Survey Date:	Lead Surveyor	Survey Type	Floor	Analysis
	13 Oct 2022	Ant Green	Refurbishment Survey	2nd Floor	N/A
	Building	Room	Item	Quantity	
	Horsforth Town Council	Archive Room - 201	No asbestos bearing materials were identified at the time of survey	N/A	
	Sample No (S,SP,P,As)	Product Type	Surface Treatment	Condition	Accessibility
	N/A	N/A	N/A	N/A	N/A
	Material Risk Score				
N/A					
Recommended action	No further action required				
Surveyor comments	N/A

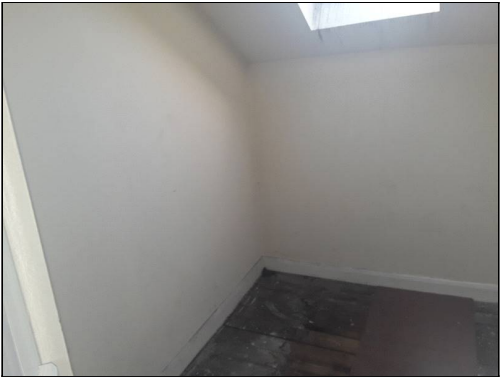
Survey Date:	Lead Surveyor	Survey Type	Floor	Analysis
	13 Oct 2022	Ant Green	Refurbishment Survey	2nd Floor	N/A
	Building	Room	Item	Quantity	
	Horsforth Town Council	Store - 202	No asbestos bearing materials were identified at the time of survey	N/A	
	Sample No (S,SP,P,As)	Product Type	Surface Treatment	Condition	Accessibility
	N/A	N/A	N/A	N/A	N/A
	Material Risk Score				
N/A					
Recommended action	No further action required				
Surveyor comments	N/A

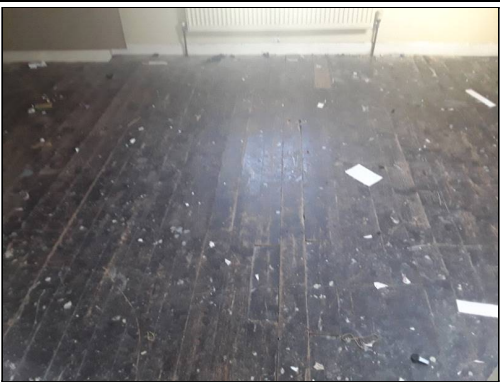
Survey Date:	Lead Surveyor	Survey Type	Floor	Analysis
	13 Oct 2022	Ant Green	Refurbishment Survey	2nd Floor	N/A
	Building	Room	Item	Quantity	
	Horsforth Town Council	Office - 205	Refurb Location: Timber floorboards accessed	N/A	
	Sample No (S,SP,P,As)	Product Type	Surface Treatment	Condition	Accessibility
	N/A	N/A	N/A	N/A	N/A
Material Risk Score					
N/A					
Recommended action	No further action required				
Surveyor comments	N/A

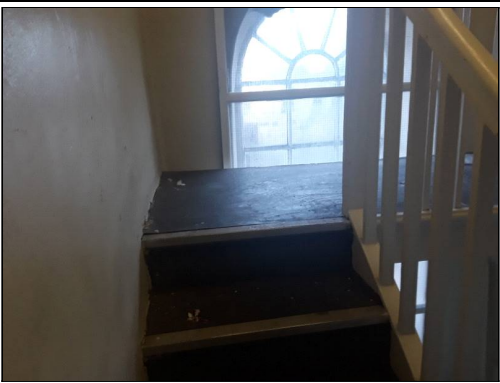
Survey Date:	Lead Surveyor	Survey Type	Floor	Analysis
	13 Oct 2022	Ant Green	Refurbishment Survey	2nd Floor	No Asbestos Detected (0)
	Building	Room	Item	Quantity	
	Horsforth Town Council	Stairs/landing - 206	Grey vinyl to stairs	8m ²	
	Sample No (S,SP,P,As)	Product Type	Surface Treatment	Condition	Accessibility
	S MF001018	Reinforced Composite (1)	N/A	N/A	N/A
	Material Risk Score				
N/A					
Recommended action	No further action required				
Surveyor comments	N/A

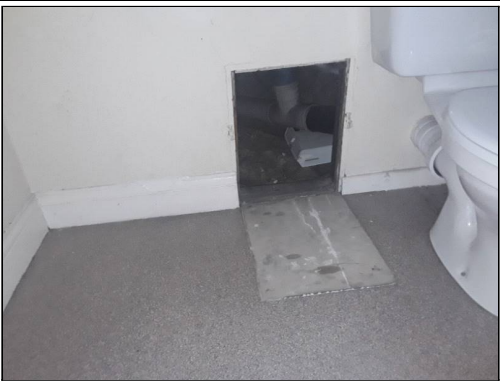
Survey Date:	Lead Surveyor	Survey Type	Floor	Analysis
	13 Oct 2022	Ant Green	Refurbishment Survey	2nd Floor	N/A
	Building	Room	Item	Quantity	
	Horsforth Town Council	Eaves space - 207	Access to eaves space from hatch only due to small hatch and no crawlboards for safe access	N/A	
	Sample No (S,SP,P,As)	Product Type	Surface Treatment	Condition	Accessibility
	N/A	N/A	N/A	N/A	N/A
	Material Risk Score				
N/A					
Recommended action	No further action required				
Surveyor comments	N/A

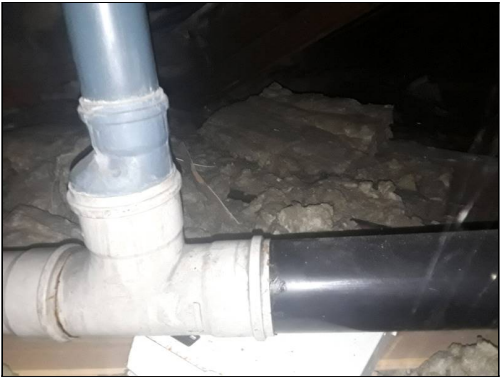
Survey Date:	Lead Surveyor	Survey Type	Floor	Analysis
	13 Oct 2022	Ant Green	Refurbishment Survey	2nd Floor	N/A
	Building	Room	Item	Quantity	
	Horsforth Town Council	Eaves space - 207	No asbestos bearing materials were identified at the time of survey	N/A	
	Sample No (S,SP,P,As)	Product Type	Surface Treatment	Condition	Accessibility
	N/A	N/A	N/A	N/A	N/A
	Material Risk Score				
N/A					
Recommended action	No further action required				
Surveyor comments	N/A

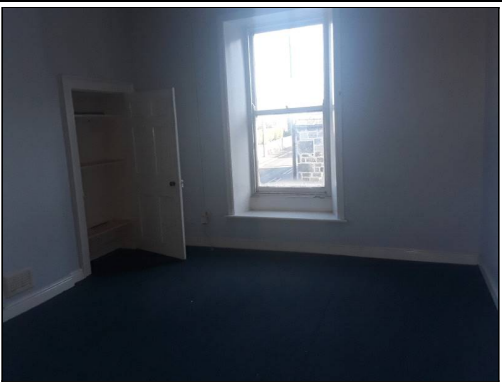
Survey Date:	Lead Surveyor	Survey Type	Floor	Analysis
	13 Oct 2022	Ant Green	Refurbishment Survey	1st Floor	N/A
	Building	Room	Item	Quantity	
	Horsforth Town Council	Office - 102	No asbestos bearing materials were identified at the time of survey	N/A	
	Sample No (S,SP,P,As)	Product Type	Surface Treatment	Condition	Accessibility
	N/A	N/A	N/A	N/A	N/A
	Material Risk Score				
N/A					
Recommended action	No further action required				
Surveyor comments	N/A

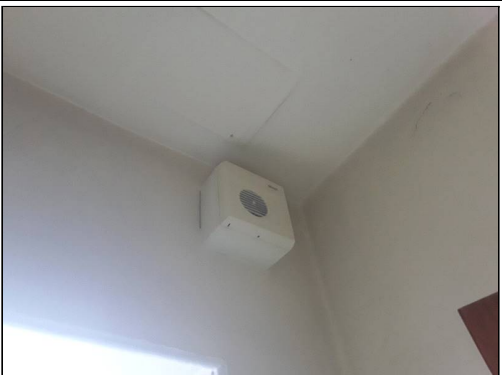
Survey Date:	Lead Surveyor	Survey Type	Floor	Analysis
	13 Oct 2022	Ant Green	Refurbishment Survey	1st Floor	N/A
	Building	Room	Item	Quantity	
	Horsforth Town Council	Toilet - 103	Refurb Location: Timber panel to ceiling	N/A	
	Sample No (S,SP,P,As)	Product Type	Surface Treatment	Condition	Accessibility
	N/A	N/A	N/A	N/A	N/A
	Material Risk Score				
N/A					
Recommended action	No further action required				
Surveyor comments	N/A

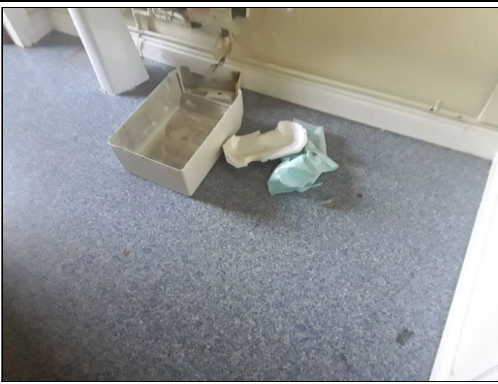
Survey Date:	Lead Surveyor	Survey Type	Floor	Analysis
	13 Oct 2022	Ant Green	Refurbishment Survey	1st Floor	N/A
	Building	Room	Item	Quantity	
	Horsforth Town Council	Toilet lobby - 104	Refurb Location: Timber floor beneath vinyl	N/A	
	Sample No (S,SP,P,As)	Product Type	Surface Treatment	Condition	Accessibility
	N/A	N/A	N/A	N/A	N/A
	Material Risk Score				
N/A					
Recommended action	No further action required				
Surveyor comments	N/A

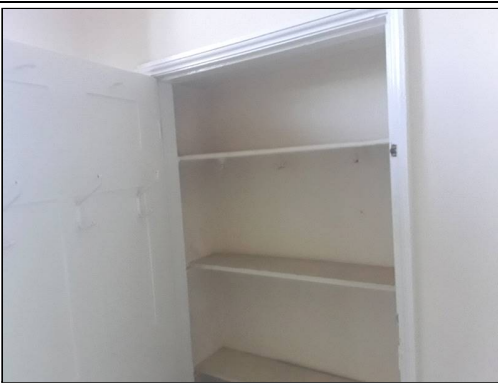
Survey Date:	Lead Surveyor	Survey Type	Floor	Analysis
	13 Oct 2022	Ant Green	Refurbishment Survey	1st Floor	N/A
	Building	Room	Item	Quantity	
	Horsforth Town Council	Cupboard - 105	No asbestos bearing materials were identified at the time of survey	N/A	
	Sample No (S,SP,P,As)	Product Type	Surface Treatment	Condition	Accessibility
	N/A	N/A	N/A	N/A	N/A
	Material Risk Score				
N/A					
Recommended action	No further action required				
Surveyor comments	N/A

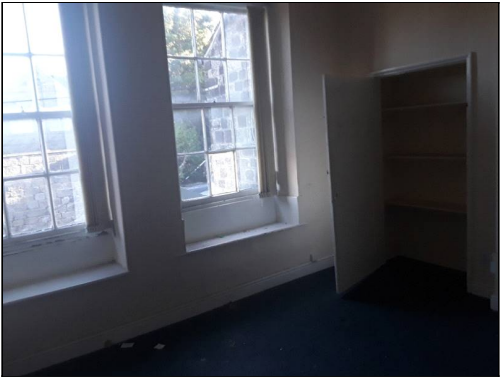
Survey Date:	Lead Surveyor	Survey Type	Floor	Analysis
	13 Oct 2022	Ant Green	Refurbishment Survey	1st Floor	N/A
	Building	Room	Item	Quantity	
	Horsforth Town Council	Office - 106	No asbestos bearing materials were identified at the time of survey	N/A	
	Sample No (S,SP,P,As)	Product Type	Surface Treatment	Condition	Accessibility
	N/A	N/A	N/A	N/A	N/A
Material Risk Score					
N/A					
Recommended action	No further action required				
Surveyor comments	N/A

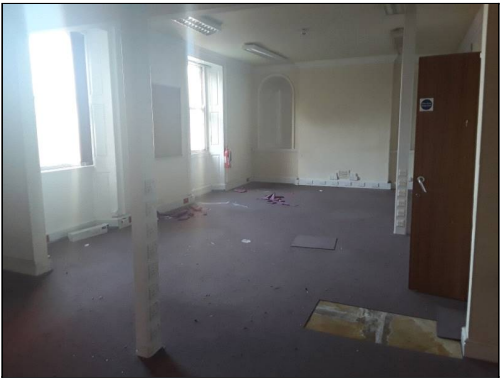
Survey Date:	Lead Surveyor	Survey Type	Floor	Analysis
	13 Oct 2022	Ant Green	Refurbishment Survey	1st Floor	N/A
	Building	Room	Item	Quantity	
	Horsforth Town Council	Main Office - 107	No asbestos bearing materials were identified at the time of survey	N/A	
	Sample No (S,SP,P,As)	Product Type	Surface Treatment	Condition	Accessibility
	N/A	N/A	N/A	N/A	N/A
Material Risk Score					
N/A					
Recommended action	No further action required				
Surveyor comments	N/A

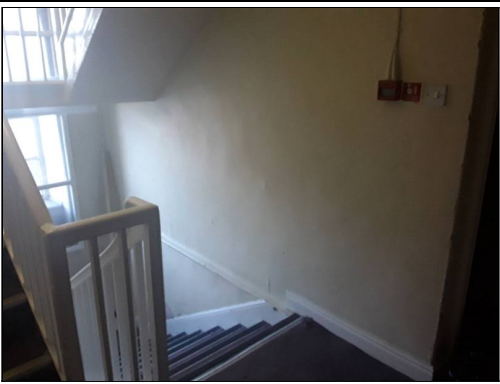
Survey Date:	Lead Surveyor	Survey Type	Floor	Analysis
	13 Oct 2022	Ant Green	Refurbishment Survey	1st Floor	N/A
	Building	Room	Item	Quantity	
	Horsforth Town Council	Landing/stairs - 108	No asbestos bearing materials were identified at the time of survey	N/A	
	Sample No (S,SP,P,As)	Product Type	Surface Treatment	Condition	Accessibility
	N/A	N/A	N/A	N/A	N/A
	Material Risk Score				
N/A					
Recommended action	No further action required				
Surveyor comments	N/A

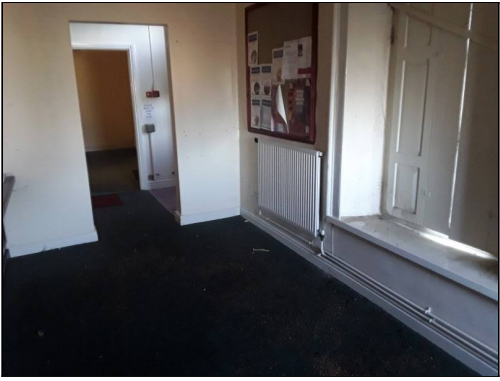
Survey Date:	Lead Surveyor	Survey Type	Floor	Analysis
	13 Oct 2022	Ant Green	Refurbishment Survey	Ground Floor	N/A
	Building	Room	Item	Quantity	
	Horsforth Town Council	Waiting area - G04	No asbestos bearing materials were identified at the time of survey	N/A	
	Sample No (S,SP,P,As)	Product Type	Surface Treatment	Condition	Accessibility
	N/A	N/A	N/A	N/A	N/A
	Material Risk Score				
N/A					
Recommended action	No further action required				
Surveyor comments	N/A

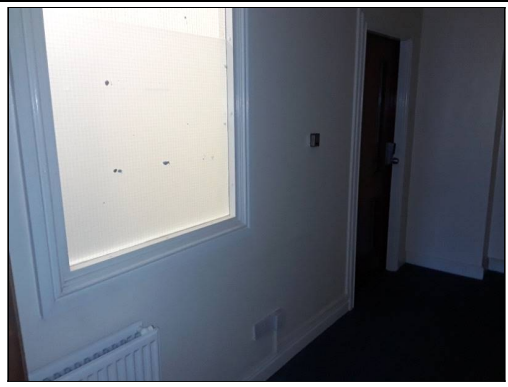
Survey Date:	Lead Surveyor	Survey Type	Floor	Analysis
	13 Oct 2022	Ant Green	Refurbishment Survey	Ground Floor	N/A
	Building	Room	Item	Quantity	
	Horsforth Town Council	Office - G06	Refurb Location: Solid and plasterboard walls	N/A	
	Sample No (S,SP,P,As)	Product Type	Surface Treatment	Condition	Accessibility
	N/A	N/A	N/A	N/A	N/A
	Material Risk Score				
N/A					
Recommended action	No further action required				
Surveyor comments	N/A

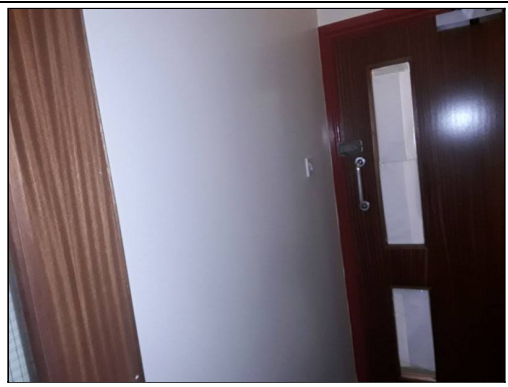
Survey Date:	Lead Surveyor	Survey Type	Floor	Analysis
	13 Oct 2022	Ant Green	Refurbishment Survey	Ground Floor	N/A
	Building	Room	Item	Quantity	
	Horsforth Town Council	Cloakroom - G07	Refurb Location: Solid and plasterboard walls	N/A	
	Sample No (S,SP,P,As)	Product Type	Surface Treatment	Condition	Accessibility
	N/A	N/A	N/A	N/A	N/A
	Material Risk Score				
N/A					
Recommended action	No further action required				
Surveyor comments	N/A

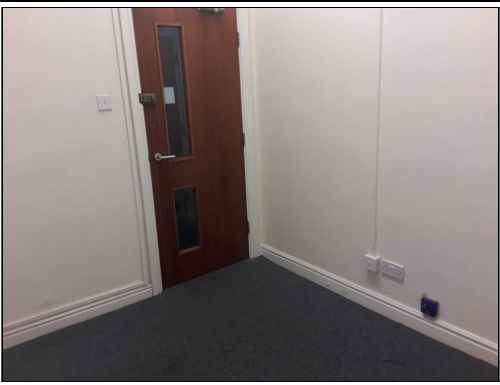
Survey Date:	Lead Surveyor	Survey Type	Floor	Analysis
	13 Oct 2022	Ant Green	Refurbishment Survey	Ground Floor	N/A
	Building	Room	Item	Quantity	
	Horsforth Town Council	Office - G08	Refurb Location: Solid and plasterboard walls	N/A	
	Sample No (S,SP,P,As)	Product Type	Surface Treatment	Condition	Accessibility
	N/A	N/A	N/A	N/A	N/A
	Material Risk Score				
N/A					
Recommended action	No further action required				
Surveyor comments	N/A

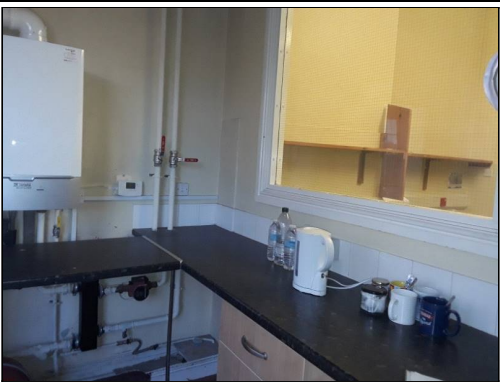
Survey Date:	Lead Surveyor	Survey Type	Floor	Analysis
	13 Oct 2022	Ant Green	Refurbishment Survey	Ground Floor	N/A
	Building	Room	Item	Quantity	
	Horsforth Town Council	Kitchen - G10	Refurb location: Solid and plasterboard walls	N/A	
	Sample No (S,SP,P,As)	Product Type	Surface Treatment	Condition	Accessibility
	N/A	N/A	N/A	N/A	N/A
	Material Risk Score				
N/A					
Recommended action	No further action required				
Surveyor comments	N/A

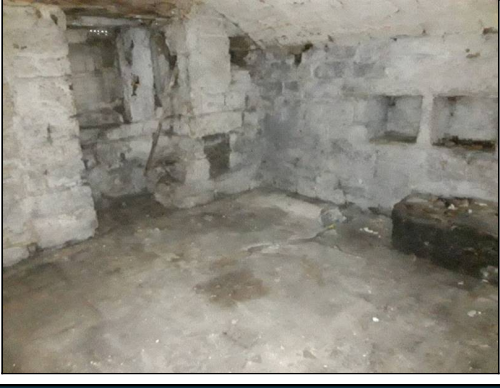
Survey Date:	Lead Surveyor	Survey Type	Floor	Analysis
	13 Oct 2022	Ant Green	Refurbishment Survey	Z-Sub Level 1	N/A
	Building	Room	Item	Quantity	
	Horsforth Town Council	Store - Z102	No asbestos bearing materials were identified at the time of survey	N/A	
	Sample No (S,SP,P,As)	Product Type	Surface Treatment	Condition	Accessibility
	N/A	N/A	N/A	N/A	N/A
	Material Risk Score				
N/A					
Recommended action	No further action required				
Surveyor comments	N/A

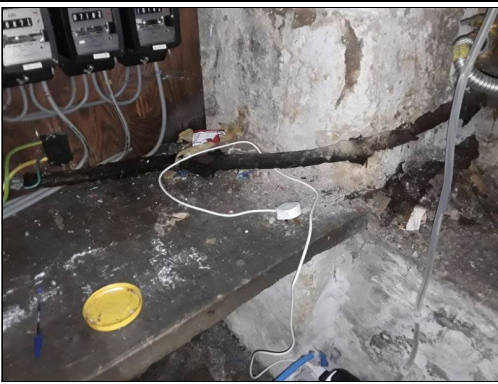
Survey Date:	Lead Surveyor	Survey Type	Floor	Analysis
	13 Oct 2022	Ant Green	Refurbishment Survey	Z-Sub Level 1	No Asbestos Detected (0)
	Building	Room	Item	Quantity	
	Horsforth Town Council	Store - Z103	Bitumen cable wrap to electrics	11m	
	Sample No (S,SP,P,As)	Product Type	Surface Treatment	Condition	Accessibility
	S MF001021	Reinforced Composite (1)	N/A	N/A	N/A
	Material Risk Score				
N/A					
Recommended action	No further action required				
Surveyor comments	N/A

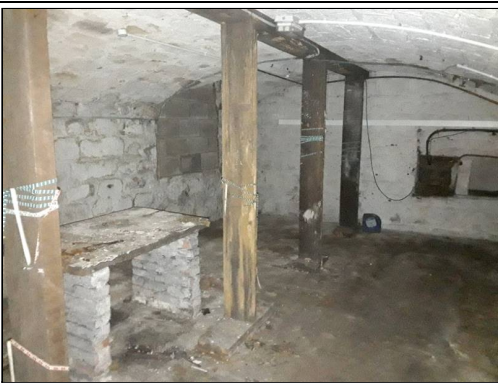
Survey Date:	Lead Surveyor	Survey Type	Floor	Analysis
	13 Oct 2022	Ant Green	Refurbishment Survey	Z-Sub Level 1	N/A
	Building	Room	Item	Quantity	
	Horsforth Town Council	Store - Z104	No asbestos bearing materials were identified at the time of survey	N/A	
	Sample No (S,SP,P,As)	Product Type	Surface Treatment	Condition	Accessibility
	N/A	N/A	N/A	N/A	N/A
	Material Risk Score				
N/A					
Recommended action	No further action required				
Surveyor comments	N/A

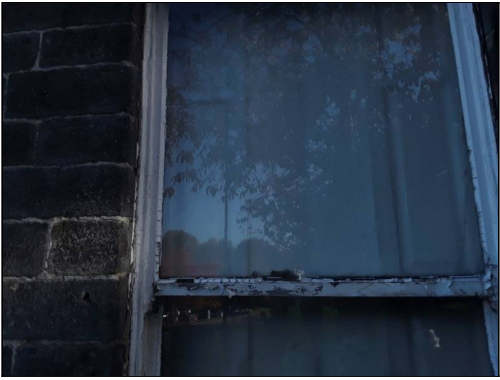
Survey Date:	Lead Surveyor	Survey Type	Floor	Analysis
	13 Oct 2022	Ant Green	Refurbishment Survey	External	No Asbestos Detected (0)
	Building	Room	Item	Quantity	
	Horsforth Town Council	All areas - E01	Putty to timber framed windows	100lm	
	Sample No (S,SP,P,As)	Product Type	Surface Treatment	Condition	Accessibility
	S MF001022	Reinforced Composite (1)	N/A	N/A	N/A
	Material Risk Score				
	N/A				
	Recommended action	No further action required			
	Surveyor comments	N/A
