# Coronation Lake, Helston.

## Investigation of site

Project No: 63684

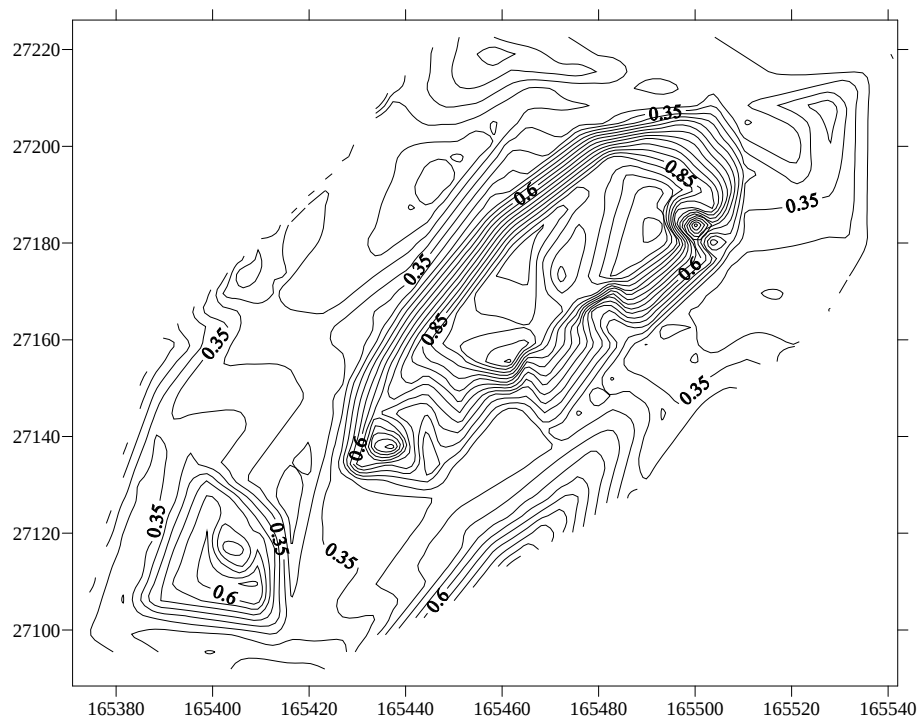
**contour map showing thickness of silt**

The calculations below are based of the contour map below using Golden Software Surfer 8 program. It produces the map using the profile coordinates only. The above map is the same overlaid onto a lake drawing.
