Asbestos Management Survey Report for The Pavillion, Englefield Rd, Theale

8 August 2013

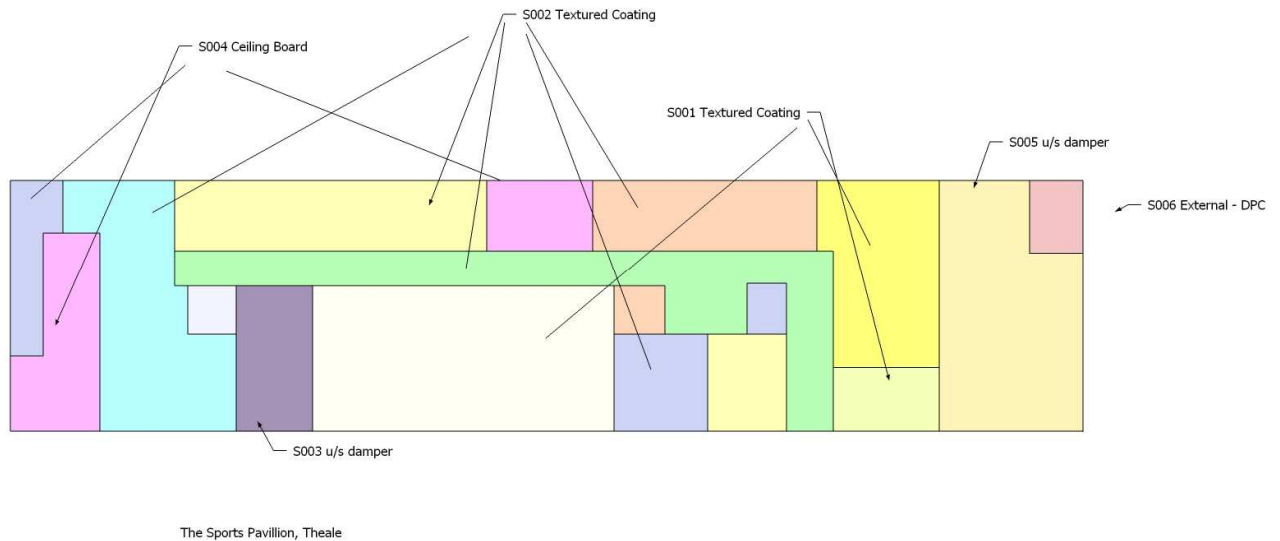
Figure 2 Floorplan and locations of sampling

The following diagram shows the site and the area surveyed. This is not to scale and should not be used for estimation purposes.
