the play inspection company

Annual Inspection

Central Swindon North Parish Council

Inglesham Road

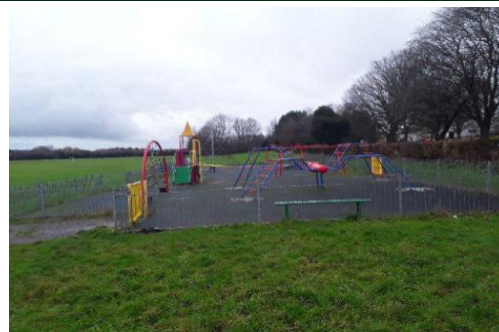
Item: Site General
Manufacturer: Owner/Operator
Surface Type: Mixed Surface
Item Quantity: 1
Equipment Compliance: N/A
Surface Area Compliance: N/A

There is algae, silt or moss growth on the surface resulting in slippery conditions - Clean and treat appropriately

There are significant gaps (over 30mm) between the surface and the edging or between the joints in the surface; these are large enough for a small foot to enter - Repair surfacing

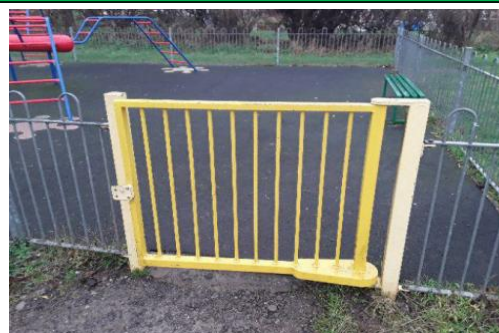
Item: Gate - Self Closing
Manufacturer: I.A.E. Fencing
Surface Type: Grass
Item Quantity: 2
Equipment Compliance: N/A
Surface Area Compliance: N/A

The area under the gate has eroded leaving uneven areas, or the concrete foundations exposed, resulting in trip hazards at the entrance/exit to the playground - Reinstate to level with surrounding surfaces

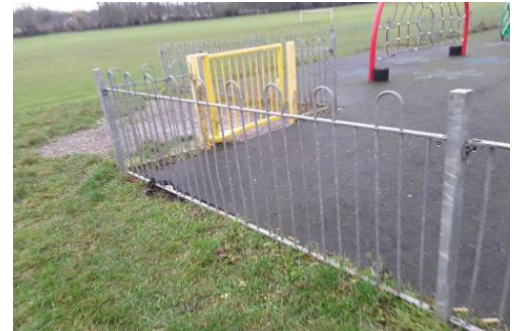
Item: Fence - Bow Top
Manufacturer: Not Identified
Surface Type: Grass
Item Quantity: 1
Equipment Compliance: N/A
Surface Area Compliance: N/A

There is some damage to the fence sections - Monitor for any further deterioration and repair as required

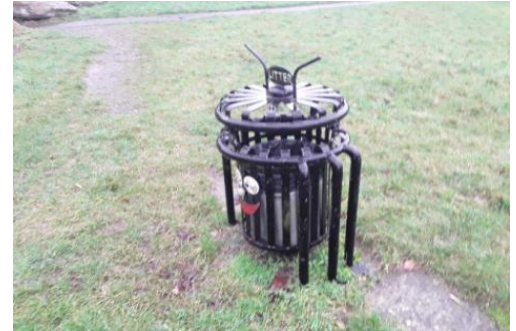
Item: Litter Bin
Manufacturer: Glasdon
Surface Type: Grass
Item Quantity: 1
Equipment Compliance: N/A
Surface Area Compliance: N/A

The lid or door of the litter bin is not secured - Ensure the lid or door is kept locked

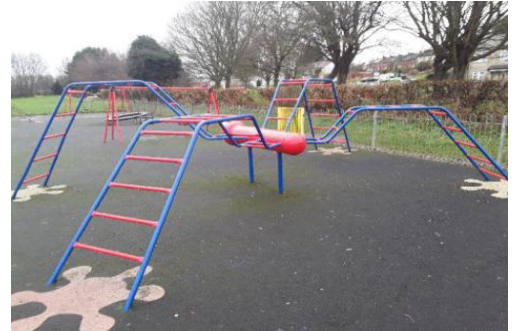
Item: Climbing Frame
Manufacturer: Wicksteed Playgrounds
Surface Type: Wet Pour
Item Quantity: 1
Equipment Compliance: No
Surface Area Compliance: Yes

The item fails to meet the requirements of BS EN 1176 Part 1 4.2.7.2 for head and neck entrapment in the frame - Monitor - No remedial work recommended

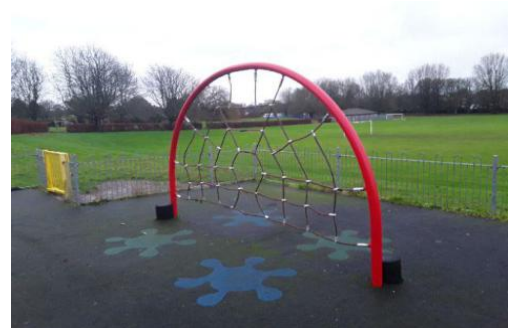
Item: Net Climber
Manufacturer: S M P (Playgrounds Ltd)
Surface Type: Wet Pour
Item Quantity: 1
Equipment Compliance: Yes
Surface Area Compliance: Yes

The ropes on this item have been taped and we are unable to fully assess the condition of the rope, ensure no wire strands are broken beneath the tape - Repair or replace as required

The ropes/nets are worn/damaged in places - Monitor for any further deterioration and repair or replace as required

A number of fixing(s) have worked loose - Secure all loose fixings

The rubber stepping posts have some minor damage - Monitor for any further deterioration and replace as required

There is some wear to the shackles. - Monitor for any further deterioration and replace when 40% worn

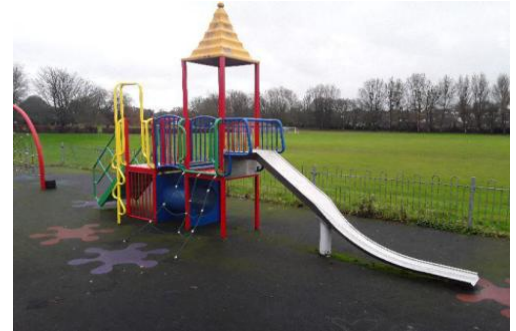
Item: Multi Play (Junior)
Manufacturer: Wicksteed Playgrounds
Surface Type: Wet Pour
Item Quantity: 1
Equipment Compliance: Yes
Surface Area Compliance: Yes

There are a number of dents in the slide surface - Monitor for any further deterioration and repair as required

The ropes/nets are worn/damaged in places - Monitor for any further deterioration and repair or replace as required

There is or are fixings missing on the item - Replace all missing fixings

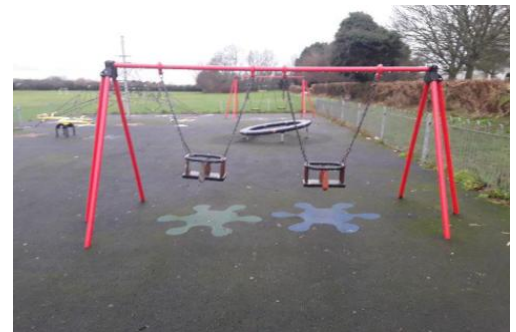
Item: 1 Bay 2 Seat (Cradle)
Manufacturer: Wicksteed Playgrounds
Surface Type: Wet Pour
Item Quantity: 1
Equipment Compliance: No
Surface Area Compliance: Yes

The connecting links are in excess of 8.6mm and less than 12mm and fail the requirements of BS EN 1176 Part 1; clause 4.2.13, Chains - Monitor - No remedial work recommended

There is some notable evidence of chain wear - Monitor for any further deterioration and replace when 40% worn

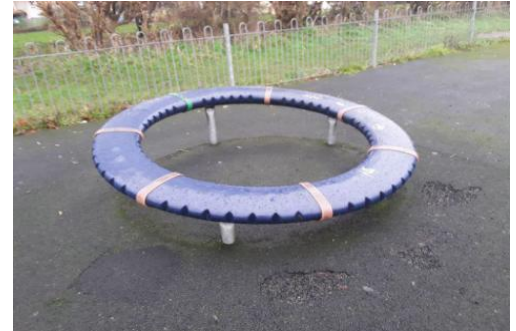
Item: Supernova
Manufacturer: Kompan Ltd
Surface Type: Wet Pour
Item Quantity: 1
Equipment Compliance: No
Surface Area Compliance: Yes

There is moderate damage to the surface - Repair the damaged areas of surfacing

There is/are bolt cap covers missing or damaged on the item - Replace missing or damaged bolt cap covers

The plastic body has been damaged - Monitor for any further deterioration and replace as required

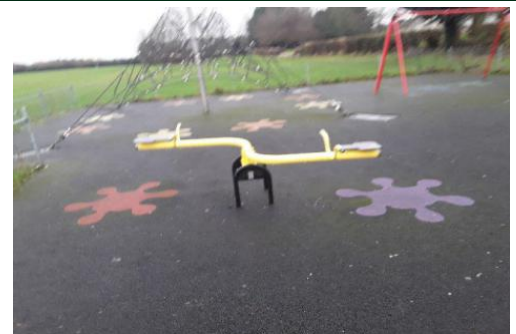
Item: See Saw
Manufacturer: Wicksteed Playgrounds
Surface Type: Wet Pour
Item Quantity: 1
Equipment Compliance: Yes
Surface Area Compliance: Yes

There is some minor damage to the seat - Monitor for any further deterioration and replace as required

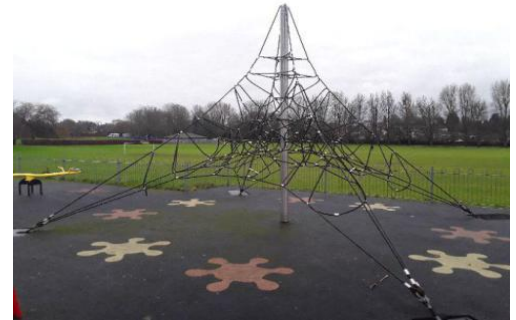
Item: Space Net
Manufacturer: Tayplay Ltd
Surface Type: Wet Pour
Item Quantity: 1
Equipment Compliance: No
Surface Area Compliance: Yes

The connecting or tensioning ropes on the net are not tensioned correctly - Tighten tensioners equally to provide stability to the net structure

There are trip hazards present - Reinstate surrounding surfaces to level to remove the trip points

The ropes/nets are worn/damaged in places - Monitor for any further deterioration and repair or replace as required

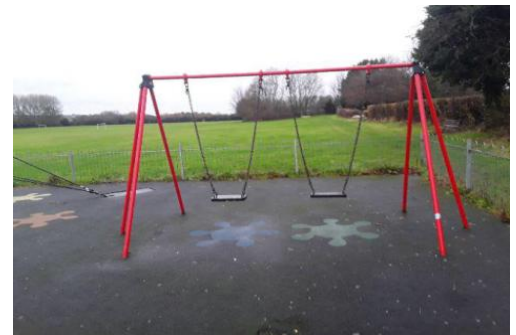
Item: 1 Bay 2 Seat (Flat)
Manufacturer: Wicksteed Playgrounds
Surface Type: Wet Pour
Item Quantity: 1
Equipment Compliance: No
Surface Area Compliance: Yes

There is moderate damage to the surface - Repair the damaged areas of surfacing

The seat has minor damage or wear - Monitor for any further deterioration and replace as required

The connecting links are in excess of 8.6mm and less than 12mm and fail the requirements of BS EN 1176 Part 1; clause 4.2.13, Chains - Monitor - No remedial work recommended

There is some notable evidence of chain wear - Monitor for any further deterioration and replace when 40% worn

There is some wear to the shackles. - Monitor for any further deterioration and replace when 40% worn

The bushes are worn or missing - Replace worn or missing bushes

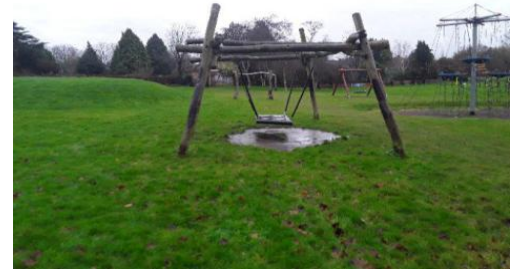
Item: Misc Swing
Manufacturer: Not Identified
Surface Type: Grass Matrix Tiles
Item Quantity: 1
Equipment Compliance: No
Surface Area Compliance: Yes

The fixings or components for this item were in excess of 2.5m above the standing surface and could not be fully accessed by the inspector. We have completed a visual inspection of the fixings from ground level but a maintenance inspection should be undertaken to assess the condition, security and wear of the components at intervals in accordance with the manufacturers recommendations. - Inspect in accordance with the manufacturers recommendations

There is/are bolt cap covers missing or damaged on the item - Replace missing or damaged bolt cap covers

There are splits running through the timber that cross through or near fixing points and may cause instability in the future - Monitor stability of fixings

There is some notable evidence of chain wear - Monitor for any further deterioration and replace when 40% worn

The surfacing is severely damaged or missing - Repair damaged areas of surfacing

The seat suspension cover has been damaged - Monitor for any further deterioration and replace as required

There is/are inserts missing - Replace missing inserts

The connecting links are in excess of 8.6mm and less than 12mm and fail the requirements of BS EN 1176 Part 1; clause 4.2.13, Chains - Monitor - No remedial work recommended

A number of secondary safety fixing(s) have worked loose - Secure all loose fixings

A number of seat connector fixing(s) have worked loose - Secure all loose fixings

The seat has minor damage or wear - Monitor for any further deterioration and replace as required

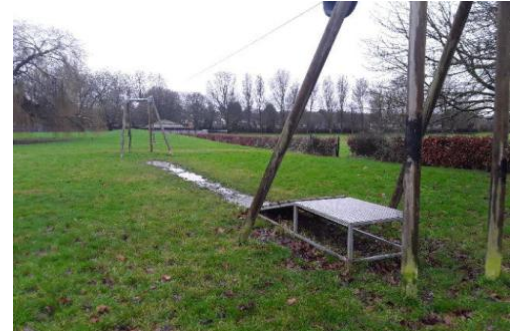
Item: Cable Runway
Manufacturer: Not Identified
Surface Type: Grass Matrix Tiles
Item Quantity: 1
Equipment Compliance: Yes
Surface Area Compliance: Yes

We have completed a visual inspection of the suspension links, cable and fixing points from ground level, however it is not possible to fully inspect these areas without either hiring equipment to gain access or removing the cable and suspension and inspecting at ground level. We recommend that the main cable and fixing security is thoroughly inspected at least in accordance with the manufacturers recommendations to check for wear, damage, security or internal rusting; this will help to ensure the continued safe use of the equipment - Inspect in accordance with the manufacturers recommendations

There is or are fixings missing on the steel brackets at both ends making the item unsafe - Replace all missing fixings

There is some evidence of rot in the timber posts - Monitor for any further deterioration and replace as required

The item is slightly loose in its foundations - Monitor for any further deterioration and repair as required

The suspension cover has been damaged - Replace

The seat has been severely damaged - Replace

There is some notable evidence of chain wear - Monitor for any further deterioration and replace when 40% worn

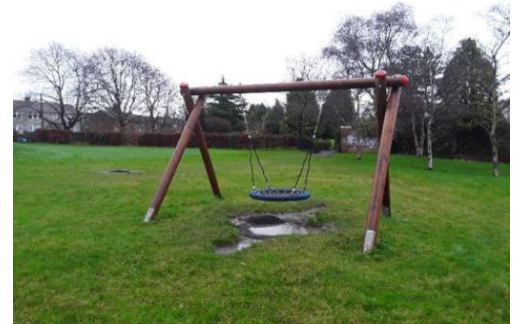
Item: Basket Swing - Type 1
Manufacturer: Kompan Ltd
Surface Type: Grass Matrix Tiles
Item Quantity: 1
Equipment Compliance: Yes
Surface Area Compliance: Yes

The surfacing is severely damaged or missing in places -
Repair damaged areas of surfacing

The surface has subsided in some areas - Monitor for any further deterioration and repair as required

There is or are fixings missing on the secondary safety -
Replace all missing fixings

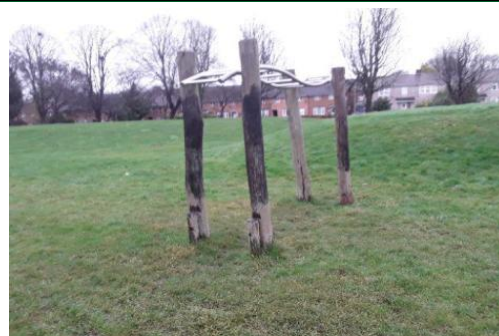
Item: Monkey Bars
Manufacturer: Richter Spielgerate GmbH (DE)
Surface Type: Grass Matrix Tiles
Item Quantity: 1
Equipment Compliance: Yes
Surface Area Compliance: Yes

The timber has a number of splits/shakes or air cracks and this may affect the stability or allow water ingress which will accelerate the rotting process - Monitor to ensure the splits do not cross through fixing points of the structure and/or cause any instability

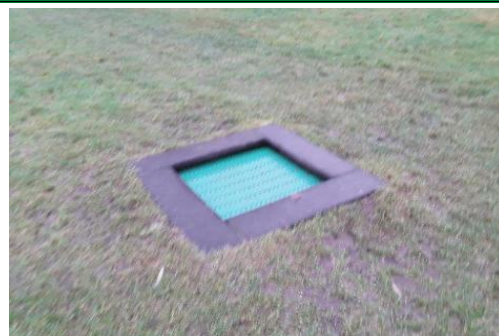
Item: Bouncing Facility
Manufacturer: Not Identified
Surface Type: Grass Matrix Tiles
Item Quantity: 1
Equipment Compliance: N/A
Surface Area Compliance: N/A

On site visits it is not possible to test the ground clearance of the Bouncing Facility bed as specified in BS EN 1176; ensure that the clearance between the Bouncing Facility Bed and the ground underneath is in accordance with the manufacturers recommendations (It was not possible recorded the nominal depth at time of inspection due to the design of the bed). - Refer to the manufacturers recommendations

There are trip hazards at the edges of the surface - Reinstate surrounding surface levels to remove the trip points

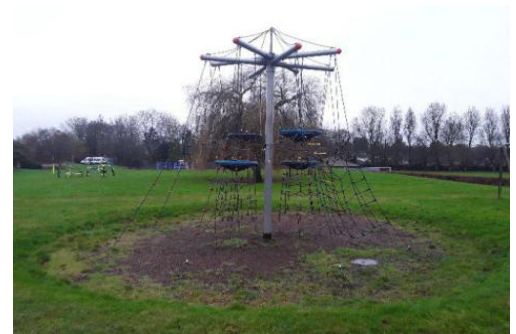
Item: Rope Climber
Manufacturer: Huck Nets (UK) Ltd
Surface Type: Woodchip
Item Quantity: 1
Equipment Compliance: Yes
Surface Area Compliance: Yes

The fixings or components for this item were in excess of 2.5m above the standing surface and could not be fully accessed by the inspector. We have completed a visual inspection of the fixings from ground level but a maintenance inspection should be undertaken to assess the condition, security and wear of the components at intervals in accordance with the manufacturers recommendations. - Inspect in accordance with the manufacturers recommendations

There is some notable evidence of chain and shackle wear - Monitor for any further deterioration and replace when 40% worn

The depth of the loose fill surfacing is lower than the recommended depth specified in BS EN 1176 for a fall height over 2.0m. A minimum depth of 400mm is recommended (including an extra 100mm to allow for compaction and displacement as per BS EN 1176 Part 1 - Table 4) - Top up loosefill to recommended levels

The ropes/nets are worn/damaged in places - Monitor for any further deterioration and repair or replace as required

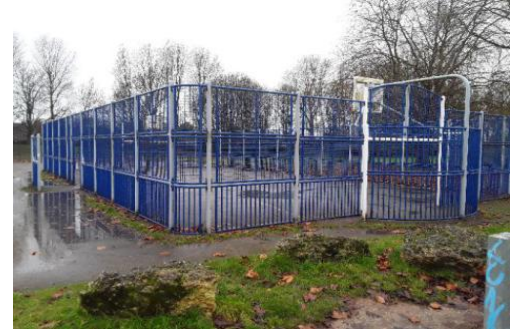
Item: Multi Use Games Area (MUGA)
Manufacturer: S M P (Playgrounds Ltd)
Surface Type: Bitmac
Item Quantity: 1
Equipment Compliance: No
Surface Area Compliance: N/A

A clearly visible facility sign should be provided in a prominent position with the wording as detailed BS EN 15312- the equipment is not intended for children less than 3 years old- the warning - Do not climb on the framework or nets- the warning - Do not hang on the ring (if provided)- the warning - Do not wear rings or other jewellery- name and telephone number of the administrator- number to call in case of accident - Provide signage to BS EN 15312

The item fails to meet the requirements of BS EN 15312 4.4.2.1 head and neck entrapment in the frame - Monitor - No remedial work recommended

There is or are fixings missing on the backboard - Replace all missing fixings

The hoop netting has been severely damaged - Replace

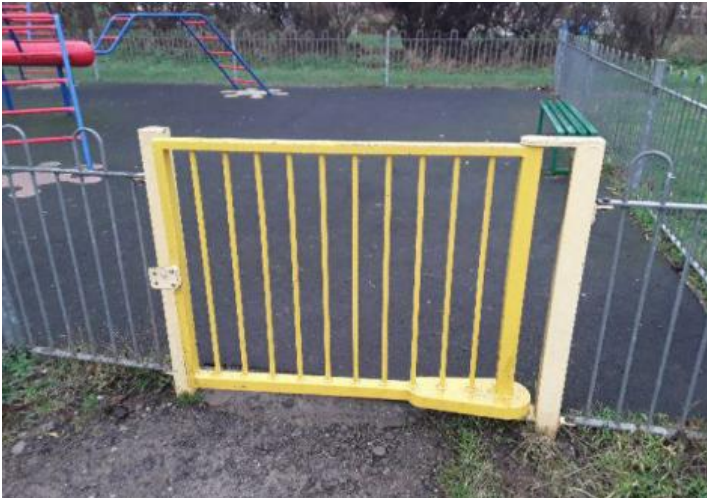
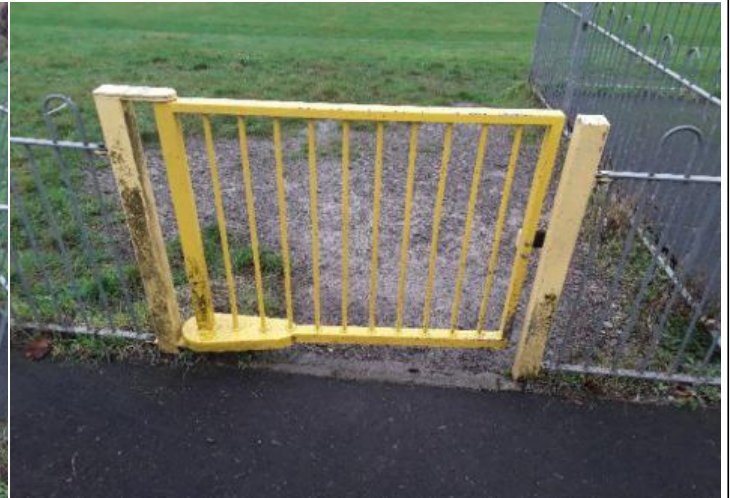
Item: Gates - Gate - Self Closing
Manufacturer: I.A.E. Fencing

Finding: The gate is closing too quickly (less than 4 seconds)

Action: Take corrective action to ensure that the gate closes in 4-8 seconds

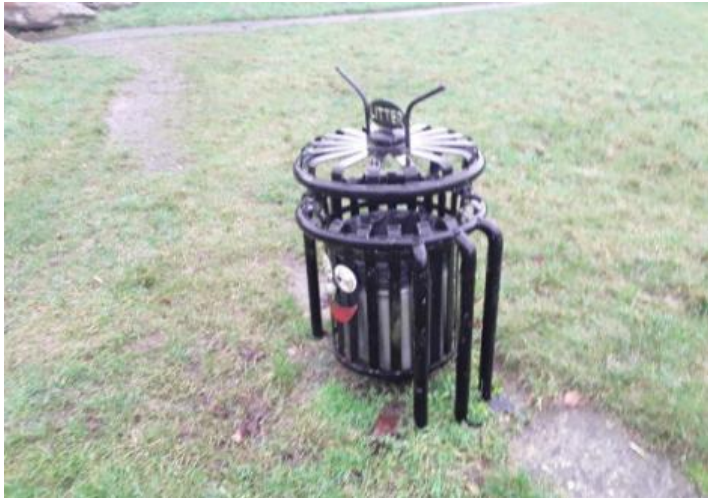
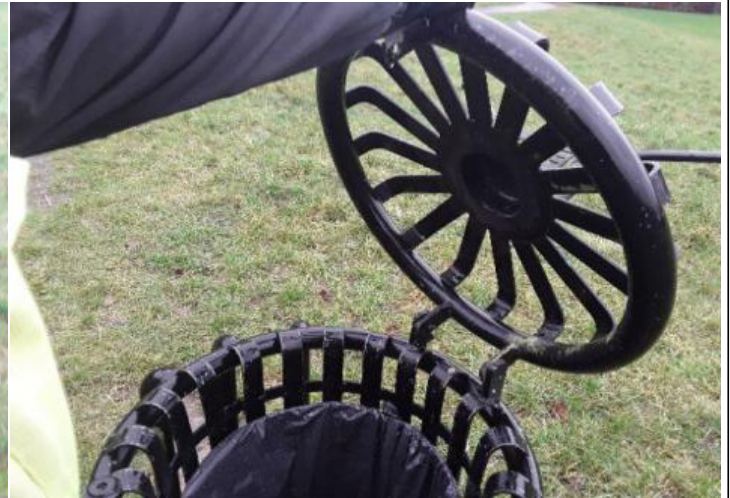
Item: Ancillary Items - Litter Bin
Manufacturer: Glasdon

Finding: The lid or door of the litter bin is not secured

Action: Ensure the lid or door is kept locked

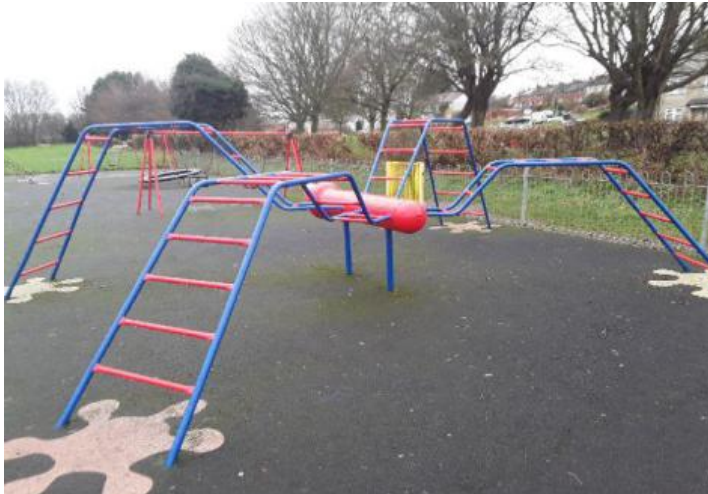
Item: Activity Equipment - Climbing Frame
Manufacturer: Wicksteed Playgrounds

Finding: The item fails to meet the requirements of BS EN 1176 Part 1 4.2.7.2 for head and neck entrapment in the frame

Action: Monitor - No remedial work recommended

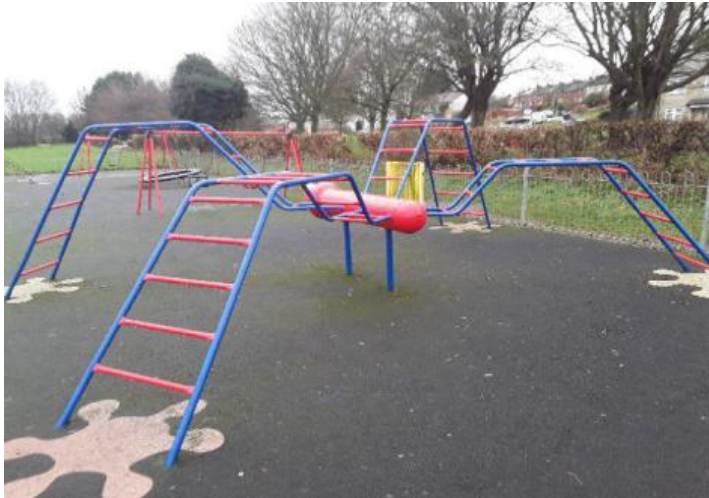
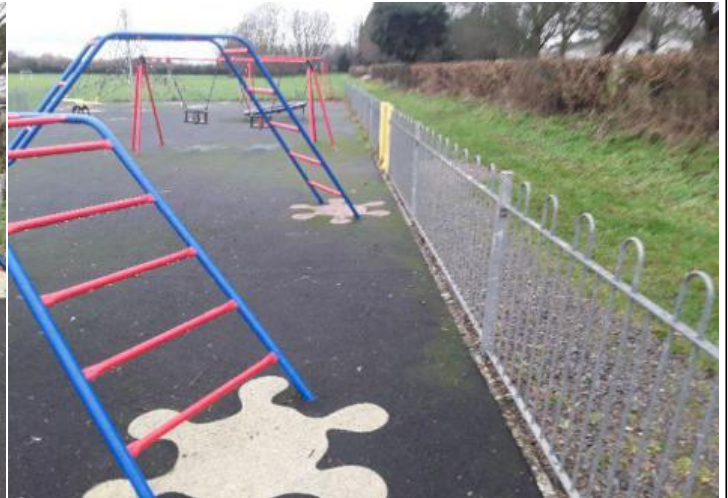
Item: Activity Equipment - Climbing Frame
Manufacturer: Wicksteed Playgrounds

Finding: The fence forms a hard object within the falling space of the equipment in contravention of the requirements of BS EN 1176 Part 1
Action: Monitor the risk assessment regularly and modify the design if required

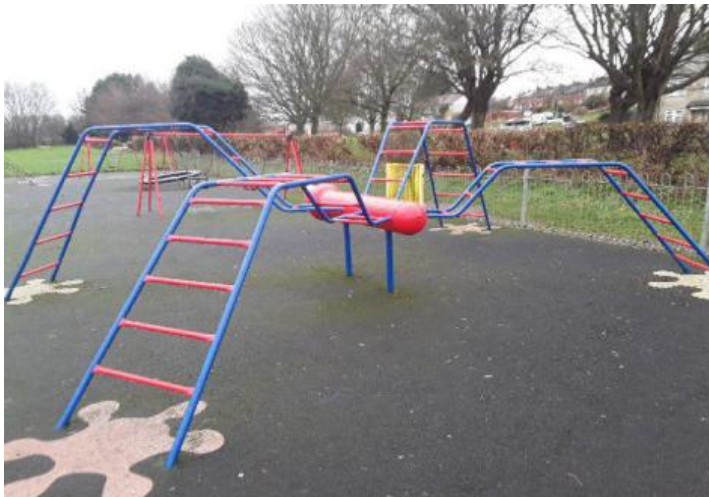
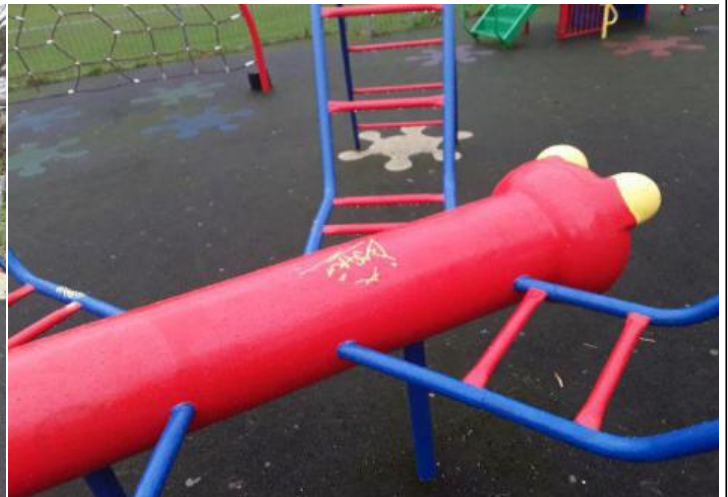
Item: Activity Equipment - Climbing Frame
Manufacturer: Wicksteed Playgrounds

Finding: There is some graffiti present

Action: Remove the graffiti

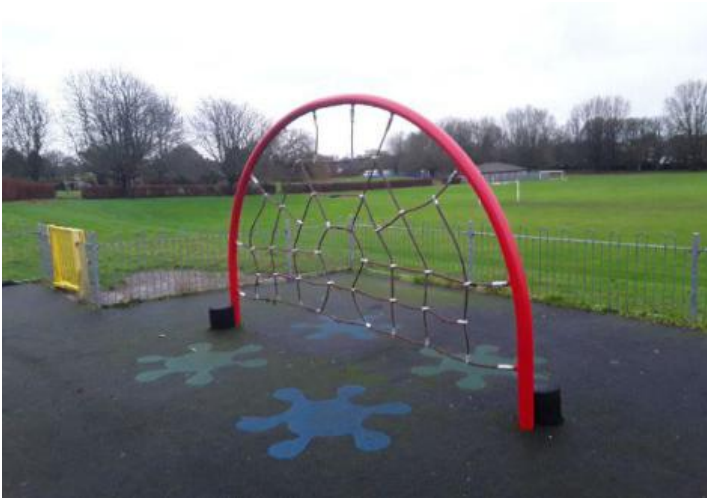
Item: Activity Equipment - Net Climber
Manufacturer: S M P (Playgrounds Ltd)

Finding: The ropes/nets are worn/damaged in places

Action: Monitor for any further deterioration and repair or replace as required

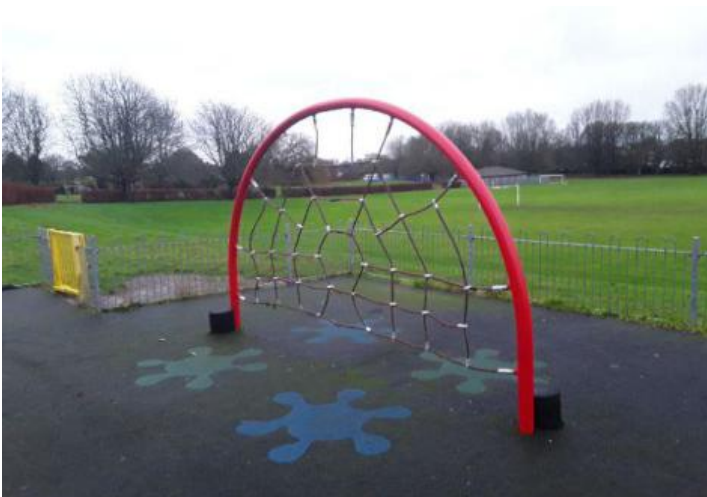
Item: Activity Equipment - Net Climber
Manufacturer: S M P (Playgrounds Ltd)

Finding: A number of fixing(s) have worked loose

Action: Secure all loose fixings

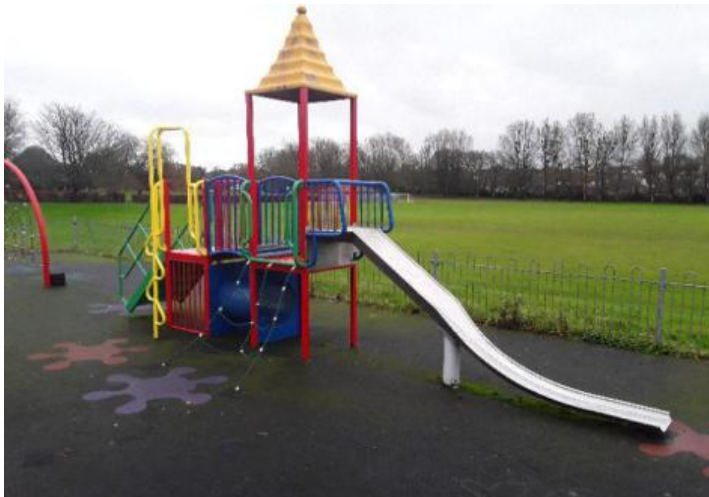
Item: Activity Equipment - Multi Play (Junior)
Manufacturer: Wicksteed Playgrounds

Finding: There are a number of dents in the slide surface

Action: Monitor for any further deterioration and repair as required

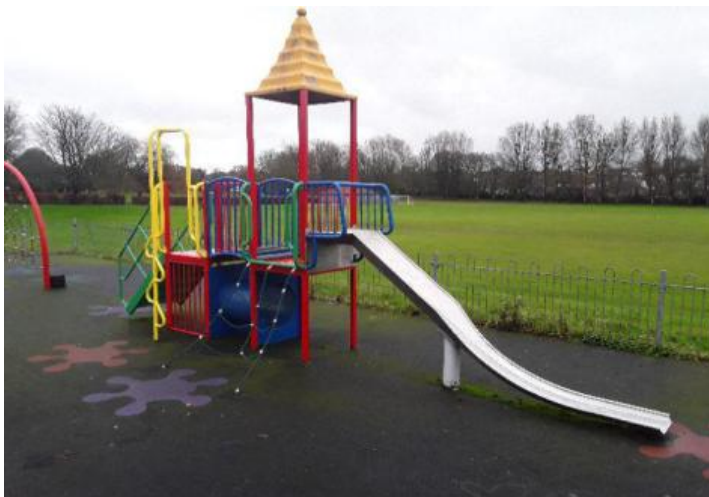
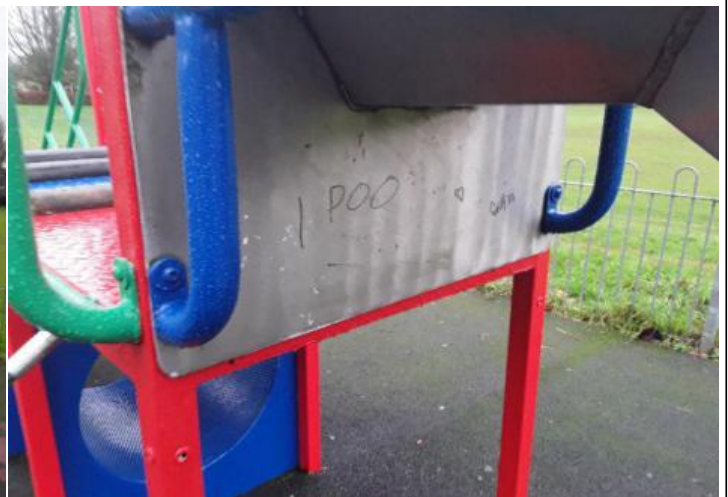
Item: Activity Equipment - Multi Play (Junior)
Manufacturer: Wicksteed Playgrounds

Finding: There is some graffiti present

Action: Remove the graffiti

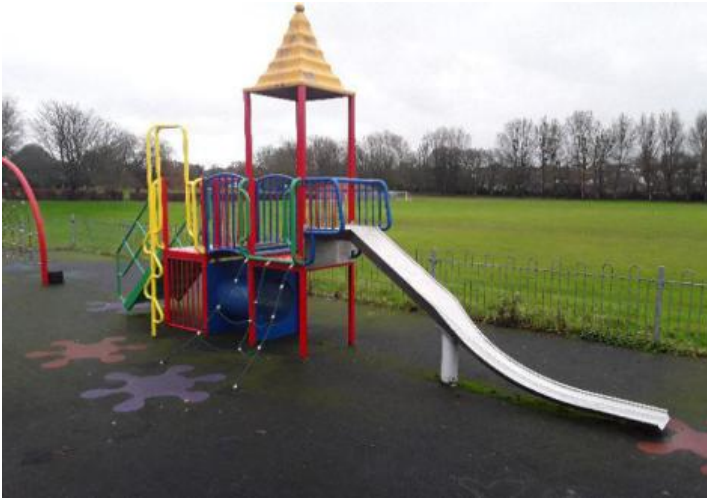
Item: Activity Equipment - Multi Play (Junior)
Manufacturer: Wicksteed Playgrounds

Finding: The ropes/nets are worn/damaged in places

Action: Monitor for any further deterioration and repair or replace as required

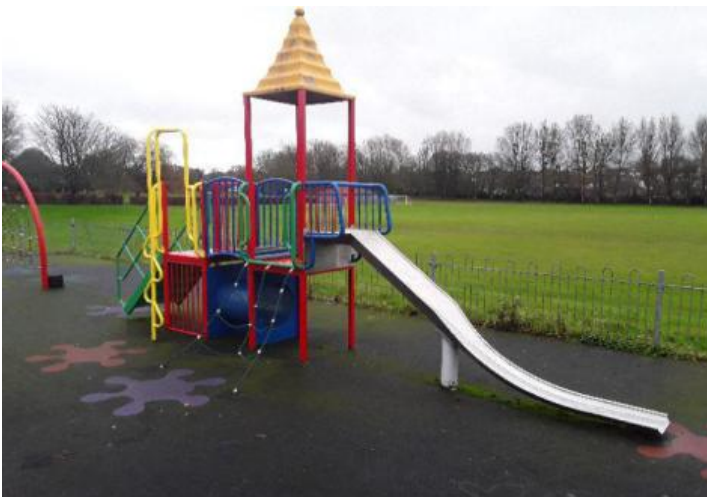
Item: Activity Equipment - Multi Play (Junior)
Manufacturer: Wicksteed Playgrounds

Finding: There is or are fixings missing on the item

Action: Replace all missing fixings

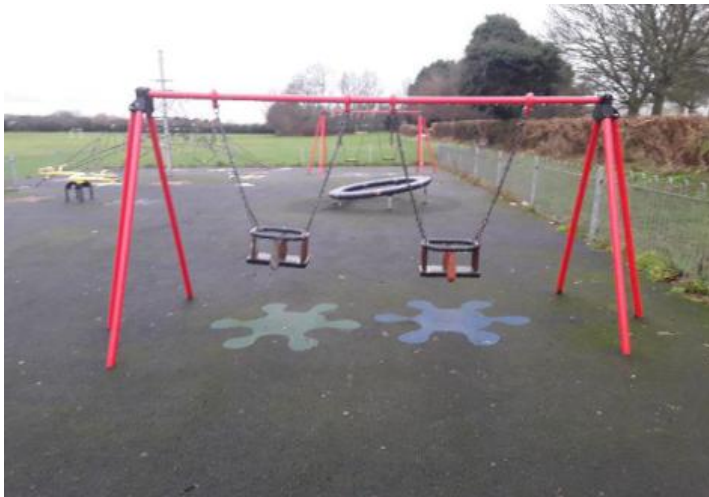
Item: Swings - 1 Bay 2 Seat (Cradle)
Manufacturer: Wicksteed Playgrounds

Finding: There is some notable evidence of chain wear

Action: Monitor for any further deterioration and replace when 40% worn

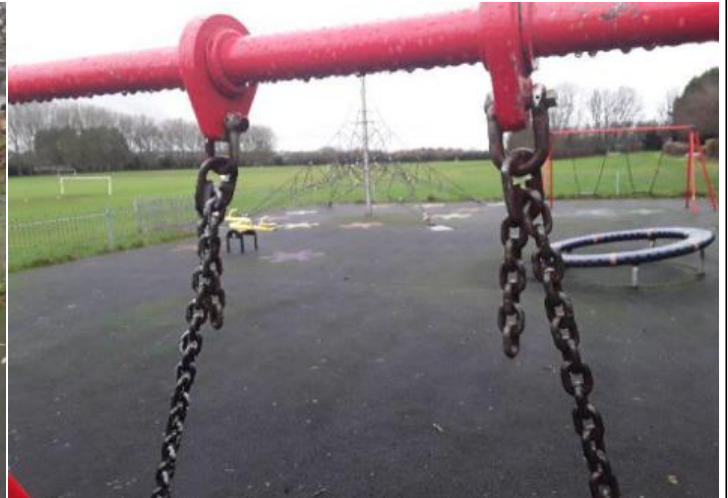
Item: Swings - 1 Bay 2 Seat (Cradle)
Manufacturer: Wicksteed Playgrounds

Finding: There are excessive chain tails provided, however a minimum of 2 additional links should always be provided with crucifix connectors

Action: Cut back excess chain tails but ensure a minimum of 2 additional links remain through the crucifix

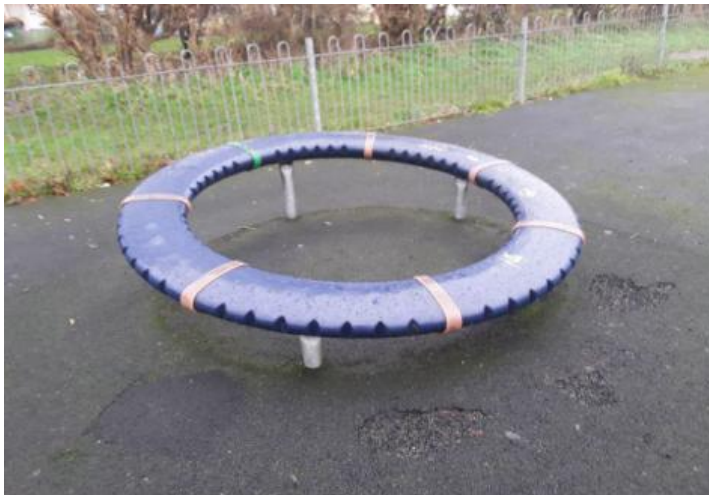
Item: Rotor Play - Supernova
Manufacturer: Kompan Ltd

Finding: There is moderate damage to the surface

Action: Repair the damaged areas of surfacing

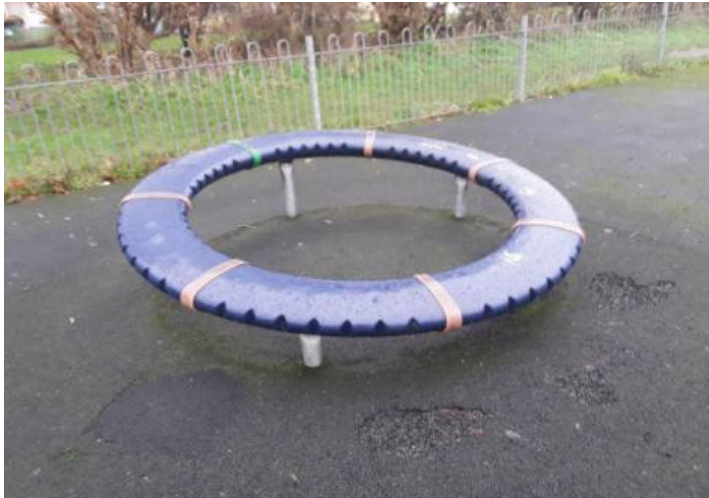
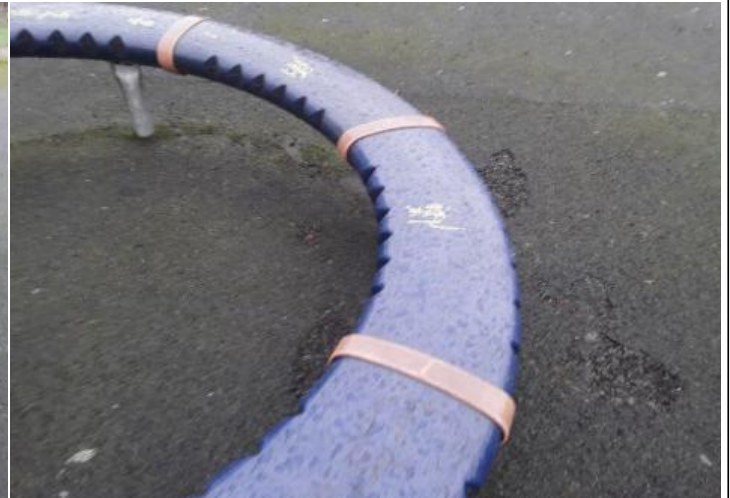
Item: Rotor Play - Supernova
Manufacturer: Kompan Ltd

Finding: There is some graffiti present

Action: Remove the graffiti

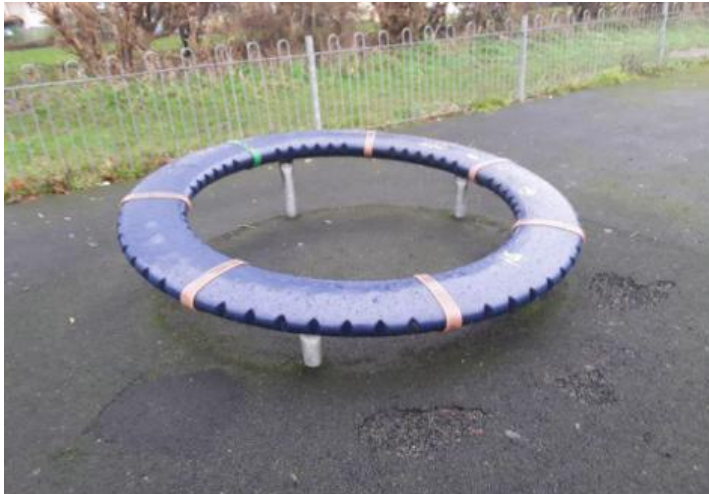
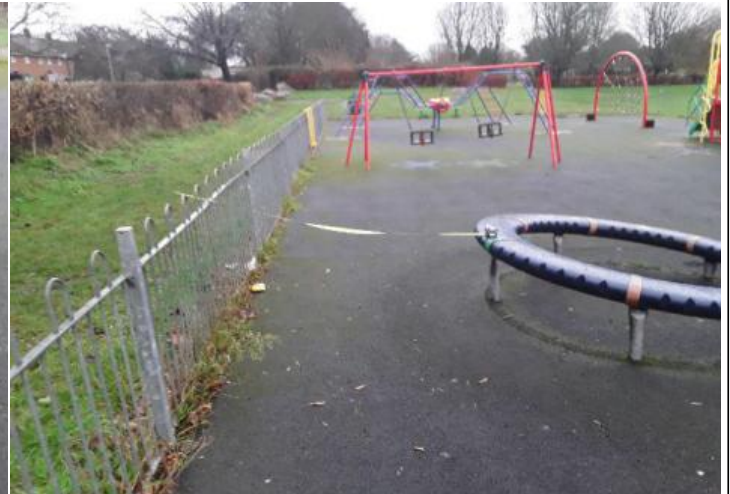
Item: Rotor Play - Supernova
Manufacturer: Kompan Ltd

Finding: The fence forms a hard object within the falling space of the equipment in contravention of the requirements of BS EN 1176 Part 1

Action: Monitor the risk assessment regularly and modify the design if required

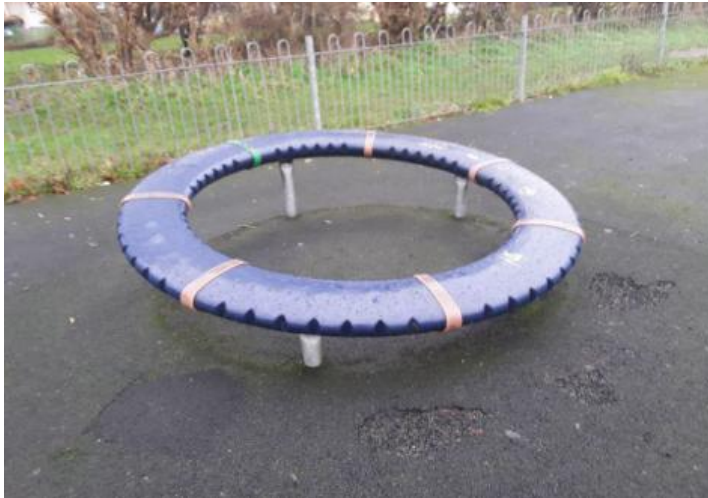
Item: Rotor Play - Supernova
Manufacturer: Kompan Ltd

Finding: The plastic body has been damaged

Action: Monitor for any further deterioration and replace as required

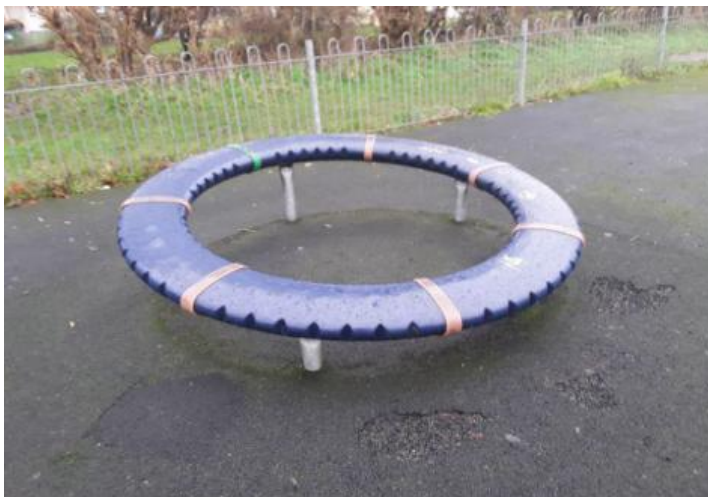
Item: Rotor Play - Supernova
Manufacturer: Kompan Ltd

Finding: There is/are bolt cap covers missing or damaged on the item

Action: Replace missing or damaged bolt cap covers

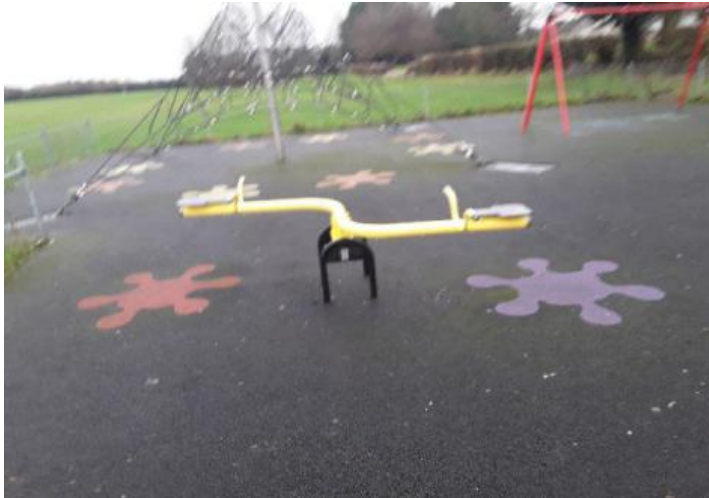
Item: Rocking Equipment - See Saw
Manufacturer: Wicksteed Playgrounds

Finding: There is some minor damage to the seat

Action: Monitor for any further deterioration and replace as required

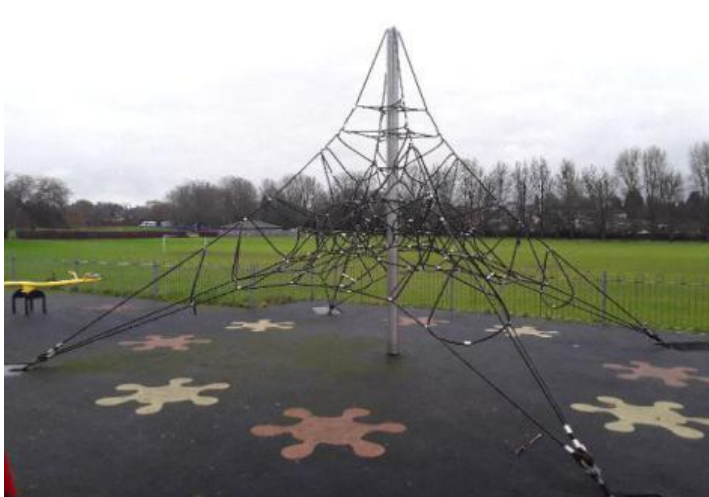
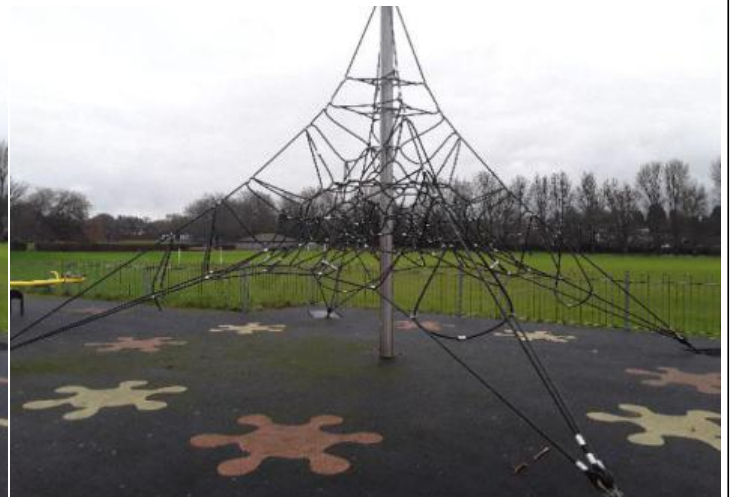
Item: Activity Equipment - Space Net
Manufacturer: Tayplay Ltd

Finding: The connecting or tensioning ropes on the net are not tensioned correctly

Action: Tighten tensioners equally to provide stability to the net structure

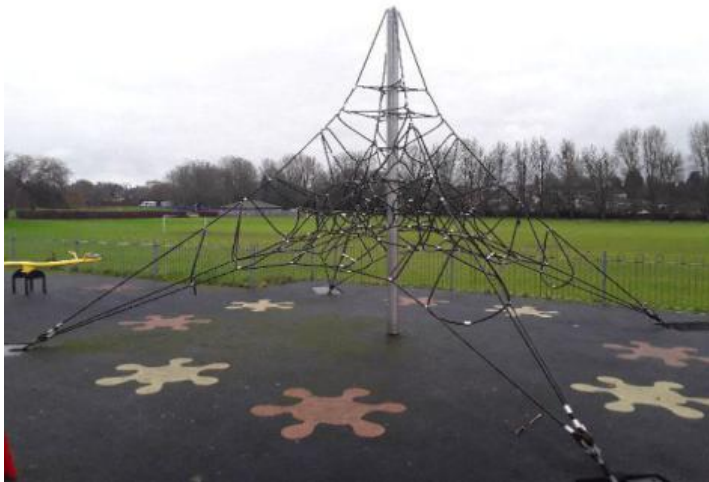
Item: Activity Equipment - Space Net
Manufacturer: Tayplay Ltd

Finding: There are trip hazards present

Action: Reinstate surrounding surfaces to level to remove the trip points

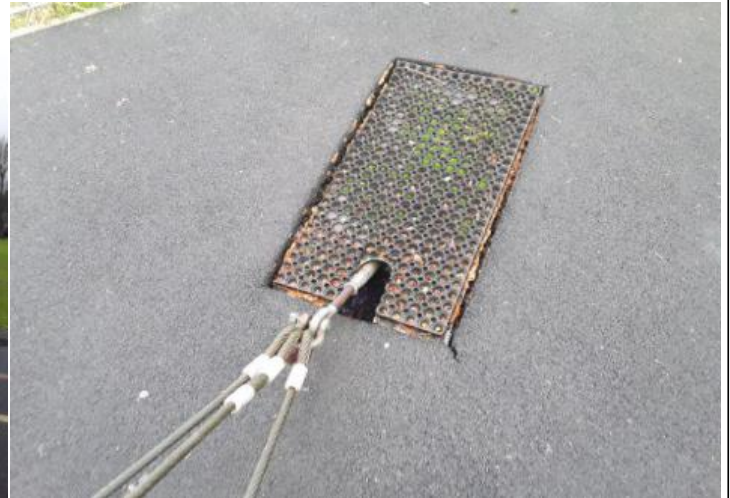
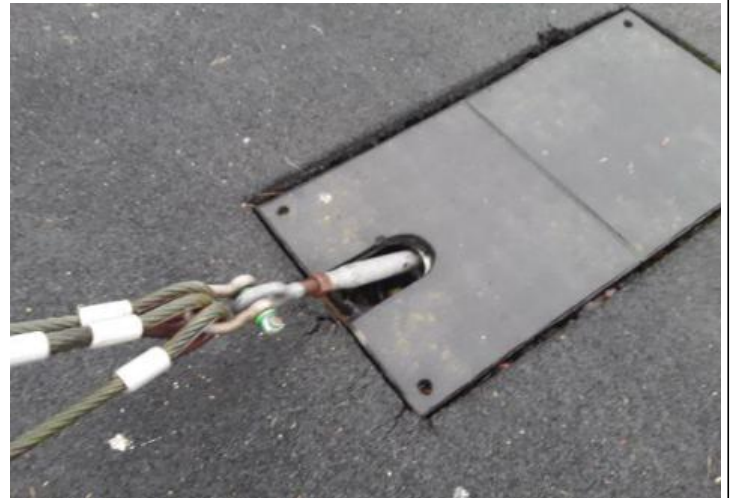
Item: Activity Equipment - Space Net
Manufacturer: Tayplay Ltd

Finding: There are gaps in excess of 30mm in the direction of travel creating foot entrapment/s in contravention of BS EN 1176 Part 1 around the cable fixing points

Action: Fill, gals to remove the entrapments

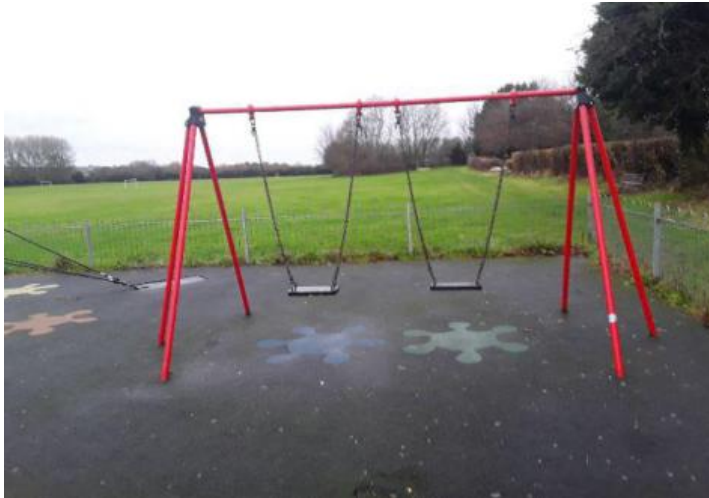
Item: Swings - 1 Bay 2 Seat (Flat)
Manufacturer: Wicksteed Playgrounds

Finding: The seat has minor damage or wear

Action: Monitor for any further deterioration and replace as required

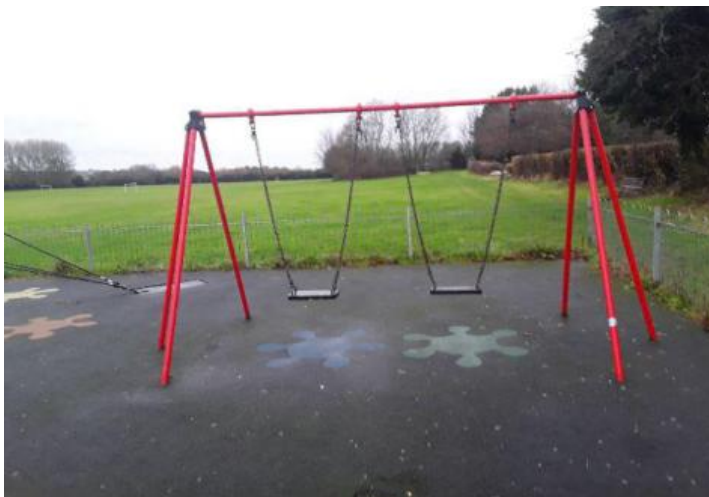
Item: Swings - 1 Bay 2 Seat (Flat)
Manufacturer: Wicksteed Playgrounds

Finding: The connecting links are in excess of 8.6mm and less than 12mm and fail the requirements of BS EN 1176 Part 1; clause 4.2.13, Chains

Action: Monitor - No remedial work recommended

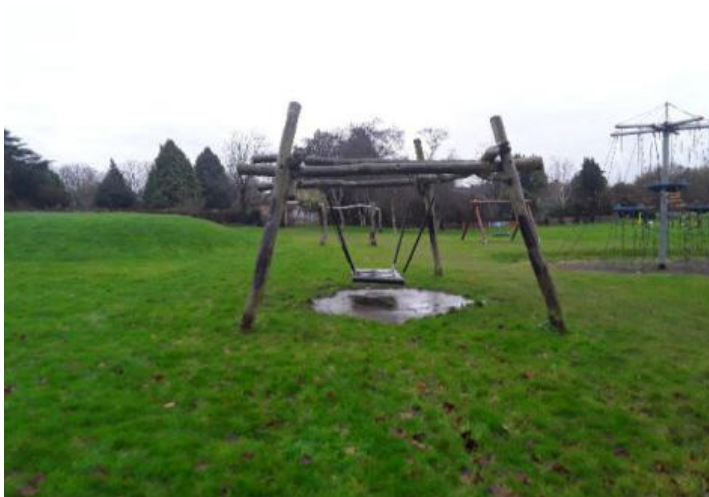
Item: Swings - Misc Swing
Manufacturer: Not Identified

Finding: The fixings or components for this item were in excess of 2.5m above the standing surface and could not be fully accessed by the inspector. We have completed a visual inspection of the fixings from ground level but a maintenance inspection should be undertaken to assess the condition, security and wear of the components at intervals in accordance with the manufacturers recommendations.

Action: Inspect in accordance with the manufacturers recommendations

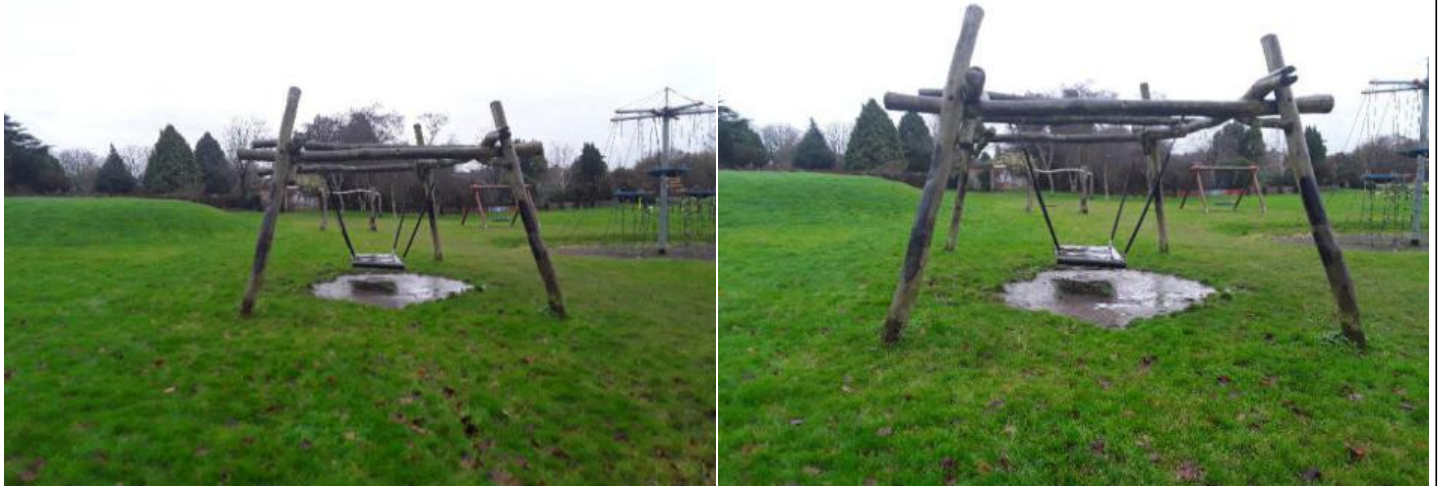
Item: Swings - Misc Swing
Manufacturer: Not Identified

Finding: There is algae or moss on the surface of the equipment

Action: Clean and treat appropriately

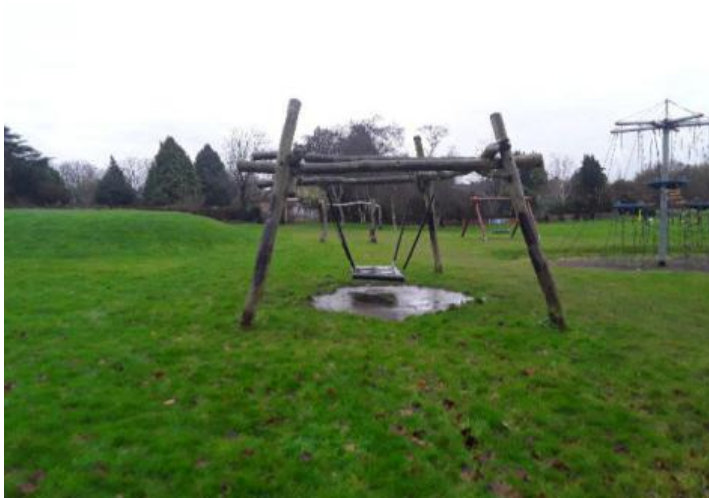
Item: Swings - Misc Swing
Manufacturer: Not Identified

Finding: There is/are inserts missing

Action: Replace missing inserts

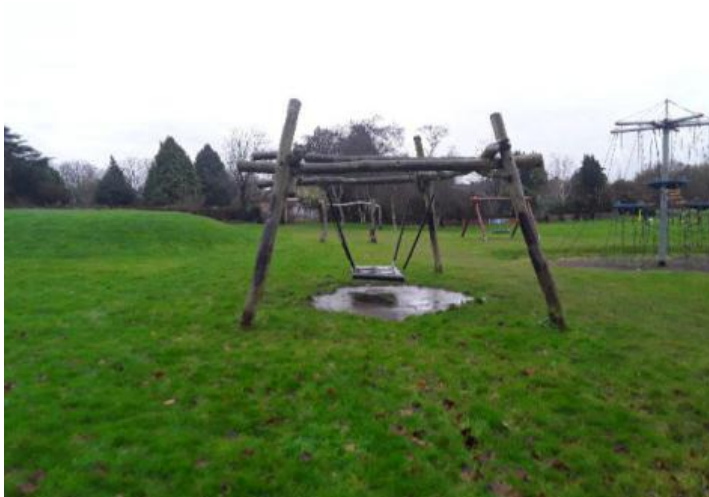
Item: Swings - Misc Swing
Manufacturer: Not Identified

Finding: There are splits running through the timber that cross through or near fixing points and may cause instability in the future

Action: Monitor stability of fixings

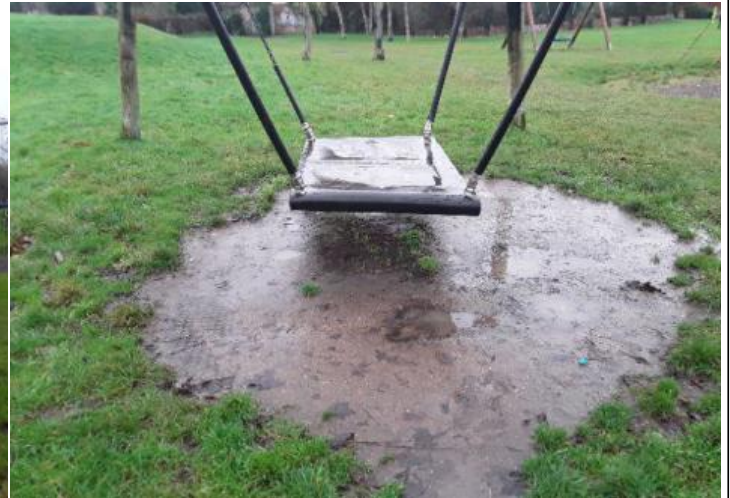
Item: Swings - Misc Swing
Manufacturer: Not Identified

Finding: There is a lack of grass growth under the item and this may have an effect on the impact absorbing properties of the surface
Action: Encourage grass growth

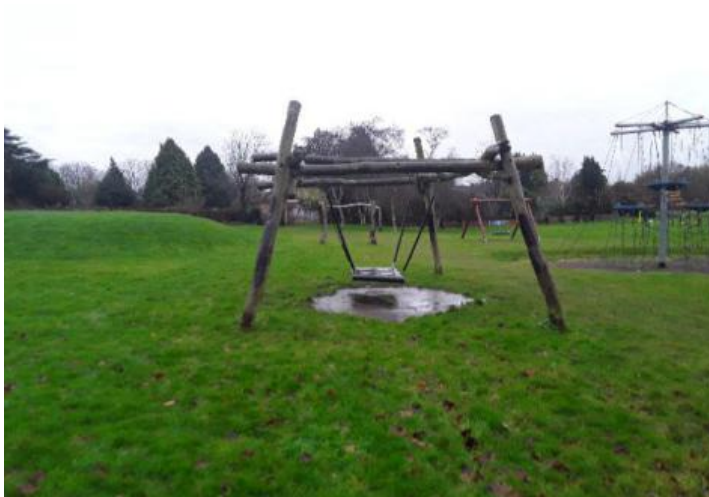
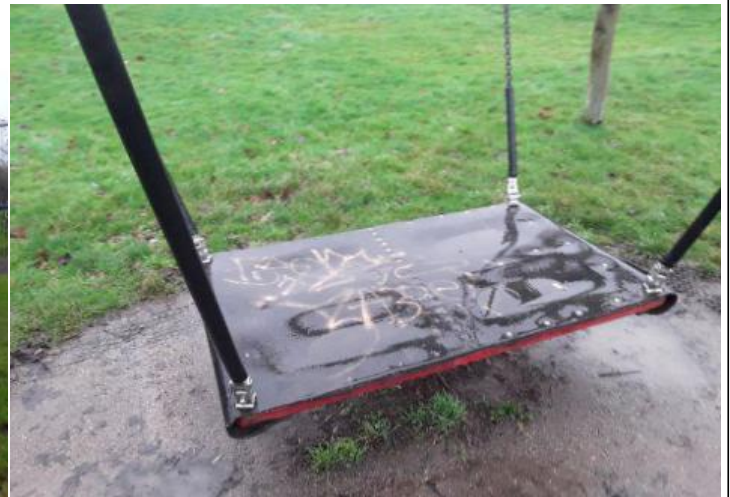
Item: Swings - Misc Swing
Manufacturer: Not Identified

Finding: There is some graffiti present
Action: Remove the graffiti
