the play inspection company

Annual Inspection

Central Swindon North Parish Council

Inglesham Road

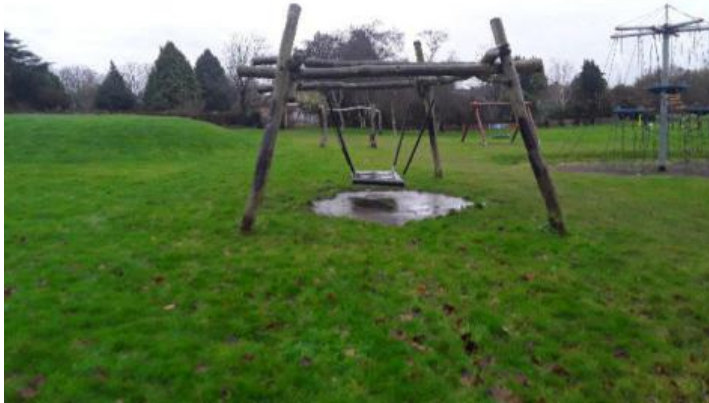
Item: Swings - Misc Swing
Manufacturer: Not Identified

Finding: The connecting links are in excess of 8.6mm and less than 12mm and fail the requirements of BS EN 1176 Part 1; clause 4.2.13, Chains

Action: Monitor - No remedial work recommended

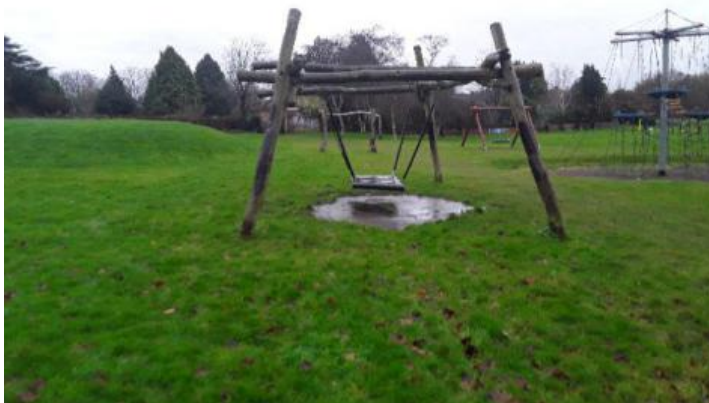
Item: Swings - Misc Swing
Manufacturer: Not Identified

Finding: There is some notable evidence of chain wear

Action: Monitor for any further deterioration and replace when 40% worn

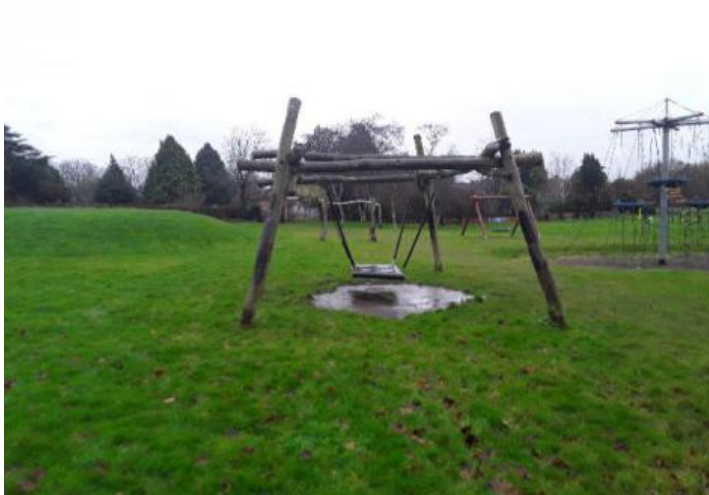
Item: Swings - Misc Swing
Manufacturer: Not Identified

Finding: The surfacing is severely damaged or missing

Action: Repair damaged areas of surfacing

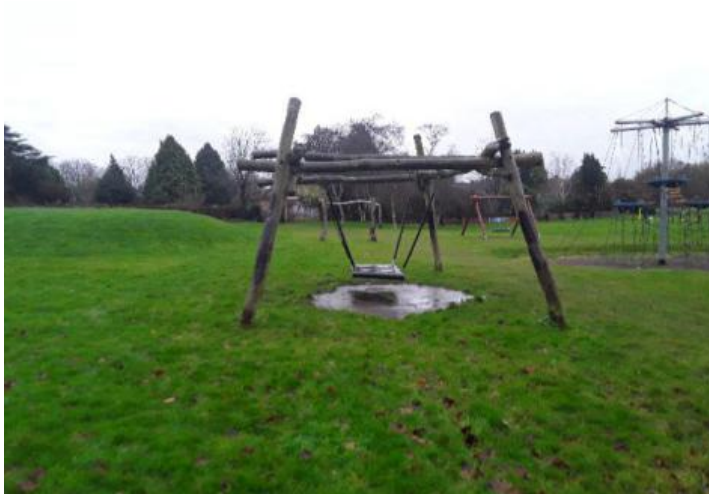
Item: Swings - Misc Swing
Manufacturer: Not Identified

Finding: A number of seat connector fixing(s) have worked loose

Action: Secure all loose fixings

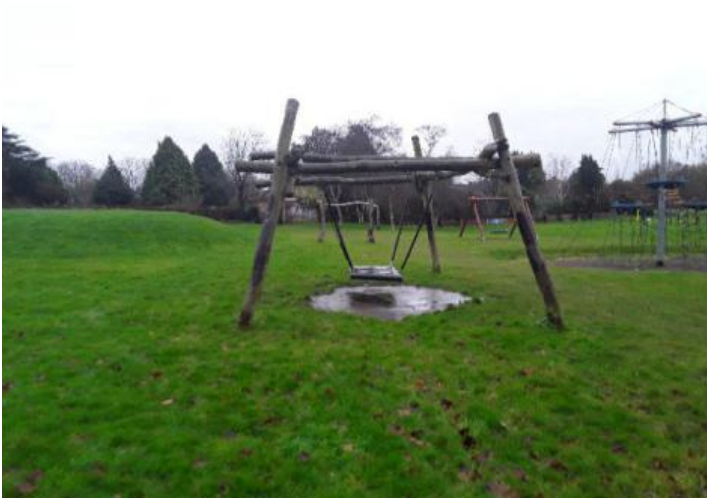
Item: Swings - Misc Swing
Manufacturer: Not Identified

Finding: The seat suspension cover has been damaged

Action: Monitor for any further deterioration and replace as required

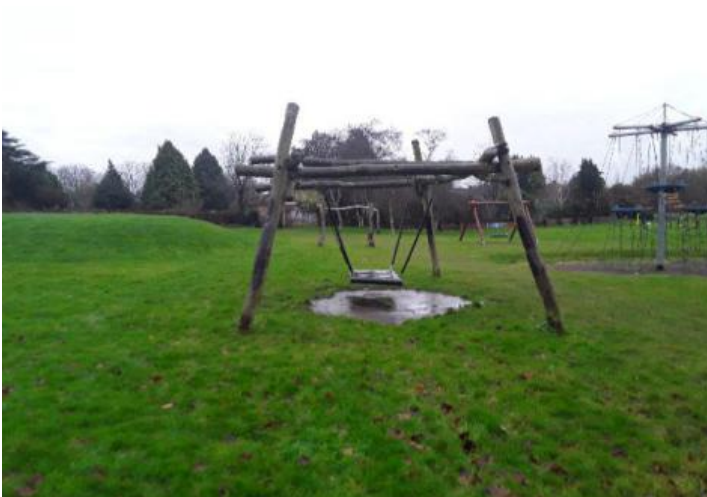
Item: Swings - Misc Swing
Manufacturer: Not Identified

Finding: The seat has minor damage or wear

Action: Monitor for any further deterioration and replace as required

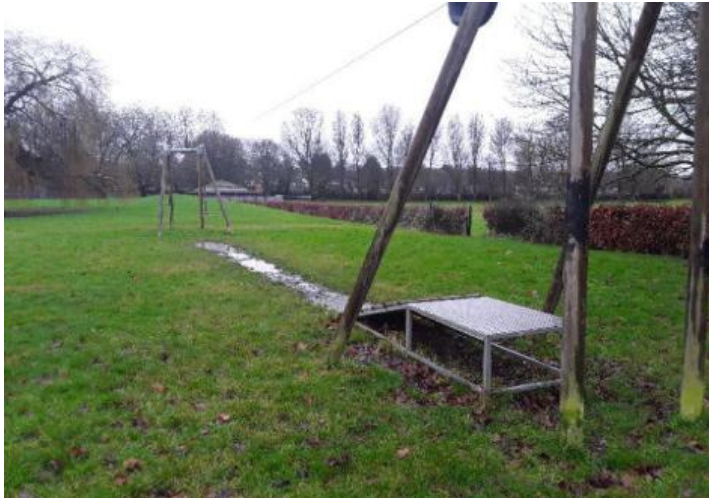
Item: Other - Cable Runway
Manufacturer: Not Identified

Finding: We have completed a visual inspection of the suspension links, cable and fixing points from ground level, however it is not possible to fully inspect these areas without either hiring equipment to gain access or removing the cable and suspension and inspecting at ground level. We recommend that the main cable and fixing security is thoroughly inspected at least in accordance with the manufacturers recommendations to check for wear, damage, security or internal rusting; this will help to ensure the continued safe use of the equipment

Action: Inspect in accordance with the manufacturers recommendations

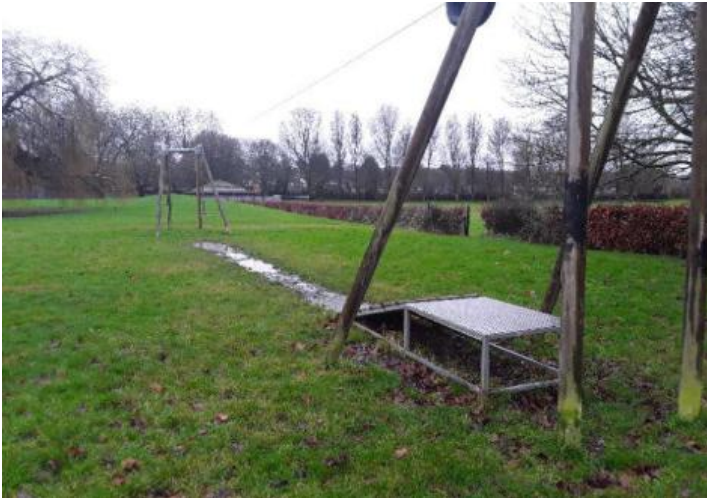
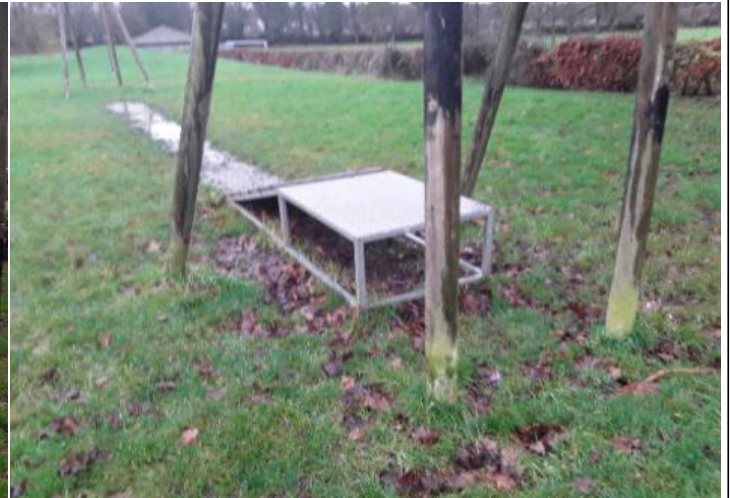
Finding: There is algae or moss on the surface of the equipment

Action: Clean and treat appropriately

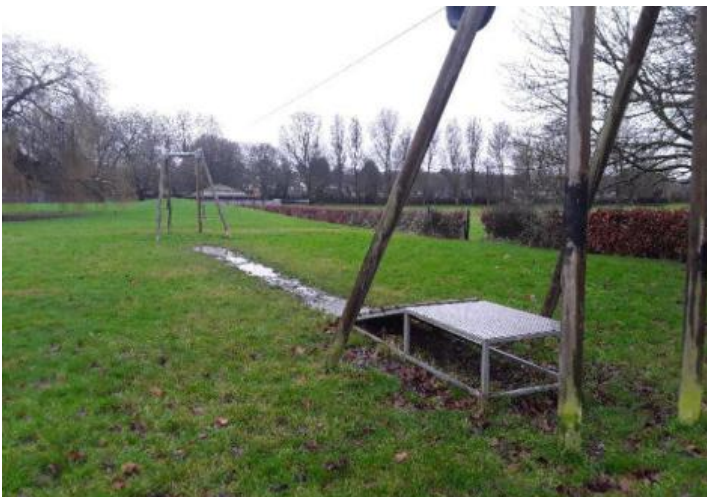
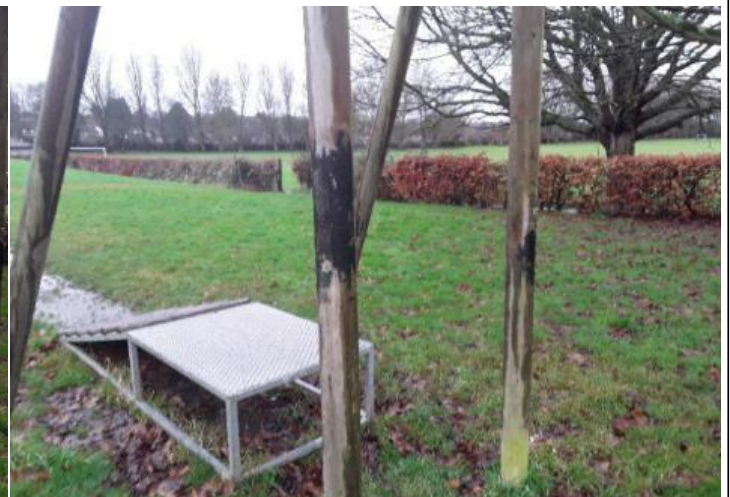
Finding: There is some graffiti present

Action: Remove the graffiti

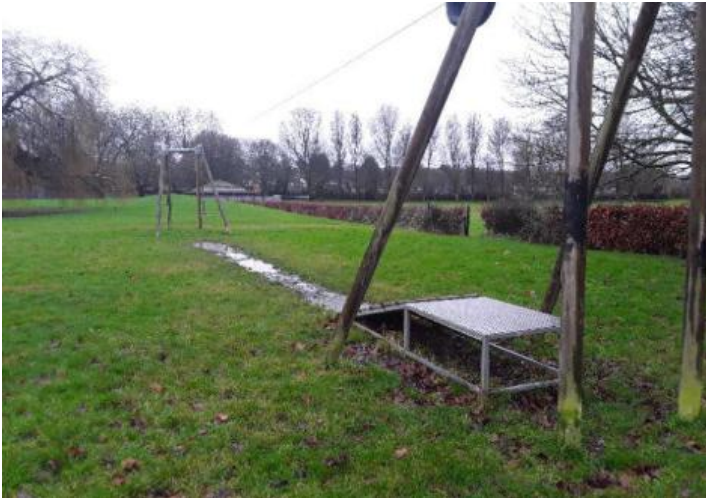
Finding: There is some evidence of rot in the timber posts

Action: Monitor for any further deterioration and replace as required

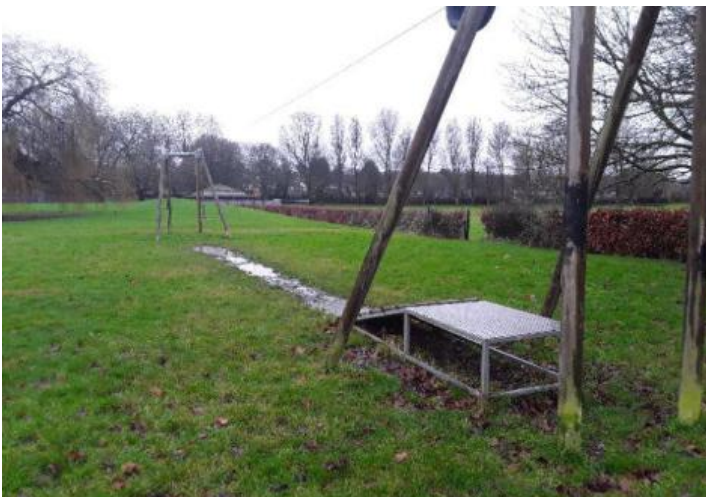
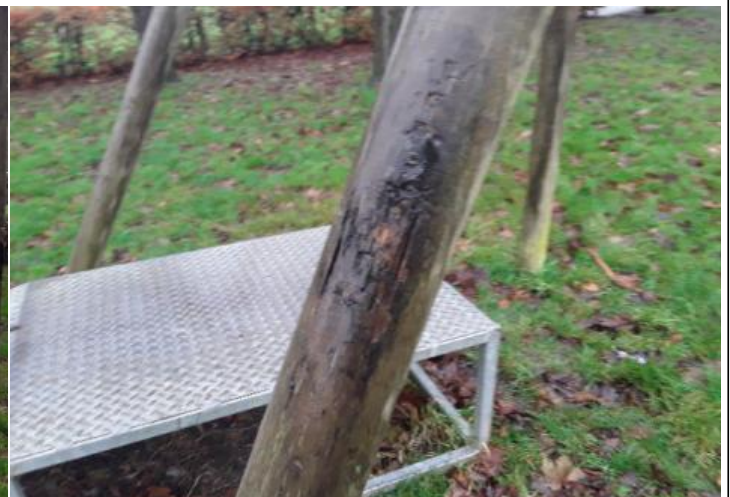
Finding: Parts of the timber are rough or splintered

Action: Remove all rough or sharp edges

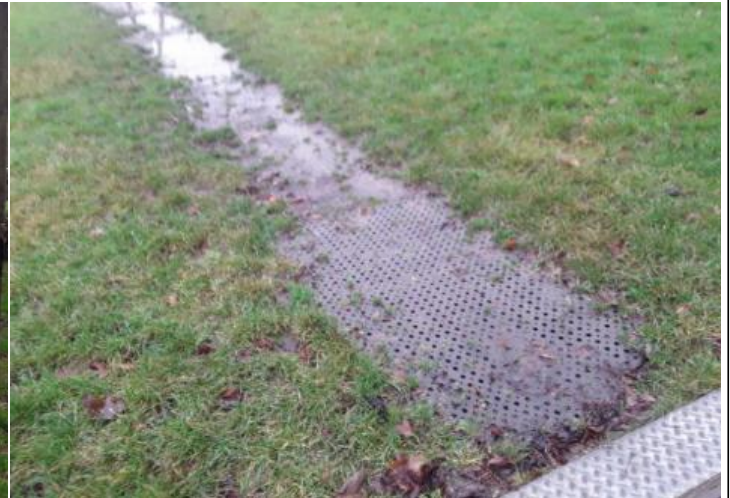
Finding: A grass matrix tile has been installed upside down **Action:** Re install the grass matrix tile the correct way up

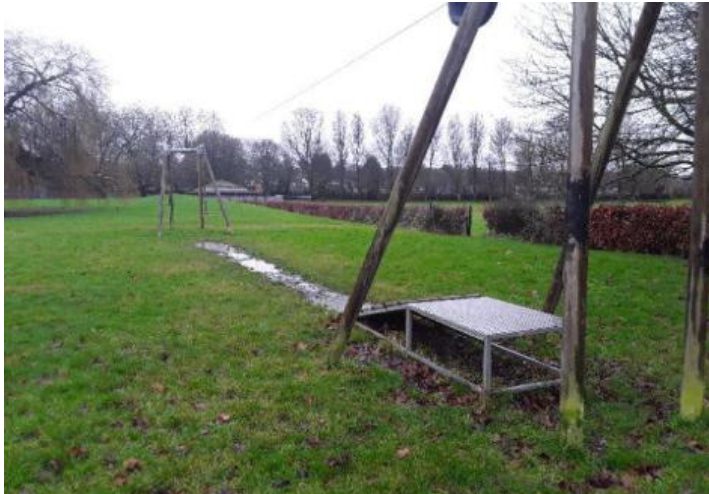
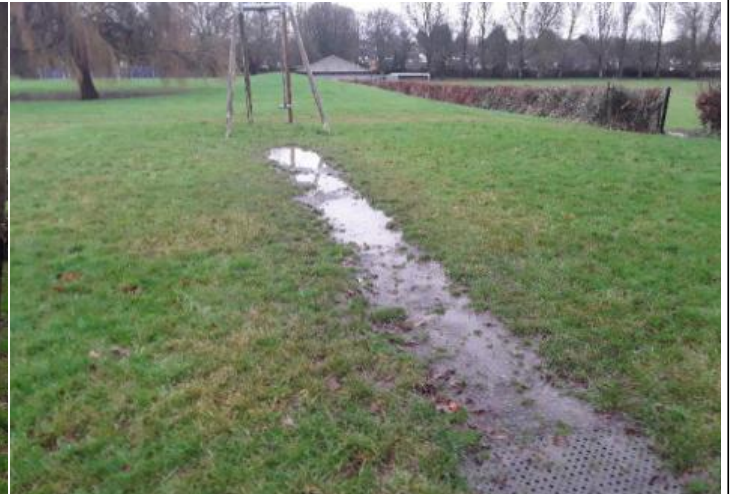
Finding: The grass mats are silted up and the soil is compacted; this may have an effect on the impact absorbing properties of the surface. Consideration should be given to HIC testing the surface to verify impact attenuating properties (<https://playinspections.co.uk/inspection-services/safety-surface-testing/>) **Action:** Contact our office for a quotation for this service

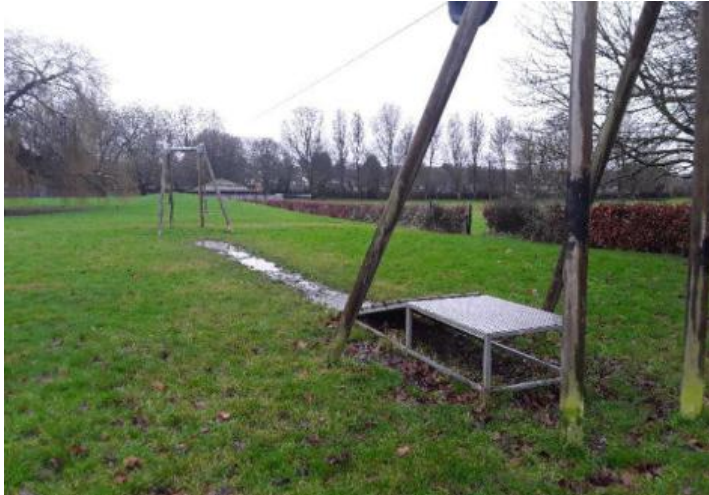
Finding: There is or are fixings missing on the steel brackets at both ends making the item unsafe

Action: Replace all missing fixings

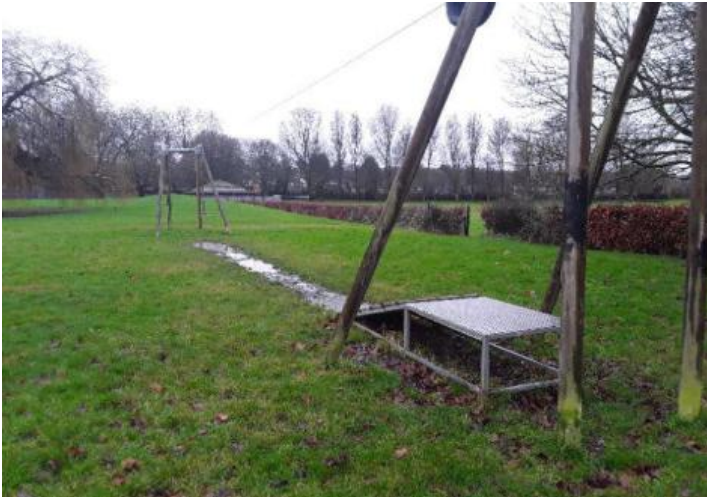
Finding: There is some notable evidence of chain wear

Action: Monitor for any further deterioration and replace when 40% worn

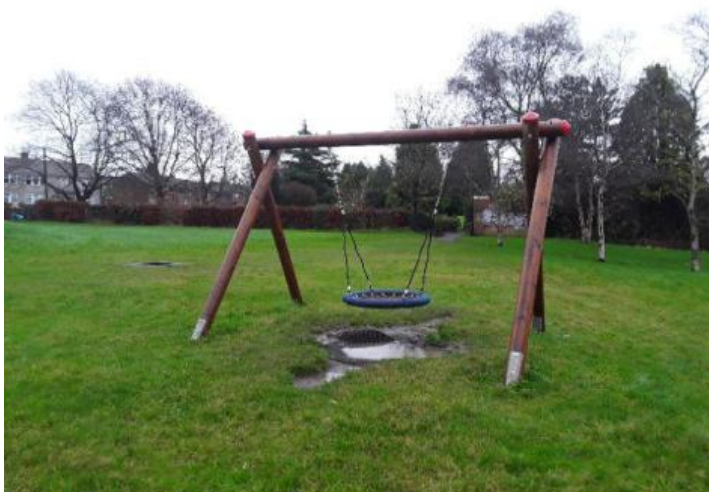
Finding: The surfacing is severely damaged or missing in places

Action: Repair damaged areas of surfacing

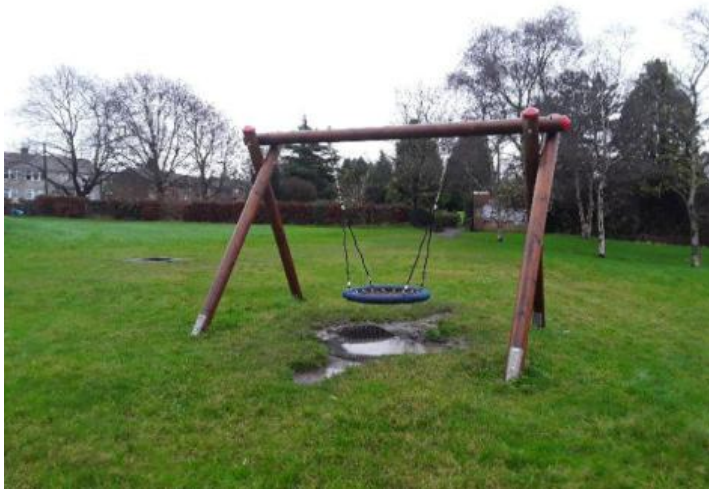
Finding: There is or are fixings missing on the secondary safety

Action: Replace all missing fixings

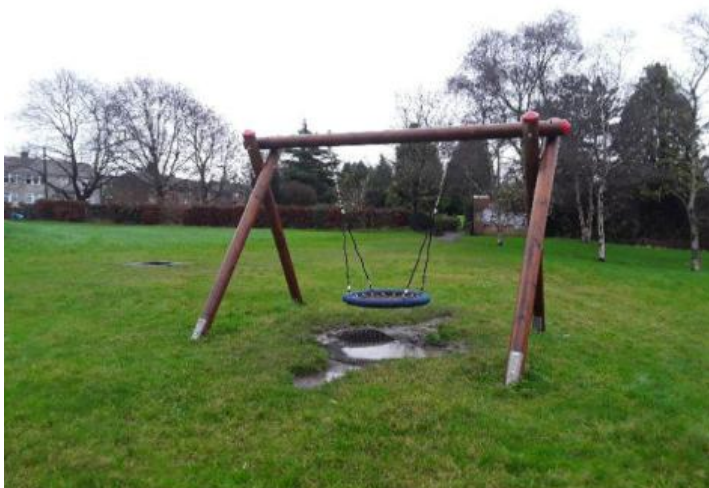
Finding: The surface has subsided in some areas

Action: Monitor for any further deterioration and repair as required

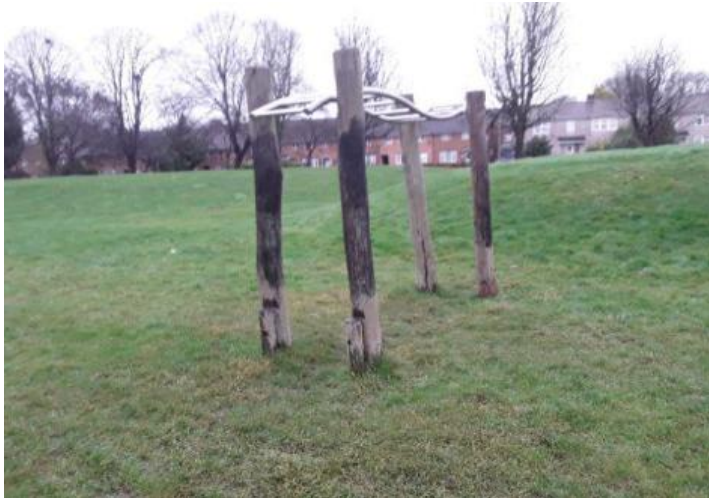
Finding: The timber has a number of splits/shakes or air cracks and this may affect the stability or allow water ingress which will accelerate the rotting process

Action: Monitor to ensure the splits do not cross through fixing points of the structure and/or cause any instability

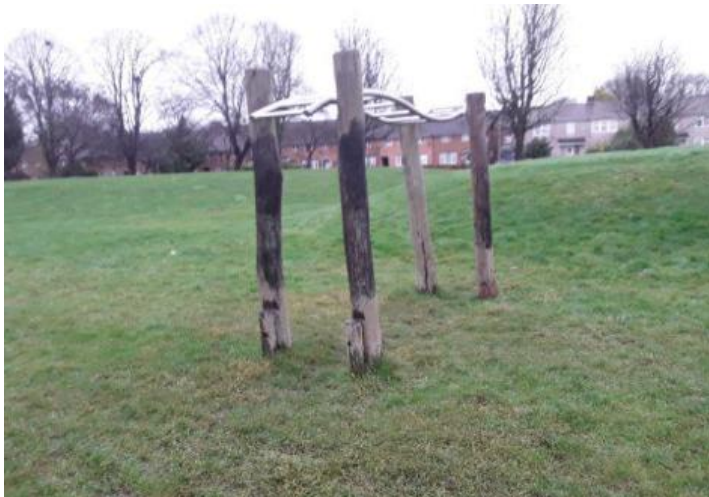
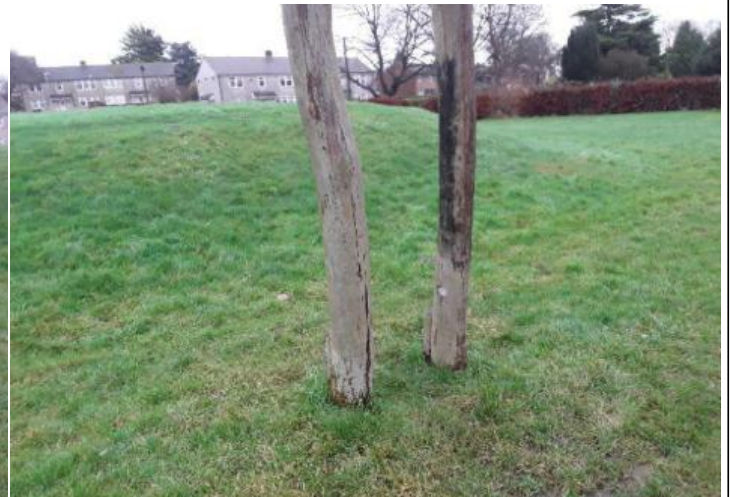
Finding: There is algae or moss on the surface of the equipment

Action: Clean and treat appropriately

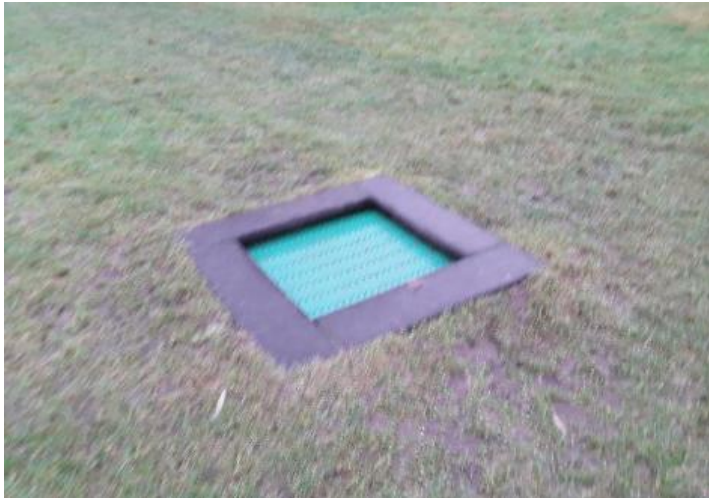
Finding: On site visits it is not possible to test the ground clearance of the Bouncing Facility bed as specified in BS EN 1176; ensure that the clearance between the Bouncing Facility Bed and the ground underneath is in accordance with the manufacturers recommendations (It was not possible recorded the nominal depth at time of inspection due to the design of the bed).

Action: Refer to the manufacturers recommendations

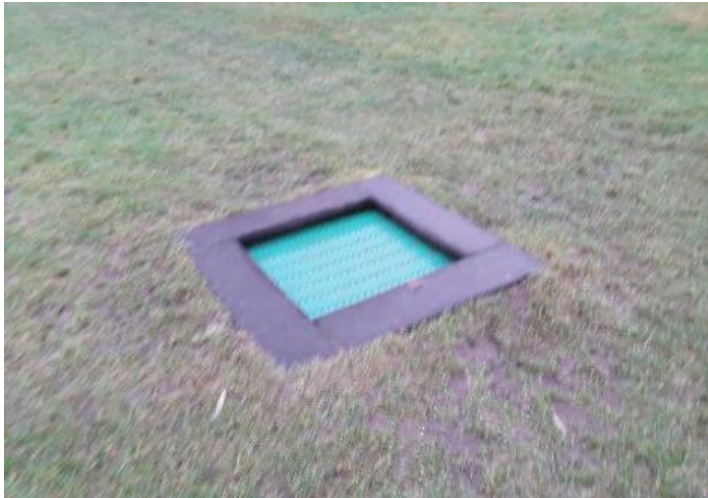
Finding: There are trip hazards at the edges of the surface **Action:** Reinstate surrounding surface levels to remove the trip points

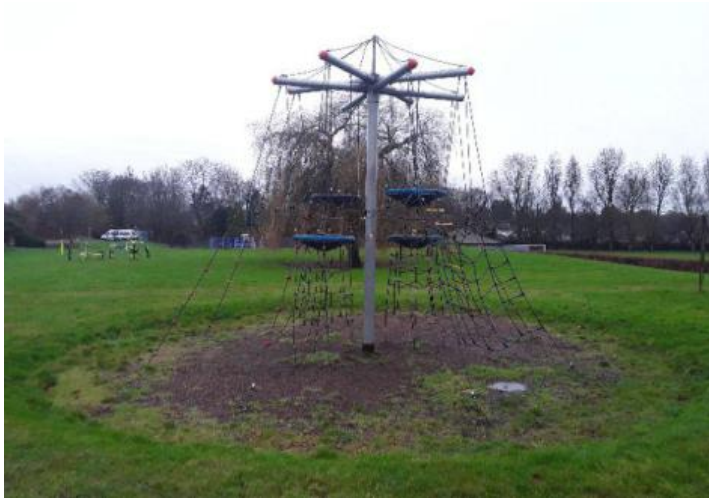
Finding: The fixings or components for this item were in excess of 2.5m above the standing surface and could not be fully accessed by the inspector. We have completed a visual inspection of the fixings from ground level but a maintenance inspection should be undertaken to assess the condition, security and wear of the components at intervals in accordance with the manufacturers recommendations.

Action: Inspect in accordance with the manufacturers recommendations

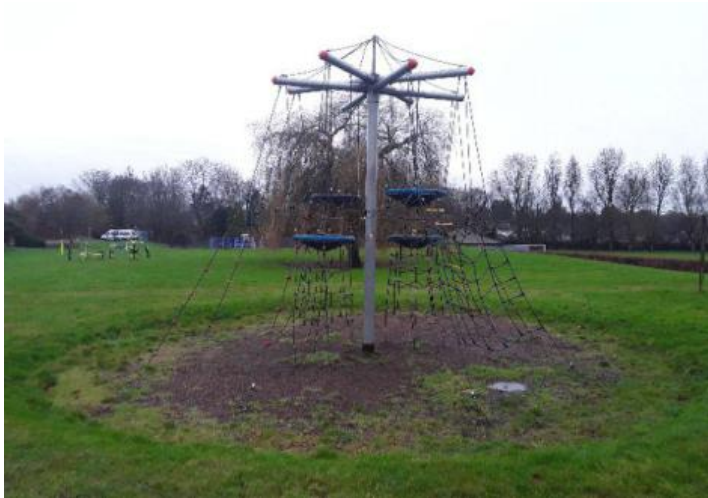
Finding: The depth of the loose fill surfacing is lower than the recommended depth specified in BS EN 1176 for a fall height over 2.0m. A minimum depth of 400mm is recommended (including an extra 100mm to allow for compaction and displacement as per BS EN 1176 Part 1 - Table 4)

Action: Top up loosefill to recommended levels

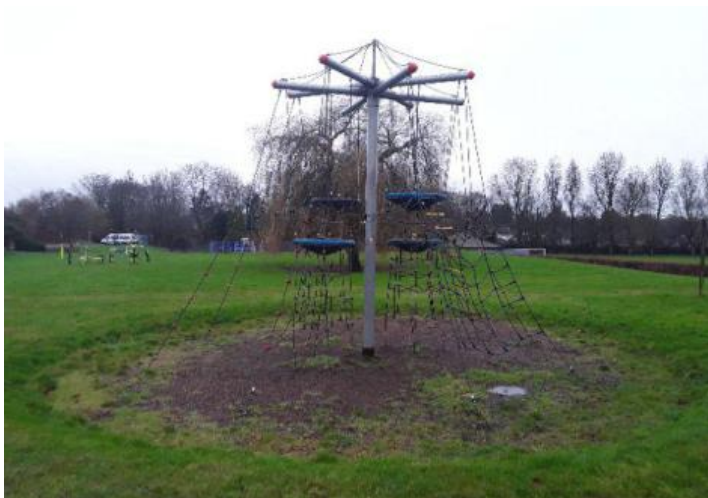
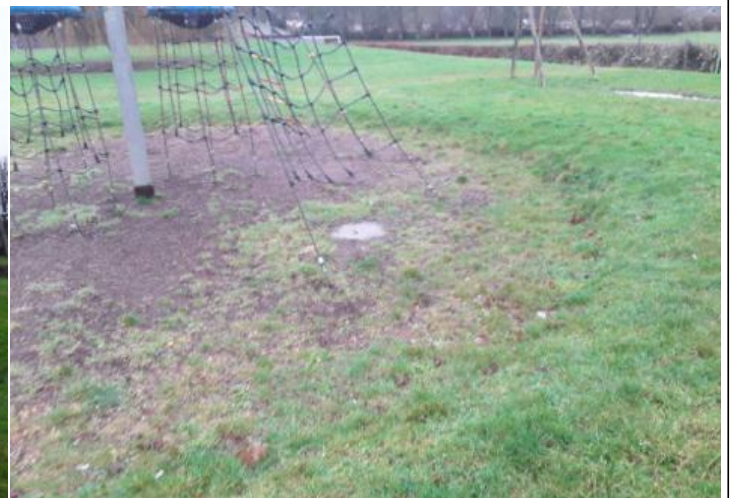
Finding: There is weed / vegetation growth on, between, or around the edges of the surfacing

Action: Remove weed / vegetation growth

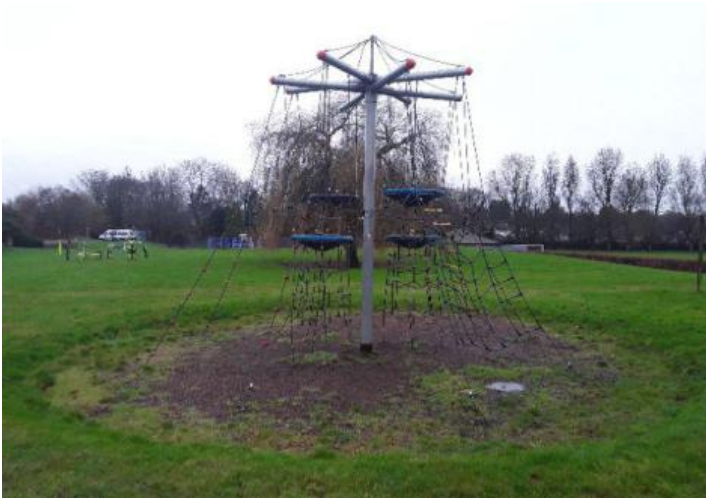
Finding: The ropes/nets are worn/damaged in places

Action: Monitor for any further deterioration and repair or replace as required

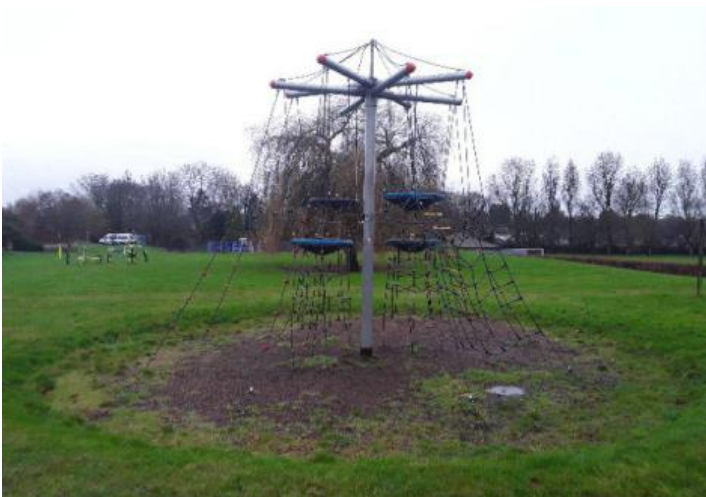
Finding: There is some notable evidence of chain and shackle wear

Action: Monitor for any further deterioration and replace when 40% worn

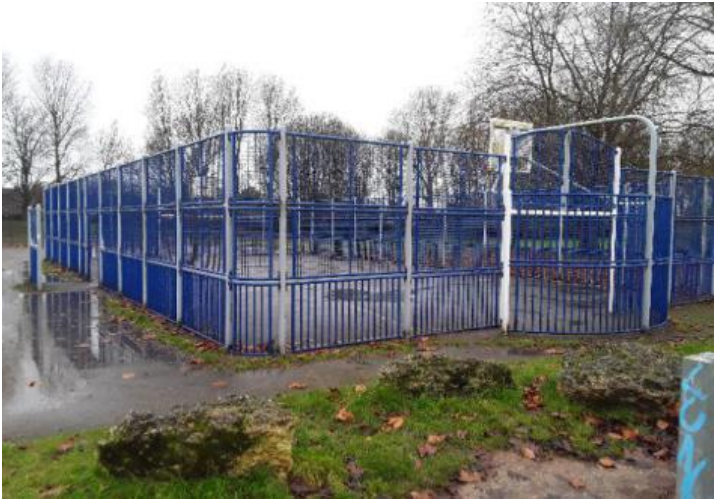
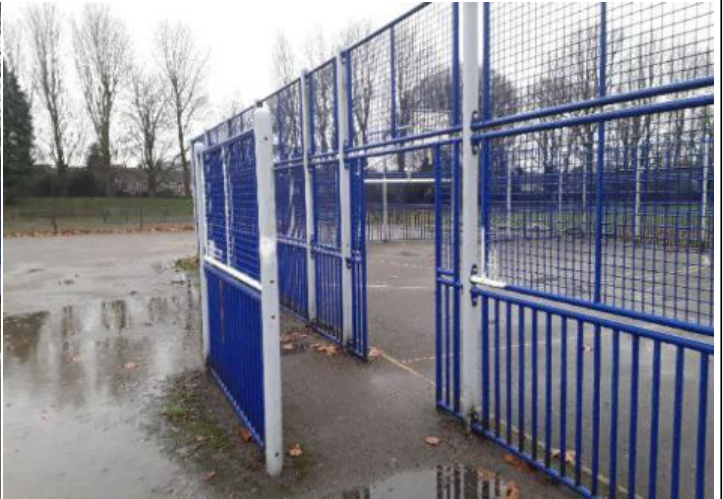
Finding: There is some graffiti present

Action: Remove the graffiti

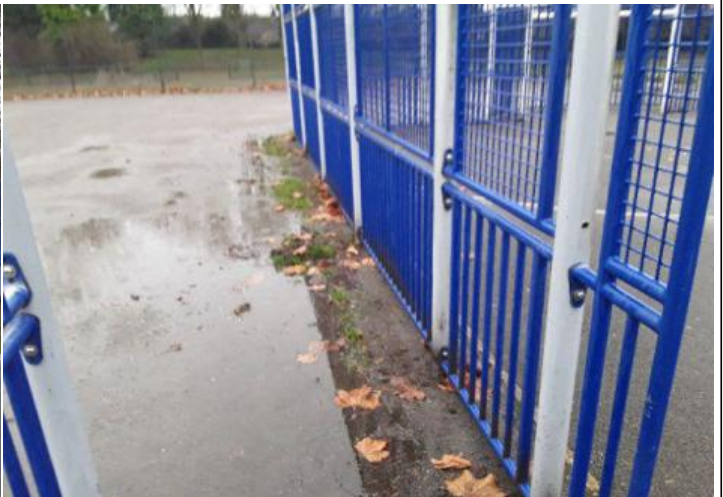
Finding: There is weed / vegetation growth on, between, or around the edges of the surfacing

Action: Remove weed / vegetation growth

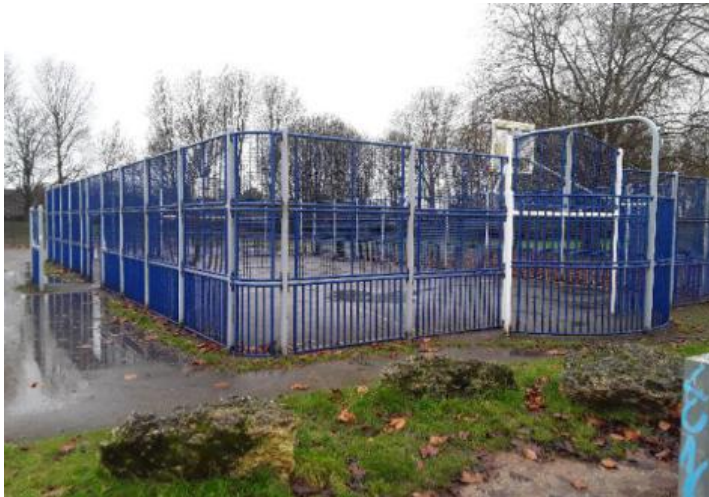
The hoop netting has been severely damaged - Replace

Finding: The hoop netting has been severely damaged
Action: Replace

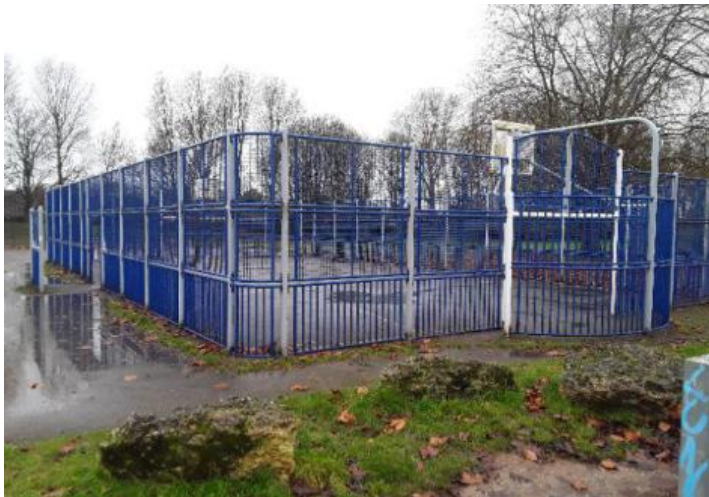
The item fails to meet the requirements of BS EN 15312 4.4.2.1 head and neck entrapment in the frame - Monitor - No remedial work recommended

Finding: The item fails to meet the requirements of BS EN 15312 4.4.2.1 head and neck entrapment in the frame
Action: Monitor - No remedial work recommended

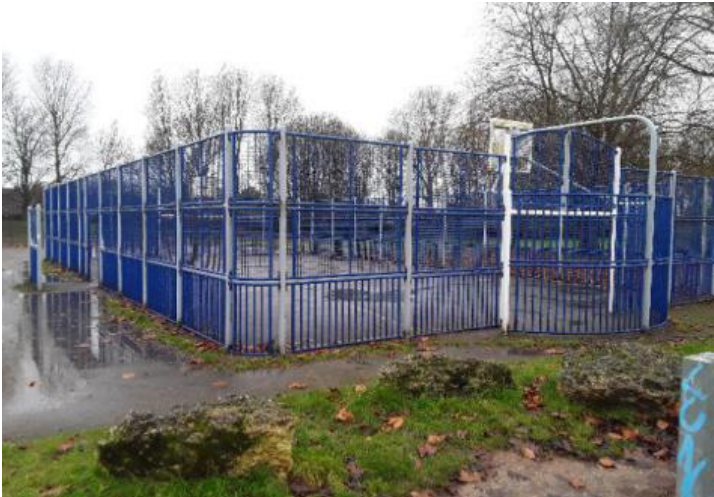
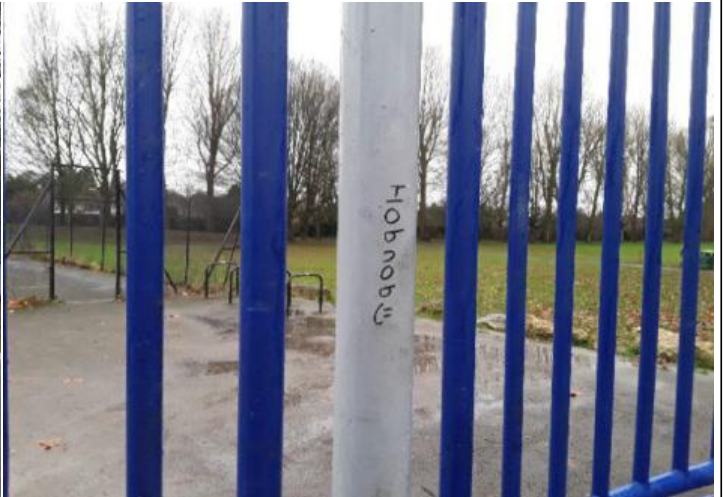
Finding: There is some graffiti present

Action: Remove the graffiti
