# **Beverley Town Council New Town Hall Project Manager**

## **TENDER PACK**

# Condition Report

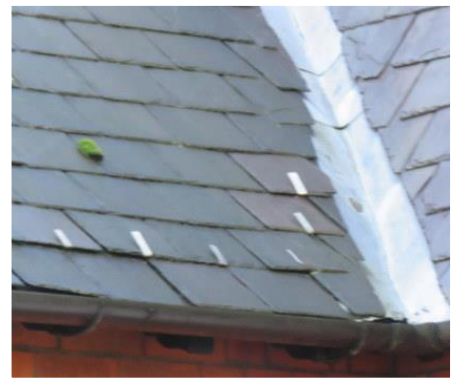
Tingles evident to entrance roof.

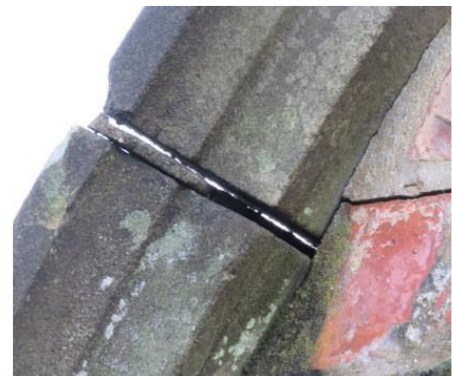
Open joints to gable parapet capping stones.

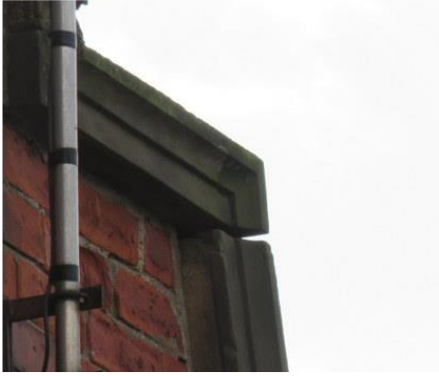
Open joints to gable parapet capping stones.

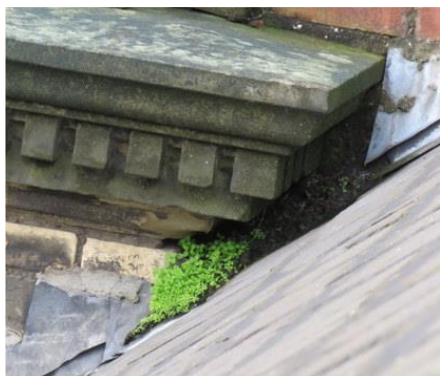
Plant growth in flashings behind gables.

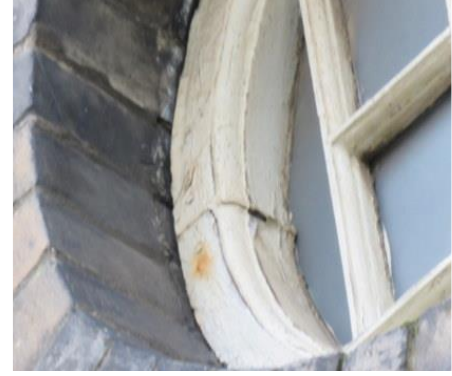
Seal around wooden windows have perished.

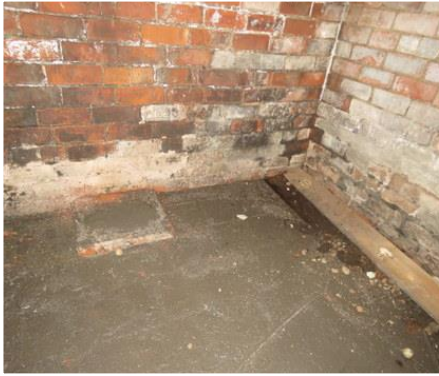
Potential floor detritus in reception room void.

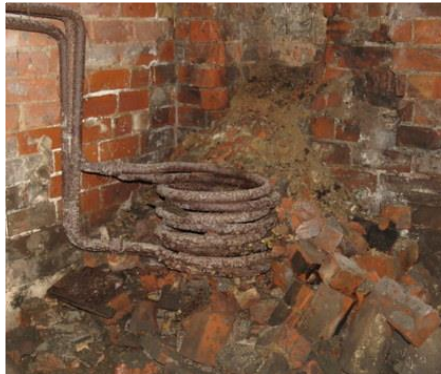
Redundant heating coil to perimeter underfloor heating.

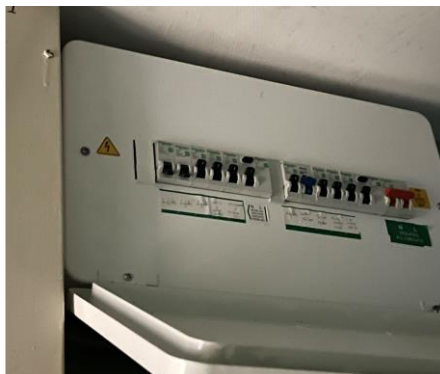
Main electrical board tripped during survey.
