# Asbestos Demolition Survey

Benson The youth Hall  
Oxford Road  
Wallingford  
Oxfordshire  
OX10 6LX

**Job Reference:** J033322

**Survey Type:** Demolition Survey

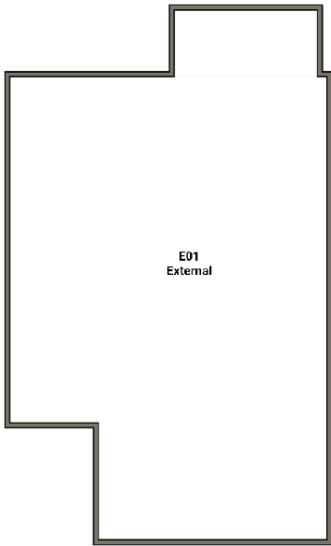
External

Material Description				Material Risk			
Over flat roof – Felt Bitumen Material				Product Type	N/A	Surface Treatment	N/A
				Extent of Damage	N/A	Asbestos Type	N/A
Asbestos Type				Score - Material Risk			
No Asbestos Detected				N/A		N/A	
Additional Information				Accessibility			
N/A				N/A			
Recommendations				Review Date			
No further action required				N/A
