Annual Inspection

Surrey Heath Borough Council

School Lane Field

School Lane, Bagshot, GU19 5BP

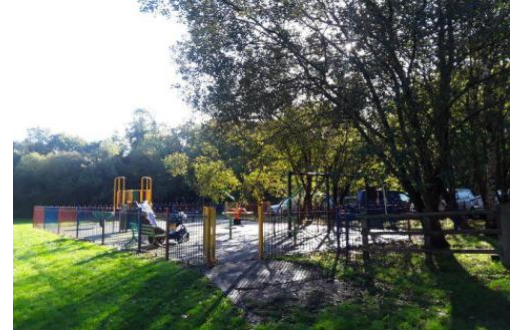
Item: Site General
Manufacturer: Owner/Operator
Surface Type: N/A
Item Quantity: 1
Equipment Compliance: N/A
Surface Area Compliance: N/A

There is some tree debris on the surfacing - Remove and maintain

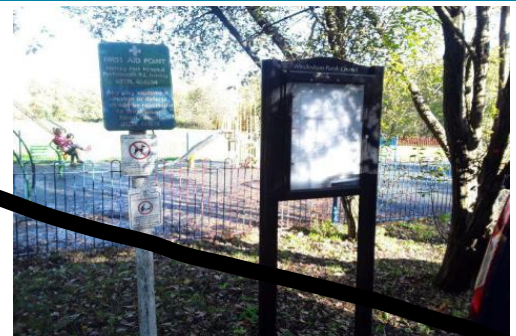
Item: Sign
Manufacturer: Owner/Operator
Surface Type: Grass
Item Quantity: 1
Equipment Compliance: N/A
Surface Area Compliance: N/A

BS EN 1176 Part 7 recommends that signage shall include the site name / address - Provide additional information

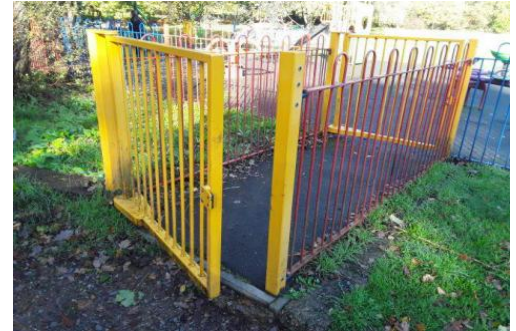
Item: Gate - Self Closing
Manufacturer: I.A.E. Fencing
Surface Type: Bitmac
Item Quantity: 3
Equipment Compliance: N/A
Surface Area Compliance: N/A

The area under the gate has eroded leaving uneven areas, or the concrete foundations exposed, resulting in trip hazards at the entrance/exit to the playground - Reinststate to level with surrounding surfaces

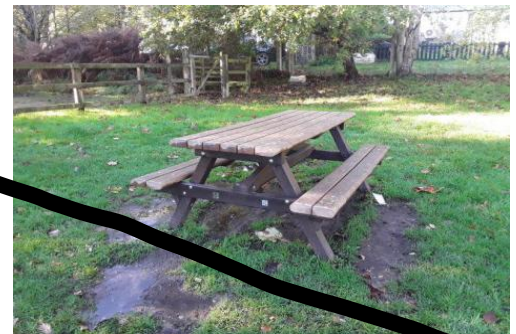
Item: Picnic Table
Manufacturer: Not Identified
Surface Type: Grass
Item Quantity: 1
Equipment Compliance: N/A
Surface Area Compliance: N/A

The area around the item has eroded and may become slippery - Reinstate eroded area

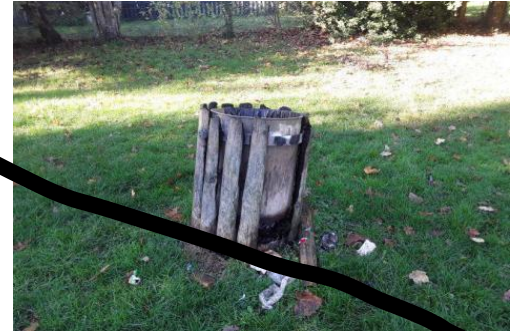
Item: Litter Bin
Manufacturer: Not Identified
Surface Type: Grass
Item Quantity: 1
Equipment Compliance: N/A
Surface Area Compliance: N/A

There is some evidence of fire damage to the item - Replace

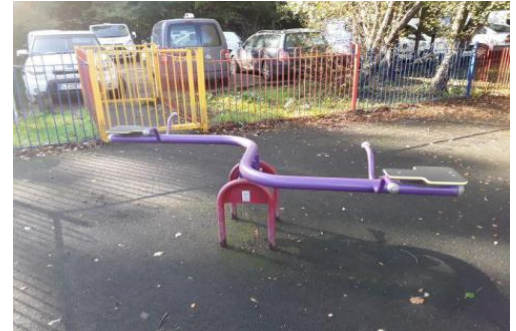
Item: See Saw
Manufacturer: Wicksteed Playgrounds
Surface Type: Wet Pour
Item Quantity: 1
Equipment Compliance: Yes
Surface Area Compliance: Yes

There is some minor damage to the surface - Monitor for any further deterioration and repair as required

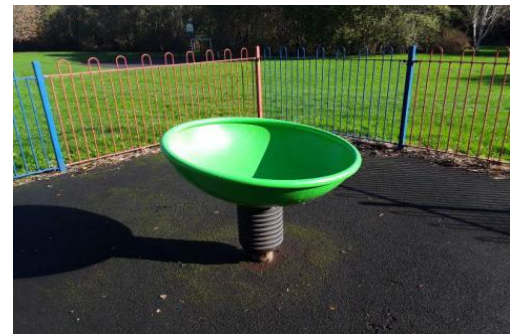
Item: Spinner Bowl
Manufacturer: Wicksteed Playgrounds
Surface Type: Wet Pour
Item Quantity: 1
Equipment Compliance: Yes
Surface Area Compliance: Yes

There is some minor damage to the surface - Monitor for any further deterioration and repair as required

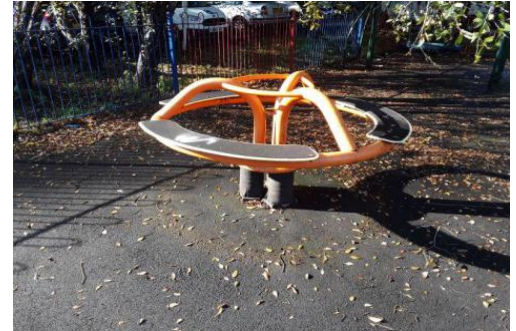
Item: Misc Springer
Manufacturer: Wicksteed Playgrounds
Surface Type: Wet Pour
Item Quantity: 1
Equipment Compliance: Yes
Surface Area Compliance: Yes

The tree canopy overhangs the equipment and is less than 2.0m away - Lift tree canopy to ensure a minimum clearance of 2.0m from the equipment

There is some damage to the spring gaiters - Monitor for any further deterioration and replace as required

There is/are bolt cap covers missing or damaged on the item - Replace missing or damaged bolt cap covers

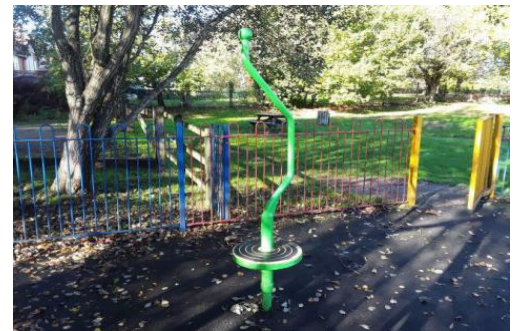
Item: Spinning Pole
Manufacturer: Wicksteed Playgrounds
Surface Type: Wet Pour
Item Quantity: 1
Equipment Compliance: No
Surface Area Compliance: No

The bearing is showing signs of wear - Monitor for any further deterioration and replace as required

The fencing forms a hard object within the falling space of the equipment and there is also insufficient surfacing provided in contravention of BS EN 1176 Part 1 - Monitor - no remedial work recommended

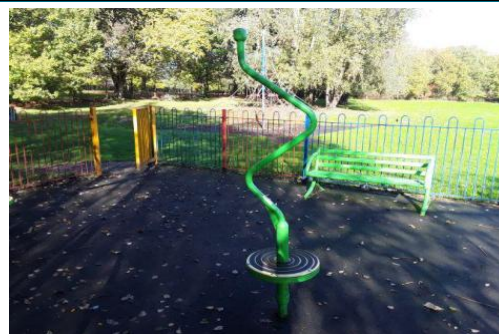
Item: Spinning Pole
Manufacturer: Wicksteed Playgrounds
Surface Type: Wet Pour
Item Quantity: 1
Equipment Compliance: No
Surface Area Compliance: Yes

There is some minor damage to the surface - Monitor for any further deterioration and repair as required

The swing frame forms a hard object within the falling space of the equipment in contravention of the requirements of BS EN 1176 Part 1 - Monitor - No remedial work recommended

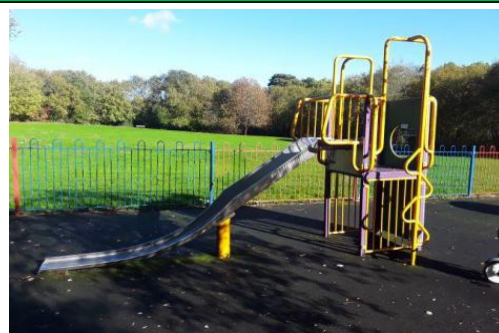
Item: Multi Play (Junior)
Manufacturer: Wicksteed Playgrounds
Surface Type: Wet Pour
Item Quantity: 1
Equipment Compliance: Yes
Surface Area Compliance: Yes

A number of fixing(s) have worked loose - Secure all loose fixings

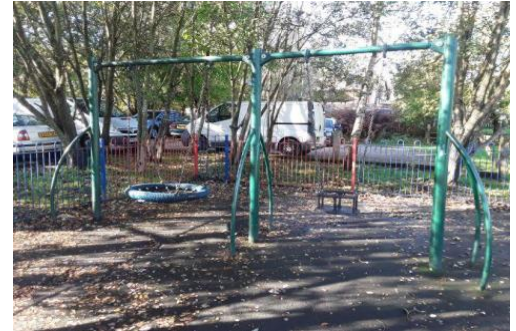
Item: 2 Bay Swing
Manufacturer: Wicksteed Playgrounds
Surface Type: Wet Pour
Item Quantity: 1
Equipment Compliance: No
Surface Area Compliance: Yes

There is moderate damage to the surface - Repair the damaged areas of surfacing

There is some notable evidence of chain wear - Monitor for any further deterioration and replace when 40% worn

There is some evidence of fire damage to the item - Monitor for any further deterioration and repair as required

The chain openings are in excess of the 8.6mm as recommended by BS EN 1176 - Monitor - No remedial work recommended

BS EN 1176 Part 2: Annex A makes a recommendation that fences or enclosures should be upto 1.50m from the edges of the swing seat to the sides, and subject to risk assessment, from the edge of the impact area. This is however, a low risk finding and no remedial action is recommended. - Monitor - No remedial work recommended

There is some wear to the shackles. - Monitor for any further deterioration and replace when 40% worn

The seat bushes are showing signs of wear - Monitor for any further deterioration and replace as required

The seats are too close to the frame as defined in BS EN 1176 Part 2; this is a low risk failure and no remedial action is required - Monitor - No remedial work recommended

BS EN 1176 requires an additional 0.5m of unobstructed space at each end of the swing surfacing area. This is a relatively low risk finding and no remedial action is recommended at this point. - Monitor - No remedial work recommended

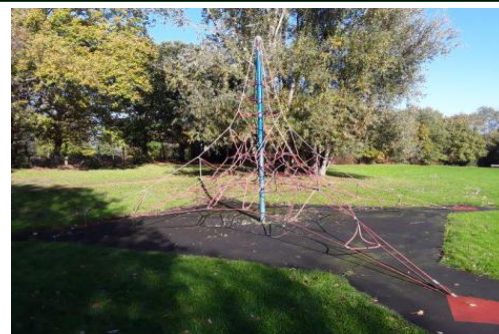
Item: Space Net
Manufacturer: Wicksteed Playgrounds
Surface Type: Wet Pour
Item Quantity: 1
Equipment Compliance: Yes
Surface Area Compliance: Yes

There is some tree debris on the surfacing - Remove and maintain

There is algae, silt or moss growth on the surface resulting in slippery conditions - Clean and treat appropriately

The paintwork on this item has been damaged or worn exposing the metal underneath which is rusting - Treat any rusting components and repaint

The post is slightly loose in the ground - Monitor for any further deterioration and repair as required

There is moderate damage to the surface - Repair the damaged areas of surfacing

There are gaps opening between the surfacing and the edging surround or between the joints in the surfacing - Monitor for any further deterioration and repair as required

The ropes/nets are worn/damaged in places - Monitor for any further deterioration and repair or replace as required

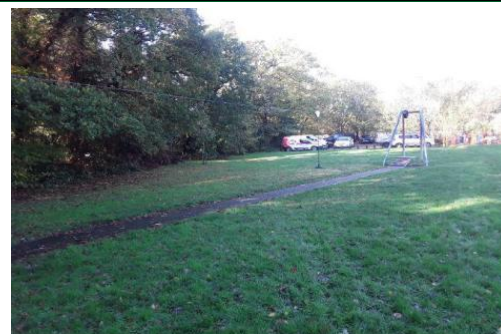
Item: Cable Runway
Manufacturer: Wicksteed Playgrounds
Surface Type: Wet Pour
Item Quantity: 1
Equipment Compliance: Yes
Surface Area Compliance: Yes

We have completed a visual inspection of the suspension links, cable and fixing points from ground level, however it is not possible to fully inspect these areas without either hiring equipment to gain access or removing the cable and suspension and inspecting at ground level. We recommend that the main cable and fixing security is thoroughly inspected at least in accordance with the manufacturers recommendations to check for wear, damage, security or internal rusting; this will help to ensure the continued safe use of the equipment - Inspect in accordance with the manufacturers recommendations

The nylon inserts are worn or missing at the point the cable enters the traveller - Replace worn or missing inserts as required

The cableway seat has been damaged - Monitor for any further deterioration and replace as required

There are significant gaps (over 30mm) between the surface and the edging or between the joints in the surface; these are large enough for a small foot to enter - Repair surfacing

There is some notable evidence of chain wear - Monitor for any further deterioration and replace when 40% worn

There is some wear to the chain bars - Monitor for any further deterioration and replace when 40% worn

There is some evidence of rot in the ramp treads - Monitor for any further deterioration and replace as required

There is moderate damage to the surface - Repair the damaged areas of surfacing

There are trip hazards at the edges of the surface - Reinstate surrounding surface levels to remove the trip points

There is some wear to the shackles. - Monitor for any further deterioration and replace when 40% worn

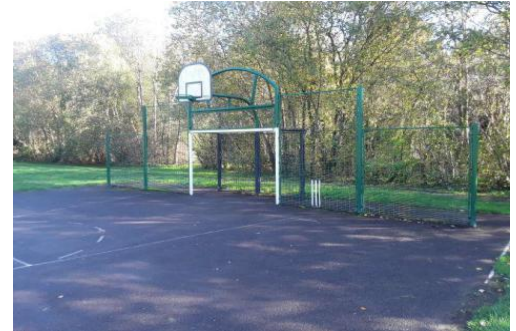
Item: Goal End
Manufacturer: Bigfoot Play Systems
Surface Type: Bitmac
Item Quantity: 1
Equipment Compliance: No
Surface Area Compliance: N/A

A clearly visible facility sign should be provided in a prominent position with the wording as detailed BS EN 15312- the equipment is not intended for children less than 3 years old- the warning - Do not climb on the framework or nets- the warning - Do not hang on the ring (if provided)- the warning - Do not wear rings or other jewellery- name and telephone number of the administrator- number to call in case of accident - Provide signage to BS EN 15312

There is/are bolt cap covers missing or damaged on the item - Replace missing or damaged bolt cap covers

There is/are finger entrapments in the framework and the item fails to meet the requirements of BS EN 15312 Clause 4.4.2.2 Entrapment of fingers - Monitor - No remedial work recommended

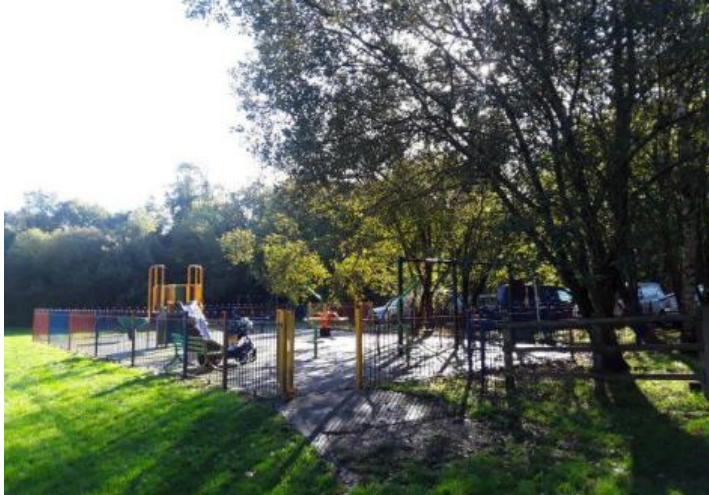
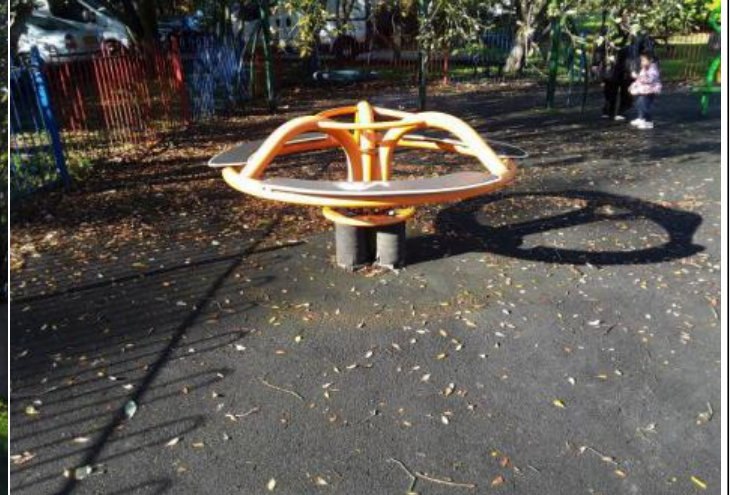
Item: Ancillary Items - Site General
Manufacturer: Owner/Operator

Finding: There is some tree debris on the surfacing

Action: Remove and maintain

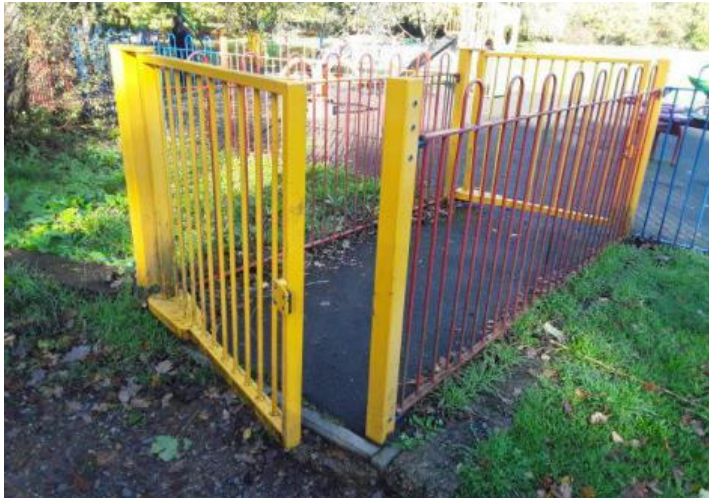
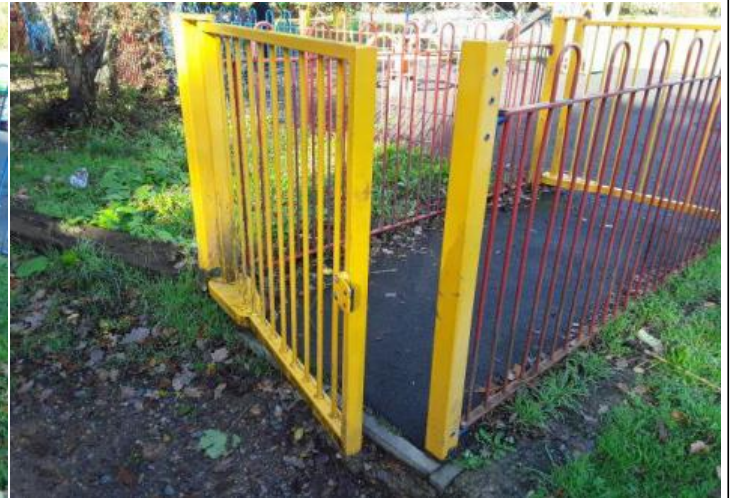
Item: Gates - Gate - Self Closing
Manufacturer: I.A.E. Fencing

Finding: The gate is not operating correctly

Action: Take effective action to ensure the gate closes between 4 and 8 seconds

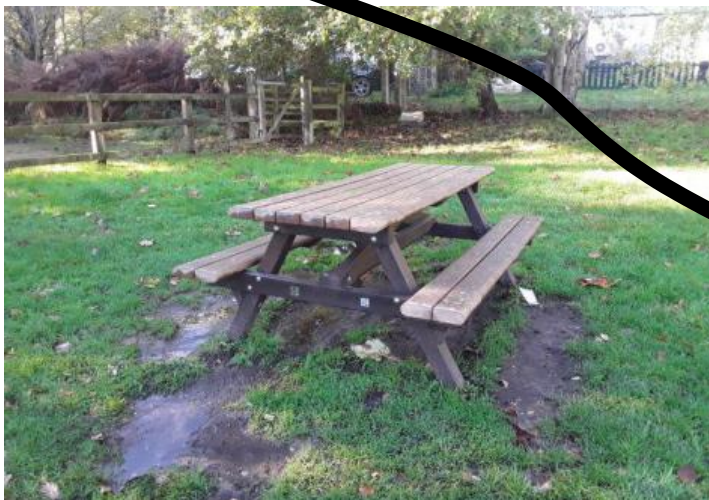
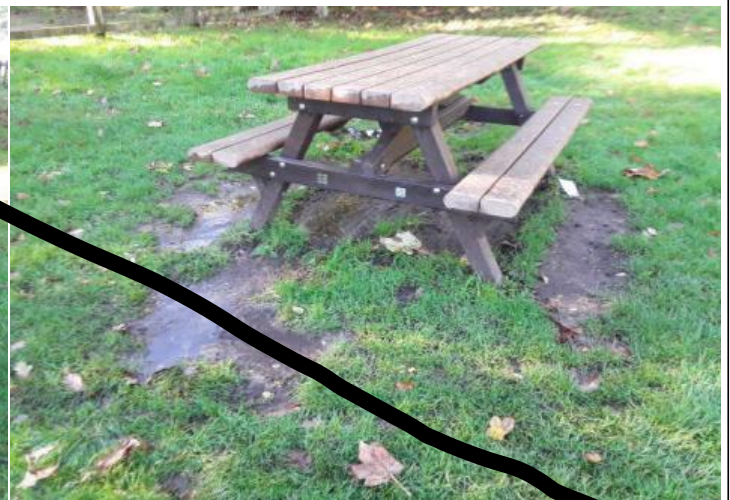
Item: Ancillary Items - Picnic Table
Manufacturer: Not Identified

Finding: The area around the item has eroded and may become slippery

Action: Reinstate eroded area

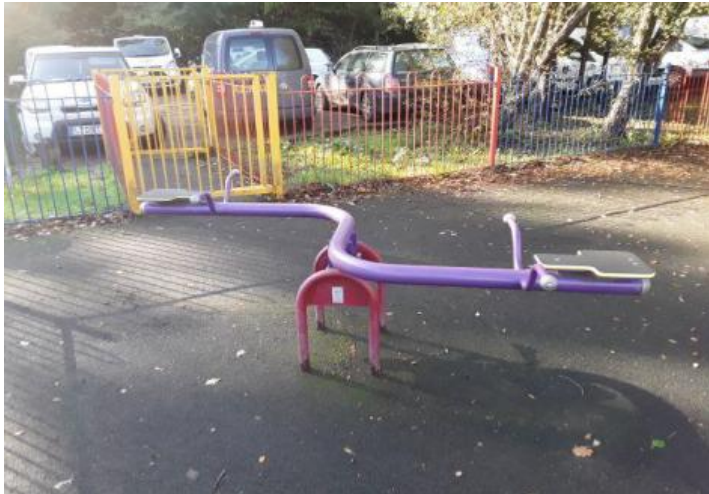
Item: Rocking Equipment - See Saw
Manufacturer: Wicksteed Playgrounds

Finding: There is some minor damage to the surface **Action:** Monitor for any further deterioration and repair as required

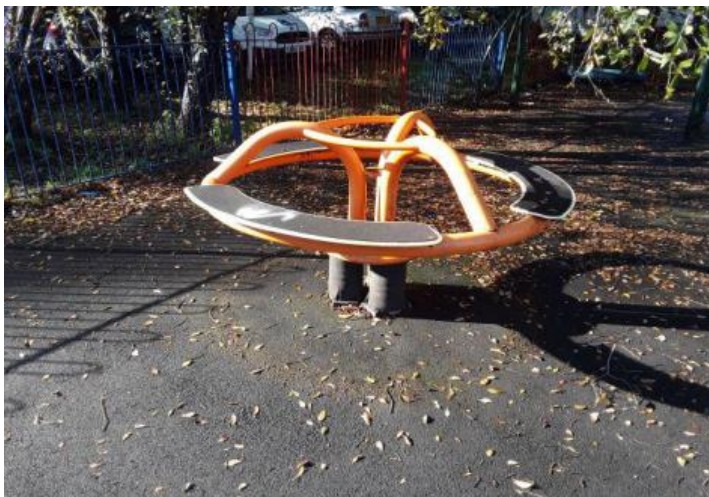
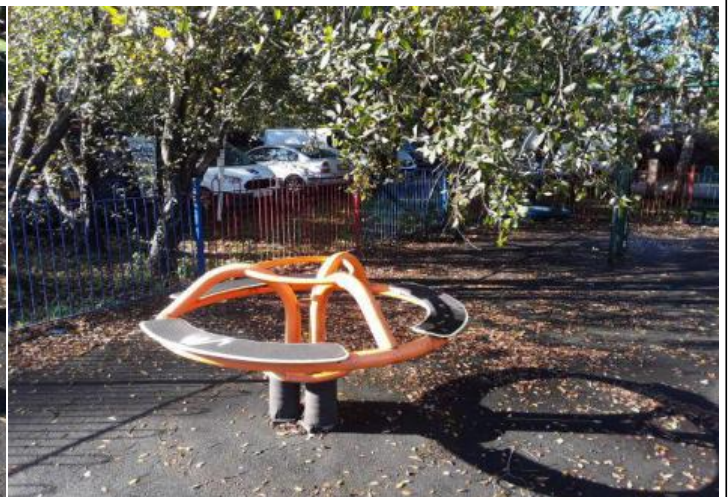
Item: Rocking Equipment - Misc Springer
Manufacturer: Wicksteed Playgrounds

Finding: The tree canopy overhangs the equipment and is less than 2.0m away

Action: Lift tree canopy to ensure a minimum clearance of 2.0m from the equipment

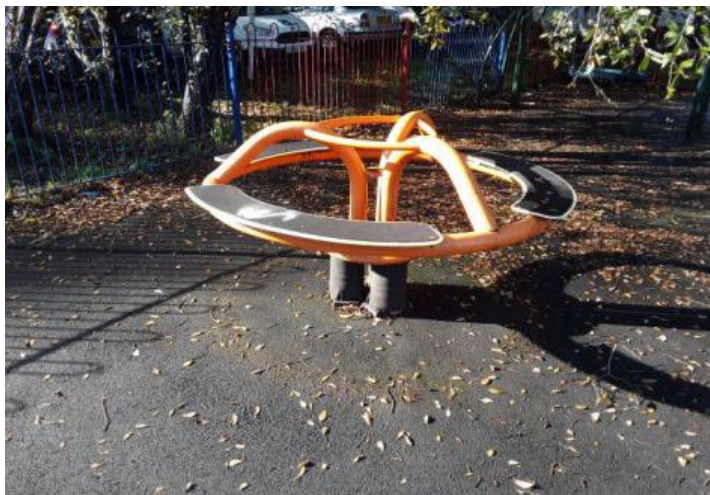
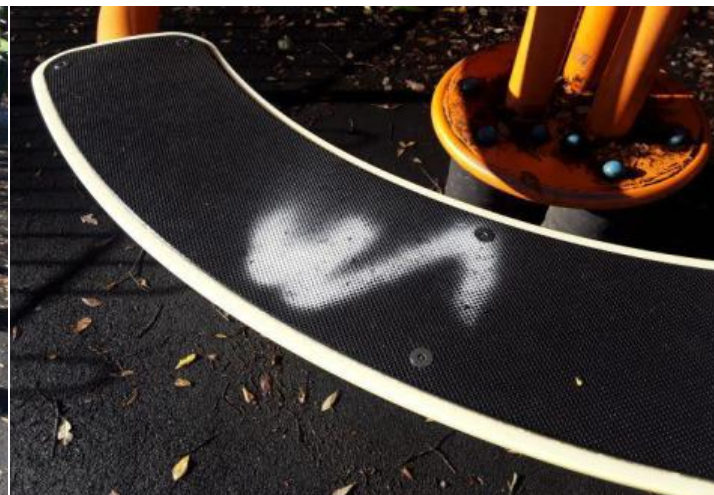
Item: Rocking Equipment - Misc Springer
Manufacturer: Wicksteed Playgrounds

Finding: There is some graffiti present

Action: Remove the graffiti

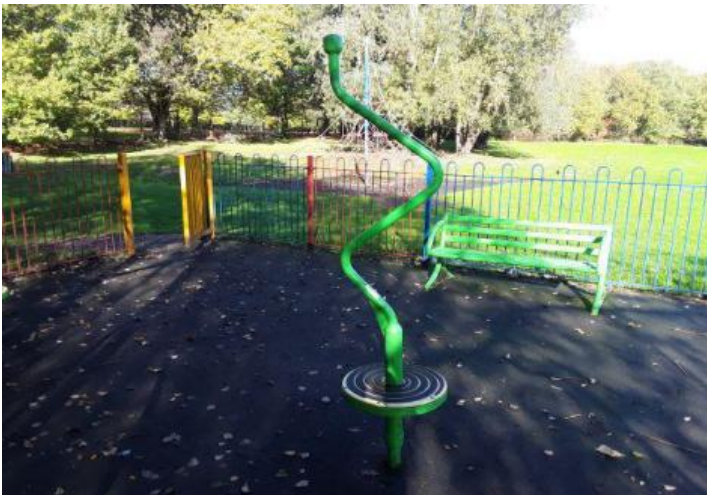
Item: Rotor Play - Spinning Pole
Manufacturer: Wicksteed Playgrounds

Finding: There is some minor damage to the surface

Action: Monitor for any further deterioration and repair as required

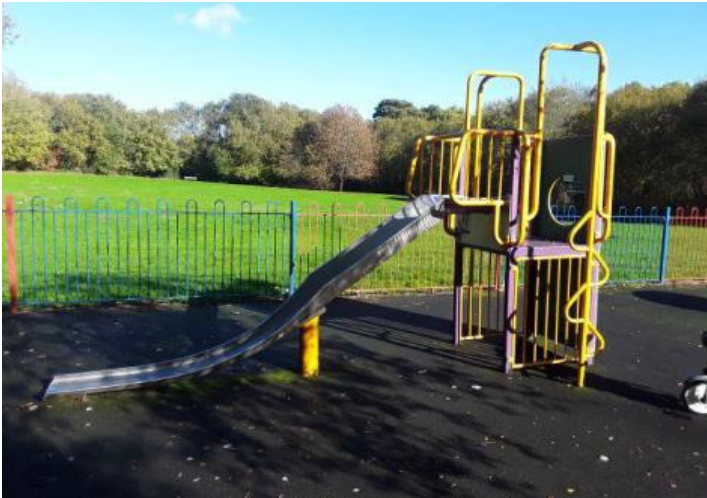
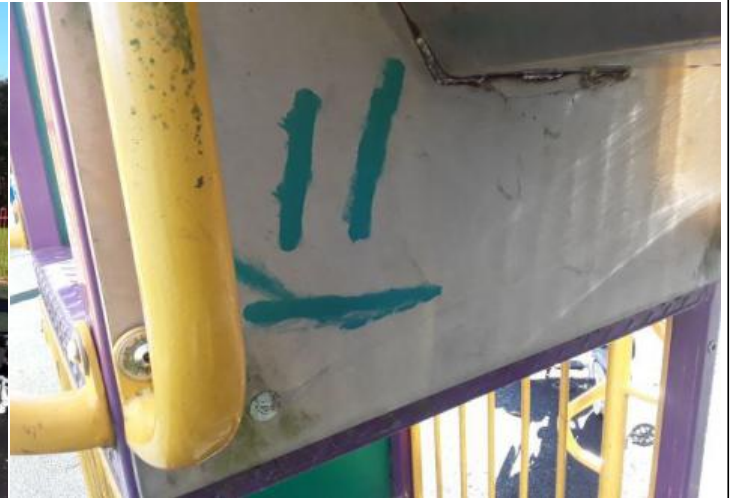
Item: Activity Equipment - Multi Play (Junior)
Manufacturer: Wicksteed Playgrounds

Finding: There is some graffiti present

Action: Remove the graffiti

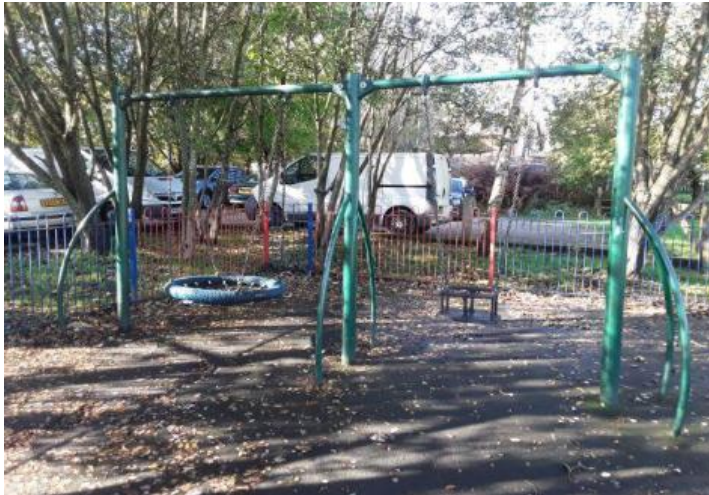
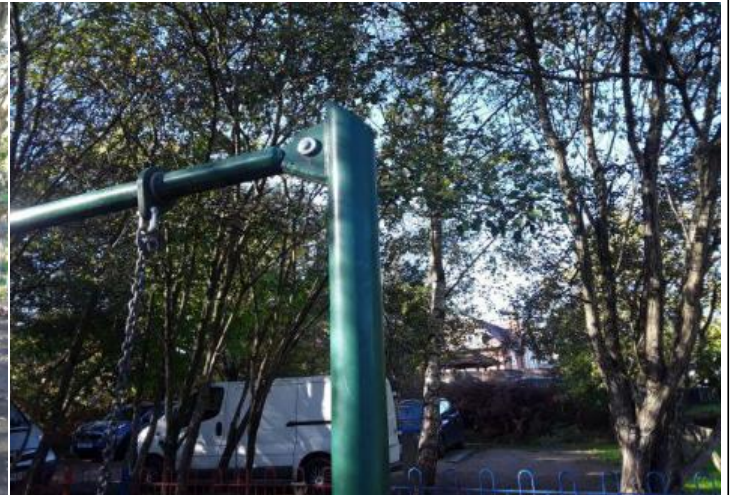
Item: Swings - 2 Bay Swing
Manufacturer: Wicksteed Playgrounds

Finding: The tree canopy overhangs the equipment and is less than 2.0m away

Action: Lift tree canopy to ensure a minimum clearance of 2.0m from the equipment

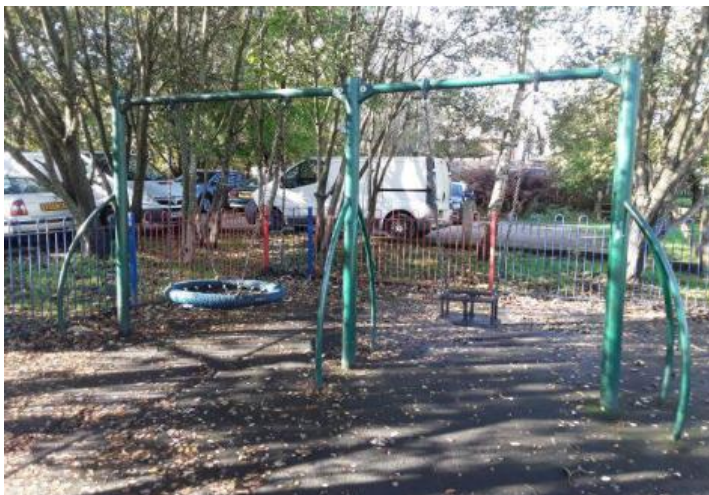
Item: Swings - 2 Bay Swing
Manufacturer: Wicksteed Playgrounds

Finding: There is some notable evidence of chain wear

Action: Monitor for any further deterioration and replace when 40% worn

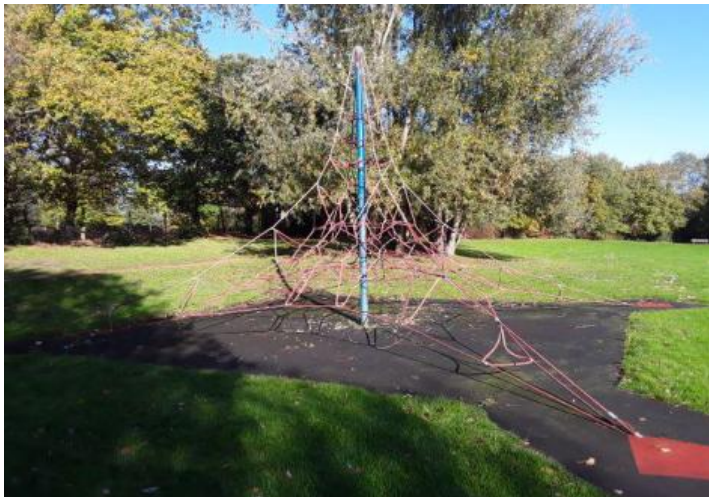
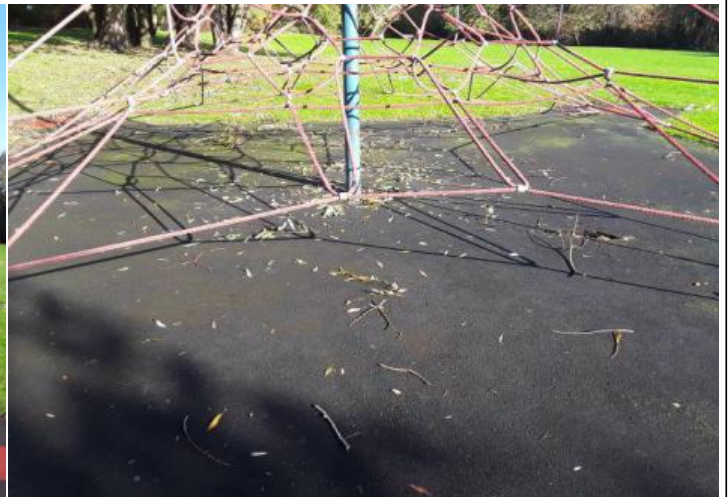
Item: Activity Equipment - Space Net
Manufacturer: Wicksteed Playgrounds

Finding: There is some tree debris on the surfacing

Action: Remove and maintain

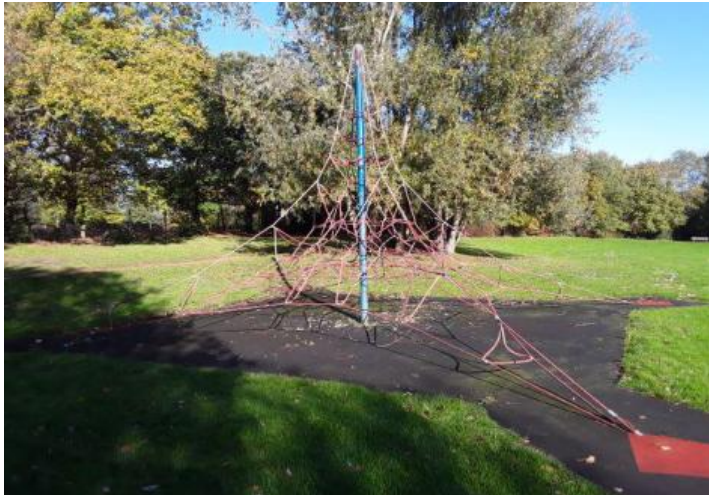
Item: Activity Equipment - Space Net
Manufacturer: Wicksteed Playgrounds

Finding: There is moderate damage to the surface

Action: Repair the damaged areas of surfacing

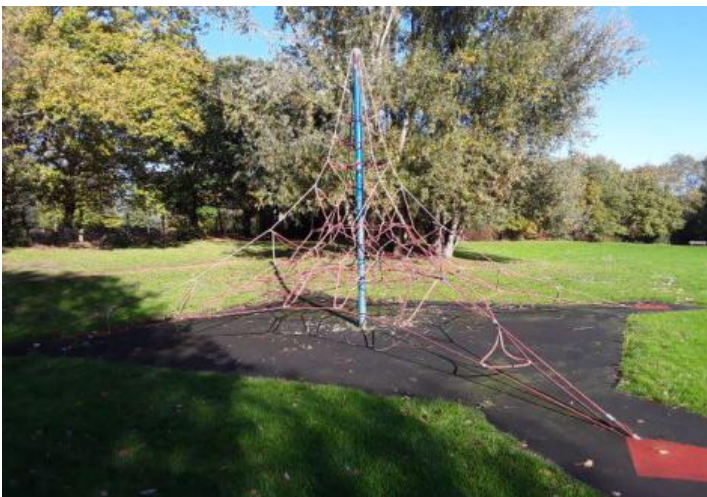
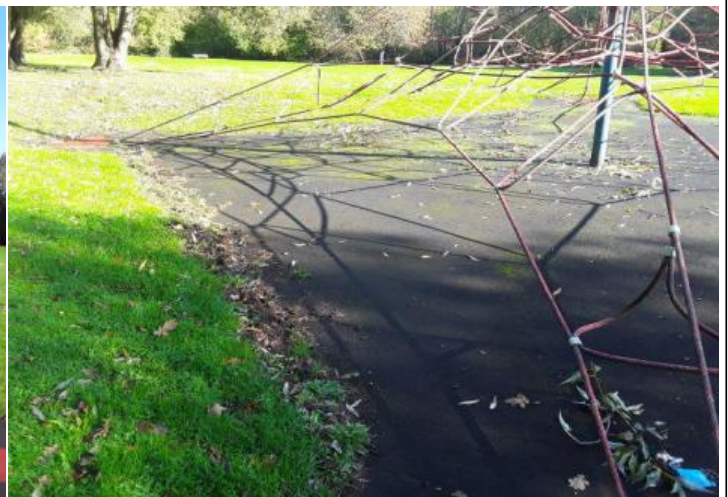
Item: Activity Equipment - Space Net
Manufacturer: Wicksteed Playgrounds

Finding: There is weed / vegetation growth on, between, or around the edges of the surfacing **Action:** Remove weed / vegetation growth

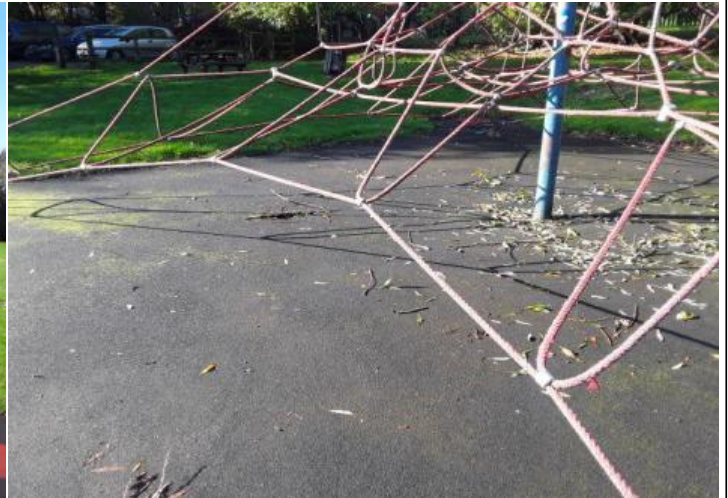
i 8 - Low Risk (Finding 6)

Item: Activity Equipment - Space Net
Manufacturer: Wicksteed Playgrounds

Finding: The connecting or tensioning ropes on the net are not tensioned correctly

Action: Tighten tensioners equally to provide stability to the net structure

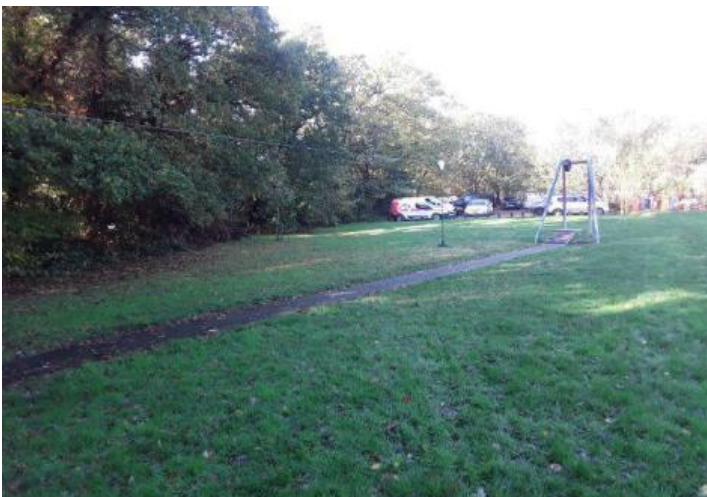
Item: Other - Cable Runway
Manufacturer: Wicksteed Playgrounds

Finding: The cableway seat has been damaged

Action: Monitor for any further deterioration and replace as required

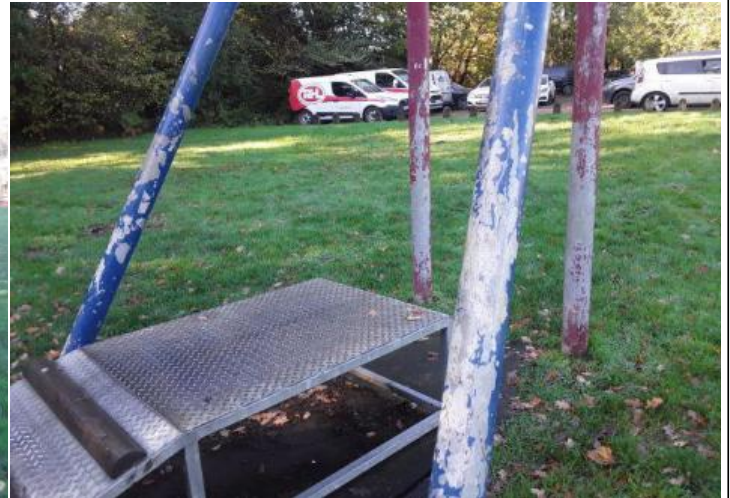
Item: Other - Cable Runway
Manufacturer: Wicksteed Playgrounds

Finding: The paint is flaking off the metalwork

Action: Rub down and re-paint

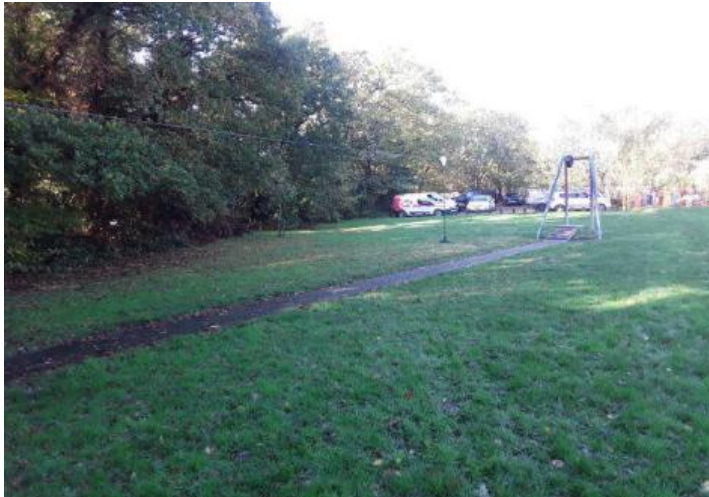
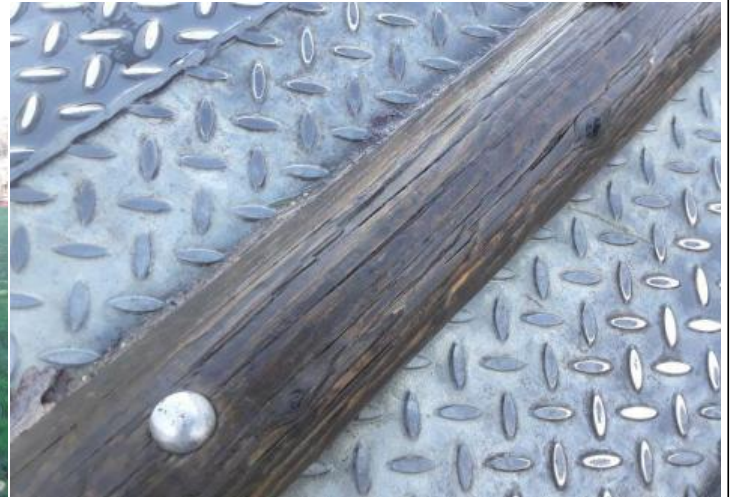
Item: Other - Cable Runway
Manufacturer: Wicksteed Playgrounds

Finding: Parts of the timber are rough or splintered

Action: Remove all rough or sharp edges

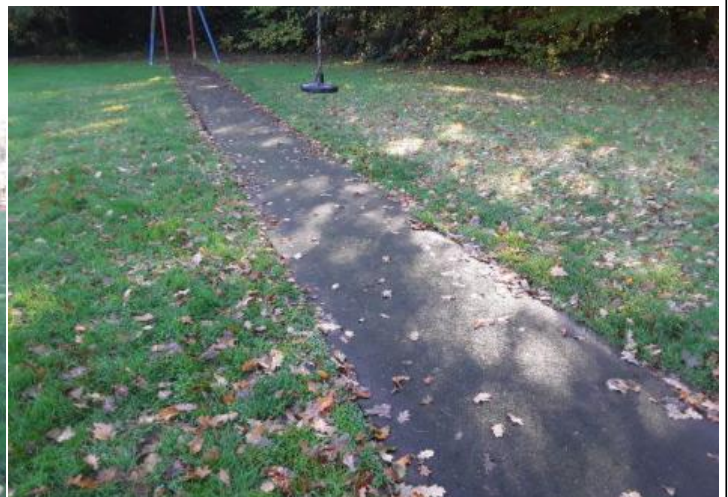
Item: Other - Cable Runway
Manufacturer: Wicksteed Playgrounds

Finding: There is some tree debris on the surfacing

Action: Remove and maintain

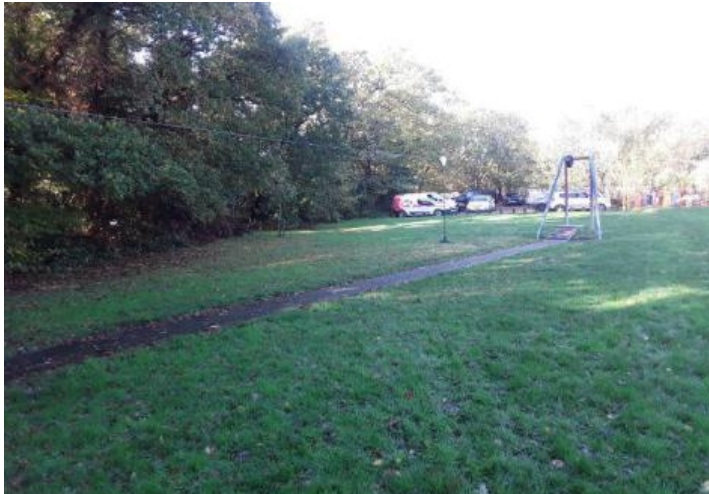
Item: Other - Cable Runway
Manufacturer: Wicksteed Playgrounds

Finding: There are significant gaps (over 30mm) between the surface and the edging or between the joints in the surface; these are large enough for a small foot to enter

Action: Repair surfacing

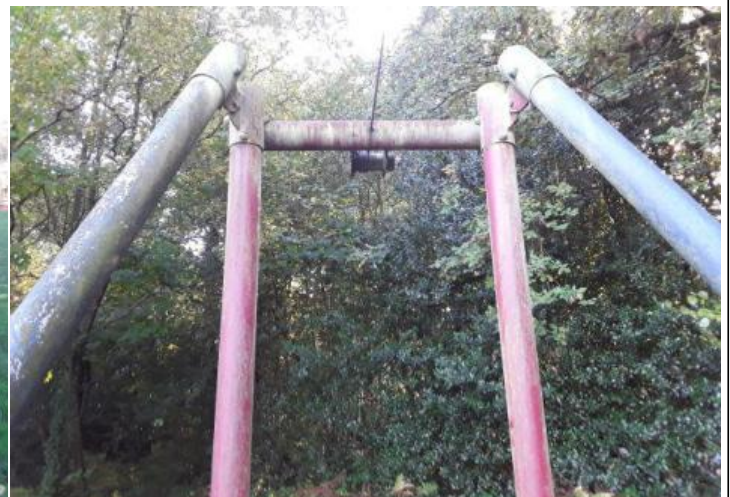
i 6 - Low Risk (Finding 14)

Item: Other - Cable Runway
Manufacturer: Wicksteed Playgrounds

Finding: There is algae or moss on the surface of the equipment
Action: Clean and treat appropriately
