23 April 2010
IG09/309/JH/le

J P Chick & Partners Limited
Consulting Civil & Structural Engineers

STRUCTURAL INVESTIGATION REPORT

**ST PETERS CHURCH
THETFORD**

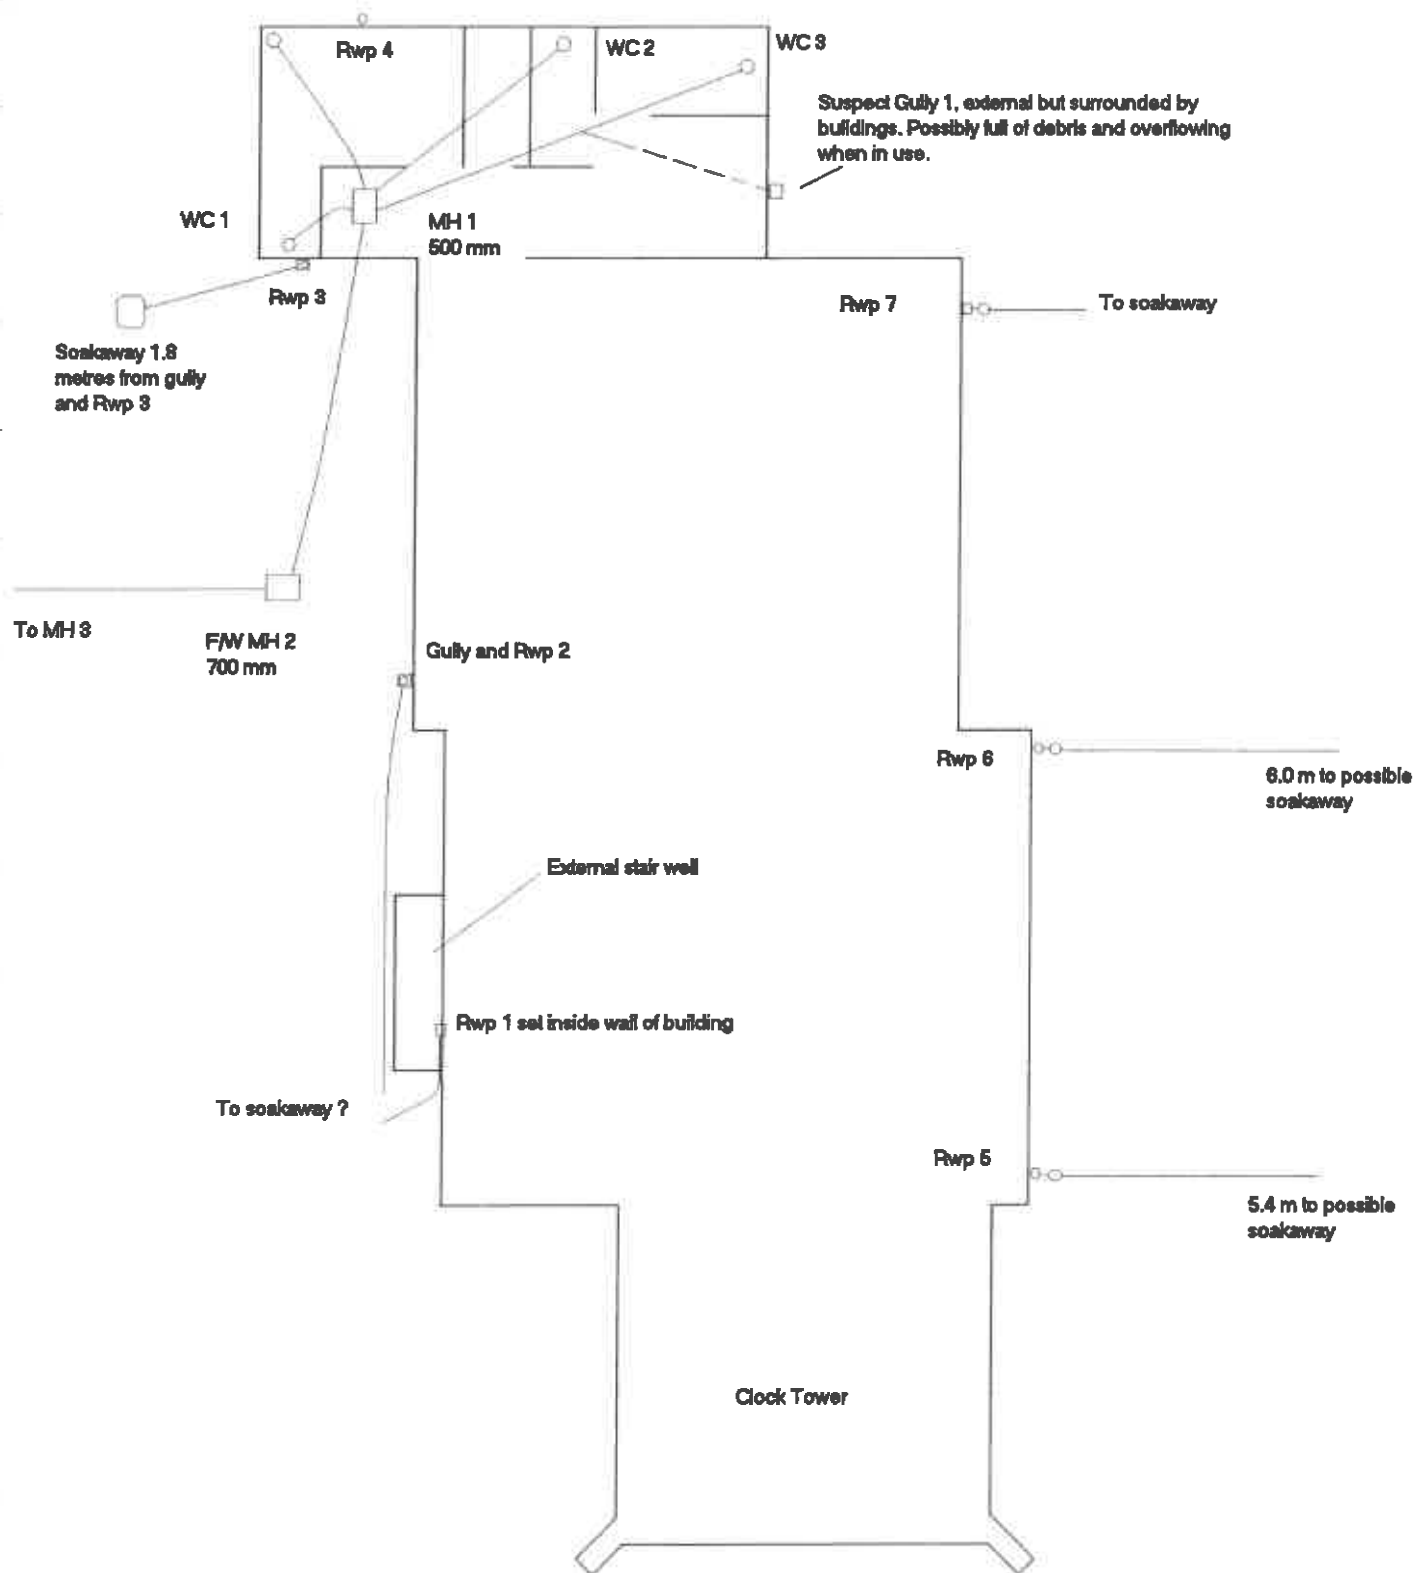
Chainage Metres	OBSERVATIONS
	<u>SVP DOWNSTREAM (100mm dia. salt glazed) via access point on the side of stack.</u>
0.6	Pipework bends to the horizontal. Broken vent cowl laying in pipework.
2.6	Internal manhole chamber under floor covering.
	<u>MH 1 UPSTREAM TO W.C. 1 (100mm dia. salt glazed)</u>
0.1	Pipework bends to the left.
0.5	Pipework bends upwards.
0.7	Connection to W.C. 1.
	<u>MH 1 UPSTREAM TO W.C. 2 (100mm dia. salt glazed)</u>
0.4	Hairline radial crack.
2.6	Pipework bends upwards.
2.8	Connection to W.C. 2.
	<u>MH 1 UPSTREAM TO W.C. 3 (100mm dia. salt glazed)</u>
2.8	Hairline longitudinal crack 08.00 (photo).

7.9	Source of root penetration through joint 03.00 (photo).
7.5	Fibrous roots laying in pipework (photo).
6.4	Radial crack to joint with fibrous root penetration through the joint (photo).

0.0	Root penetration through joint with roots travelling downstream.
1.6	Slightly displaced joint (photo).
2.1	Radial crack (hairline).
12.7	MH 3 located to the rear of neighbouring property with roots hanging down in chamber (photo).
