Asbestos Management Survey Report

Survey, Sampling and Assessment of Asbestos Containing Materials

At
MRCC Liverpool
Hall Road West
L23 8SY

Report Reference Number: AP000499-01-003

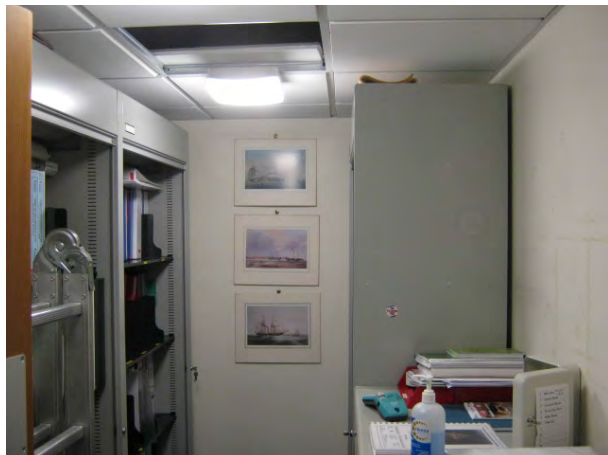
Sample Information	
Site Name/Building Name	MRCC Liverpool / Maritime Rescue Co-ordination Centre
Location	Room 0.9 Eye Test/Store
Floor	Ground
Position	Throughout - See Comments
Int/Ext	Int
Description	No suspect ACM detected
Product Type	
Extent (actual)	No Asbestos Detected
Identification	No Suspect ACM
Sample Ref	No Sample Taken
Visually Similar to Sample

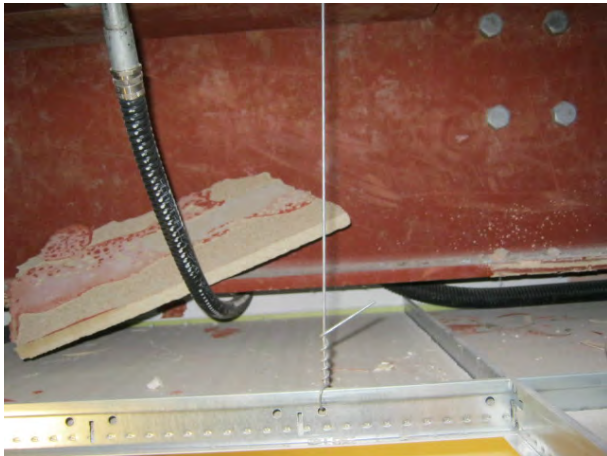
Sample Information	
Site Name/Building Name	MRCC Liverpool / Maritime Rescue Co-ordination Centre
Location	Room 0.9 Eye Test/Store
Floor	Ground
Position	Within the ceiling void to the RSJs and steel supports.
Int/Ext	Int
Description	Vermiculite Boarding
Product Type	Insulating Board
Extent (actual)	10.00 m ²
Identification	Visually Similar To
Sample Ref	No Sample Taken
Visually Similar to Sample	AP000499-01-003/0009

Material Risk Assessment	As Per HSG 264
Product Category	2 - Insulating Board
Damage/Deterioration	2 - Medium
Surface Treatment	1 - Unsealed Cement
Asbestos Type(s)	0 - No Asbestos Detected
Material Score	0
Material Risk Category	Non asbestos

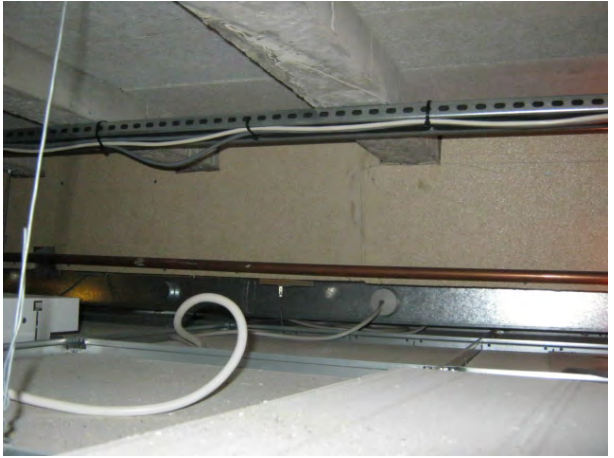
Sample Information	
Site Name/Building Name	MRCC Liverpool / Maritime Rescue Co-ordination Centre
Location	Room 0.8 Control Room
Floor	Ground
Position	Within the ceiling void to the RSJ's
Int/Ext	Int
Description	Vermiculite Boarding
Product Type	Insulating Board
Extent (actual)	50.00 m ²
Identification	Visually Similar To
Sample Ref	No Sample Taken
Visually Similar to Sample	AP000499-01-003/0009

Material Risk Assessment	As Per HSG 264	Priority Risk Assessment	Mean Scores Only, Calculated as per HSG 227.
Product Category	2 - Insulating Board	Normal Occ Activity	0
Damage/Deterioration	2 - Medium	Likelihood Disturbance	0
Surface Treatment	2 - Unsealed Board	Human Exposure Potential	0
Asbestos Type(s)	0 - No Asbestos Detected	Maintenance Activity	0
Material Score	0	Priority Score	0
Material Risk Category	Non asbestos

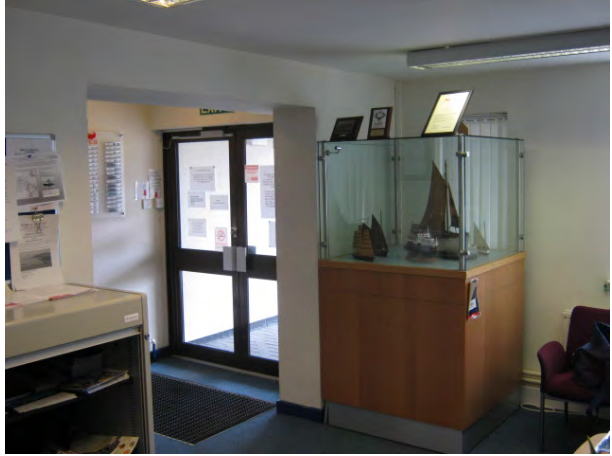
Sample Information	
Site Name/Building Name	MRCC Liverpool / Maritime Rescue Co-ordination Centre
Location	Room 0.23 Entrance Lobby
Floor	Ground
Position	Throughout including ceiling void via loft hatch
Int/Ext	Int
Description	No suspect ACM detected
Product Type	
Extent (actual)	No Asbestos Detected
Identification	No Suspect ACM
Sample Ref	No Sample Taken
Visually Similar to Sample

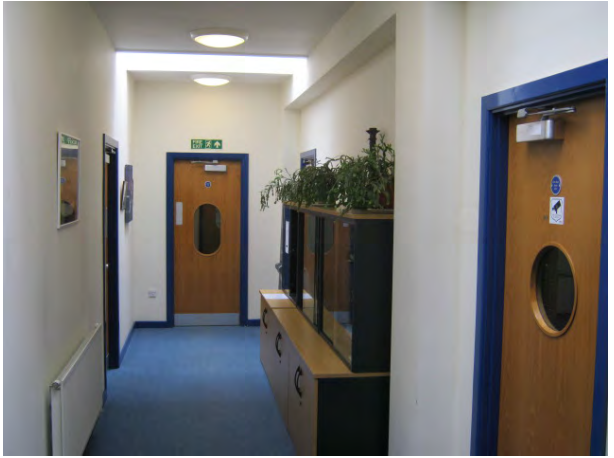
Sample Information	
Site Name/Building Name	MRCC Liverpool / Maritime Rescue Co-ordination Centre
Location	Room 0.24 Corridor, Room 0.26 Corridor
Floor	Ground
Position	Throughout - See Comments
Int/Ext	Int
Description	No suspect ACM detected
Product Type	
Extent (actual)	No Asbestos Detected
Identification	No Suspect ACM
Sample Ref	No Sample Taken
Visually Similar to Sample

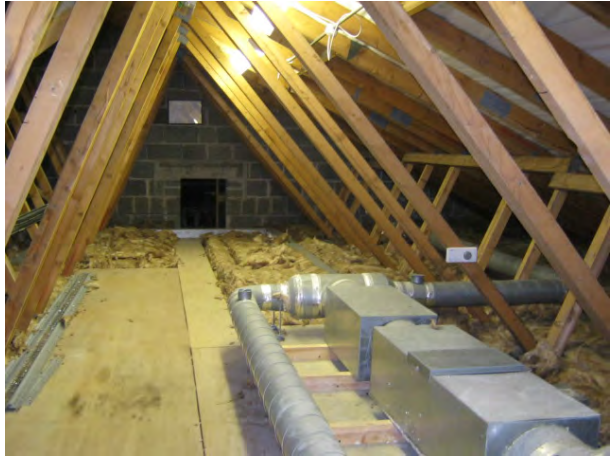
Sample Information	
Site Name/Building Name	MRCC Liverpool / Maritime Rescue Co-ordination Centre
Location	Room 1.7 Ceiling Void
Floor	Floor 1
Position	Throughout - See Comments
Int/Ext	Int
Description	No suspect ACM detected
Product Type	
Extent (actual)	No Asbestos Detected
Identification	No Suspect ACM
Sample Ref	No Sample Taken
Visually Similar to Sample

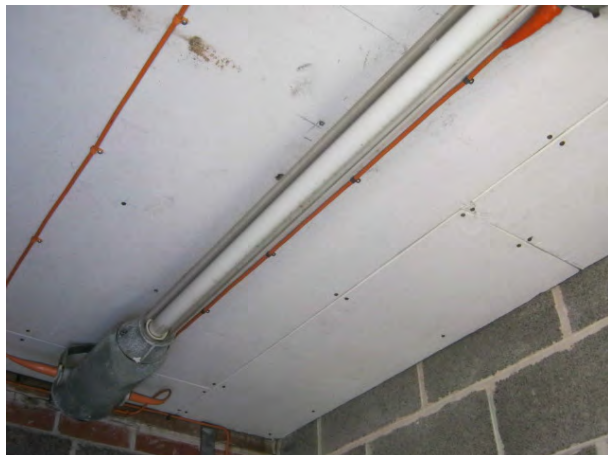
Sample Information	
Site Name/Building Name	MRCC Liverpool / Pyrotechnic Store
Location	Room 0.37 Quarantine Store
Floor	Ground
Position	Panels to the ceiling
Int/Ext	Int
Description	Insulating Board - Supalux
Product Type	Insulating Board
Extent (actual)	2.00 m ²
Identification	Sampled
Sample Ref	AP000499-01-003/0035
Visually Similar to Sample

Material Risk Assessment	As Per HSG 264
Product Category	2 - Insulating Board
Damage/Deterioration	2 - Medium
Surface Treatment	2 - Unsealed Board
Asbestos Type(s)	0 - No Asbestos Detected
Material Score	0
Material Risk Category	Non asbestos

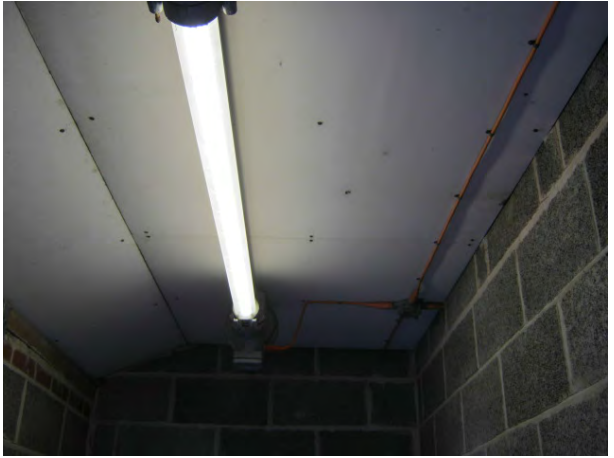
Sample Information	
Site Name/Building Name	MRCC Liverpool / Pyrotechnic Store
Location	Room 0.36 Store Room
Floor	Ground
Position	Panels to the ceiling
Int/Ext	Int
Description	Insulating Board - Supalux
Product Type	Insulating Board
Extent (actual)	2.00 m ²
Identification	Visually Similar To
Sample Ref	No Sample Taken
Visually Similar to Sample	AP000499-01-003/0035

Material Risk Assessment	As Per HSG 264	Priority Risk Assessment	Mean Scores Only, Calculated as per HSG 227.
Product Category	2 - Insulating Board	Normal Occ Activity	0
Damage/Deterioration	2 - Medium	Likelihood Disturbance	0
Surface Treatment	2 - Unsealed Board	Human Exposure Potential	0
Asbestos Type(s)	0 - No Asbestos Detected	Maintenance Activity	0
Material Score	0	Priority Score	0
Material Risk Category	Non asbestos

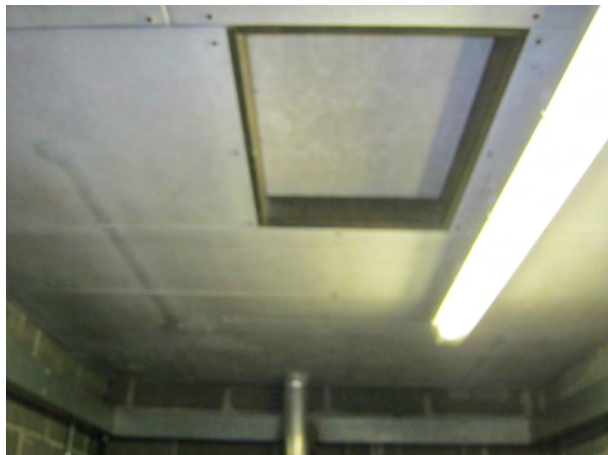
Sample Information	
Site Name/Building Name	MRCC Liverpool / Boiler House
Location	Room 038 Boiler Room
Floor	Ground
Position	To the ceiling
Int/Ext	Int
Description	Insulating Board - Supalux
Product Type	Insulating Board
Extent (actual)	8.00 m ²
Identification	Sampled
Sample Ref	AP000499-01-003/0040
Visually Similar to Sample

Material Risk Assessment	As Per HSG 264
Product Category	2 - Insulating Board
Damage/Deterioration	2 - Medium
Surface Treatment	2 - Unsealed Board
Asbestos Type(s)	0 - No Asbestos Detected
Material Score	0
Material Risk Category	Non asbestos

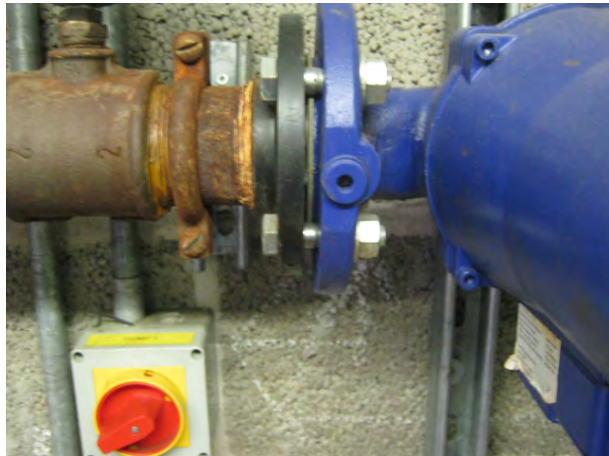
Sample Information	
Site Name/Building Name	MRCC Liverpool / Boiler House
Location	Room 038 Boiler Room
Floor	Ground
Position	Pipe flanges
Int/Ext	Int
Description	Gasket
Product Type	Gasket
Extent (actual)	6 Items
Identification	Sampled
Sample Ref	AP000499-01-003/0041
Visually Similar to Sample

Material Risk Assessment	As Per HSG 264
Product Category	2 - Gasket
Damage/Deterioration	1 - Low
Surface Treatment	2 - Unsealed Board
Asbestos Type(s)	0 - No Asbestos Detected
Material Score	0
Material Risk Category	Non asbestos
