## Asbestos Management Building Survey

**Uplands Manor Primary School, Addenbrooke Road, Smethwick, West Midlands, B67 6HT**

**SCOPE:** In Accordance With HSG 264 And SMBC Job No. 2177, Conduct An Asbestos Management Survey To The School Where Safe And Unrestricted Access Permits.

UPLANDS MANOR PRIMARY  
SCHOOL  
ADDENBROOKE ROAD  
SMETHWICK  
WEST MIDLANDS, B67 6HT  
REPORT NUMBER J125739

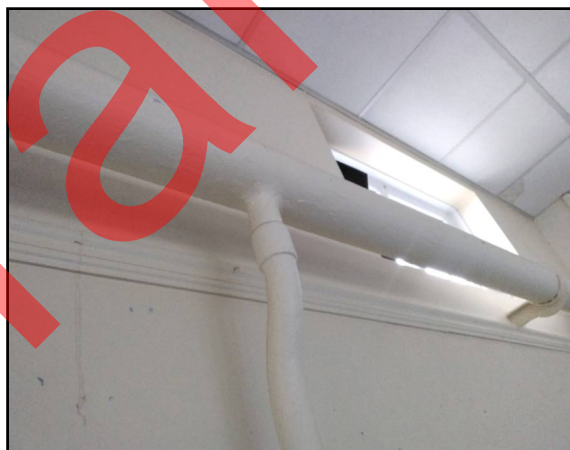
1st Floor Classroom 2s (10)  
Composite Bitumen  
Under Sink Mat 140
