## Refurbishment Asbestos Survey

**The Old Priory  
Leominster  
HR6 8EQ**

**Leominster Town Council**

Refurbishment Asbestos Survey  
 The Old Priory  
 Leominster  
 HR6 8EQ  
 Leominster Town Council

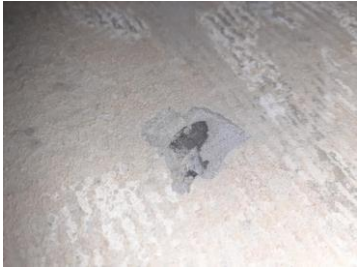
Location / Description	Photograph	Sample ref / Presumed	Licensed?	Quantity	Access.	Product	Condition	Surface	Asbestos Type	MRA Score	Comments / Recommendations
Ground Floor, Office, 042 Bitumen Residue - Bitumen Below carpet and screed.	 	E-44446/S013	N	16 m <sup>2</sup>	Difficult	1	0	0	Chrysotile 1	2 Very Low	<b>Manage</b>
Ground Floor, Store, 043 Bitumen Residue - Bitumen Below carpet and screed.

E-44446/VS013	N	7 m <sup>2</sup>	Difficult	1	0	0	Chrysotile 1	2 Very Low	<b>Manage</b>
Ground Floor, Office, 044 Bitumen Residue - Bitumen Below carpet and screed.	 	E-44446/VS013	N	18 m <sup>2</sup>	Difficult	1	0	0	Chrysotile 1	2 Very Low	<b>Manage</b>

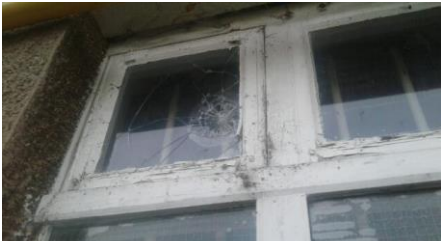
<p align="center">External 143 Rainwater Goods - Putty</p>		<p align="center">E-44446/PSE- 12645/011</p>	<p align="center">No Asbestos Detected in Sample</p>	
<p align="center">External 143 Window Frame - Putty</p>	 	<p align="center">E-44446/PSE- 12645/013</p>	<p align="center">No Asbestos Detected in Sample</p>	<p align="center">On old mortuary.</p>
<p align="center">External 143 Window - Putty</p>

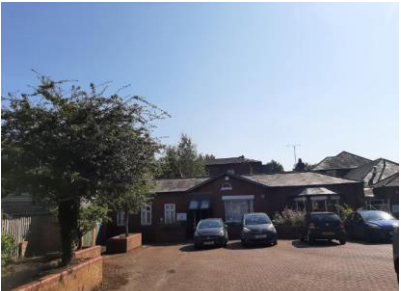
Location / Description	Photograph	Recommended Action
<p align="center">The Old Priory Throughout Intrusive Investigation - Limited Access Gained</p>

<p align="center">Intrusive surveying was kept to an absolute minimum throughout site due to historical and listed standing of the site.</p>
<p align="center">Ground Floor, Hall &amp; Stairwell 026 Understairs Cupboard - No Access Gained</p>

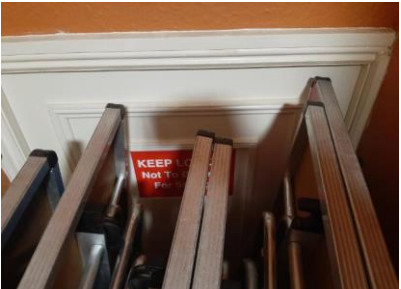
<p align="center">Cupboard locked.</p>
<p align="center">Ground Floor, Cupboard 032 -</p>

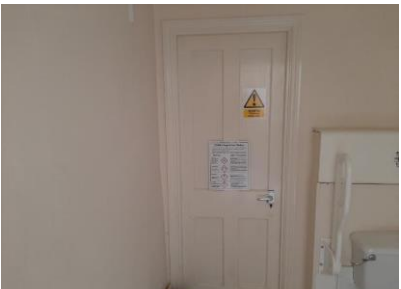
<p align="center">Cupboard locked.</p>

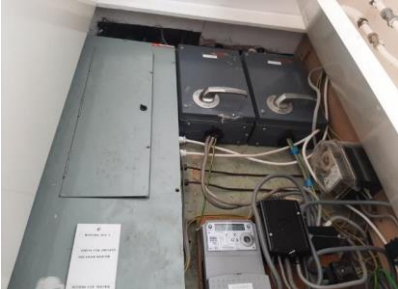
<p>Ground Floor, Male WC 035 Electrics - No Access Gained</p>

<p>It was not possible to access as the equipment was live at the time of the survey. Only qualified operatives holding task specific and appropriate asbestos awareness training should undertake work on live equipment.</p>
<p>Ground Floor, Toilets 036 Duct - No Access Gained</p>

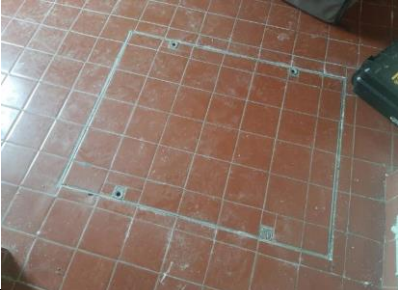
<p>Duct has been mortered in and requires plant equipment to lift.</p>
<p>Ground Floor, Toilets 036 Beam - Limited Access Gained</p>

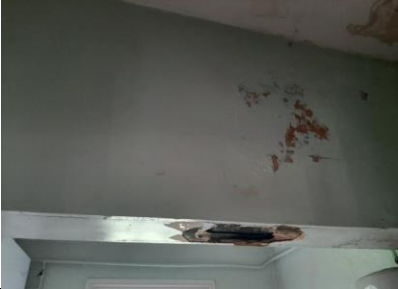
<p>Beam has been opened up beyond single skinned plasterboard lining to show timber beam.</p>
<p>Ground Floor, Store 048 -</p>

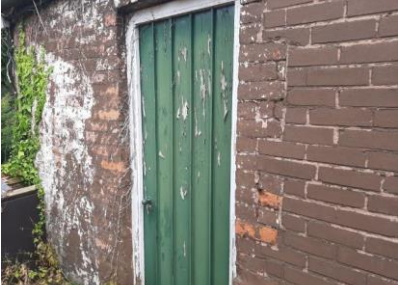
<p>Access was not possible because the room was locked and a key was not available.</p>

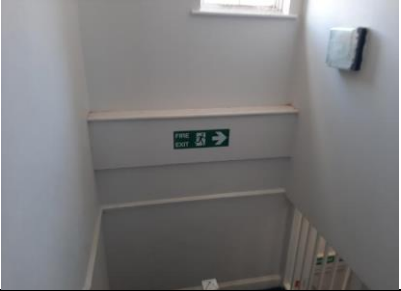
<p align="center">1st Floor, Stairwell 063 Box Work - No Access Gained</p>

<p align="center">Within box work is outside of the scope.</p>
<p align="center">2nd Floor, Corridor &amp; Stairwell 013 Electrics - No Access Gained</p>

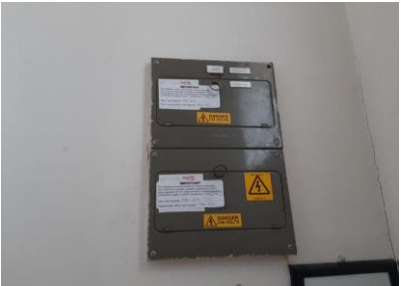
<p align="center">It was not possible to access as the equipment was live at the time of the survey. Only qualified operatives holding task specific and appropriate asbestos awareness training should undertake work on live equipment.</p>
<p align="center">External 143 Beyond Lead Flashing - No Access Gained</p>

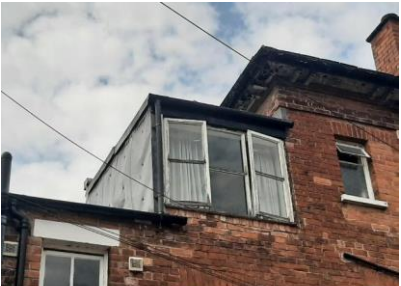
<p align="center">Access was not possible as it would cause unacceptable damage.</p>
<p align="center">External 143 Roof - No Access Gained</p>

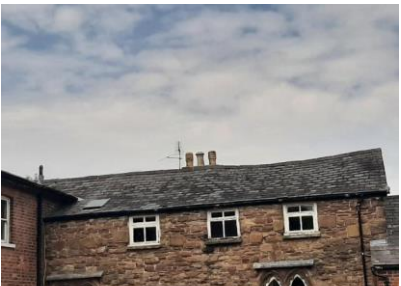
<p align="center">Access was not possible due to height restrictions.</p>

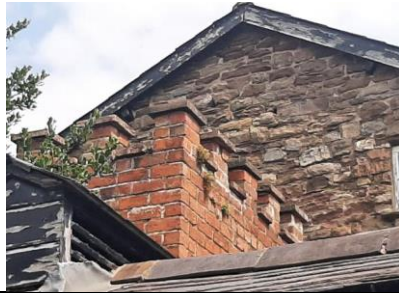
External 143  
Flat Roof - No Access Gained

Access was not possible due to height restrictions.
