Jubilee Hall  
Stadon Road  
Anstey

**Site Investigation  
For  
Anstey Parish Council**

**GeoDyne Limited**  
Clarendon House, Clarendon Park,  
Clumber Avenue, Nottingham NG5 1AH  
Tel: 0115 962 0001 email: [info@geodyne.co.uk](mailto:info@geodyne.co.uk)

Project No: 42116		Date: 29 <sup>th</sup> June 2022	
Issue/revision	Prepared by	Checked By	Approved By
	Amy Newman BSc (Hons) MRes MIEnvSc <b>Principal</b>	Jason Hollands BSc (Hons) MSc MIEnvSc CGeol FGS <b>Director</b>	Jason Hollands BSc (Hons) MSc MIEnvSc CGeol FGS <b>Director</b>

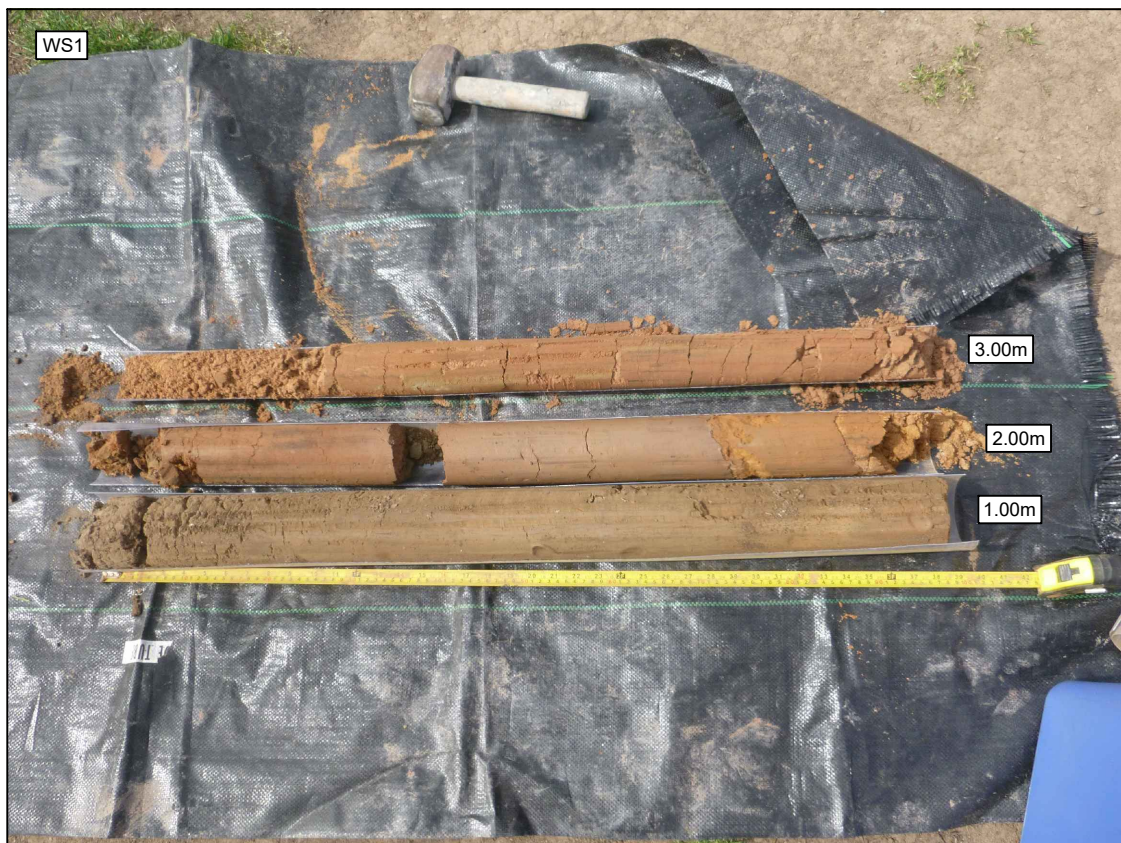
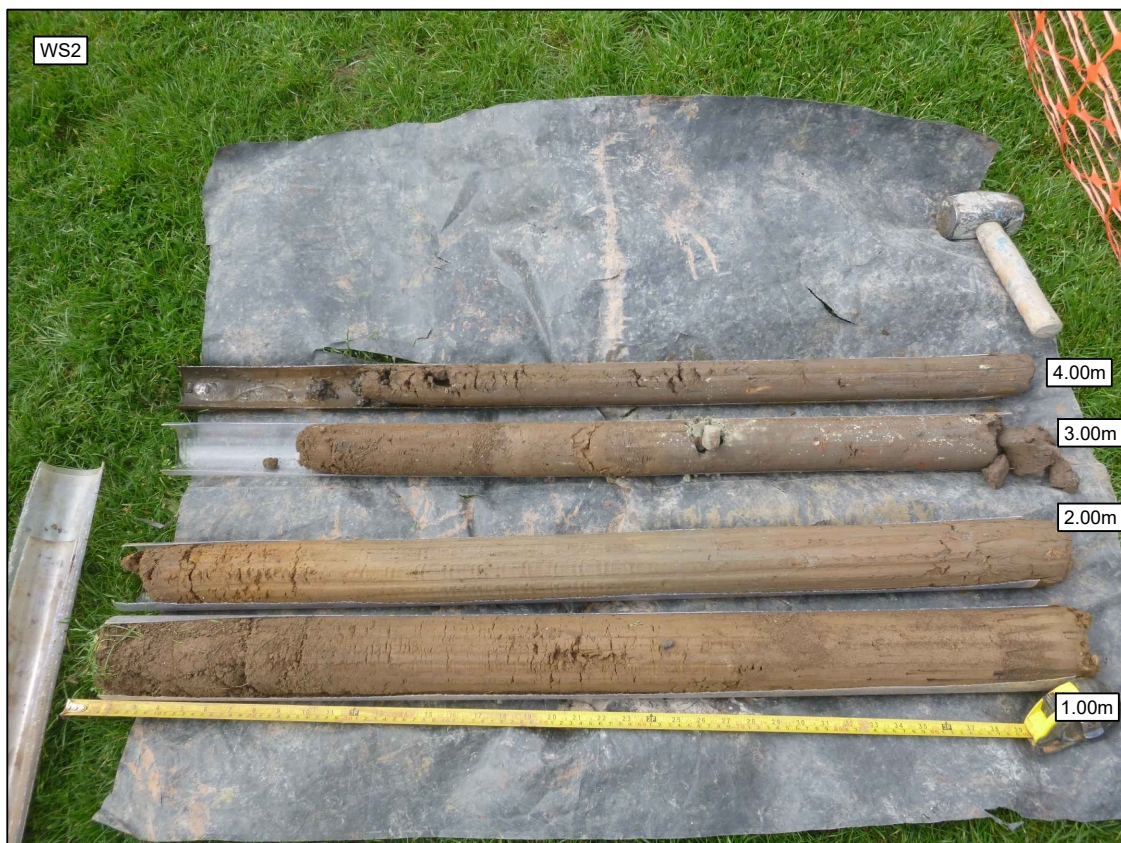
Nottingham 0115 962 0001 Derby 01332 290 798  info@geodyne.co.uk www.geodyne.co.uk
Client	Anstey Parish Council	Checked By	AN	
		Approved By	JPH	
Project	Jubilee Hall, Staddon Road, Anstey	Scale	NTS	
		Date Drawn	07/06/2022	
Title	Views of Arisings From Exploratory Holes WS1 and WS2	Revision		42116/P1
		Figure No.

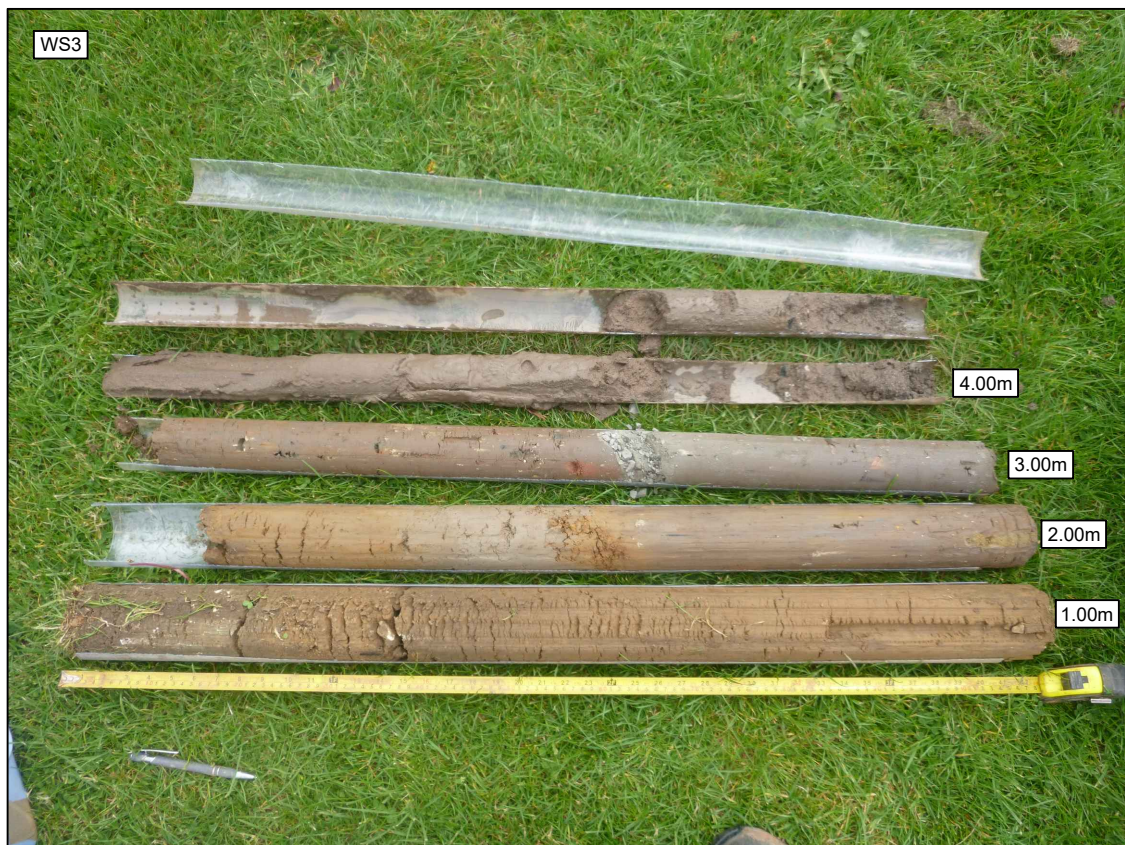
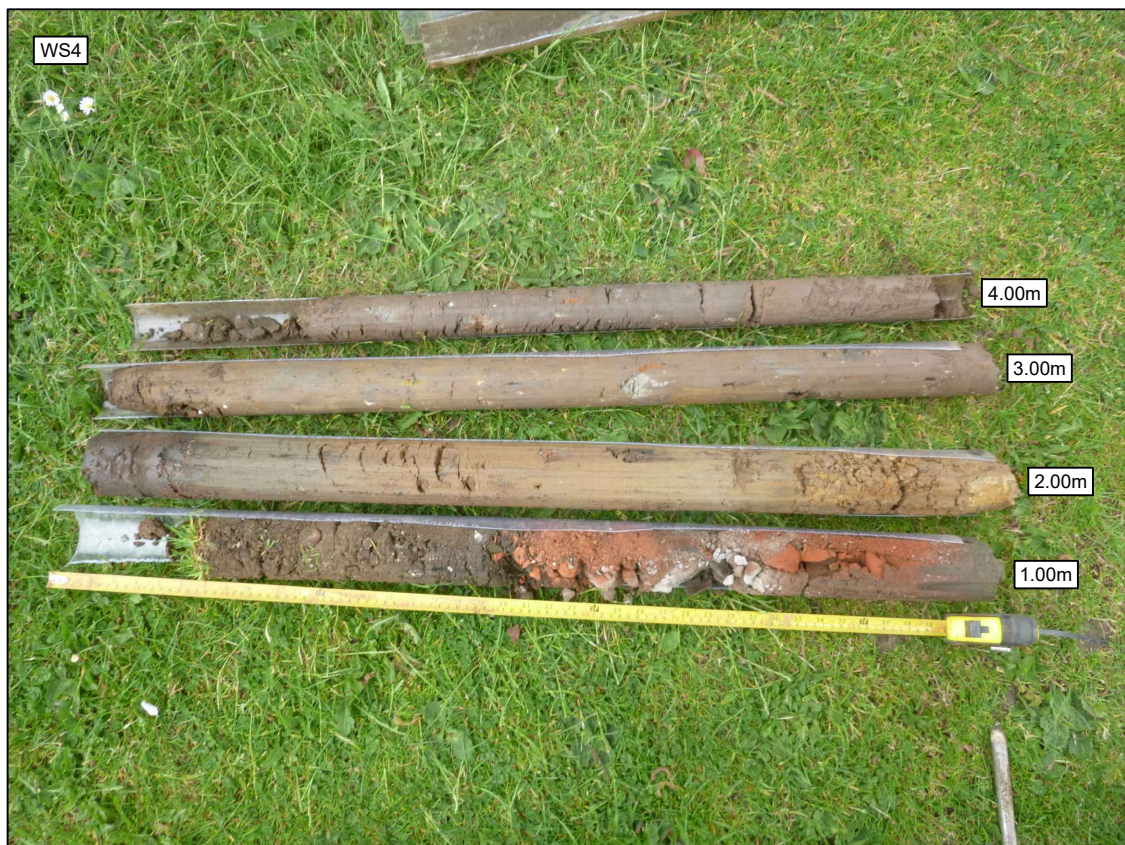
Nottingham 0115 962 0001 Derby 01332 290 798  info@geodyne.co.uk www.geodyne.co.uk
Client	Anstey Parish Council	Checked By	AN	
		Approved By	JPH	
Project	Jubilee Hall, Staddon Road, Anstey	Scale	NTS	
		Date Drawn	07/06/2022	
Title	Views of Arisings From Exploratory Holes WS3 and WS4	Revision		42116/P2
		Figure No.
