The Manor House

Report on a Structural

Inspection of cracking present to the Property

May 2016

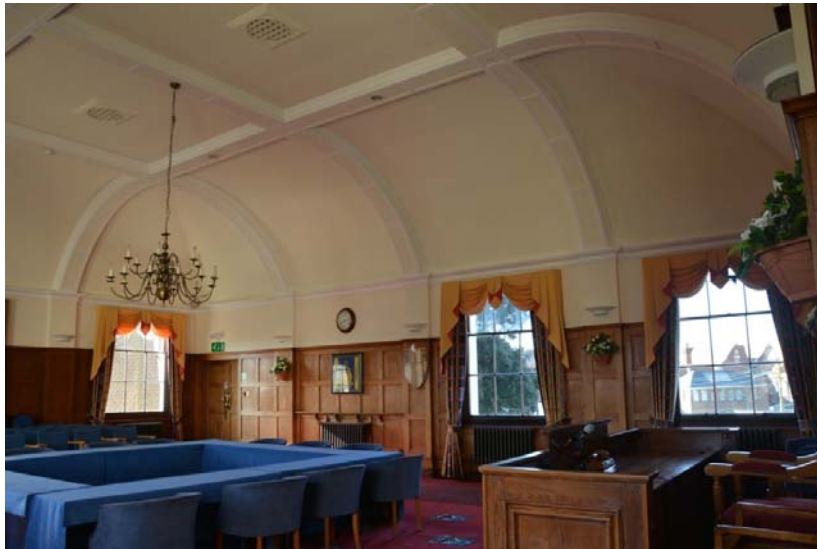
Inspection internally adjacent to the area of cracking present revealed a large open plan room measuring some 12m long by 10m wide.

On the internal face of the wall two piers were evident in the vicinity of the vertical cracking present with evidence of beams to the roof structure also.

General Internal view
