HENLEY TOWN COUNCIL

A feasibility study for the proposed natural turf pitch improvement works at Jubilee Park, 357 Reading Road, Henley-on-Thames, RG9 4HA.

13th November 2023 [Revision 3, 23rd February 2024]

TGMS1315.2 [ABRIDGED VERSION]

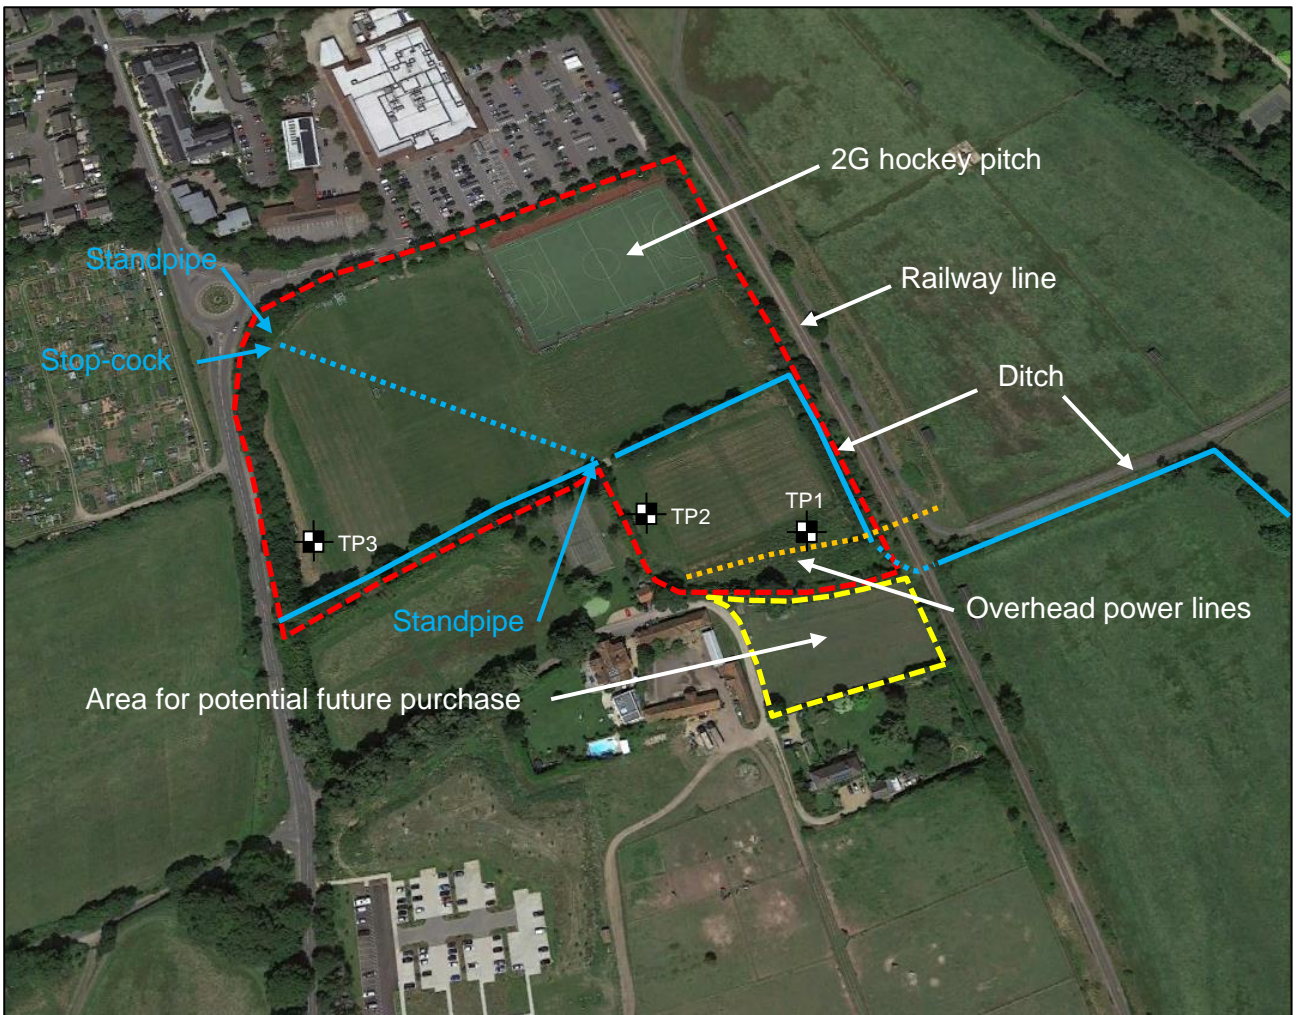
Figure 2. Site overview. The red hatched line demarcates the extent of the site, and the yellow hatched line demarcates an area for potential future purchase (indicative and not to scale). TP1 to TP3 mark the approximate locations of the test pits.
 (Aerial photograph courtesy of Google Earth Pro).

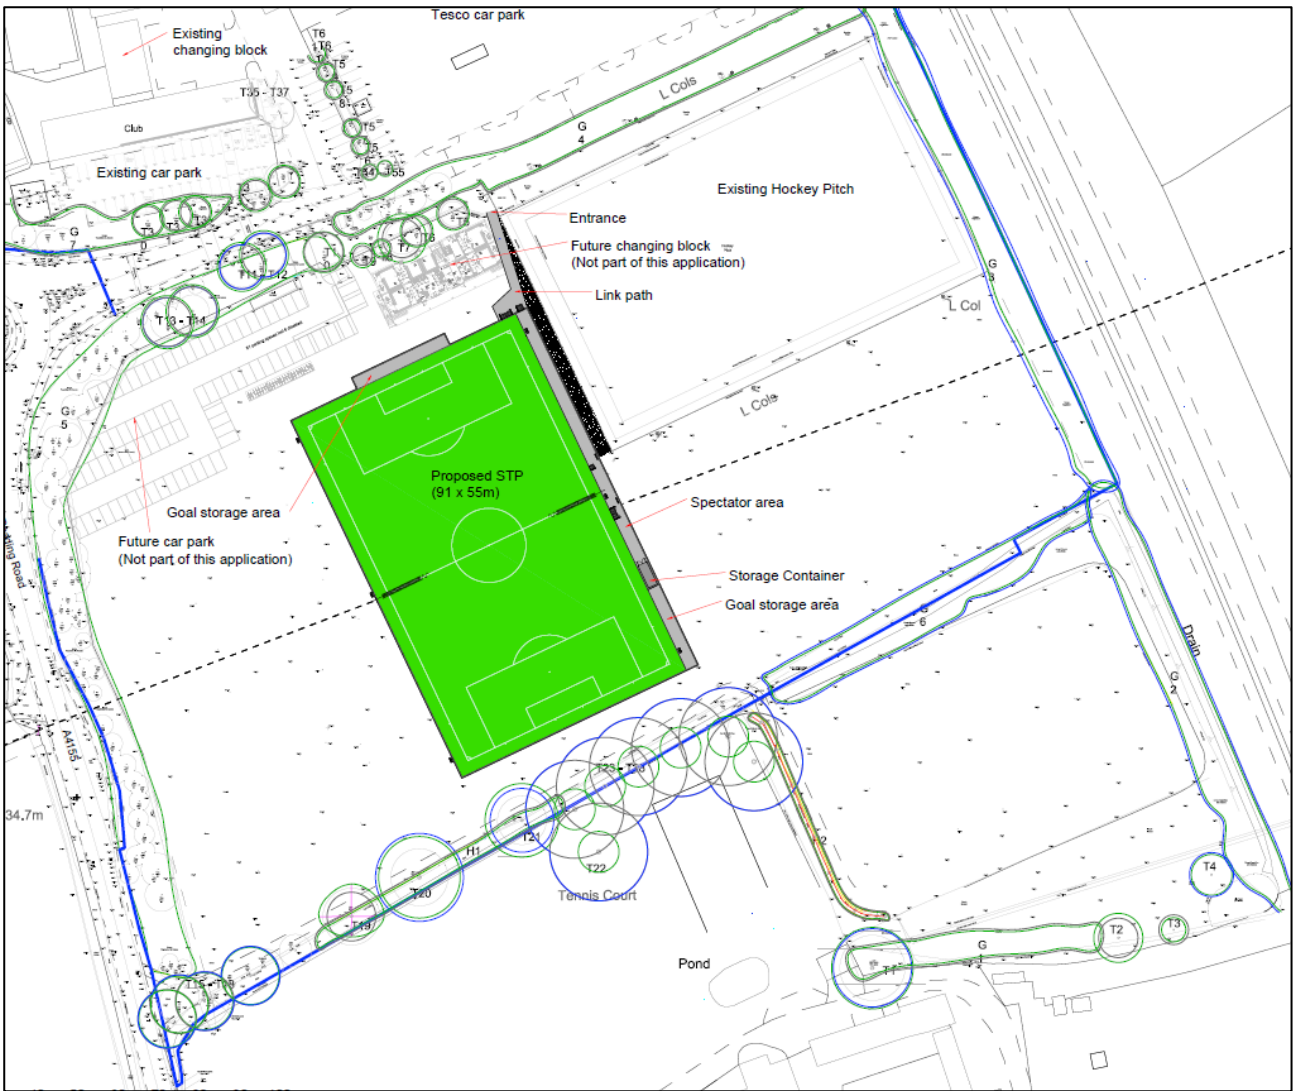
It is proposed to construct a new 3G pitch towards the centre of the site, along with changing rooms and a car park towards the north-western boundary Figure 3.

Figure 3. Proposed site layout.
(Excerpt from drawing MCA-MUK2942-07 courtesy of McArdle Sport Tec).

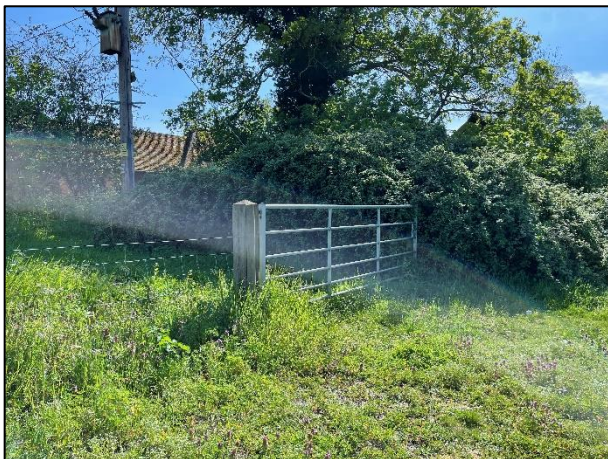
Figure 16. Gate into the fallow triangular area.

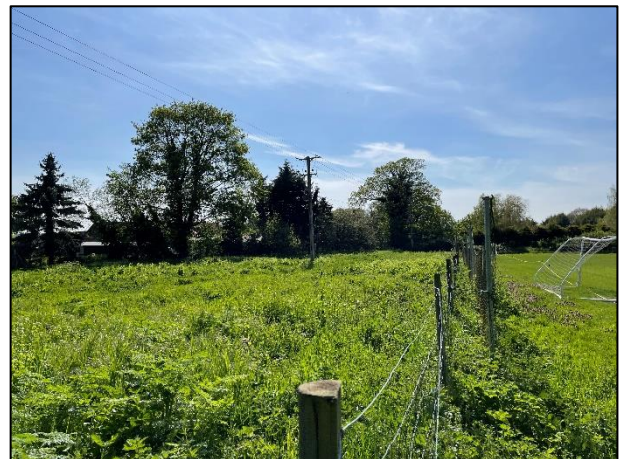
Figure 17. General view across the fallow triangular area towards the south.

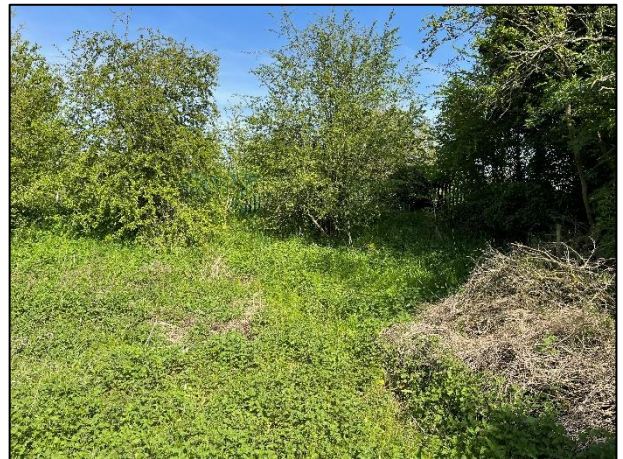
Figure 21. Old pond in the eastern corner of the fallow triangular area.

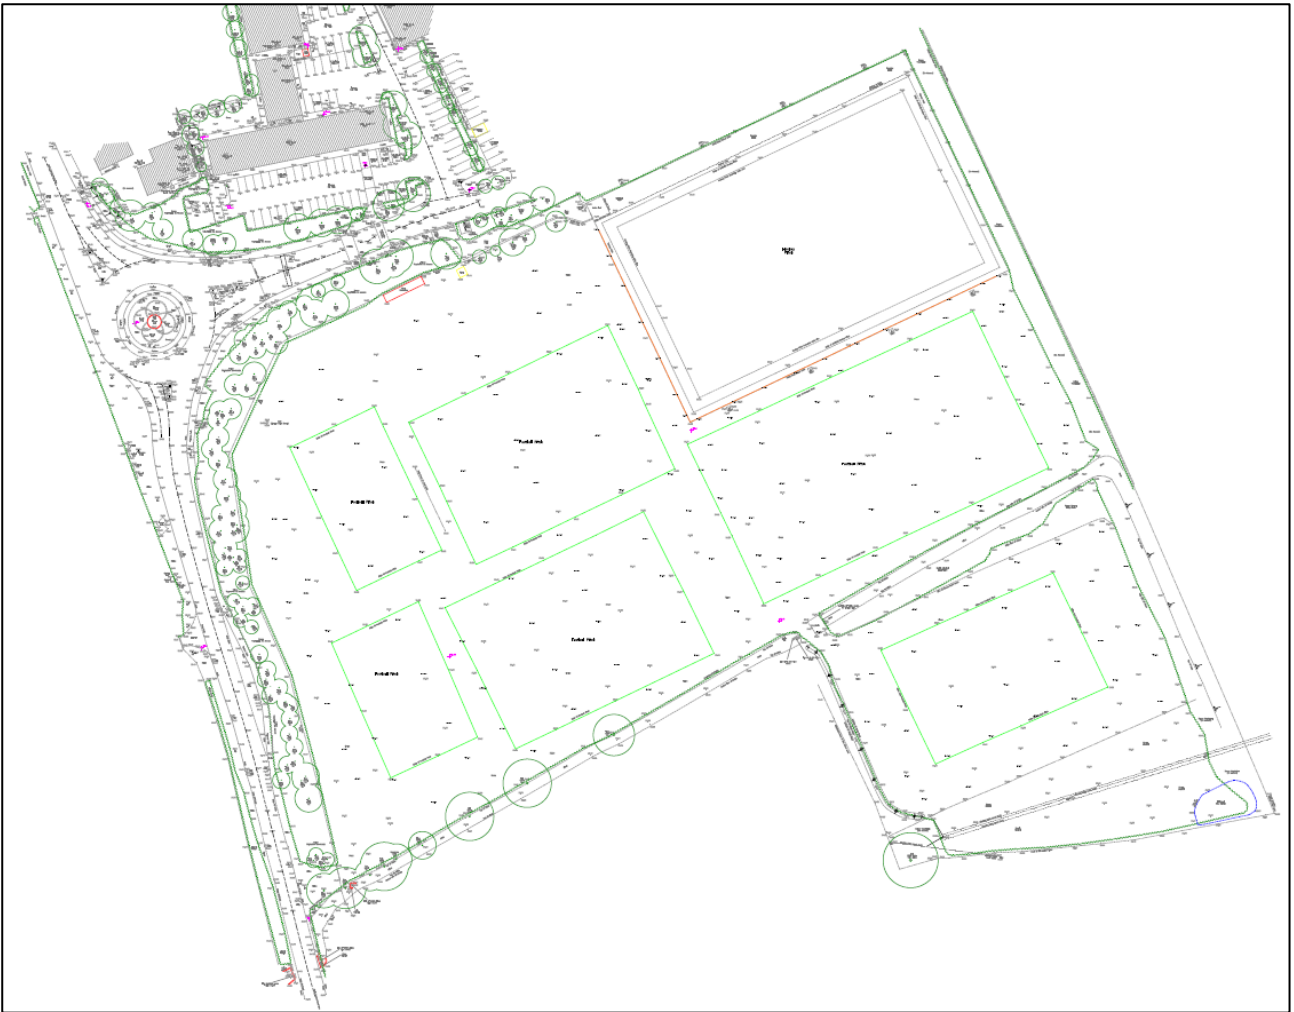
With reference to a topographical survey conducted by Peter J H Roberts (Figure 31), the six pitches marked out on the day of the survey were for the following dimensions:

- 1 Nr. 91 m x 50 m (100 x 55 yards).
- 2 Nr. 64 m x 45.7 m (70 x 50 yards).
- 1 Nr. 45.7 m x 27 m (50 x 30 yards).
- 1 Nr. 42.5 m x 27 m (46.5 x 30 yards).
- 1 Nr. 55 m x 36.5 m (60 x 40 yards).

This equates to a total pitch area, excluding safety margins, of 14,900 m².

Figure 31. Excerpt from a topographical survey drawing by Peter J H Roberts.

With reference to Figure 31 (existing pitch layout) the two smaller pitches near Reading Road are orientated at 334° and therefore comply with the guidance. The remaining four larger pitches are orientated at 64° which is outside the guidance.

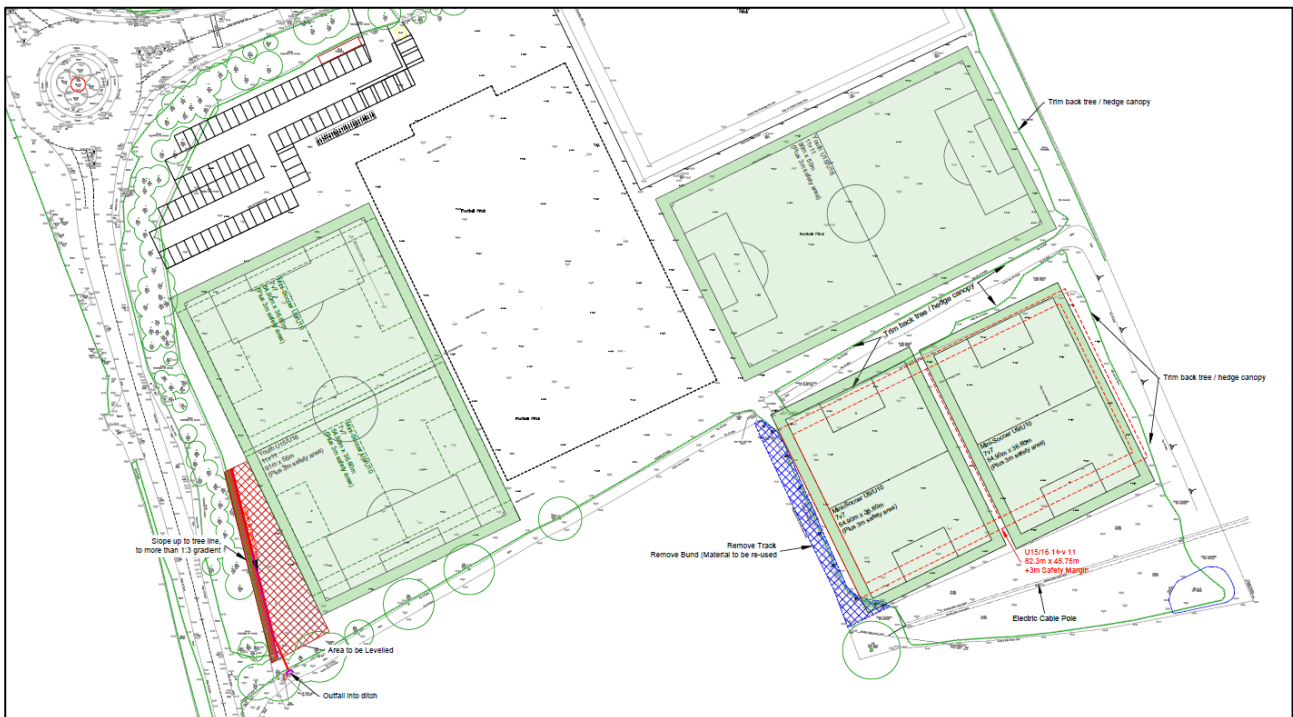
1. To the west (near Reading Road), it may be possible to fit in a Youth (U15/U16 11v11) 91 m x 55 m (plus 3 m safety margin) pitch.
2. As an alternative, this pitch can be marked out with two Mini-soccer pitches (U9/U10 7v7 54.9 m x 36.6 m plus 3 m safety margins and 2 m Respect Zone) running across it (hatched green lines).
3. It is also proposed to level a triangular area near the site entrance (red hatching) to provide additional space.
4. The north-eastern area (next to the existing hockey pitch) can accommodate a Youth (U15/U16 11v11 90 m x 50 m plus 3 m safety margin) pitch.

5. If the south-eastern area (next to the “pylons” area) is enlarged by removing a hardcore track and a soil bund, it may just be able to accommodate a Youth (U15/U16 11v11 82.3 m x 45.75 m plus 3 m safety margin) pitch running approximately east-west (hatched red lines).
6. Alternatively, this area can be marked out with two Mini-soccer (U9/U10 7v7 54.9 m x 36.6 m plus 3 m safety margin) pitches.

Figure 32A. Proposed pitch reconfiguration (maintaining existing pitch area boundaries).

This arrangement equates to a total pitch area, excluding safety margins, of 13,524 m² which is less (1,376 m²) than the pitch provision presented in Figure 31.

With reference to Figures 32A and 32B (proposed layouts) the Youth pitch near Reading Road and the two pitches near the power lines are orientated at 334° and therefore comply with the guidance. The Youth pitch near the hockey pitch is orientated at 64° which is outside the guidance, but given the geometry of the site, re-orientation is not possible.

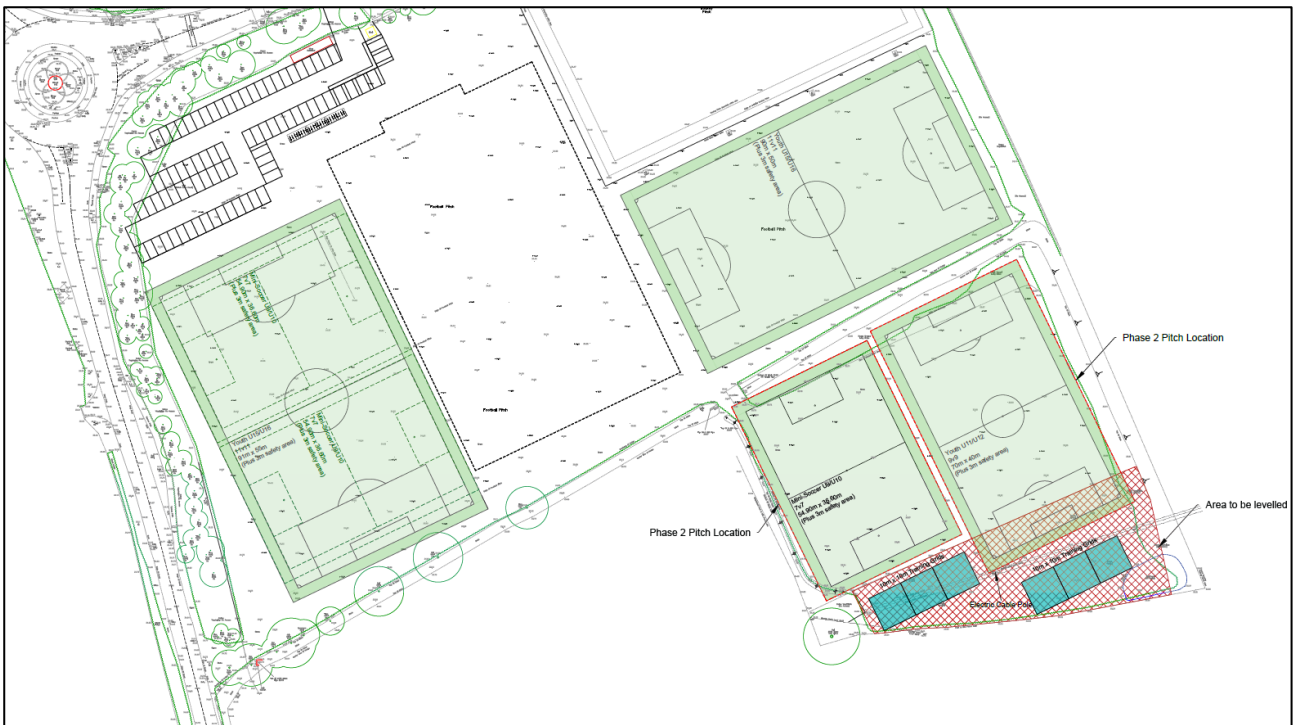
1. The south-eastern area (including the “pylon” area) could be developed using soil arisings from construction of the proposed 3G pitch, car park and changing block to accommodate:
 - I. A Youth (U11/U12 9v9 70 m x 40 m plus 3 m safety margin) pitch.
 - II. A Mini-soccer (U9/U10 7v7 54.9 m x 36.6 m plus 3 m safety margin) pitch.
 - III. Six 10 m x 10 m training grids.
2. Alternatively, this area can be marked out with a Youth (U15/U16 11v11 82.3 m x 45.75 m plus 3 m safety margin) pitch running approximately east-west.

This arrangement equates to a total pitch area, excluding safety margins, of 14,914 m² which is marginally greater (14 m²) than the pitch provision presented in Figure 31.

Figure 32B. Proposed pitch reconfiguration (including extension into the triangular “pylon” area).

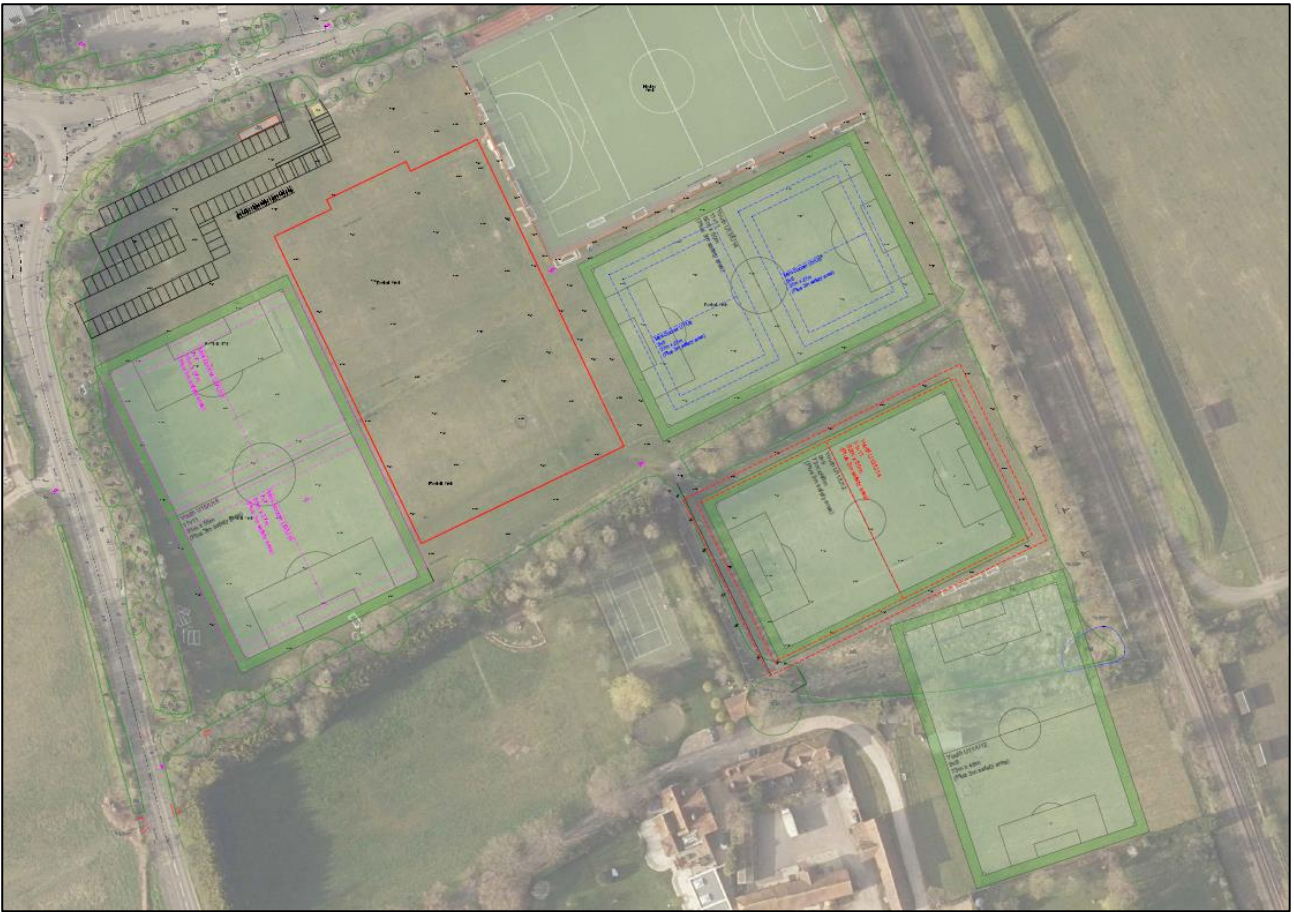
5. The south-eastern area (near the pylons) may be able to accommodate:
 - I. A Youth pitch (U13/U14 11v11 82 m x 50 m plus 3 m safety margin).
 - II. A Youth pitch (U11/U12 9v9 73 m x 46 m plus 3 m safety margin).

Figure 33. Proposed pitch reconfiguration (including additional land purchase, and burial of overhead power lines).

This arrangement equates to a total pitch area, excluding safety margins, of 16,560 m² which is 1,663 m² greater than the pitch provision presented in Figure 31.

With reference to Figures 33 and 34 (proposed layouts including land purchase) the Youth pitch near Reading Road and larger pitches over the footprint of the purchased land are orientated between 334° and 346° and therefore comply with the guidance. The Youth pitches near the hockey pitch and near the tennis court are orientated at 64° which is outside the guidance, but given the geometry of the site, re-orientation is not recommended.

6. This lower area is quite tight, and so there will be a need to remove the hardcore track and the soil bund that run along the south-western boundary (adjacent to the neighbouring tennis court).

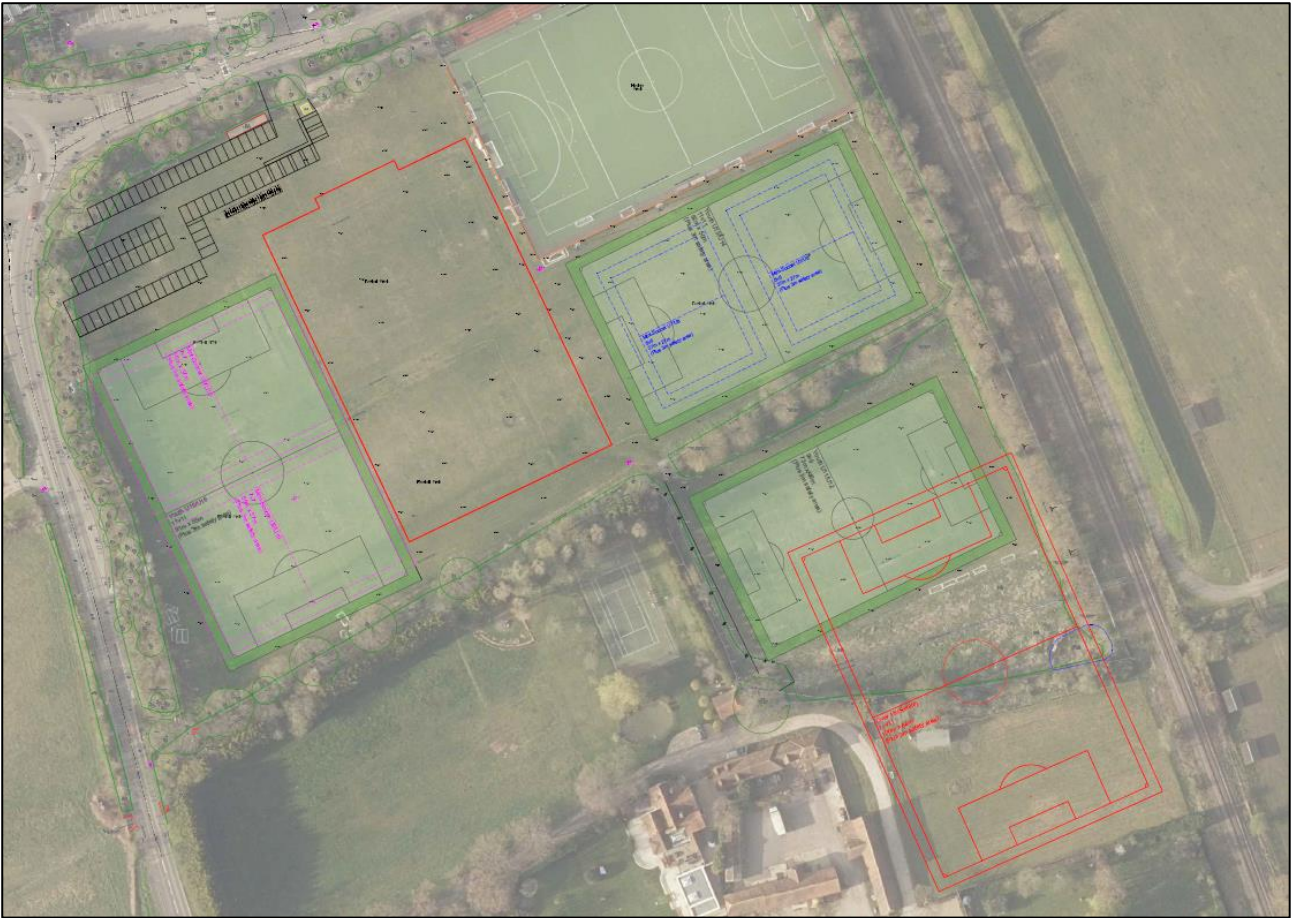
- II. Alternatively, it may just be possible to fit in a Senior pitch (Over 18 11v11 100 m x 64 m plus 3 m safety margin - red lines).

Figure 34. Proposed pitch reconfiguration (including additional land purchase, and burial of overhead power lines).

This arrangement equates to a total pitch area, excluding safety margins, of 19,605 m² which is 4,705 m² greater than the pitch provision presented in Figure 31.

- This lower area is quite tight, and so there will be a need to remove the hardcore track and the soil bund that run along the south-western boundary (adjacent to the neighbouring tennis court).

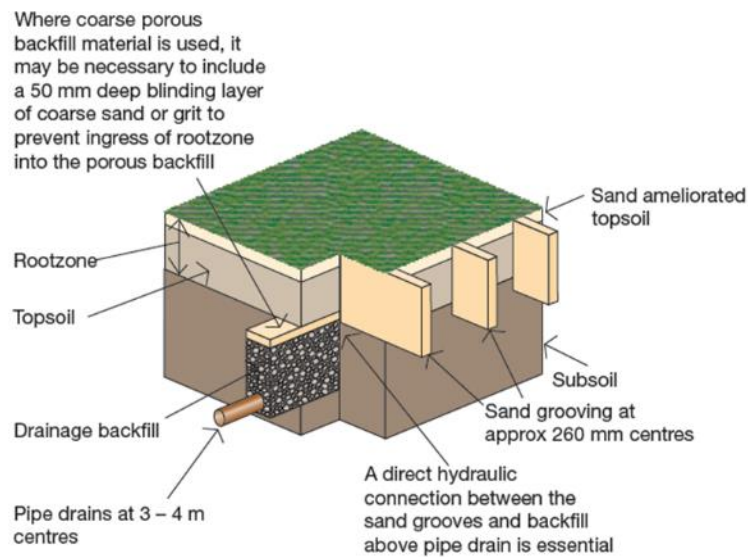
Figure 44. Typical sand groove-based surface by-pass drainage system (Ref: Sport England Design Guidance Note “Natural Turf for Sport”, 2011).

Following soil importation from the 3G pitch, car park and pavilion construction works, and re-grading earthworks to create the desired pitch gradients, the installation of a land drainage scheme that is designed to intercept rain water at the surface before it has had an opportunity to soak in to the soil profile is recommended.

These systems work by using a primary drainage system comprising closely spaced, deep lateral drains combined with a secondary drainage system of closely spaced sand grooves or sand bands cut into the surface that link into the primary system below.

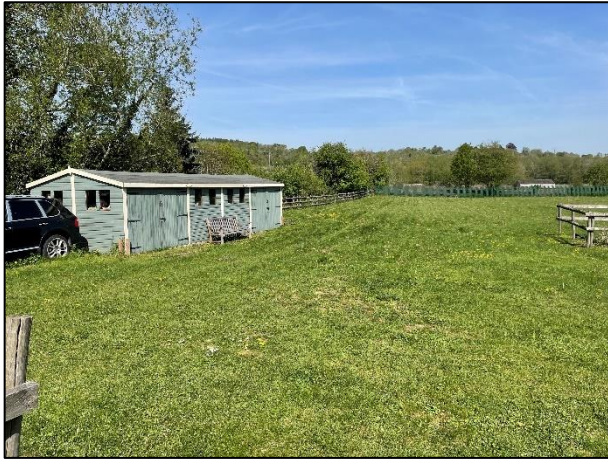
The paddock area to the south-east that is potentially for sale currently comprises grass grazing land (Figures 51 and 52).

Figure 51. Grazing land to the south-east.

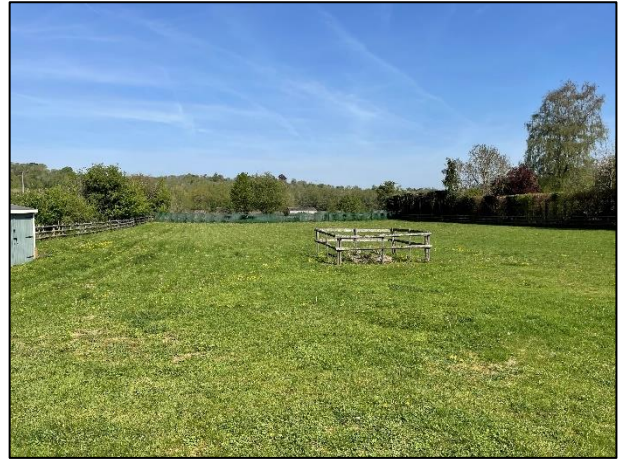
Figure 52. Grazing land to the south-east.
