HORNCastle CEMETERY CHAPEL

Project No. 6013

YORKSILLS DRAWINGS 6013/01 & 100
CHAPEL LAYOUT SKETCH

YORK SILLS INSPECTION REPORT LETTER

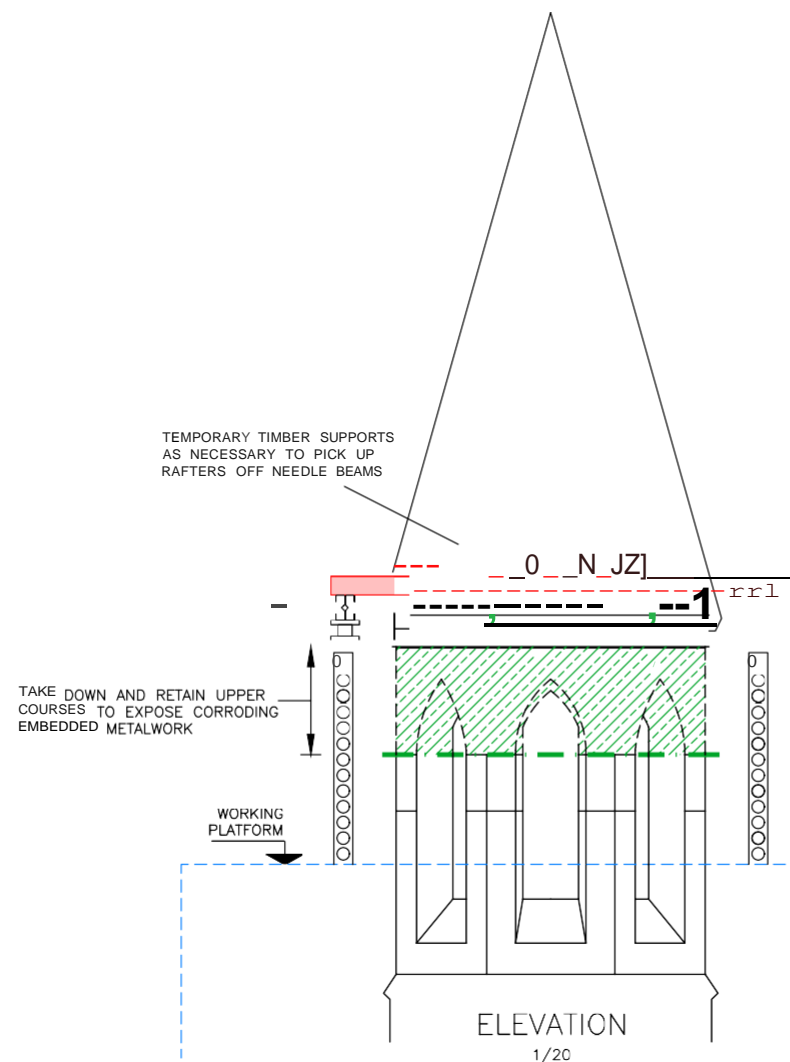
TEMPORARY NEEDLES AND JACKING PROPS BY SPECIALISTS: APPROXIMATE SPIRE LOADING (SWL):
500kg TILES, LEAD
400kg TIMBER SELF WEIGHT

- INSTALL WORKING PLATFORM SCAFFOLD (DESIGN AND INSTALLATION BY SPECIALIST CONTRACTOR). NOTE: BACK-PROPPING INSIDE THE CHAPEL WILL BE REQUIRED IF PROPPING OFF THE ROOF SLOPE.
- STRIP SPIRE ROOF, INSTALL NEEDLES AND JACKING PROPS, CUT RAFTER OVERHANG NOTCHES IF REQUIRED TO PERMIT SPIRE TO BE LIFTED VERTICALLY.
- RELEASE SPIRE BY UNBOLTING OR CUTTING OFF TIE BARS, THEN JACK UP APPROXIMATELY 300mm TO PROVIDE ACCESS TO MASONRY.
- TAKE DOWN UPPER COURSES OF MASONRY DOWN TO SOUND MASONRY AND SET ASIDE. ALLOW FOR INDENT REPAIRS TO CRACKED BLOCKS AS SHOWN PLUS CONTINGENCIES OUTLINED IN SPECIFICATION.
