# Southfield Brook Flood Alleviation Scheme

*Prepared for*

Cheltenham Borough Council

Date: February 2016

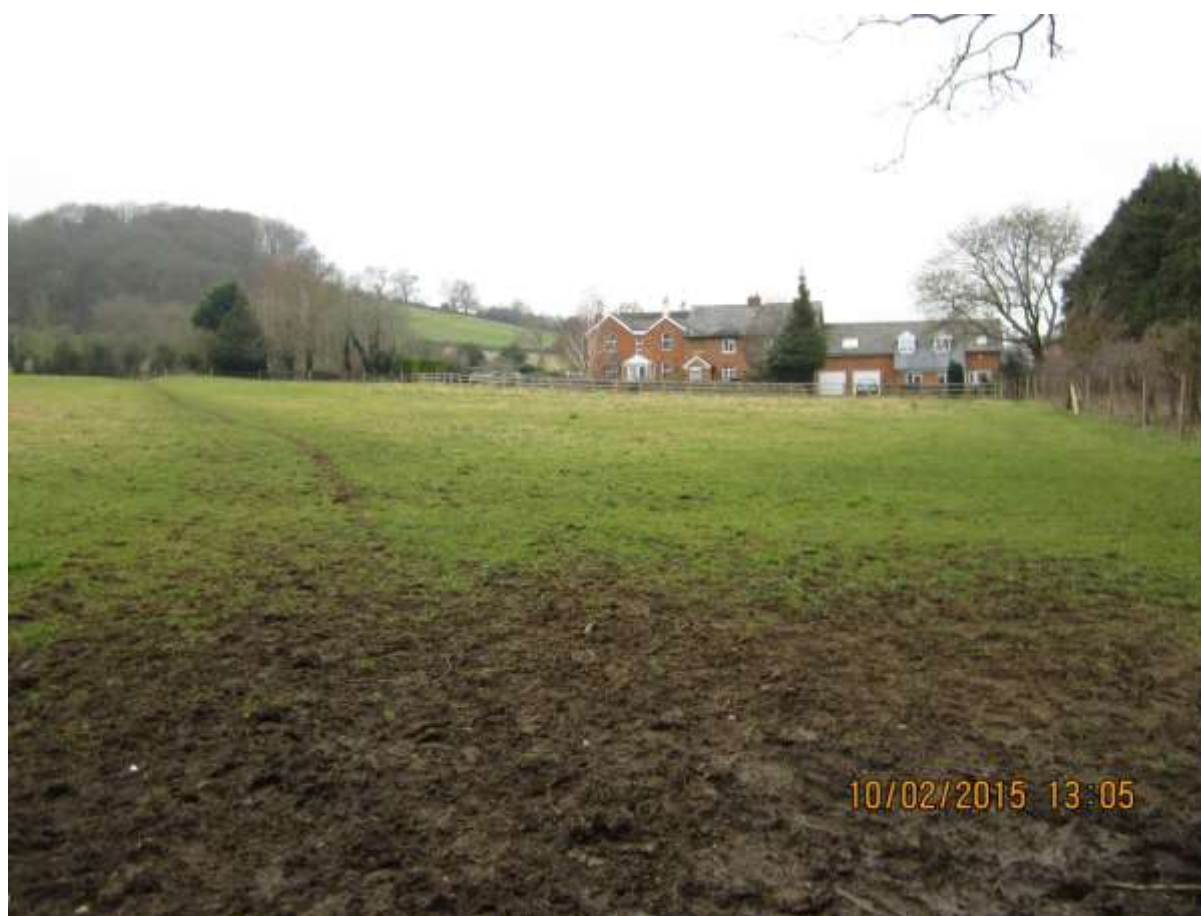
Figure 2-1: Central field in which Location A is situated. Looking towards the west

Location A was observed from the central field in which the bund is proposed (Figure 2-1). Access was made through the gate on Sandy Lane with permission of the landowner. The site is bounded by Sandy Lane to the east and the Manor Park access road to the north, separated by a fence and small ditch. The fields are bounded by fences to the south and west.

The proposed flood bund is located over three adjacent fields, each divided by a small stream or drainage ditch lined by trees and mixed hedges. The streams flow towards the north and are culverted beneath Southfield Manor and Sandy Lane. The fields are laid to grass with horses grazing at the time of the survey. The ground was noted to be hummocky in places.

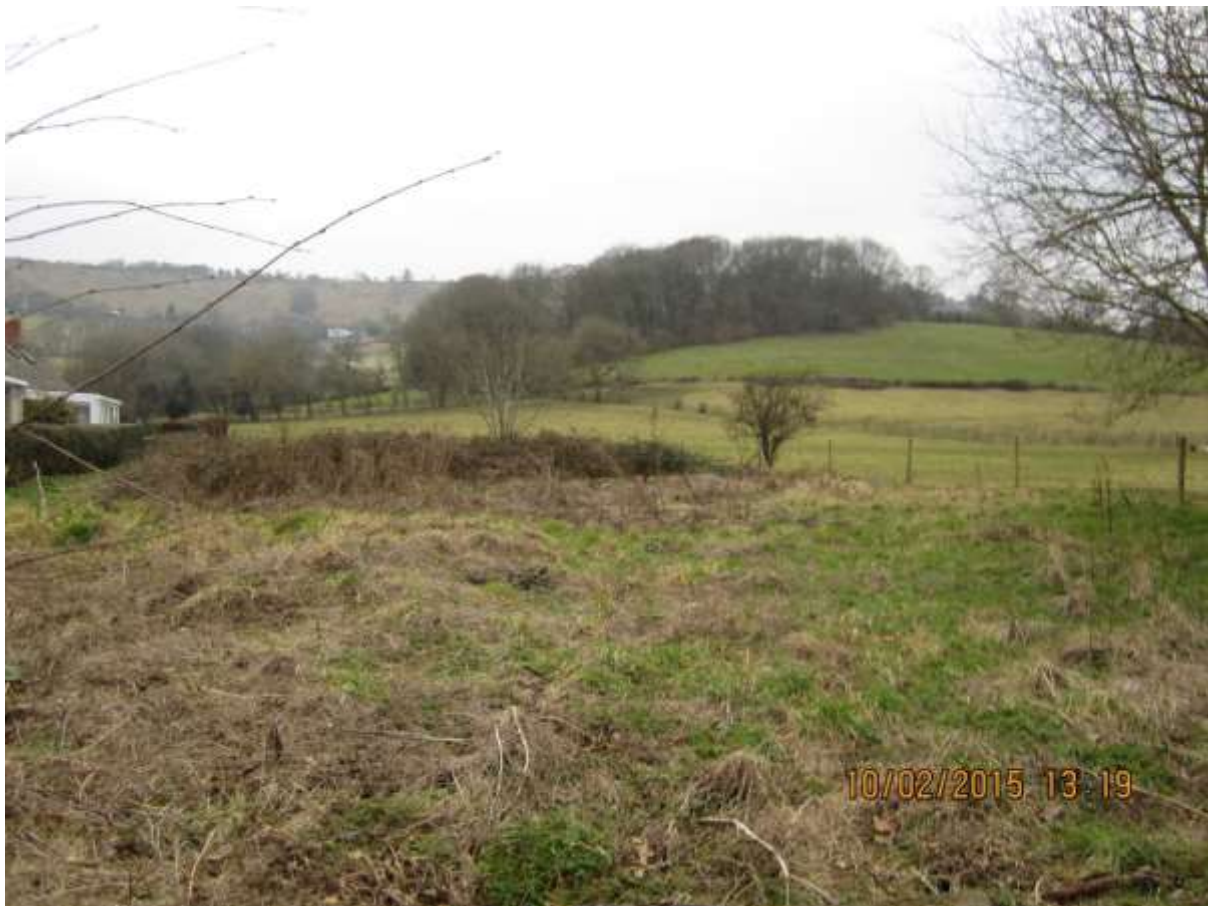
Figure 2-2: Site of Location B, situated in an area of rough ground and adjoining field. Looking south

The proposed bund is located over an area of rough ground and a field, currently divided by a fence. The field is laid to grass with horses grazing at the time of the survey. The area of rough ground consists of tall grasses and brambles with scattered trees. The land is relatively flat adjacent to the path and rises towards the south and the Cotswold escarpment (Figure 2-2).

The existing ditch runs adjacent to the public footpath and is separated by a fence and tall grasses. Towards the eastern edge where the ditch will meet the proposed bund, the ditch is very overgrown with brambles.
