# BRITTEN PEARNS ARTS

**Britten Pears Building  
RIBA 3 REPORT  
January 2025**

**de  
matos  
ryan**

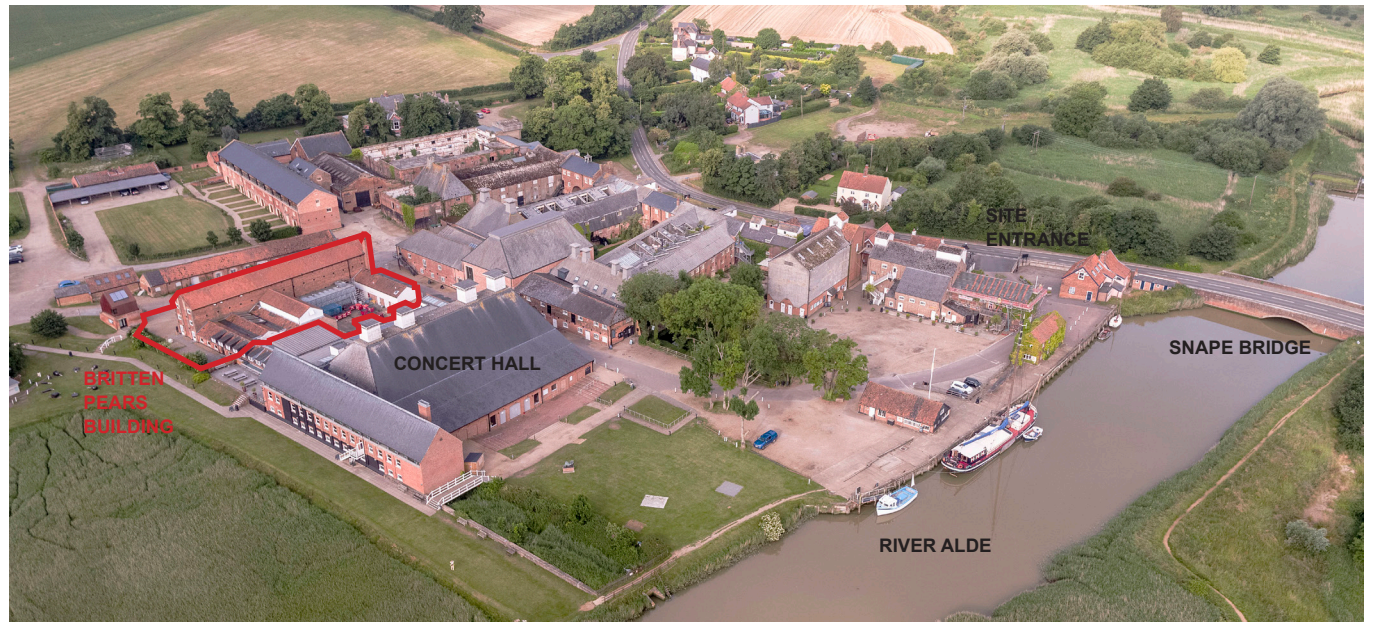
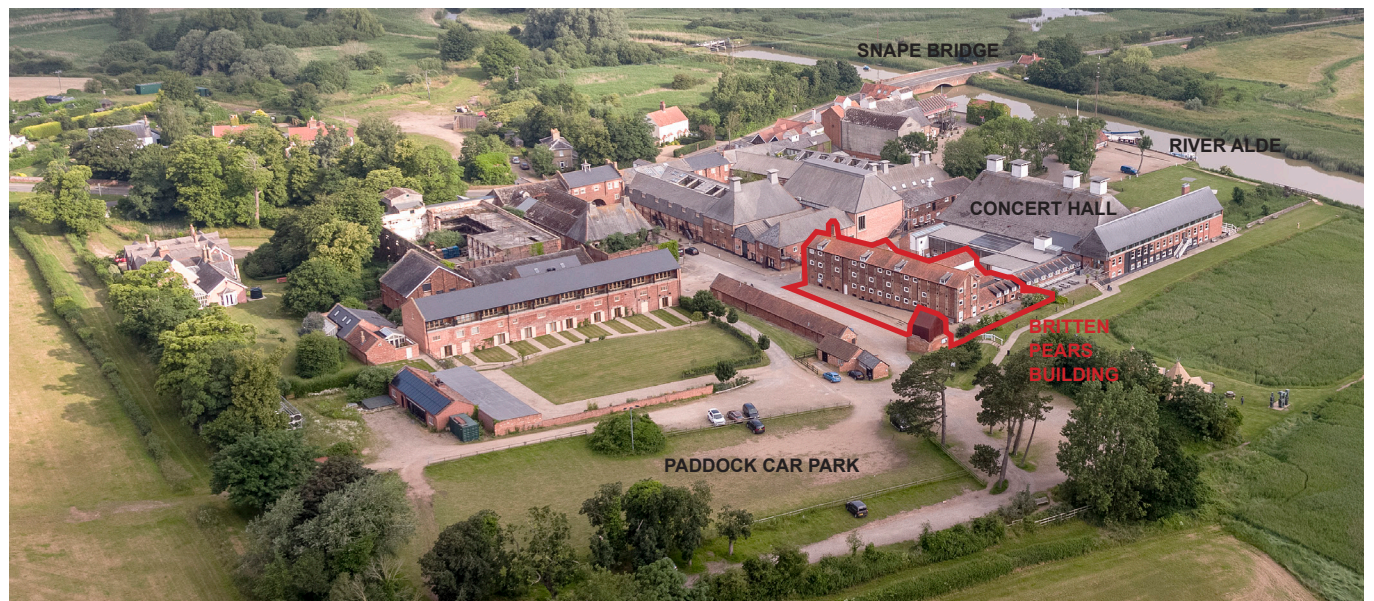
The aerial photos adjacent note the locations of the River Alde and Snape Bridge to the far North, and the Concert Hall directly North of the application building. The application building is ringed in red.

The Britten Pears Building is located on the Eastern edge of the collection of buildings at Snape Maltings. It is linked to the Concert Hall at its North Eastern corner, and shares a service yard with the Concert Hall, which is accessed via the central vehicular route through the middle of the Maltings site.

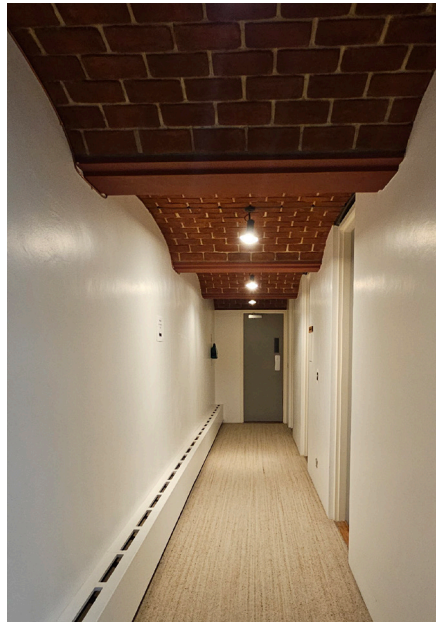
Photos showing the vaulted brick soffits of the concrete floor slabs

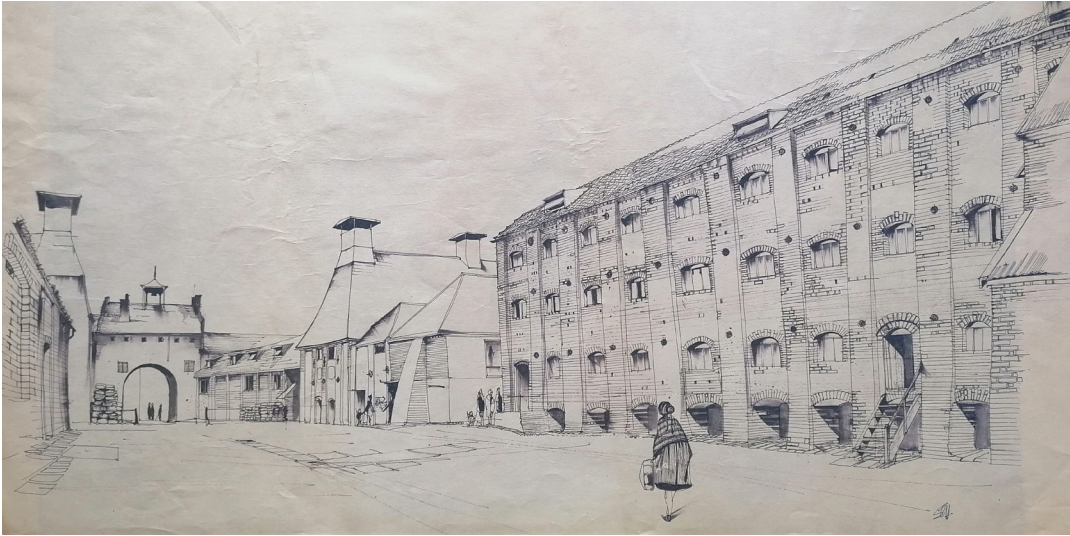
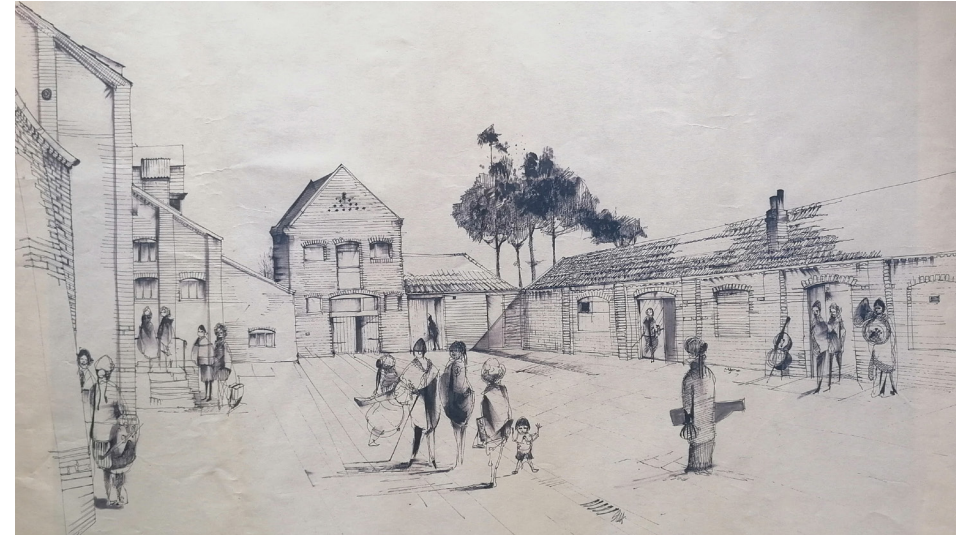
Artist impressions taken from Arup 1971 Feasibility report for extensions to the Concert Hall. At the time, the brief did not include the school of music, and instead called for exhibition space, a multi-purpose rehearsal space and a library

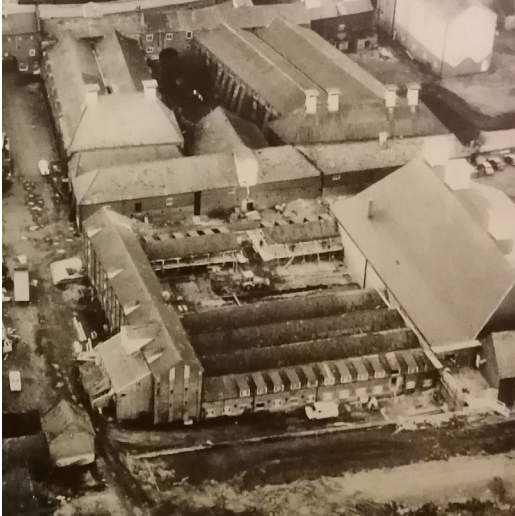
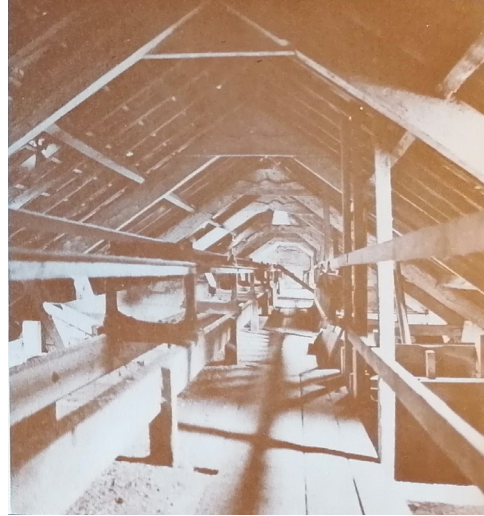
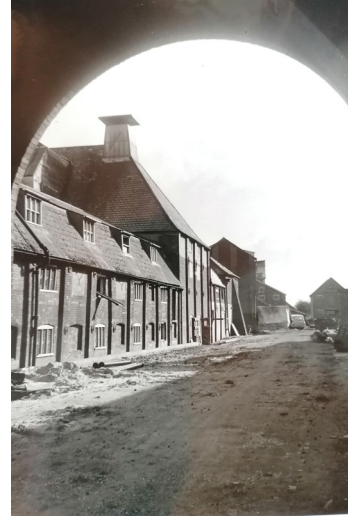
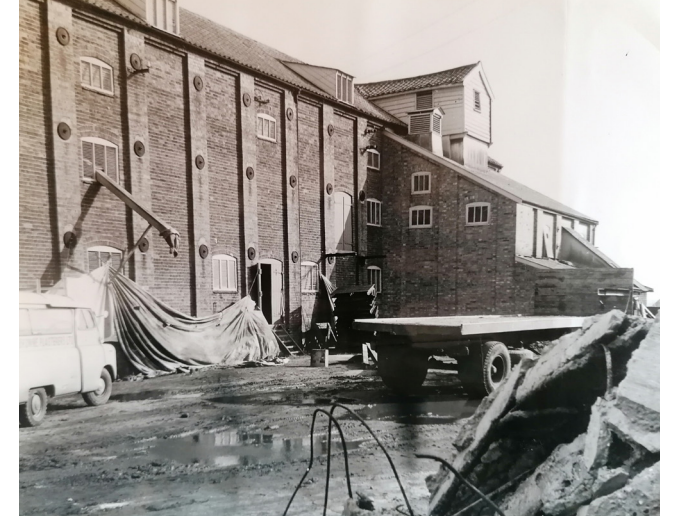
Photos taken of the site prior to the building works in 1977-79 for the conversion of the building into the music school

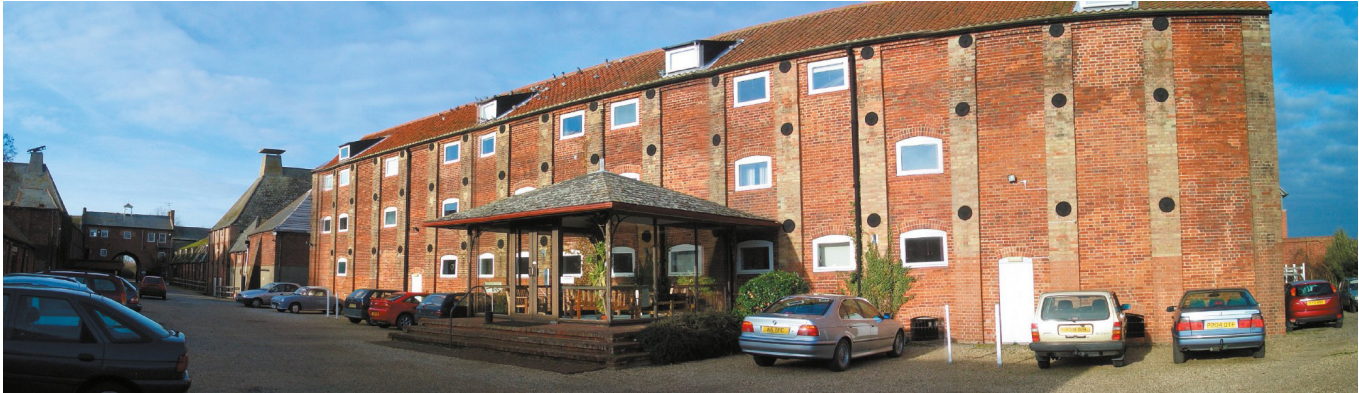
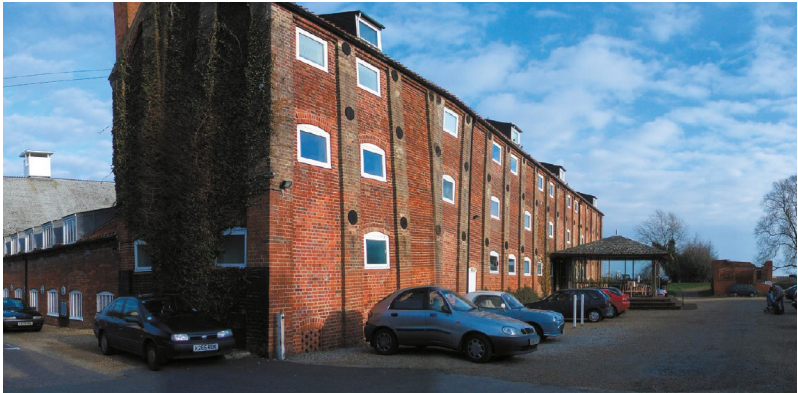
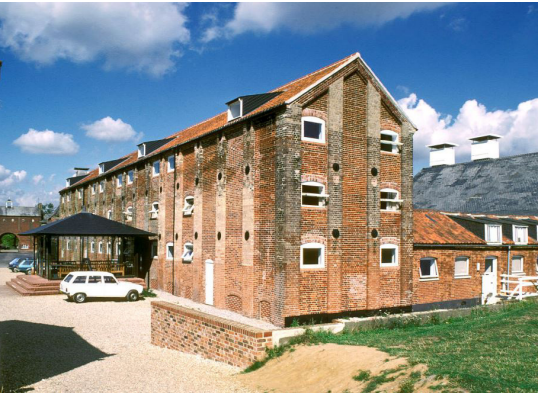
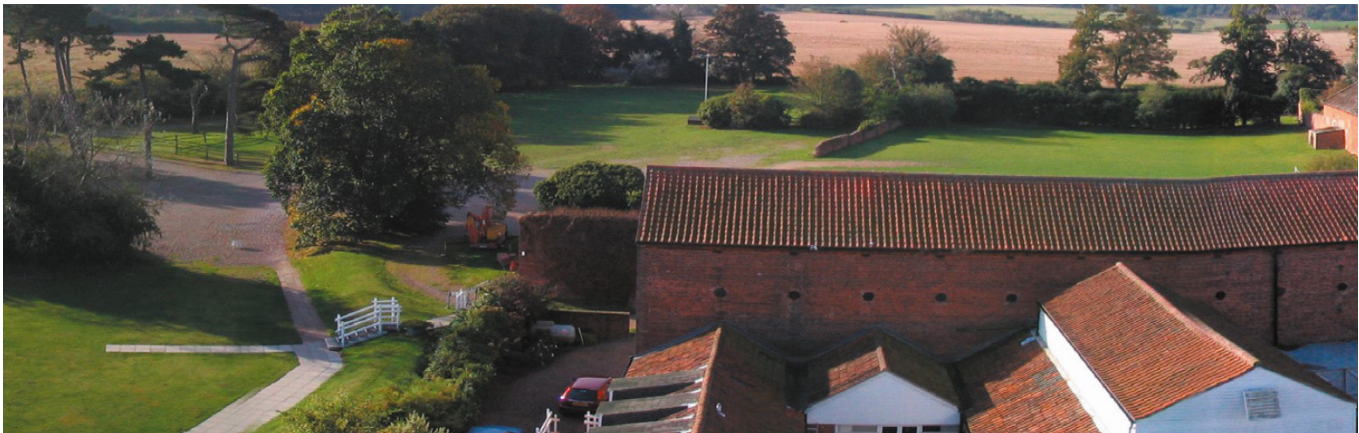
Photos showing the building condition circa 2005, prior to Trask Cafe works  
de matos ryan

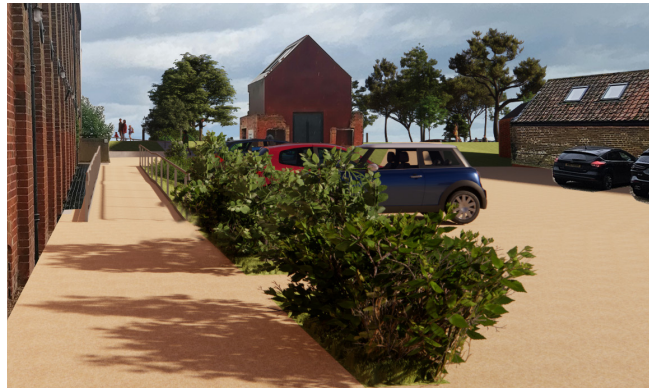
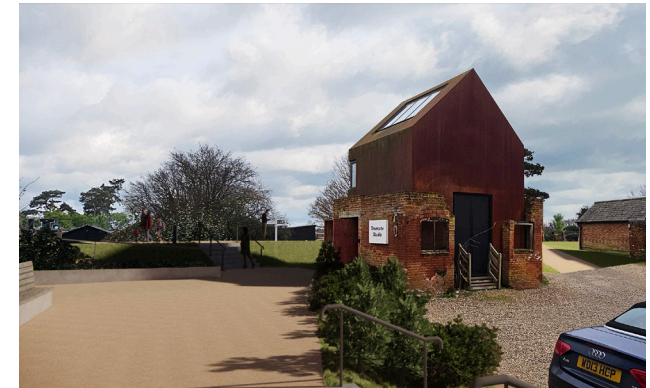
Top: visuals showing the newly surfaced and pedestrian route from 3no. newly formed blue badge bays New planting beds control and define the boundary between pedestrian and vehicle zones, and improve the frontage of the existing Dove Cote to the Eastern end of the parking area.

The existing building approach is over loose gravel ground in a geogrid which is not suitable for wheelchair use or users with mobility or visual impairments. The proposed works aim to replace this construction with a bound surface, along with handrails to the ramped route and the stepped route.

The proposals replan the parking area to provide 3no new Blue Badge accessible parking spaces at the end of the ramp, and define a clear boundary between the public footway zone and the vehicular area using planting.

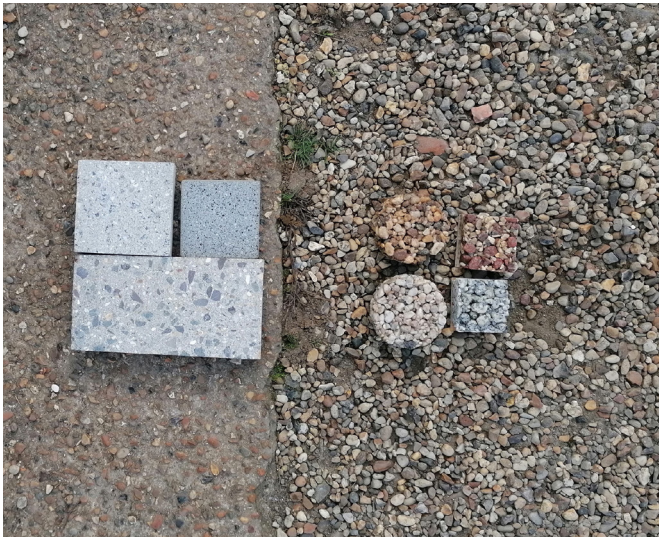
Testing samples of gravel options and step materials on site against existing loose gravel and concrete with exposed aggregate

The proposed new landscaping surface dressing is to use bound gravel in a mix that is sympathetic with the existing aggregate found around the site in the concrete and loose gravel finishes.

For the stepped route, this will be in precast concrete to match the flood defences stepped routes.

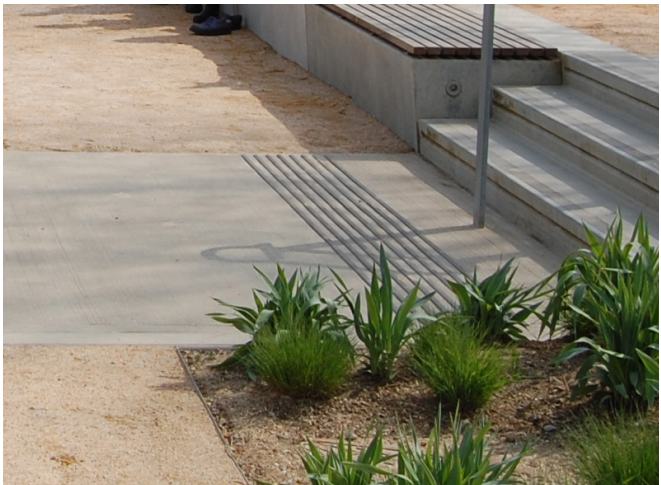
Options of gravel aggregate specification being considered

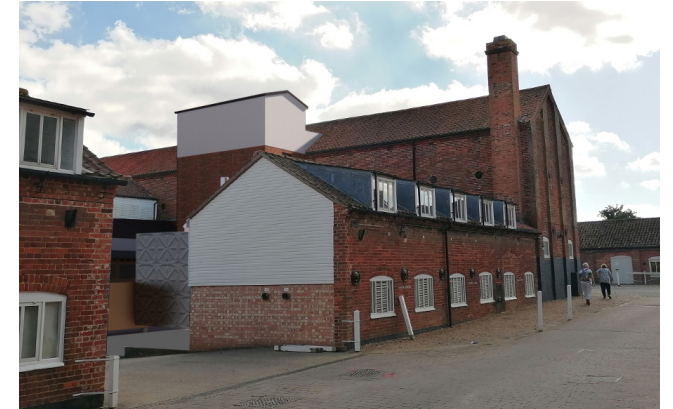
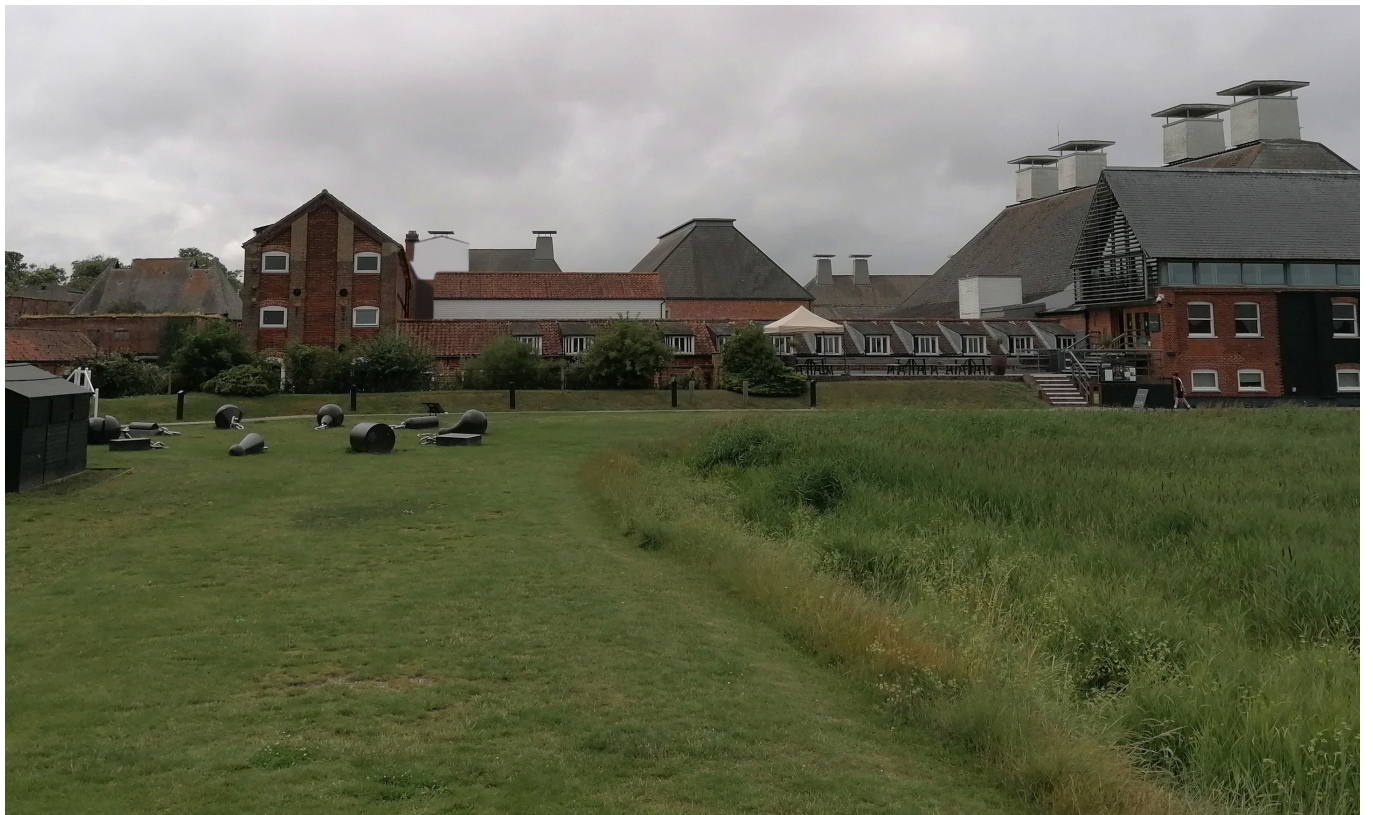
The design that was presented in the Pre Application Advice stage is presented on this page for reference. A meeting was held with ESC officers on 13.11.2024 to review the developed design approach presented on the following pages, which was welcomed as an improved design.

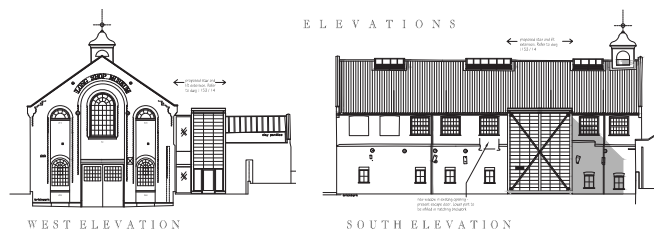
Elevations from a reference planning application in the ESC district which was consented at Long Shop Museum in Leiston, for a new lift and stair core structure against a listed building. This design took the approach of a distinct and modern design for the new element, rather than trying to appear as an original part of the historic building.

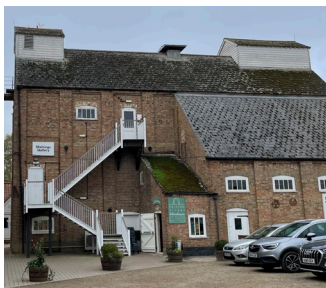
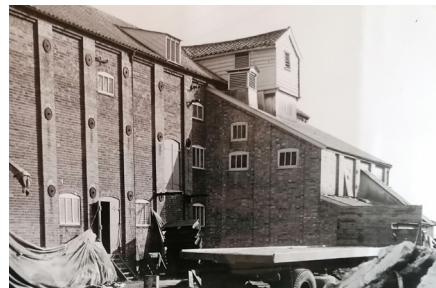
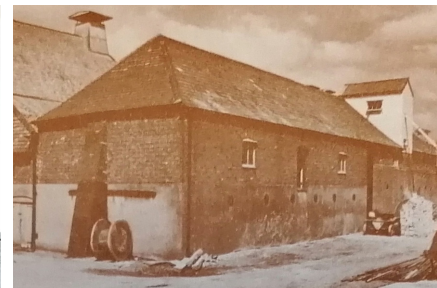
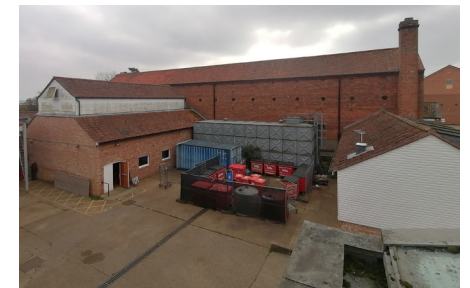
The concept proposal for the massing is to present a simple form that reflects the lucam roof features around the maltings site, and the forms within the service yard of the Boiler House and the Recital Room, which both present a gable end of very similar proportions and materiality.

Typical of these was a roof plane running perpendicular to the main roof, and then simple openings on one or often two sides, to enable communication with workers below, but also more importantly to pass items out so they could be lowered to below. Therefore we propose some openings punched into this form, to provide views out and daylight in.

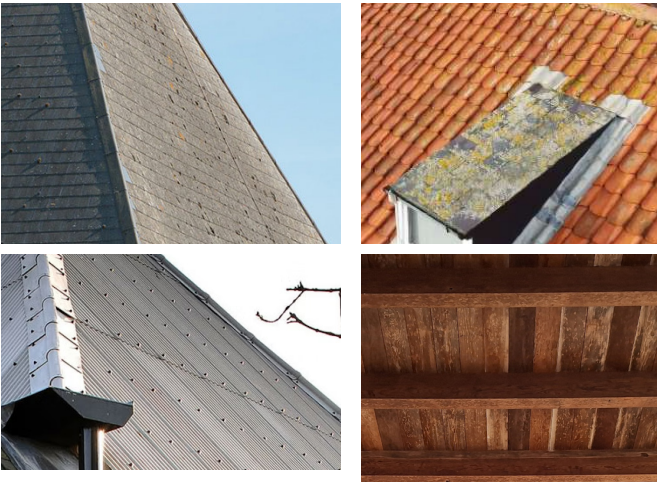
Roof coverings and external soffits  
Slate tiles, Clay pantiles, Corrugated Sheet, Timber soffits

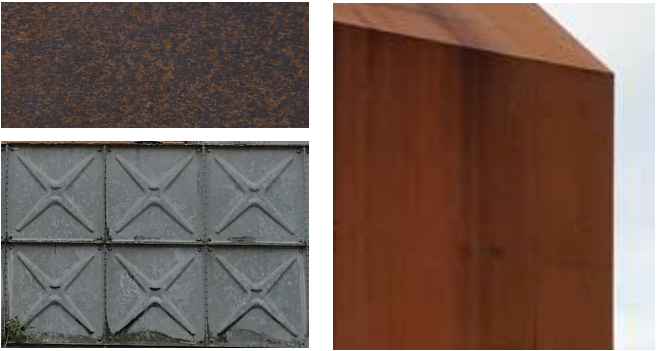
Dark weathered metal cladding  
Pre oxidised copper. Corten steel, Galvanised Sprinkler tank

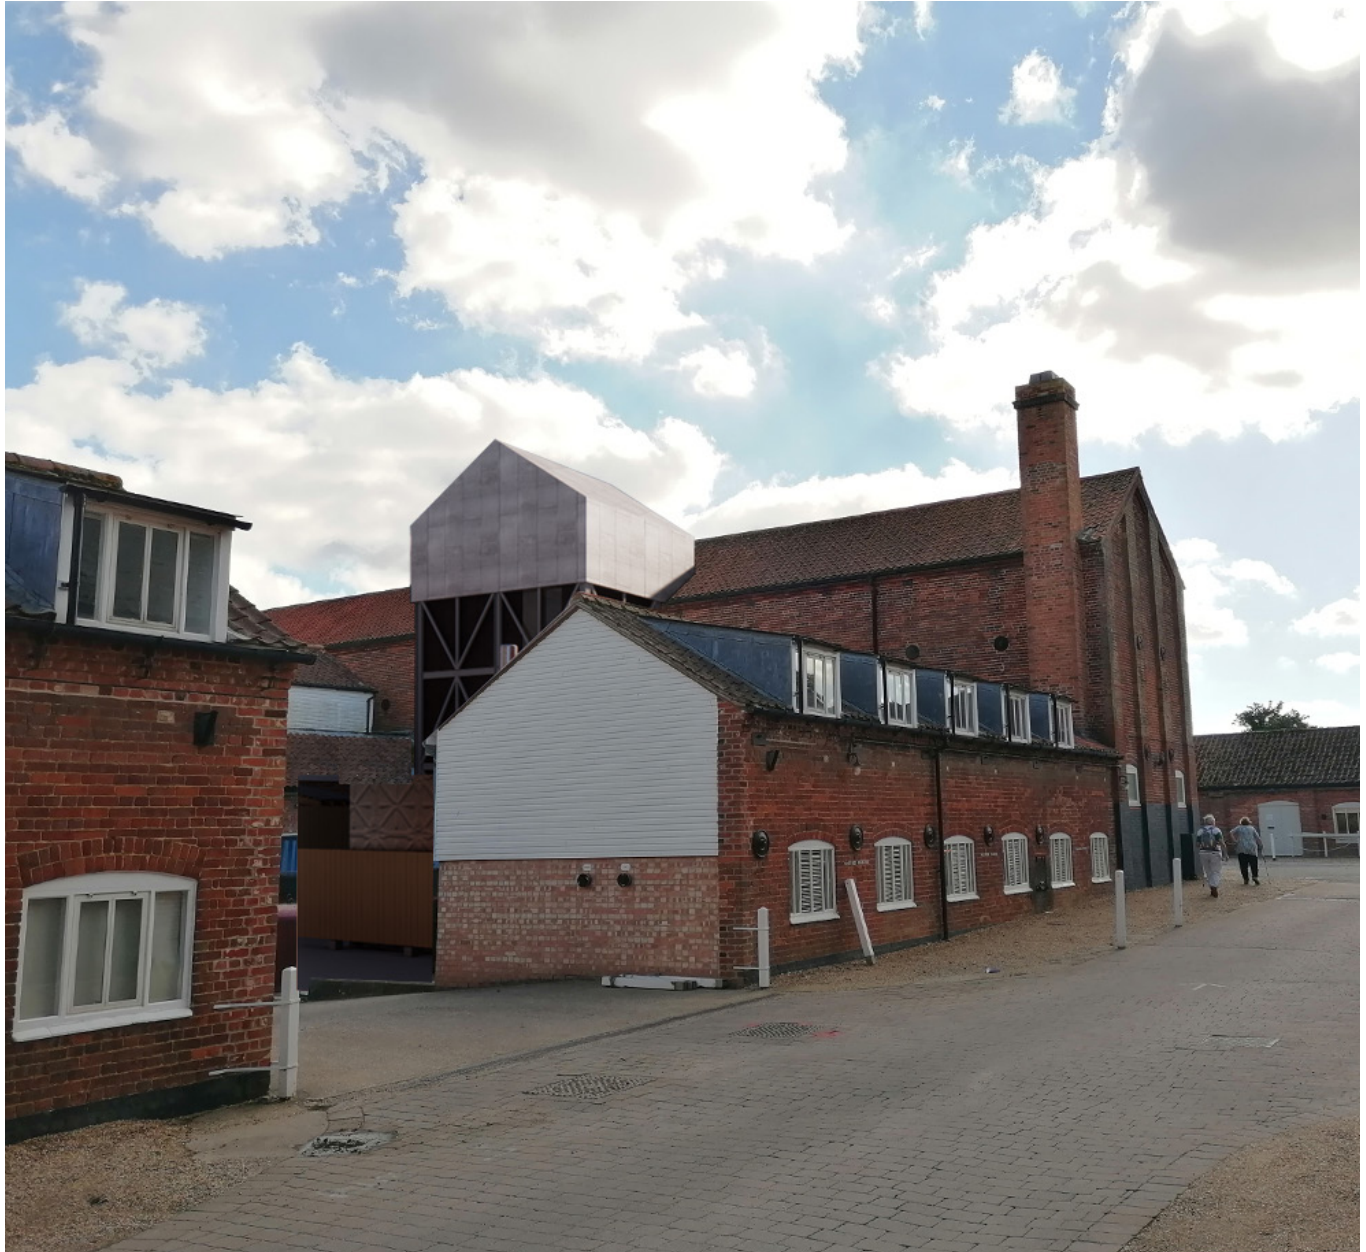
The developed design proposal suggests a new lucam within the Maltings roofscape. While familiar in geometry, it is distinctly modern with galvanised sheet steel cladding to the upper form, and darker weather metal cladding to the lower section to create a backgrounded volume. The expressed external structure will be light to match the tone of the upper volume, to enhance the impression of support to this geometry.

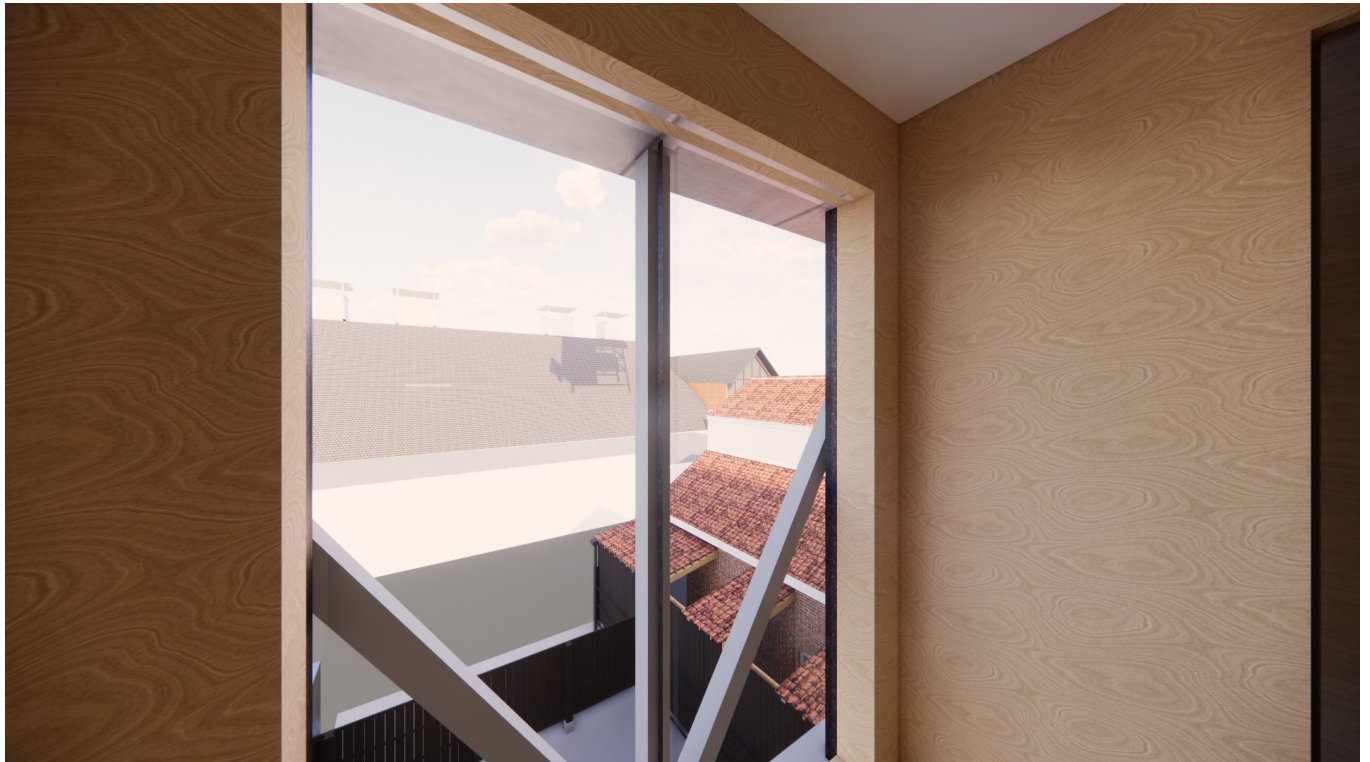
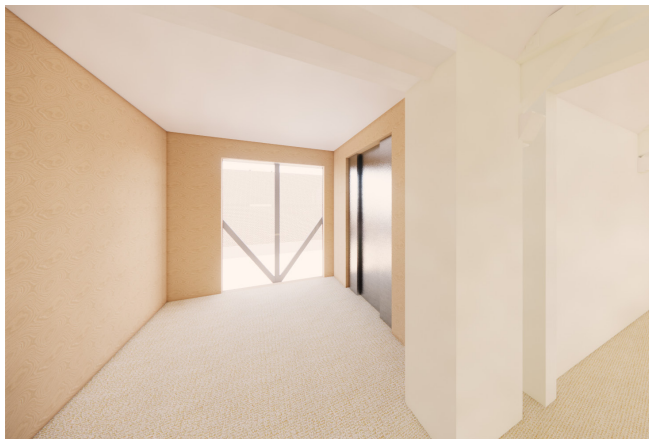
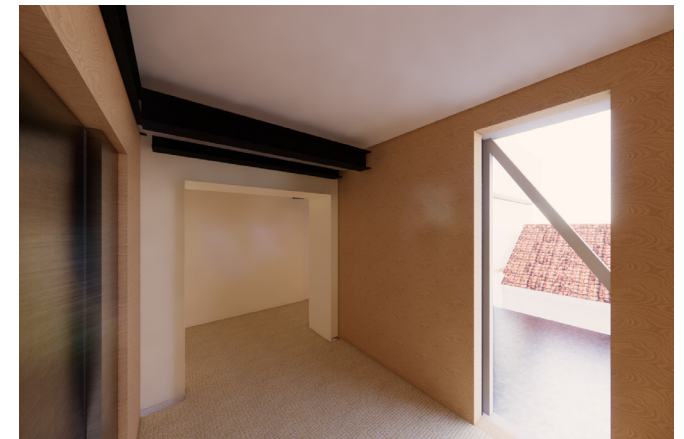
As users will be delivered at the top floor of this new lift tower, they will be afforded rare views across the Concert Hall roofscape and beyond. To take advantage of this opportunity, and create a celebratory welcome to the new public venue of the Cranbrook Room at this level, we have proposed a feature viewing window at the second floor of the lift lobby, looking North.

A the first floor level, we propose a secondary viewing window looking West, towards the Hoffmann building.

Both of these windows provide the benefit of natural daylight into the single aspect building, which is crucial on the first floor where the circulation spaces are currently lit only by artificial sources.

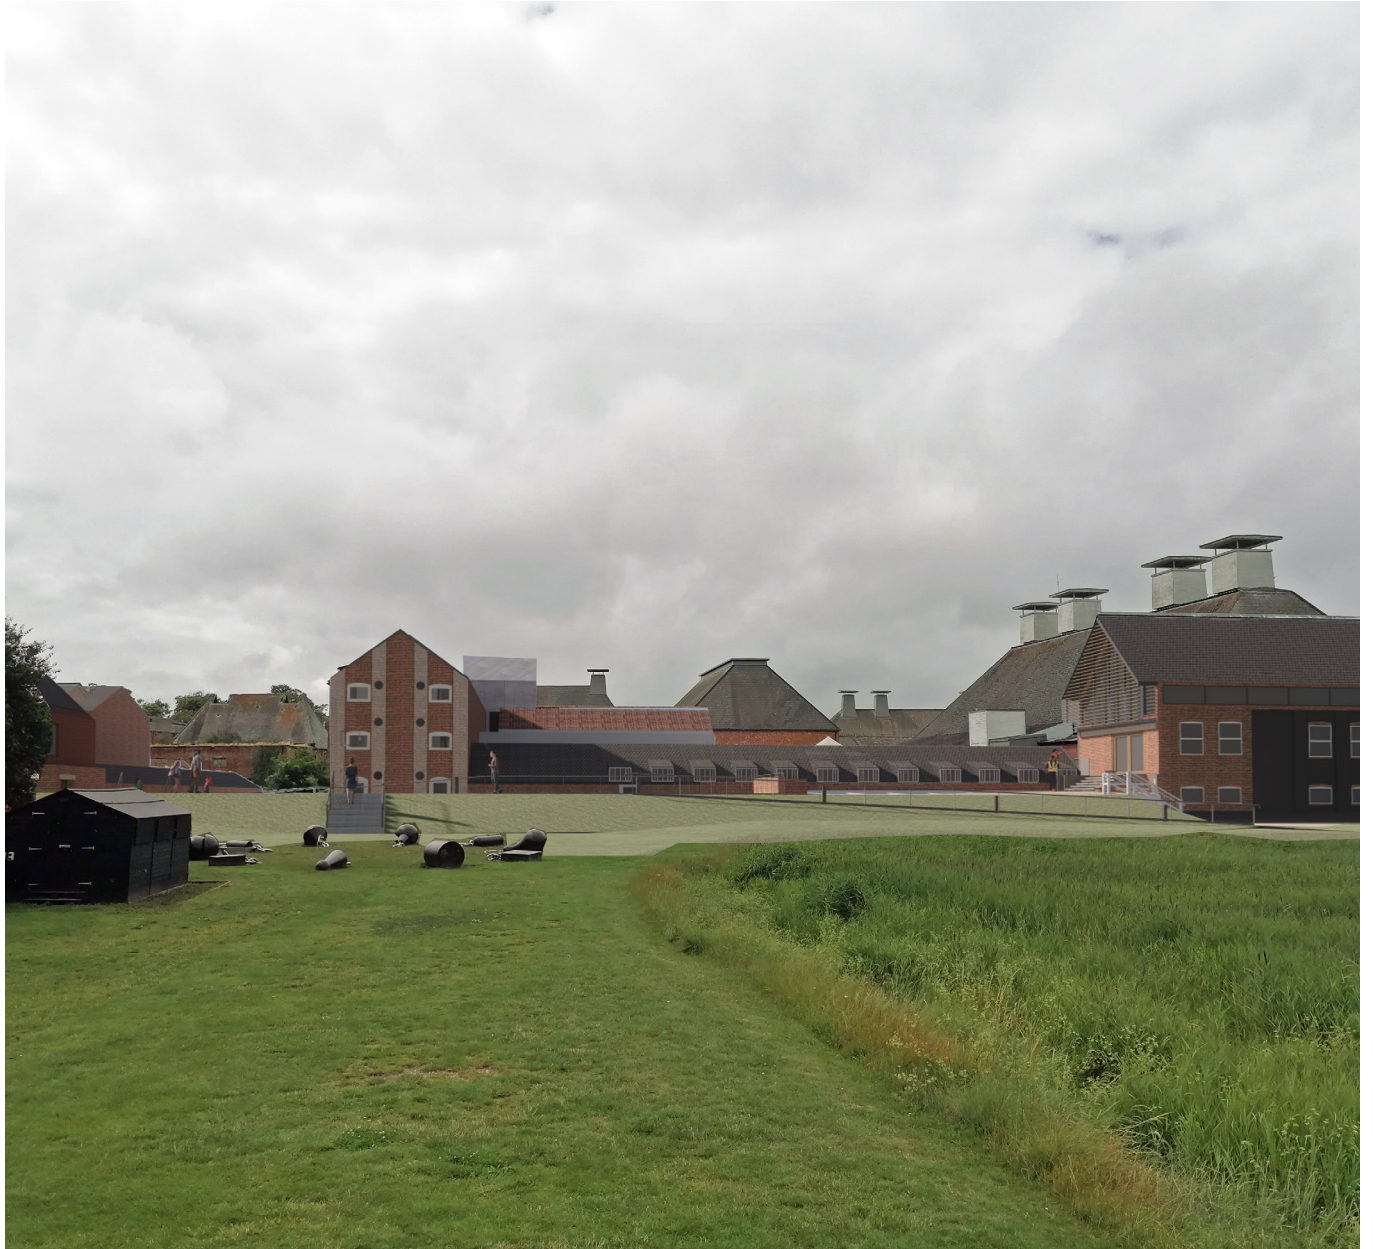
When viewed from the Barbara Hepworth lawn and the reedbeds beyond, the new lift tower roof and massing aims to be reflective and light against the existing roovescape of the Maltings.

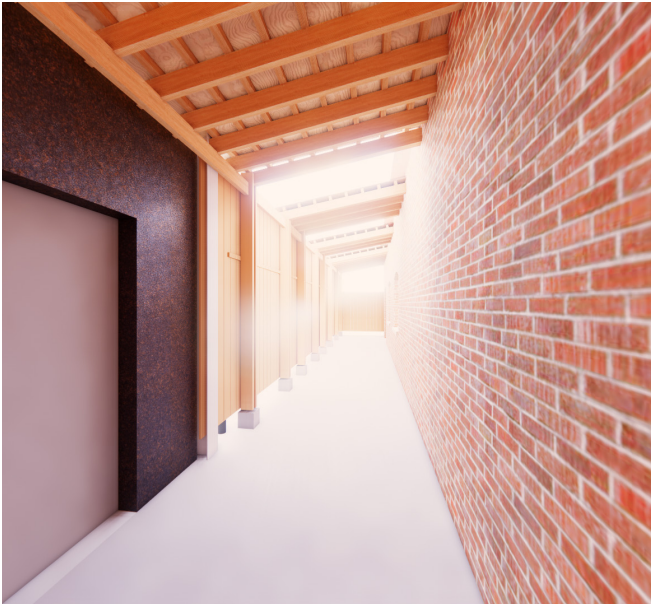
Access to the Recital Room will be possible via the external exit at service yard level. A new covered route will be provided from this point to the Recital Room side door via a cloister with rooflights in its pitched roof to allow daylight into the route and into the Recital Room via the side windows, which is useful for school groups.

Visual of route from external exit of lift, via cloister, to Recital Room side door

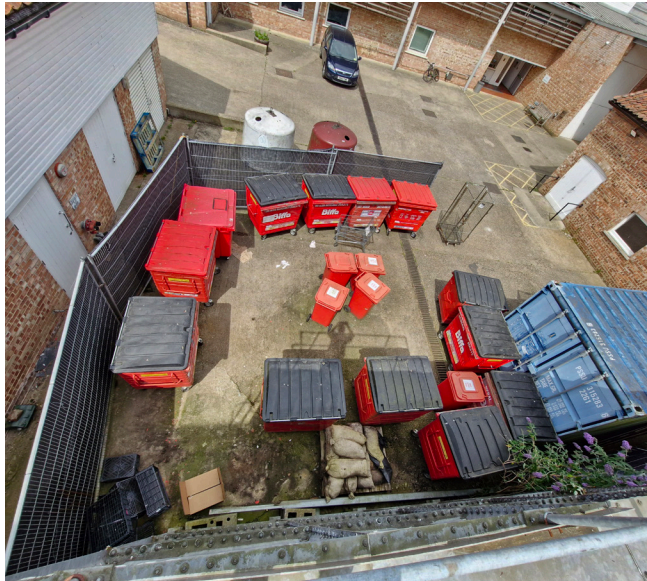
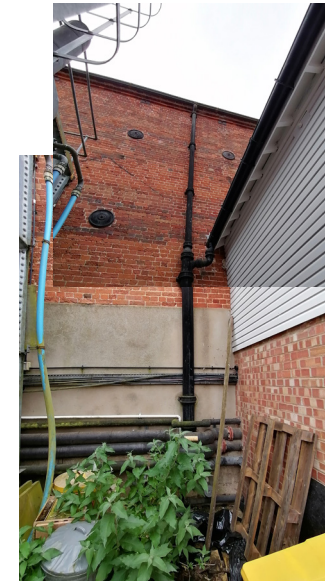
The sprinkler tank is 136m<sup>3</sup> and made up of 90no. 1.2 x 1.2m modules. It has been inspected for asbestos and none was found. However it is coming to the end of its service life of 25 years, so it is unlikely we can relocate it and still receive a warranty for use. So it would be sensible to procure a new tank as part of the works. It is assumed the sprinkler system to the concert hall must be retained for insurance purposes, and that it will need a secondary means of power, which the existing tank does not benefit from.

There is an ad hoc refuse store area in the yard that houses 13no. 1100 litre bins and 5 wheelie bins and 2 bottle banks. There is a need to rehouse these in a visually appealing way to avoid views from the recital room.

The new lift is being designed to provide evacuation in a fire event. Therefore the new bin store compound needs to be isolated from the new cloister egress route via a fire rated partition wall to ensure there is no risk from a fire event within the bin store itself jeopardising egress from the building.

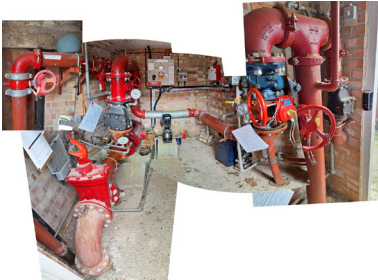
The Sprinkler system was first installed in 1969 during the re-construction after the fire in the Concert Hall. The original pipework ran to a tank located in the current Winch Gallery. When this area was re-developed in the late 90s to create the current Winch Gallery wing with staff offices, recording studio, lift and WCs, the old tank was removed and the current tank was installed in the boiler house building to serve the system, with the fire brigade inlet. Adaptations to the below ground pipework were undertaken to connect to the retained sections of pipe as shown on the adjacent drawings of the 90s installation.

There is no secondary power provision to the pumpset at present, which a modern sprinkler would require. A modern installation would also require 2 pumpsets to be present, to cater for mechanical failure.

It is not feasible to install a biofuel generator or Battery power back up within the boilerhouse for the sprinkler tank to provide a secondary power source in the event of failure. However within this workstream the proposal is to provide a diverse route from the main electrical panel in the boilerhouse. This will not bring the system up to the latest regulations of BS12845, but will improve the system resilience.

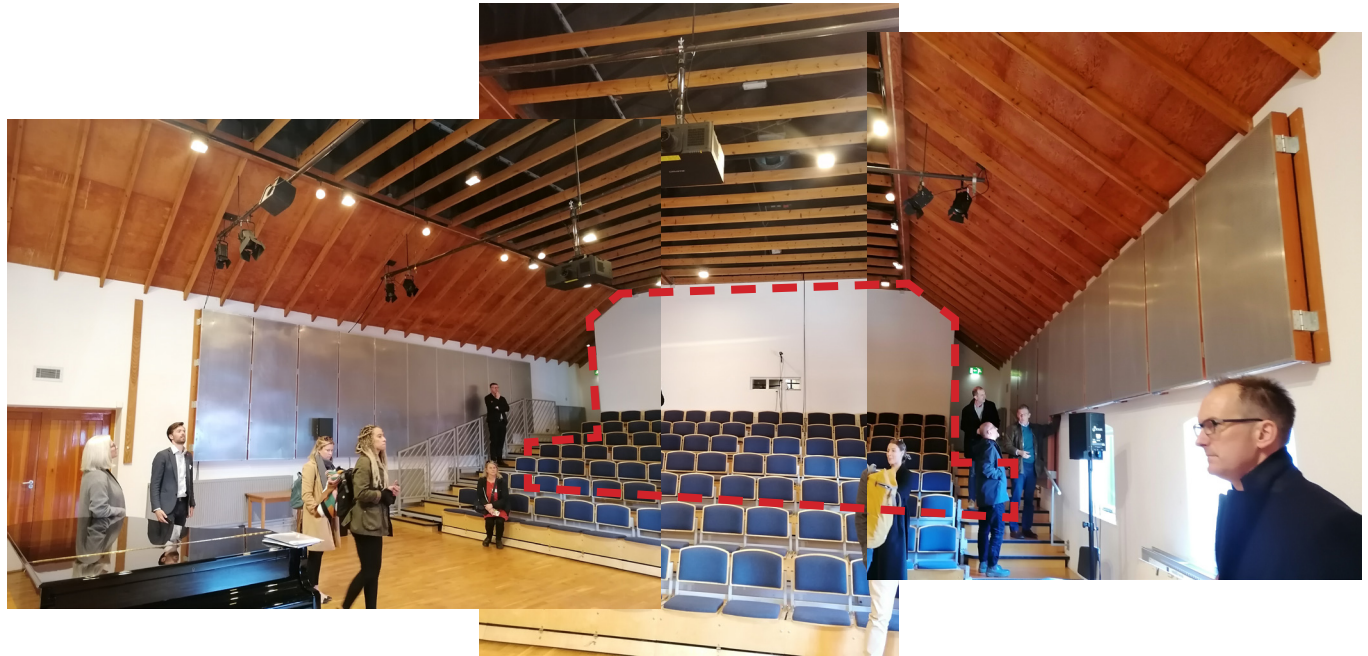
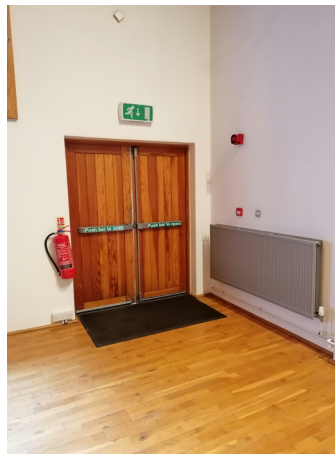
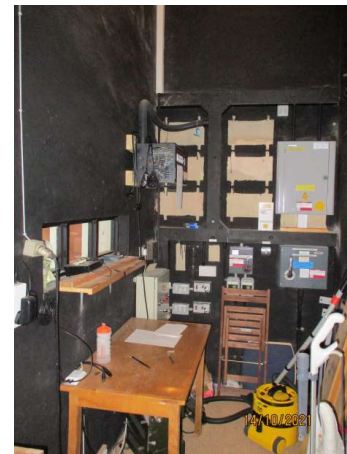
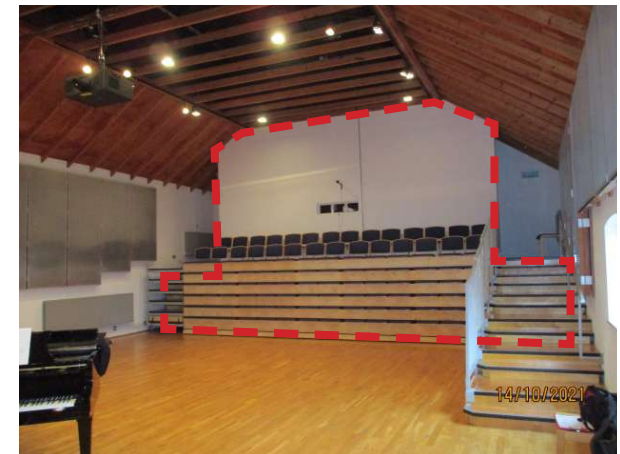
Photos of the existing Room. Red dotted line denotes the zone of demolition to remove the existing projection booth along with the sound and light lobbies

The room has undergone acoustic testing as part of the design development, and it is proposed that the wall panels are deployed in their reverse state, with curved timber plywood side exposed, for the baseline acoustic performance.

A high level drape track exists in the clerestory volume of the roof. This has a box to retract into, so it is completely cloaked acoustically when not deployed. The proposals seek to replace the drape track and install a new motor to automate its deployment and enable more variety to the room acoustic.

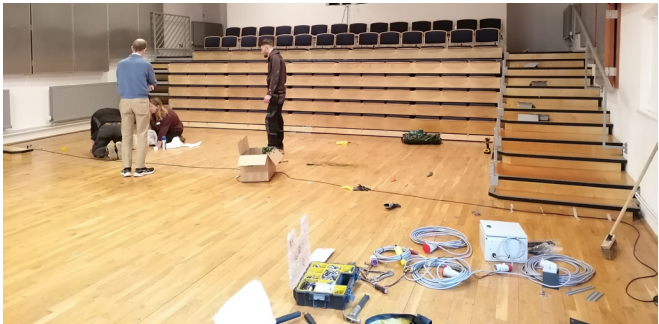
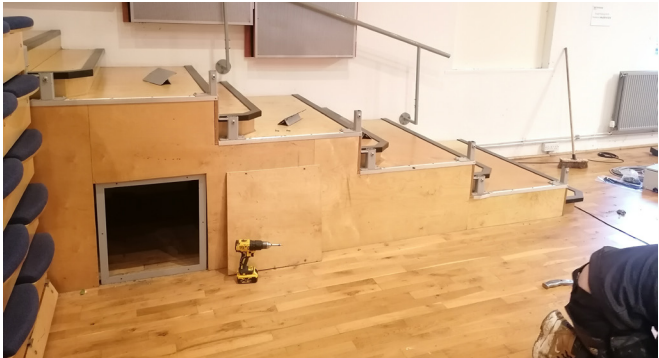
Photos taken during repair works to the tiering conducted in Jan 2025.

The tiering was repaired by Auditoria Services in January 2025. They replaced the motors which had failed, and the system is now running well again. No further works are planned to these, other than to move them forward to enable the construction works to the rear of the room.

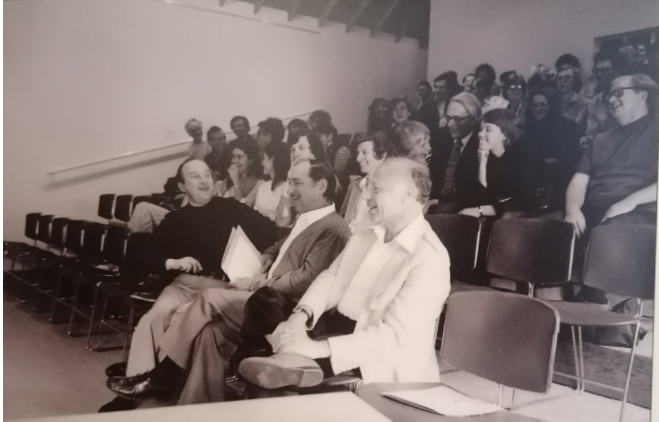
Photo of the room taken in 1981, 2 years after opening. Note the lack of acoustic wall panels and retractable seating

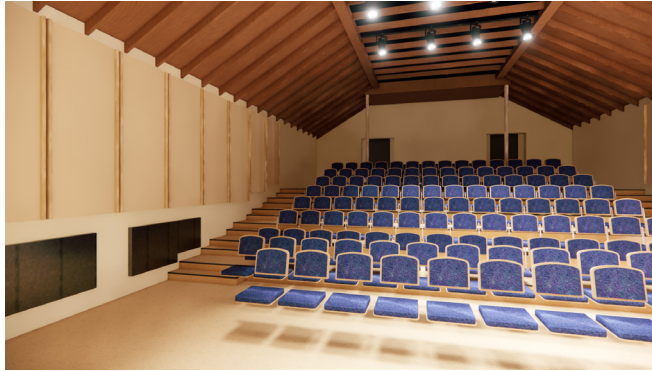
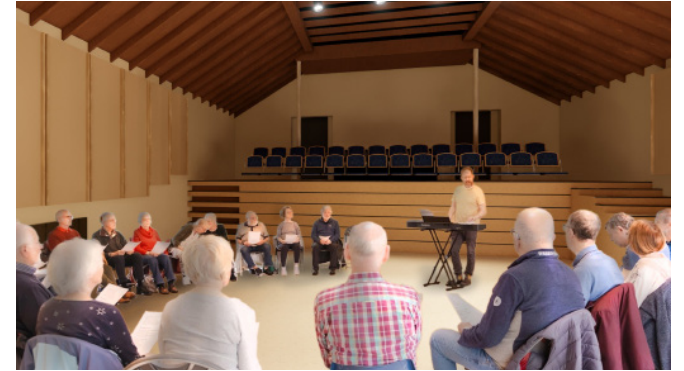
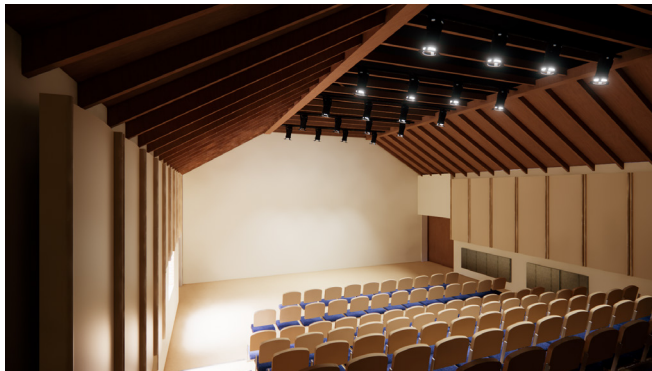
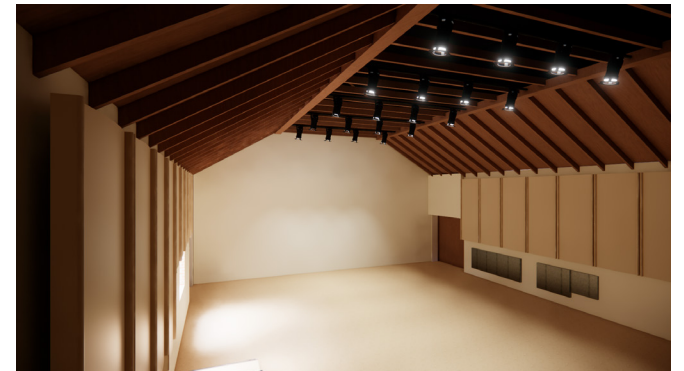
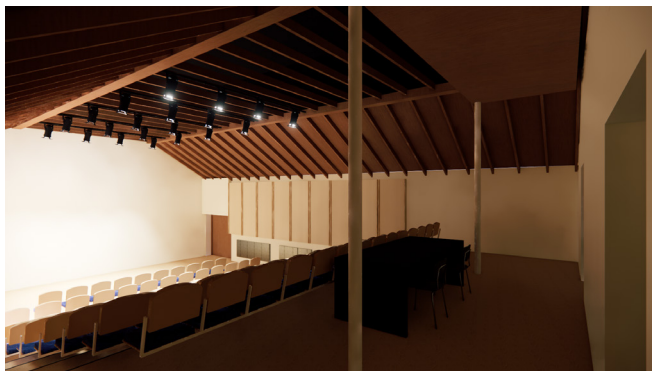
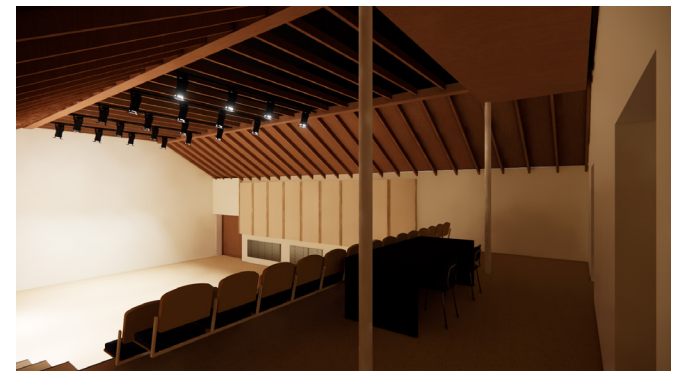
Views of the revised room layout - tiering deployed

Views of the revised room layout - tiering retracted

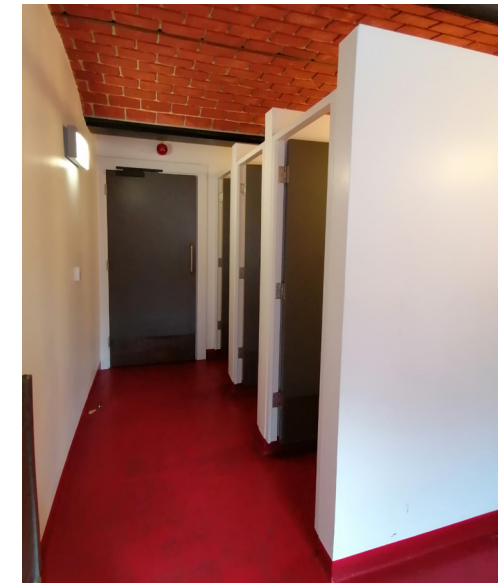
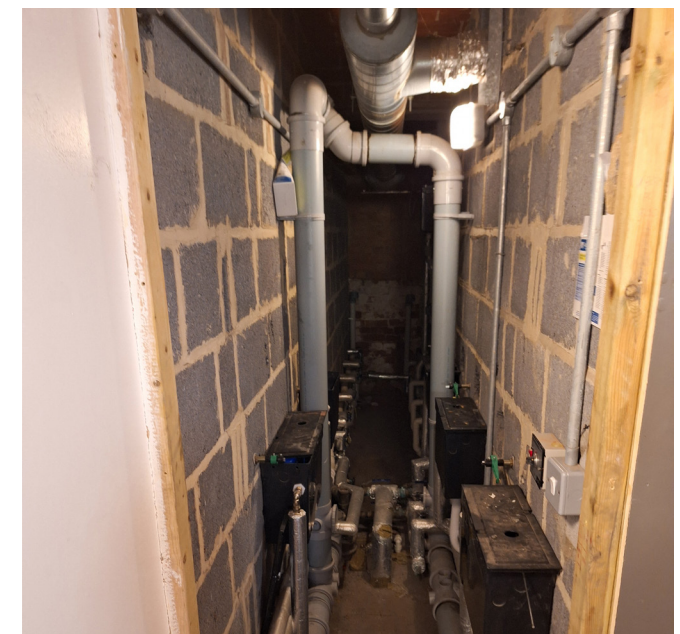
The WCs underwent some minor changes in 2010, as noted on the adjacent drawing, but in general they have remained the same since the 1979 ARUP works.

The cubicle depths are not generous, failing to deliver the 450mm dia turning circle clear of the inward opening door swing, and so use of them is challenging. There are no enlarged or ambulant cubicles. There is 1 no Accessible WC which was constructed in 2010.
