# BRITTEN PEARNS ARTS

**Britten Pears Building  
RIBA 3 REPORT  
January 2025**

**de  
matos  
ryan**

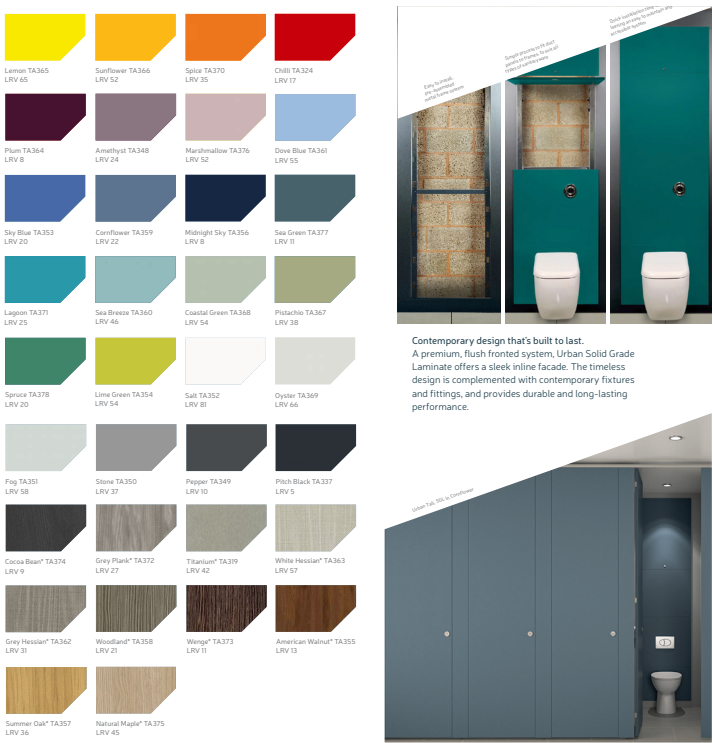
Proposed Cubicle and IPS system and range of finishes possible

The proposal is to remove the service void between the Male and Female spaces, and instead re-plan the area to provide a more accessible provision of cubicles to suit modern requirements. An IPS approach will be installed for services access. The 1no Accessible WC provision will be retained, but moved to suit the layout change.

The ceiling finishes will remain unchanged, and the painted concrete screed to MWC and mosaic tiles to FWC are to be removed and replaced with new ceramic tiling. The plastered blockwork walls will need to be demolished, but new dividing walls between spaces will use this material approach. Cubicles will use a mix of neutral tones to suit the existing materiality of the building.

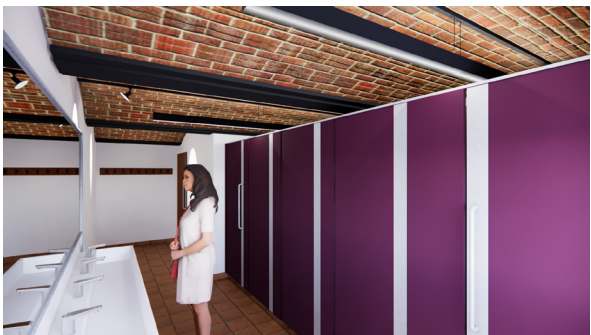
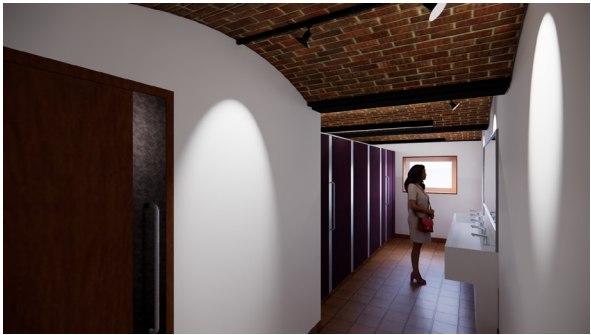
Proposed Female WC

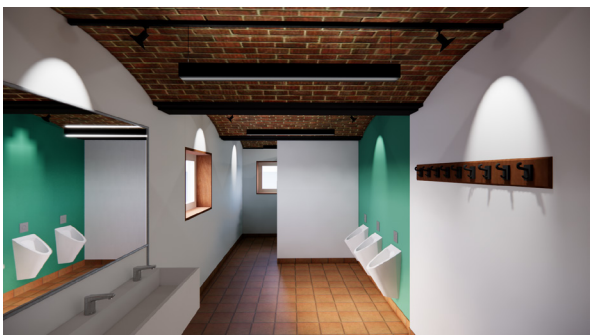
Proposed Male WC

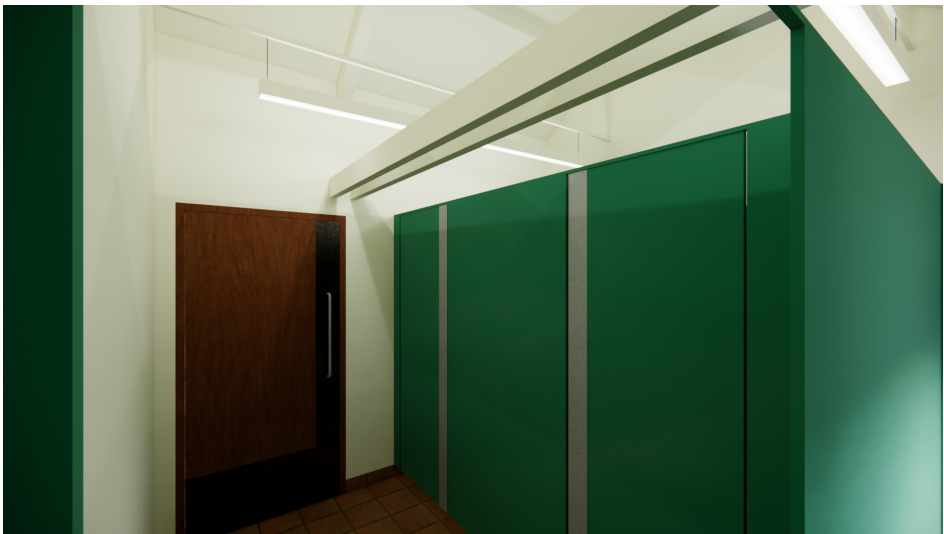
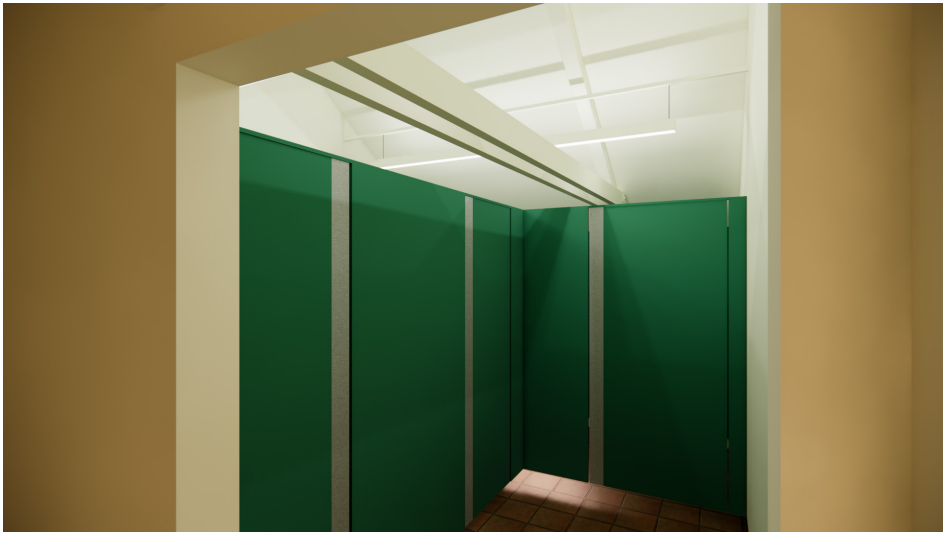
In addition to the gendered provision at ground floor level, a new non gendered set of cubicles will be provided on the second floor level of the building to support the proposed public use of the Cranbrook Room as a performance venue. This provision will include 2no cubicles and 1no Accessible WC space.

Proposed Second Floor Arrangement

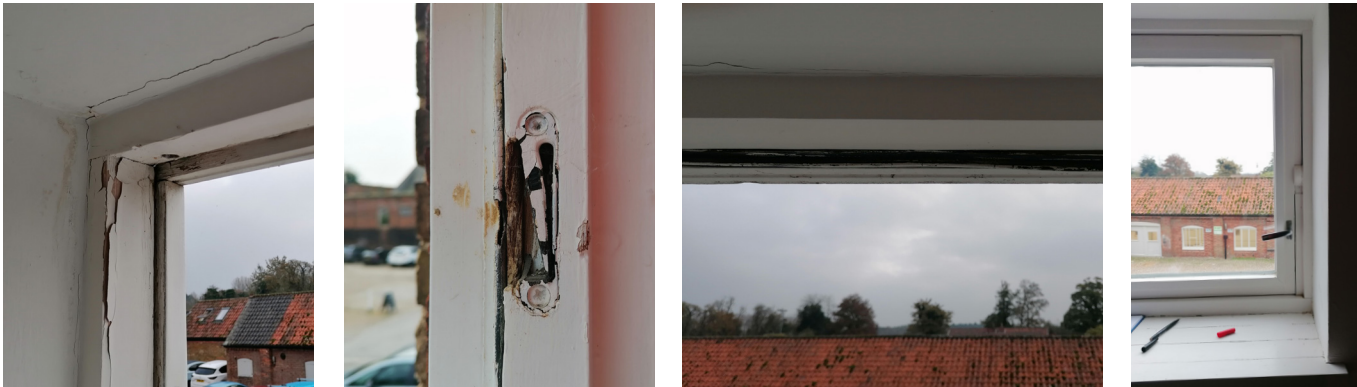
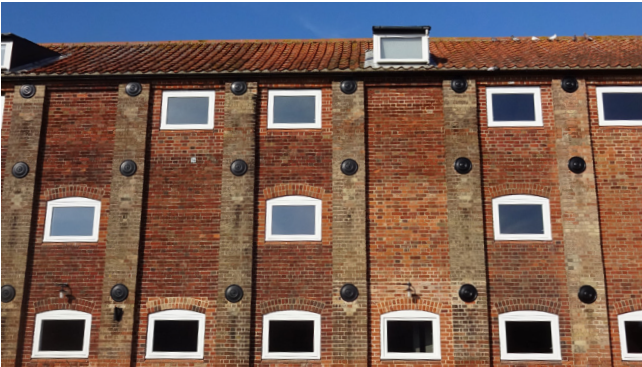
3.7.25. Windows

The existing windows are timber framed and painted white. A feature of the Maltings site is that the windows are often painted an off white colour which varies around the buildings on site from pale peach to light grey.

Most of the windows are in good working order, with double glazed units added in the past 10 years. Some units have failing keeps for the handle fasteners, so these will be replaced. Some units are missing compression seals or the seals have failed over time, so replacement seals will be installed as part of a typical maintenance procedure.

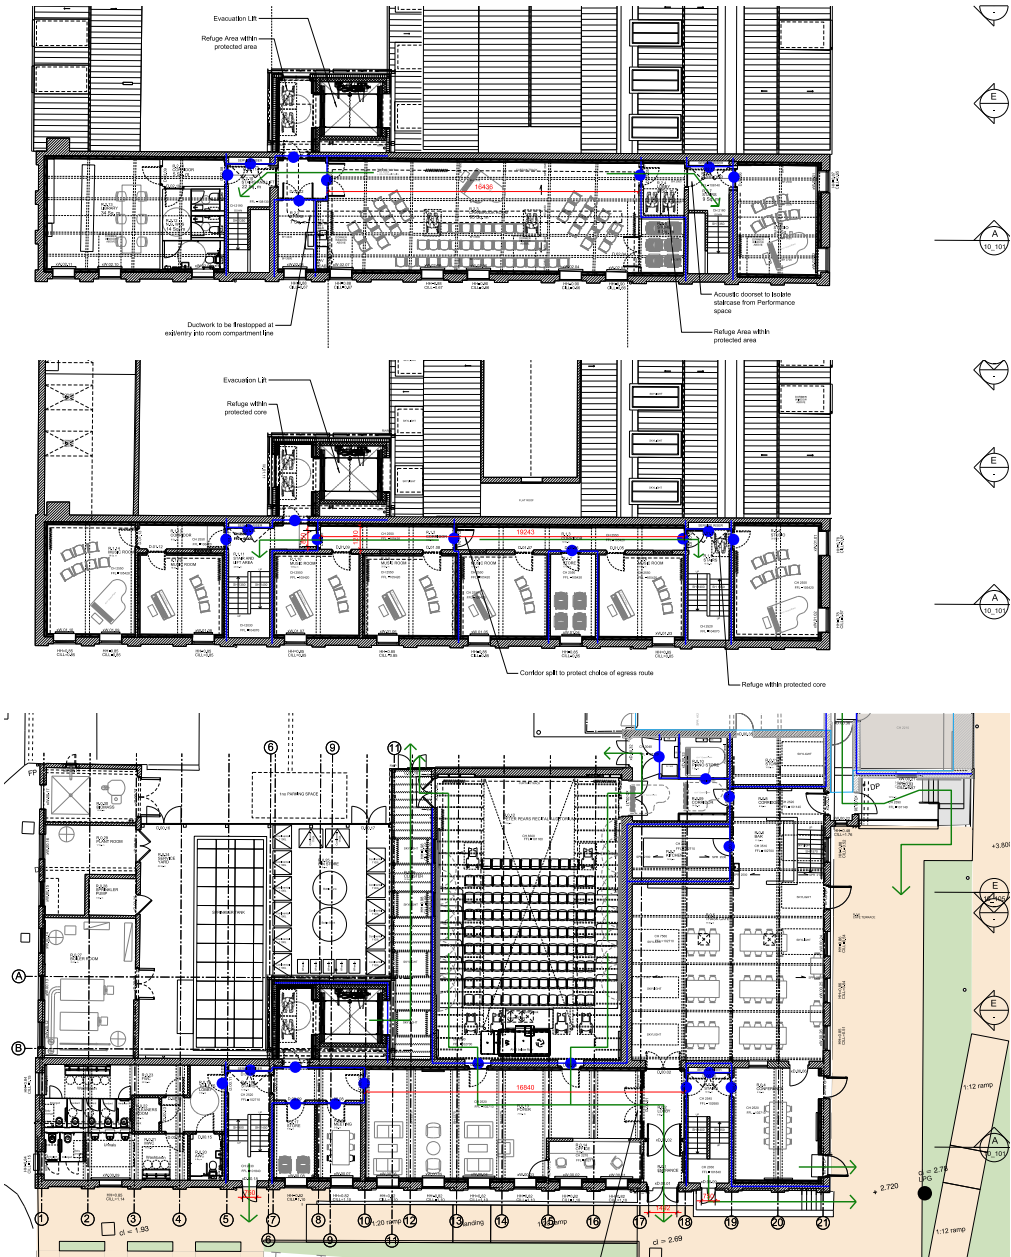
The adjacent drawing records the review of the wider site fire fighting access and strategy, with a focus on the BP building.

Generally the building is well accessed around its perimeter and is below 11m in height for a fire appliance to serve. It is beyond 100m from the site fire hydrant, so it is expected the Fire Brigade would need either refill from the Sprinkler pump inlet, or drive off to the hydrant.

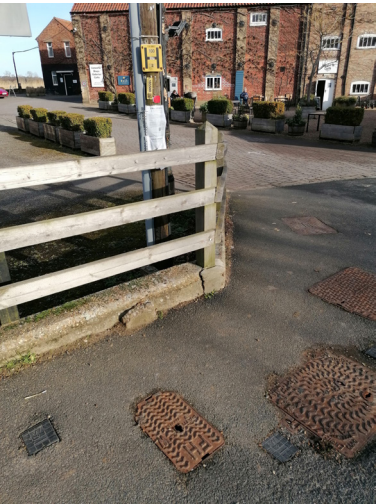
Existing mains fed hydrant at North Western corner of the site at main vehicle entrance route

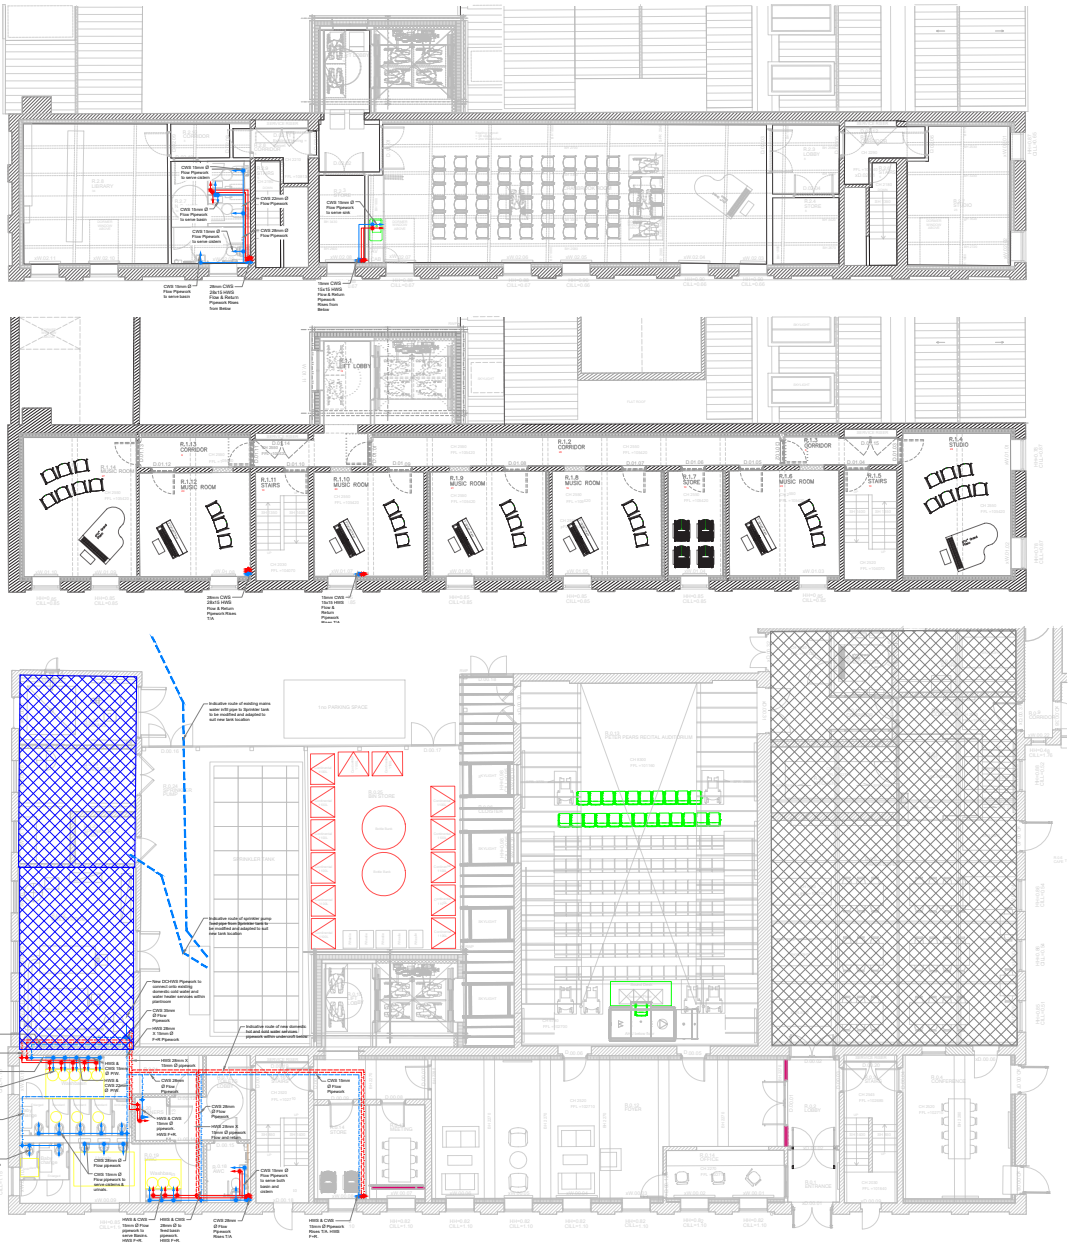
All new pipework shall be in copper and fully insulated with mineral wall silver foil faced insulation and identified accordingly.

A new vertical riser for pipework will be established to serve the second floor additional provision of WC and kitchenette, and will be concealed internally in the building via new wall linings or additional boxing if needed.

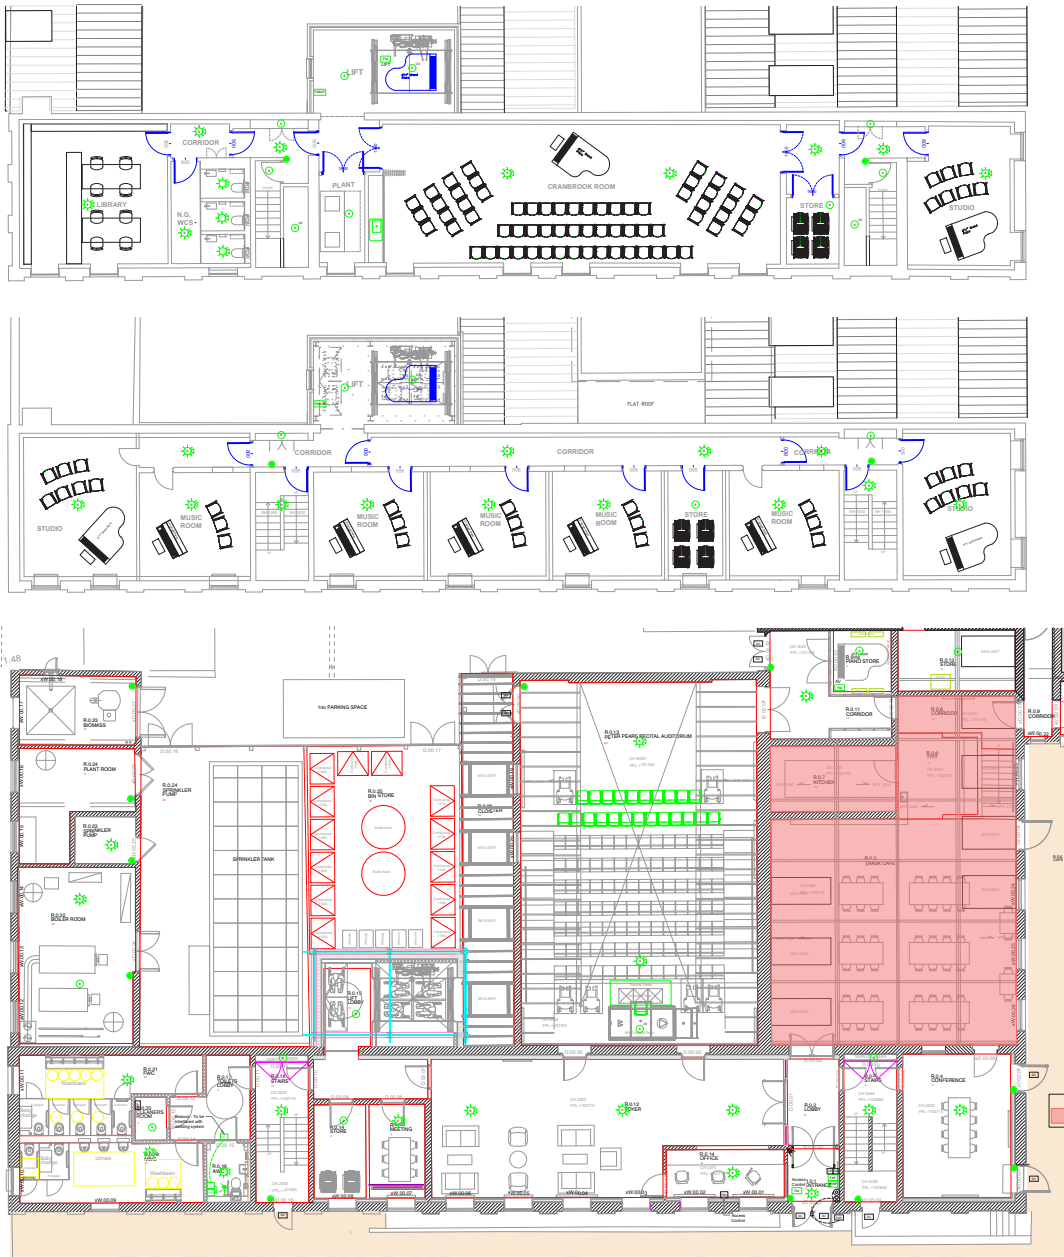
The existing analogue addressable fire alarm system shall be modified to suit the new layout with a minimum category L1 fire detection and alarm system to BS5839-1:2017. A new addressable fire alarm system shall be installed throughout the building and shall be networked to the site wide system.

The sprinkler tank which serves the Concert Hall will require relocation to a new position to suit the new lift installation. This will require a new tank installation with storage volume in the region of 135m<sup>3</sup> -180m<sup>3</sup>. The tank will need to be sectional, with structural base and supports to structural engineer's details. The tank will require repositioning of all pipework including mains water inflill, sprinkler outlet pipework. The lack of secondary/back up power supply to the sprinkler is to be rectified. All sprinkler works will need to be designed and specified by a sprinkler specialist.

The new lift will also function as an evacuation lift. This will require an alternative supply in compliance with BS9999. A new standby generator is proposed for the lift. The lift shall be supplied via an ASCO automatic changeover switch to ensure continuity of supply.

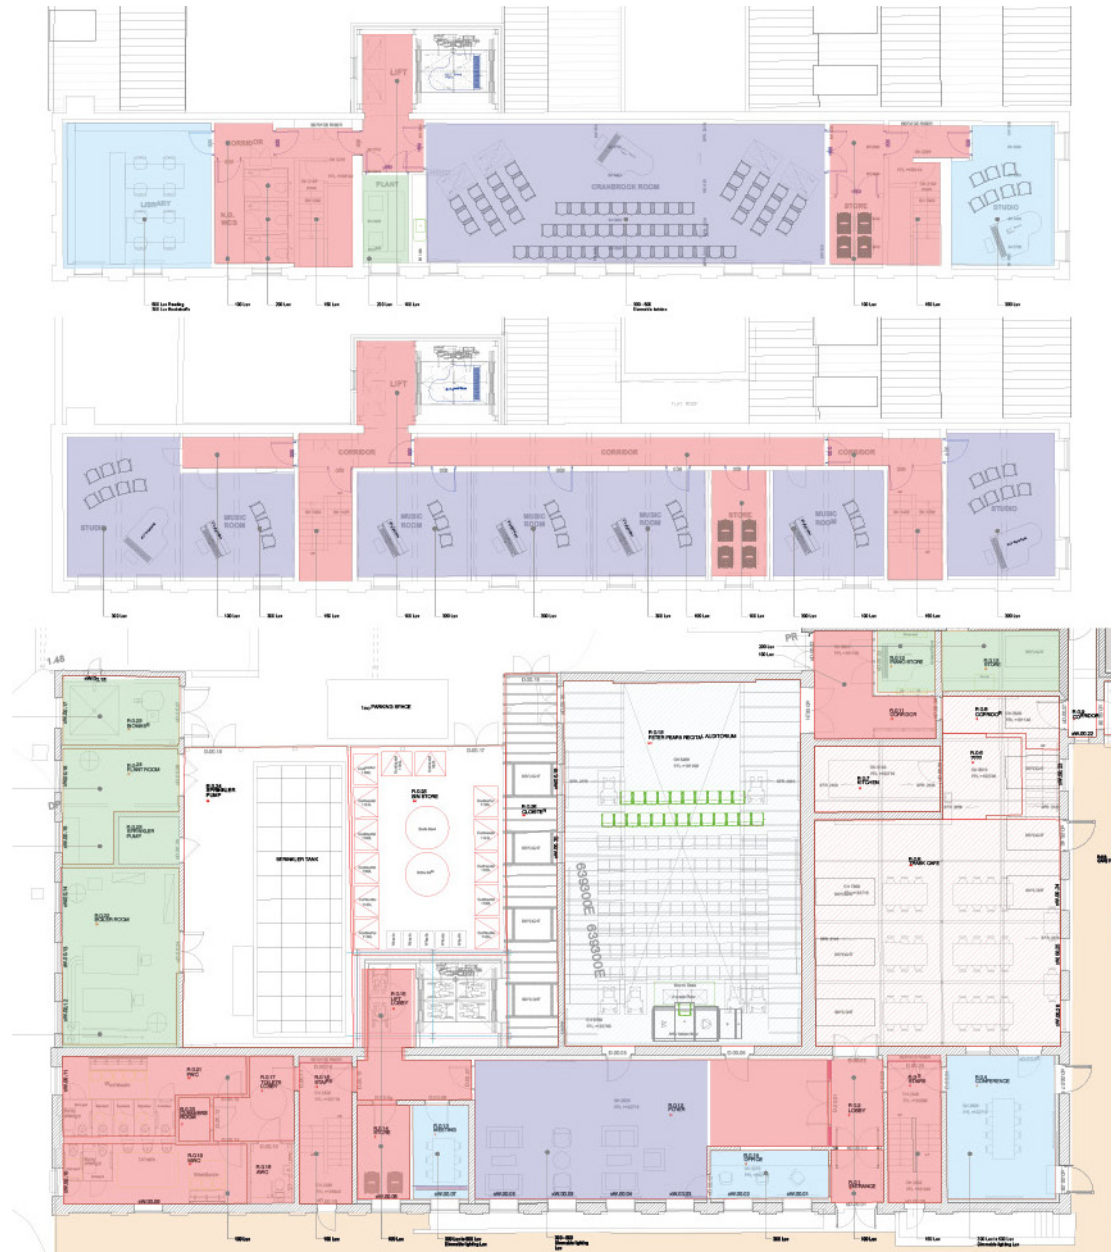
The lighting to escape routes throughout the building will be controlled via occupancy sensors, as per the existing strategy.

Emergency lighting shall be provided throughout the area of works comprising of standalone and integral LED manual/self-test emergency luminaires in accordance with BS5266. Batteries will have autonomy of at least three hours. The testing of emergency luminaires will be key-switched facility where required manually.
