Designers Risk Assessment

Date:	20/06/19	
Project Code:	02458	
Document Number:	901-02458-P01	
Assessment Coverage:	Glynn Weir

The WRT are seeking to improve fish and eel passage over Glynn Weir on the river Fowey, near Bodmin. The proposed solution seeks to install a gravity eel pass and Larinier fish pass to the existing structure.

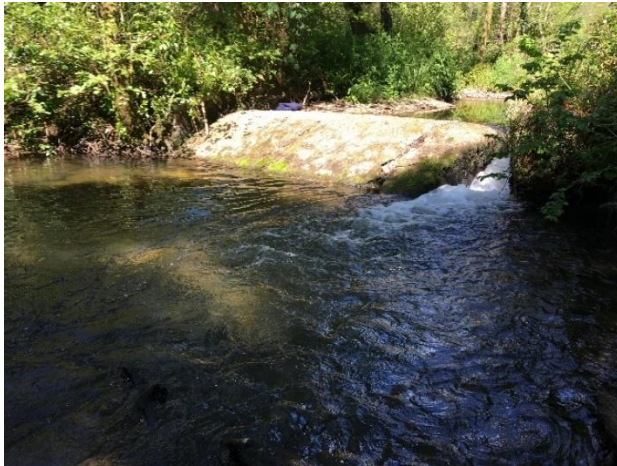
Figure 1 Glynn Weir, looking upstream (left), General Arrangement of works (right)
