# Specification for Path along the River Coln, Fairford December 2018 V5

## 1. Background

Fairford Town Council would like to upgrade the existing footpath running to the north of the River Coln to a standard suitable for disability access.

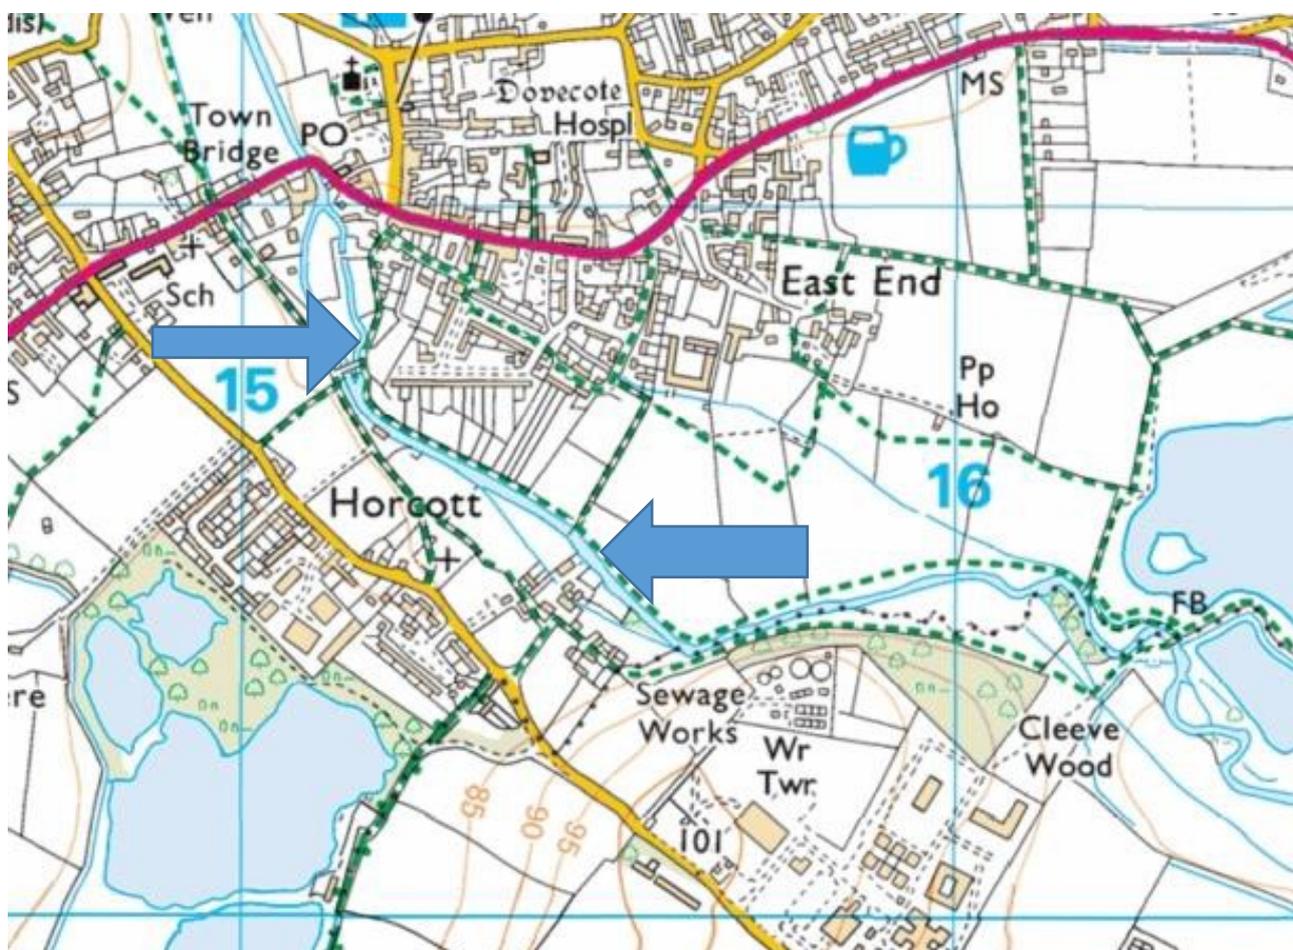
The existing path starts to the north at OS Grid Ref 152009 to 154005, the new path will be located on top of the existing path and then also an additional section slightly further along the river bank which extends the path to OS Grid Ref 155005, this extends the path along the existing right of way to a seating area overlooking the river. Path to be developed is approximately located between the two blue arrows.

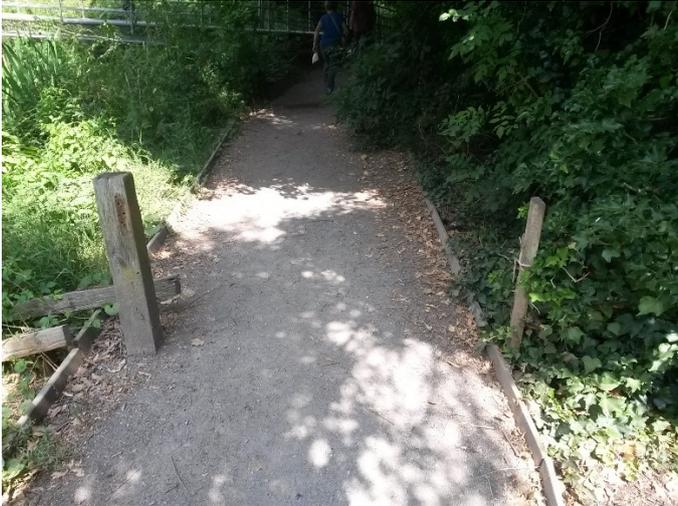
The path starts at the Fairford town end of Dilys Bridge. Cross sections of the river marked as Section 1 and 2 are available at this point. This section of path should follow the existing path alignment and width already bordered by timber edge. Obstructing post as per photo below to be removed.

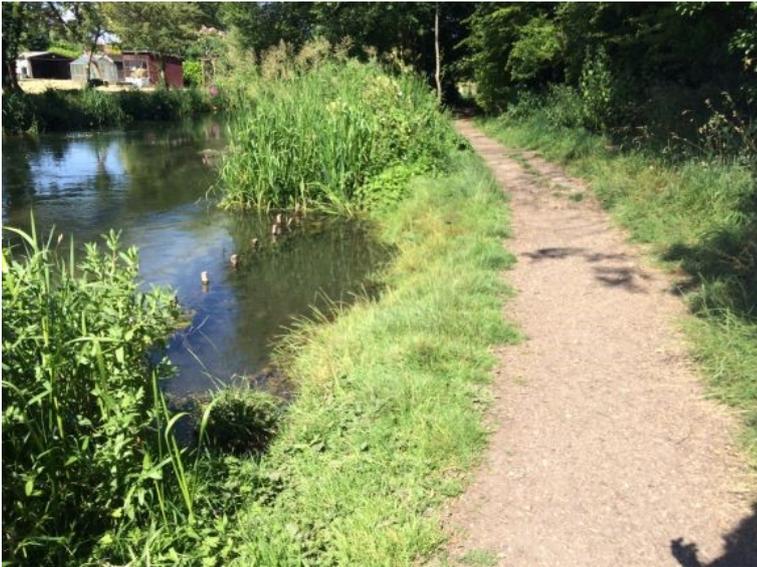
Repair work to the bank approx. 9m in length is required using a combination of plug planting which should comprise emergent vegetation typical of the existing vegetation such as reed sweet grass and yellow flag and Coir Fibre roll. Use Coir roll pre-planted with Water Vole habitat plants such as that supplied by Salix, fixed according to the manufacturer's instructions in a double height row. This needs to be protected from trampling and also grazing by wild fowl.

The repair work must be securely fastened to the bank at both ends to prevent erosion behind the works. To create good water vole habitat the Coir rolls need to be staked along the line of the existing faggots and back filled behind to create a bank face with a steep profile ideally 1:1 and then this should be levelled off at bank height. When finished the height of the bank repaired shall not exceed the height of the bank on either side of the works.

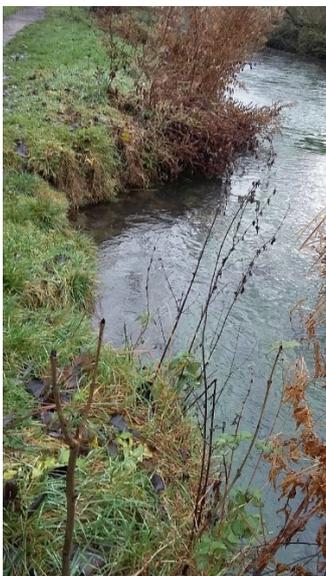
There is a likelihood of damaging burrows, to displace voles vegetation here needs to be trimmed in advance of path work. A section of bank less than 50m in length will require vegetation trimming, the exact location and length to be determined by the on-site Ecologist. Coir roll bank repair required of length 5m location at section 7 as below photo.

Repair work to the bank is required to establish a fringe of emergent vegetation along the river bank. There are three locations where Coir Rolls are required to restore the bank, these are along the line of the existing faggots/ wooden posts on sheet 4, a length on sheet 6 (adjacent to river cross section 7) and at a location close to the existing benches on sheet 9.

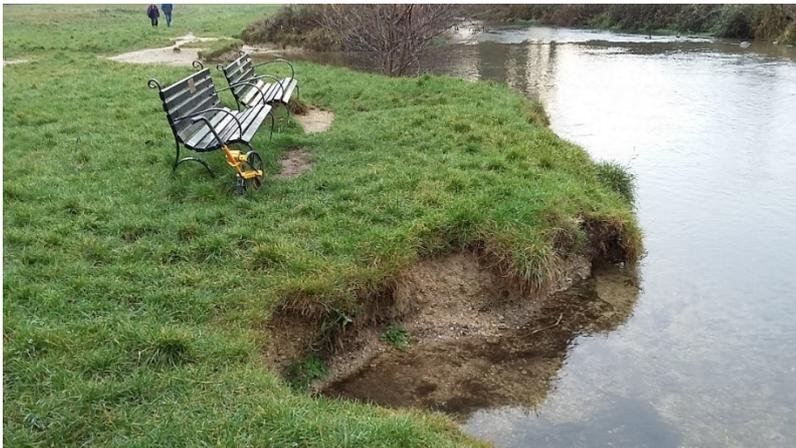
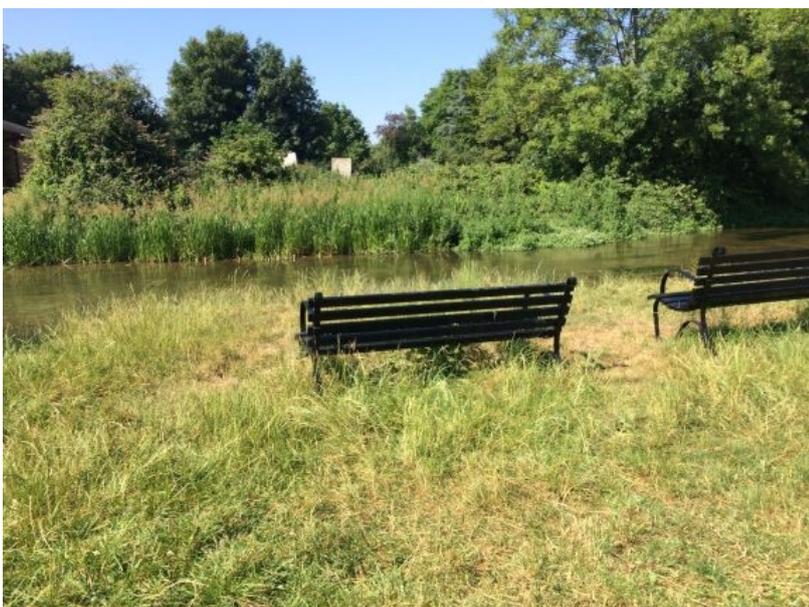
Path to be extended from the end of the existing path to the benches located by the river bank, surfaced area of compactible gravel to be constructed as per the path to be laid extending 1.5m in front of the benches and 1m to the sides and rear of the benches.

Bank stabilization work required using Coir rolls immediately up stream of the benches, approx. length of repair 5m.
